FACILITY CONDITION ASSESSMENT

Becker ES | February 2022

Executive Summary

Becker ES is located at 906 W Milton St in Austin, Texas. The oldest building is 84 years old (at time of 2020 assessment). It comprises 59,669 gross square feet.

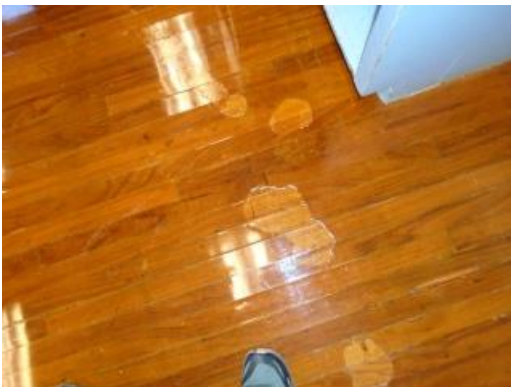
Damaged wood flooring

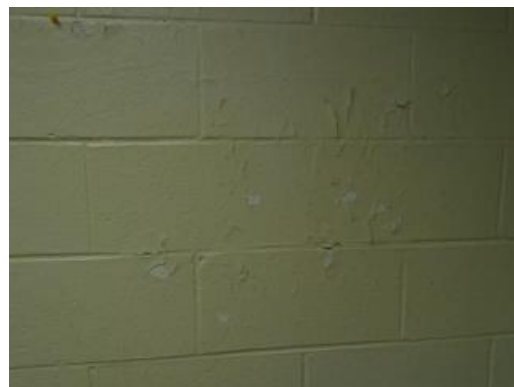
Peeling wall paint

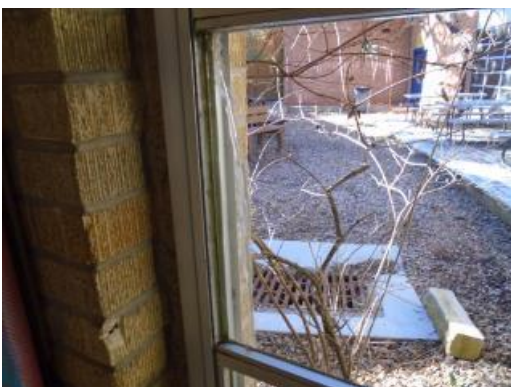
Aged aluminum windows

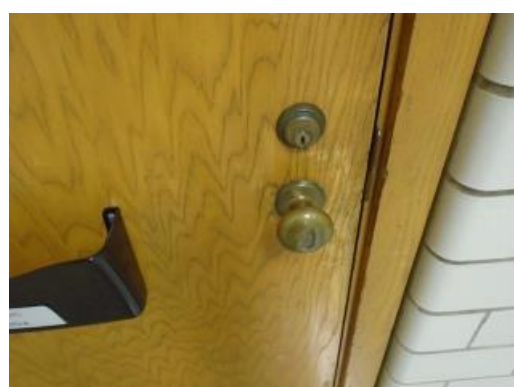
Outdated door hardware

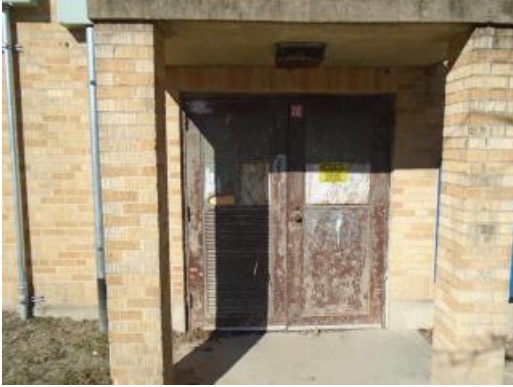
Exterior doors beyond useful life

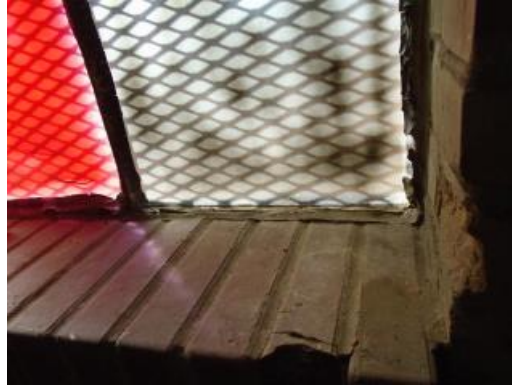
Deficiency	Category	Qty	UoM	Priority	Repair Cost	ID
Steel Window Replacement	Capital Renewal	72	SF	2	\$10,407	922
Note: Rusted frames, windows are broken and boarded up.						
Wood Exterior Door Replacement	Capital Renewal	2	Door	2	\$6,327	923
Brick Exterior Repointing	Deferred Maintenance	100	SF Wall	3	\$1,272	1314
Location: All corners of the building						
Exterior Cleaning	Deferred Maintenance	498	SF Wall	5	\$1,929	1315
Location: All exterior walls						
Sub Total for System		4	items		\$19,934

Windows at the mechanical building are beyond their useful life

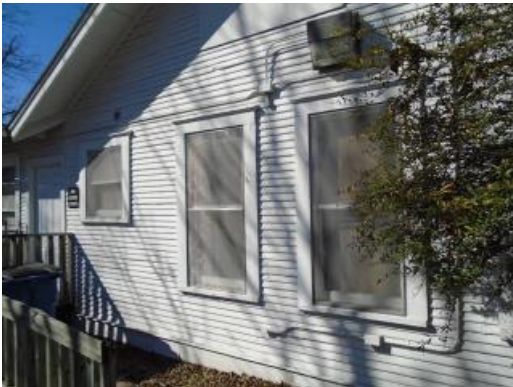
Exterior Windows are beyond their useful life

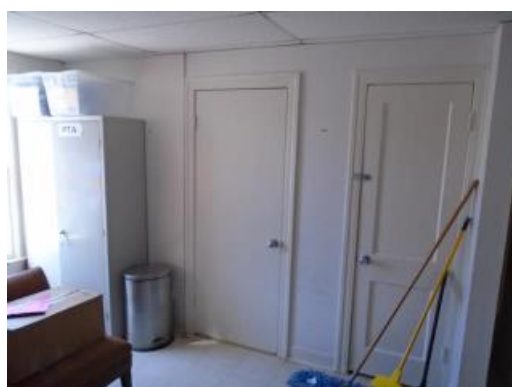
Interior Doors are aged

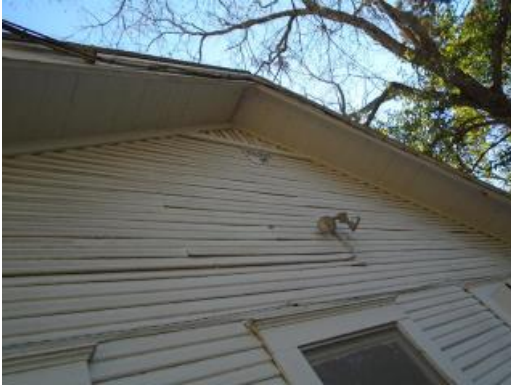
Exterior wood siding is at the end of its useful life

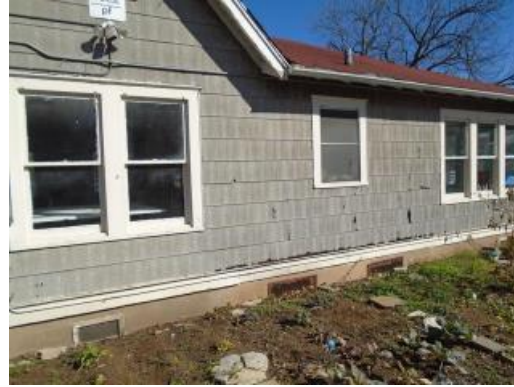
Exterior windows are beyond their useful life

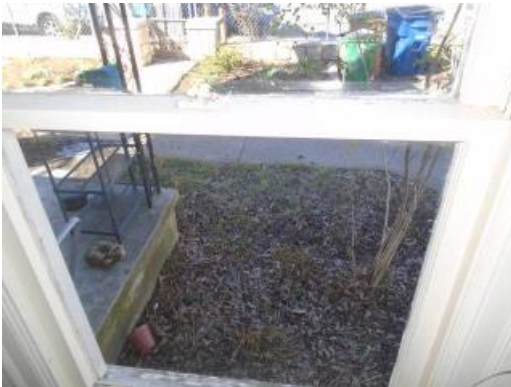
The exterior windows are beyond their useful life.

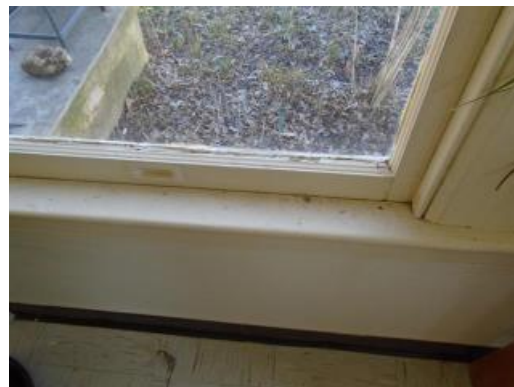
The exterior windows are beyond their useful life.

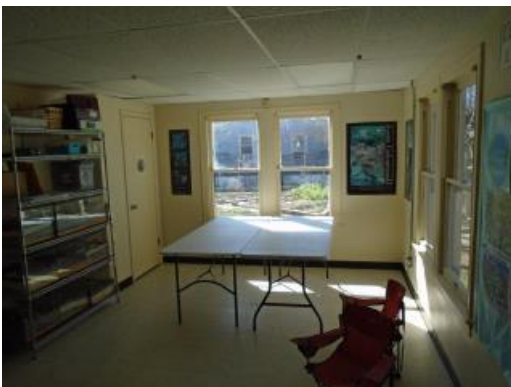
Interior finishes are worn and outdated.

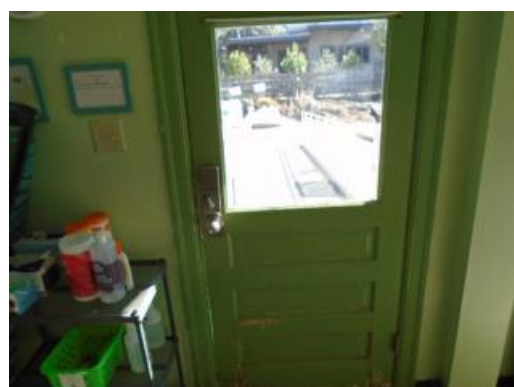
Exterior doors are beyond their useful life.
