FACILITY CONDITION ASSESSMENT

Burnet MS | February 2022

Executive Summary

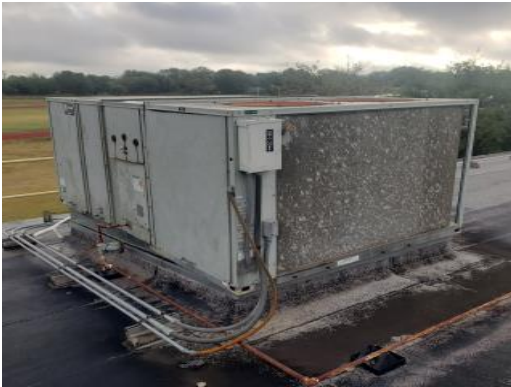
Condensing unit reaching end of life

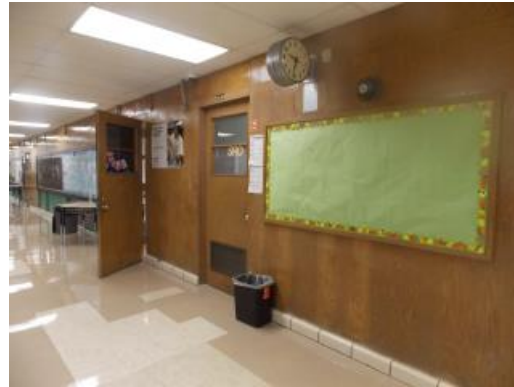
Worn wood panel and door

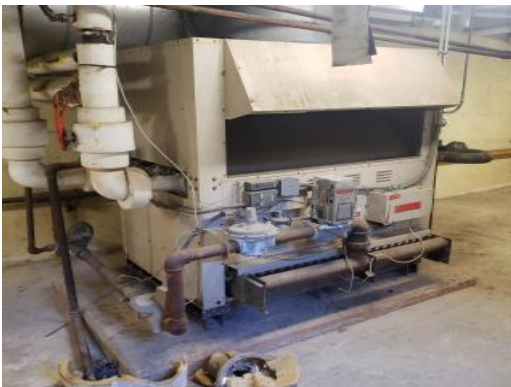
The basement boiler is beyond its useful life

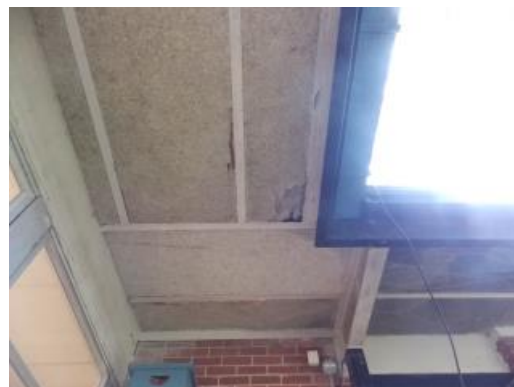
The soffit is damaged

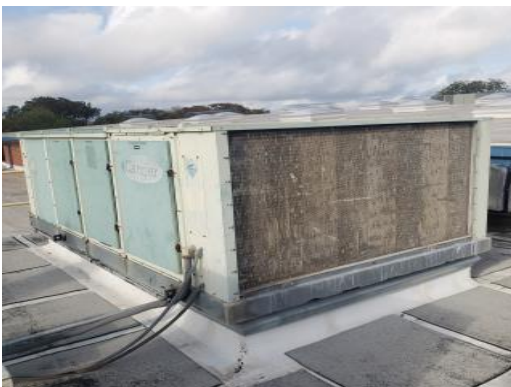
Roof top unit is beyond its useful life
