FACILITY CONDITION ASSESSMENT

Central Office Building | February 2022

Central Office Building - Deficiency Summary

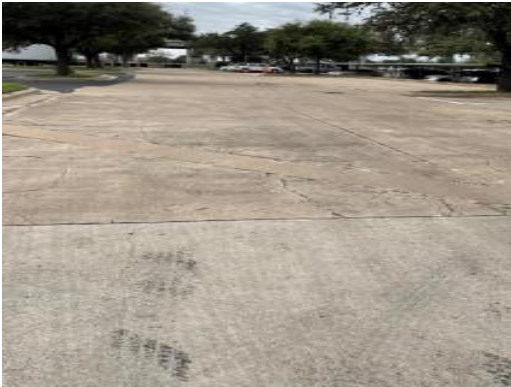
Concrete Drive

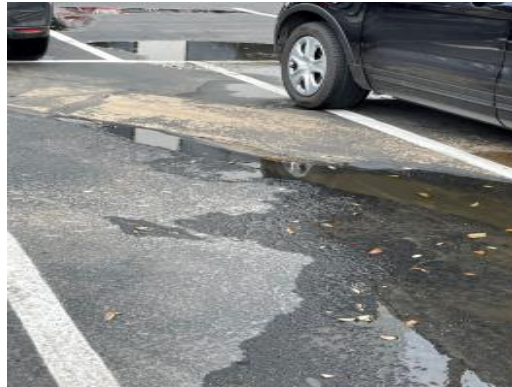
Ponding Asphalt

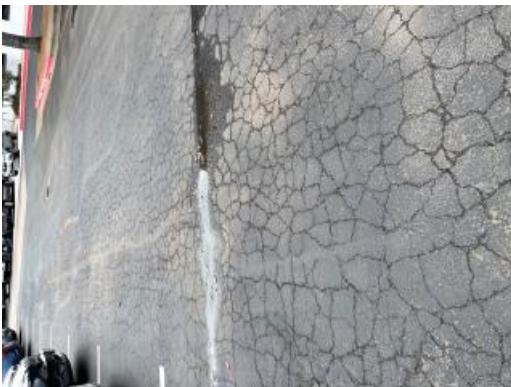
Damaged asphalt

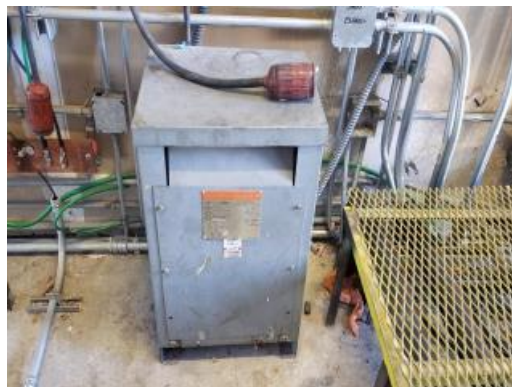
Aged transformer

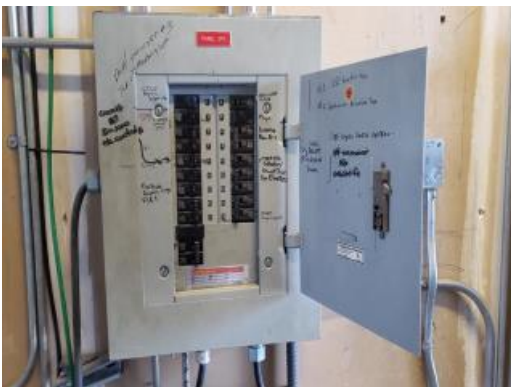
Aged Electrical Panel
