# FACILITY CONDITION ASSESSMENT

*Clifton Center* | February 2022

Clifton Center is located at 1519 Coronado Hills Dr in Austin, Texas. The oldest building is 43 years old (at time of 2020 assessment). It comprises 38,134 gross square feet.

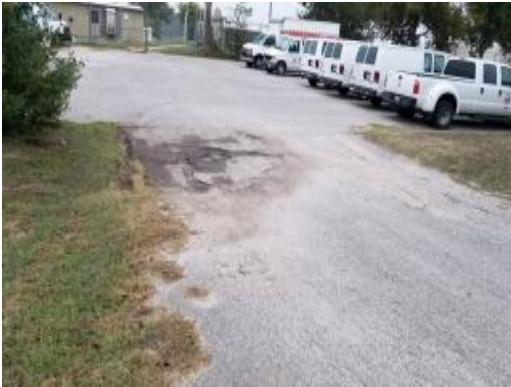
Broken pavement

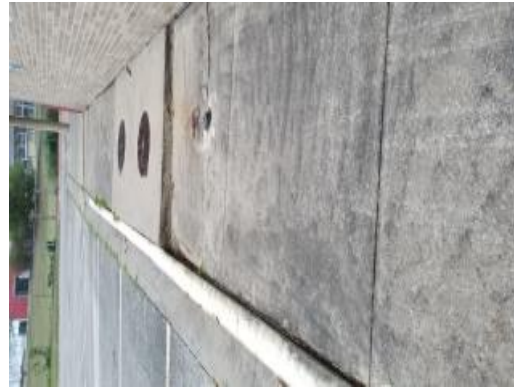
Sidewalk subsidence

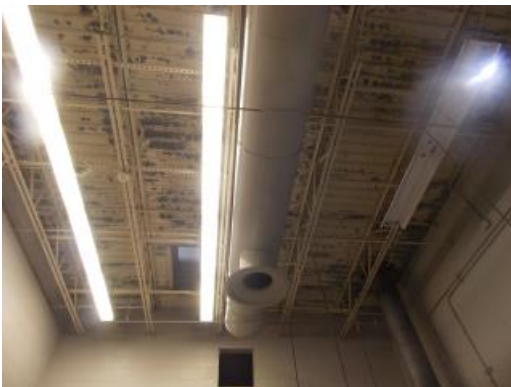
Corroded decking

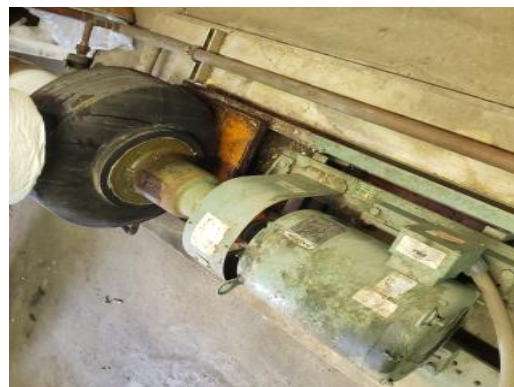
Corroded chilled water pump

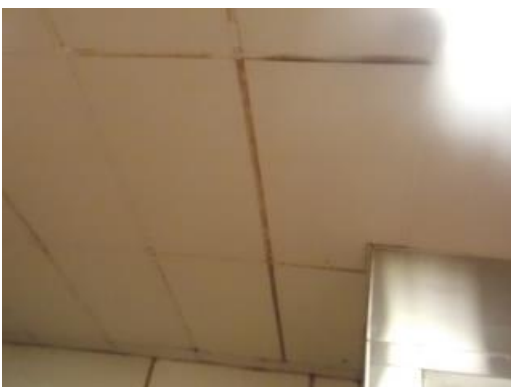
Corroded ceiling suspension ceiling grid.
