FACILITY CONDITION ASSESSMENT

Cowan ES | February 2022

Building: 183A - Main building includes Administration Offices, Classrooms, Cafeteria, & Gym.

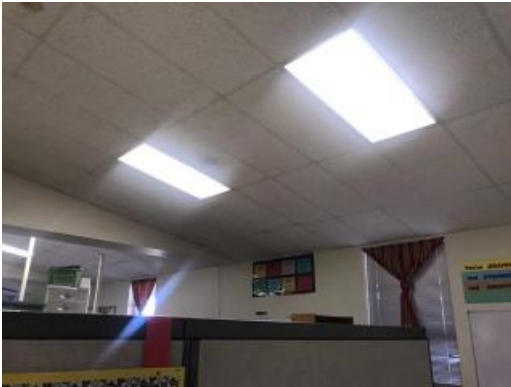
Aged acoustical ceiling tile

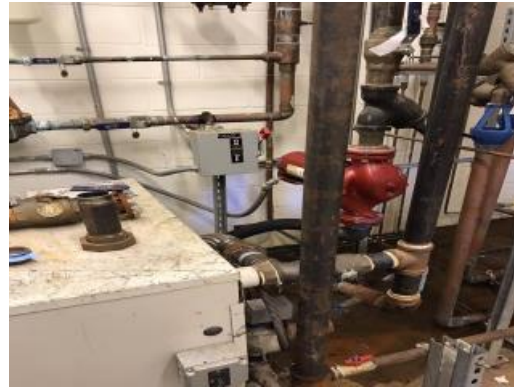
Aged boiler and heating water pipes

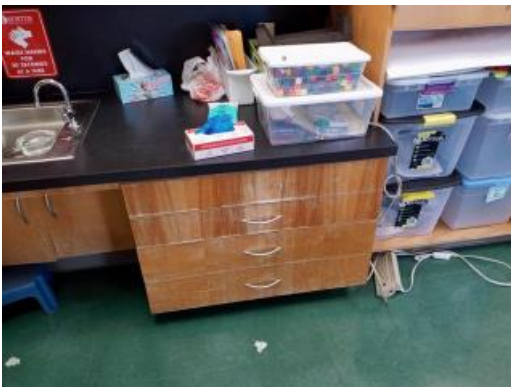
Damaged casework

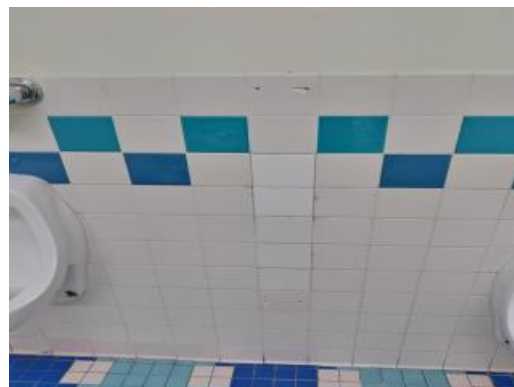
Damaged ceramic tiles

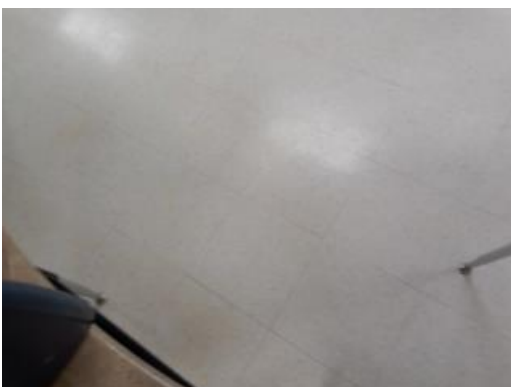
Vinyl composition tiles past useful life

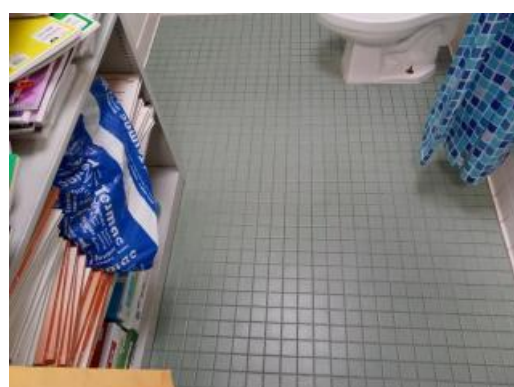
Aged floor ceramic tiles

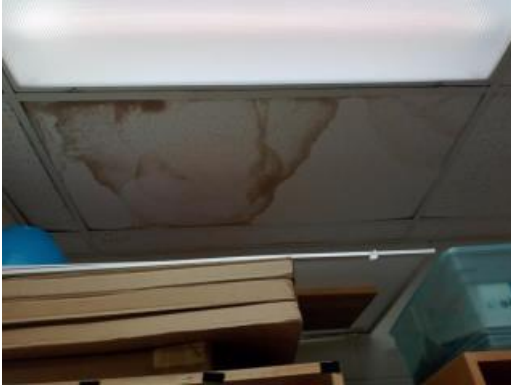
Stained ceiling tiles
