FACILITY CONDITION ASSESSMENT

Harris ES | February 2022

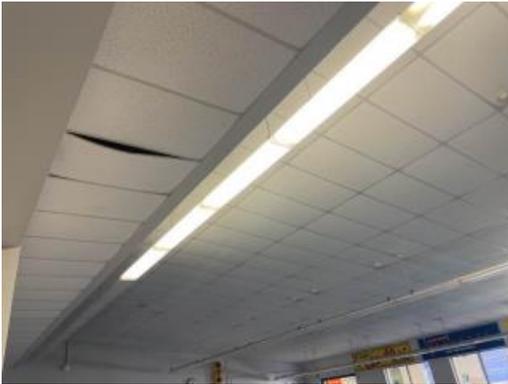
Sagging cafeteria ceiling grid and tiles

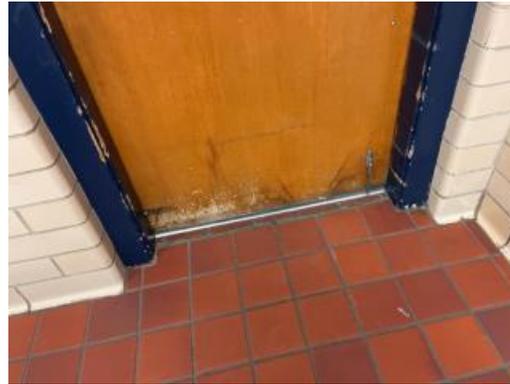
Damaged wood kitchen door

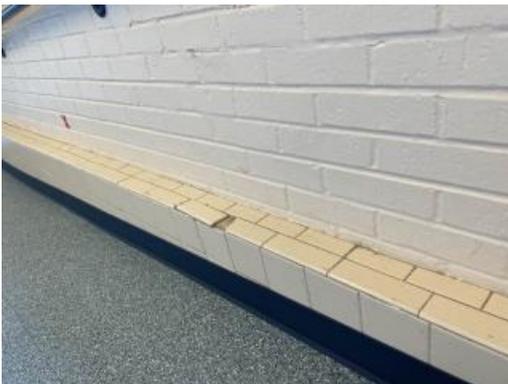
Cracked and damaged ADA ramp wall tile

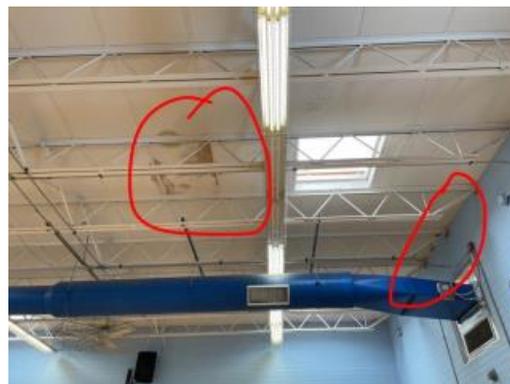
Water damage on gym ceiling

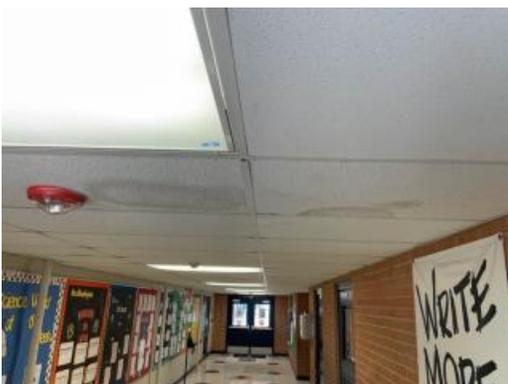
Stained acoustic ceiling

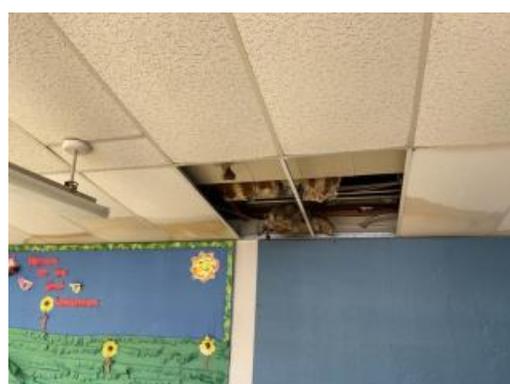
Water damage on acoustic ceiling tile

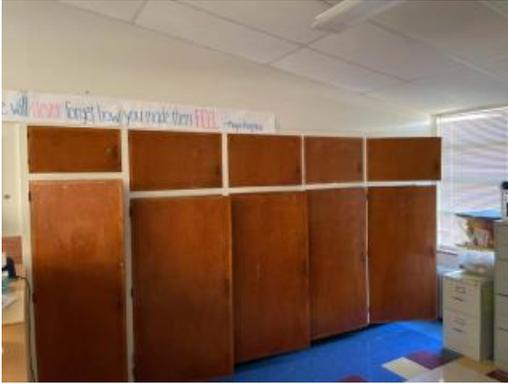
Classrooms casework needs refinishing

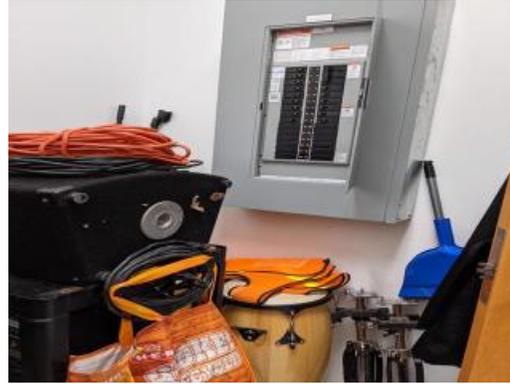
Obstructed electrical panel

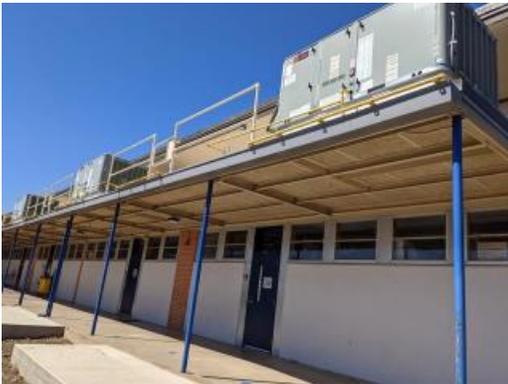
Covered walkway has air handling units overhead and is dangerous
