# FACILITY CONDITION ASSESSMENT

*Kiker ES* | February 2022

### Building: 180A - Main building includes Administration Offices, Classrooms, Cafeteria, & Gym.

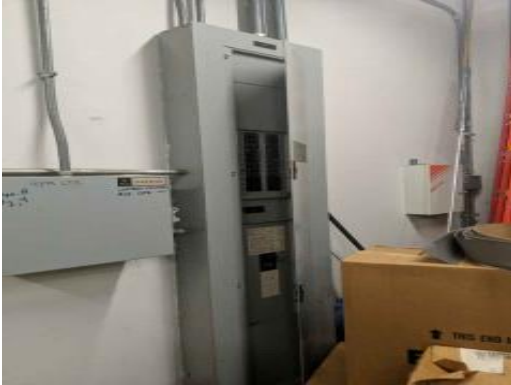
Electric Panel is hard to reach

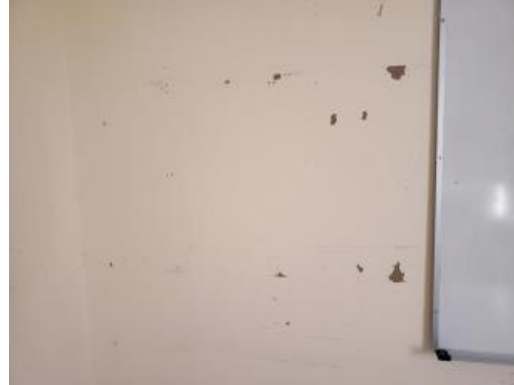
Wall finishes present scuffing

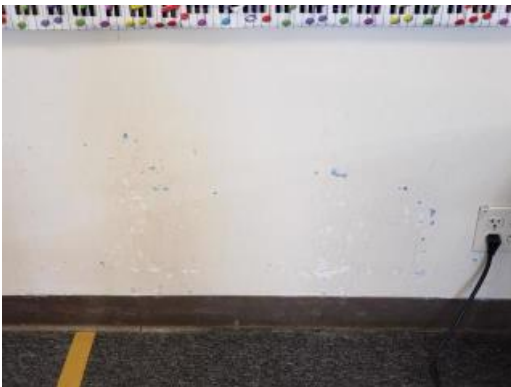
Wall is worn and aged

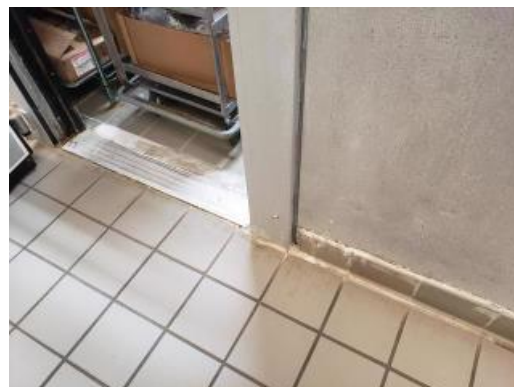
Over caulking on tile baseboards

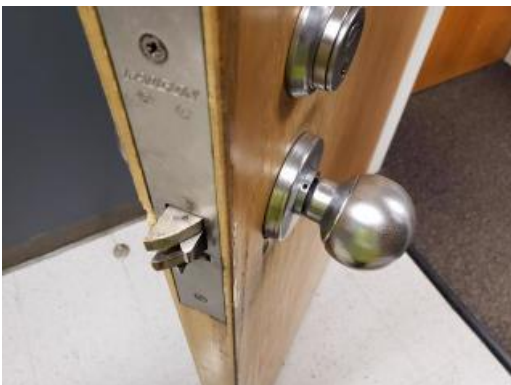
Door hardware is not accessible

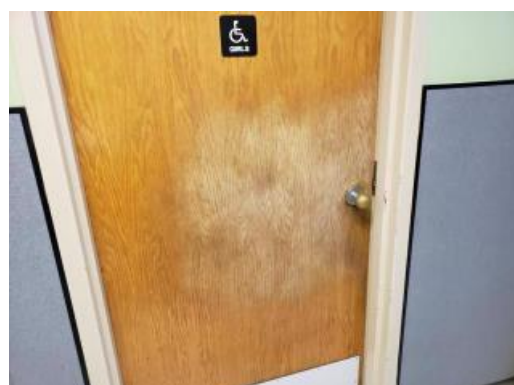
Interior wood doors showing ware.

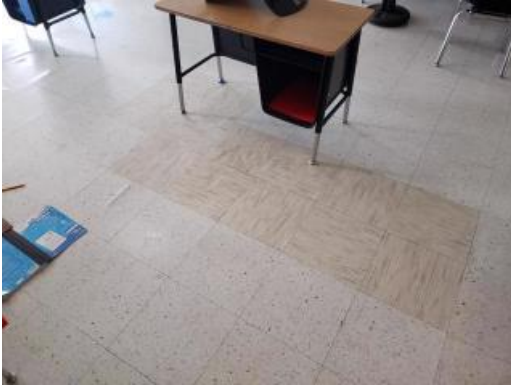
Vinyl composite tile flooring is patched and at the end of its useful life.

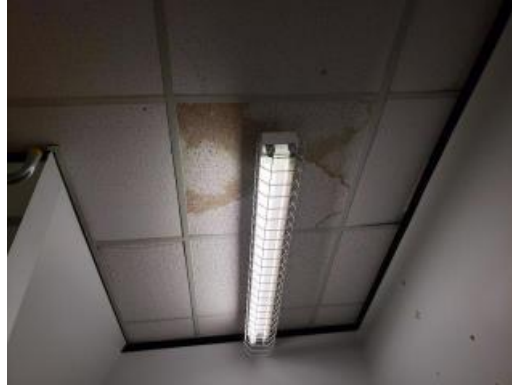
Stained ceiling tiles.

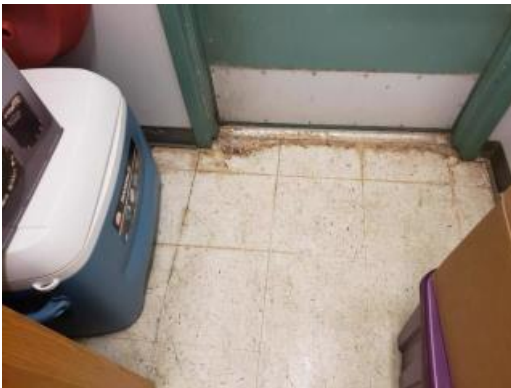
Stained floor tiles
