FACILITY CONDITION ASSESSMENT

Linder ES | February 2022

Linder ES is located at 2800 Metcalfe Rd. in Austin, Texas. The oldest building is 48 years old (at time of 2020 assessment). It comprises 69,827 gross square feet.

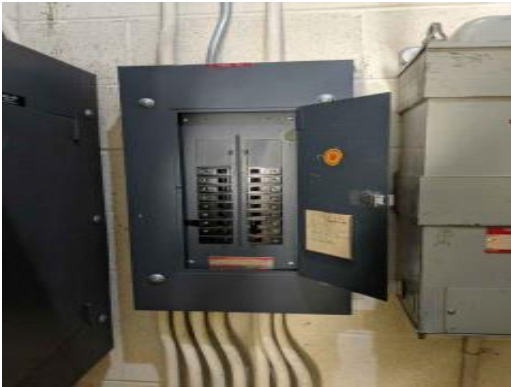
Electrical panel at end of life

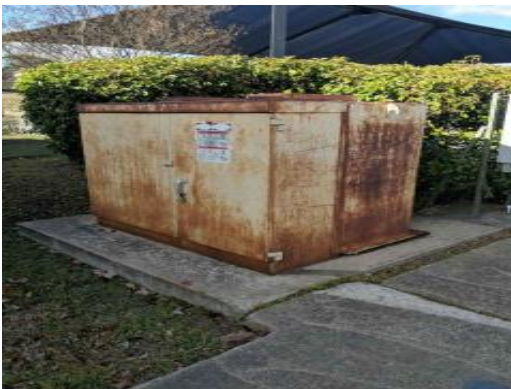
Rusted transformer on northwest side

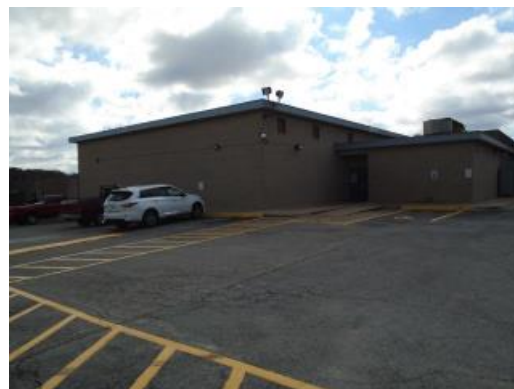
Cracked parking lot asphalt pavement

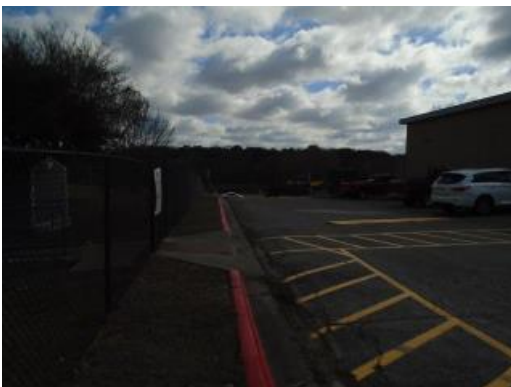
Parking lot asphalt pavement

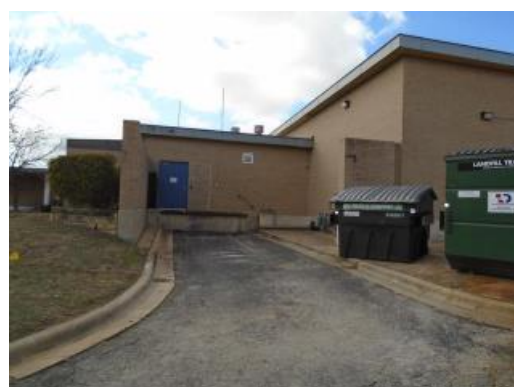
Loading dock pavement

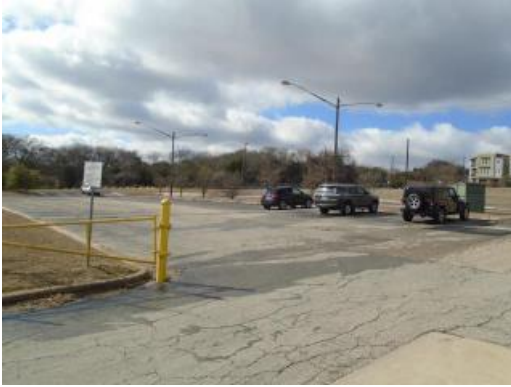
Parking lot pavement
