# FACILITY CONDITION ASSESSMENT

*Maplewood ES* | February 2022

Maplewood ES is located at 3808 Maplewood Ave in Austin, Texas. The oldest building is 69 years old (at time of 2020 assessment). It comprises 45,389 gross square feet.

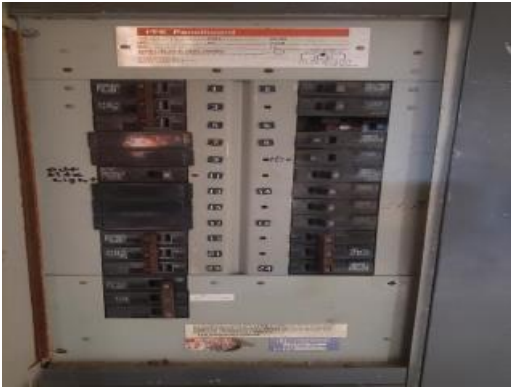
Electric distribution panel beyond its useful life

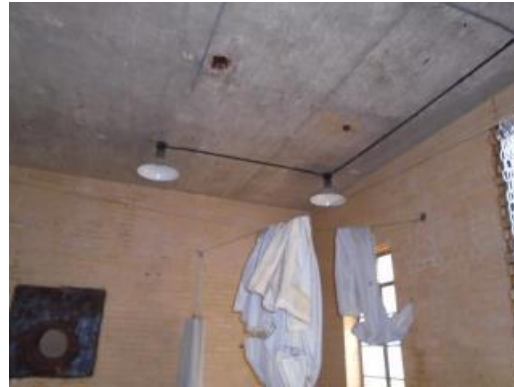
Exposed ceiling

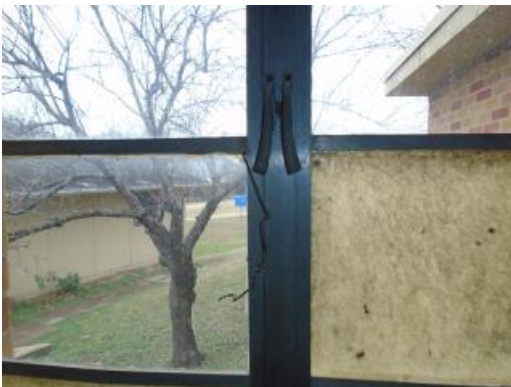
Single pane window is aged

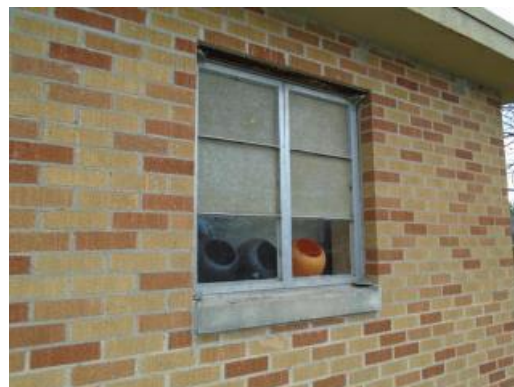
Exterior aluminum windows are past useful life

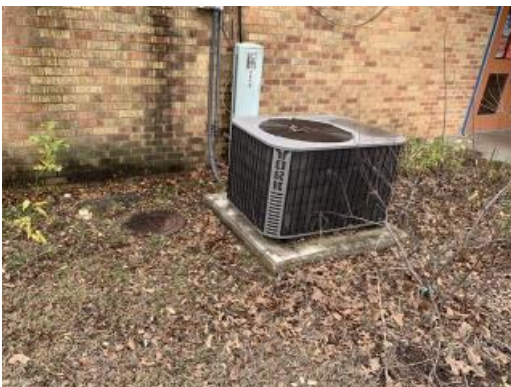
DX unit beyond its useful life

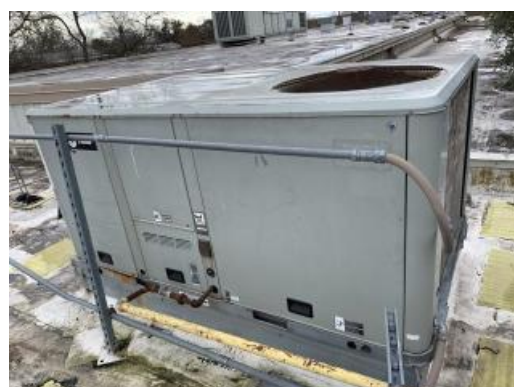
Roof top unit is aged

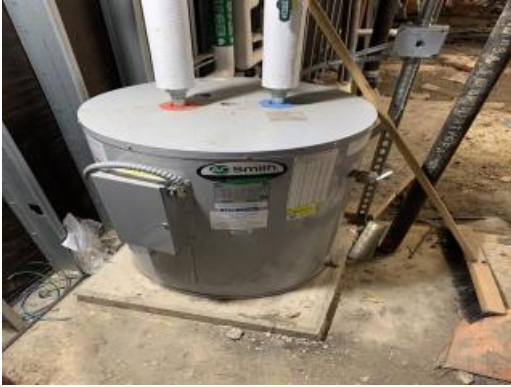
Water heaters are reaching the end of their useful life

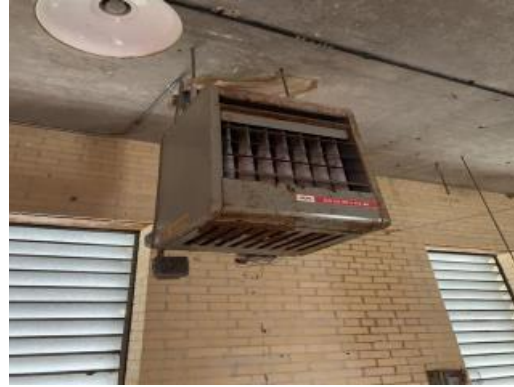
Electric unit heaters are beyond their useful life

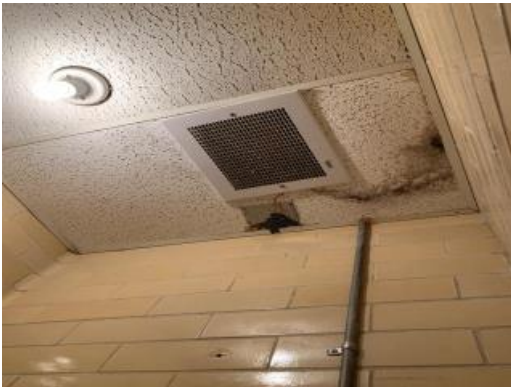
Ceiling tile is damaged
