FACILITY CONDITION ASSESSMENT

Murchison MS | February 2022

Executive Summary

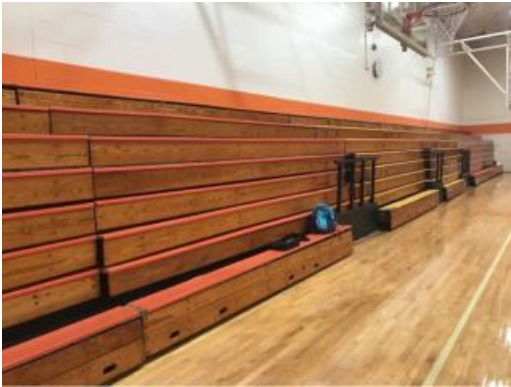
Gym bleachers beyond service life and reported safety issues

Deficiency	Category	Qty	UoM	Priority	Repair Cost	ID
Bleacher Replacement	Capital Renewal	500	Seat	4	\$206,554	4653
Sub Total for System		1	items		\$206,554	
Sub Total for Building 052A - Main building includes Administration Offices, Classrooms, Cafeteria, & Gym.		5	items		\$1,852,797

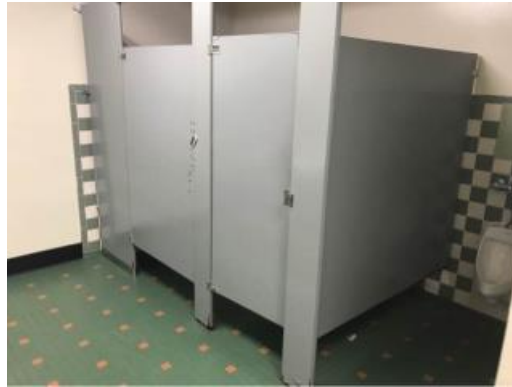
Restroom partitions rusted and damaged

Deficiency	Category	Qty	UoM	Priority	Repair Cost	ID
Toilet Partition Replacement	Capital Renewal	6	Stall	4	\$12,099	4654
Sub Total for System		1	items		\$12,099	
Sub Total for Building 052B - Stand-Alone Classroom Building		1	items		\$12,099	
Total for Campus		12	items		\$3,942,182

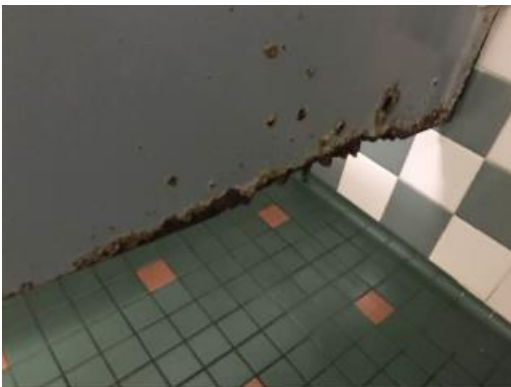
Restroom partitions rusted and damaged

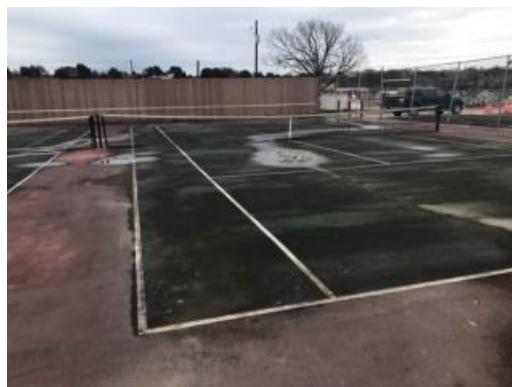
Site tennis courts beyond service life

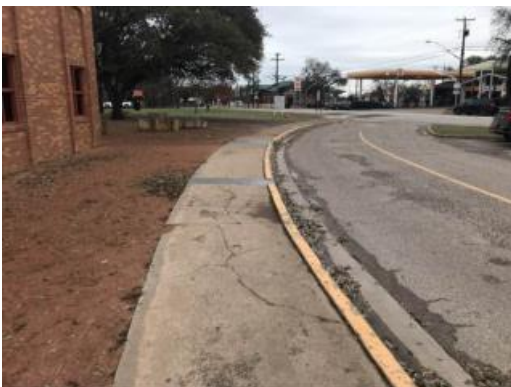
Site sidewalk damage south side

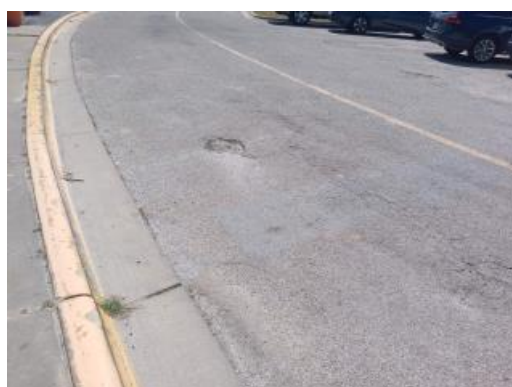
Pavement is cracked

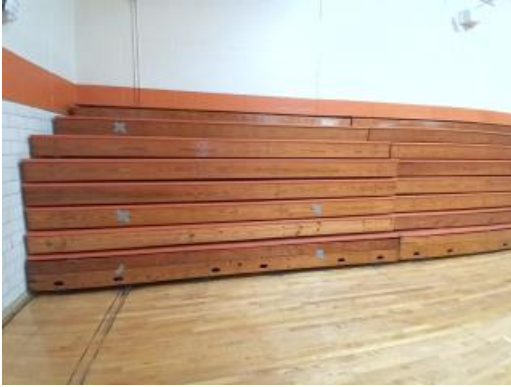
Gym seating is worn
