FACILITY CONDITION ASSESSMENT

Noack Sports Complex | February 2022

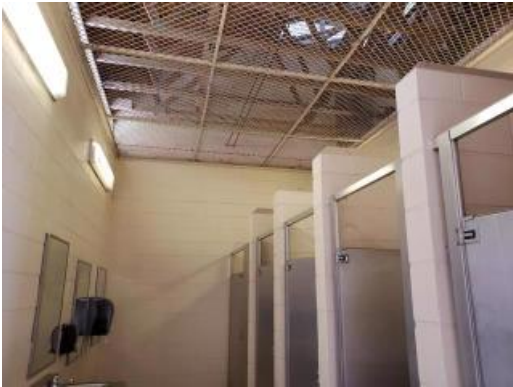
Exposed restroom ceiling

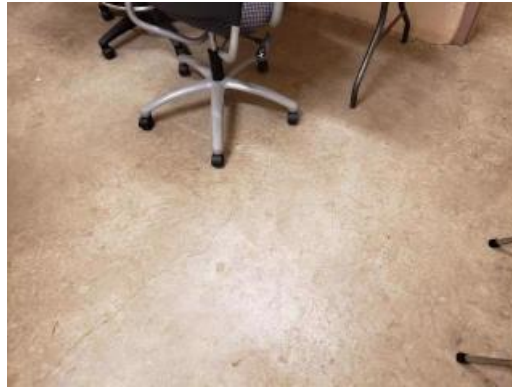
Exposed concrete

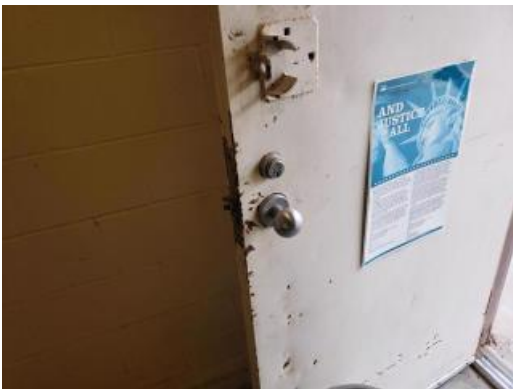
Damaged metal door

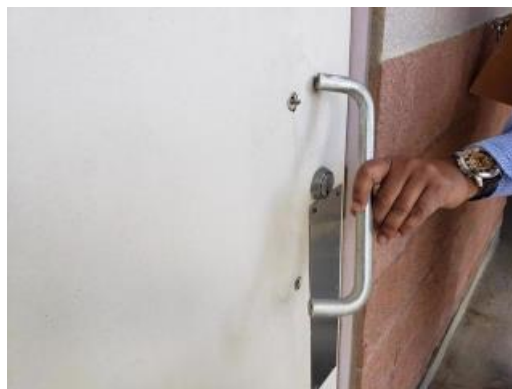
Damaged metal door hardware

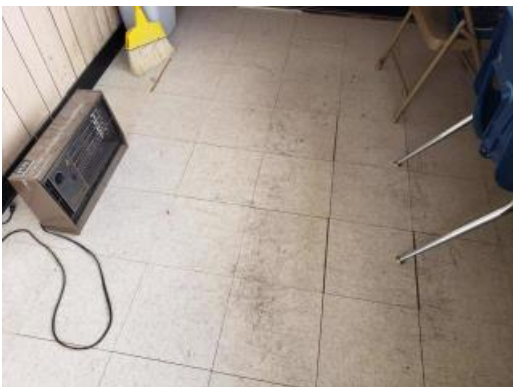
Damaged vinyl composition tiles

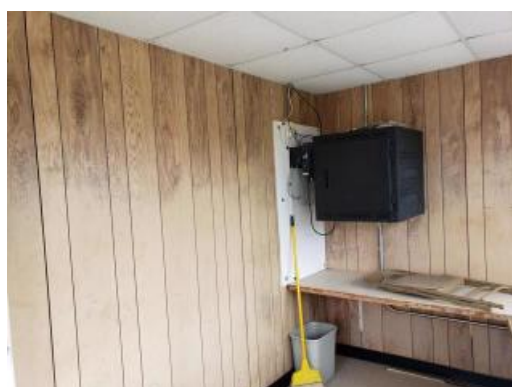
Aged wood panels

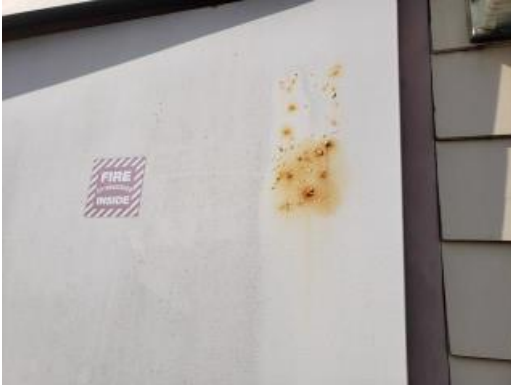
Rusted exterior door
