# FACILITY CONDITION ASSESSMENT

*O. Henry MS* | February 2022

## Executive Summary

O. Henry MS is located at 2610 W 10th St in Austin, Texas. The oldest building is 67 years old (at time of 2020 assessment). It comprises 123,694 gross square feet.

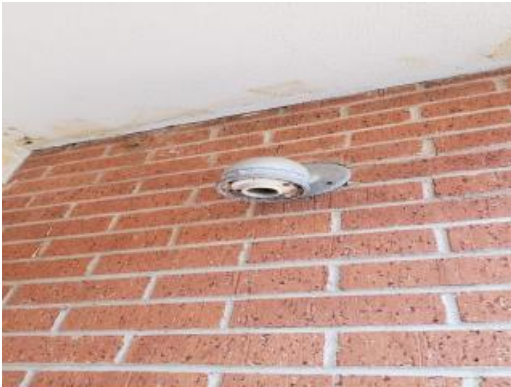
Missing light fixture

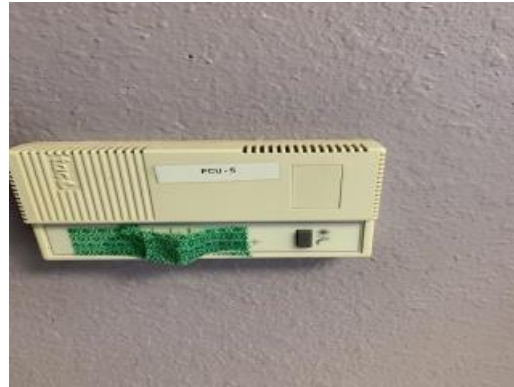
Damaged thermostat

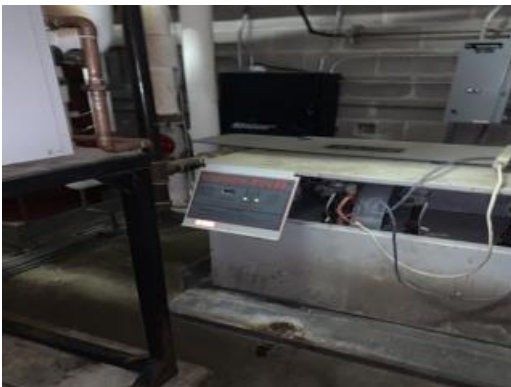
Exposed wiring in mechanical Room

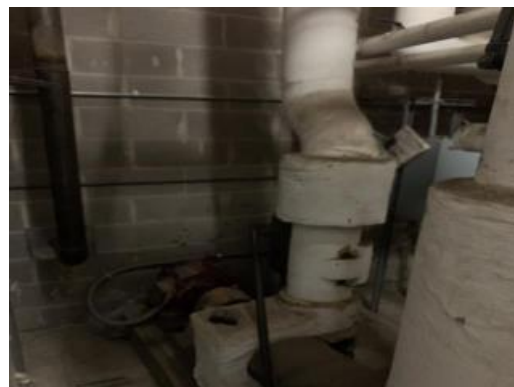
Corrugated pipes

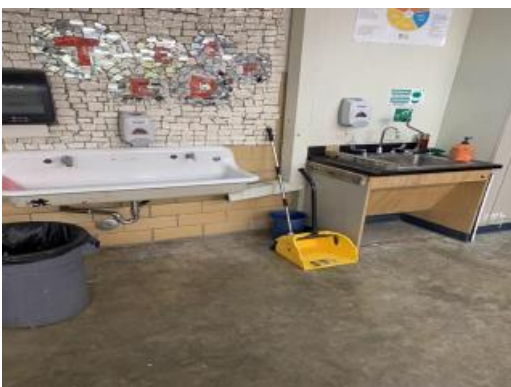
Exposed Concrete

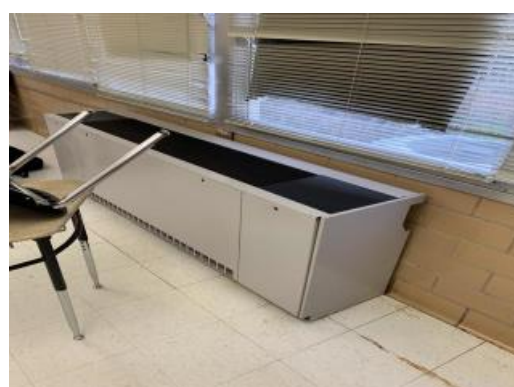
Aged ventilation Unit

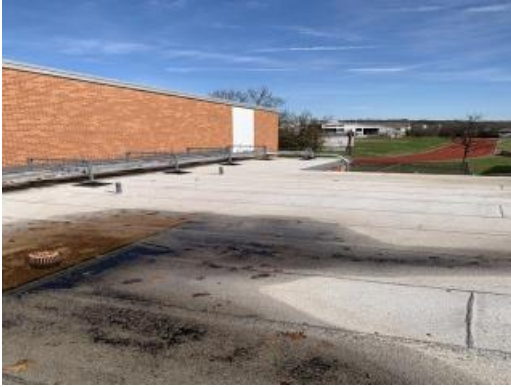
Water pooling will eventually cause serious damage

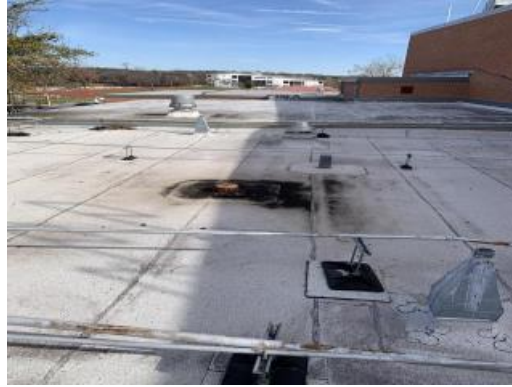
Damaged roof
