FACILITY CONDITION ASSESSMENT

Ortega ES | February 2022

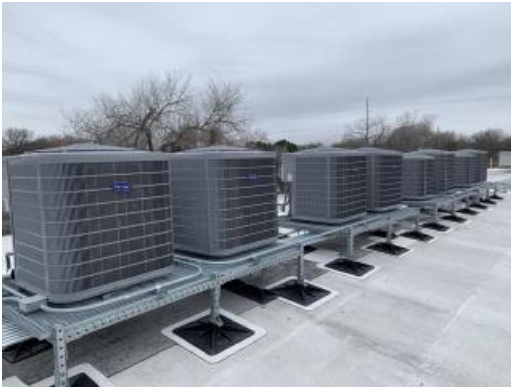
Rooftop Condensers

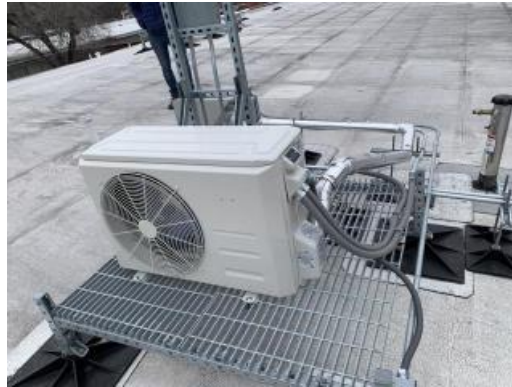
Mini Split Condenser

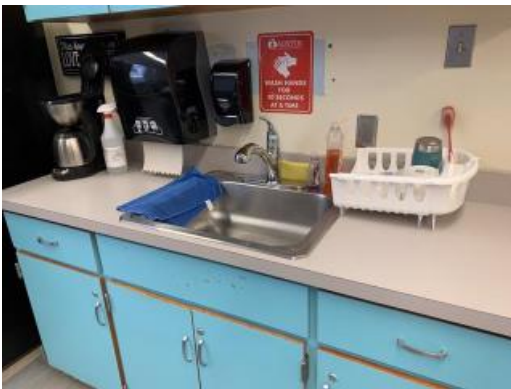
Typical casework

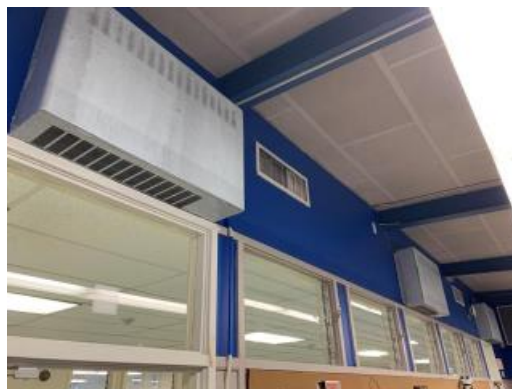
Typical unit ventilator

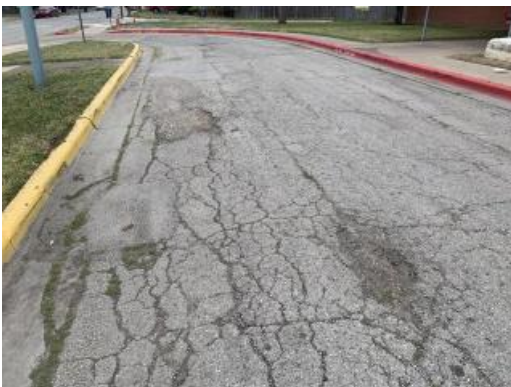
Asphalt Drive shows wear

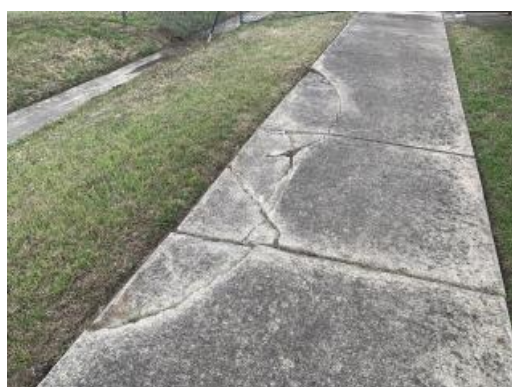
Sidewalks are worn

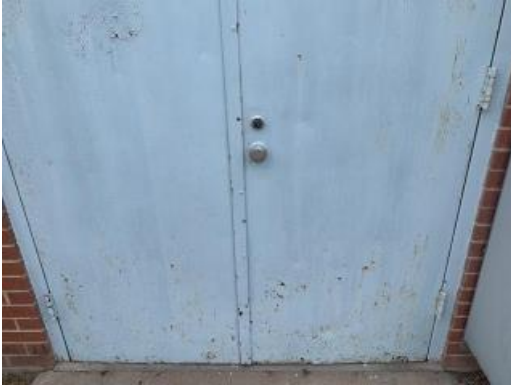
Metal Doors are rusted

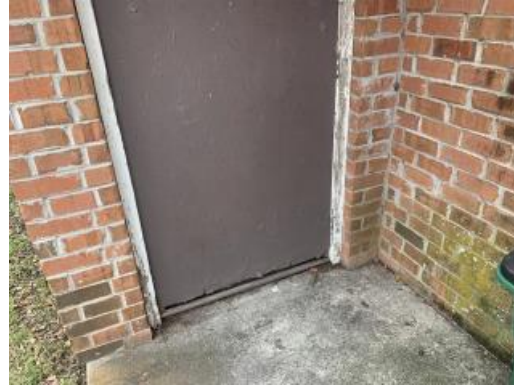
Metal Door chipped at bottom
