# FACILITY CONDITION ASSESSMENT

*Rodriguez ES* | February 2022

Rodriguez ES is located at 4400 Franklin Park Dr in Austin, Texas. The oldest building is 21 years old (at time of 2020 assessment). It comprises 83,037 gross square feet.

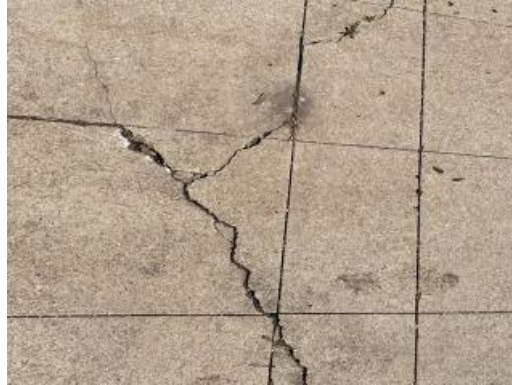
Cracked sidewalk

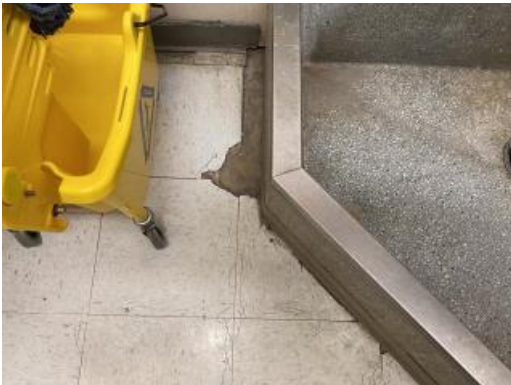
Mop sink is damaged

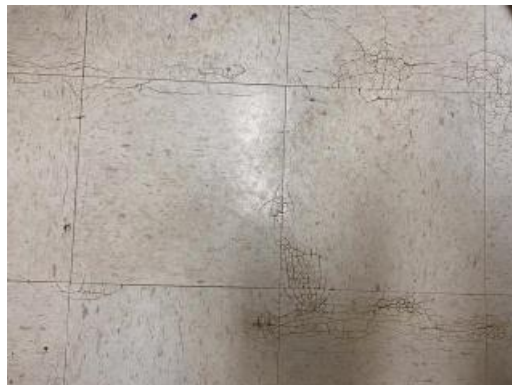
Vinyl composite tile needs replacement

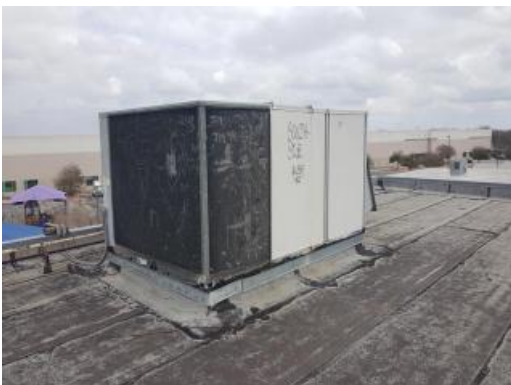
RTU reaching the end of its useful life

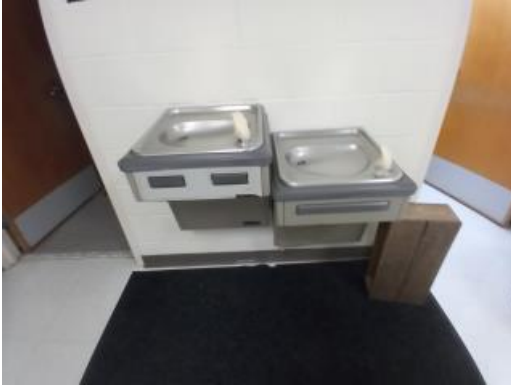
Well used drinking fountain
