FACILITY CONDITION ASSESSMENT

Service Center - Bldg & Grds | February 2022

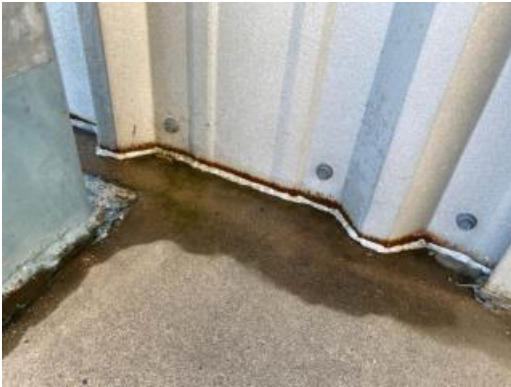
Rusted base of metal panel

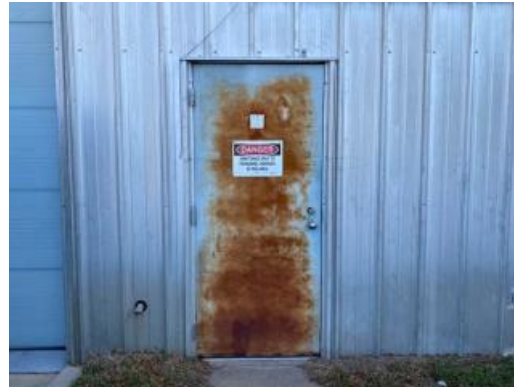
Rusted steel door

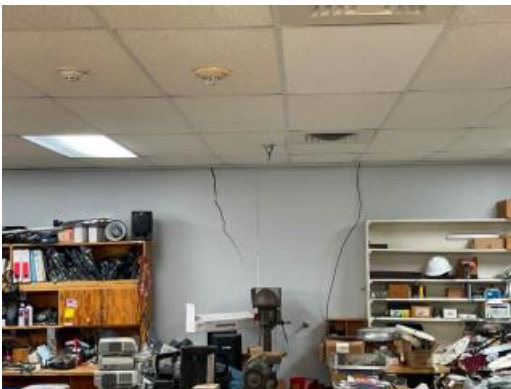
Walls need to be repaired and repainted

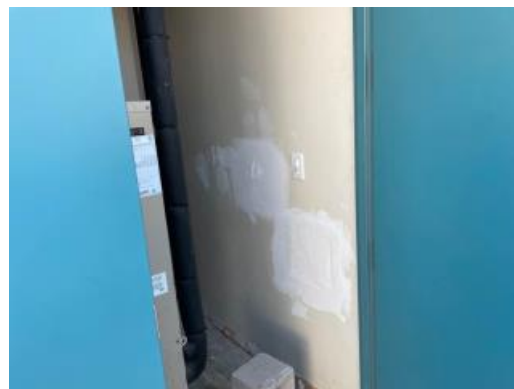
Wall to be repaired and repainted

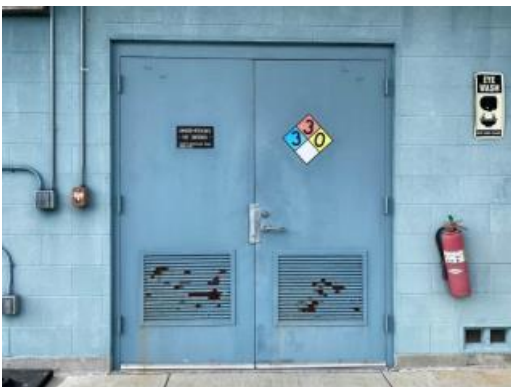
Rusted and sun bleached steel doors

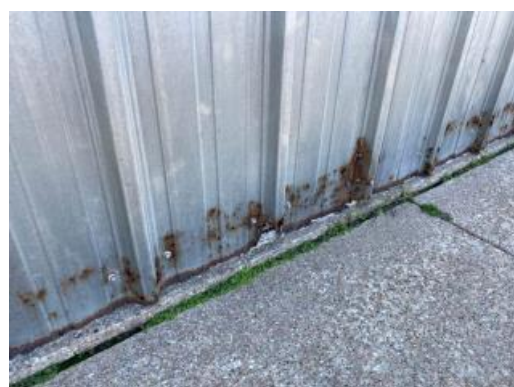
Rusted base of building metal panel

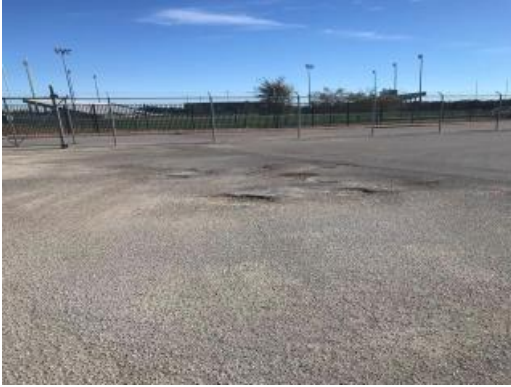
Potholes

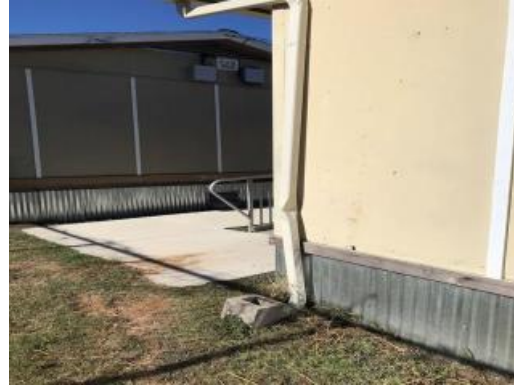
Bent downspout
