FACILITY CONDITION ASSESSMENT

Southeast Bus Terminal | February 2022

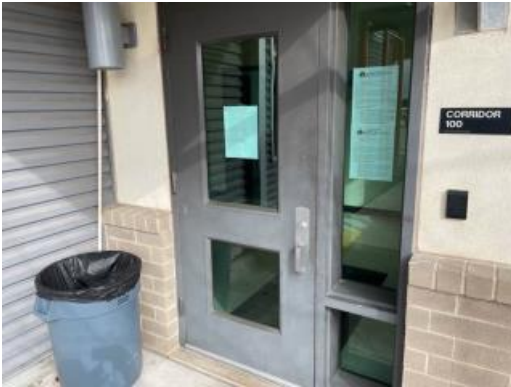
Exterior doors are fading

Deficiency	Category	Qty	UoM	Priority	Repair Cost	ID
Exterior Metal Door Repainting	Deferred Maintenance	4	Door	3	\$460	4832
Note: Faded and weathered						
Sub Total for System		1	items		\$460

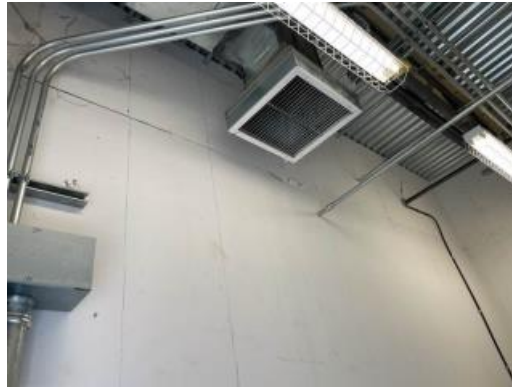
Interior walls in need of paint

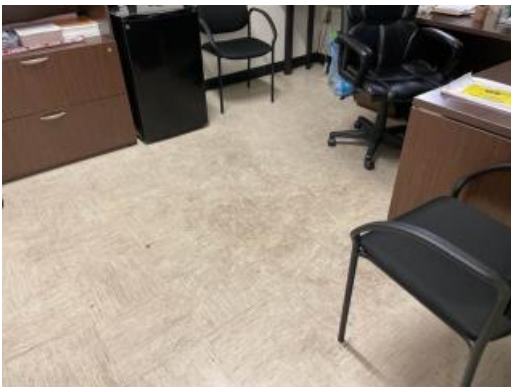
Vinyl composite tile flooring at end of life

Deficiency	Category	Qty	UoM	Priority	Repair Cost	ID
Vinyl Composition Tile Replacement	Capital Renewal	3,044	SF	4	\$24,893	4822
Note: Heavy wear/tear						
Location: Room 108 and 120						
Interior Ceiling Repainting	Deferred Maintenance	1,141	SF	5	\$2,376	4820
Note: Scuffs/chipping						
Interior Door Repainting	Deferred Maintenance	3	Door	5	\$134	4824
Interior Door Repair	Deferred Maintenance	2	Door	5	\$1,291	4823
Interior Wall Repainting	Deferred Maintenance	3,500	SF Wall	5	\$7,862	4821
Note: Scuffs/old repairs/flacking						
Sub Total for System		5	items		\$36,556

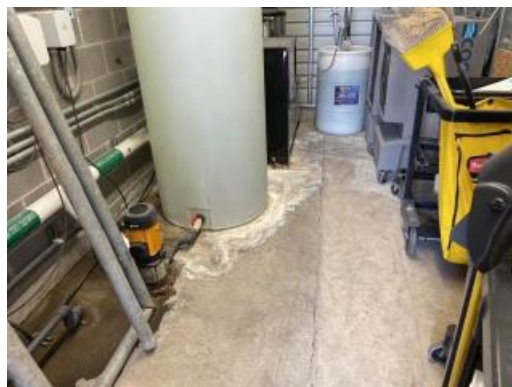
Bus washing flooring needs power wash

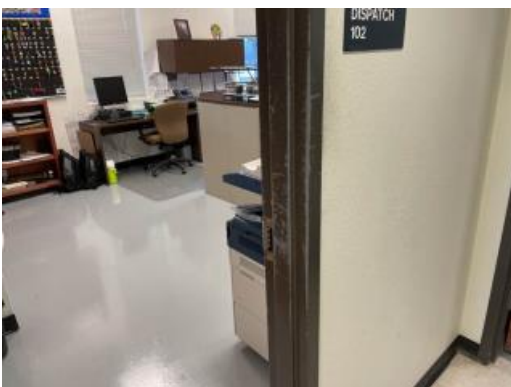
Interior door frames to be repainted

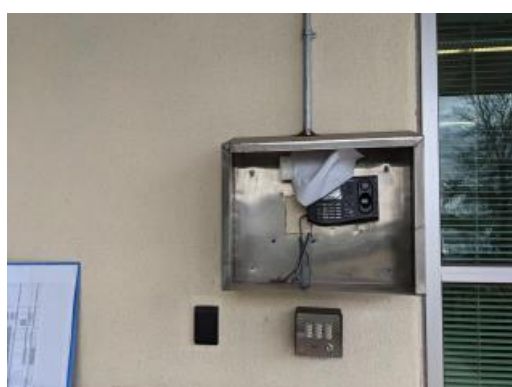
Damaged Entry Code

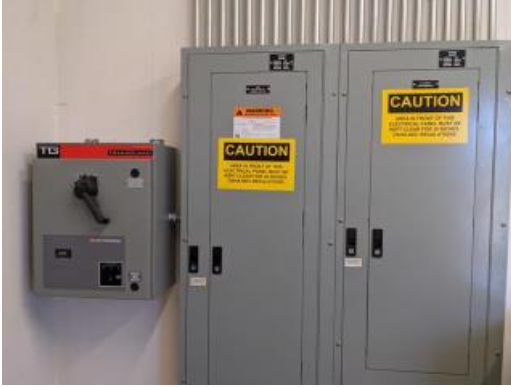
Typical Electrical Panels

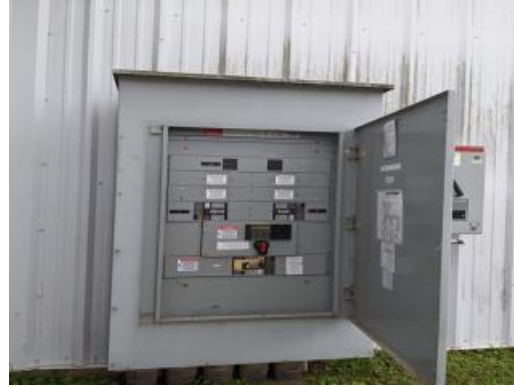
Exterior Mounted Electrical
