Educational Suitability Summary Report

Allison Elementary School – BLDG 101

Date: 07/11/2016

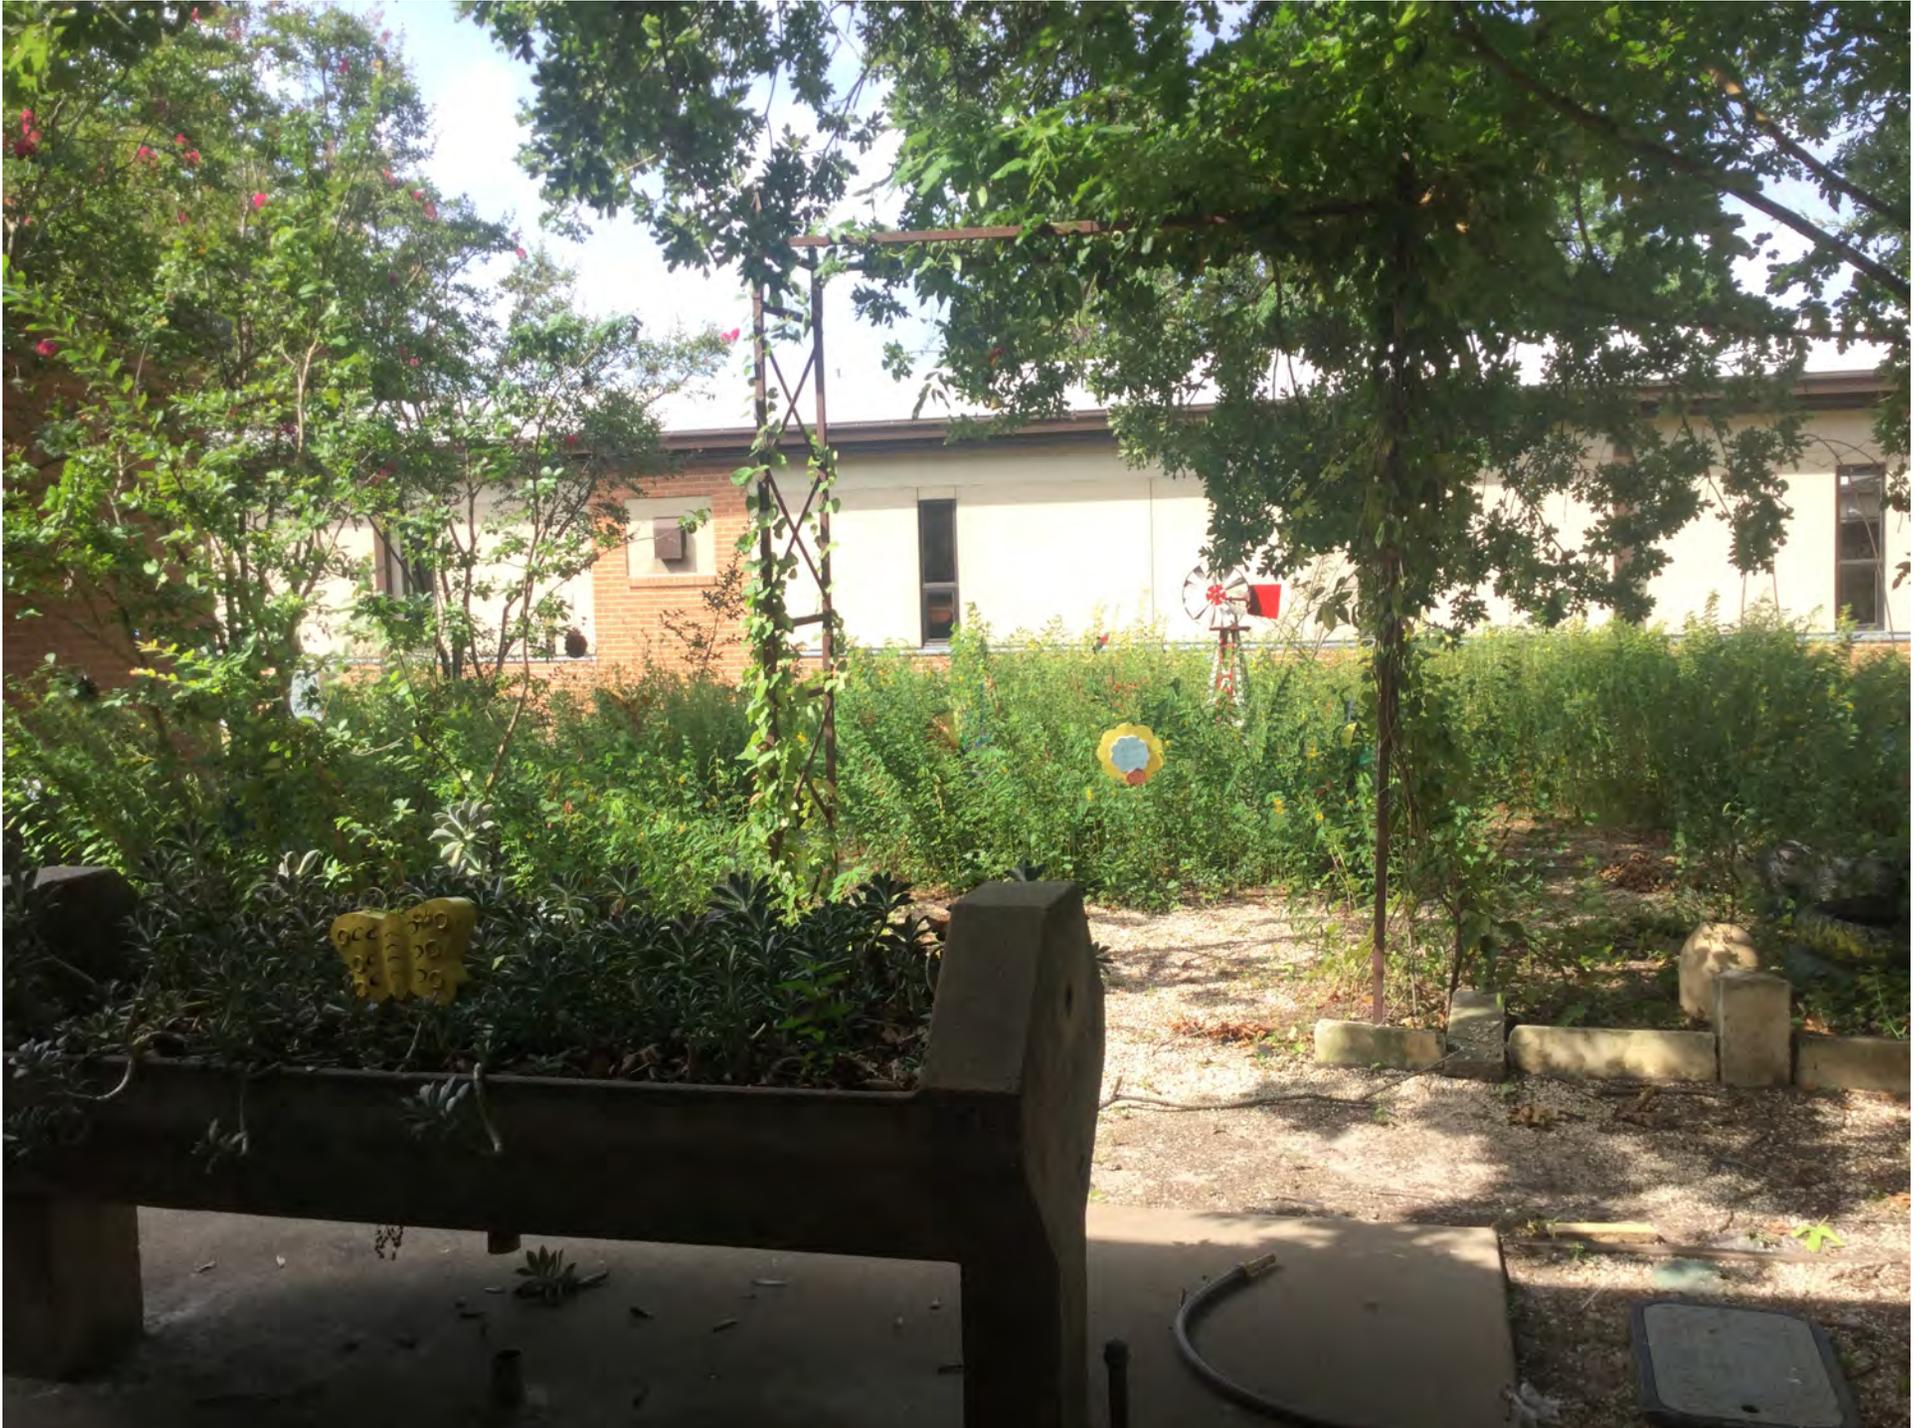
Photo 1. Outdoor Space

1.2	Are opportunities provided for outdoor learning (outdoor classrooms, gardens, etc.)?			3				Comments	1.00	3.00
1) Outdoor space exists is not developed 2)Outdoor space for learning exists but not connected to classroom learning areas. 3. Outdoor learning spaces exist and are accessible but not in good condition. 4. Outdoor learning spaces need minor improvements to function well. 5. Outdoor learning spaces are in excellent condition. N/A) Does not apply.								The courtyards are nice outdoor learning spaces, but they need upgraded outdoor furniture to function appropriately.	See Image 1

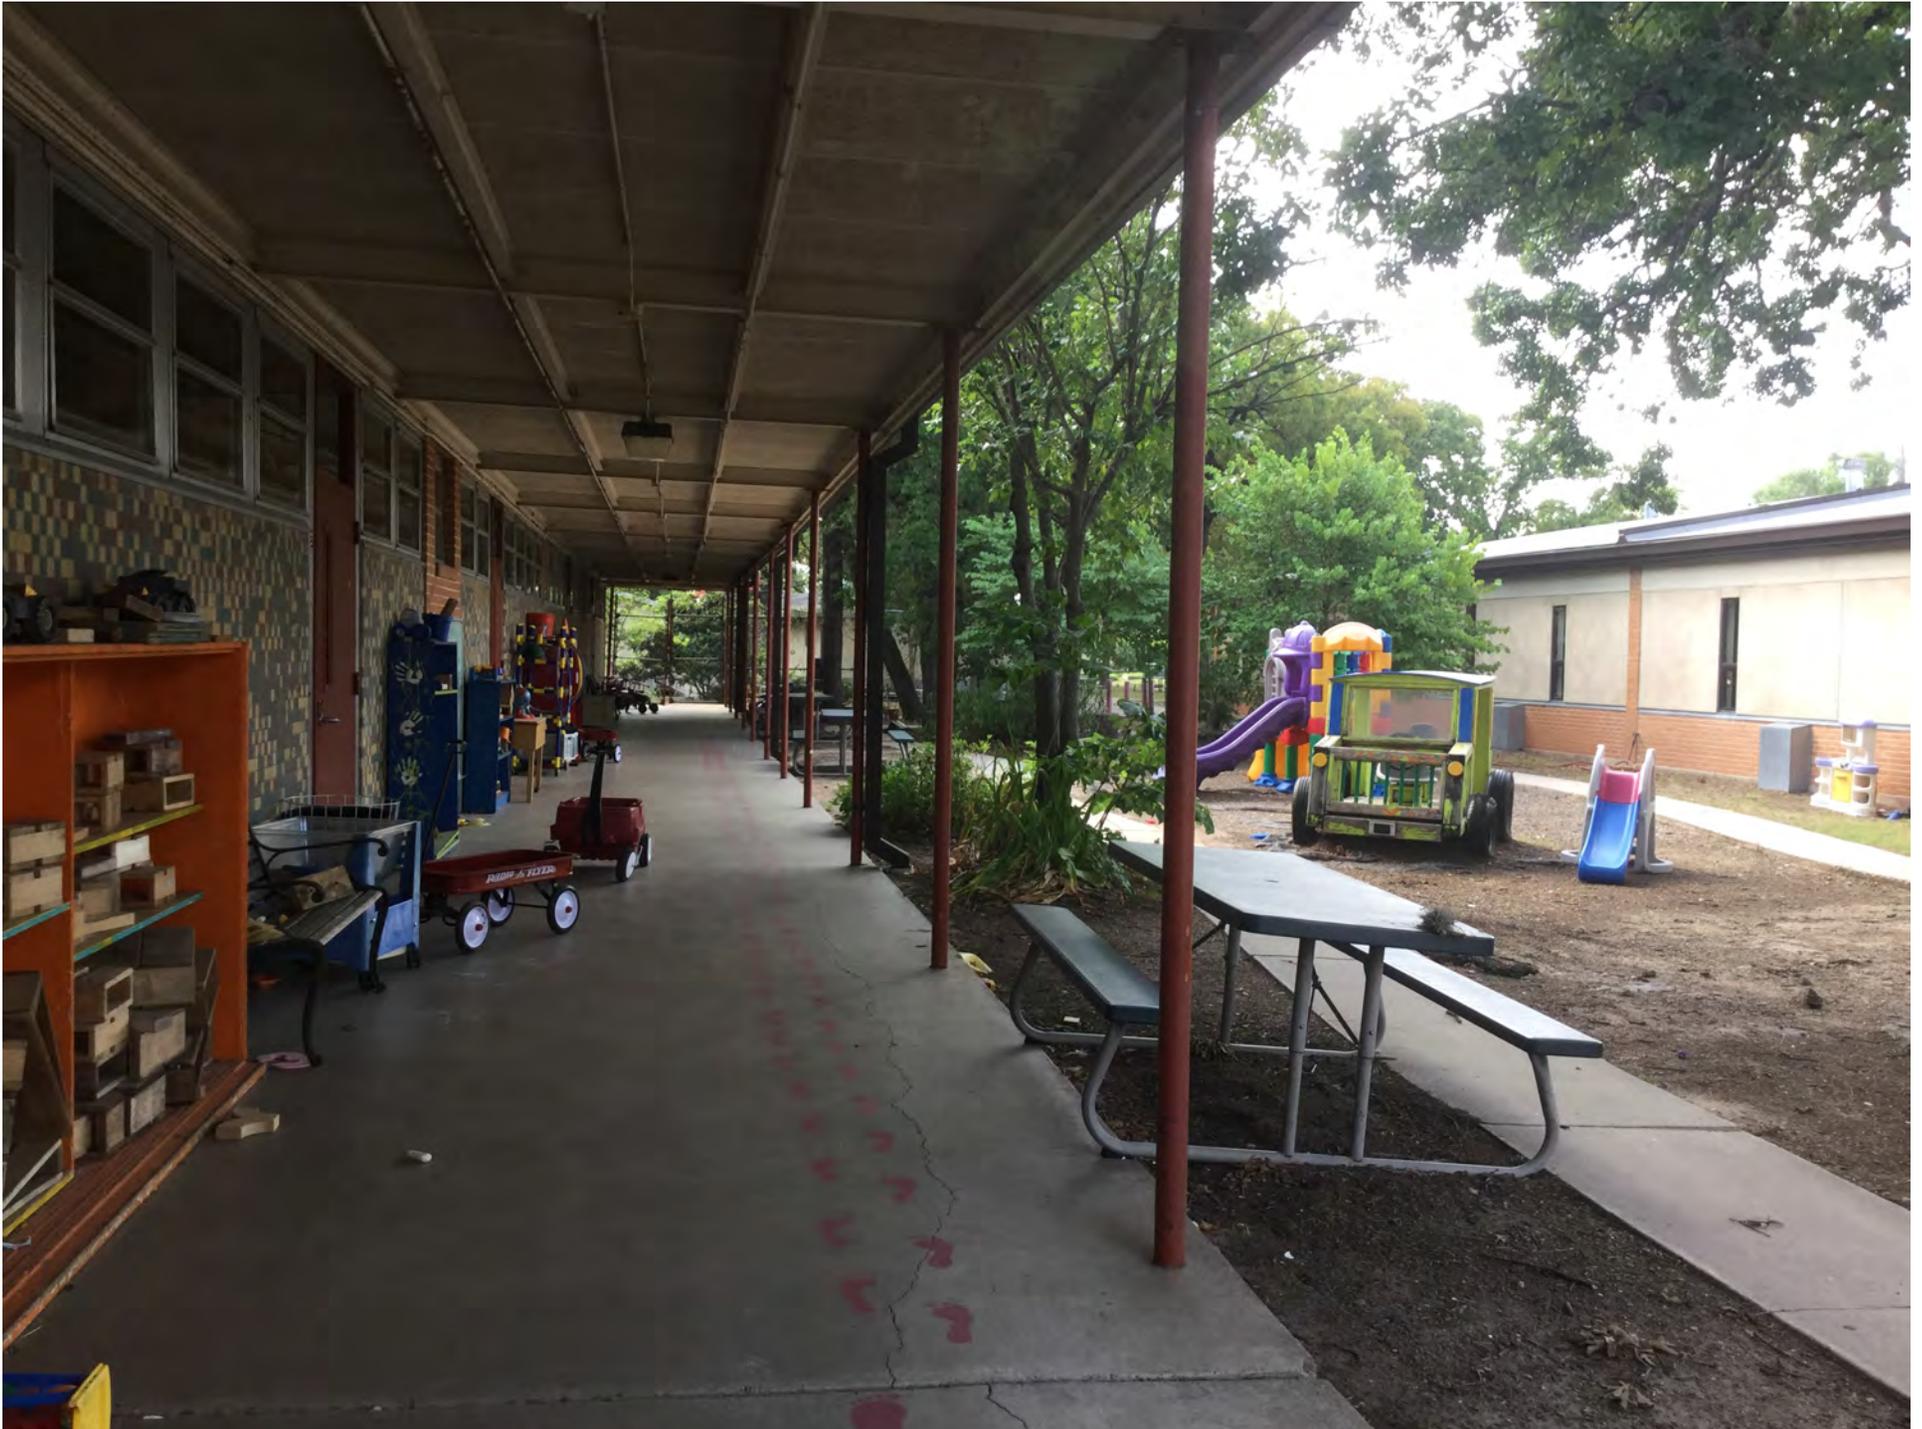
Photo 2. Kindergarten Support Space

3.3	Do Pre-K and Kinder have appropriate support spaces such as restrooms and storage per the ed spec? (elementary only)		2					Comments	1.00	2.00
1) Very unsatisfactory - No storage, casework, or restrooms 2) Unsatisfactory - unsatisfactory size or condition of storage, casework, or restrooms 3) Neutral - Moderate size or moderate condition storage, casework, and restrooms 4) Satisfactory - Satisfies ed spec for storage, casework, and restrooms 5) Very Satisfactory - exceeds ed spec for storage, casework, and restrooms N/A) Does not apply.		Classrooms have insufficient storage and the restrooms are not ADA compliant. However, the outdoor play areas were convenient to the classrooms, shaded, and enclosed.								
		See Image 2

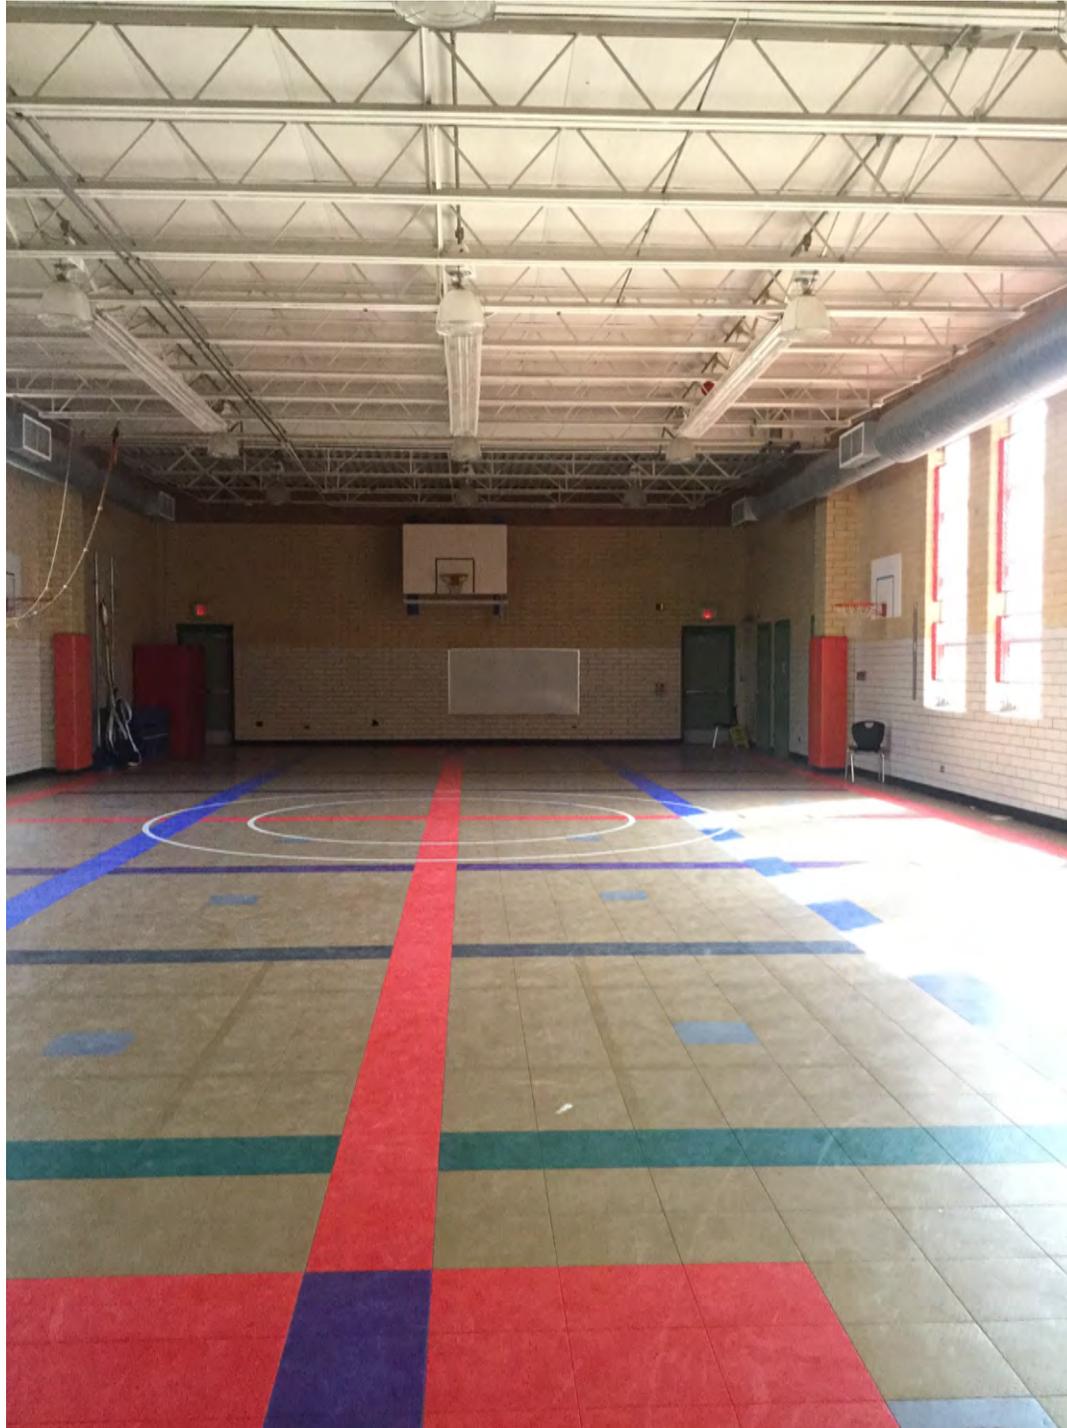
Photo 3. Gymnasium

1) Very unsatisfactory 2) Unsatisfactory 3) Average 4) Good 5) Very good N/A) Does not apply.		The gym space is large. See Image 3							
3.7	Are Physical Education and Athletic support spaces appropriately configured per the ed spec?				4			Comments	1.00 4.00

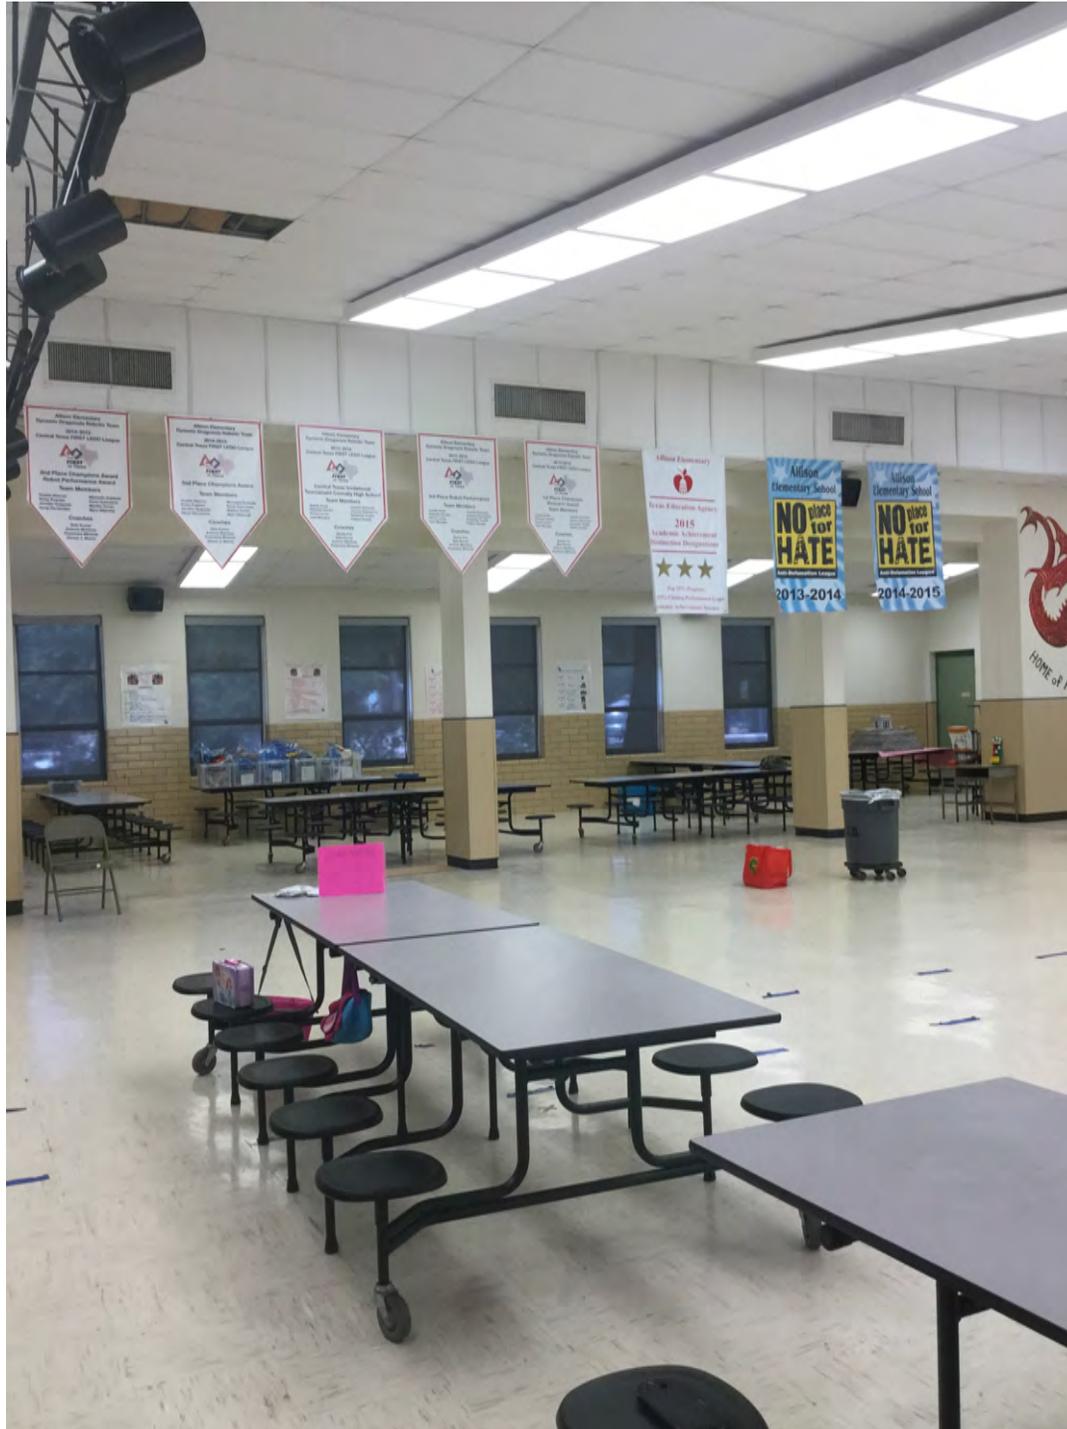
Photo 6. Cafeteria

3.16	Are the student dining facilities appropriately configured?			3				Comments	1.00	3.00
1) Very unsatisfactory - Too small, poor circulation, inflexible seating in poor condition 2) Unsatisfactory - Too small or inadequate circulation, seating in poor condition 3) Average - moderate size, with adequate circulation, seating in okay condition 4) Good - good size, adequate circulation, seating in good condition 5) Very good - good size, adequate circulation, seating in good condition, with more than one option for eating space (ex: connection to outdoor eating space) N/A) Does not apply.								See Image 6

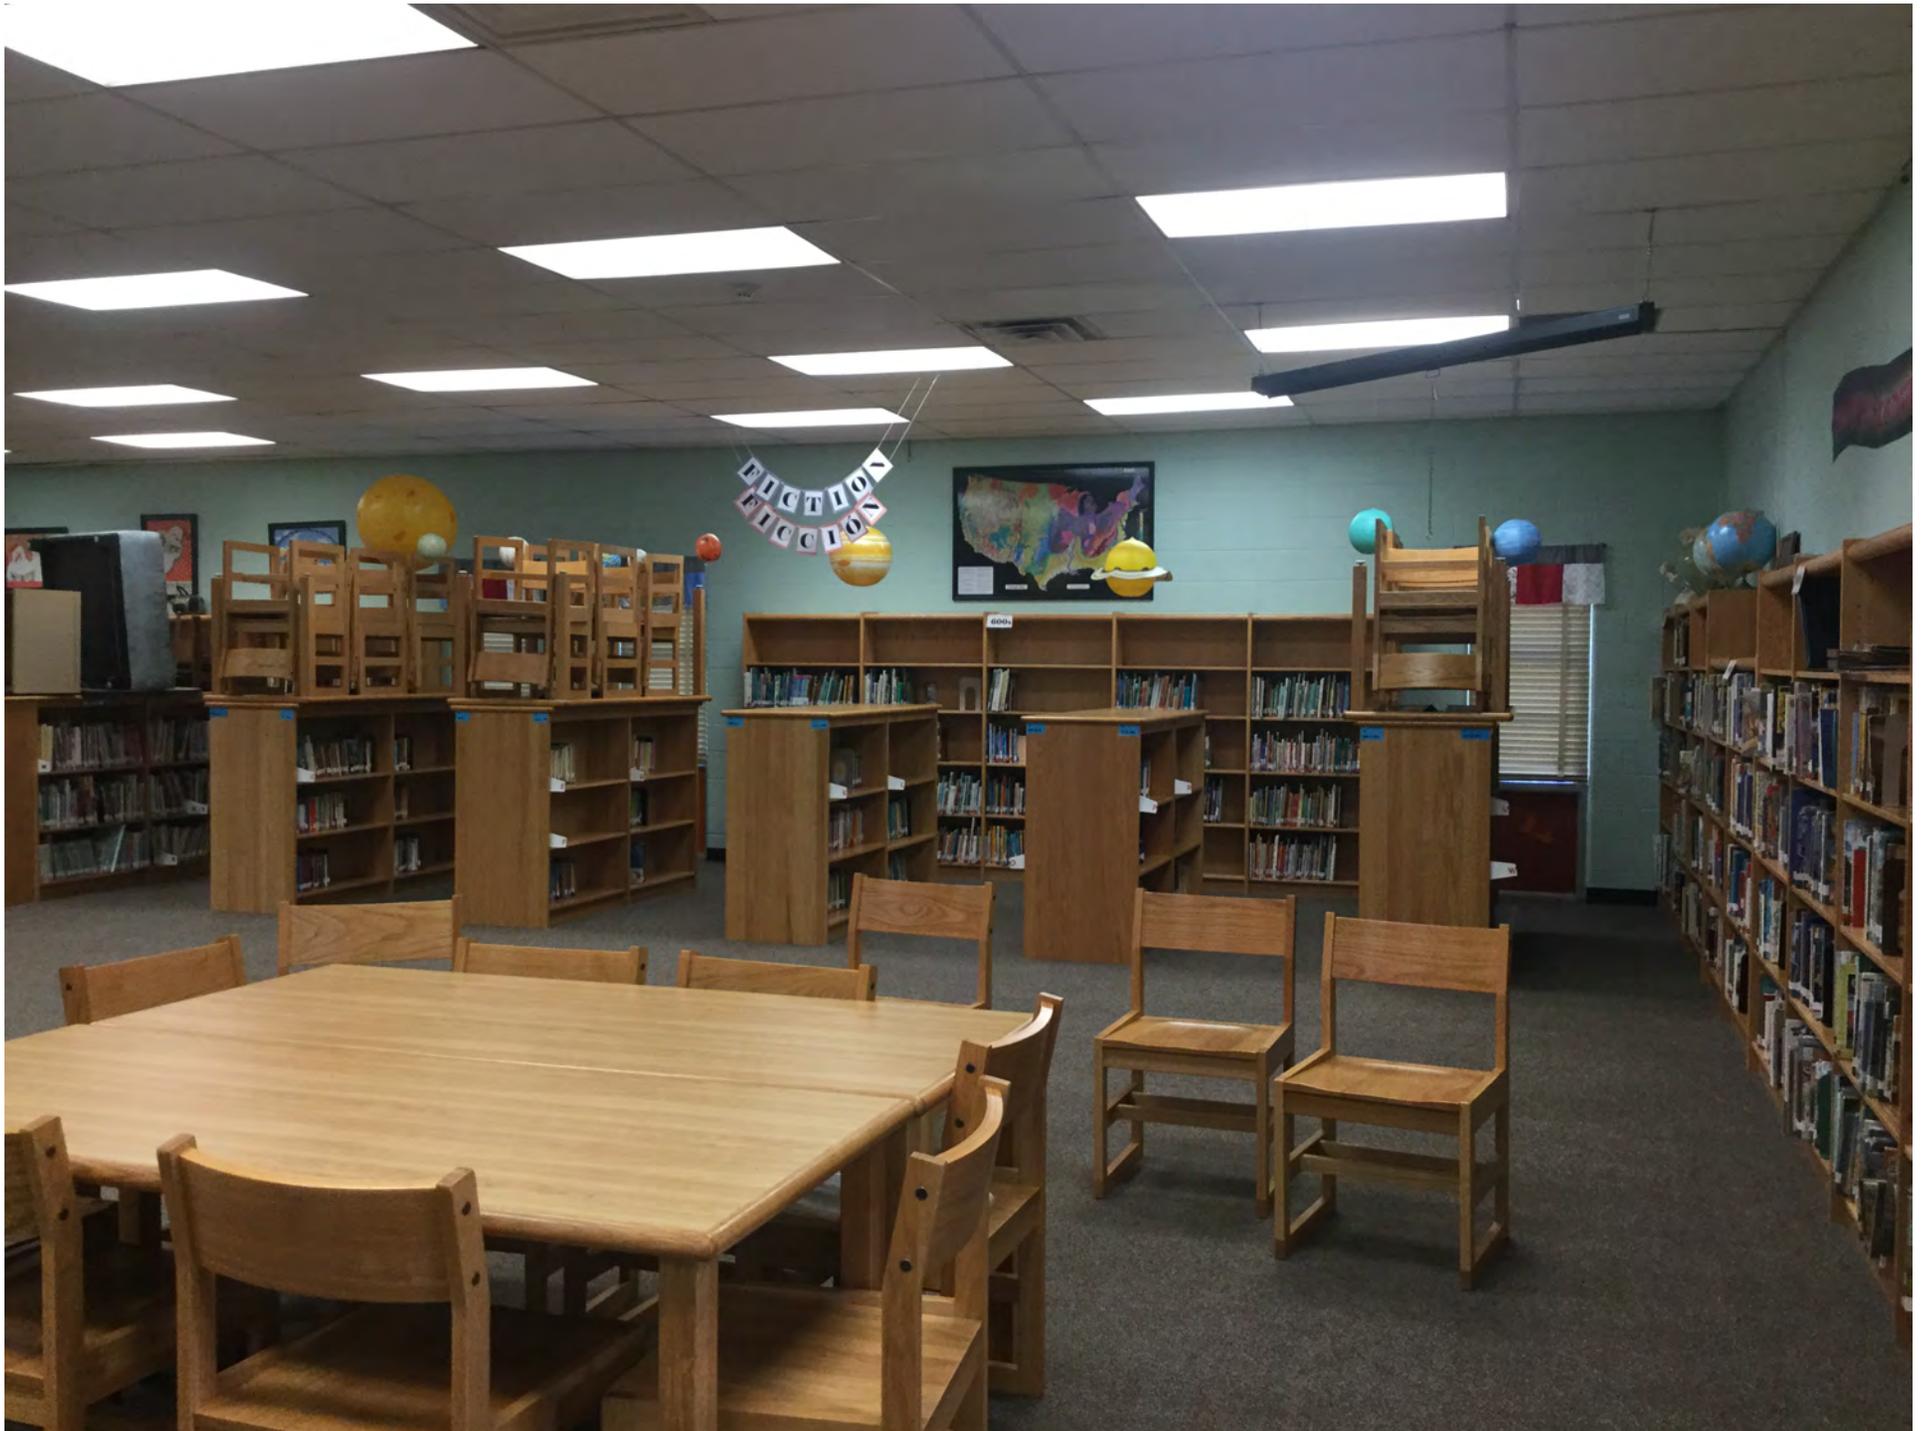
Photo 7. Library

1) Very unsatisfactory 2) Unsatisfactory 3) Average 4) Good 5) Very good N/A) Does not apply.										
		See Image 7								
5.4	How well does the Library/Media Center support collaborative work in small groups (4-8 students)?					5		Comments	1.00	5.00

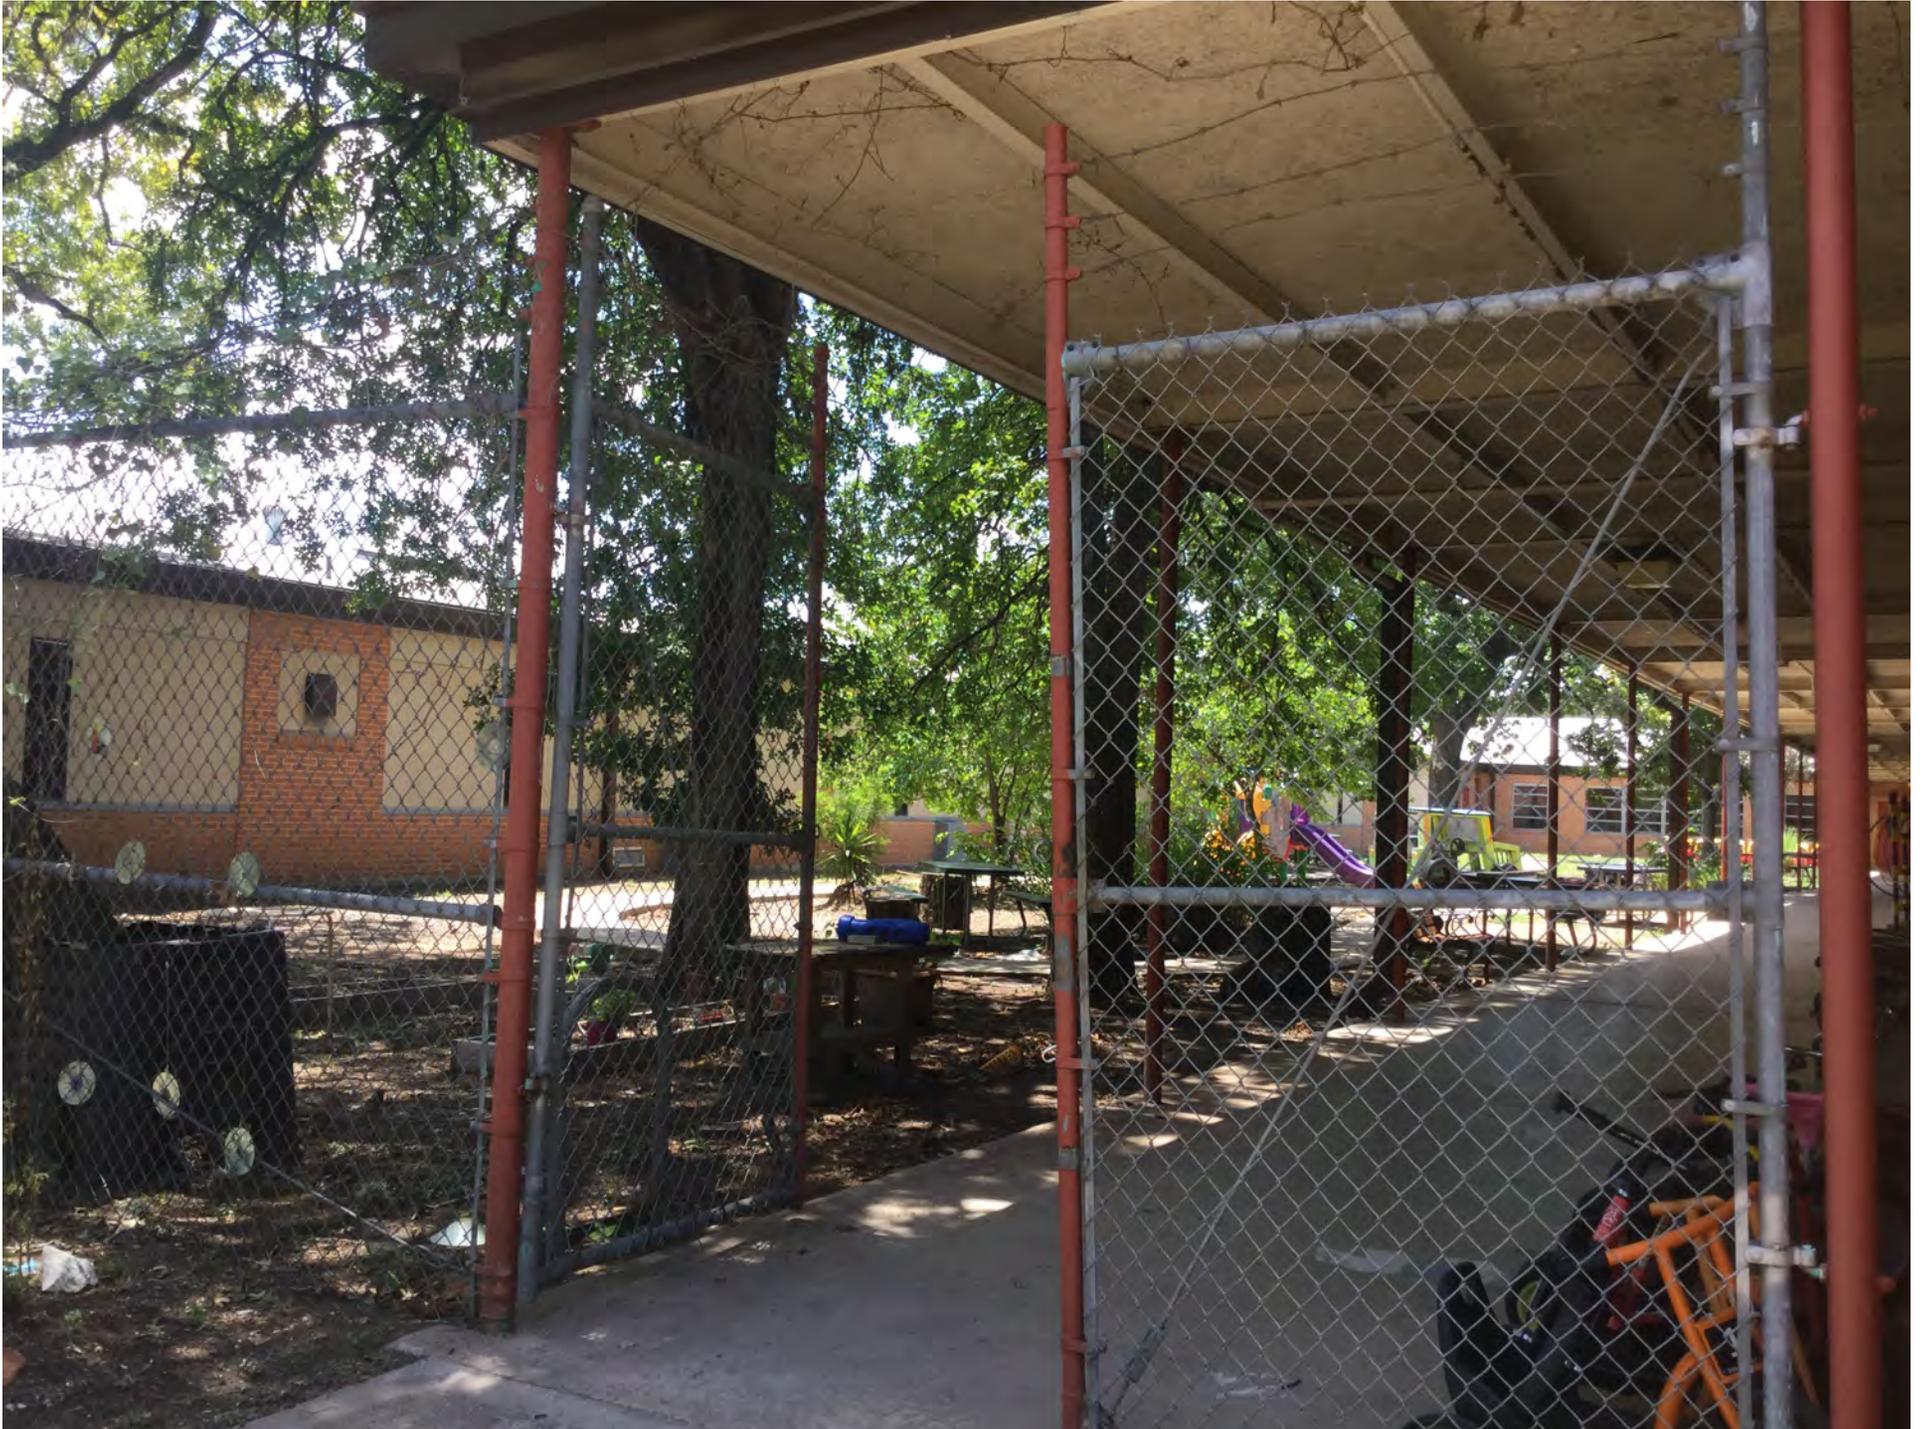
Photo 8. campus Security

6.2	How adequate is site lighting and security for the campus overall?	1						Comments	1.00	1.00
1) No exterior lighting, no secure perimeter 2) Lighting is limited to front entry only, parking lot lighting poor, security is minimal 3) Lighting at all night-use entries and parking lot, but poor condition. Security is moderate 4) Lighting at all night-use entries and parking lots, good condition, signage less visible. Perimeter is well secured, but needs updates. 5) Signage, parking lots, and entries are well lit, visible and easy to use. Perimeter is very secure. N/A) Does not apply.		Exterior walkways leading to classrooms have holiday lights strung for lighting. The exterior lighting is extremely poor throughout the campus. The video surveillance and intercom system needs improving for safety. The exterior courtyard gates need appropriate panic hardware for safe fire egress.								
		See image 8

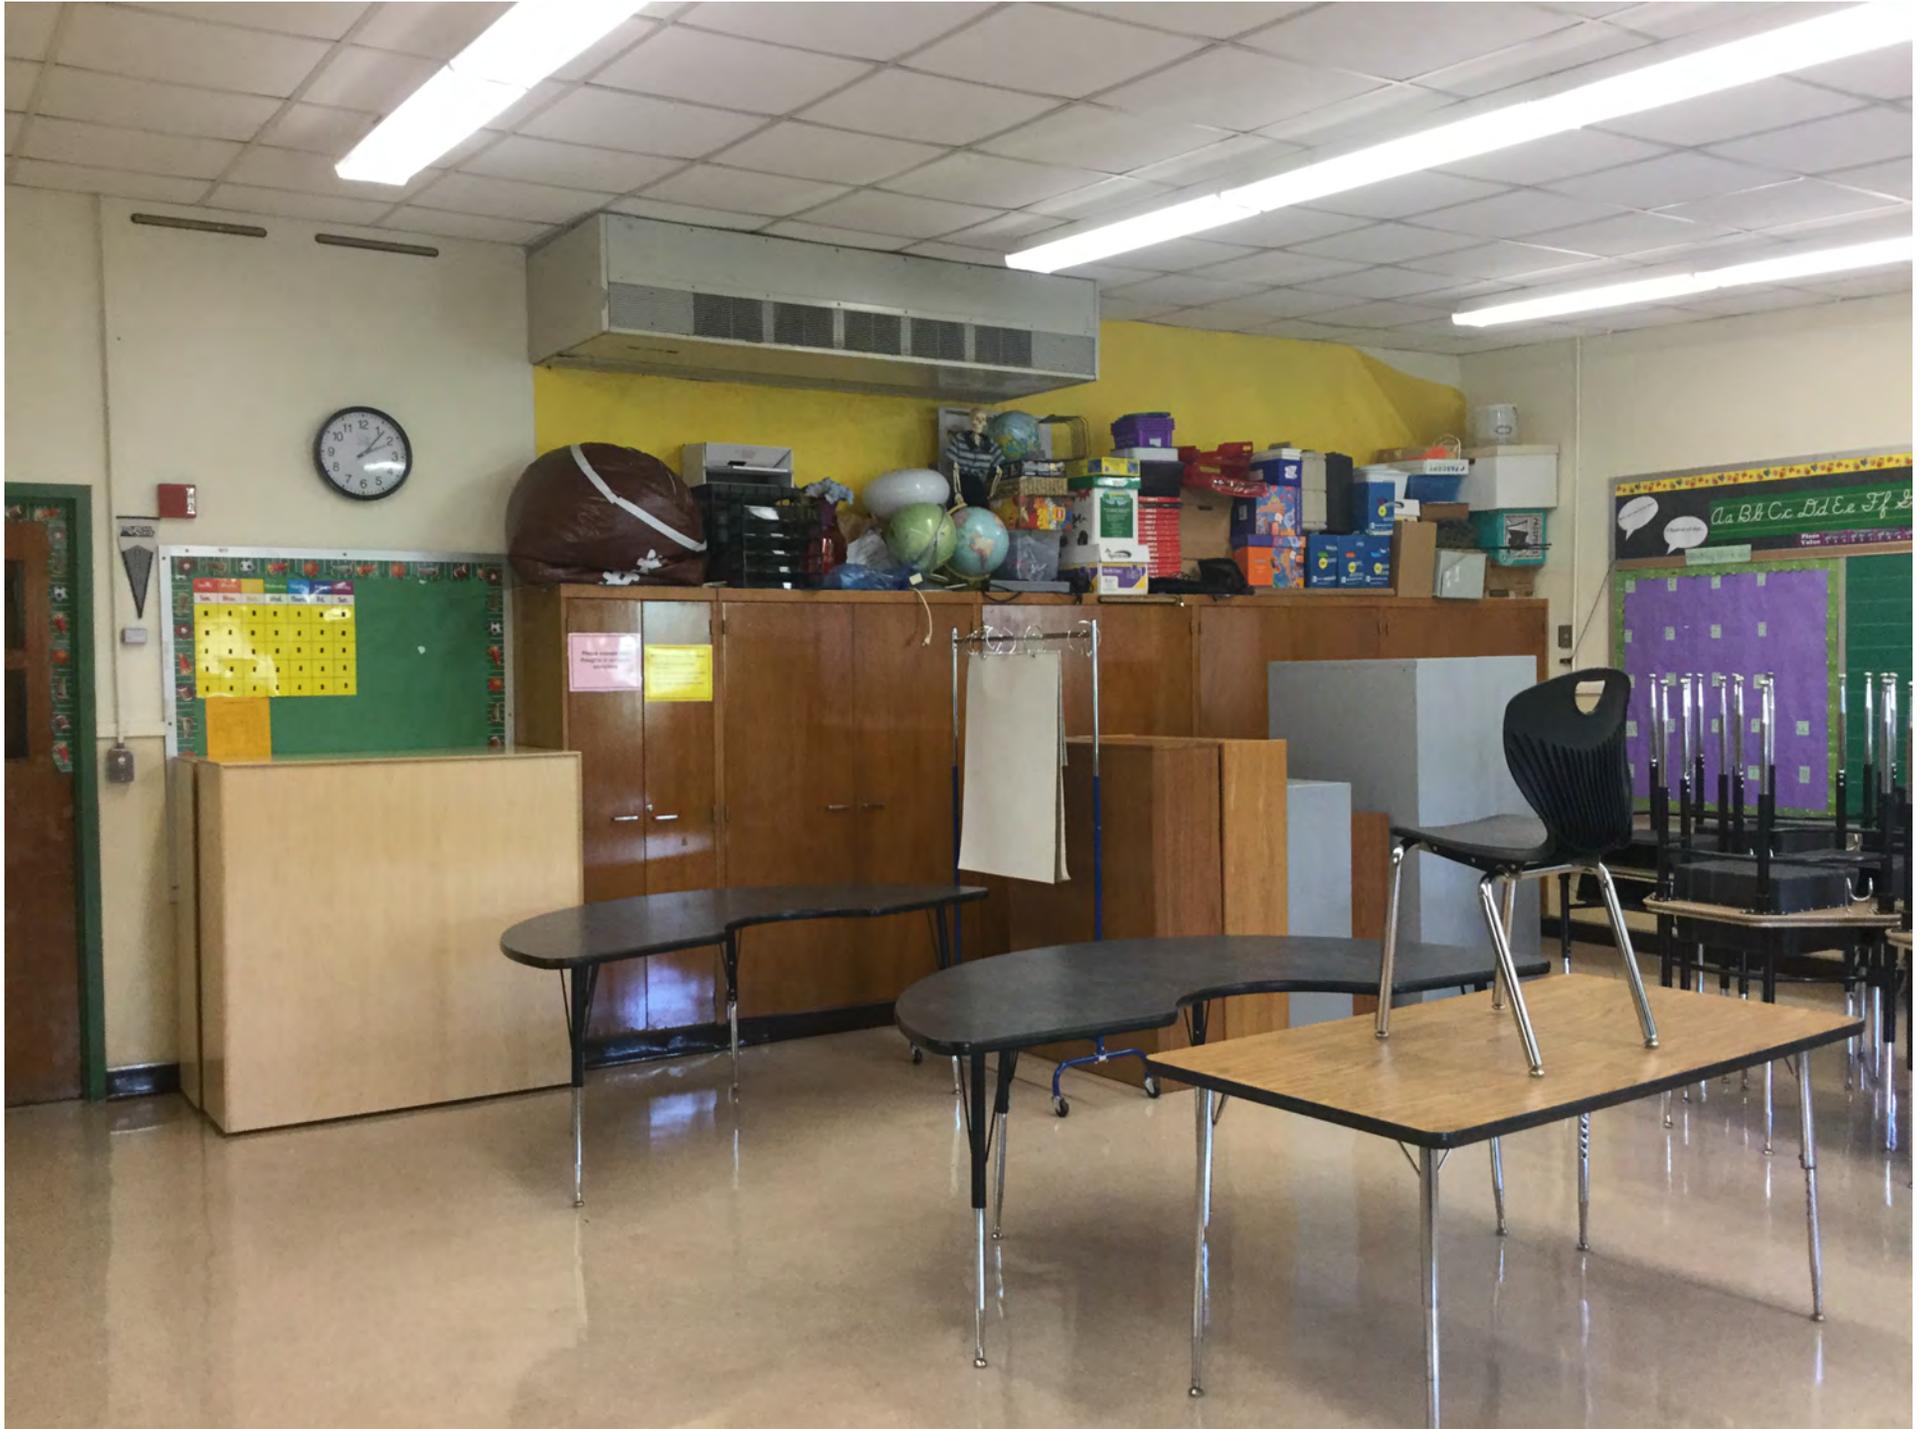
Photo 9. Classroom Storage

8 - Storage		1	2	3	4	5	N/A			5.00
8.1	Is there adequate general storage in the building?	1						Comments	1.00	1.00
1) Very unsatisfactory 2) Unsatisfactory 3) Average 4) Good 5) Very good N/A) Does not apply.		General building storage is limited. Book storage is undersized.								
8.2	Is there adequate classroom storage?		2					Comments	1.00	2.00
1) Very unsatisfactory 2) Unsatisfactory 3) Average 4) Good 5) Very good N/A) Does not apply.		Classrooms have insufficient storage.								
		See Image 9								
8.3	Is there adequate student storage?		2					Comments	1.00	2.00
1) Very unsatisfactory 2) Unsatisfactory 3) Average 4) Good 5) Very good N/A) Does not apply.		There is limited student storage space.
