Educational Suitability Summary Report

Andrews Elementary School – BLDG # 102

Date: 7/13/2016

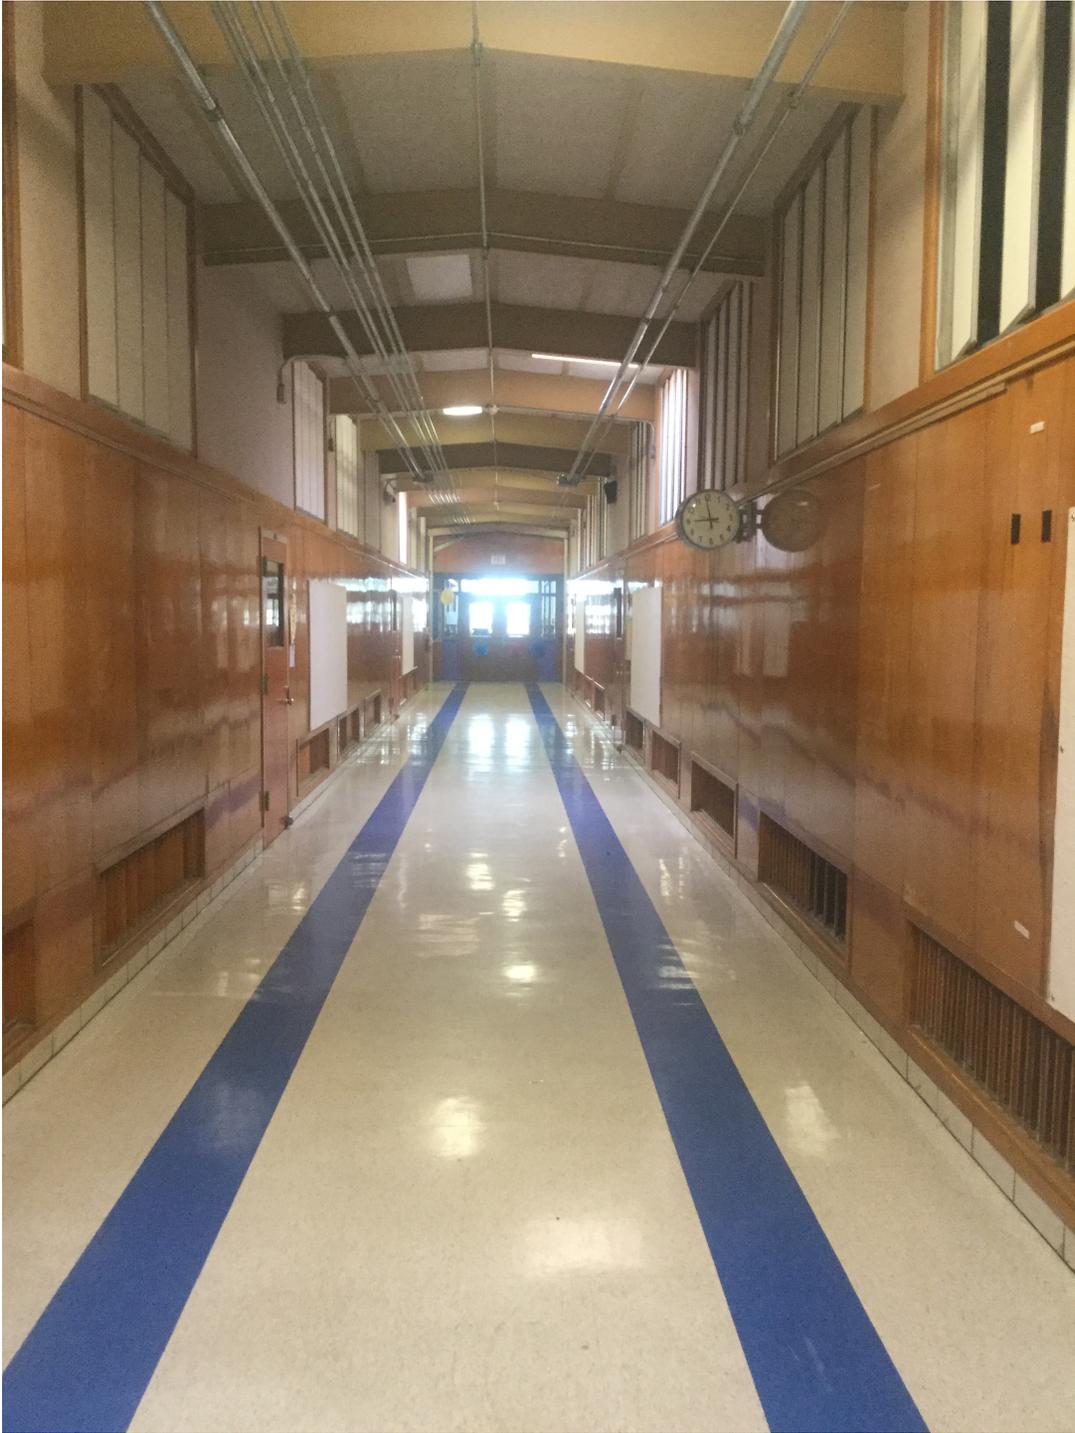
2.1 Corridor

2 - General Building		1	2	3	4	5	N/A	4.50	
2.1	Are interior circulation routes wide enough to safely and effectively accommodate student movement?				4			0.50	2.00

1) Primary circulation is 5'-0" to 6'-0" wide. 2) Primary circulation is 6'-0" to 7'-0" wide 3) Primary circulation is 7'-0" to 8'-0" wide 4) Primary circulation is 8'-0"-10'-0" wide 5) Primary circulation is 10'-0"+ wide N/A) Does not apply.		Comments
