Educational Suitability Summary Report

Baldwin Elementary School – BLDG #187

Date: 9/12/2016

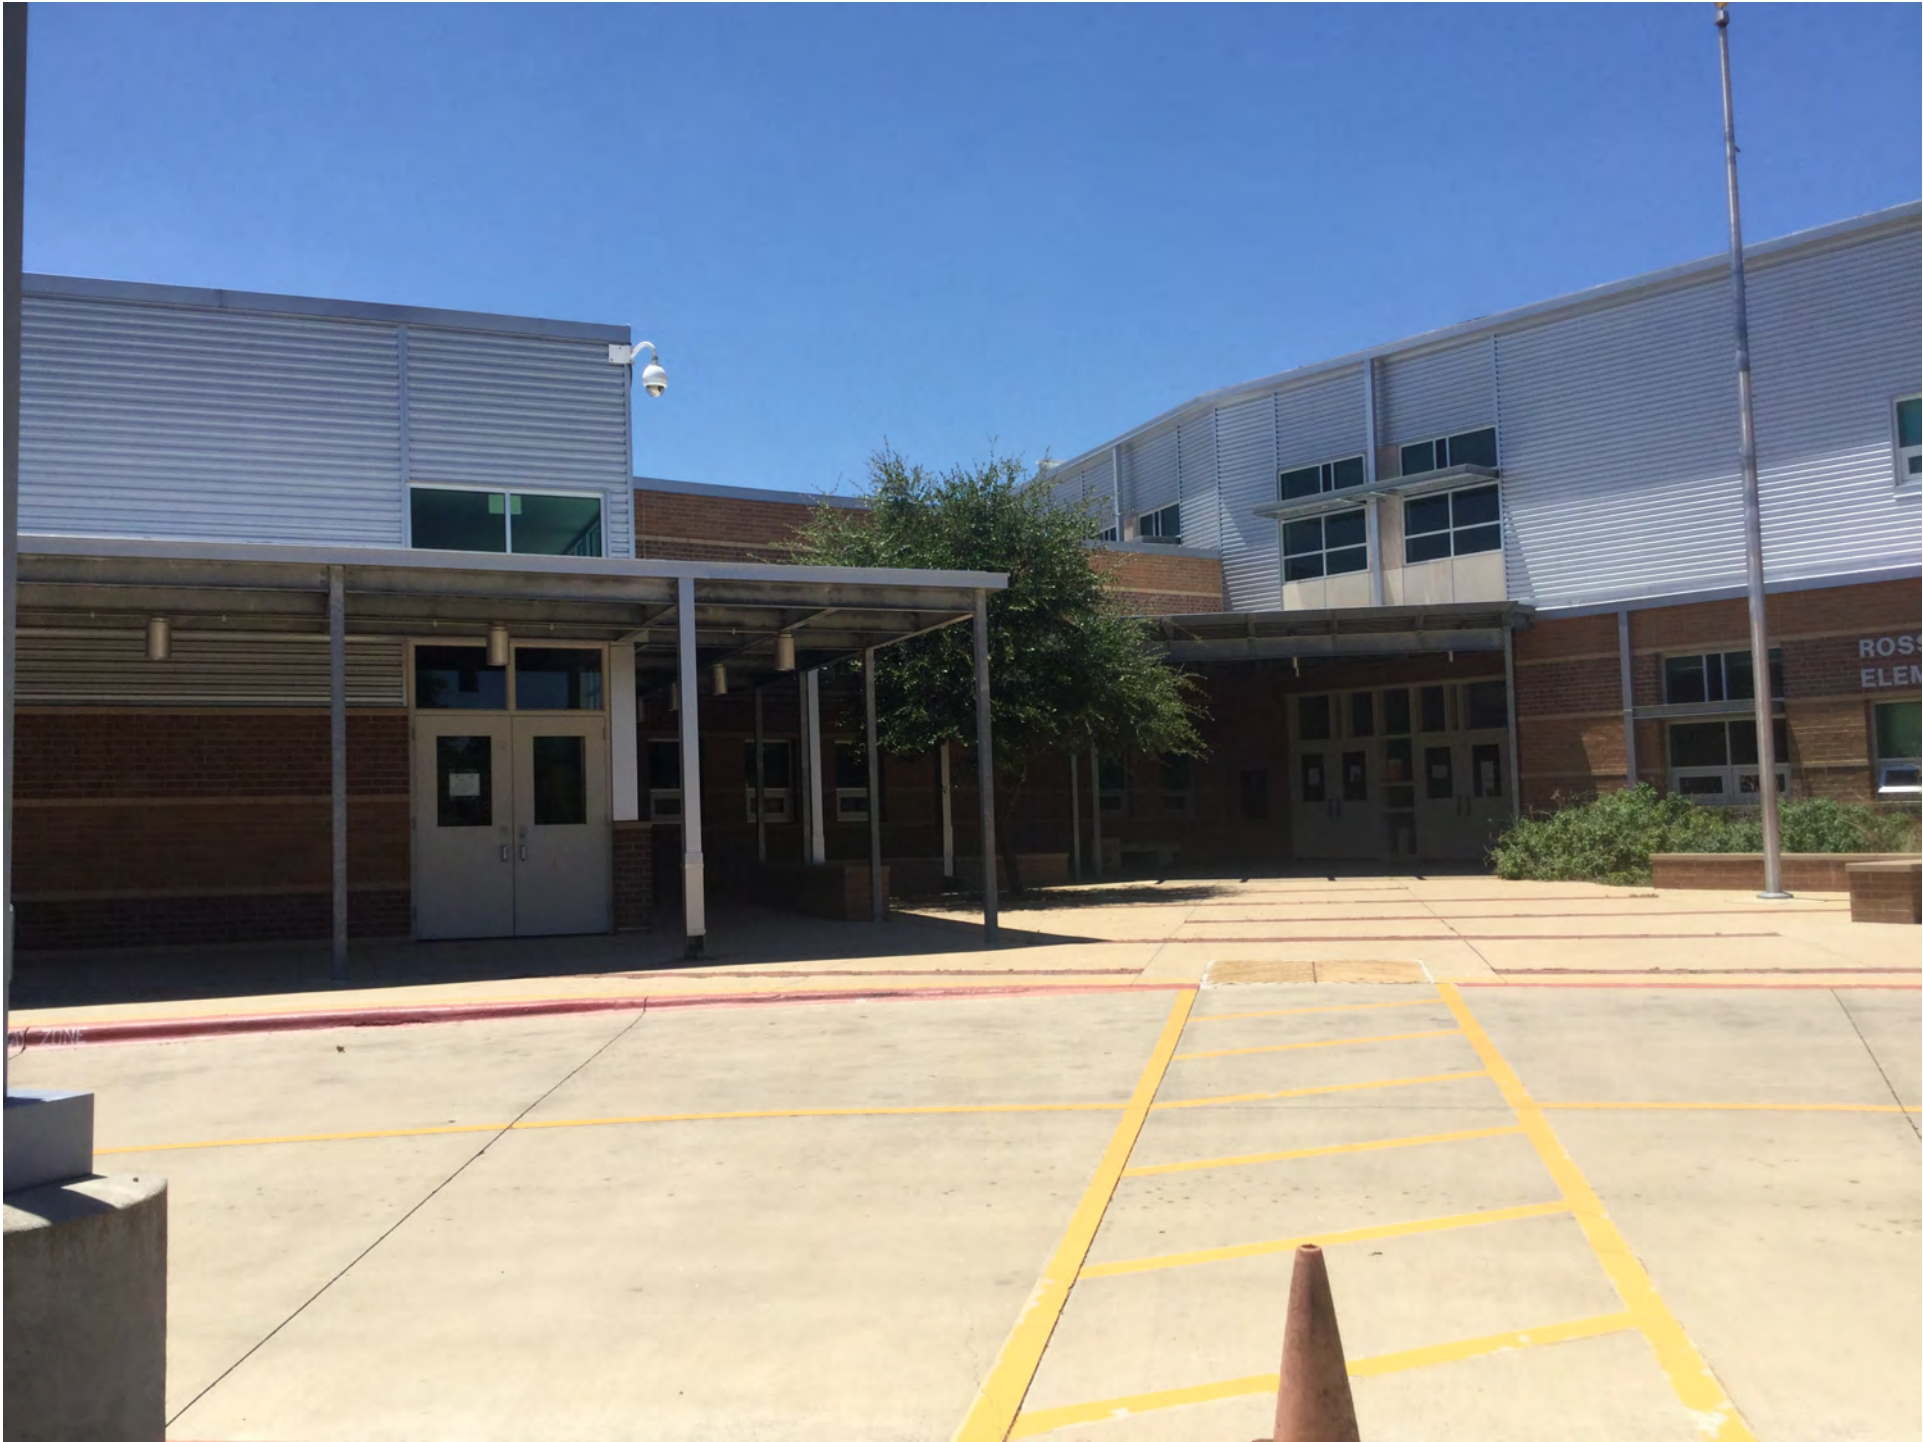
1 - Exterior		1	2	3	4	5	N/A	11.25	
1.1	Does the site permit desirable separation of vehicular, bus and pedestrian traffic?		2					Comments	1.00 2.00
	1) Bus , car and pedestrian all happen at the same location. 2) Cars and buses mix, pedestrians are separated. 3) Buses, cars, and pedestrians are separate but stack space is small. 4) Buses, cars, and pedestrians are separate but drop off does not have a canopy or a holding place like a commons or cafeteria. 5) Buses, cars, and pedestrians are separate and drop off area has a canopy and destination. N/A) Does not apply.

1.1 Traffic Mixes

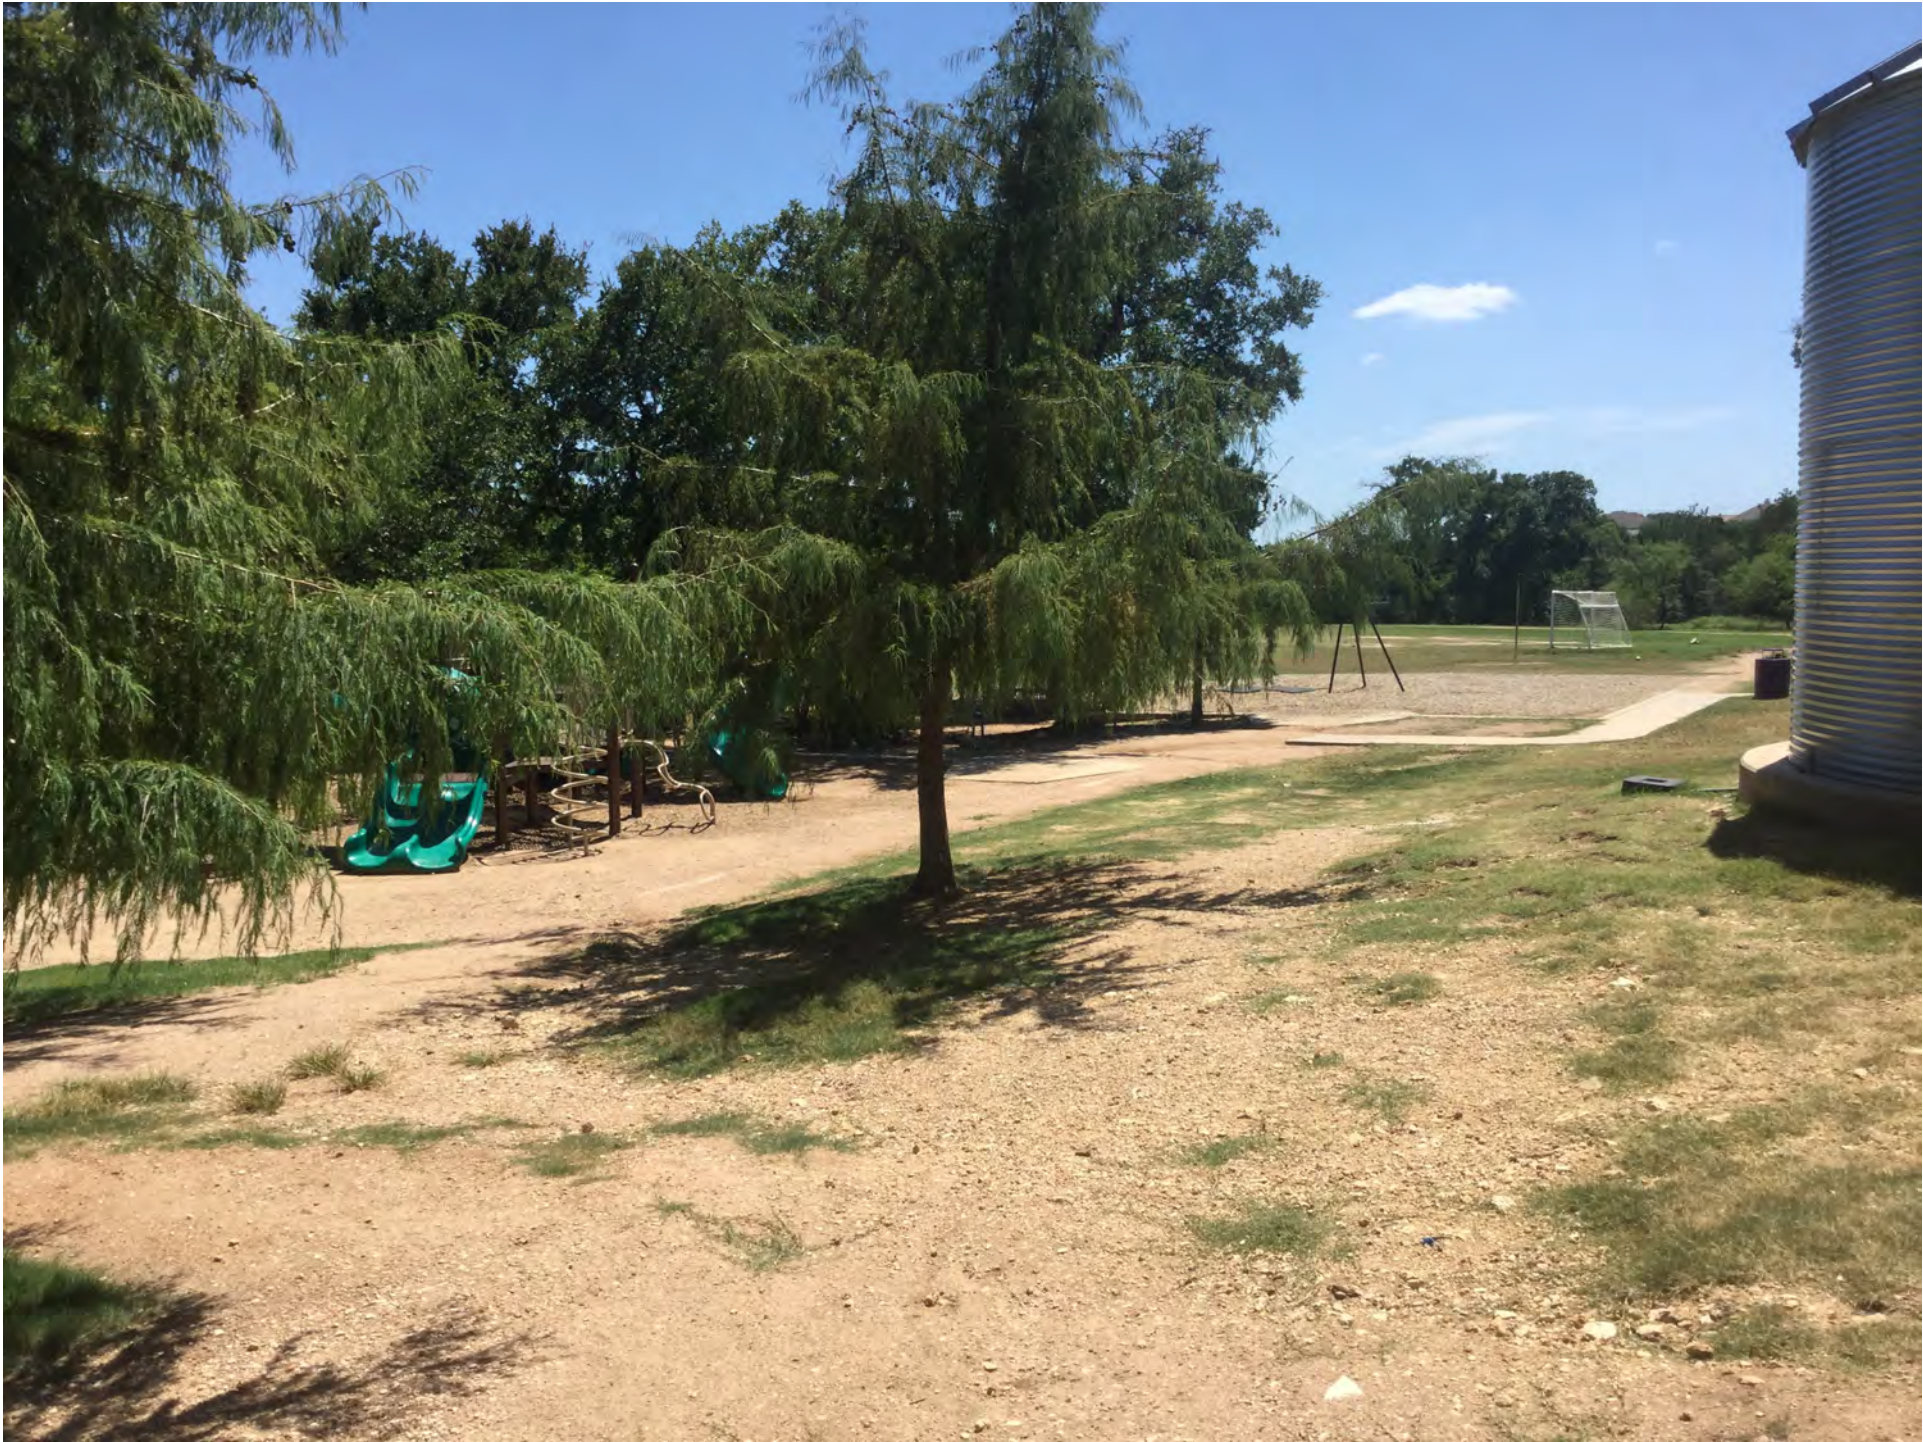
Playgrounds are overcrowded and undersized given the current size of the student body. One playground floods badly due to the building's water being directed down into the space. This requires frequent re-mulching efforts. The track is crushed gravel and is in very poor condition; it forms potholes and washes out during rain events. Site conditions around portables are very poor (no grass growth, overgrown vegetation, etc.).

1.3	Are outdoor play spaces and playfields adequate in size and configuration?				4			Comments	1.00 4.00
	1) Outdoor play space exists, not developed 2) Outdoor play space exists but is not connected to gym or other athletic support areas or is too small. 3. Outdoor play spaces exist, are connected to other athletic areas, are the right size, but are not in good condition. 4. Outdoor play spaces need minor improvements to function well. 5. Outdoor play spaces are in excellent condition. N/A) Does not apply.							Track needs to be updated. The number and size of playscapes are inadequate given the overpopulation of the school

1.3 Playground
Condition

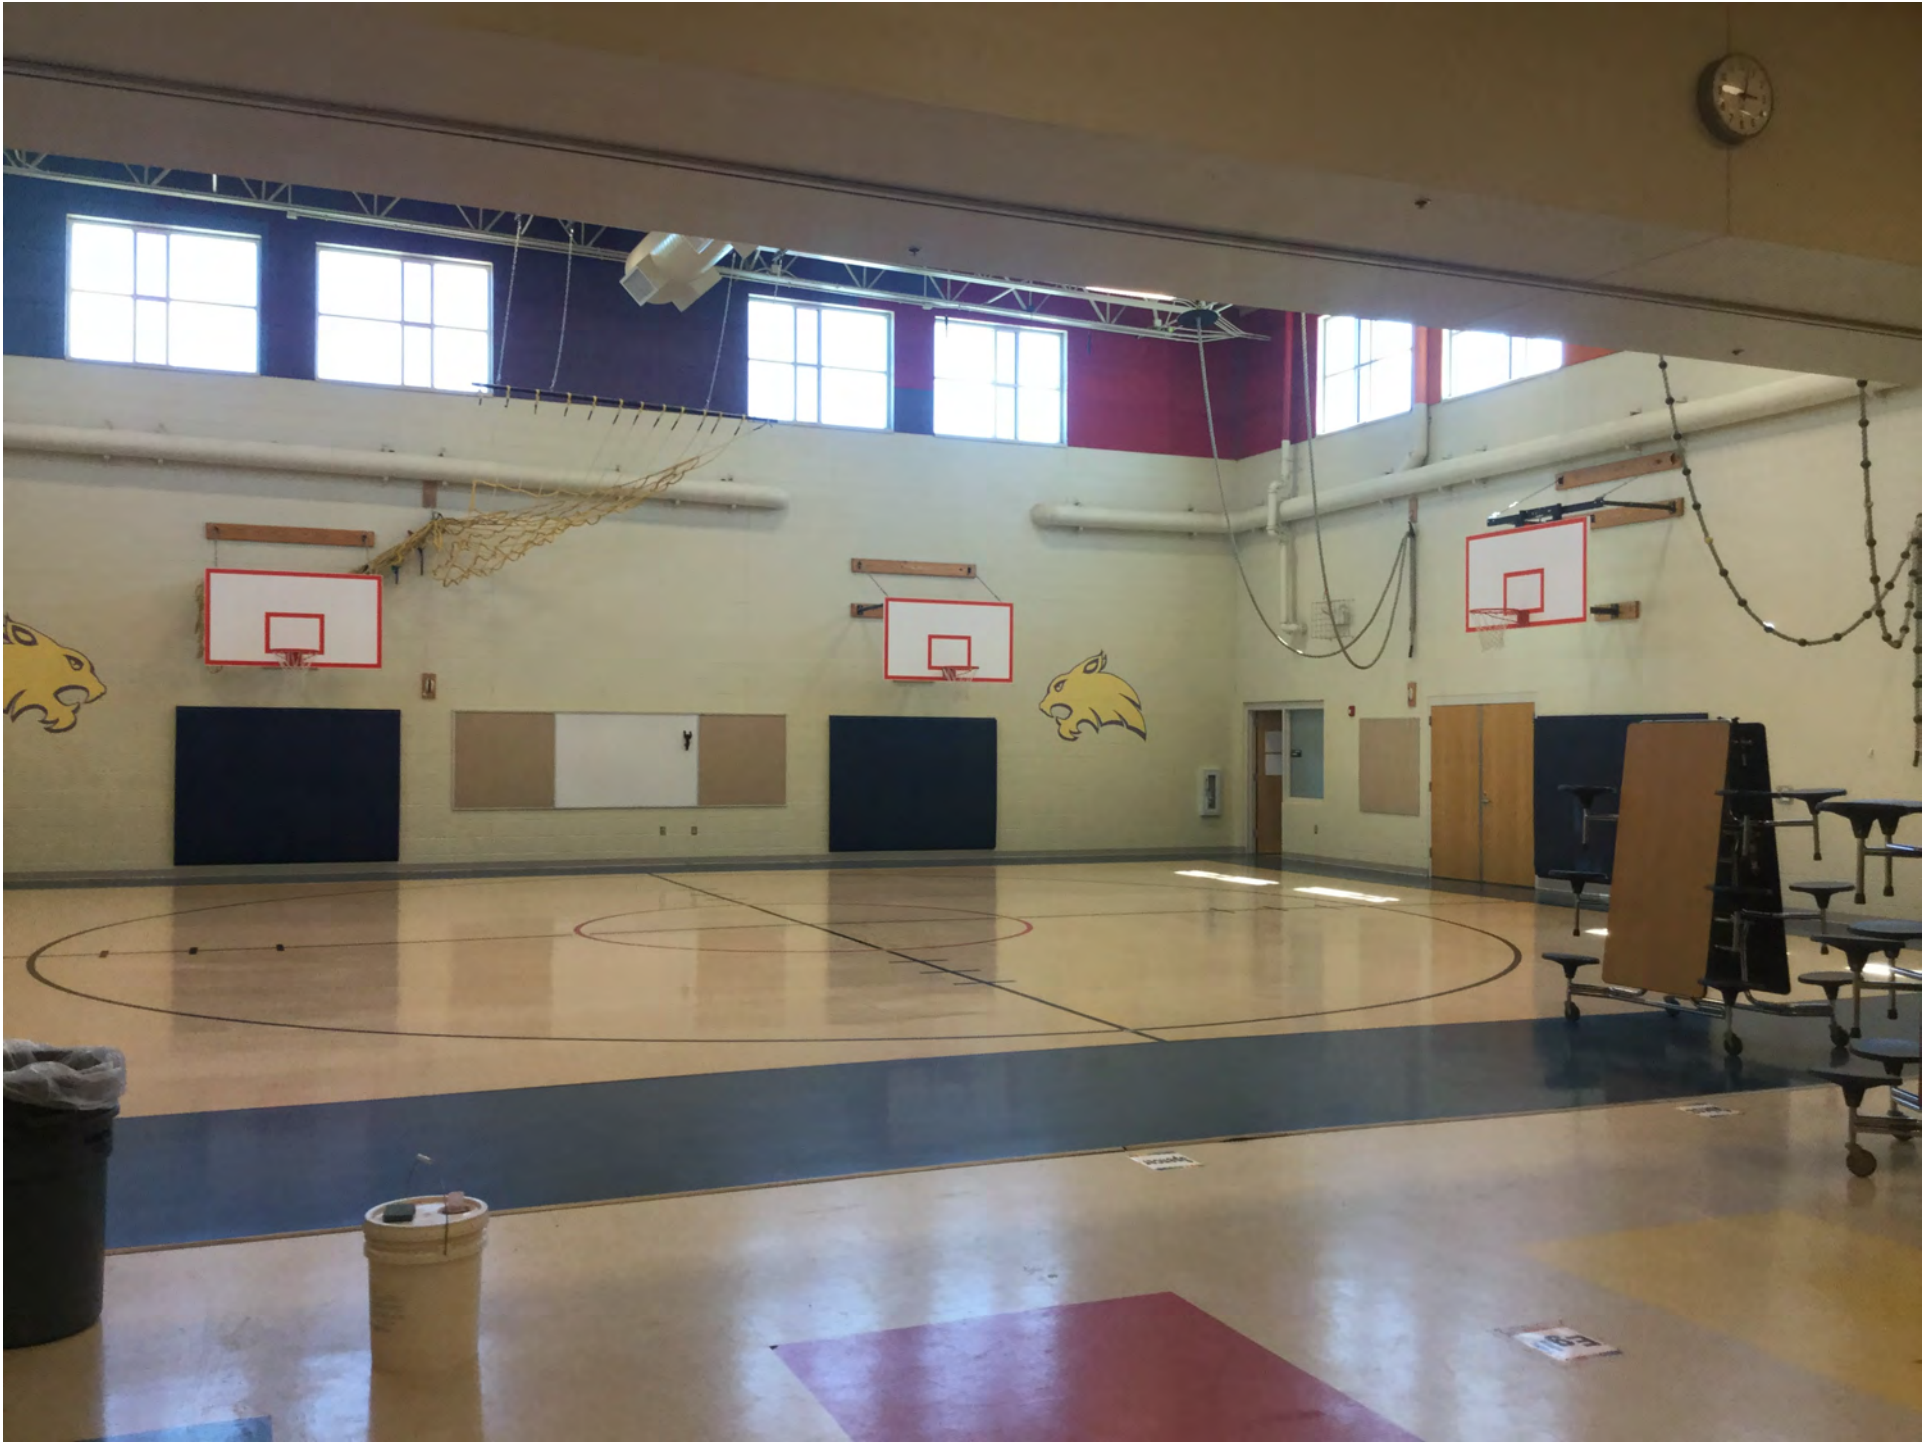
3 - Academic & Co-Curricular Support - Continued		1	2	3	4	5	N/A			
3.6	Are Physical Education and Athletic spaces appropriately configured per the ed spec?			3				Comments	1.00	3.00

1) Very unsatisfactory 2) Unsatisfactory 3) Average 4) Good 5) Very good N/A) Does not apply.								Gym is undersized. Needs to accommodate a second teacher.

3.6 Gymnasium

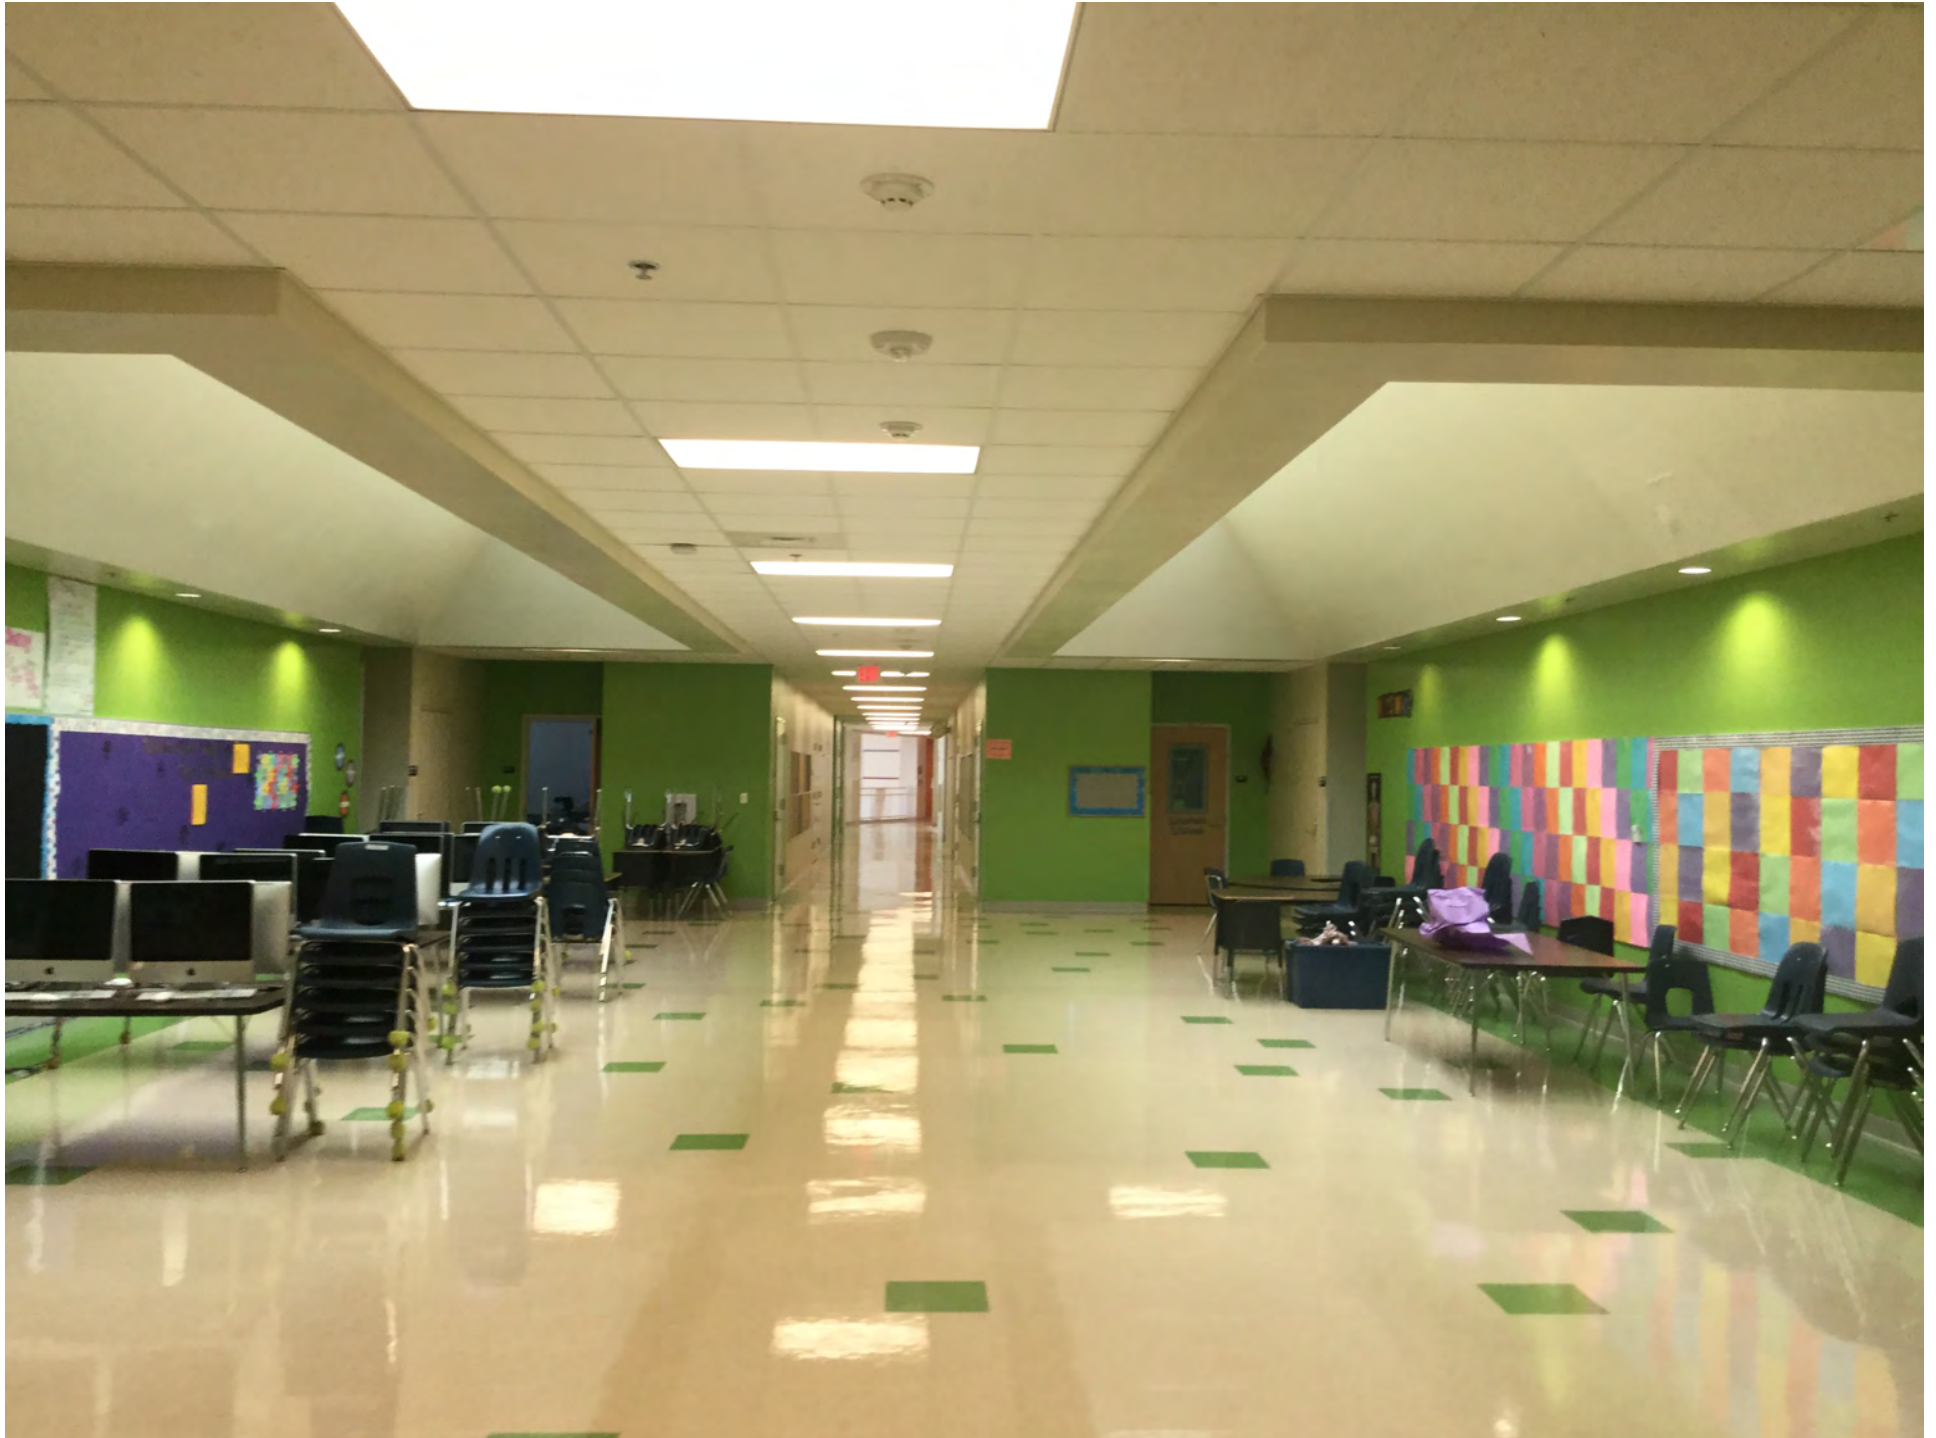
3.12	Are computer lab spaces appropriately configured?	1						Comments	1.00 1.00
1) Very unsatisfactory 2) Unsatisfactory 3) Average 4) Good 5) Very good N/A) Does not apply.							There is also a makeshift computer lab in a common space on the second floor. The main lab is in great condition, but will soon be repurposed as a standard classroom

3.12 Computer Lab
In Common Space

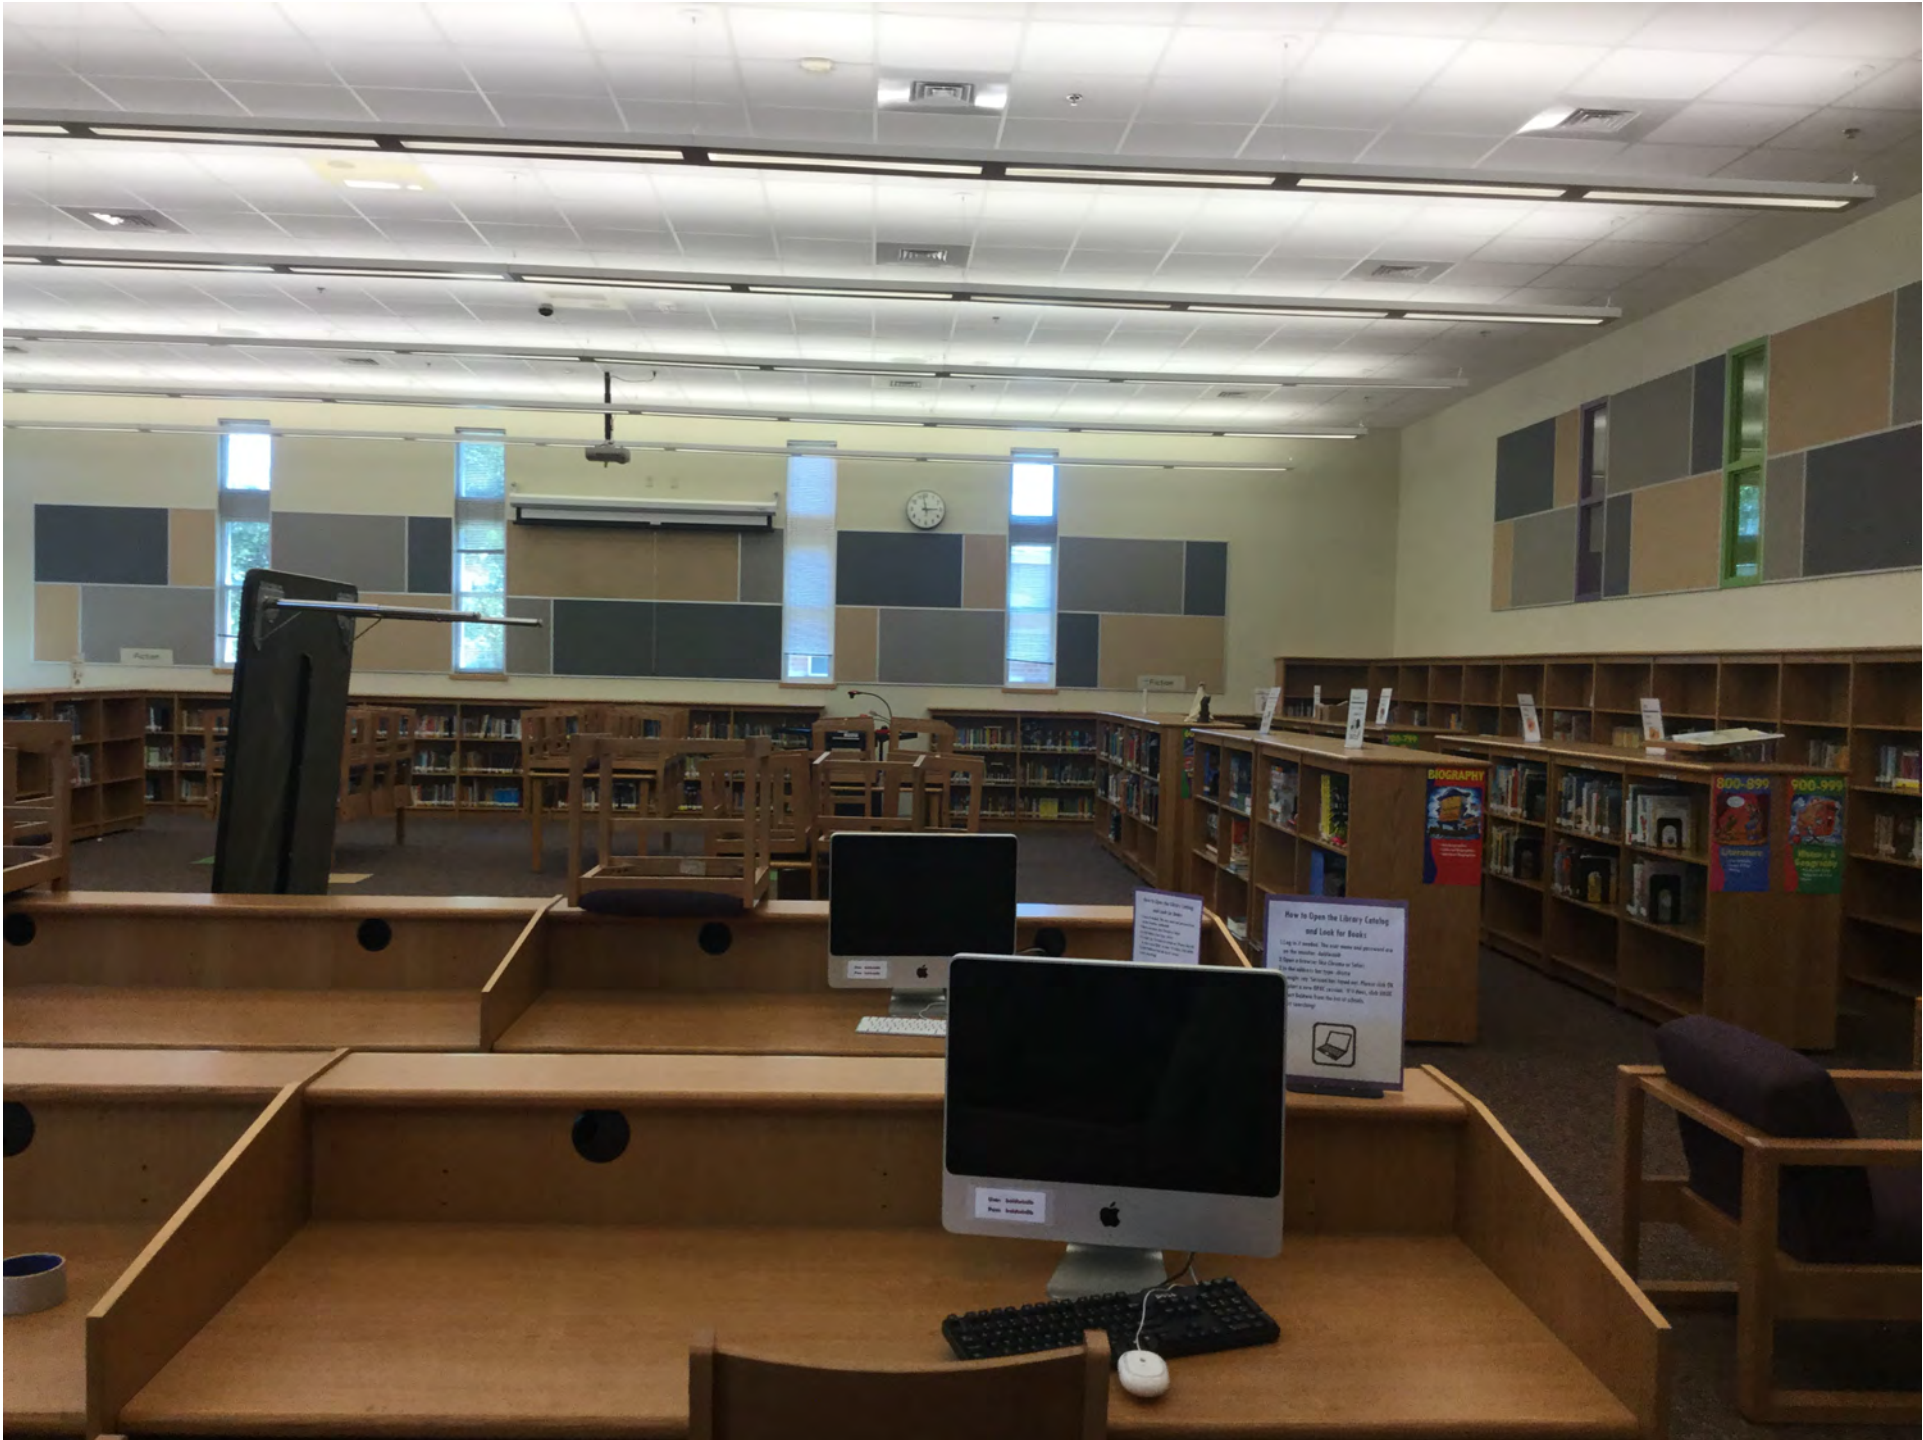
1) Very unsatisfactory 2) Unsatisfactory 3) Average 4) Good 5) Very good N/A) Does not apply.									
5.6	How well does the Library/Media Center support technology?				4			Comments	1.00 4.00

1) Very unsatisfactory - Very inadequate power outlets, no Wi-Fi capability, no computers, tablets, laptops, media carts or screens for use 2) Unsatisfactory - Some power, no Wi-Fi capability, outdated and inadequate technology available 3) Average - Some power outlets, network connectivity, technology available 4) Good - Adequate power outlets available, network connectivity, appropriate number of computers/tablets/laptops/media carts or screens available 5) Very good - Adequate power outlets available, good network connectivity, computers, tablets, laptops and media carts or screens available and adequate for number of students N/A) Does not apply.

5.6 Library Technology

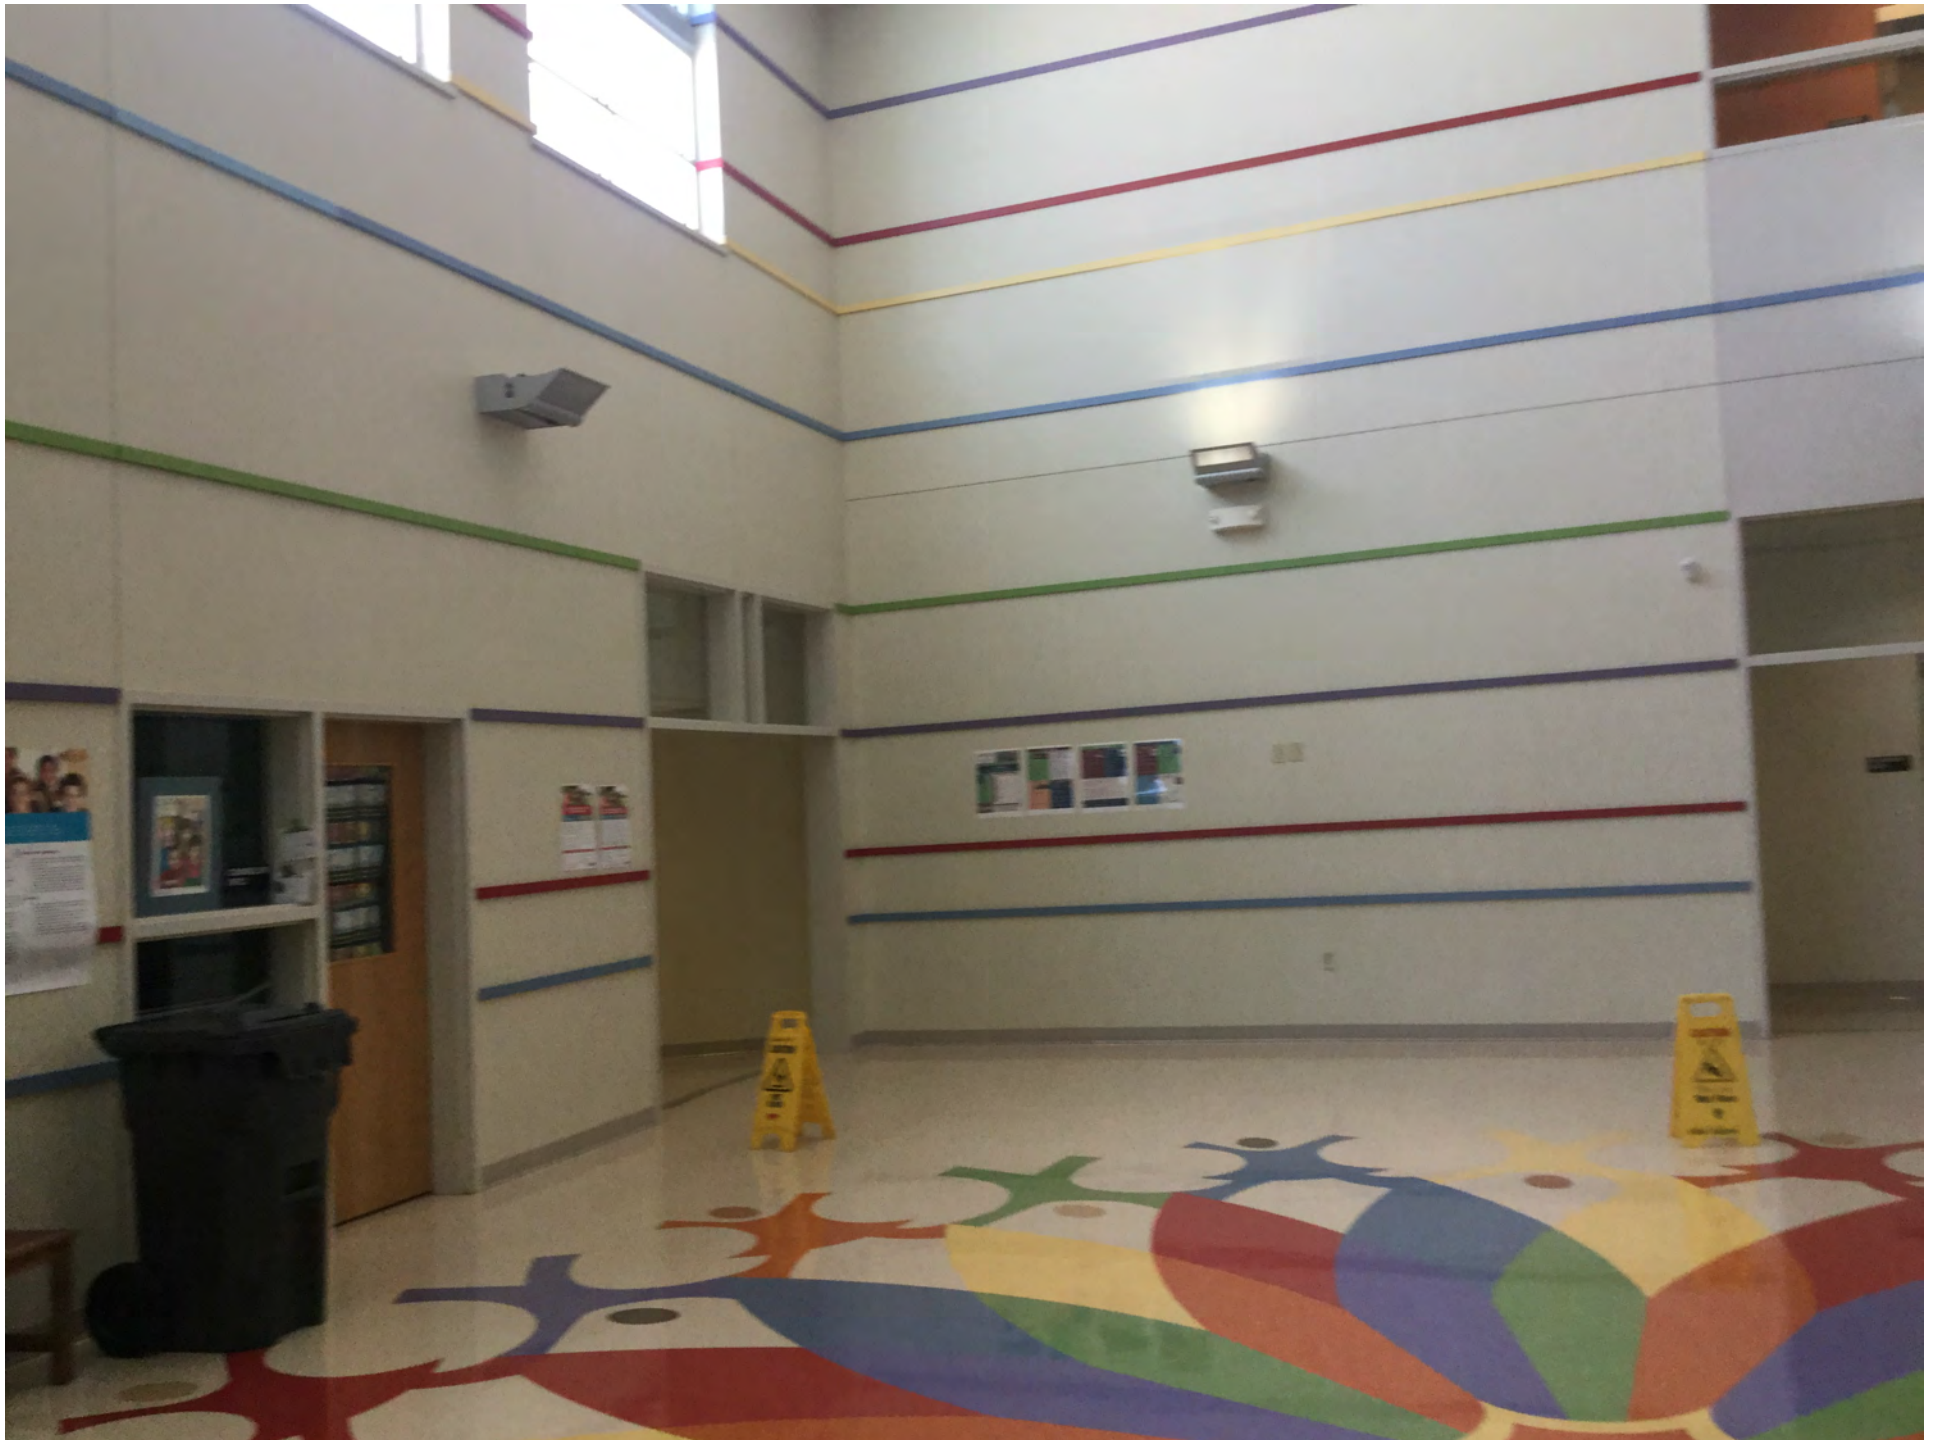
The location of the administration office is satisfactory in configuration and proximity to the main entrance, but no secure vestibule is present. The campus has adequate key card access. Site lighting is adequate, while security camera coverage needs improvement to discourage unauthorized access to the roof. Staff requested a secure perimeter that is lockable during

6.3	Is the main office properly located and configured with a secure vestibule to the main corridor?			3				Comments	1.00 3.00
1) Very unsatisfactory - No secure vestibule, office located far from main entry. Allows visitors access to school unsupervised. 2) Unsatisfactory - No secure vestibule, office located somewhat far from main entry, minimal supervision of visitors. 3) Average - Office close to entry, views of front door, but no secure vestibule 4) Good - Office is well-located with a secure vestibule, but needs updates 5) Very good - Office well-located with secure vestibule and all appropriate security features. N/A) Does not apply.

6.3 Non-Secure
Entry Vestibule

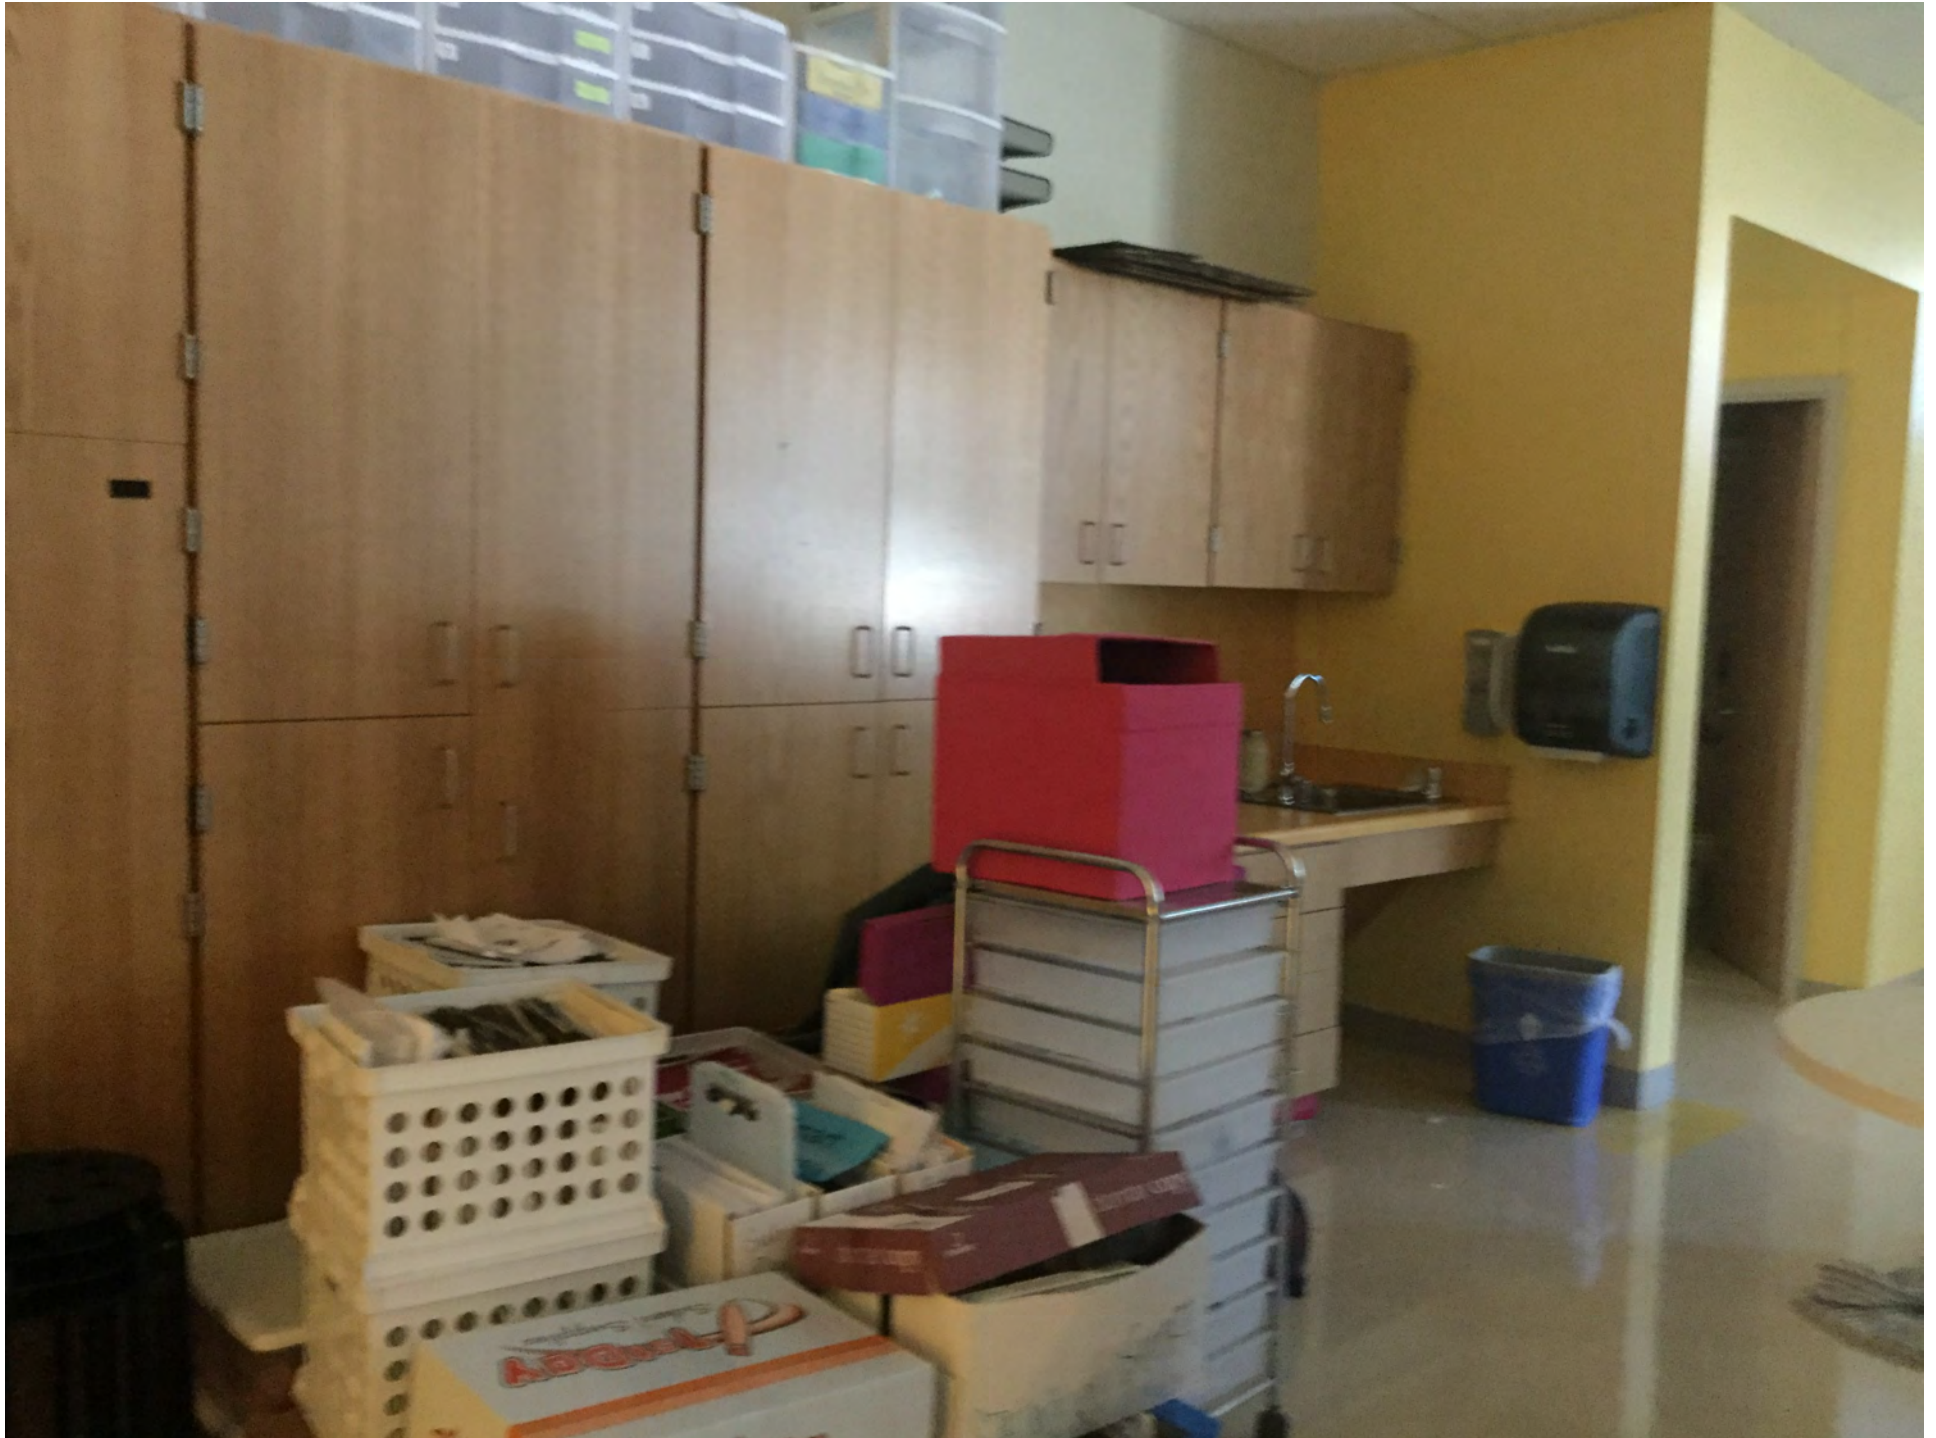
8.2 Classroom Storage
