## Educational Suitability Summary Report

Barrington Elementary School

Date: 08/02/2016

**Score 45% Unsatisfactory**

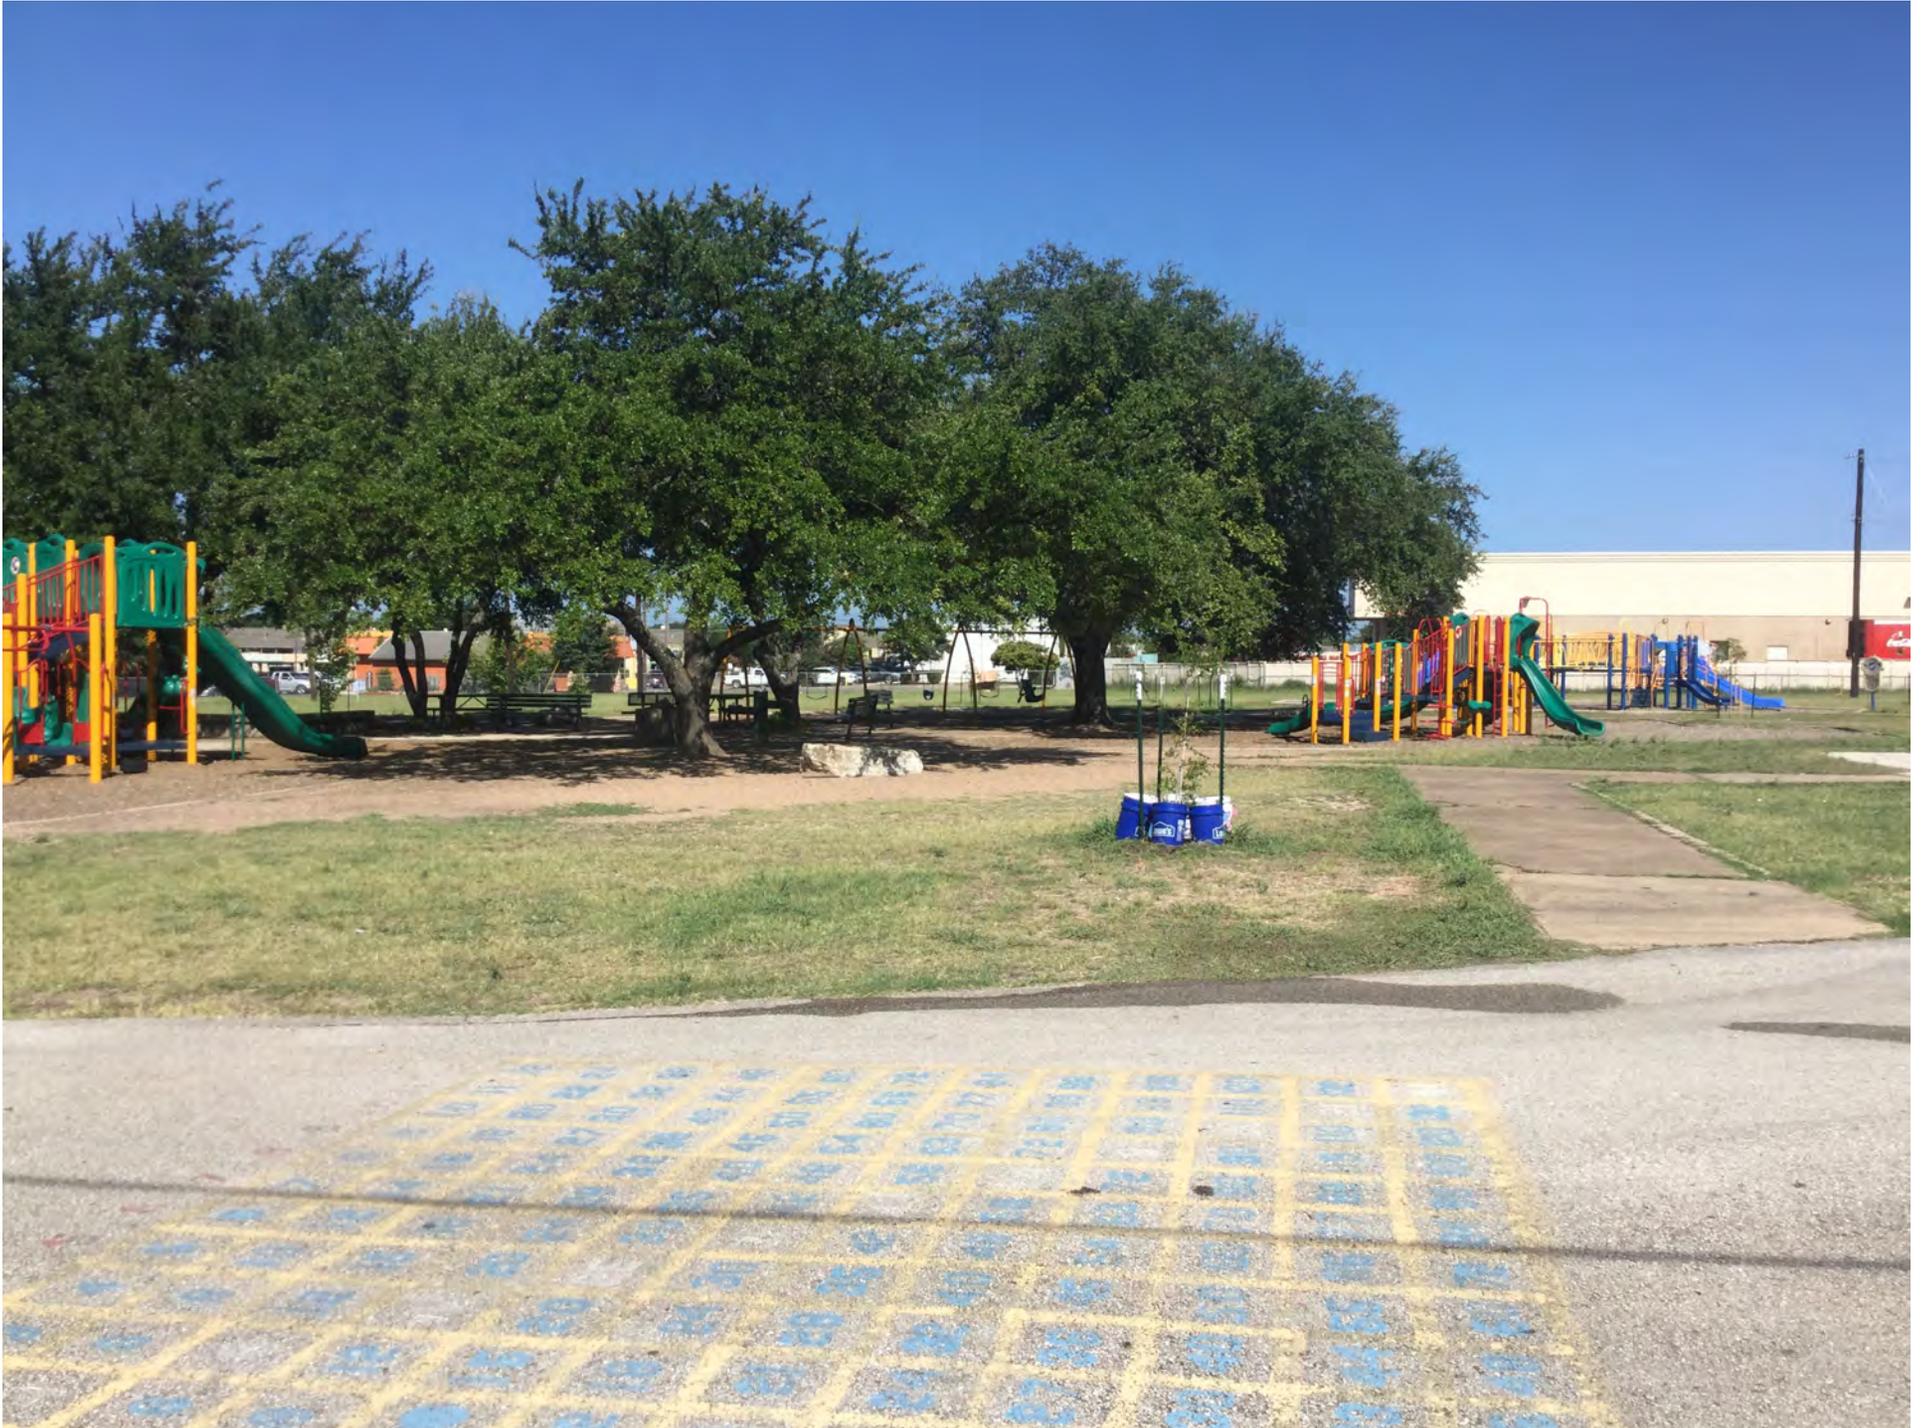
1.3 Playspace

1.3	Are outdoor play spaces and playfields adequate in size and configuration?			3				Comments	1.00	3.00
1) Outdoor play space exists, not developed 2)Outdoor play space exists but is not connected to gym or other athletic support areas or is too small. 3. Outdoor play spaces exist, are connected to other athletic areas, are the right size, but are not in good condition. 4. Outdoor play spaces need minor improvements to function well. 5. Outdoor play spaces are in excellent condition. N/A) Does not apply.

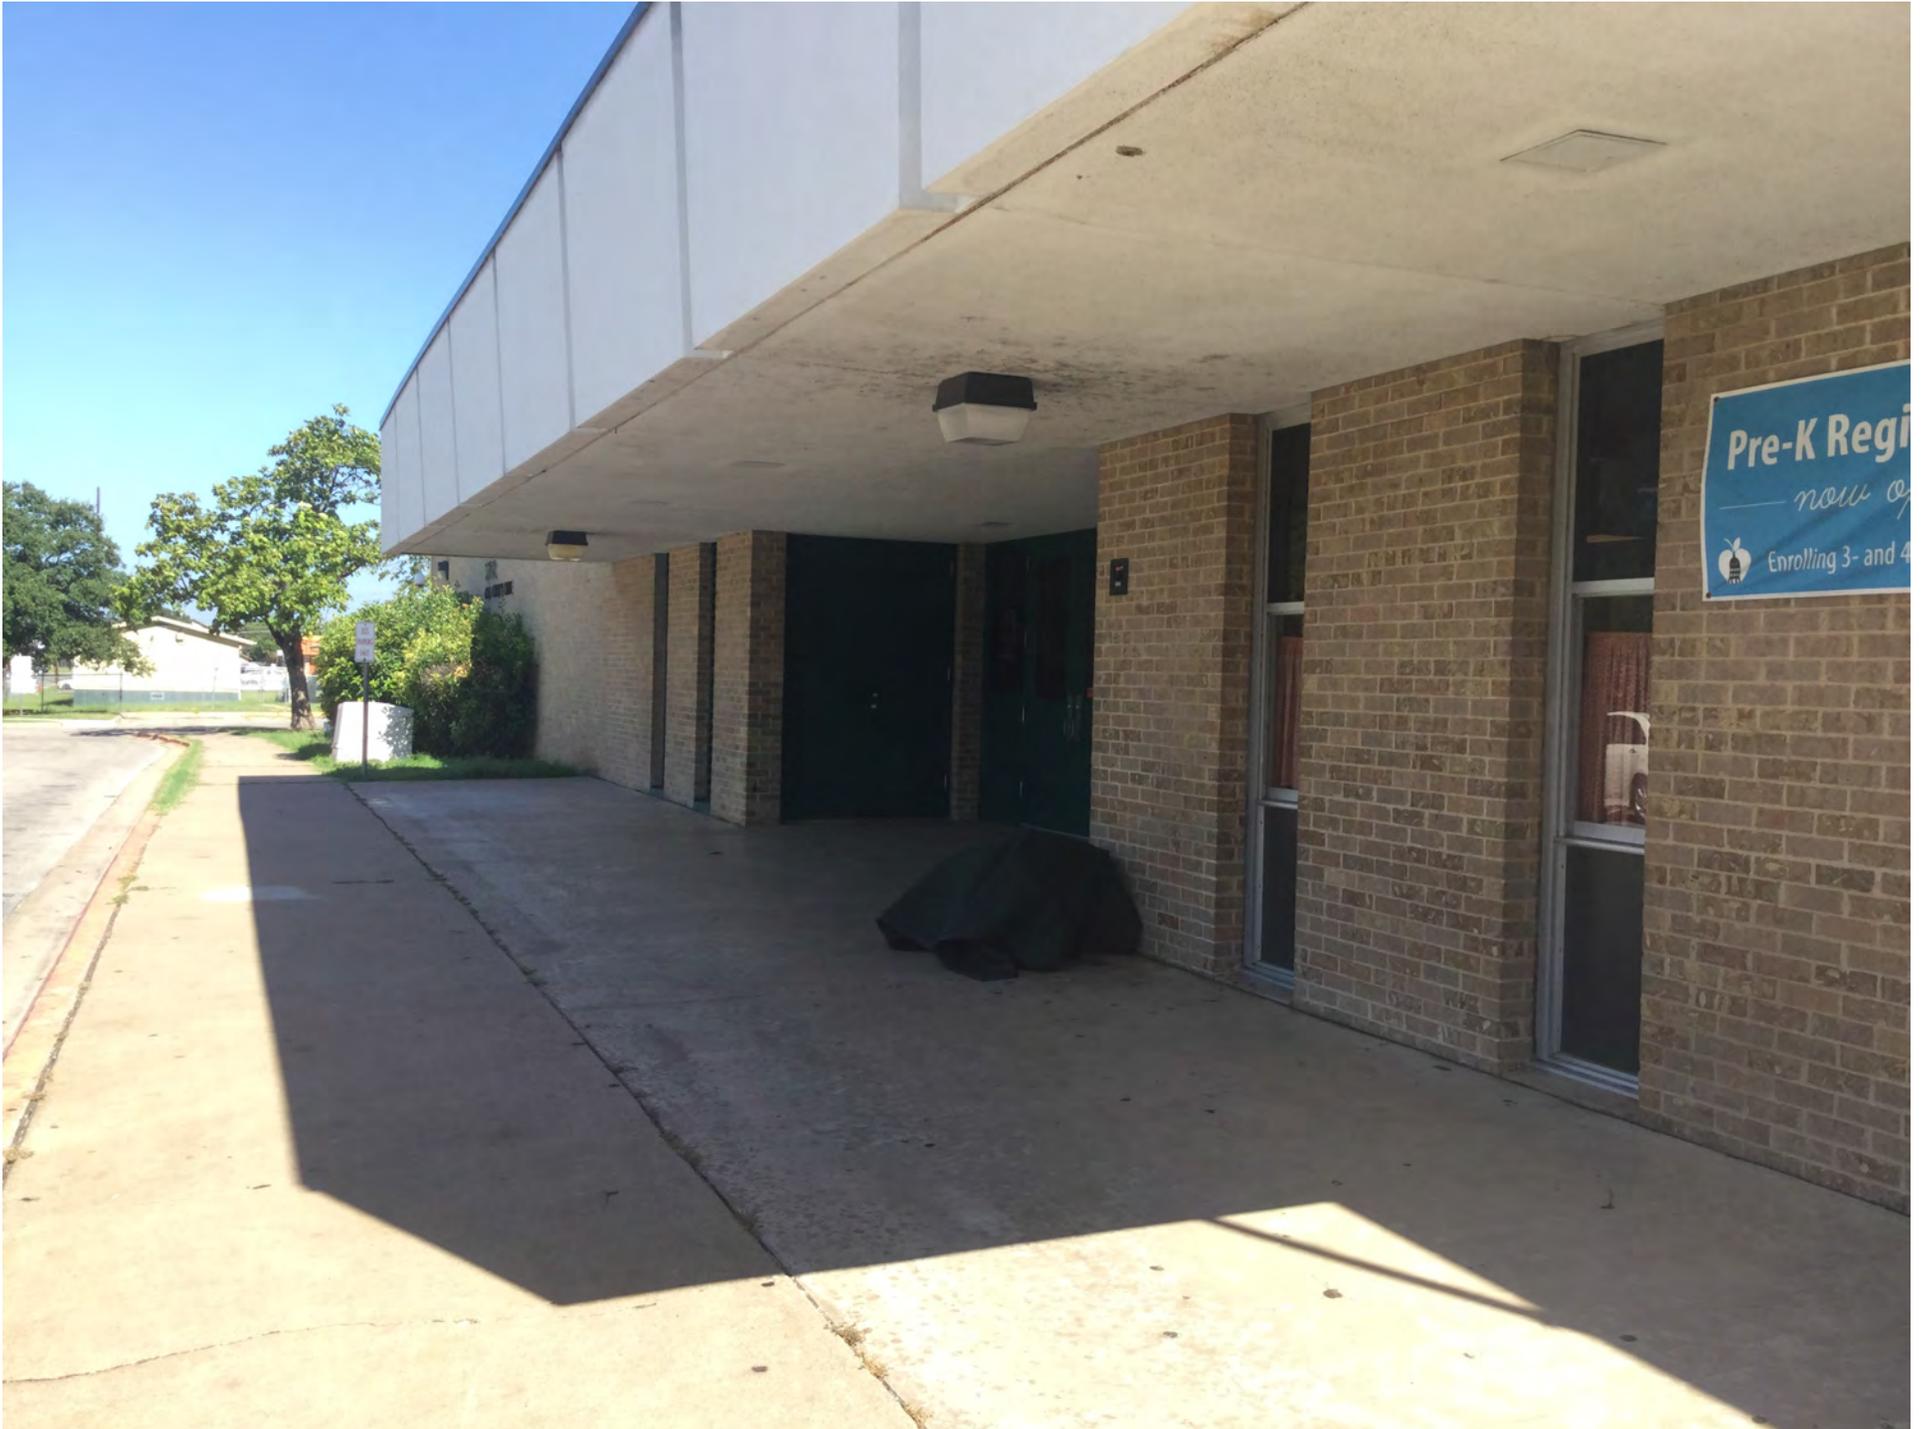
1.4 Front Entry

1.4	Is the building easily identified with appropriate signage and community wayfinding?	1						Comments	0.25	0.25
1) Campus has no signage and no striping. 2) Signage is faded/hidden. 3) Signage & striping visible but not apparent. 4) Signage is visible but not good condition. 5. Signage and wayfinding is visible and easy to use. N/A) Does not apply.		The campus wayfinding is poor, and the entrance is not easily identified.

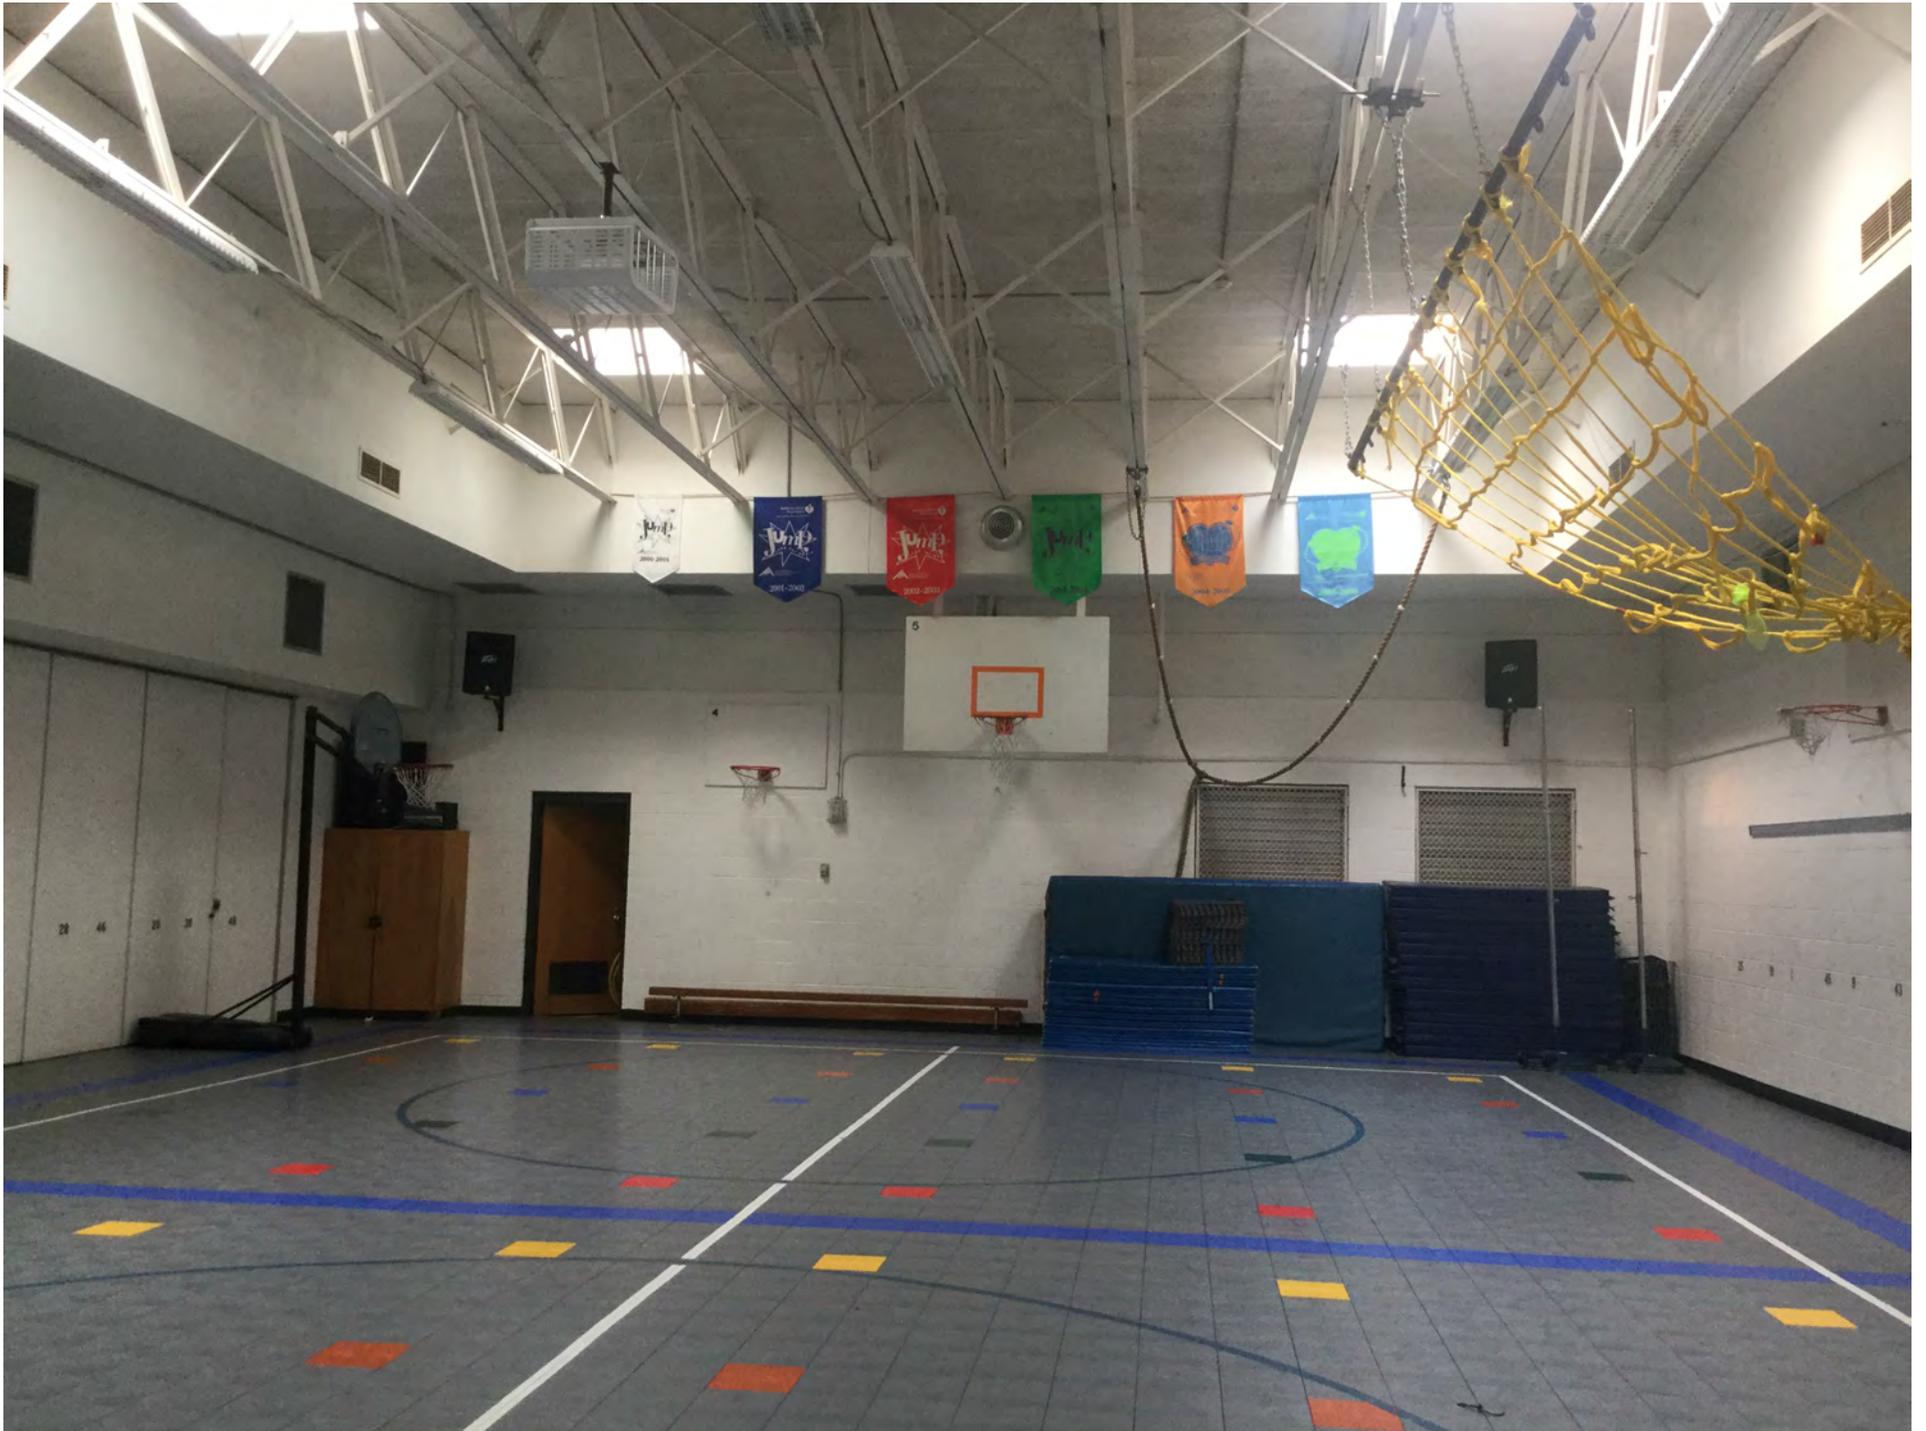
3.6 Gym

3 - Academic & Co-Curricular Support - Continued		1	2	3	4	5	N/A			
3.6	Are Physical Education and Athletic spaces appropriately configured per the ed spec?			3				Comments	1.00	3.00

1) Very unsatisfactory 2) Unsatisfactory 3) Average 4) Good 5) Very good N/A) Does not apply.		The athletic spaces are an average size, but could use some updates.

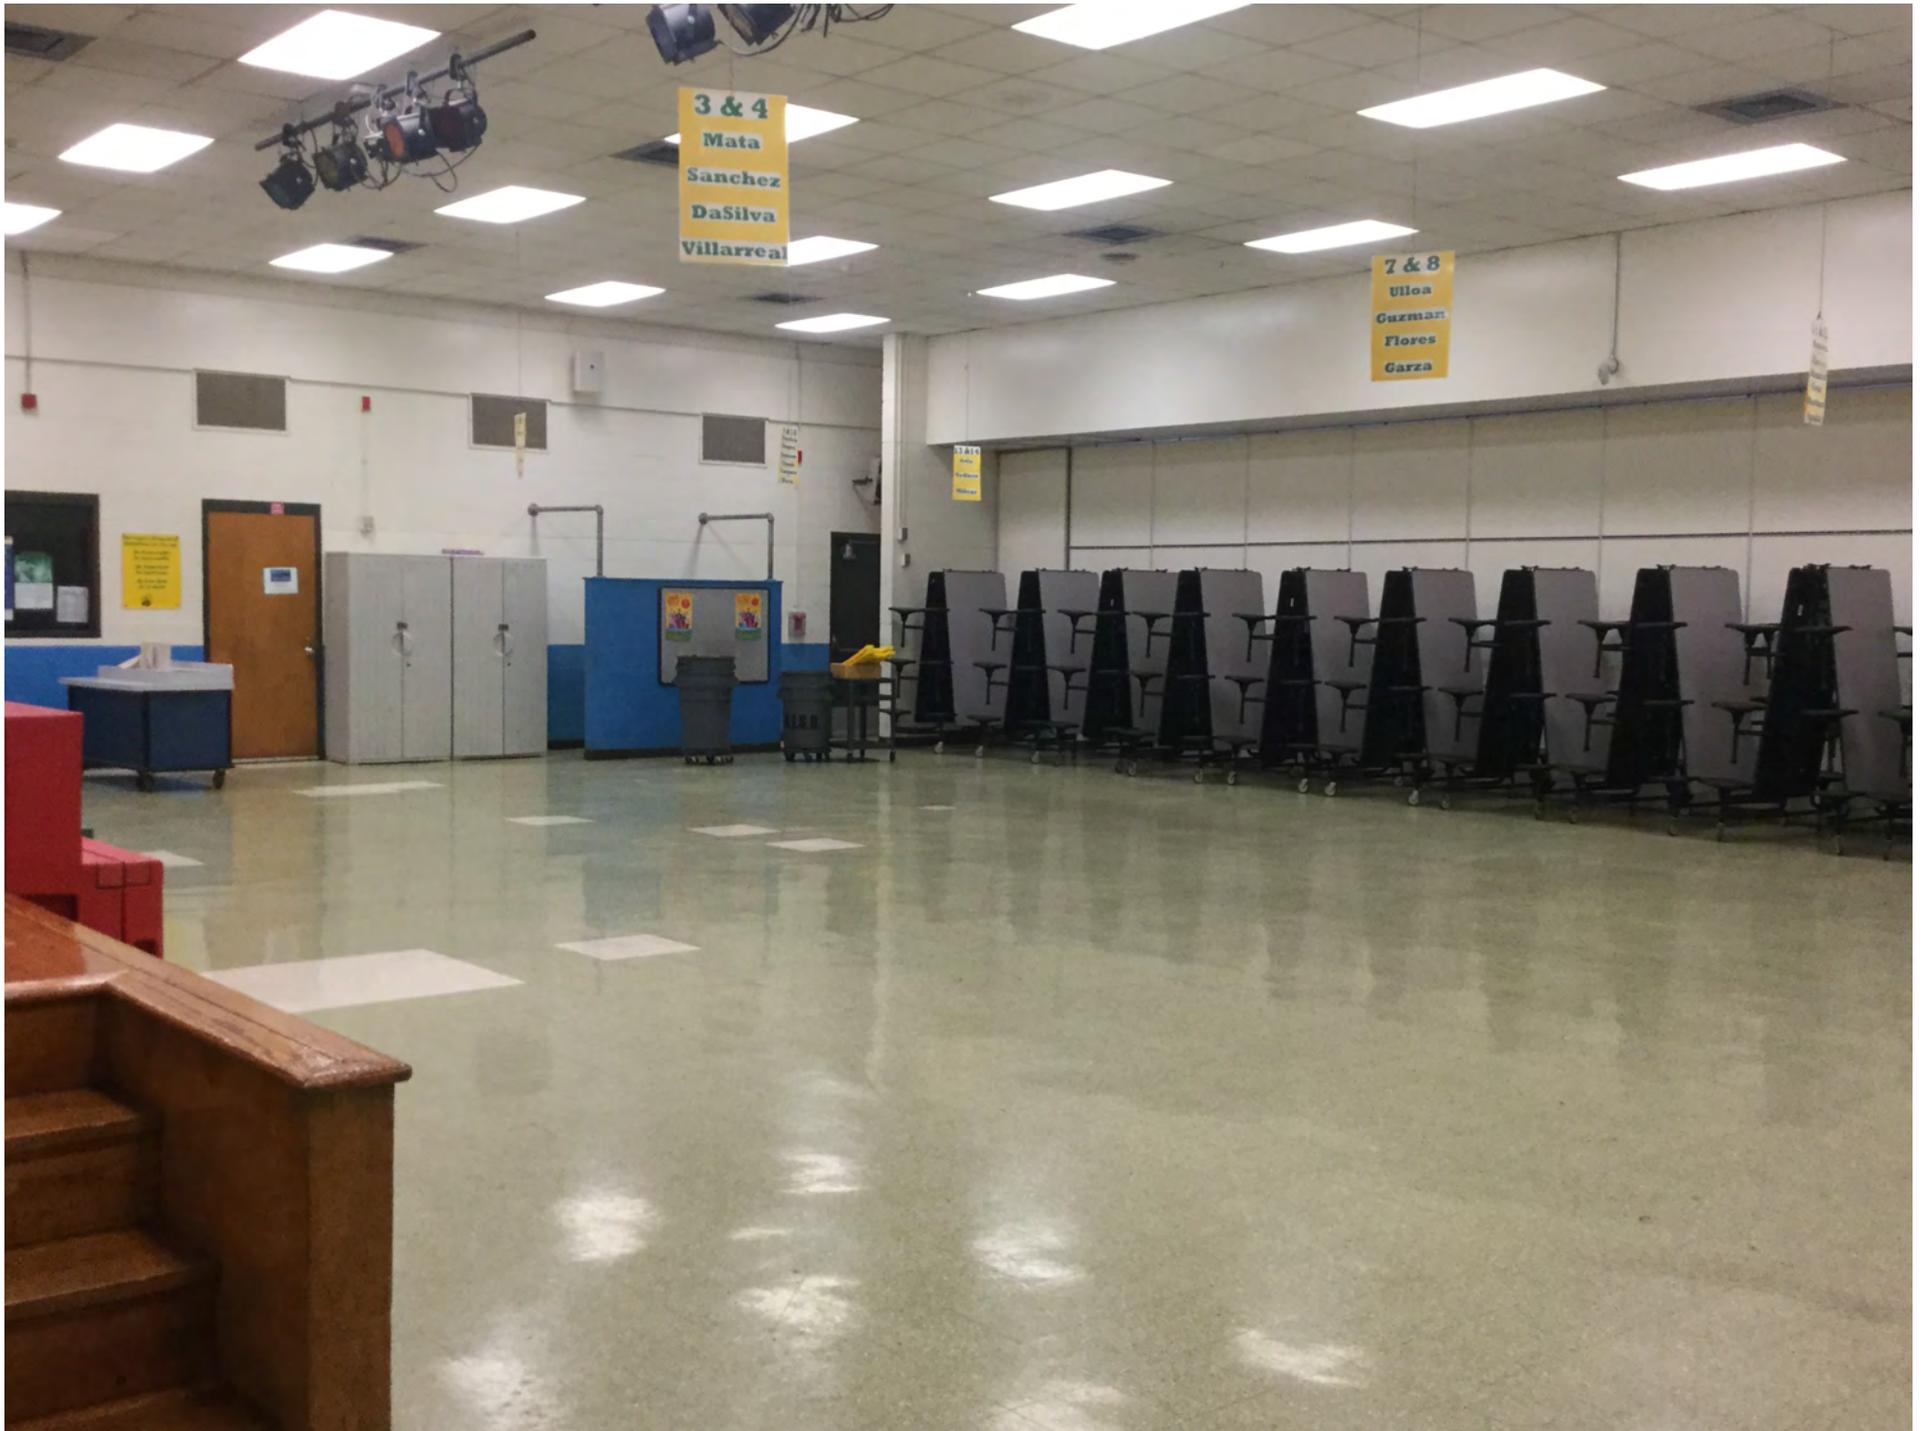
3.16 Cafeteria

3.16	Are the student dining facilities appropriately configured?		2					Comments	1.00 <b>2.00</b>
1) Very unsatisfactory - Too small, poor circulation, inflexible seating in poor condition 2) Unsatisfactory - Too small or inadequate circulation, seating in poor condition 3) Average - moderate size, with adequate circulation, seating in okay condition 4) Good - good size, adequate circulation, seating in good condition 5) Very good - good size, adequate circulation, seating in good condition, with more than one option for eating space (ex: connection to outdoor eating space) N/A) Does not apply.								The cafeteria is undersized and has a musty odor.

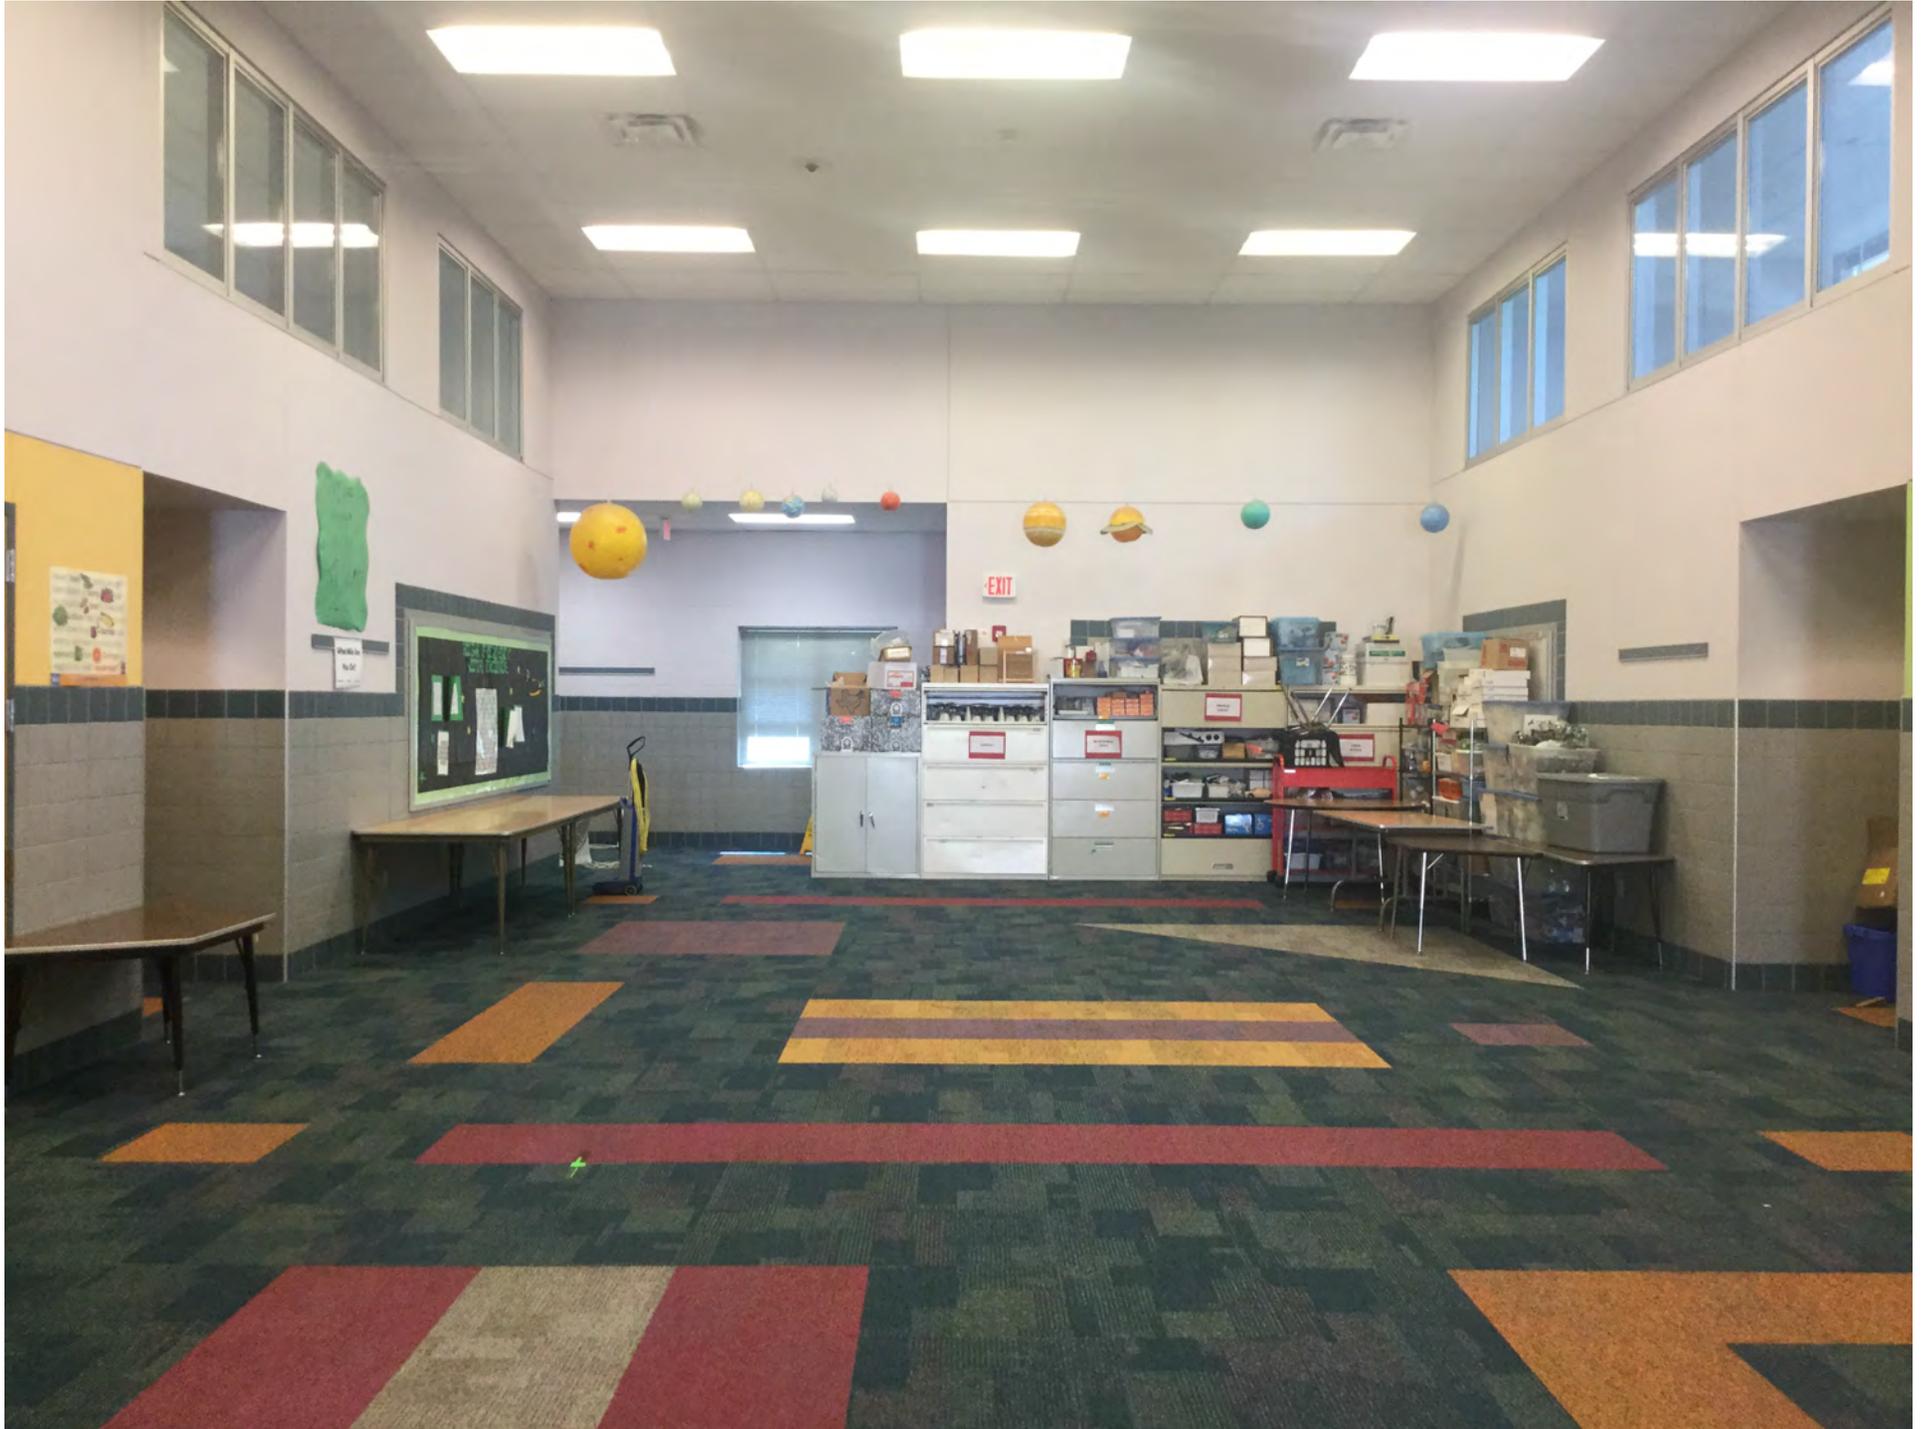
4.1 Flex Space

4 - Future Ready Student Development		1	2	3	4	5	N/A			20.00
4.1	Does the facility provide specialized space and opportunities for hands-on project-based learning?			3				Comments	1.00	3.00

1) Very unsatisfactory - No project space 2) Unsatisfactory - Non-dedicated, undersized or otherwise inadequate 3) Average - Limited dedicated spaces of moderate size and layout, equipment and furniture appropriate but need updates 4) Good - Dedicated spaces of adequate size and layout, most of the equipment and furniture is appropriate for program 5) Very good - Dedicated spaces of adequate size and layout, equipment and furniture appropriate for program N/A) Does not apply.		There are common spaces throughout the campus that need varying updates.

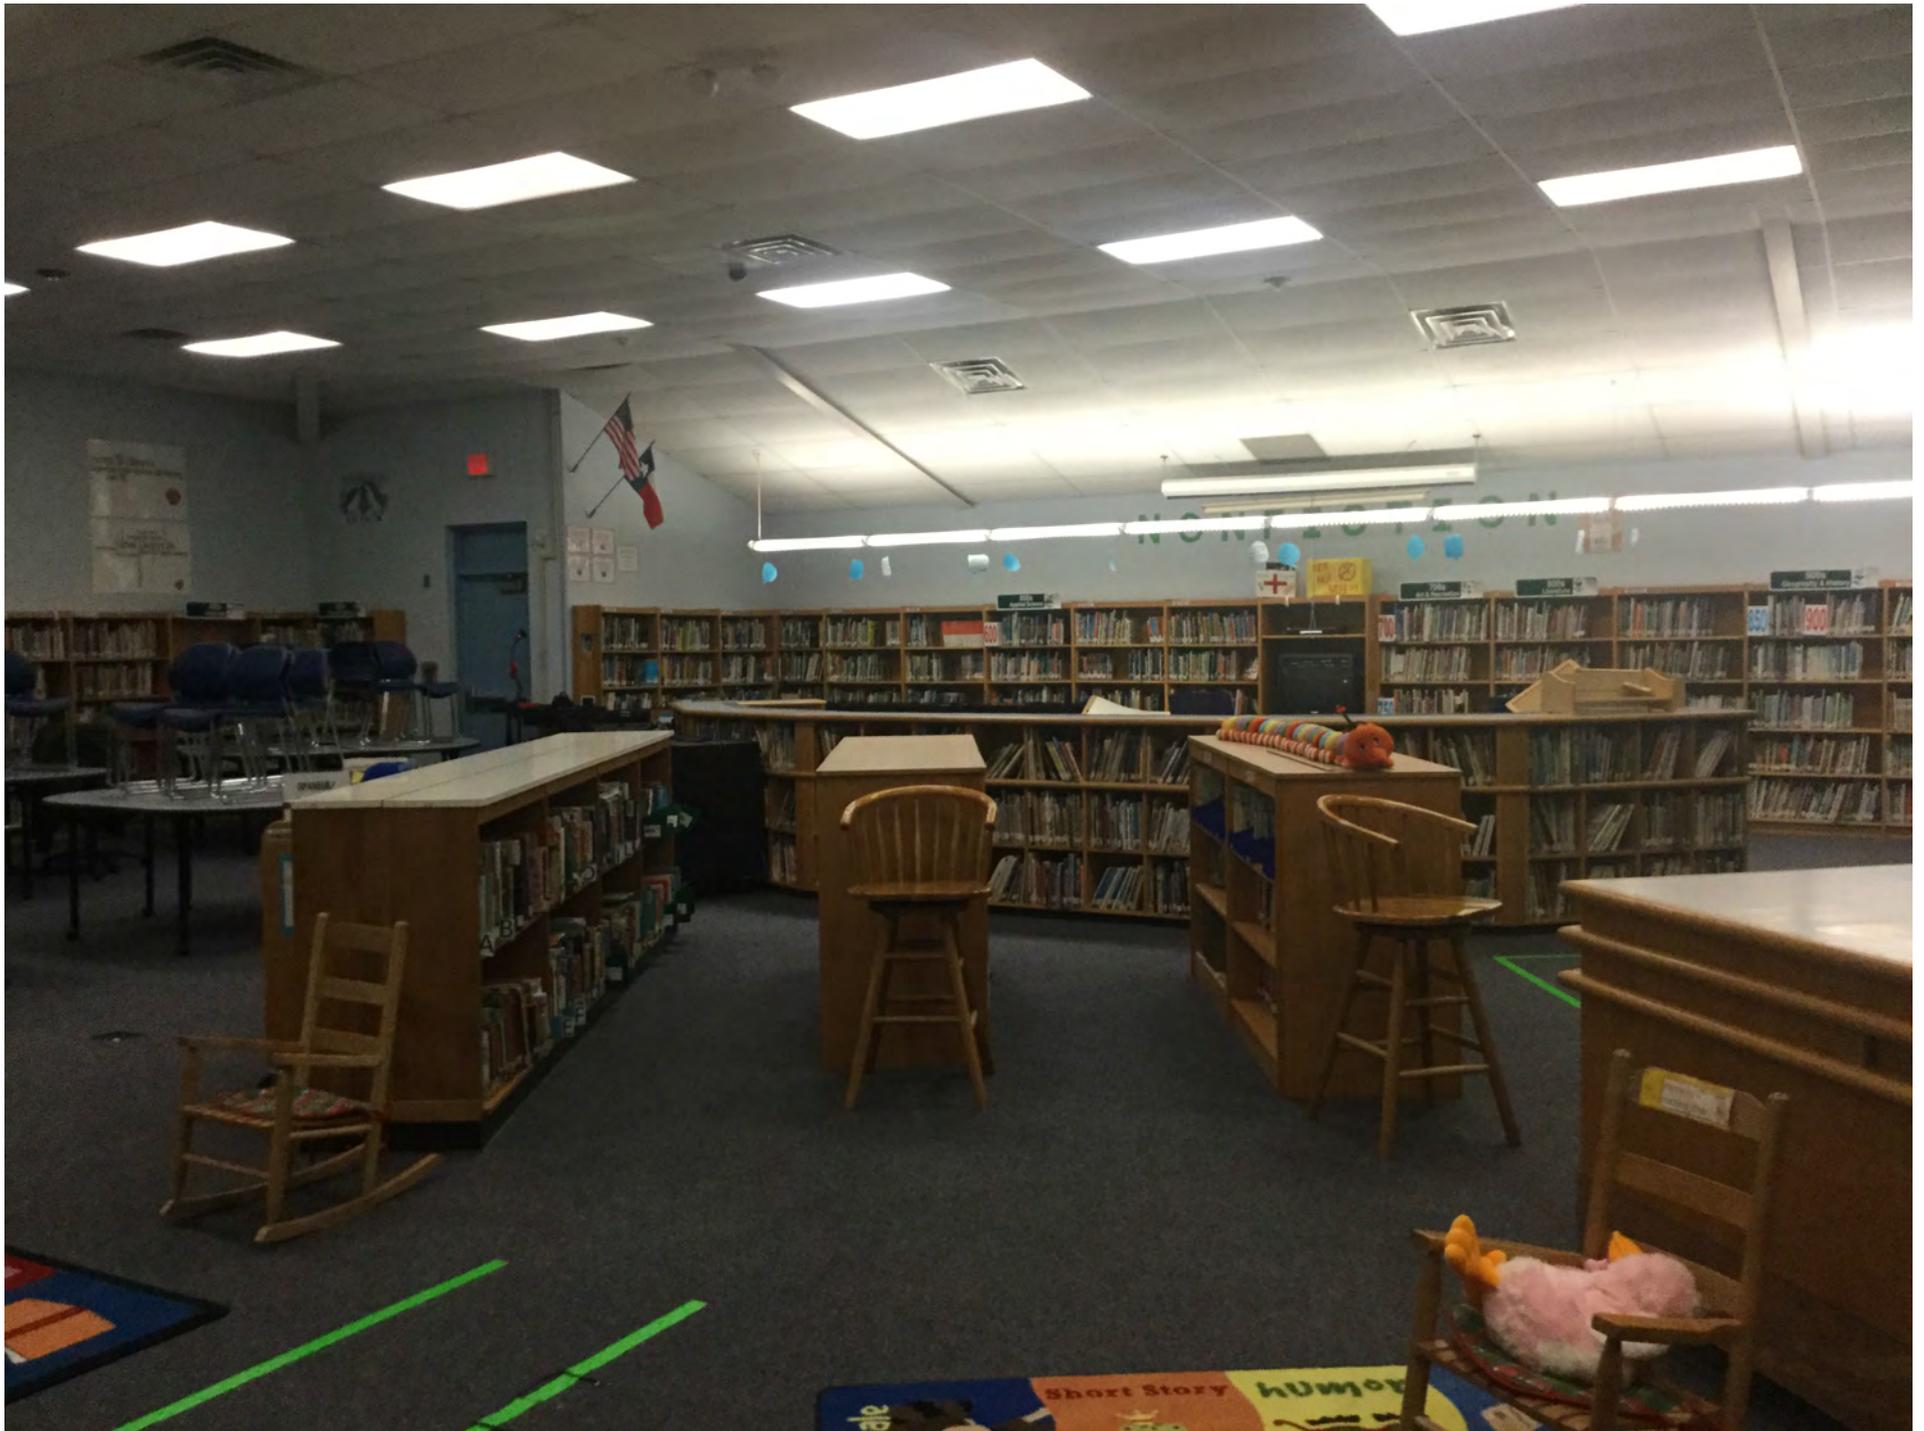
5.3 Library

5.3	How well does the Library/Media Center support social interaction?				4			Comments	1.00	4.00	
1) Very unsatisfactory 2) Unsatisfactory 3) Average 4) Good 5) Very good N/A) Does not apply.								There is a learning stair and limited casual seating.

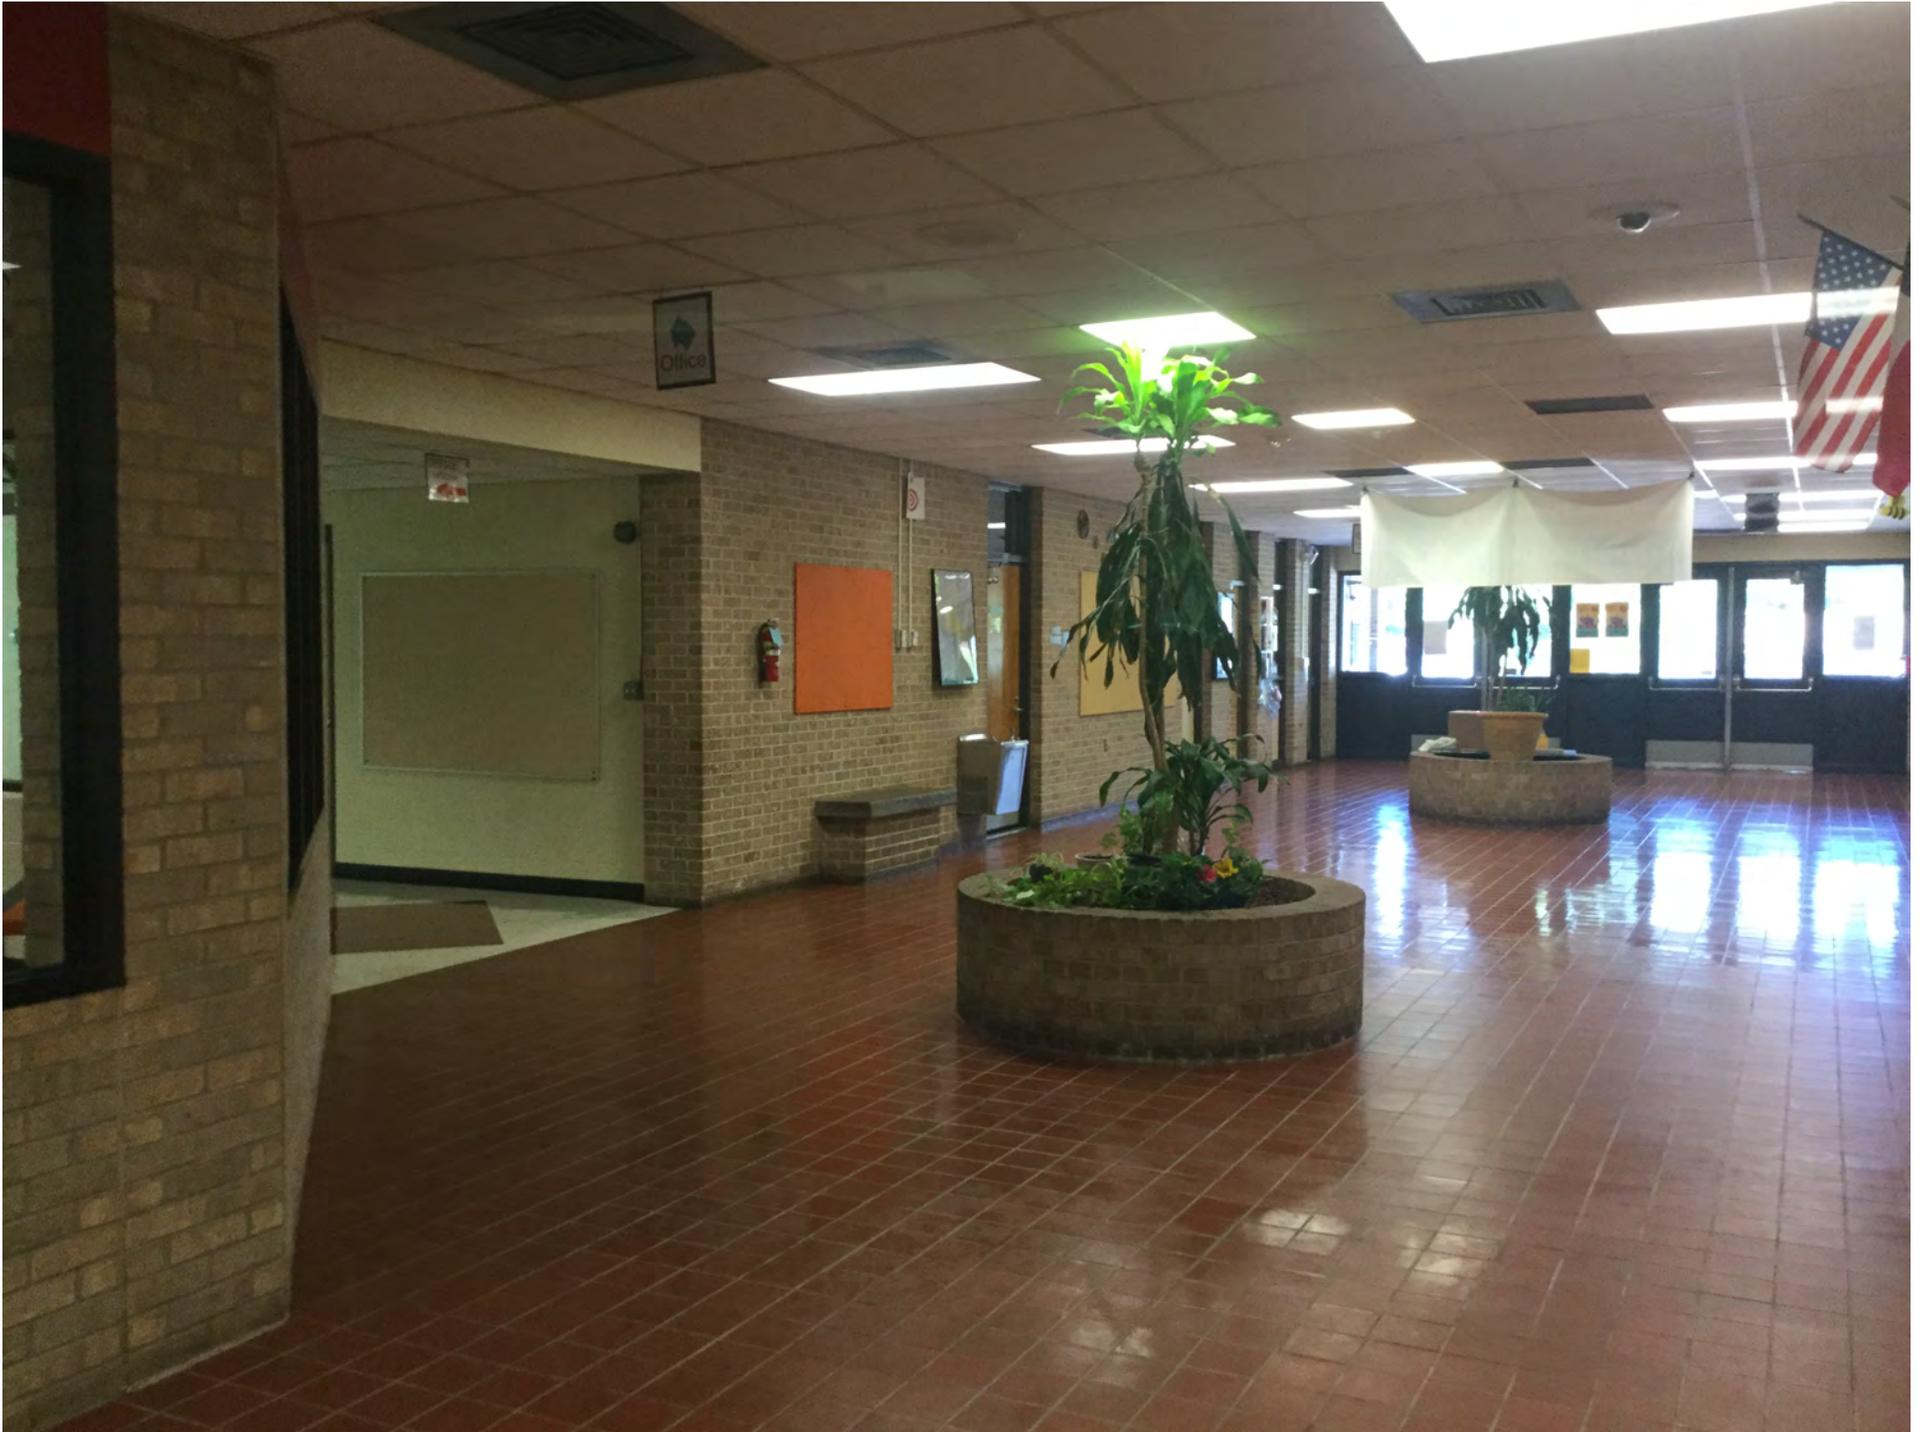
6.3 Entry

6.3	Is the main office properly located and configured with a secure vestibule to the main corridor?		2					Comments	1.00	2.00
1) Very unsatisfactory - No secure vestibule, office located far from main entry. Allows visitors access to school unsupervised. 2) Unsatisfactory - No secure vestibule, office located somewhat far from main entry, minimal supervision of visitors. 3) Average - Office close to entry, views of front door, but no secure vestibule 4) Good - Office is well-located with a secure vestibule, but needs updates 5) Very good - Office well-located with secure vestibule and all appropriate security features. N/A) Does not apply.
