## Educational Suitability Summary Report

Becker Elementary School – BLDG #104

Date: 8/17/2016 – (Rev 1 - 11/4/16 – Added Survey Responses)

**Score 41% Unsatisfactory**

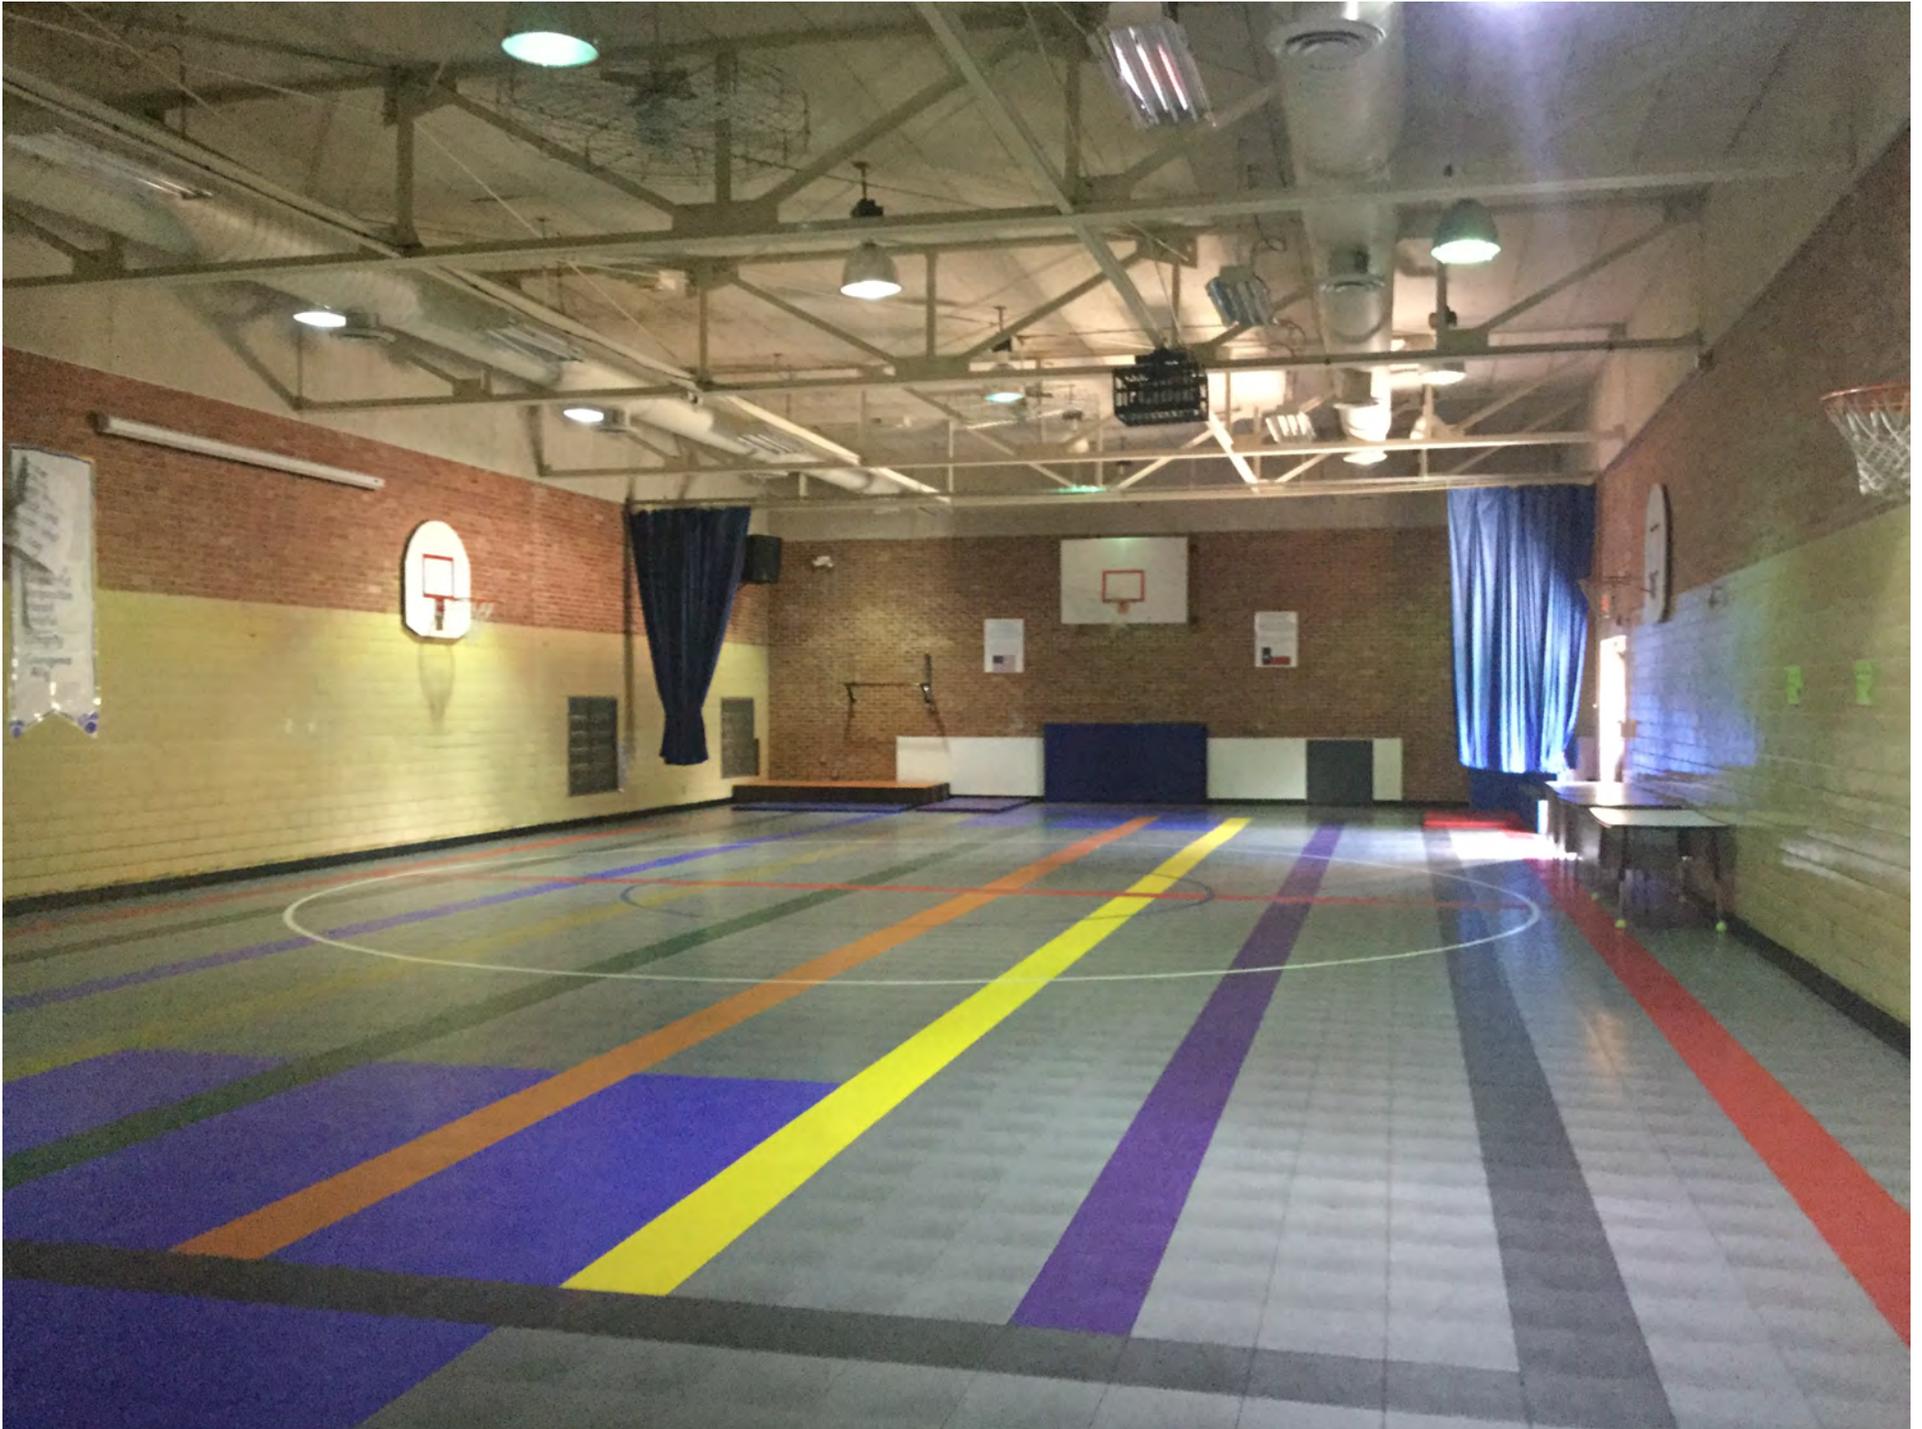
Photo 3. Gym

1) Very unsatisfactory 2) Unsatisfactory 3) Average 4) Good 5) Very good N/A) Does not apply.									Size is adequate, but the condition of space is fully inadequate. Low ceilings, dated equipment, severe mold/mildew issues, several areas of water leaks, odor issues, etc.

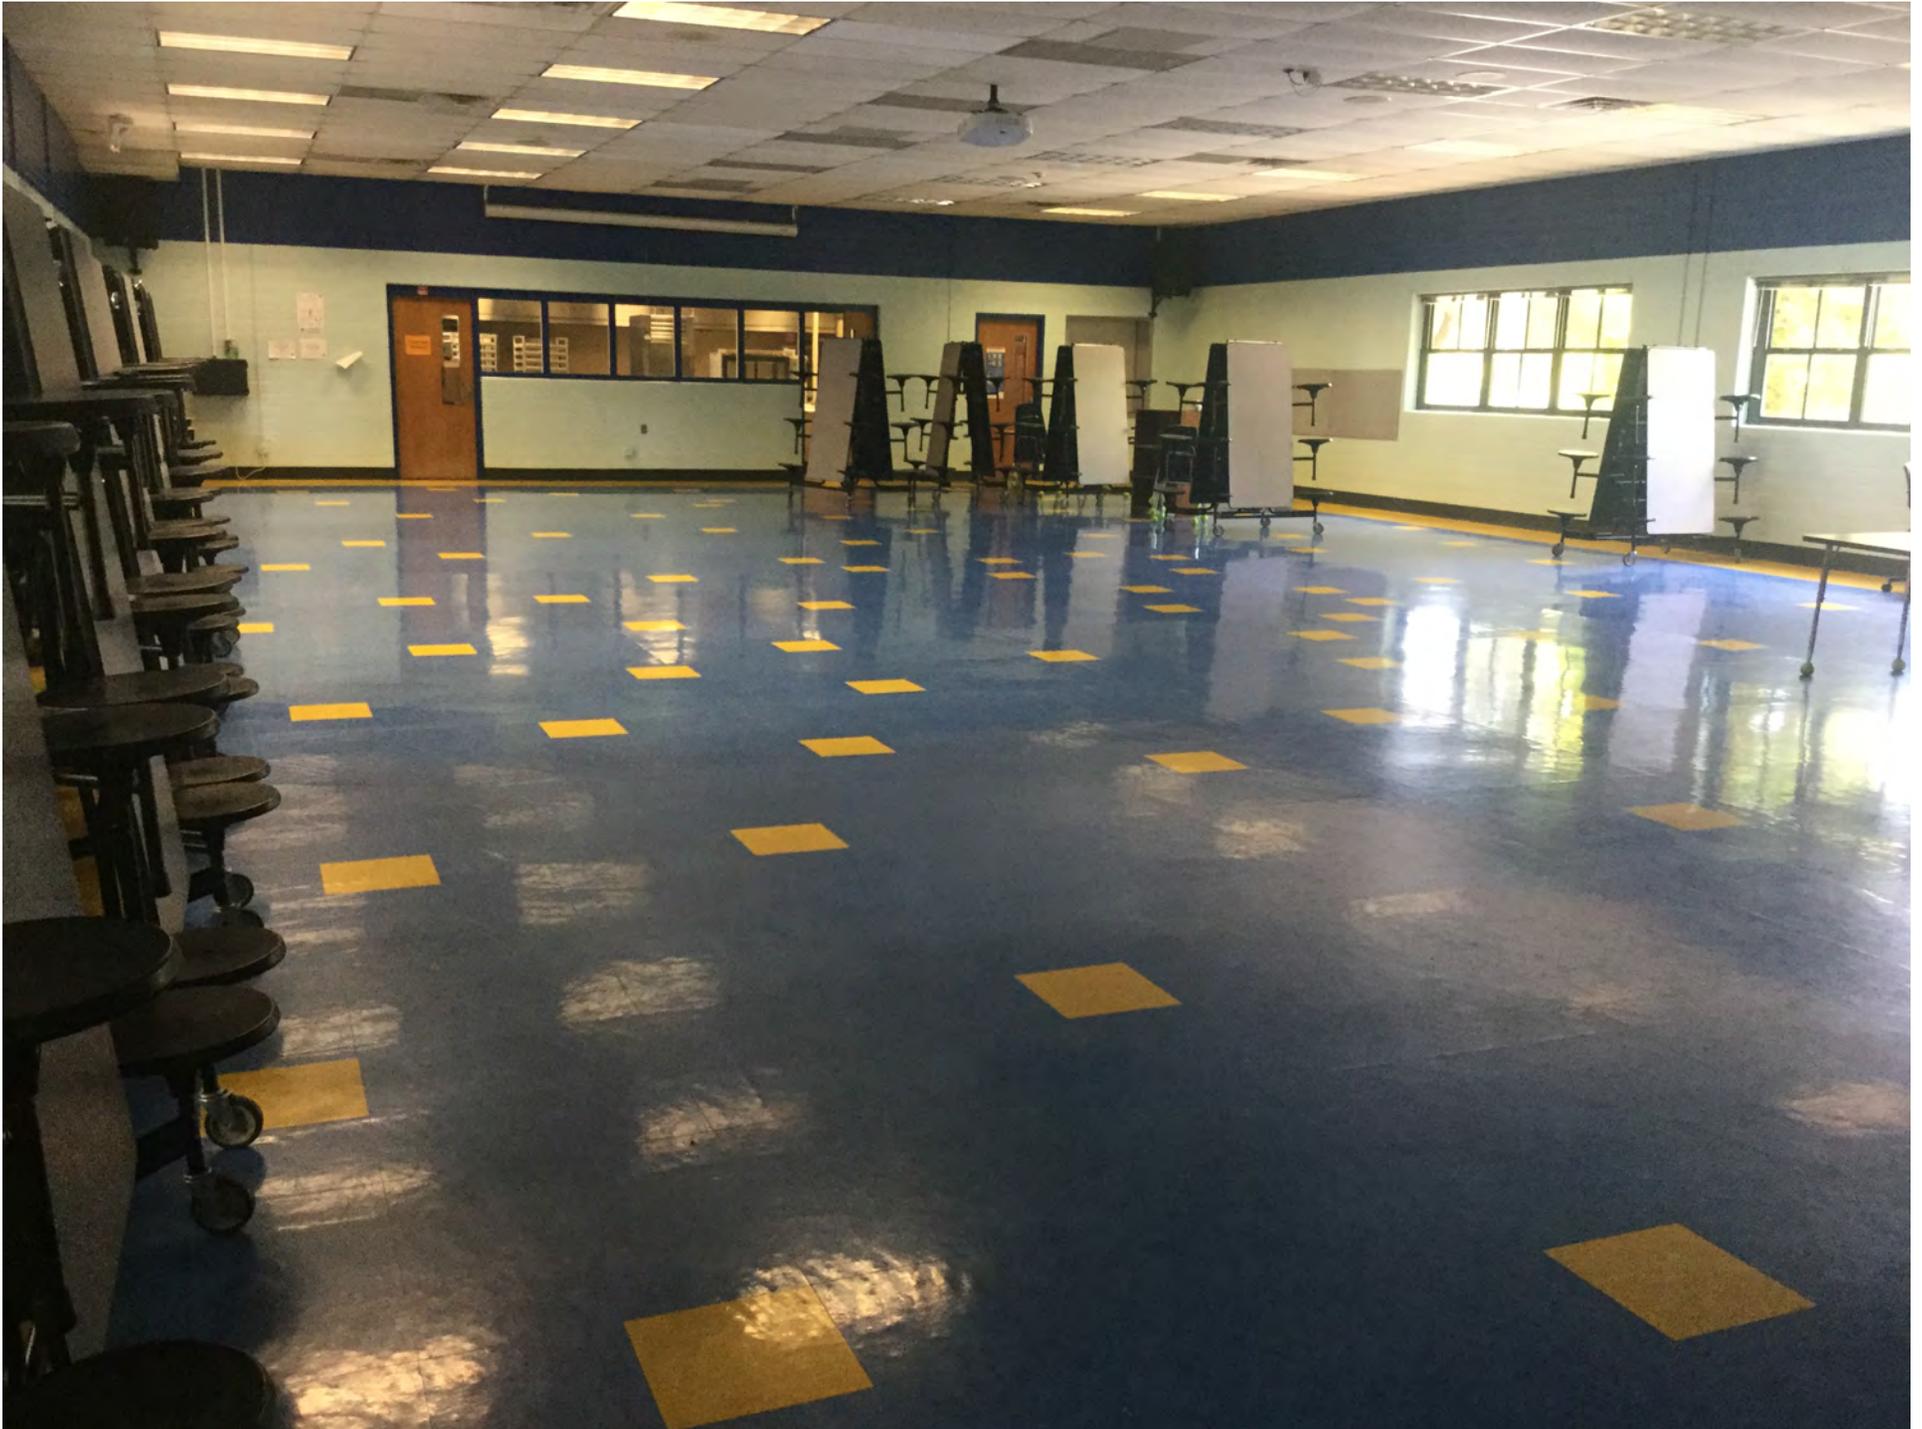
Photo 4. Cafeteria

3.16	Are the student dining facilities appropriately configured?			3				Comments	1.00 <b>3.00</b>
1) Very unsatisfactory - Too small, poor circulation, inflexible seating in poor condition 2) Unsatisfactory - Too small or inadequate circulation, seating in poor condition 3) Average - moderate size, with adequate circulation, seating in okay condition 4) Good - good size, adequate circulation, seating in good condition 5) Very good - good size, adequate circulation, seating in good condition, with more than one option for eating space (ex: connection to outdoor eating space) N/A) Does not apply.								Cafeteria is undersized for the growing population. Space does not have a built-in stage as do other AISD schools. They currently use a portable stage that is only partially functional. Kitchen equipment is limiting (dishwasher operates poorly and forces use of Styrofoam trays, milk cart isn't refrigerated, seating is old and breaking) and there are reports of poor acoustics and poor air conditioning.

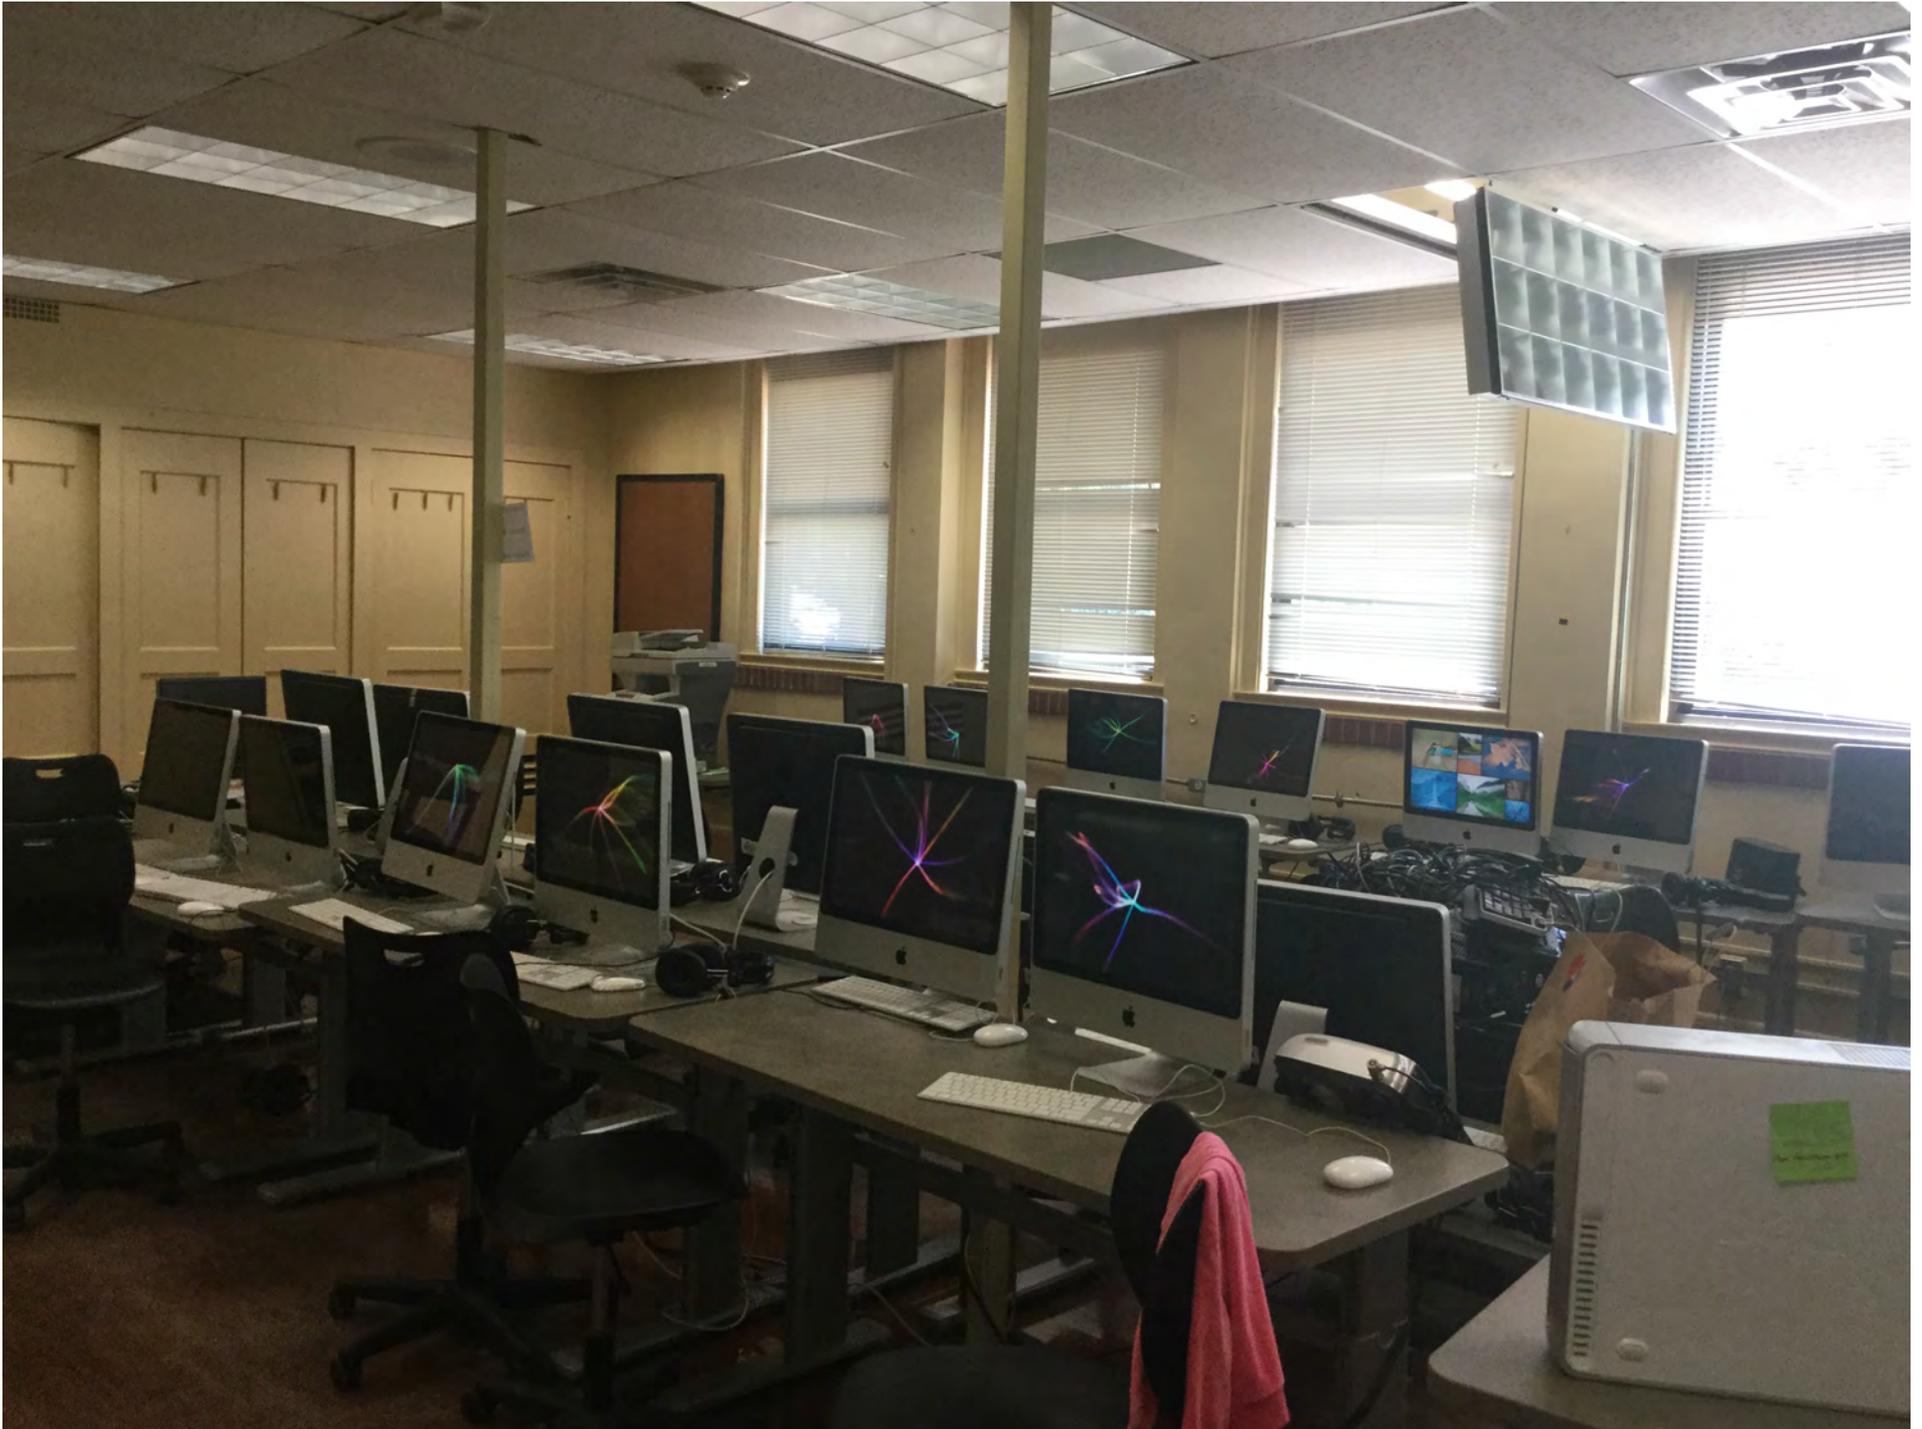
Photo 6. Computer Lab

3.12	Are computer lab spaces appropriately configured?			3				Comments	1.00	3.00
1) Very unsatisfactory 2) Unsatisfactory 3) Average 4) Good 5) Very good N/A) Does not apply.								The computer lab is small and technology is at end of life.

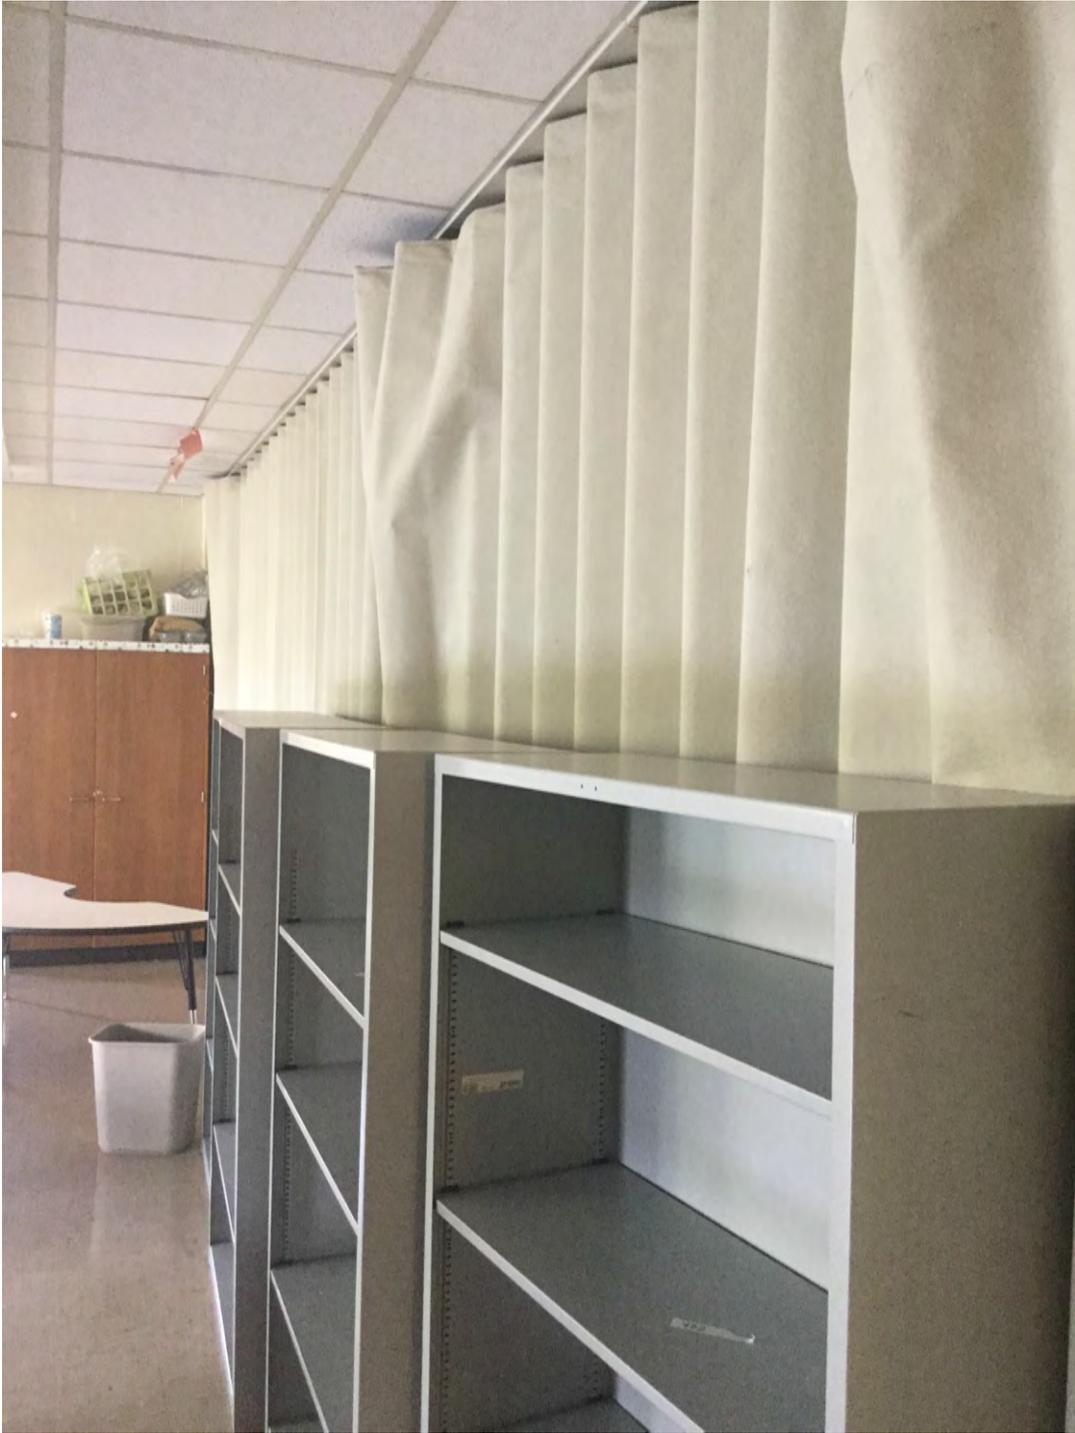
Photo 7. Furniture

The building utilizes a mix of dated, mismatched furniture and newer furniture types. While most appear in adequate condition some instances appear inappropriate for the intended student age group. For example, staff report that the newer, trapezoid shaped desks are oversized, top heavy, and frequently topple over on students. An uneven floor in the original building may contribute to this issue. Additionally, heavy wooden furniture with mismatched plastic chairs limit flexibility in the library. Cafeteria tables and chairs are dated and in poor condition (i.e. seats cracked, broken, or missing altogether).
