Educational Suitability Summary Report

Blanton Elementary School – BLDG 106

Date: 06/14/2016

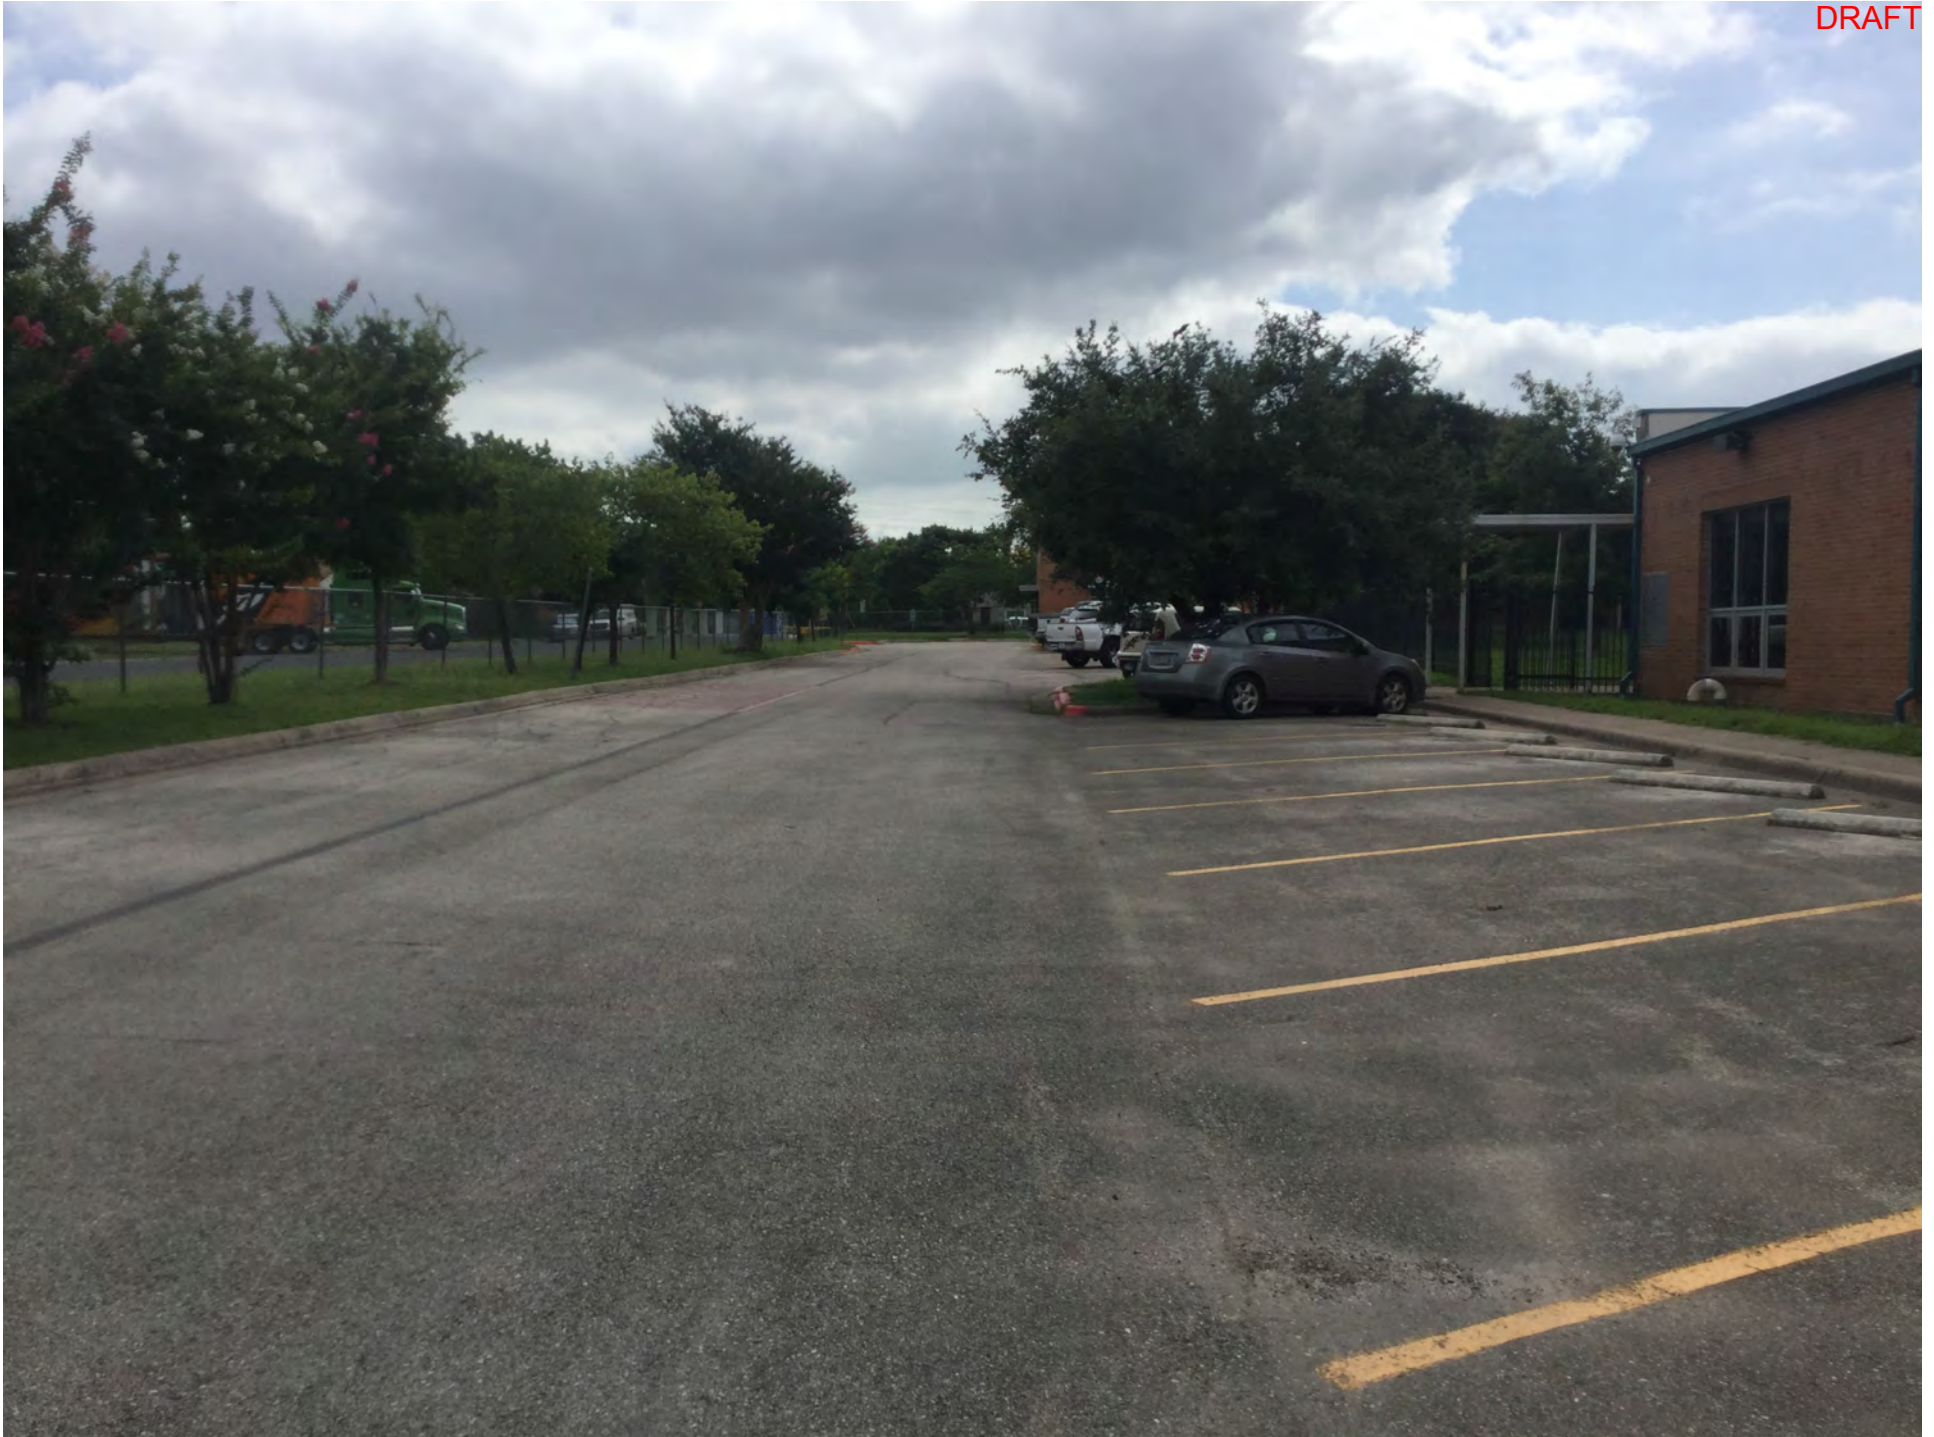
Photo 1.
1.1 Bus Lane

1 - Exterior		1	2	3	4	5	N/A	6.75	
1.1	Does the site permit desirable separation of vehicular, bus and pedestrian traffic?		2					Comments	1.00 2.00
	<p>1) Bus , car and pedestrian all happen at the same location.</p> <p>2) Cars and buses mix, pedestrians are separated.</p> <p>3) Buses, cars, and pedestrians are separate but stack space is small.</p> <p>4) Buses, cars, and pedestrians are separate but drop off does not have a canopy or a holding place like a commons or cafeteria.</p> <p>5) Buses, cars, and pedestrians are separate and drop off area has a canopy and destination.</p> <p>N/A) Does not apply.</p>							The buses sometimes cause issues blocking teachers' vehicles from exiting.	see photo 1

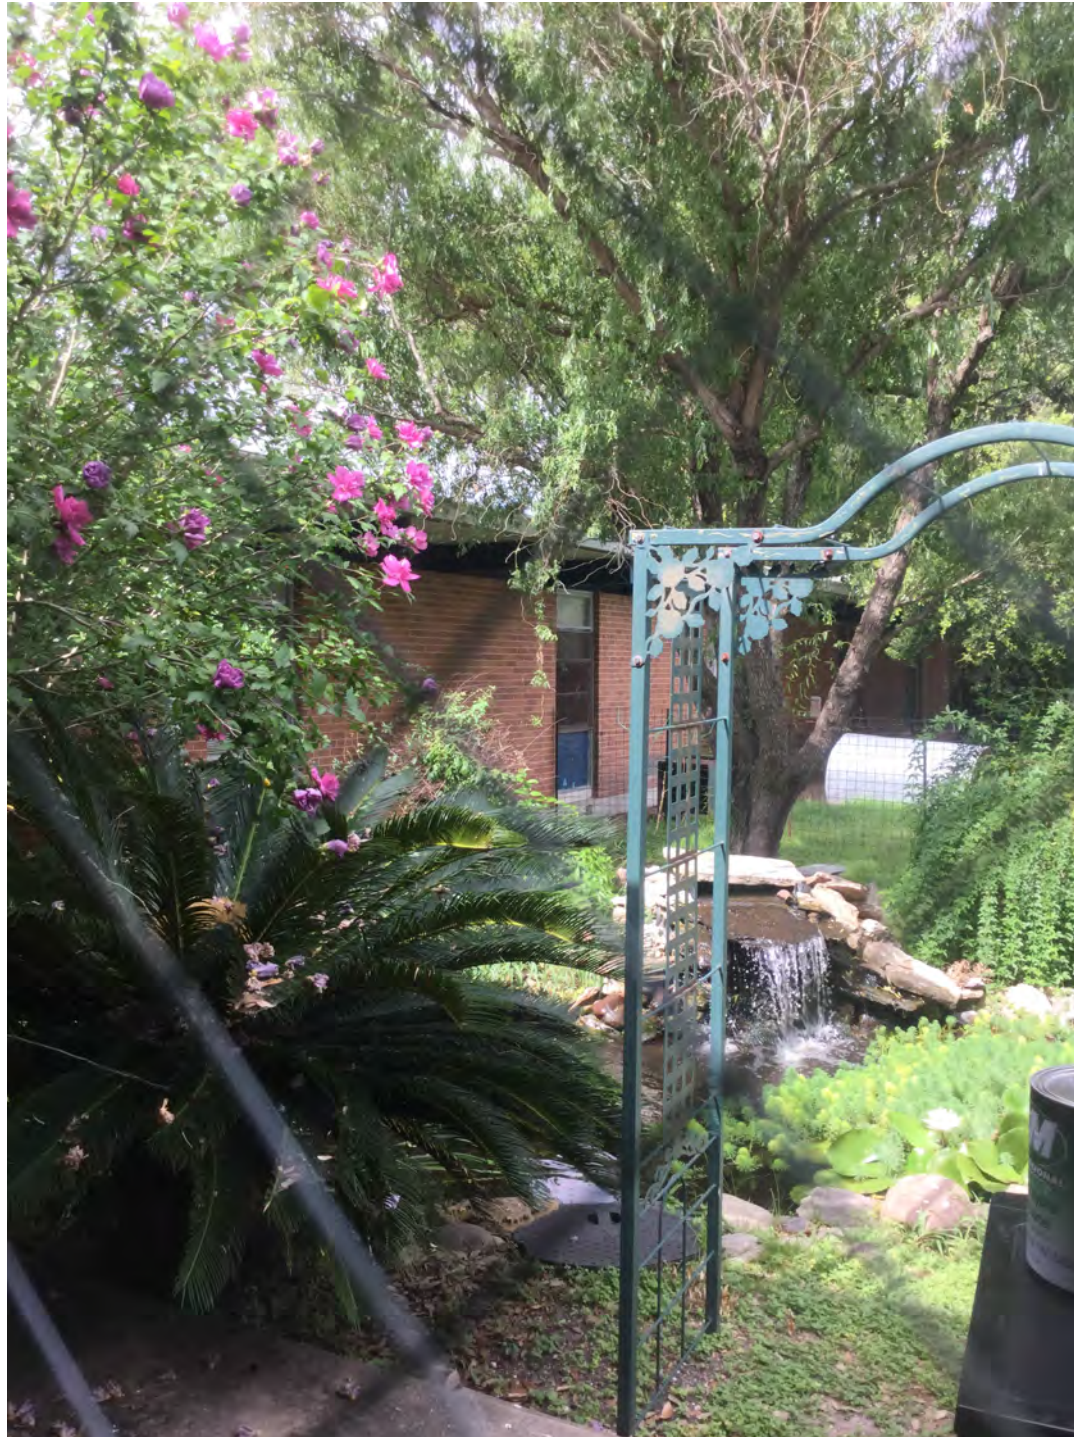
Photo 2.
1.2 Outdoor Space

1.2	Are opportunities provided for outdoor learning (outdoor classrooms, gardens, etc.)?		2					Comments	1.00 2.00
	<p>1) Outdoor space exists is not developed</p> <p>2)Outdoor space for learning exists but not connected to classroom learning areas.</p> <p>3. Outdoor learning spaces exist and are accessible but not in good condition.</p> <p>4. Outdoor learning spaces need minor improvements to function well.</p> <p>5. Outdoor learning spaces are in excellent condition.</p> <p>N/A) Does not apply.</p>							There are opportunities for outdoor learning, but they need to be developed. Garden and chicken coop are present, but faculty would like the outdoor spaces to be more easily accessible from classrooms.	see photo 2

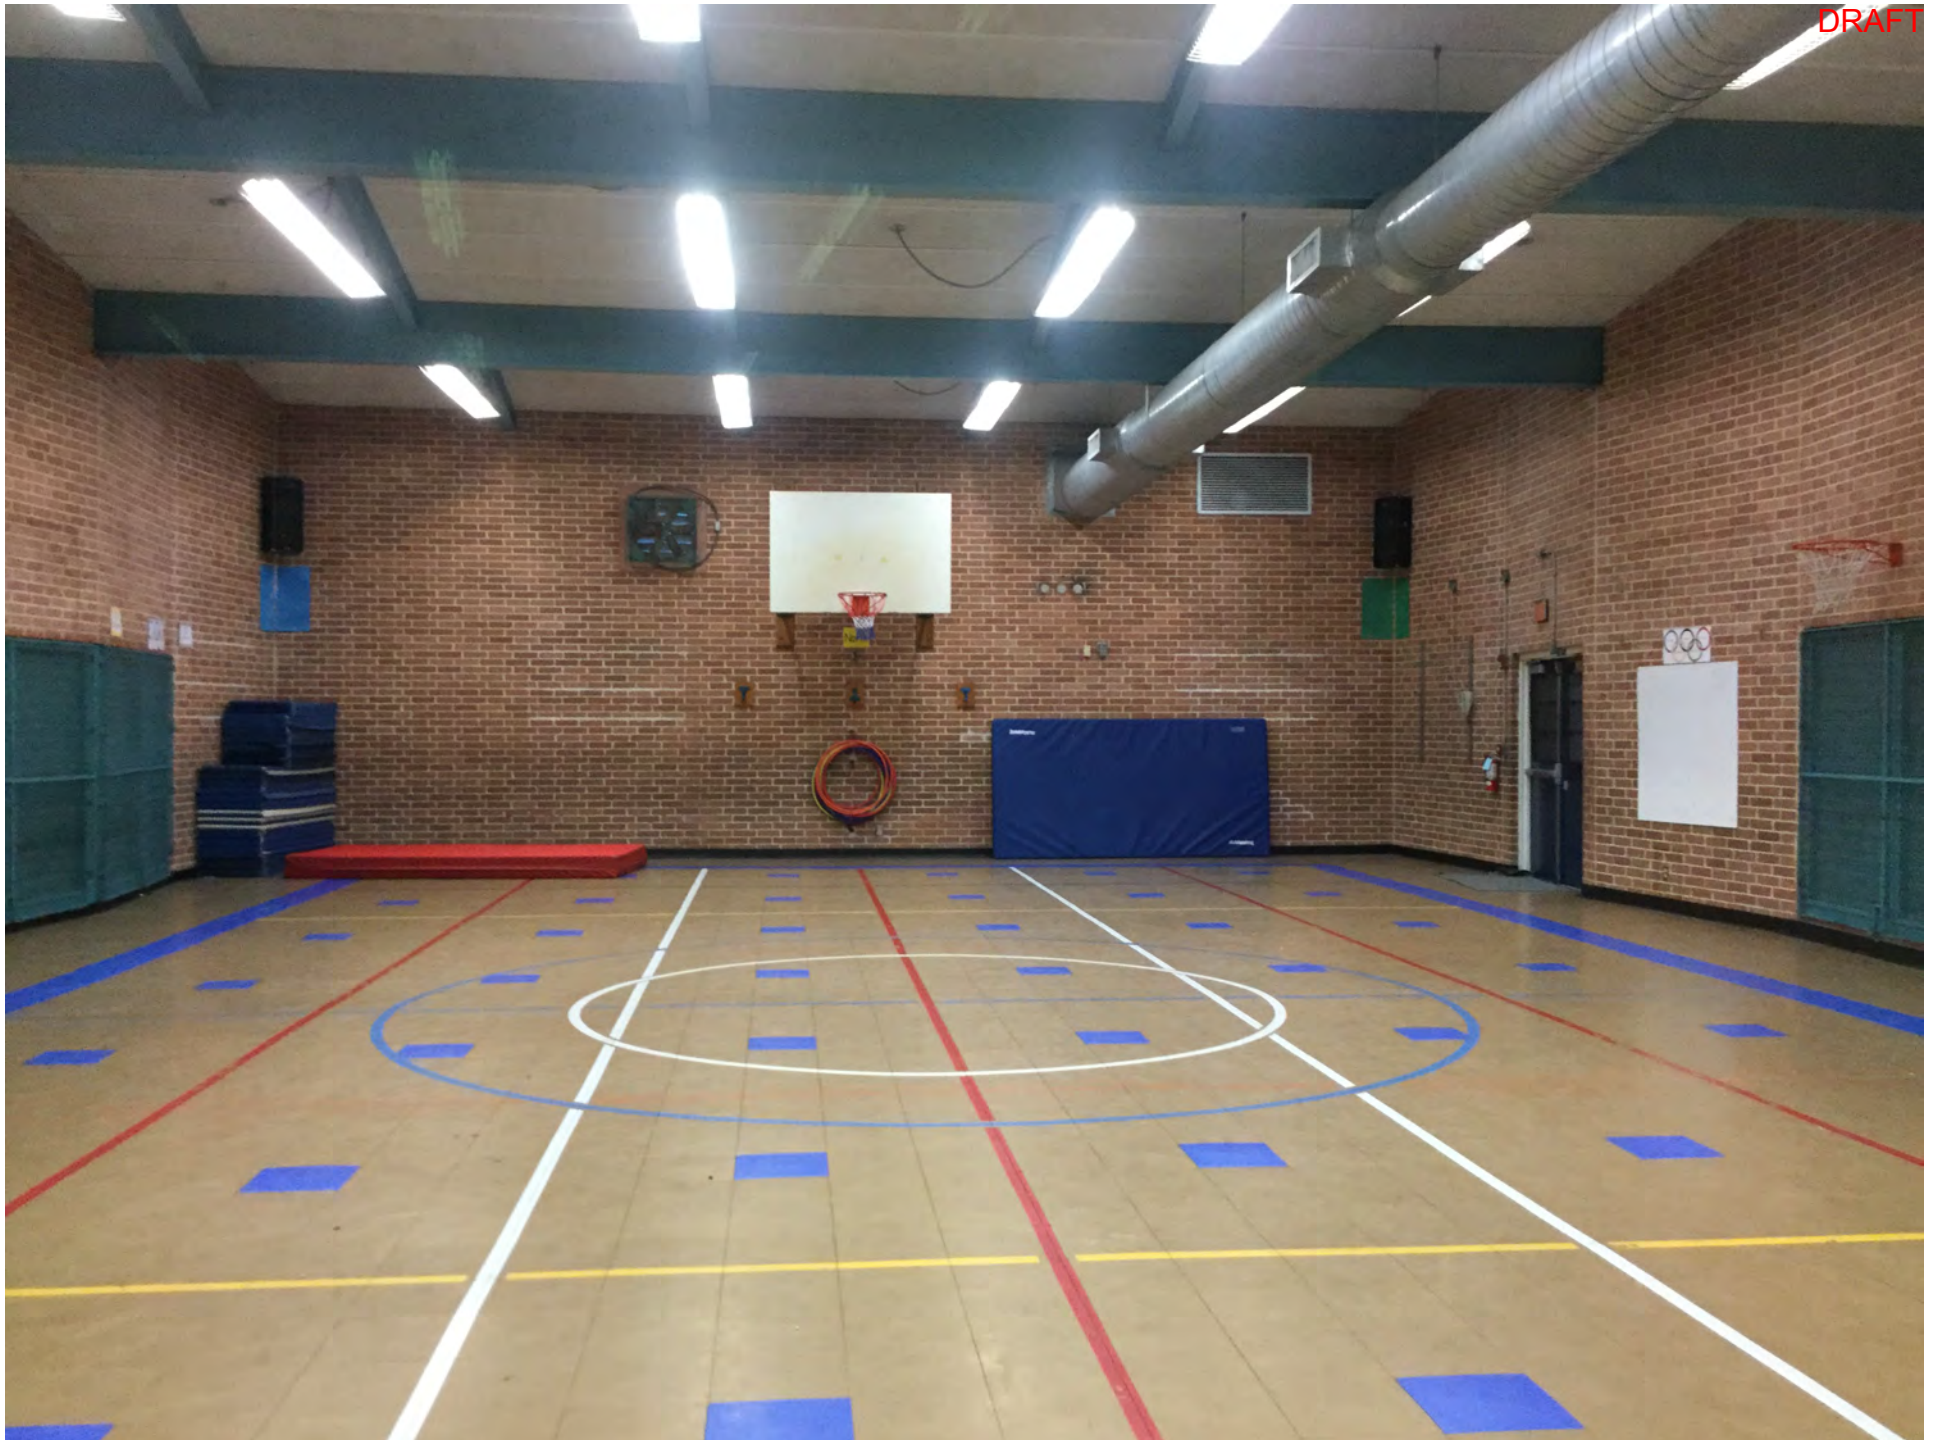
Photo 3.
3.6 Gymnasium

1) Very unsatisfactory 2) Unsatisfactory 3) Average 4) Good 5) Very good N/A) Does not apply.								The gym is somewhat dated and is in a separate building from the classroom building.	see photo 3

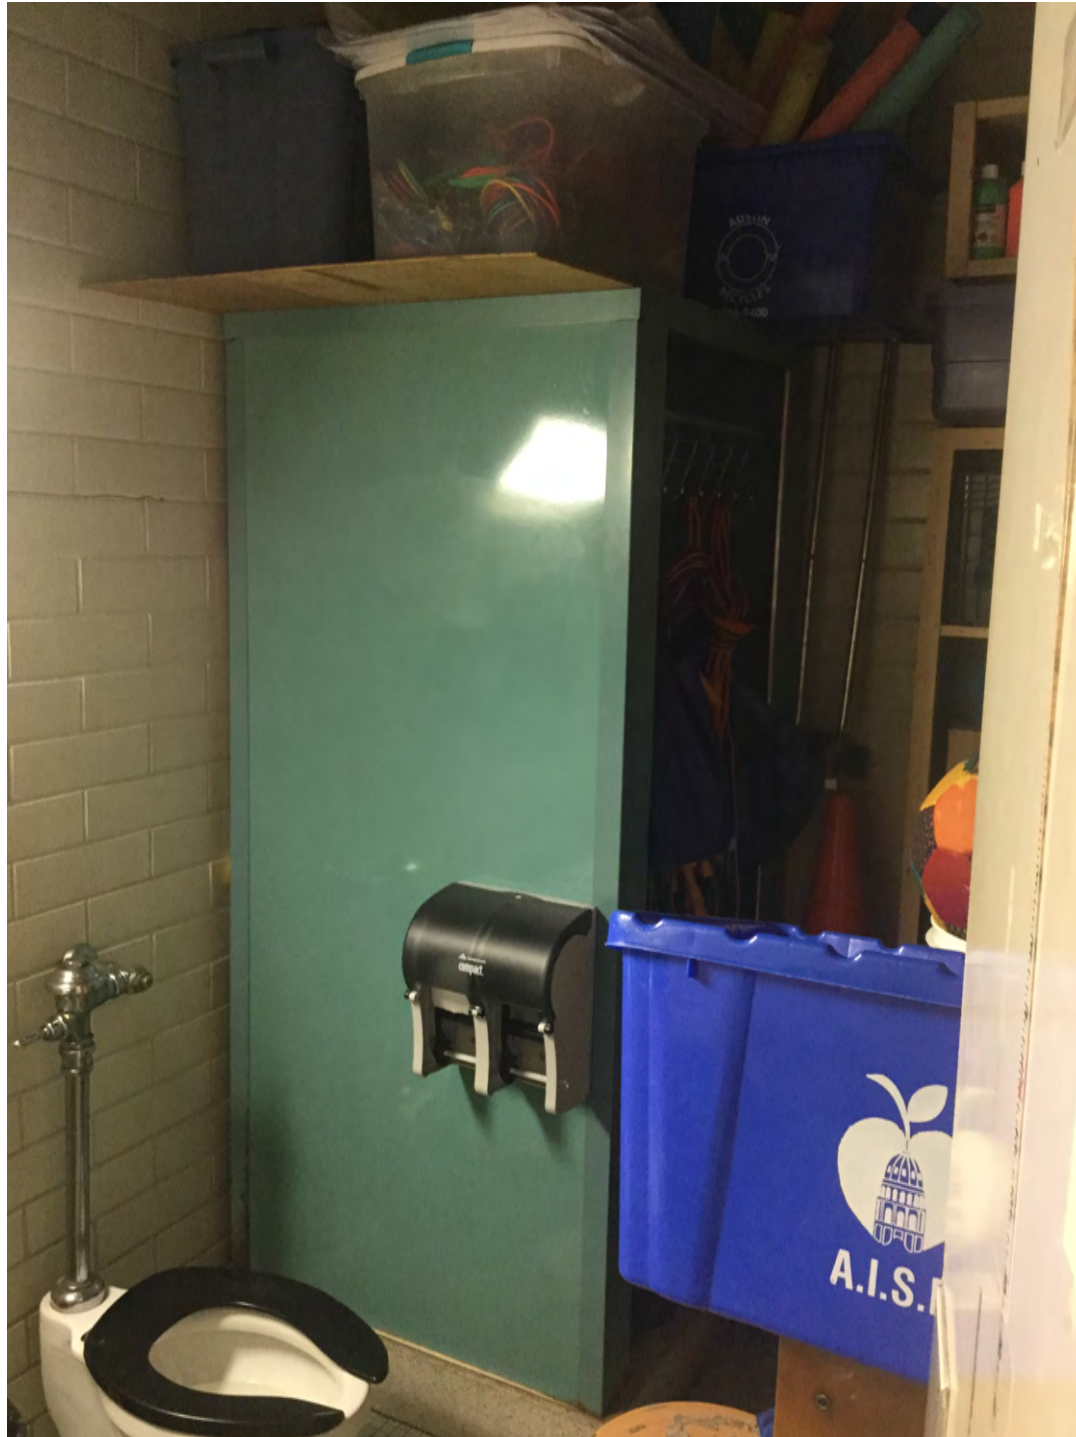
Photo 4.
3.7 Gym Storage

3.7	Are Physical Education and Athletic support spaces appropriately configured per the ed spec?	1						Comments	1.00 1.00
1) Very unsatisfactory - Support spaces are disconnected from served spaces, too small, do not meet needs 2) Unsatisfactory - Support spaces are connected, but too small, inadequate for needs 3) Average - Connected, moderate size, but need some renovations or updates to function well 4) Good - Connected, good size/layout, meets needs/functions well 5) Very good - connected, generous size, nice condition, functions appropriately N/A) Does not apply.								The office has a restroom doubling as gym storage which is very unsatisfactory.	see photo 4

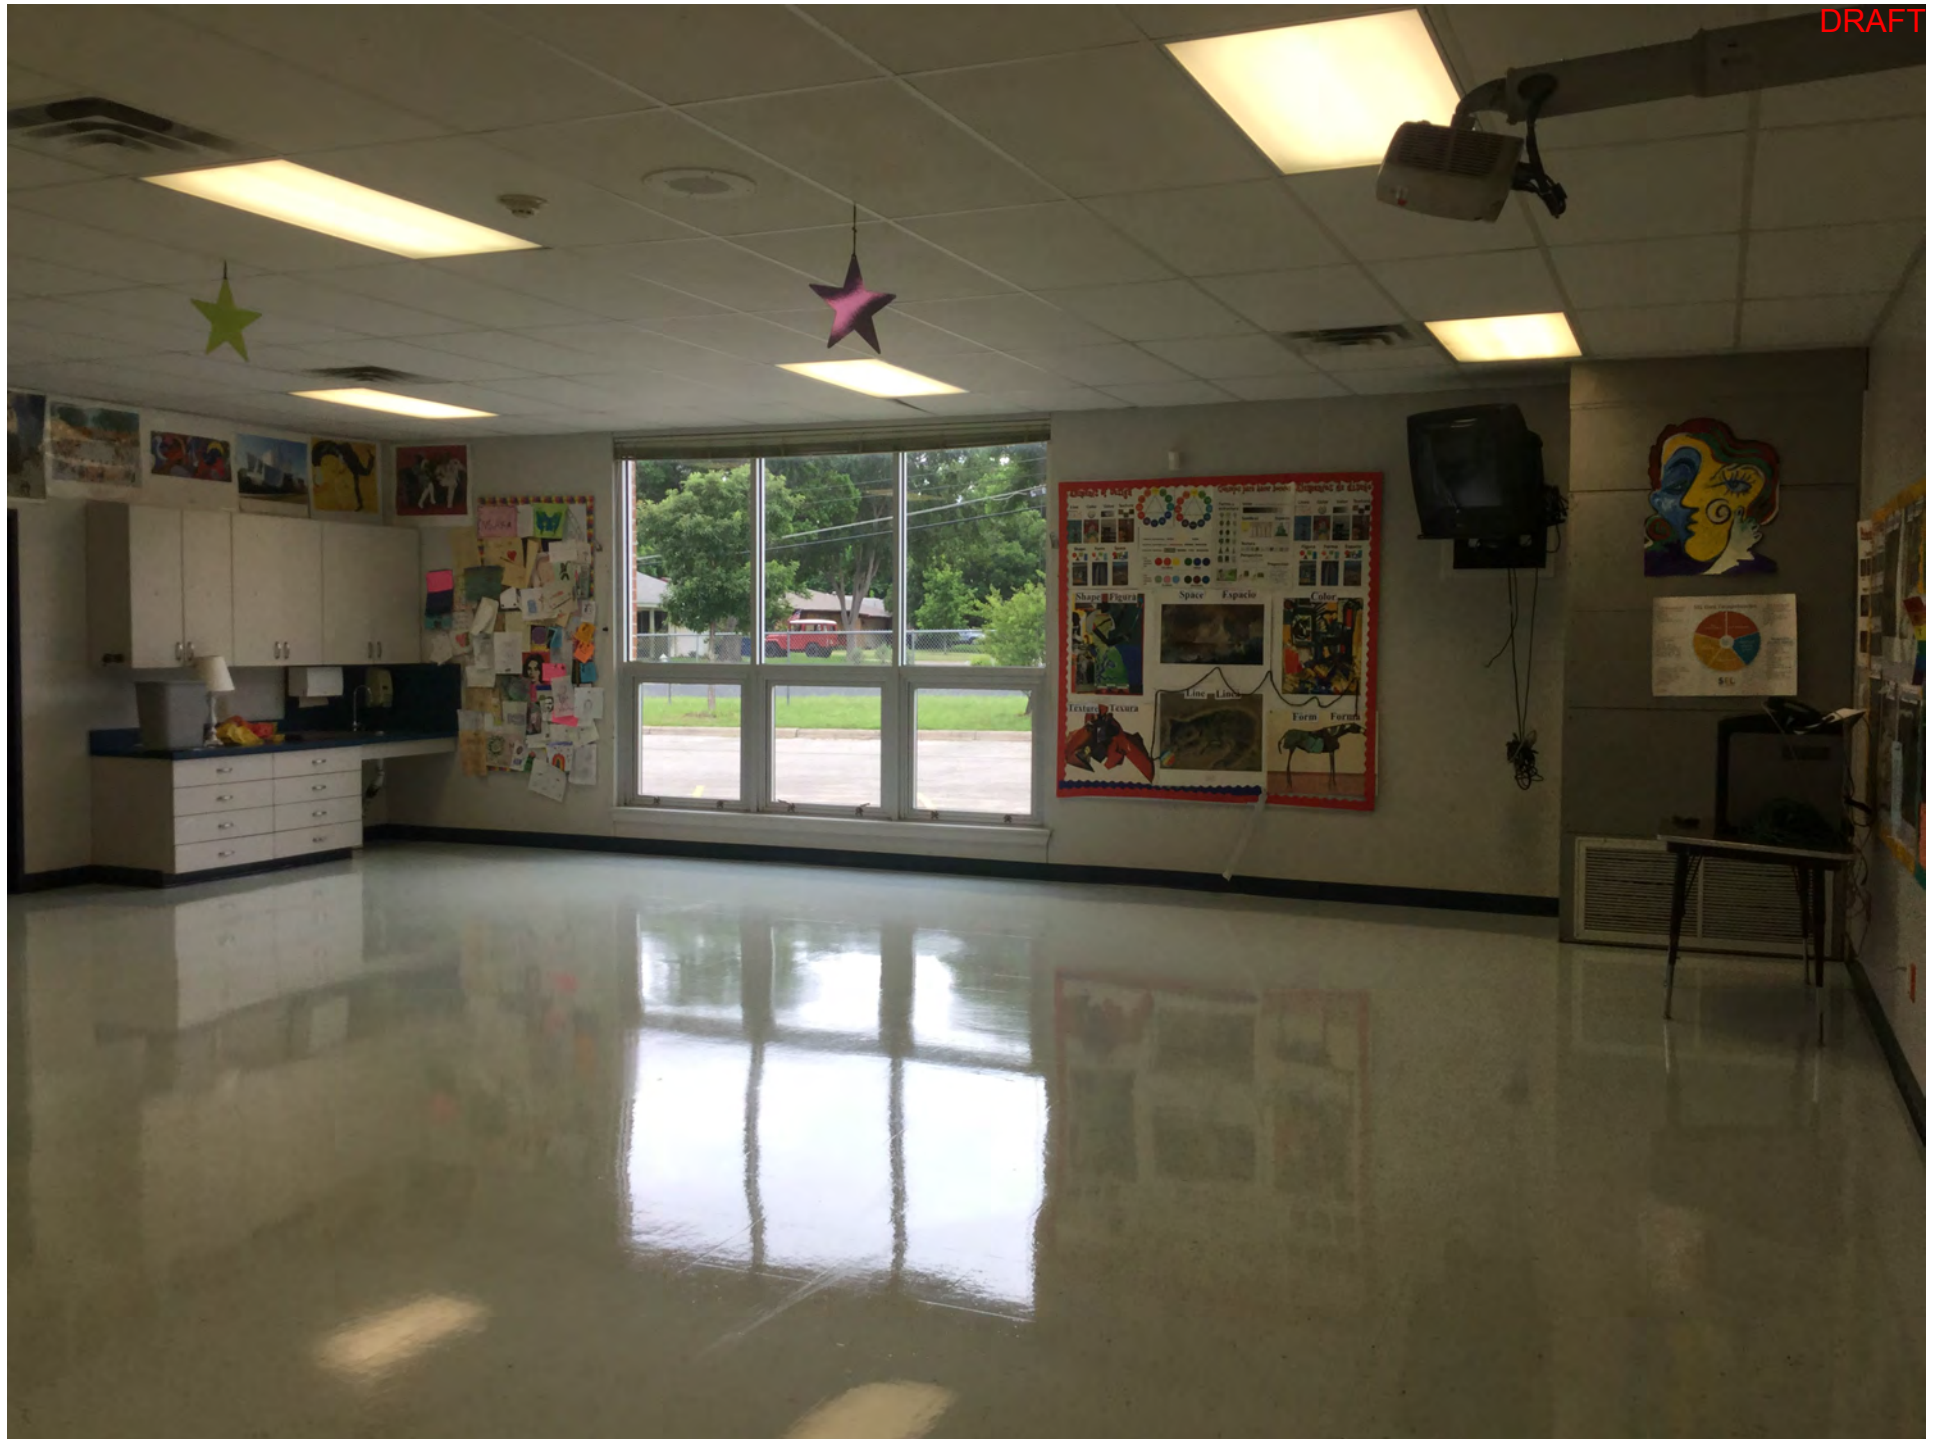
Photo 5.
3.10 Art Room

1) Very unsatisfactory 2) Unsatisfactory 3) Average 4) Good 5) Very good N/A) Does not apply.																				see photo 5	
3.11	Are Visual Arts support spaces appropriately configured per the ed spec?															5		Comments		1.00	5.00

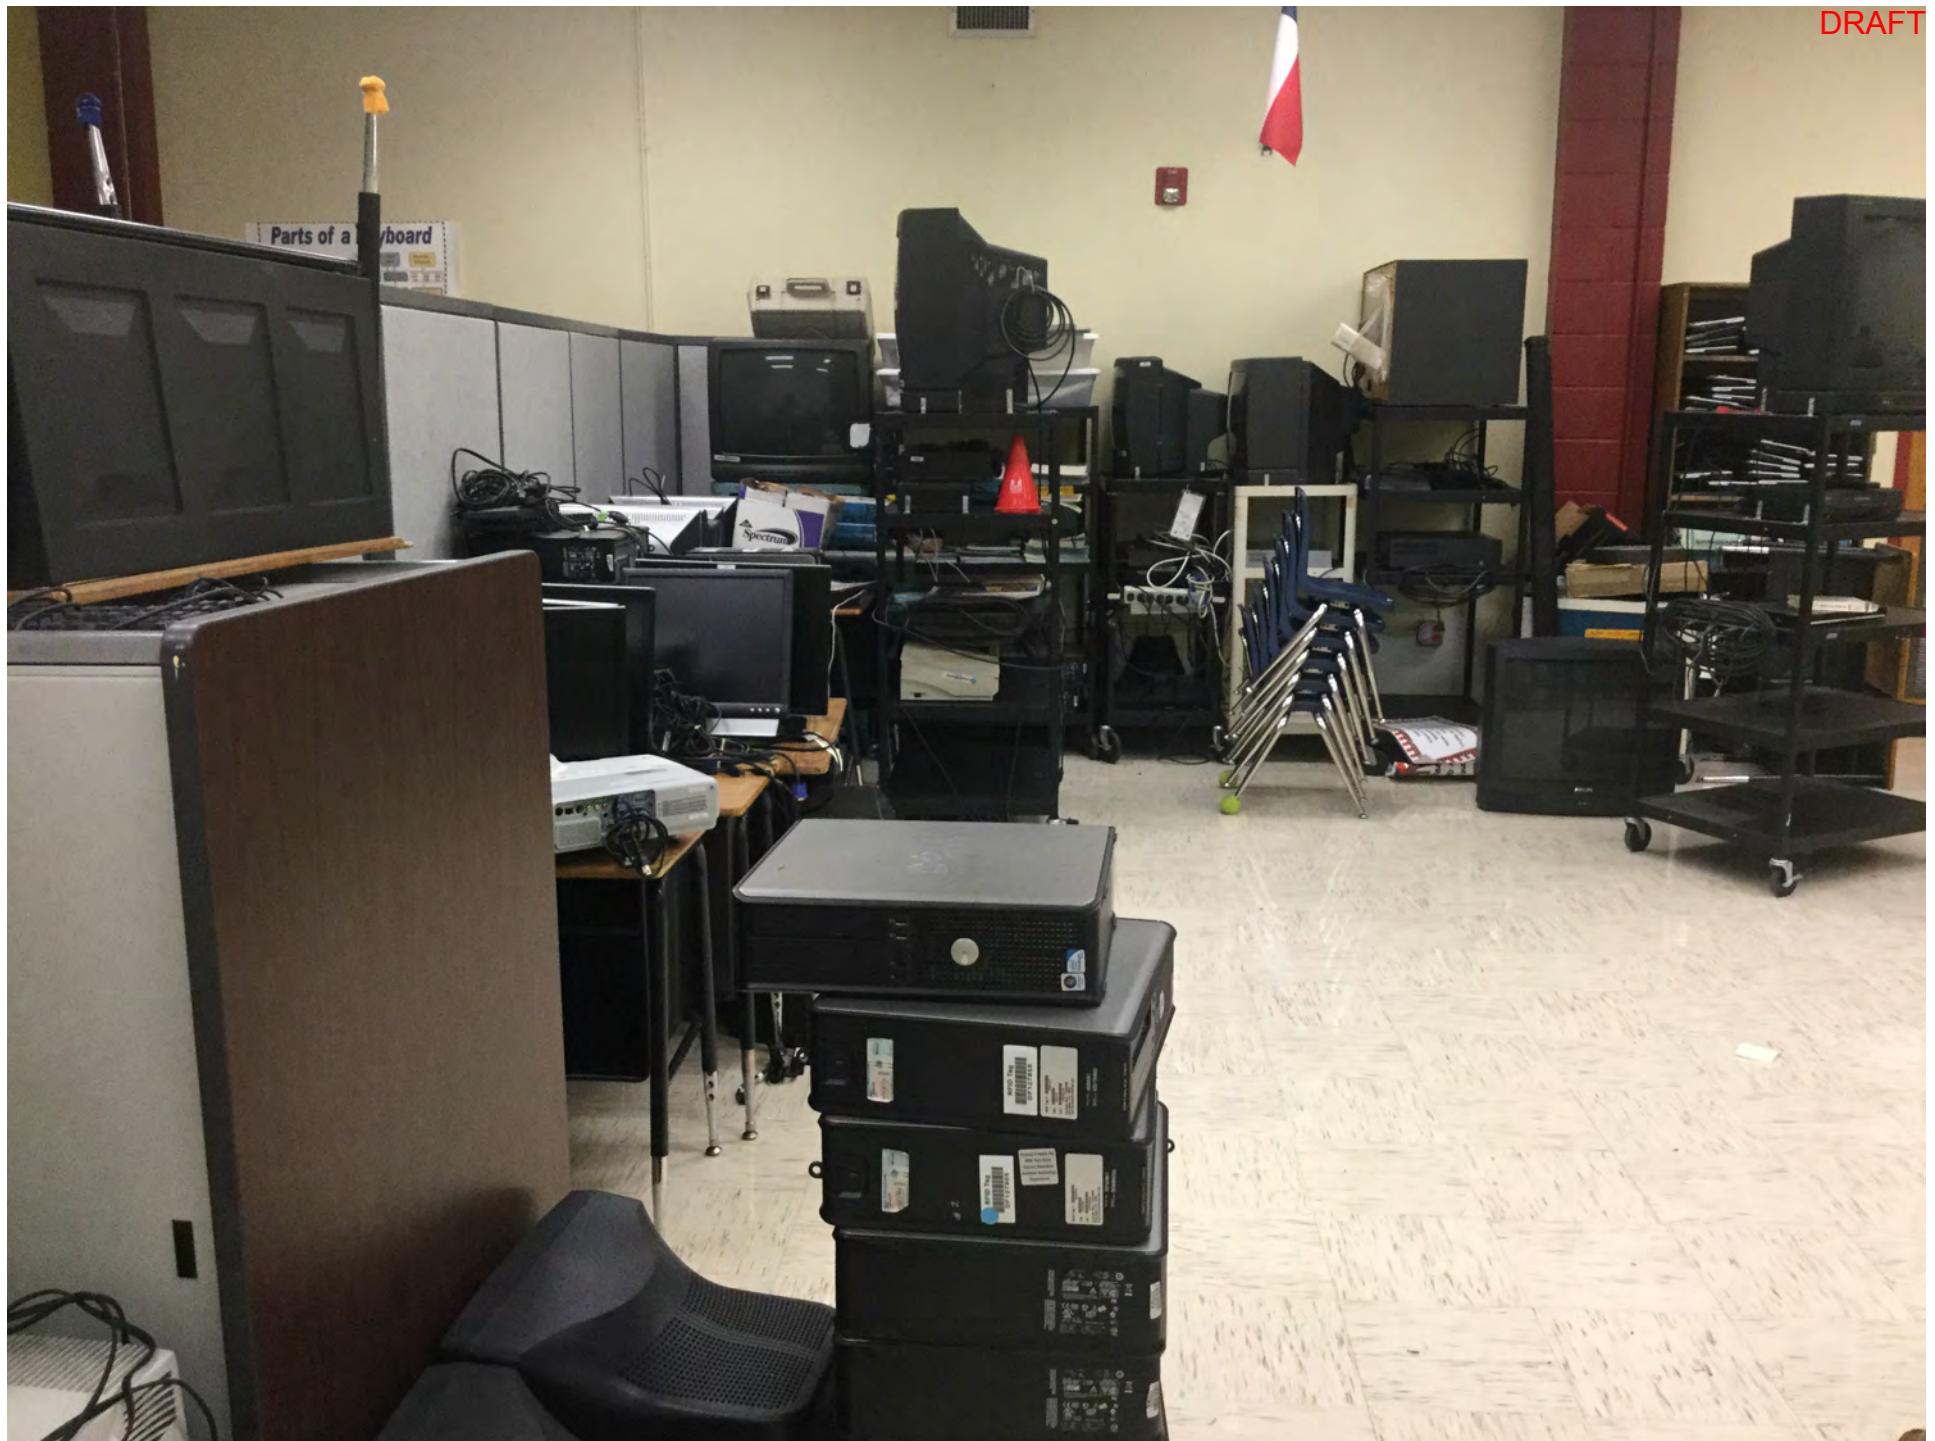
Photo 6.
3.13 Computer Lab Storage

3.13	Are computer lab support spaces appropriately configured?												2					Comments		1.00	2.00
1) Very unsatisfactory - Support spaces are disconnected from served spaces, too small, do not meet needs 2) Unsatisfactory - Support spaces are connected, but too small, inadequate for needs 3) Average - Connected, moderate size, but need some renovations or updates to function well 4) Good - Connected, good size/layout, meets needs/functions well 5) Very good - connected, generous size, nice condition, functions appropriately N/A) Does not apply.													Storage is currently a partitioned part of the actual computer lab classroom.							see photo 6

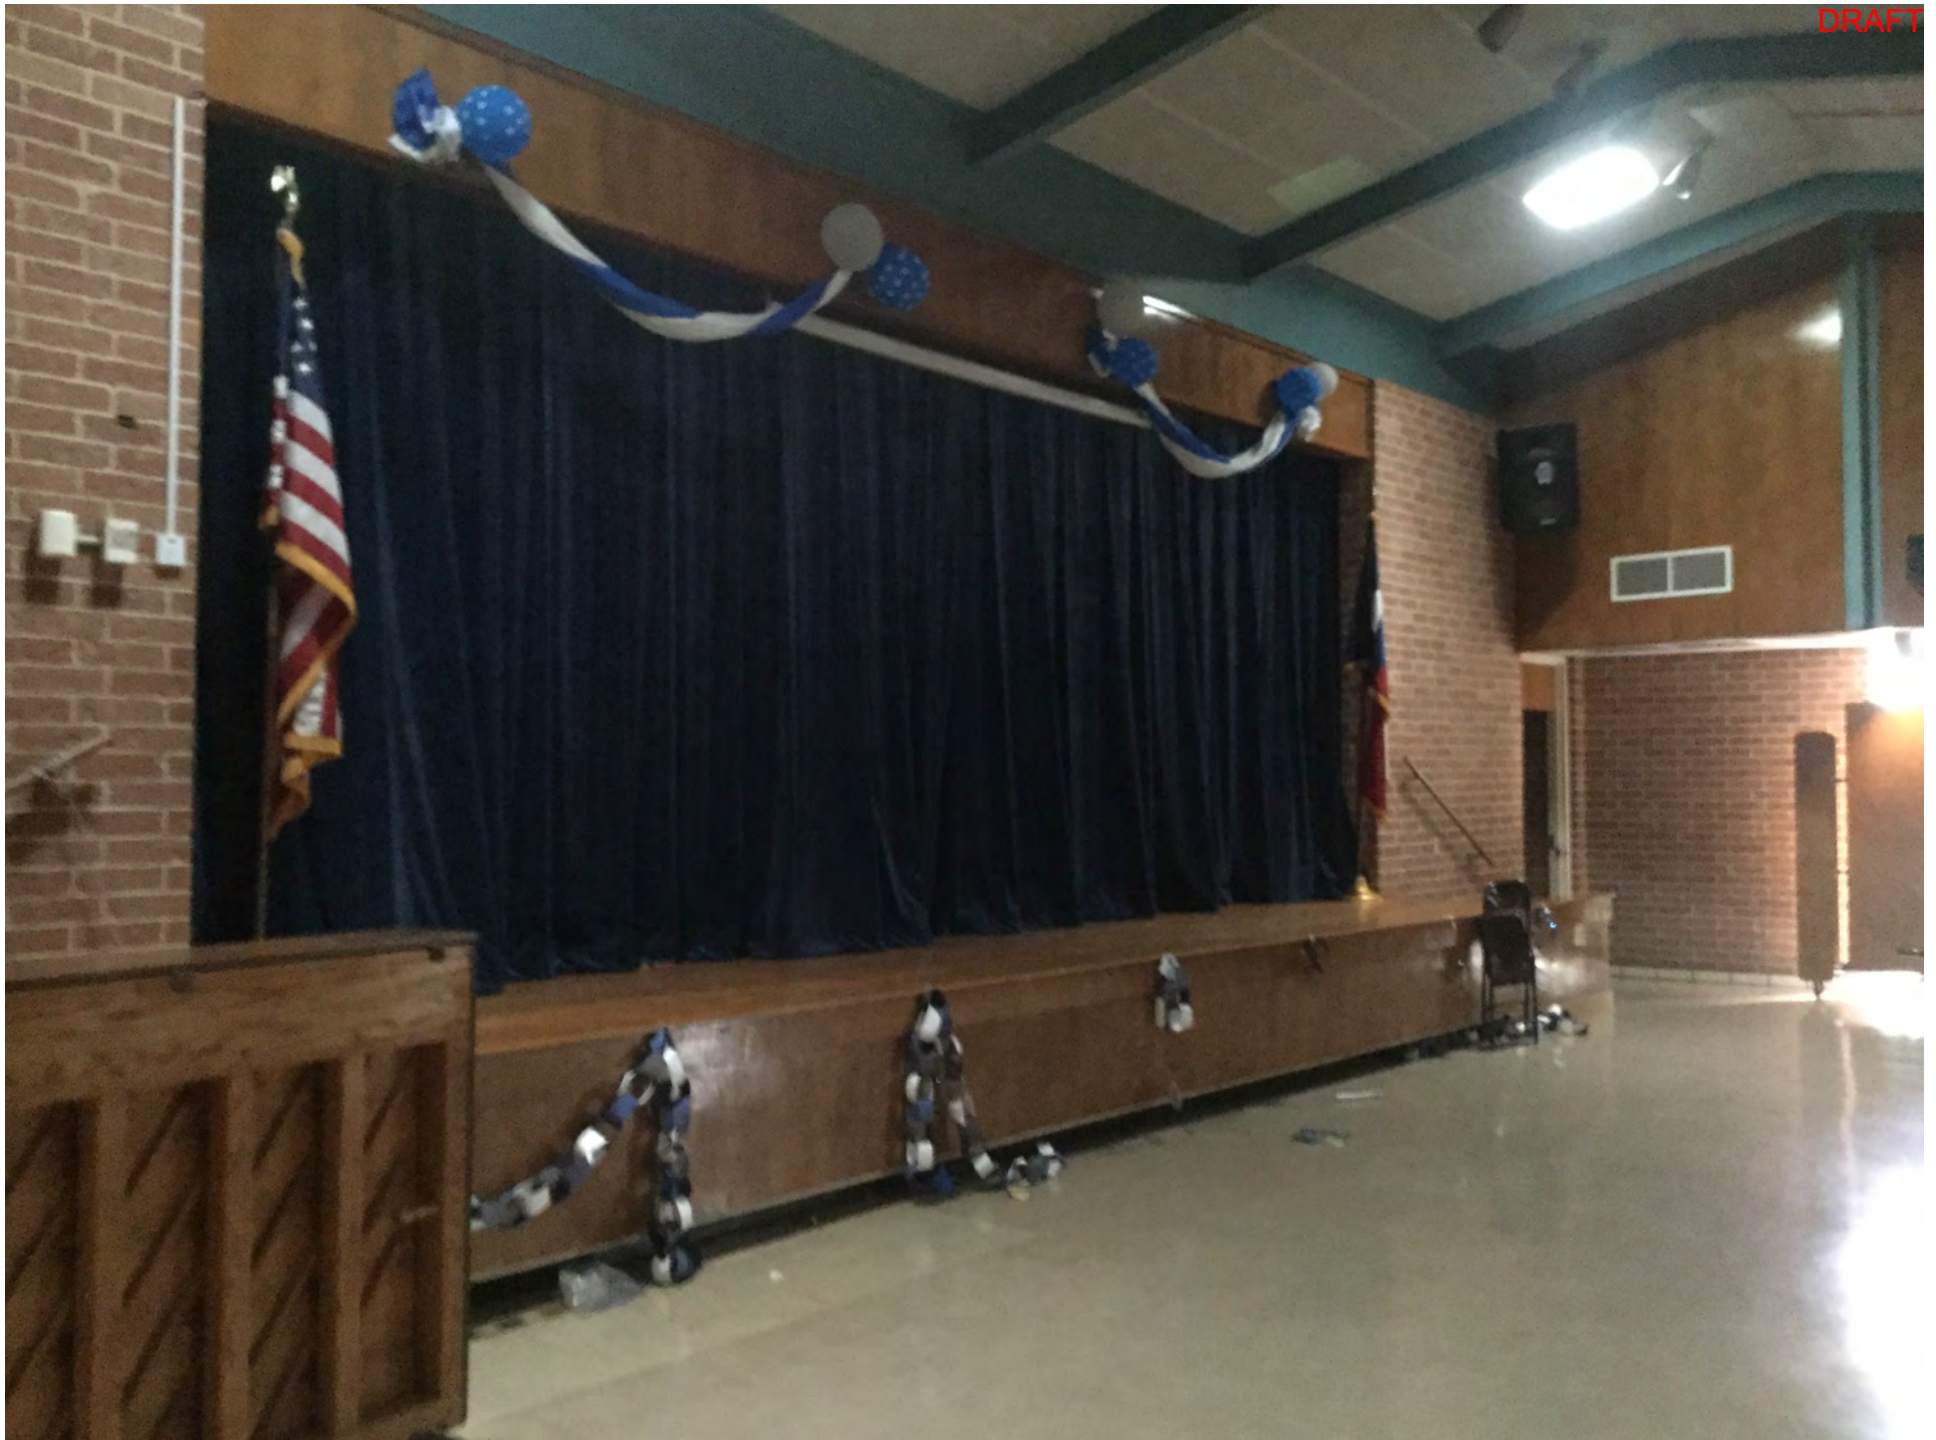
Photo 7.
3.16 Cafetorium

3.16	Are the student dining facilities appropriately configured?				4			Comments	1.00 4.00
1) Very unsatisfactory - Too small, poor circulation, inflexible seating in poor condition 2) Unsatisfactory - Too small or inadequate circulation, seating in poor condition 3) Average - moderate size, with adequate circulation, seating in okay condition 4) Good - good size, adequate circulation, seating in good condition 5) Very good - good size, adequate circulation, seating in good condition, with more than one option for eating space (ex: connection to outdoor eating space) N/A) Does not apply.							<div>see photo 7</div>

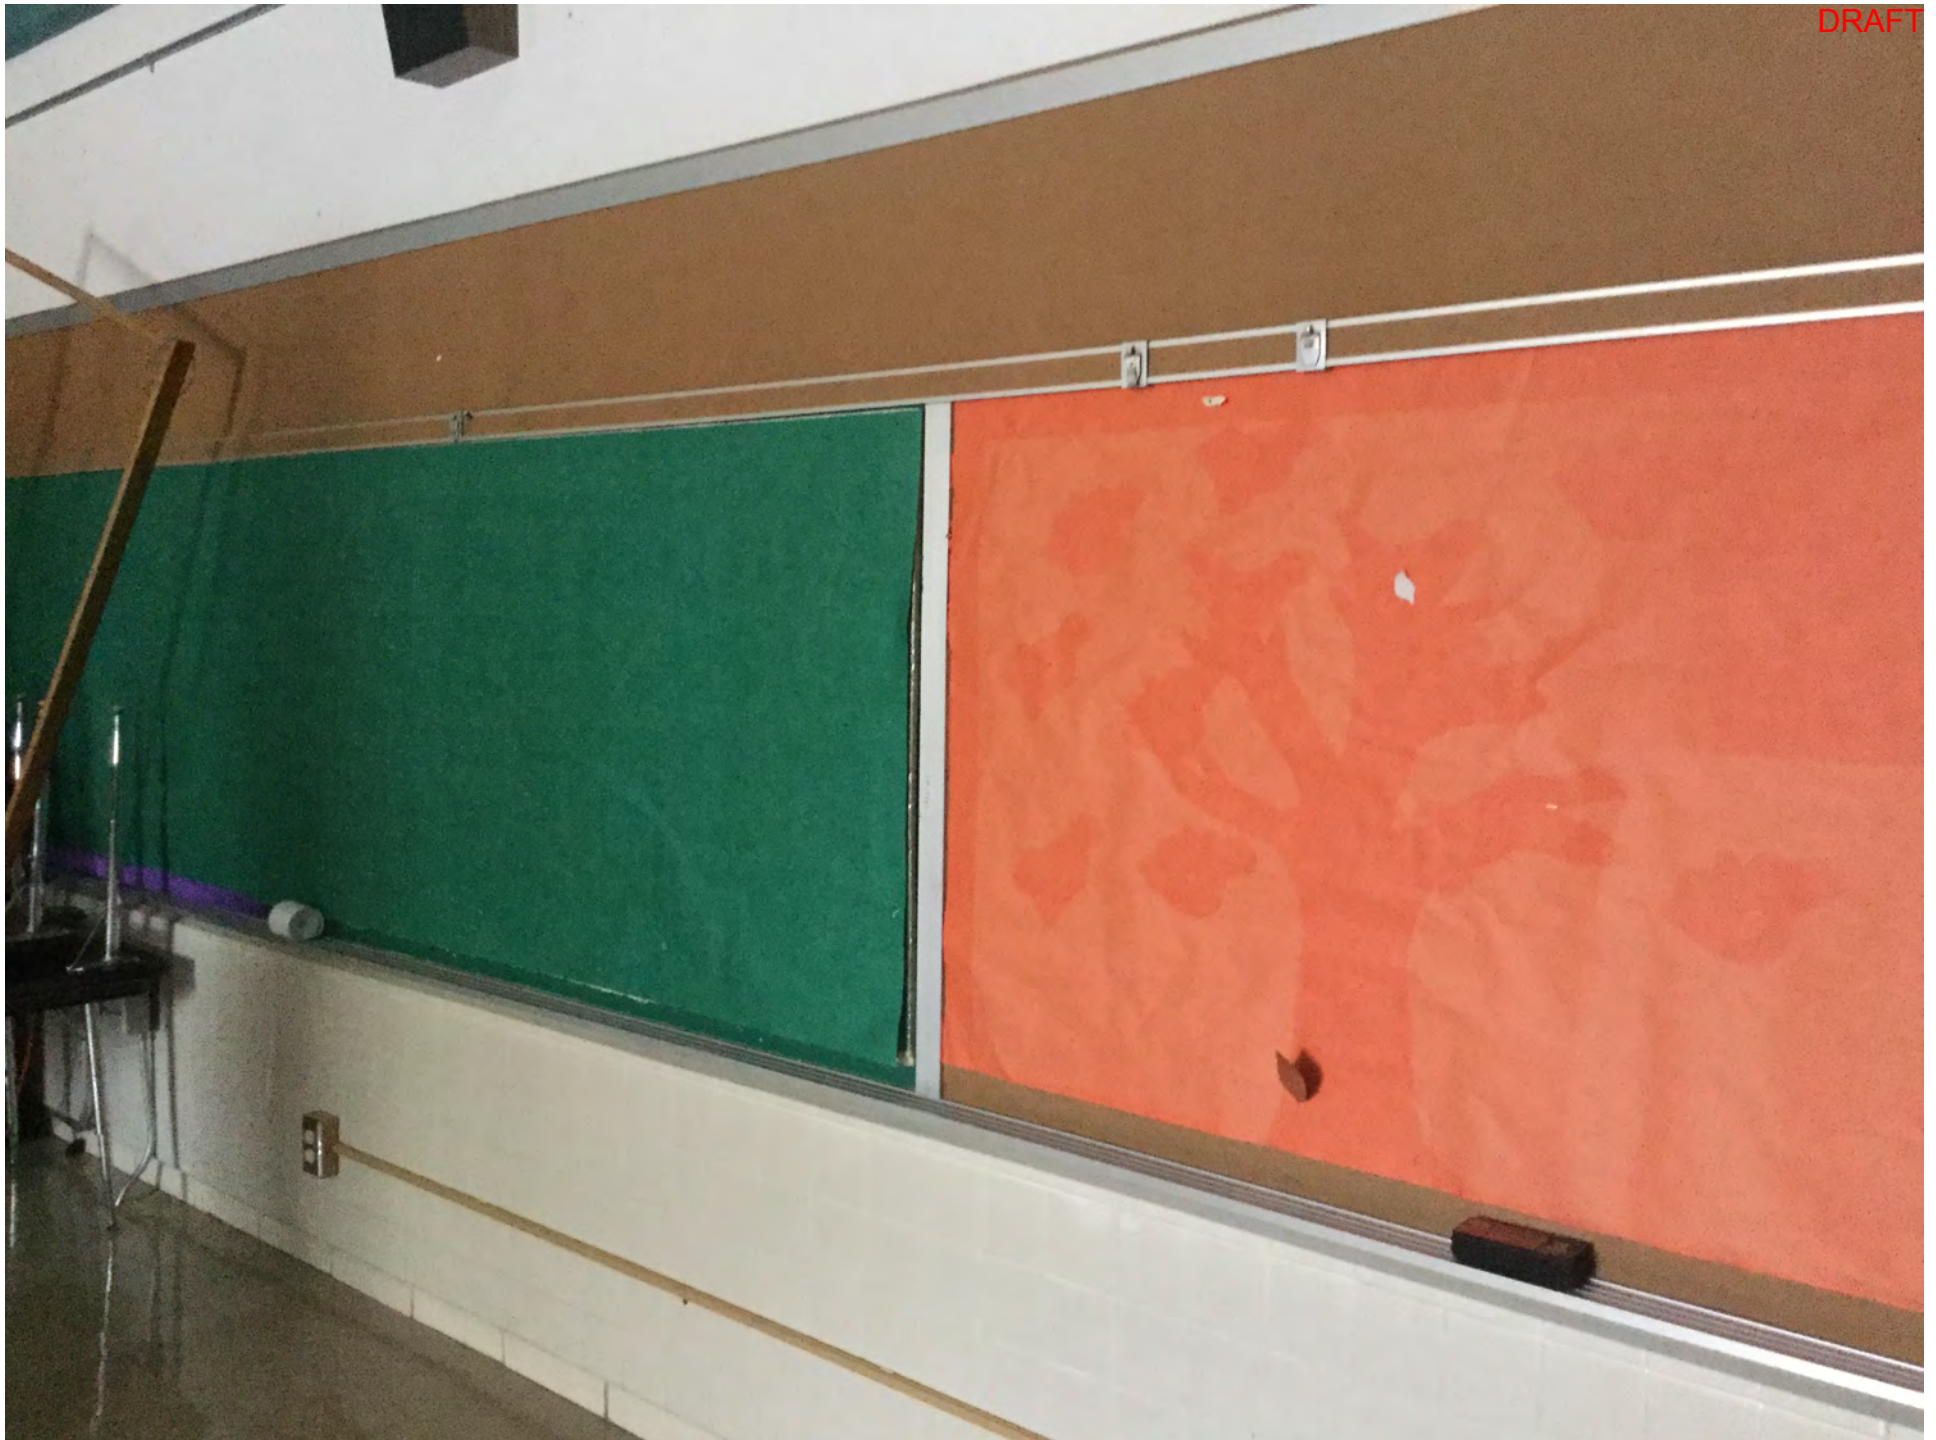
Photo 8.
4.10 Visual Communication Tools

4.10	Does the building have adequate visual communication tools?		2					Comments	1.002.00
1) Very unsatisfactory - No vis comm tools 2) Unsatisfactory - outdated, poorly functioning, or insufficient 3) Good - mix of old and new whiteboards/projectors/etc. 4) Good - projectors, marker boards, smart boards in most spaces - good condition 5) Very good - projectors, marker boards, smart boards in most spaces - new condition N/A) Does not apply.								Paper has been put over the chalkboards in most classrooms, not updated. Some projection equipment and innovation stations in some classrooms, but not in every classroom. 5th grade classrooms are newer and have white boards and projection.	see photo 8

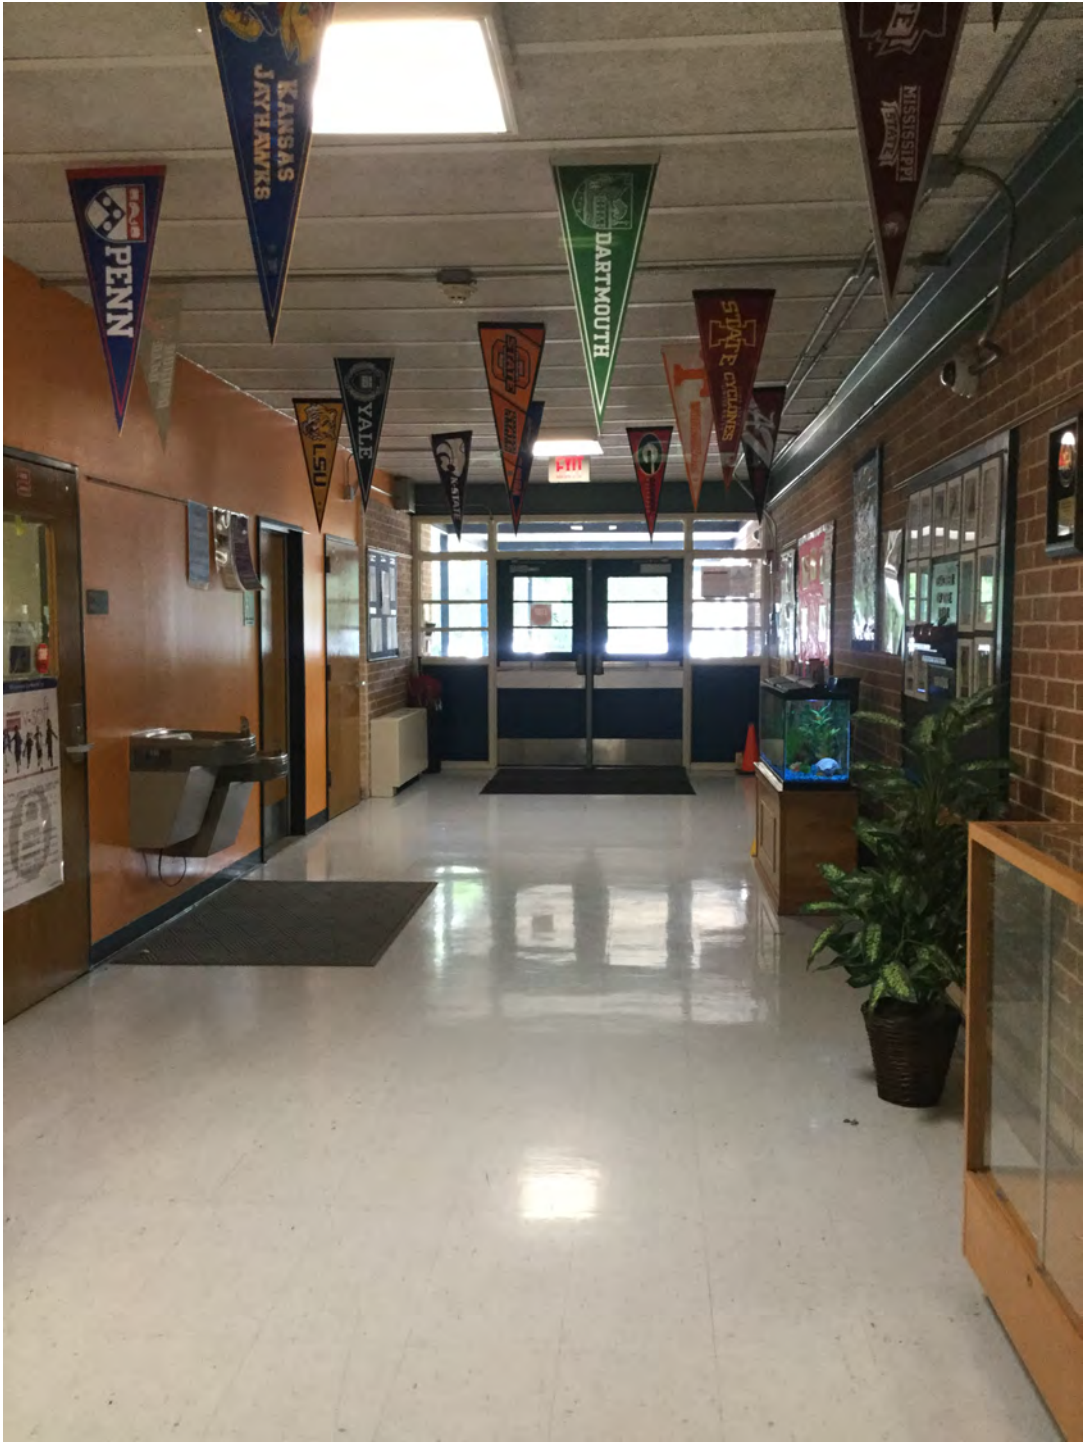
Photo 9.
6.3 Main Office Entry

6.3	Is the main office properly located and configured with a secure vestibule to the main corridor?			3				Comments	1.00 3.00
1) Very unsatisfactory - No secure vestibule, office located far from main entry. Allows visitors access to school unsupervised. 2) Unsatisfactory - No secure vestibule, office located somewhat far from main entry, minimal supervision of visitors. 3) Average - Office close to entry, views of front door, but no secure vestibule 4) Good - Office is well-located with a secure vestibule, but needs updates 5) Very good - Office well-located with secure vestibule and all appropriate security features. N/A) Does not apply.								There is no secure vestibule.	
									see photo 9
