Educational Suitability Summary Report

Blanton Elementary School – BLDG 106

Date: 06/14/2016

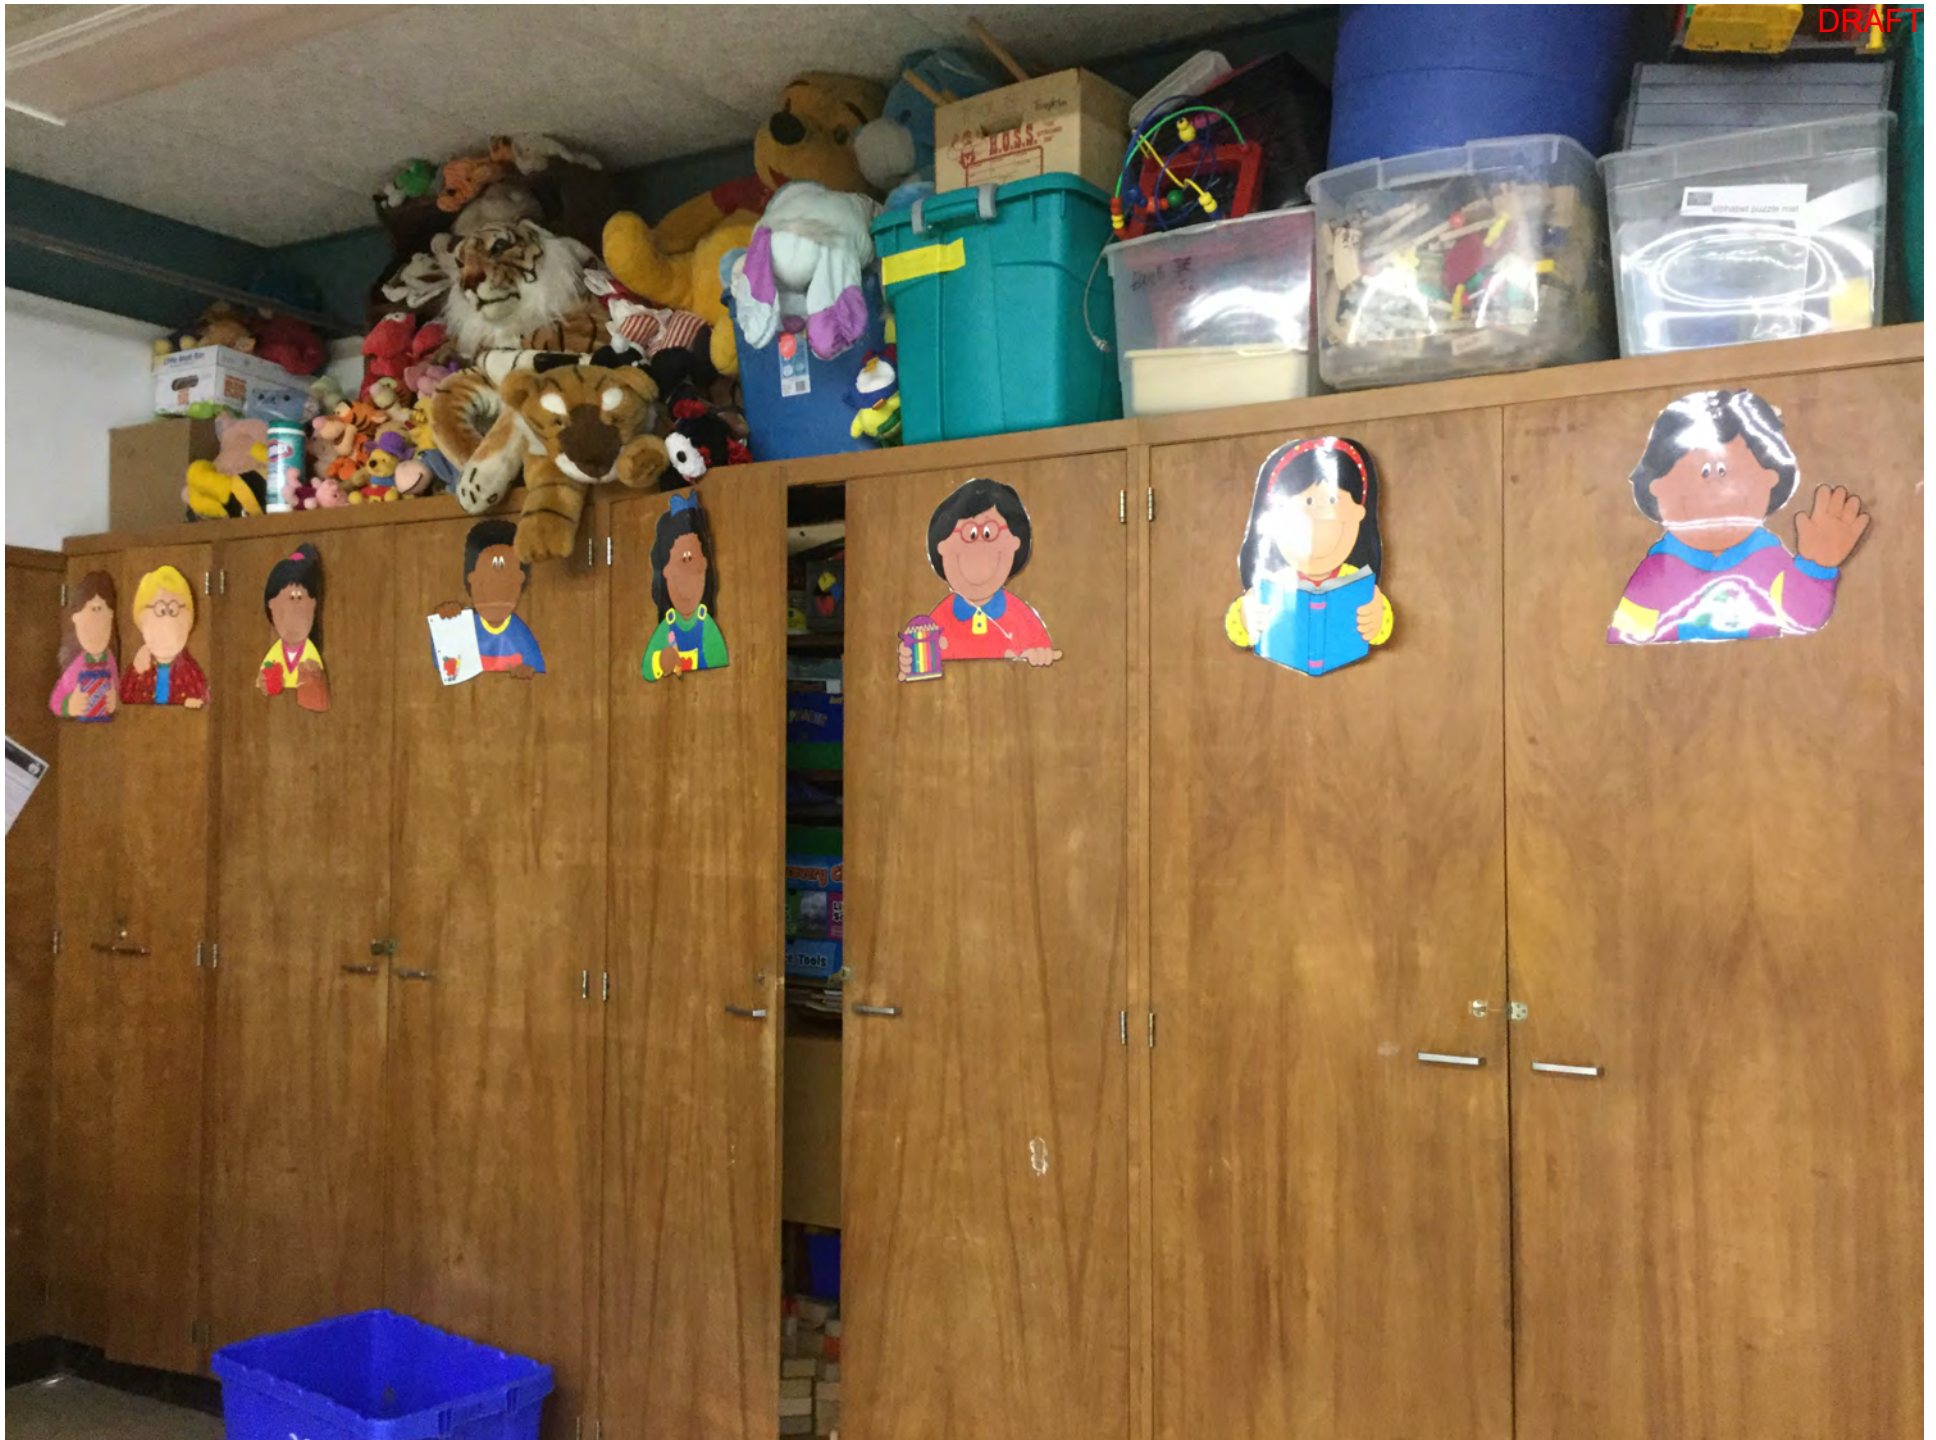
Photo 10.
8.2 Classroom Storage

General building storage is very inadequate. The most glaring issue is classroom storage. The current built-ins in most classrooms are very old and lack shelves. Therefore, teachers must pile their items on top of one another. Additionally, the built-in casework at sinks is not properly sized for students and is in poor condition.

8 - Storage		1	2	3	4	5	N/A	6.00	
8.1	Is there adequate general storage in the building?	1						Comments	1.00 1.00
1) Very unsatisfactory 2) Unsatisfactory 3) Average 4) Good 5) Very good N/A) Does not apply.								General building storage is essentially non-existent.	
8.2	Is there adequate classroom storage?		2					Comments	1.00 2.00
1) Very unsatisfactory 2) Unsatisfactory 3) Average 4) Good 5) Very good N/A) Does not apply.								The majority of classroom built-in cabinets are in poor condition and do not have shelves. Teachers currently have to stack items upon each other.	
								see photo 10	
8.3	Is there adequate student storage?			3				Comments	1.00 3.00
1) Very unsatisfactory 2) Unsatisfactory 3) Average 4) Good 5) Very good N/A) Does not apply.								Students have built -in storage in desks.
