## Educational Suitability Summary Report

Blazier Elementary School

Date: 07/29/2016

## Austin ISD Educational Suitability Assessment Criteria

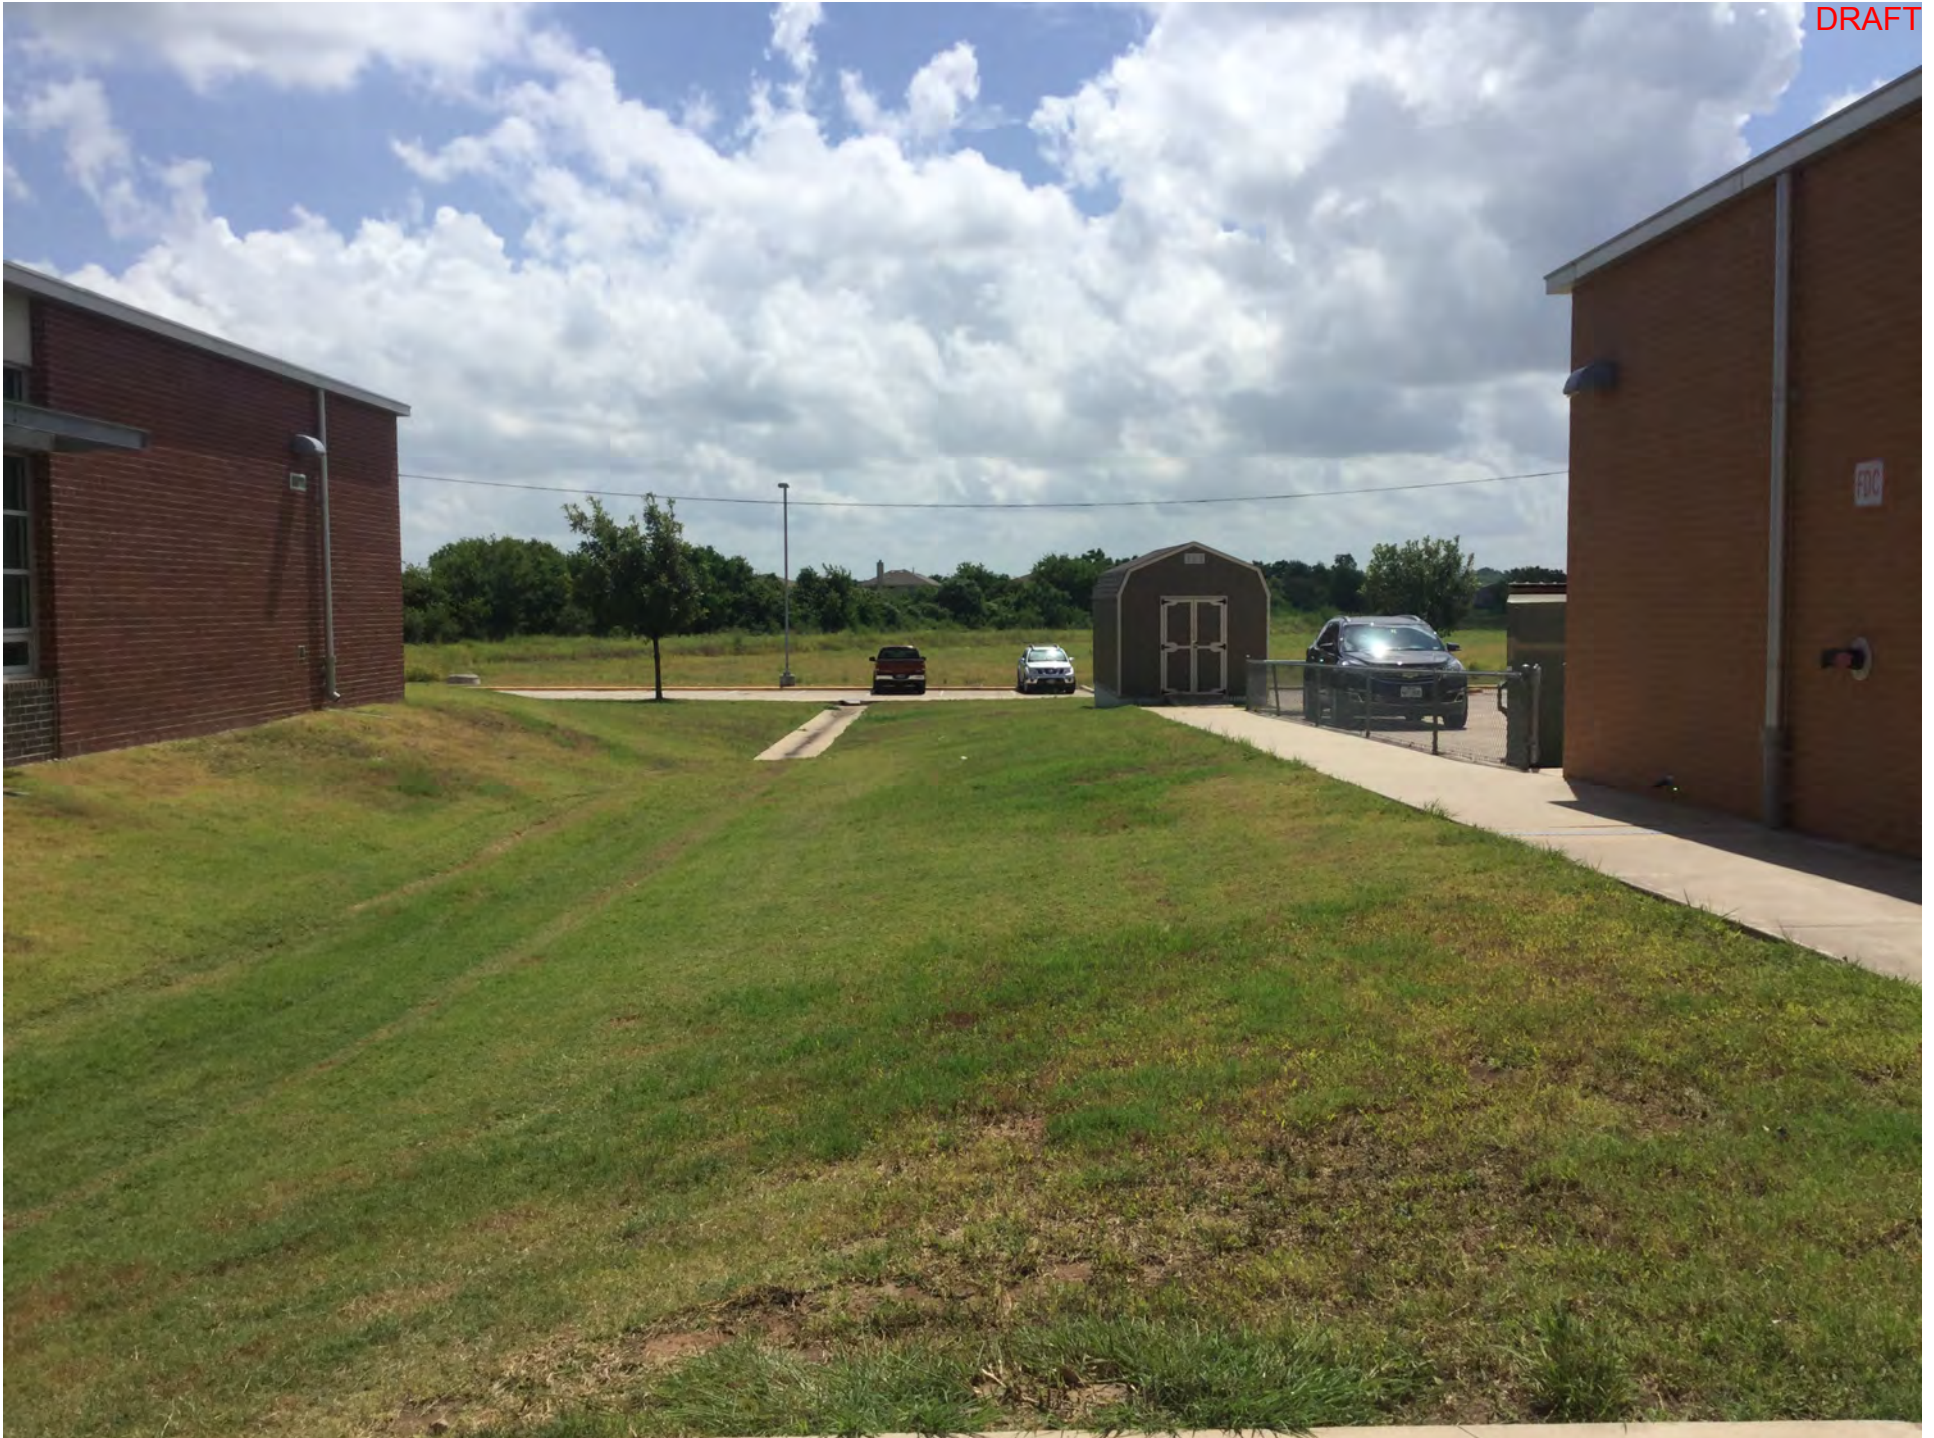
Photo 1. Outdoor Garden

1.2	Are opportunities provided for outdoor learning (outdoor classrooms, gardens, etc.)?	1						Comments	1.00 1.00
	1) Outdoor space exists is not developed 2) Outdoor space for learning exists but not connected to classroom learning areas. 3. Outdoor learning spaces exist and are accessible but not in good condition. 4. Outdoor learning spaces need minor improvements to function well. 5. Outdoor learning spaces are in excellent condition. N/A) Does not apply.							A small above ground garden has been established by the staff, but no outdoor seating area or covered space for outdoor learning is on site.	See Image 1

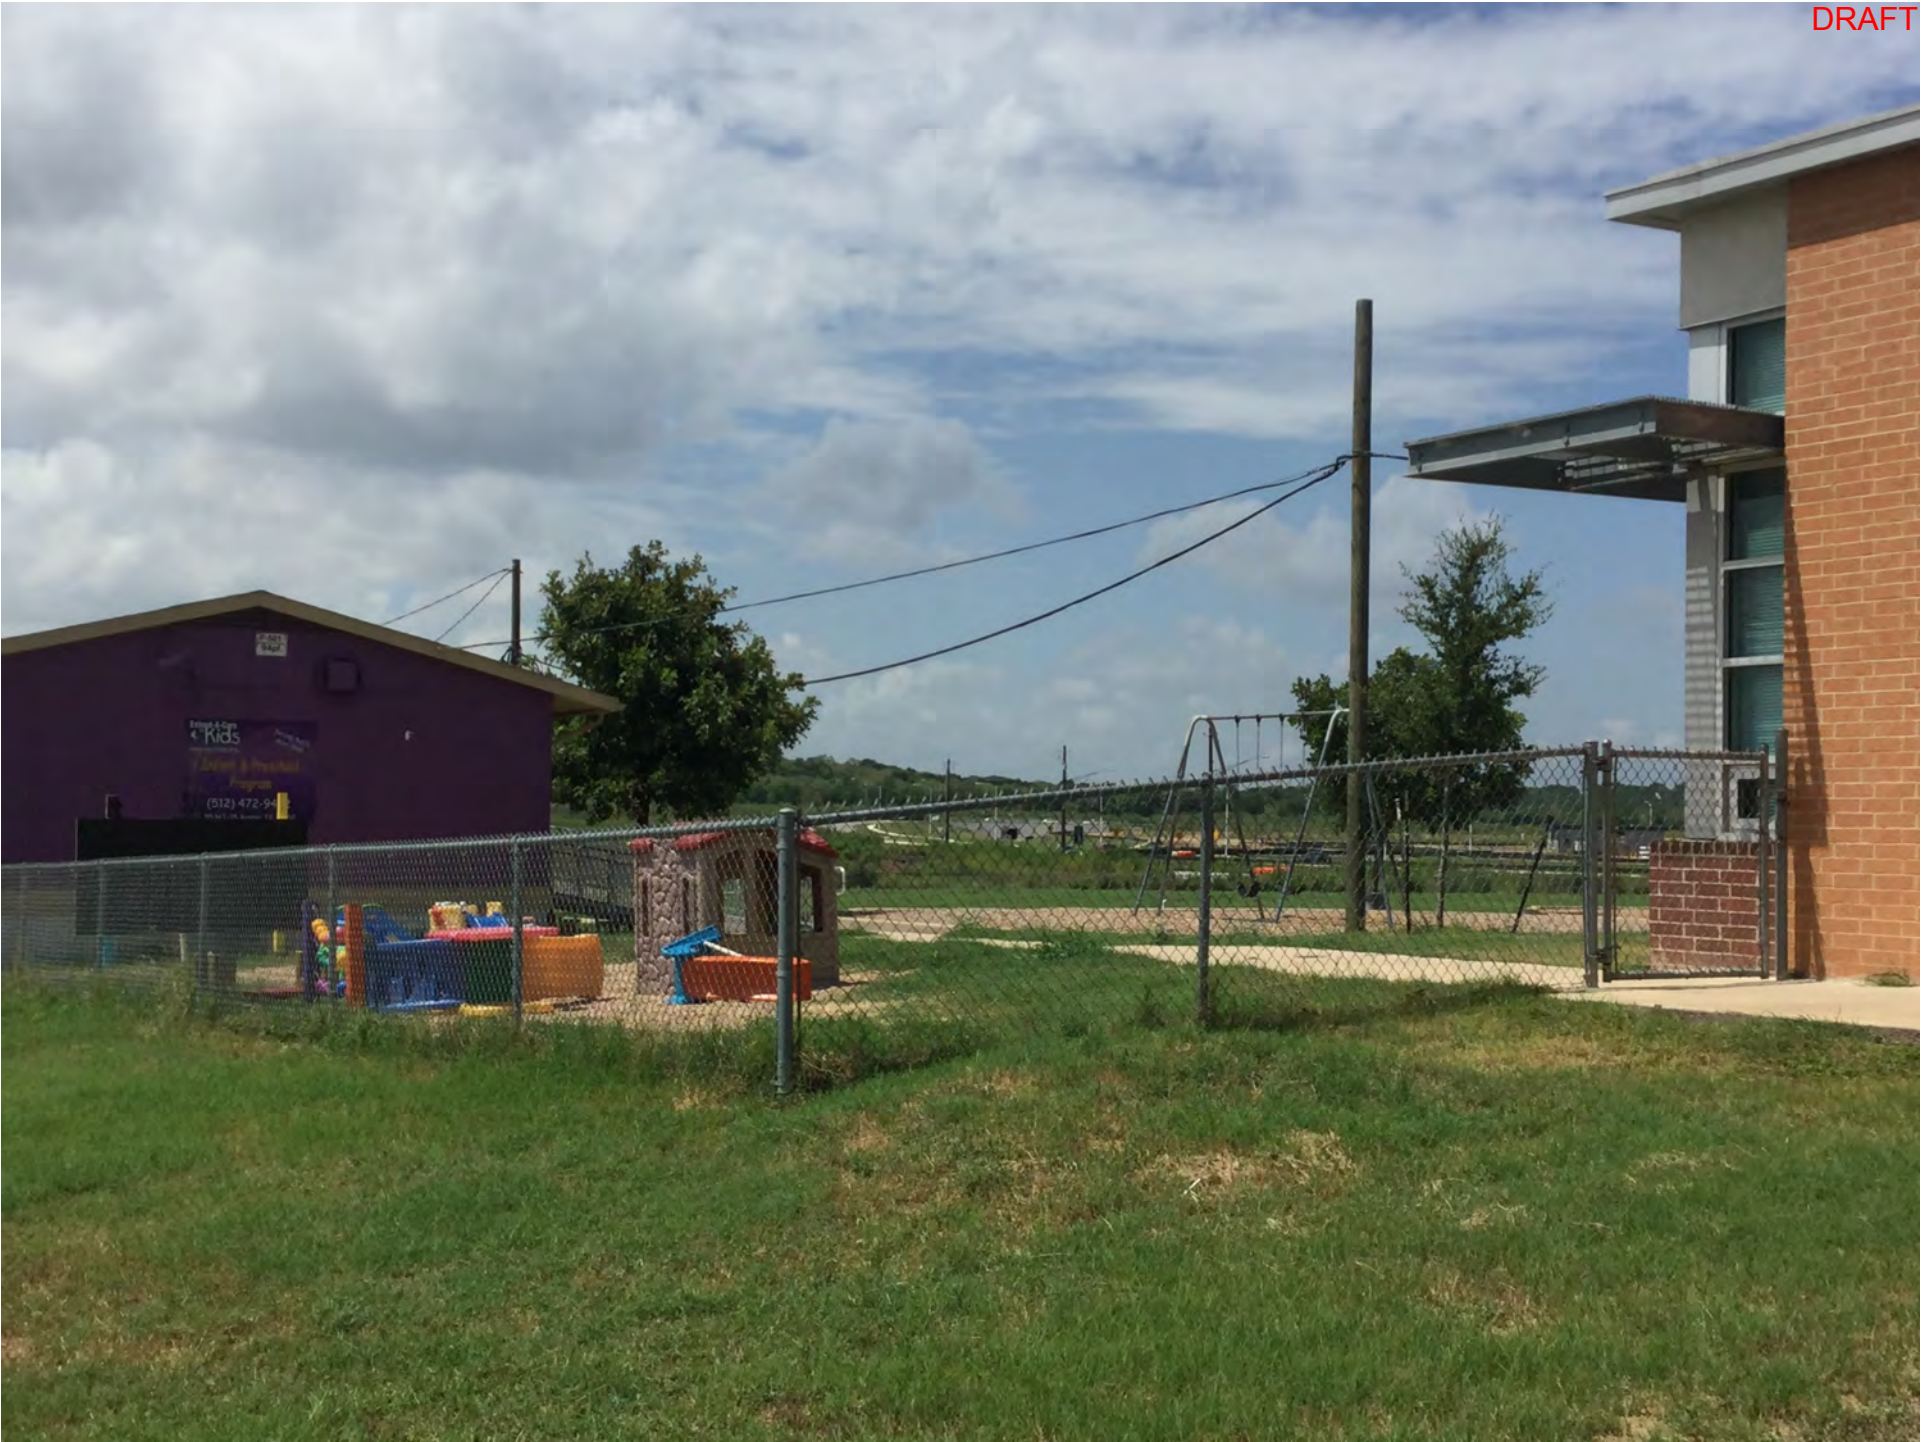
Photo 2. Playground

1.3	Are outdoor play spaces and playfields adequate in size and configuration?		2					Comments	1.00 2.00
	1) Outdoor play space exists, not developed 2) Outdoor play space exists but is not connected to gym or other athletic support areas or is too small. 3. Outdoor play spaces exist, are connected to other athletic areas, are the right size, but are not in good condition. 4. Outdoor play spaces need minor improvements to function well. 5. Outdoor play spaces are in excellent condition. N/A) Does not apply.							The play areas have shrunk in size, due to the amount of portables on the site. If capacity and enrollment were correct, play areas could be established.	See Image 2

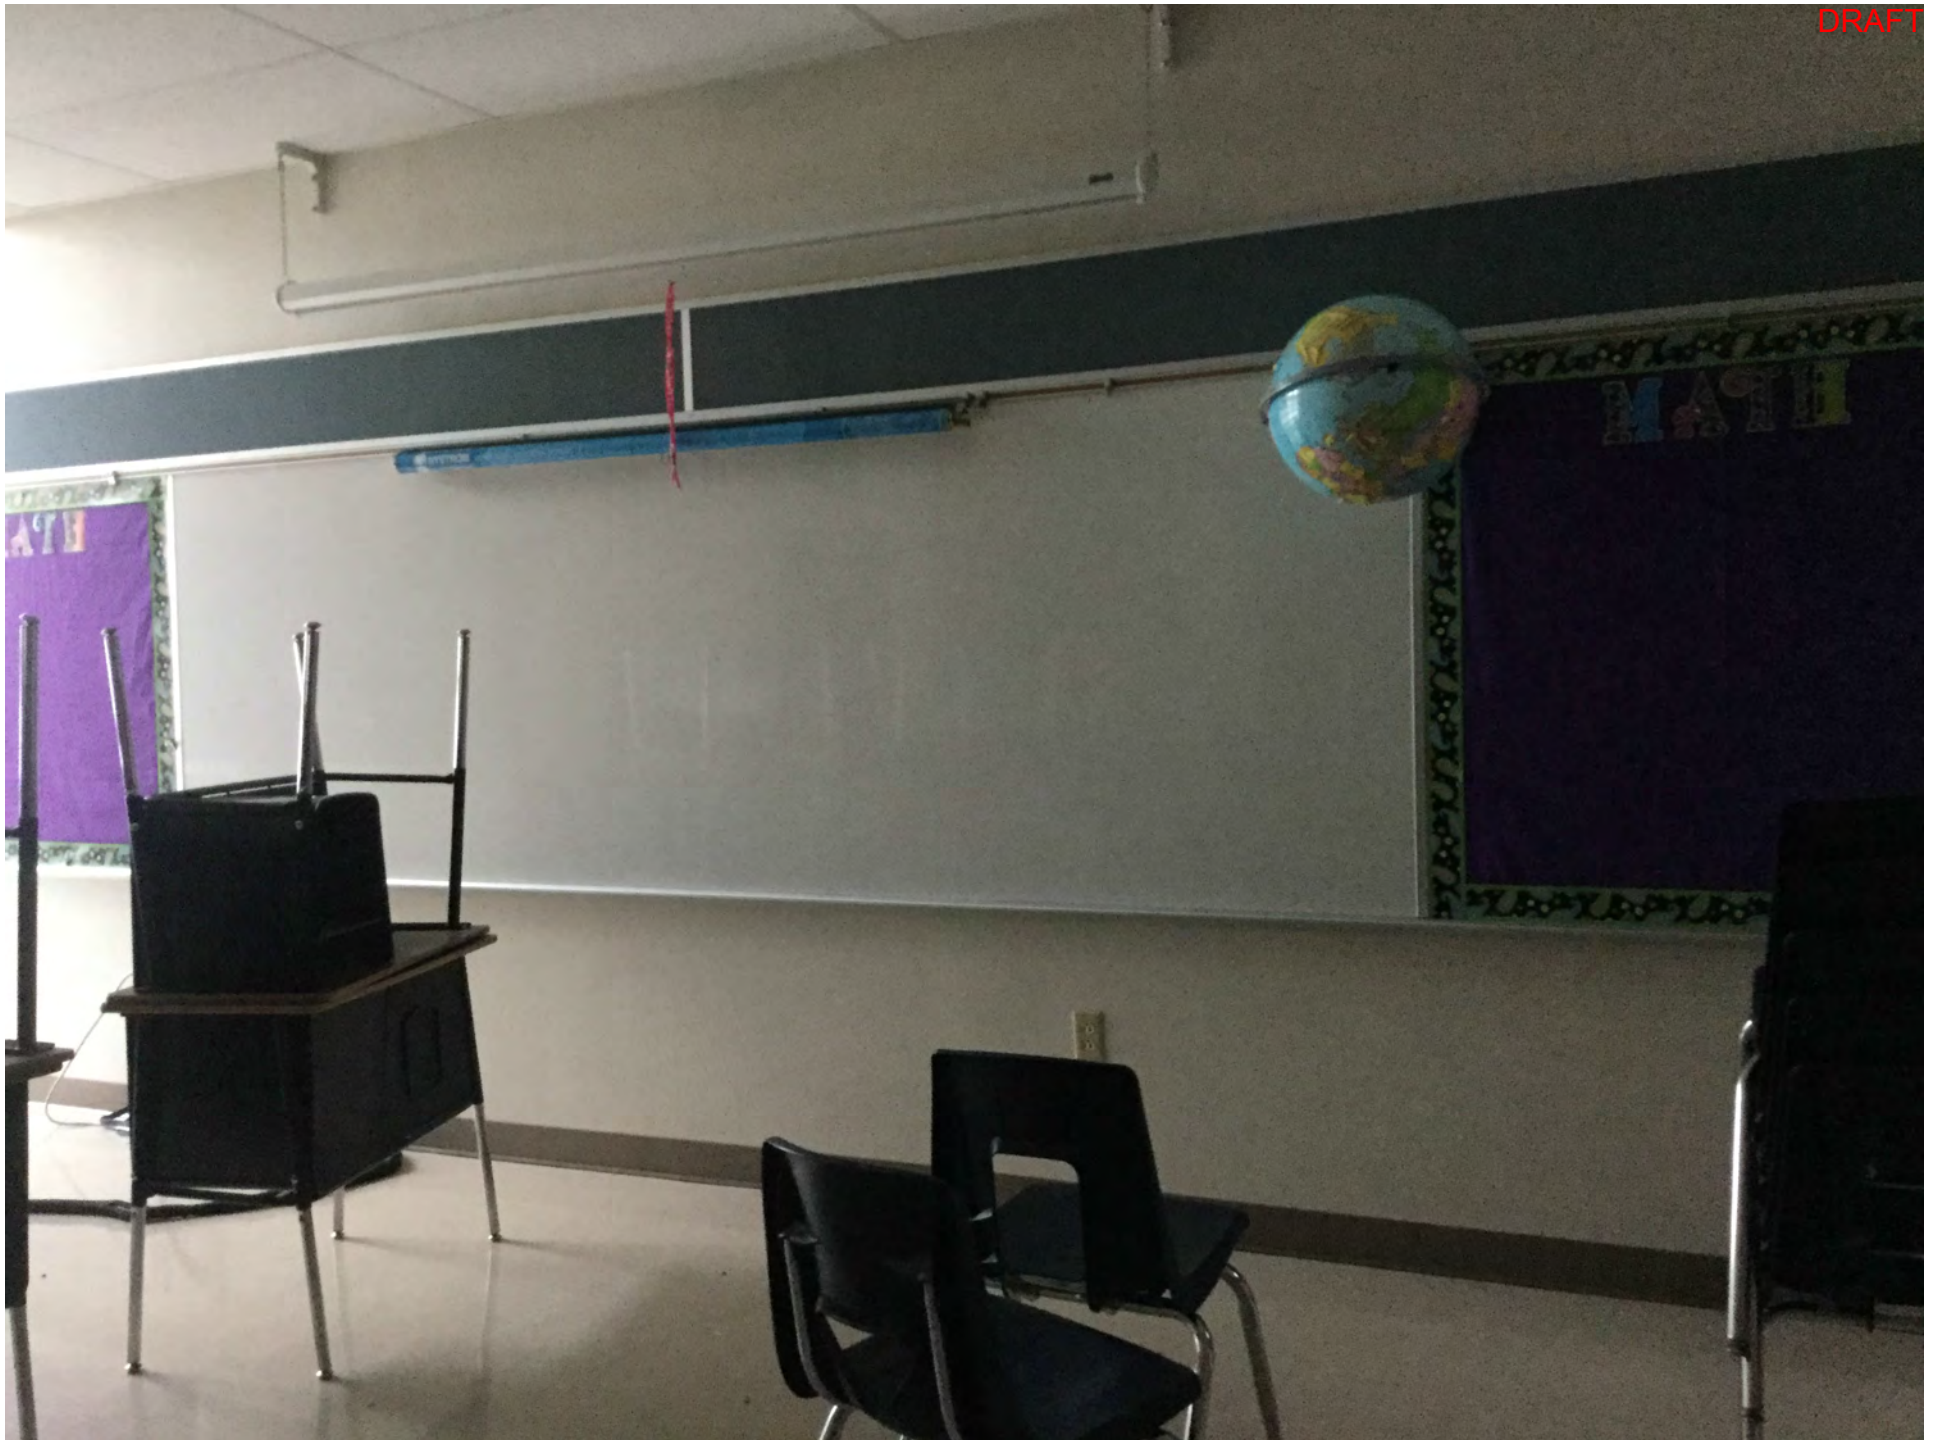
Photo 3. Classroom

1) Very unsatisfactory - Too small, awkward layout, does not meet needs 2) Unsatisfactory - Too small, only one area for all teaching methods, limited flexibility 3) Neutral - Moderate size, two areas for different teaching methods, some flexibility, access to student storage/casework 4) Satisfactory - Good size, at least two zones for different teaching methods, flexibility and student storage, not new 5) Very Satisfactory - Good size, two zones for different teaching methods, flexibility and student storage/casework, adequate display area and visual teaching tools N/A) Does not apply.								See Image 3

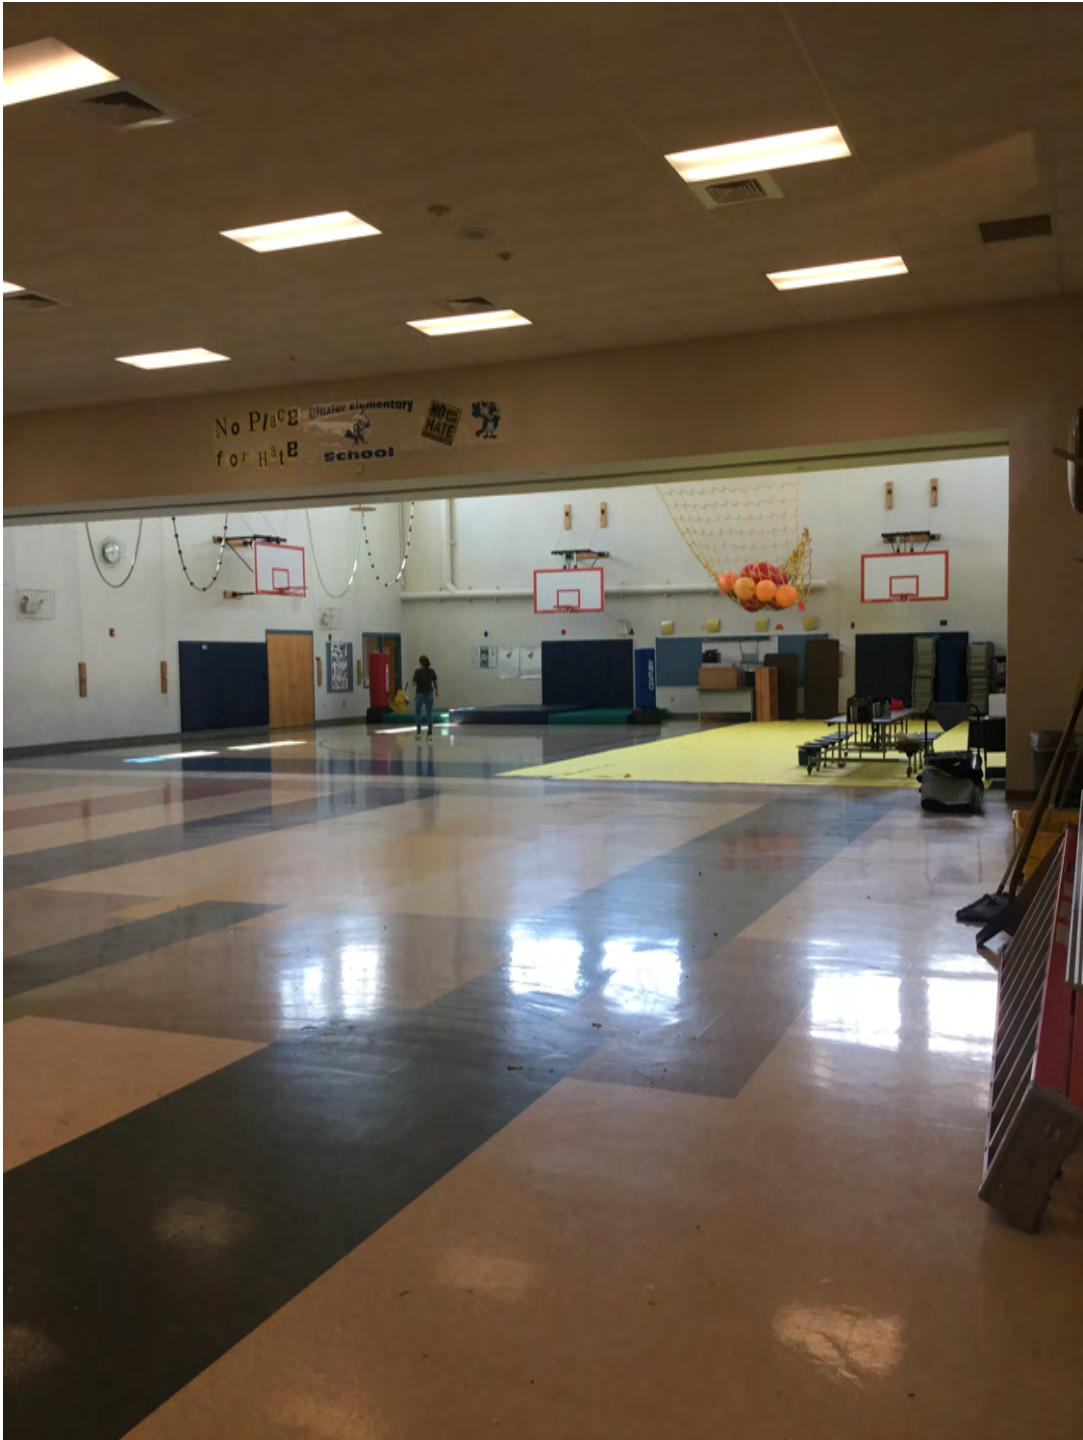
Photo 4. Gym and cafe

1) Very unsatisfactory 2) Unsatisfactory 3) Average 4) Good 5) Very good N/A) Does not apply.								The gym is a good space but the acoustical are inadequate as it is attached to the cafeteria.	See image 4

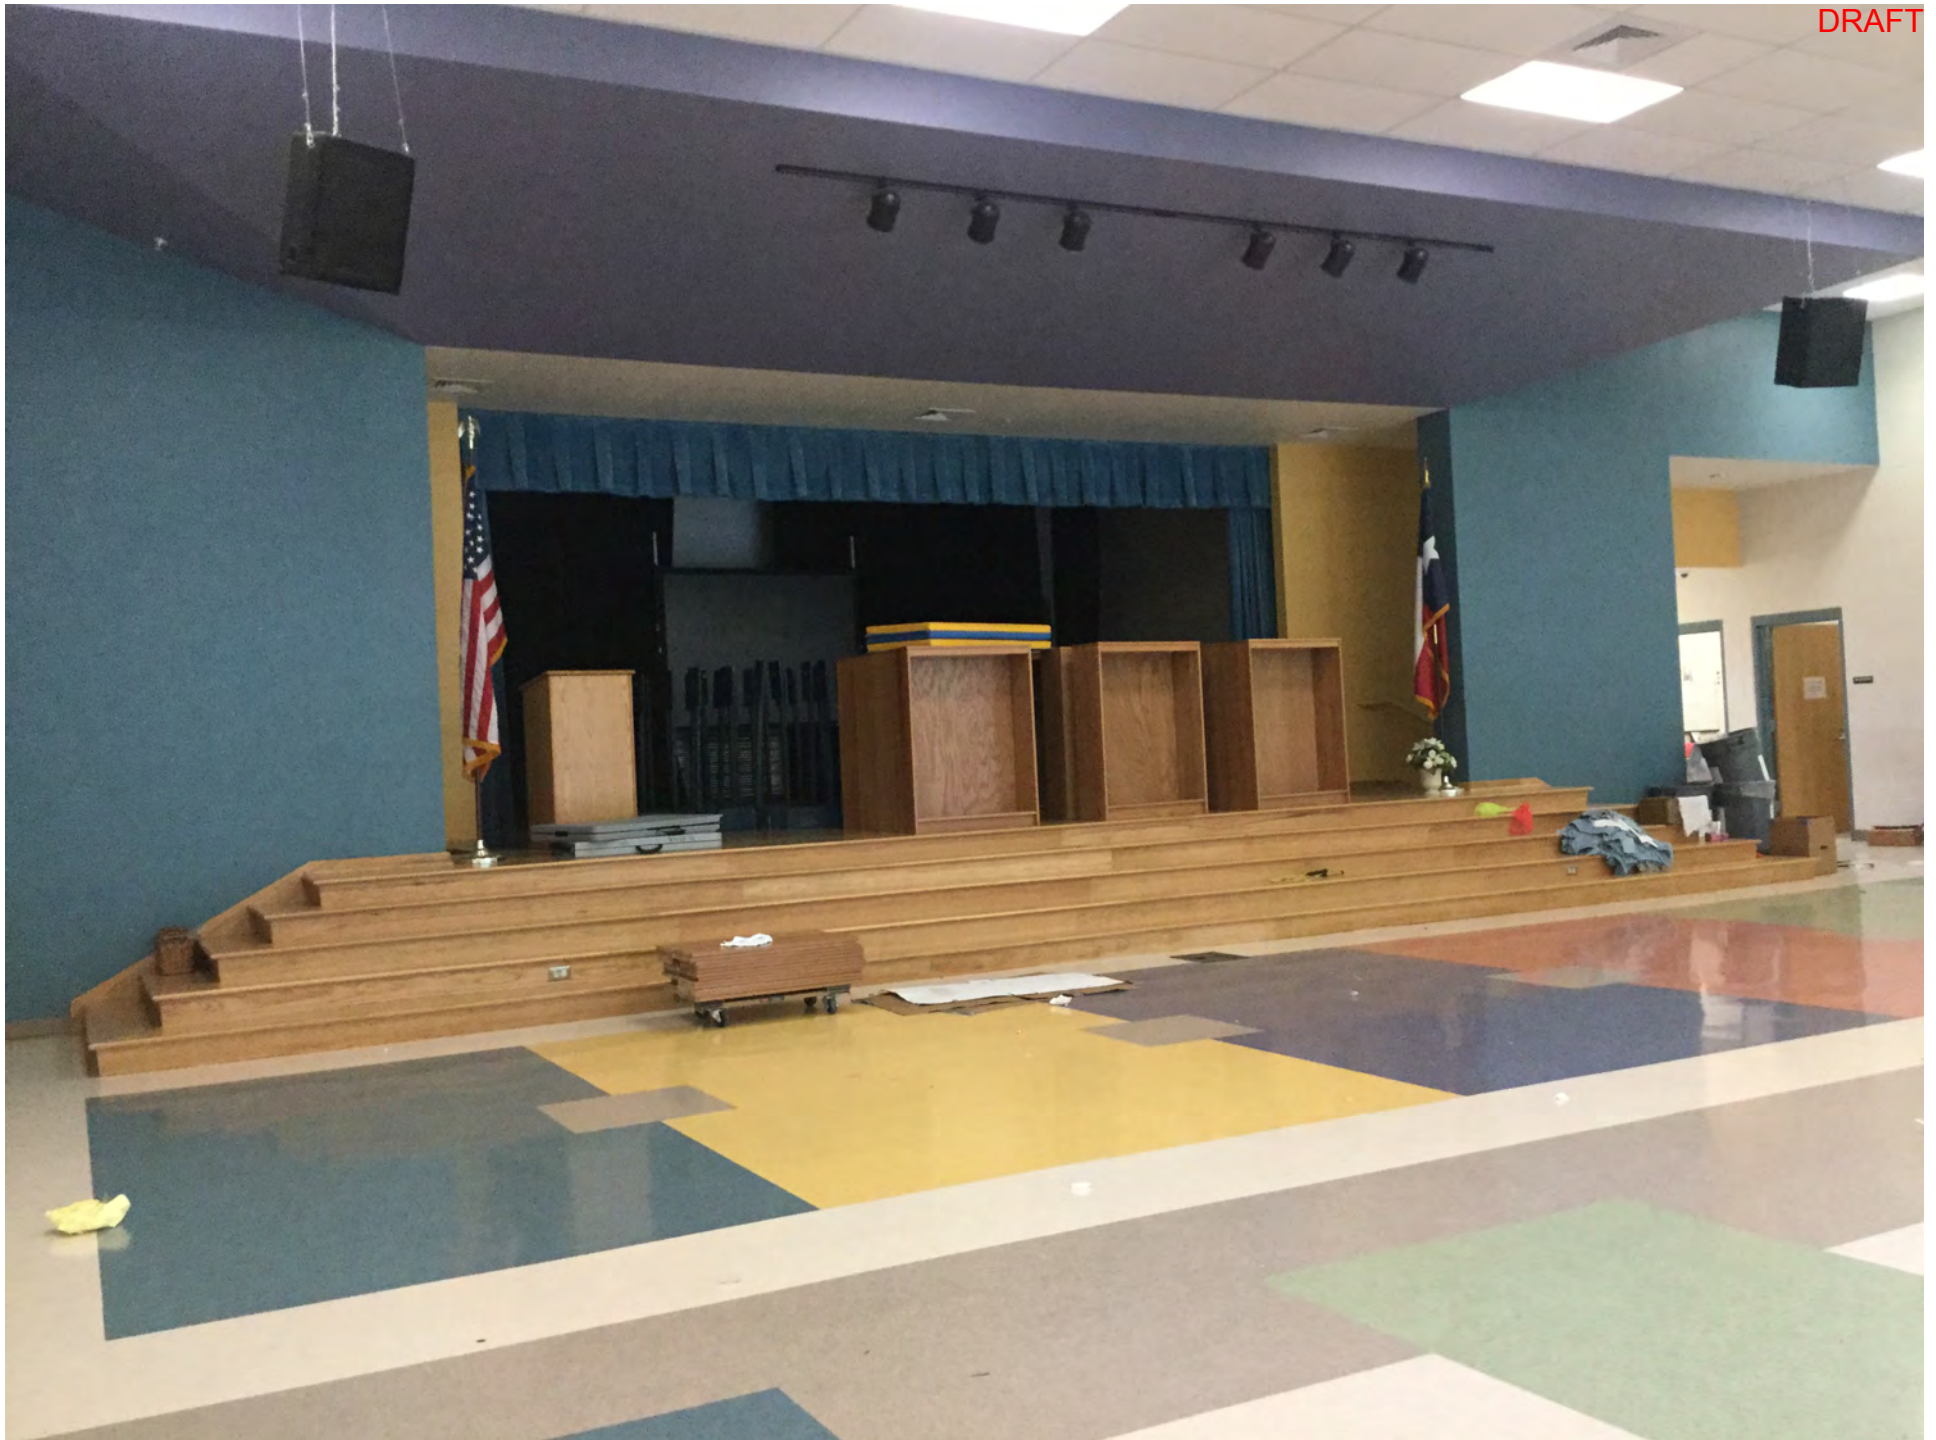
Photo 5. Stage

3.9	Are music, drama, or performance <b>support</b> spaces appropriately configured per the ed spec?			3				Comments	1.003.00
1) Very unsatisfactory - Support spaces are disconnected from served spaces, too small, do not meet needs 2) Unsatisfactory - Support spaces are connected, but too small, inadequate for needs 3) Average - Connected, moderate size, but need some renovations or updates to function well 4) Good - Connected, good size/layout, meets needs/functions well 5) Very good - connected, generous size, nice condition, functions appropriately N/A) Does not apply.								There is a general lack of storage and no dedicated storage for props/set.	See Image 5

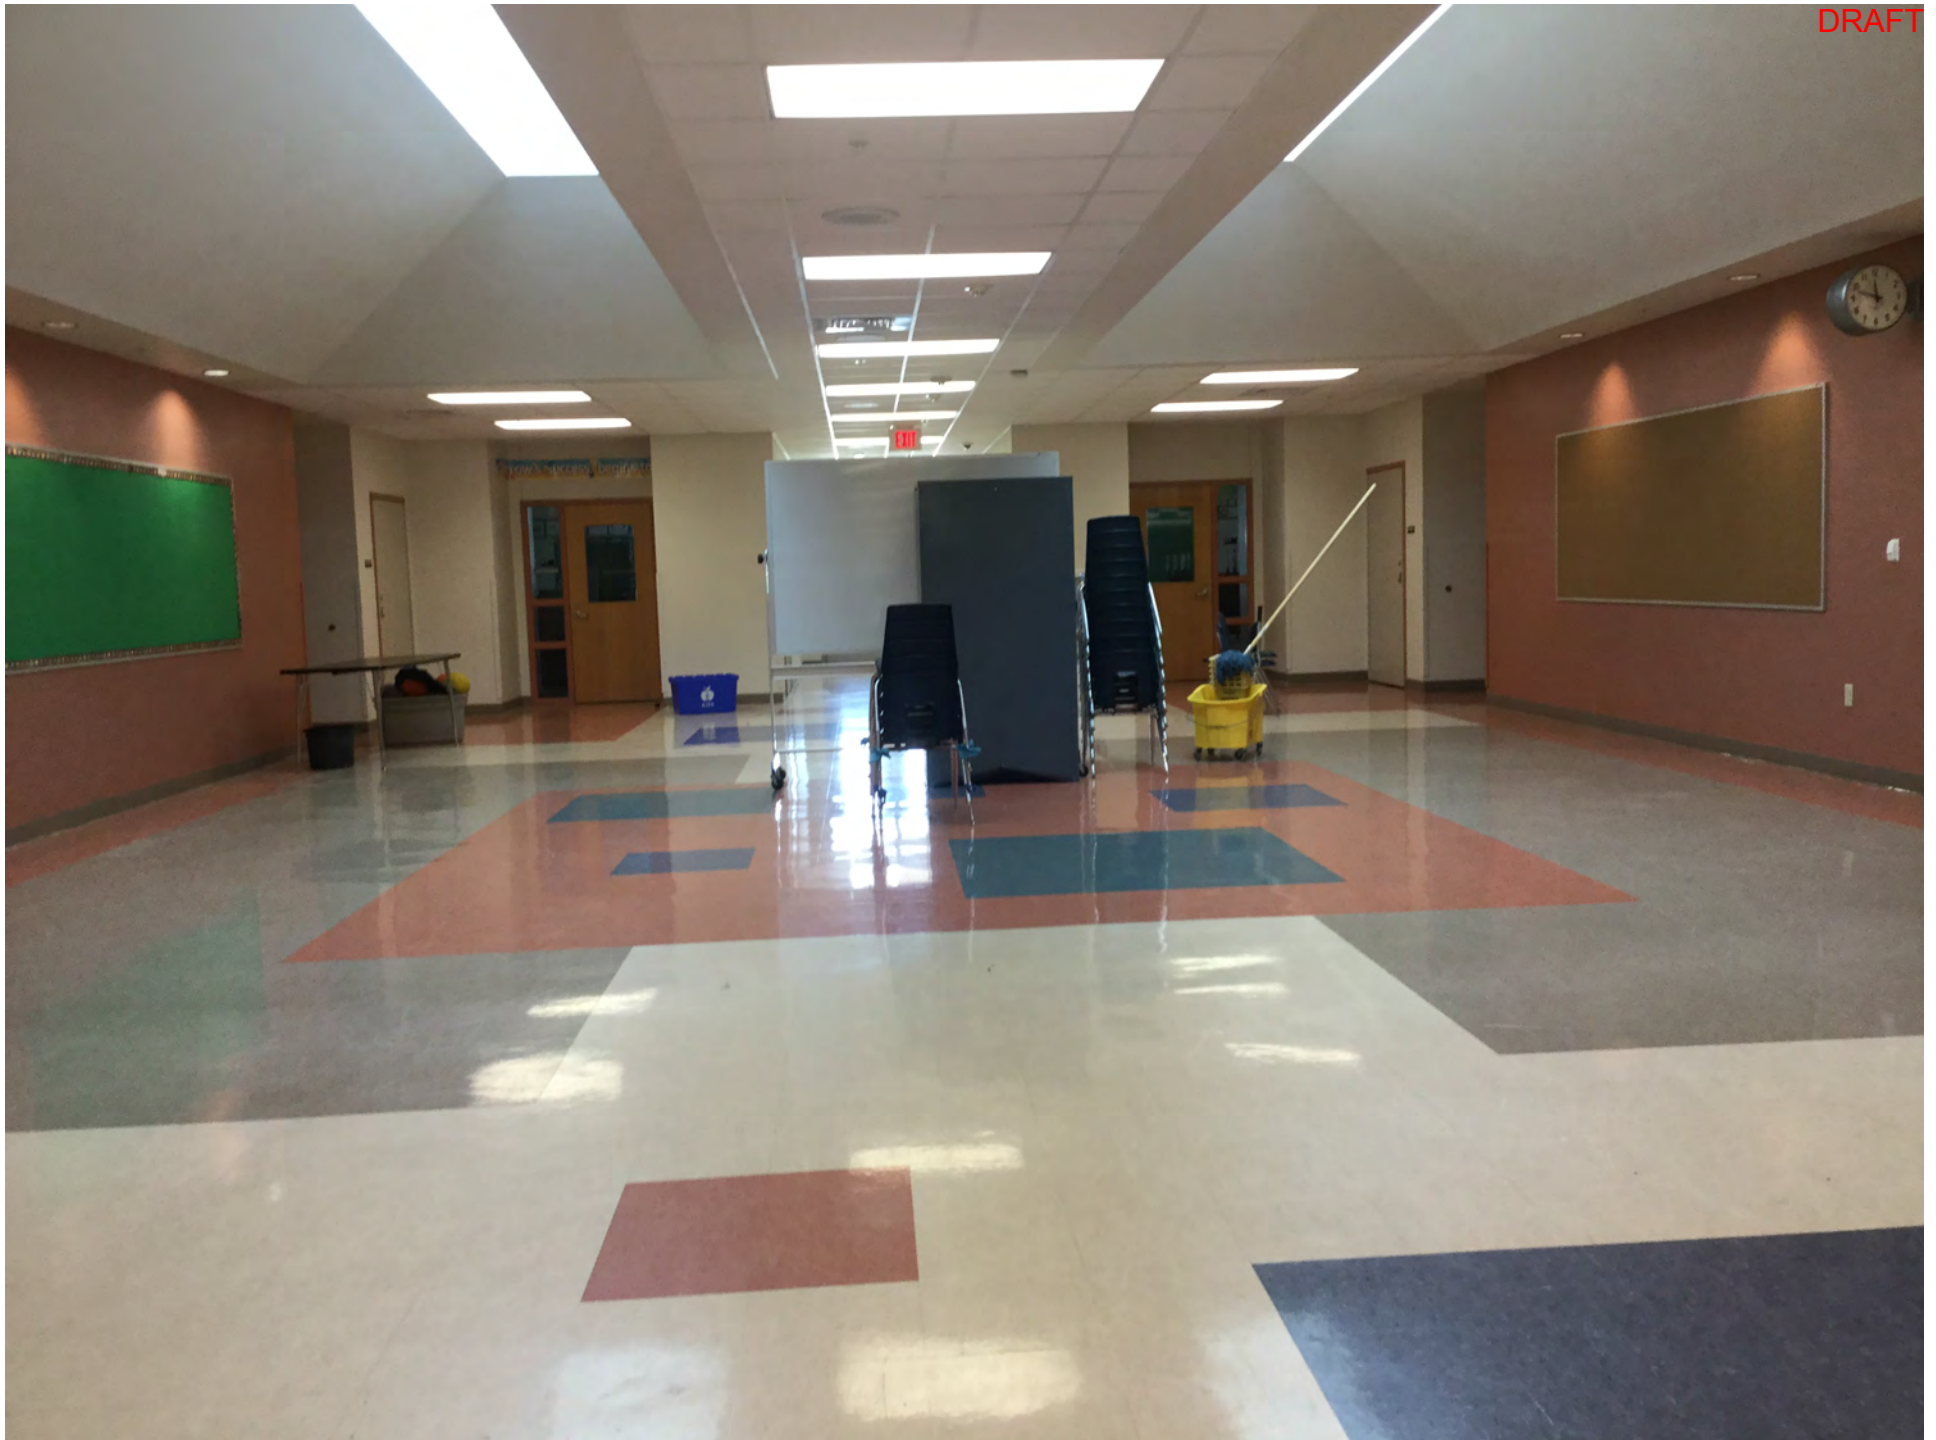
Photo 6. Flex space

1) Very unsatisfactory - No project space 2) Unsatisfactory - Non-dedicated, undersized or otherwise inadequate 3) Average - Limited dedicated spaces of moderate size and layout, equipment and furniture appropriate but need updates 4) Good - Dedicated spaces of adequate size and layout, most of the equipment and furniture is appropriate for program 5) Very good - Dedicated spaces of adequate size and layout, equipment and furniture appropriate for program N/A) Does not apply.								See image 6

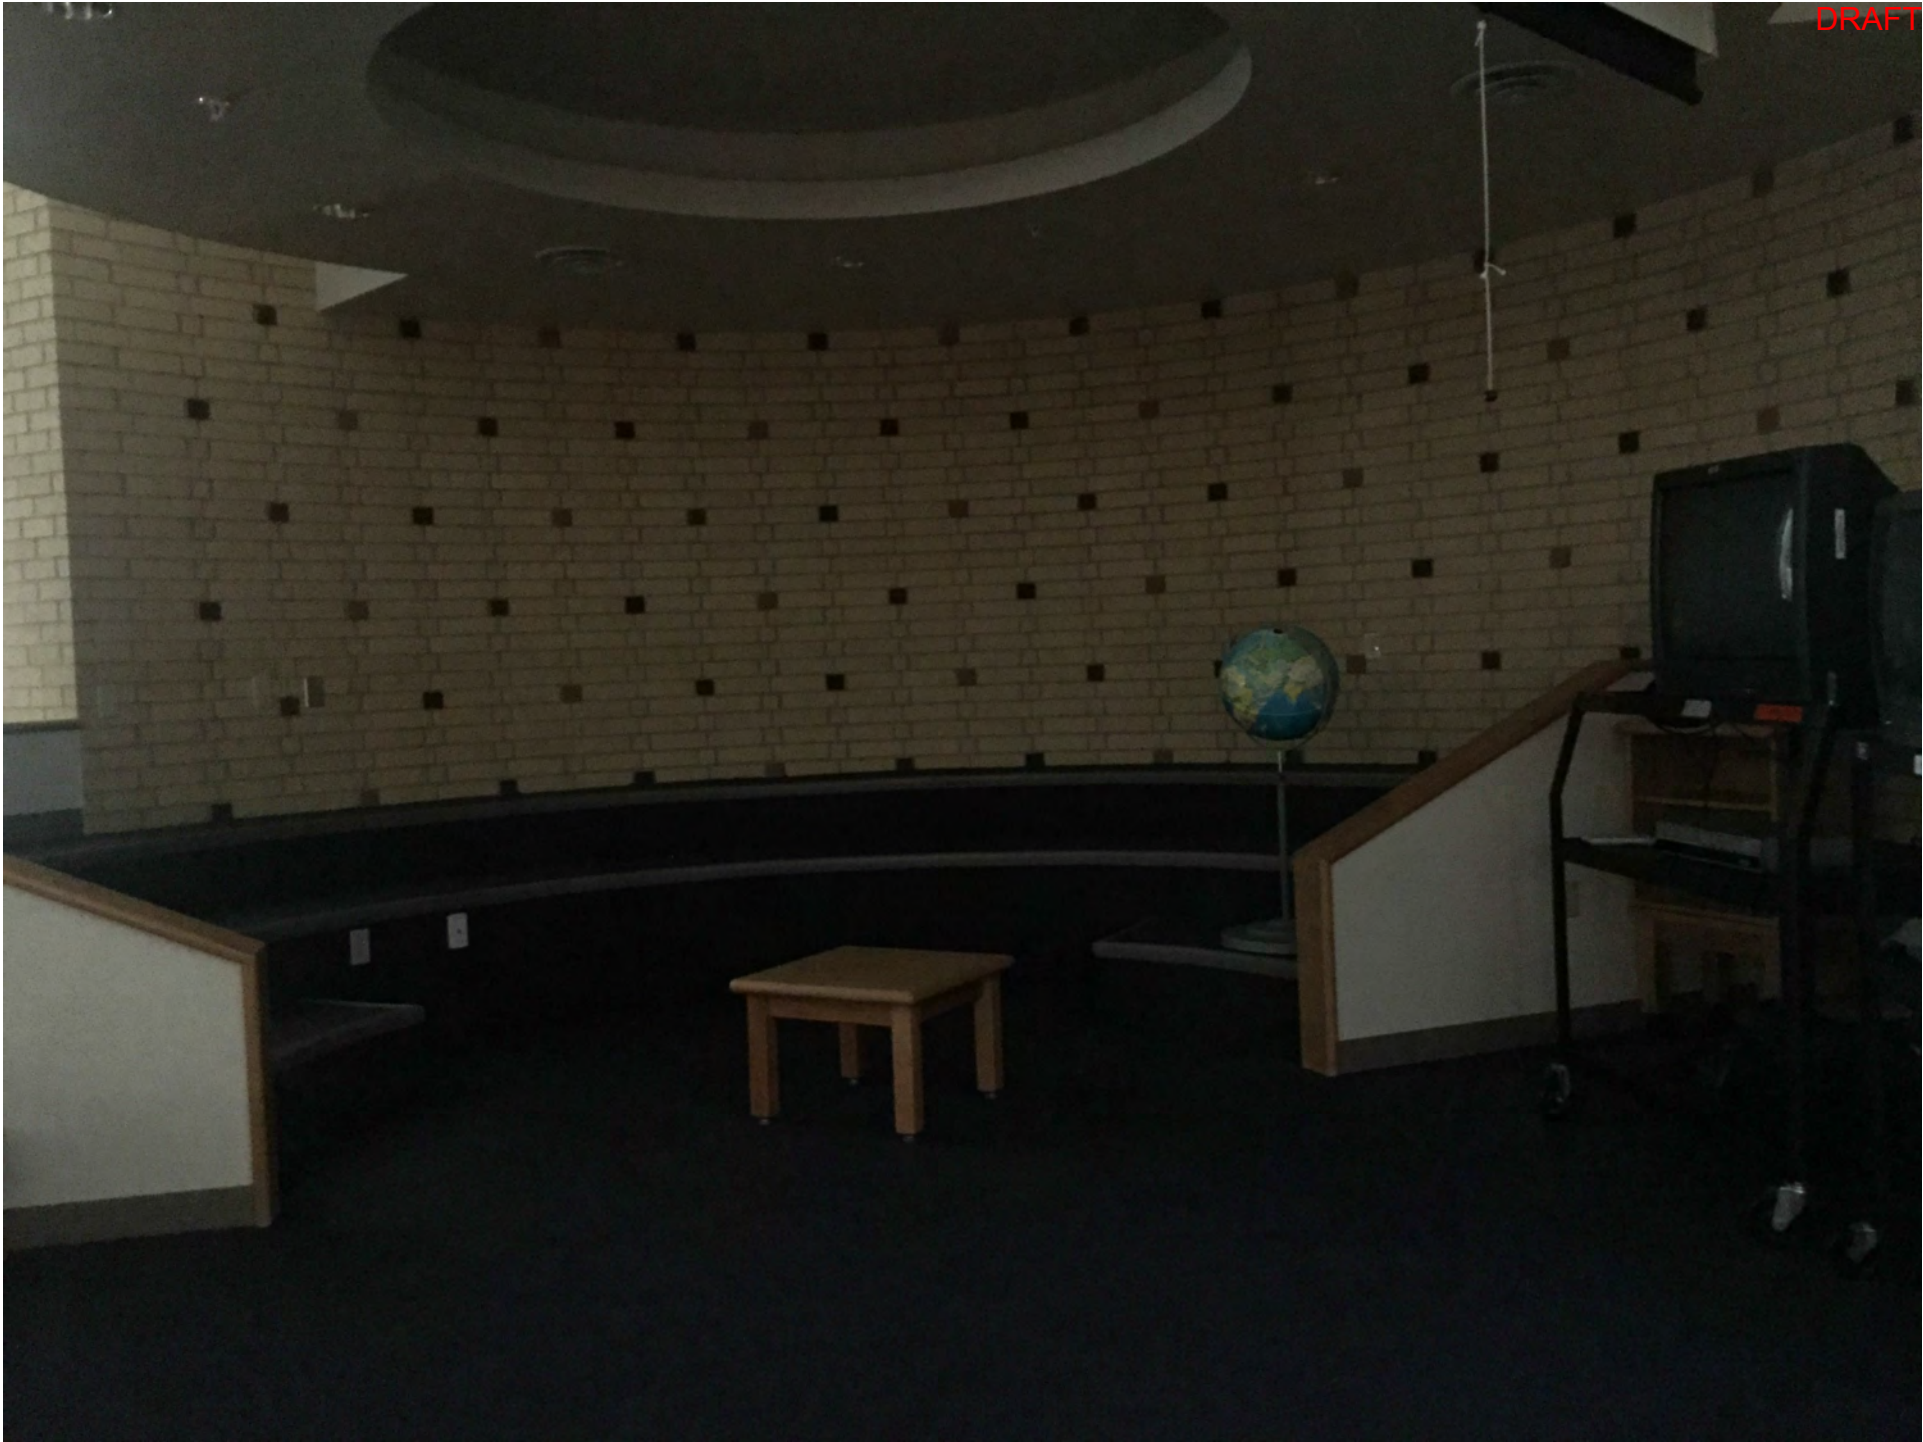
Photo 7. Library

5 - Library/Media Center - Continued		1	2	3	4	5	N/A		
5.5	How well does the Library/Media Center support collaborative work in larger groups (10-25)?					5		Comments	1.005.00
<div>1) Very unsatisfactory</div> <div>2) Unsatisfactory</div> <div>3) Average</div> <div>4) Good</div> <div>5) Very good</div> <div>N/A) Does not apply.</div>								The library has a nice amphitheater area that would support this kind of collaboration, however, the equipment (projector/screen) is cumbersome.	See image 7

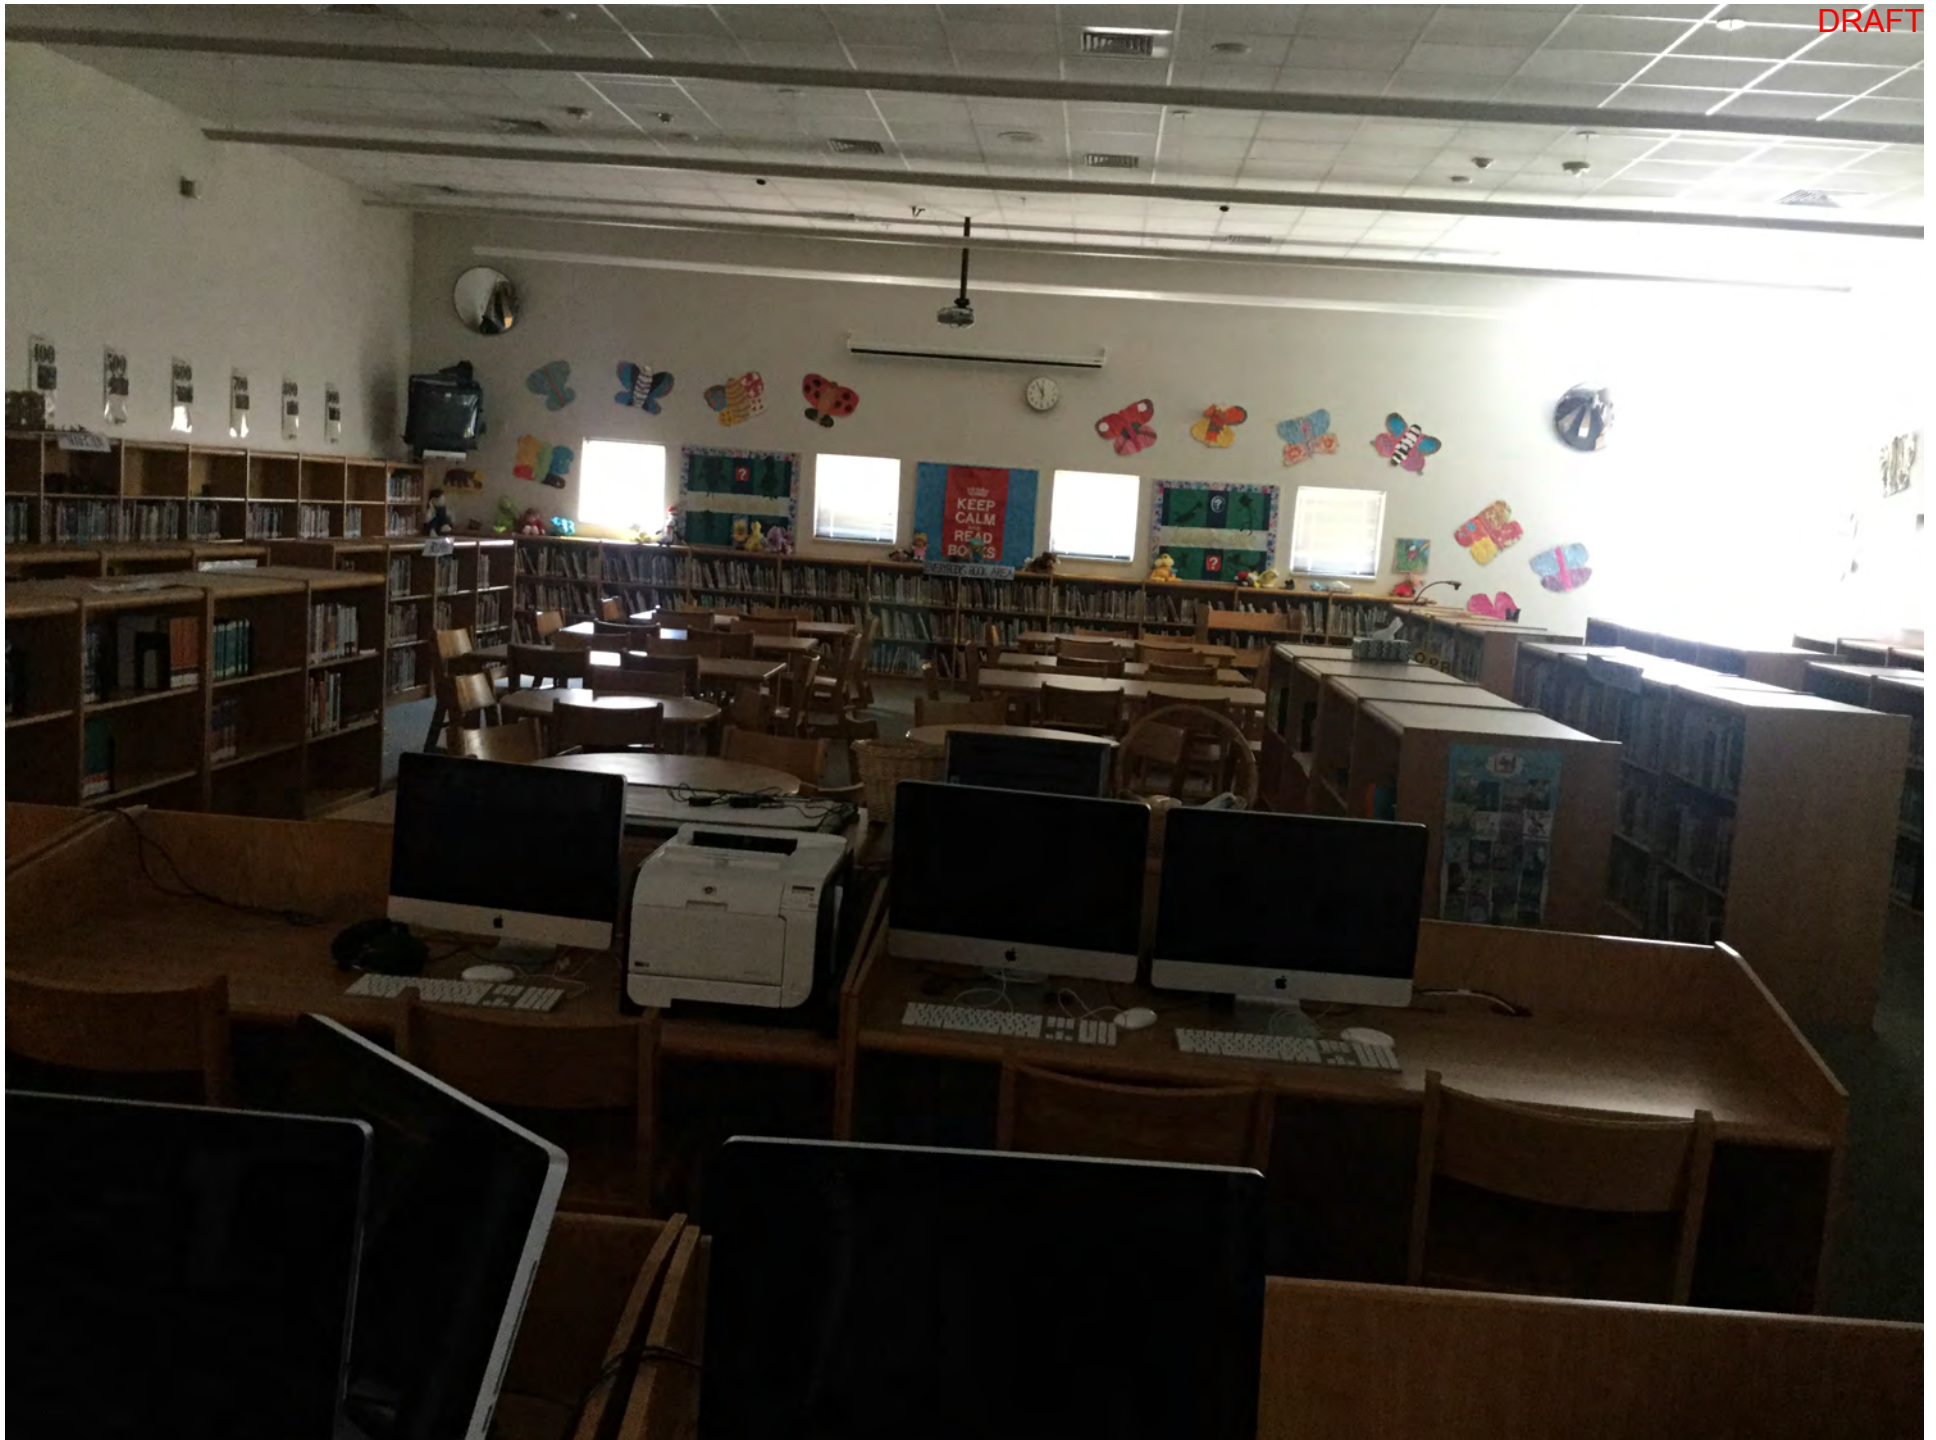
Photo 8. Library

5.6	How well does the Library/Media Center support technology?				4			Comments	1.004.00
<div>1) Very unsatisfactory - Very inadequate power outlets, no Wi-Fi capability, no computers, tablets, laptops, media carts or screens for use</div> <div>2) Unsatisfactory - Some power, no Wi-Fi capability, outdated and inadequate technology available</div> <div>3) Average - Some power outlets, network connectivity, technology available</div> <div>4) Good - Adequate power outlets available, network connectivity, appropriate number of computers/tablets/laptops/media carts or screens available</div> <div>5) Very good - Adequate power outlets available, good network connectivity, computers, tablets, laptops and media carts or screens available and adequate for number of students</div> <div>N/A) Does not apply.</div>								The equipment like the TV and the innovation station are cumbersome.	See image 8
