## Educational Suitability Summary Report

Blazier Elementary School

Date: 07/29/2016

## Austin ISD Educational Suitability Assessment Criteria

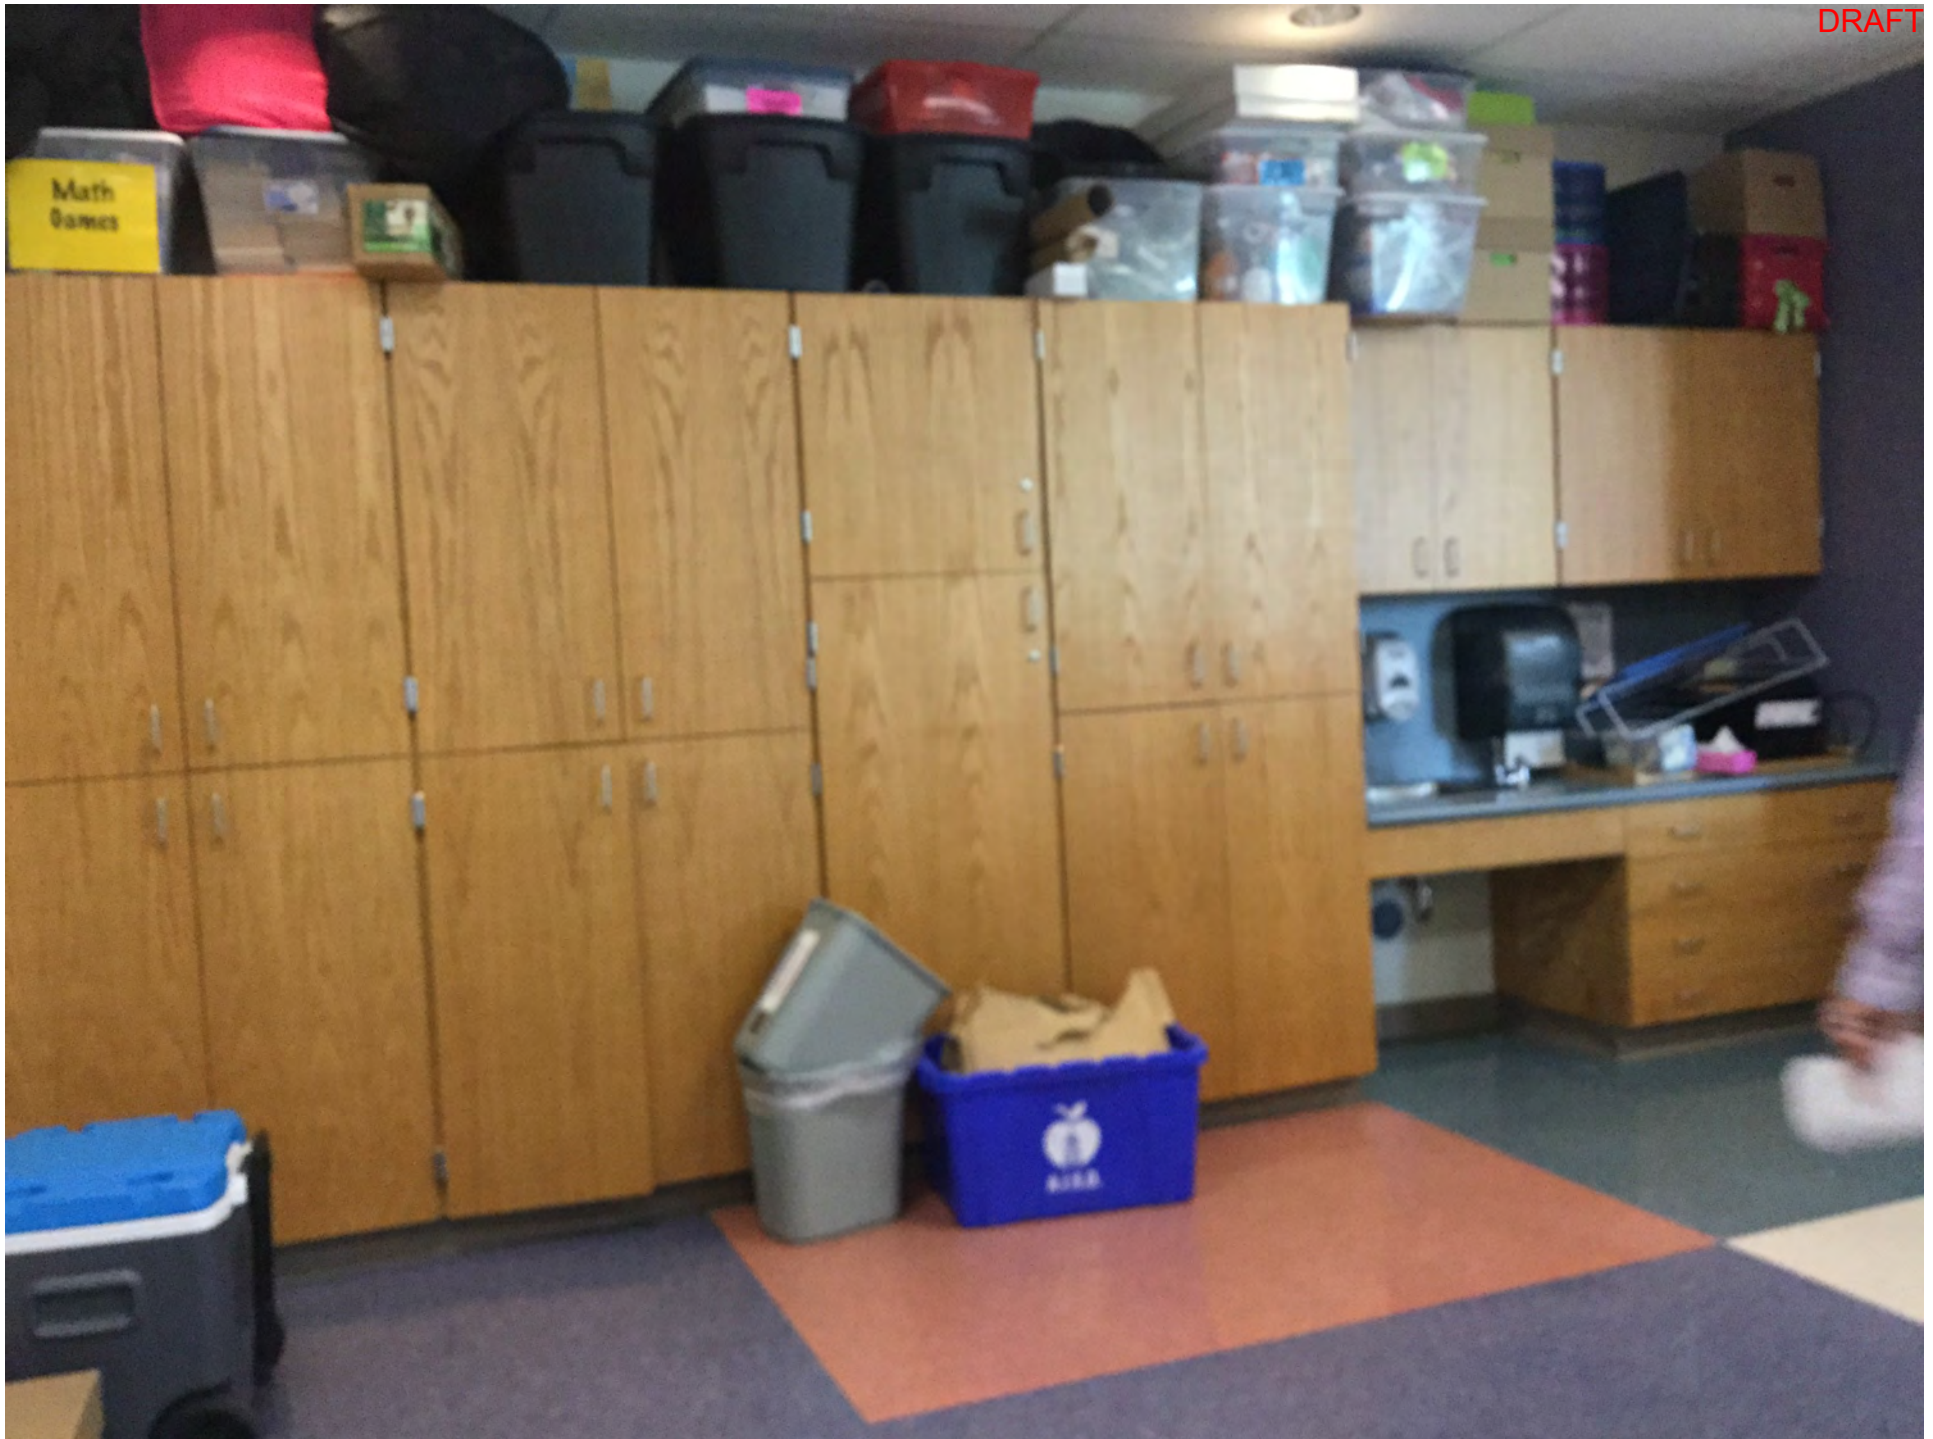
Photo 9. Storage

8 - Storage		1	2	3	4	5	N/A	13.00	
8.1	Is there adequate general storage in the building?			3				Comments	1.00 3.00
1) Very unsatisfactory 2) Unsatisfactory 3) Average 4) Good 5) Very good N/A) Does not apply.								There is a lack of storage space due to the campus being over enrolled.	See image 9
8.2	Is there adequate classroom storage?					5		Comments	1.00 5.00
1) Very unsatisfactory 2) Unsatisfactory 3) Average 4) Good 5) Very good N/A) Does not apply.									
8.3	Is there adequate student storage?					5		Comments	1.00 5.00
1) Very unsatisfactory 2) Unsatisfactory 3) Average 4) Good 5) Very good N/A) Does not apply.								The students have hooks in the classrooms to hang their bags.	See image 10
