Educational Suitability Summary Report

Boone Elementary School

Date: 10/31/2016 (REV1 - 11/3/2016)

Austin ISD Educational Suitability Assessment Criteria

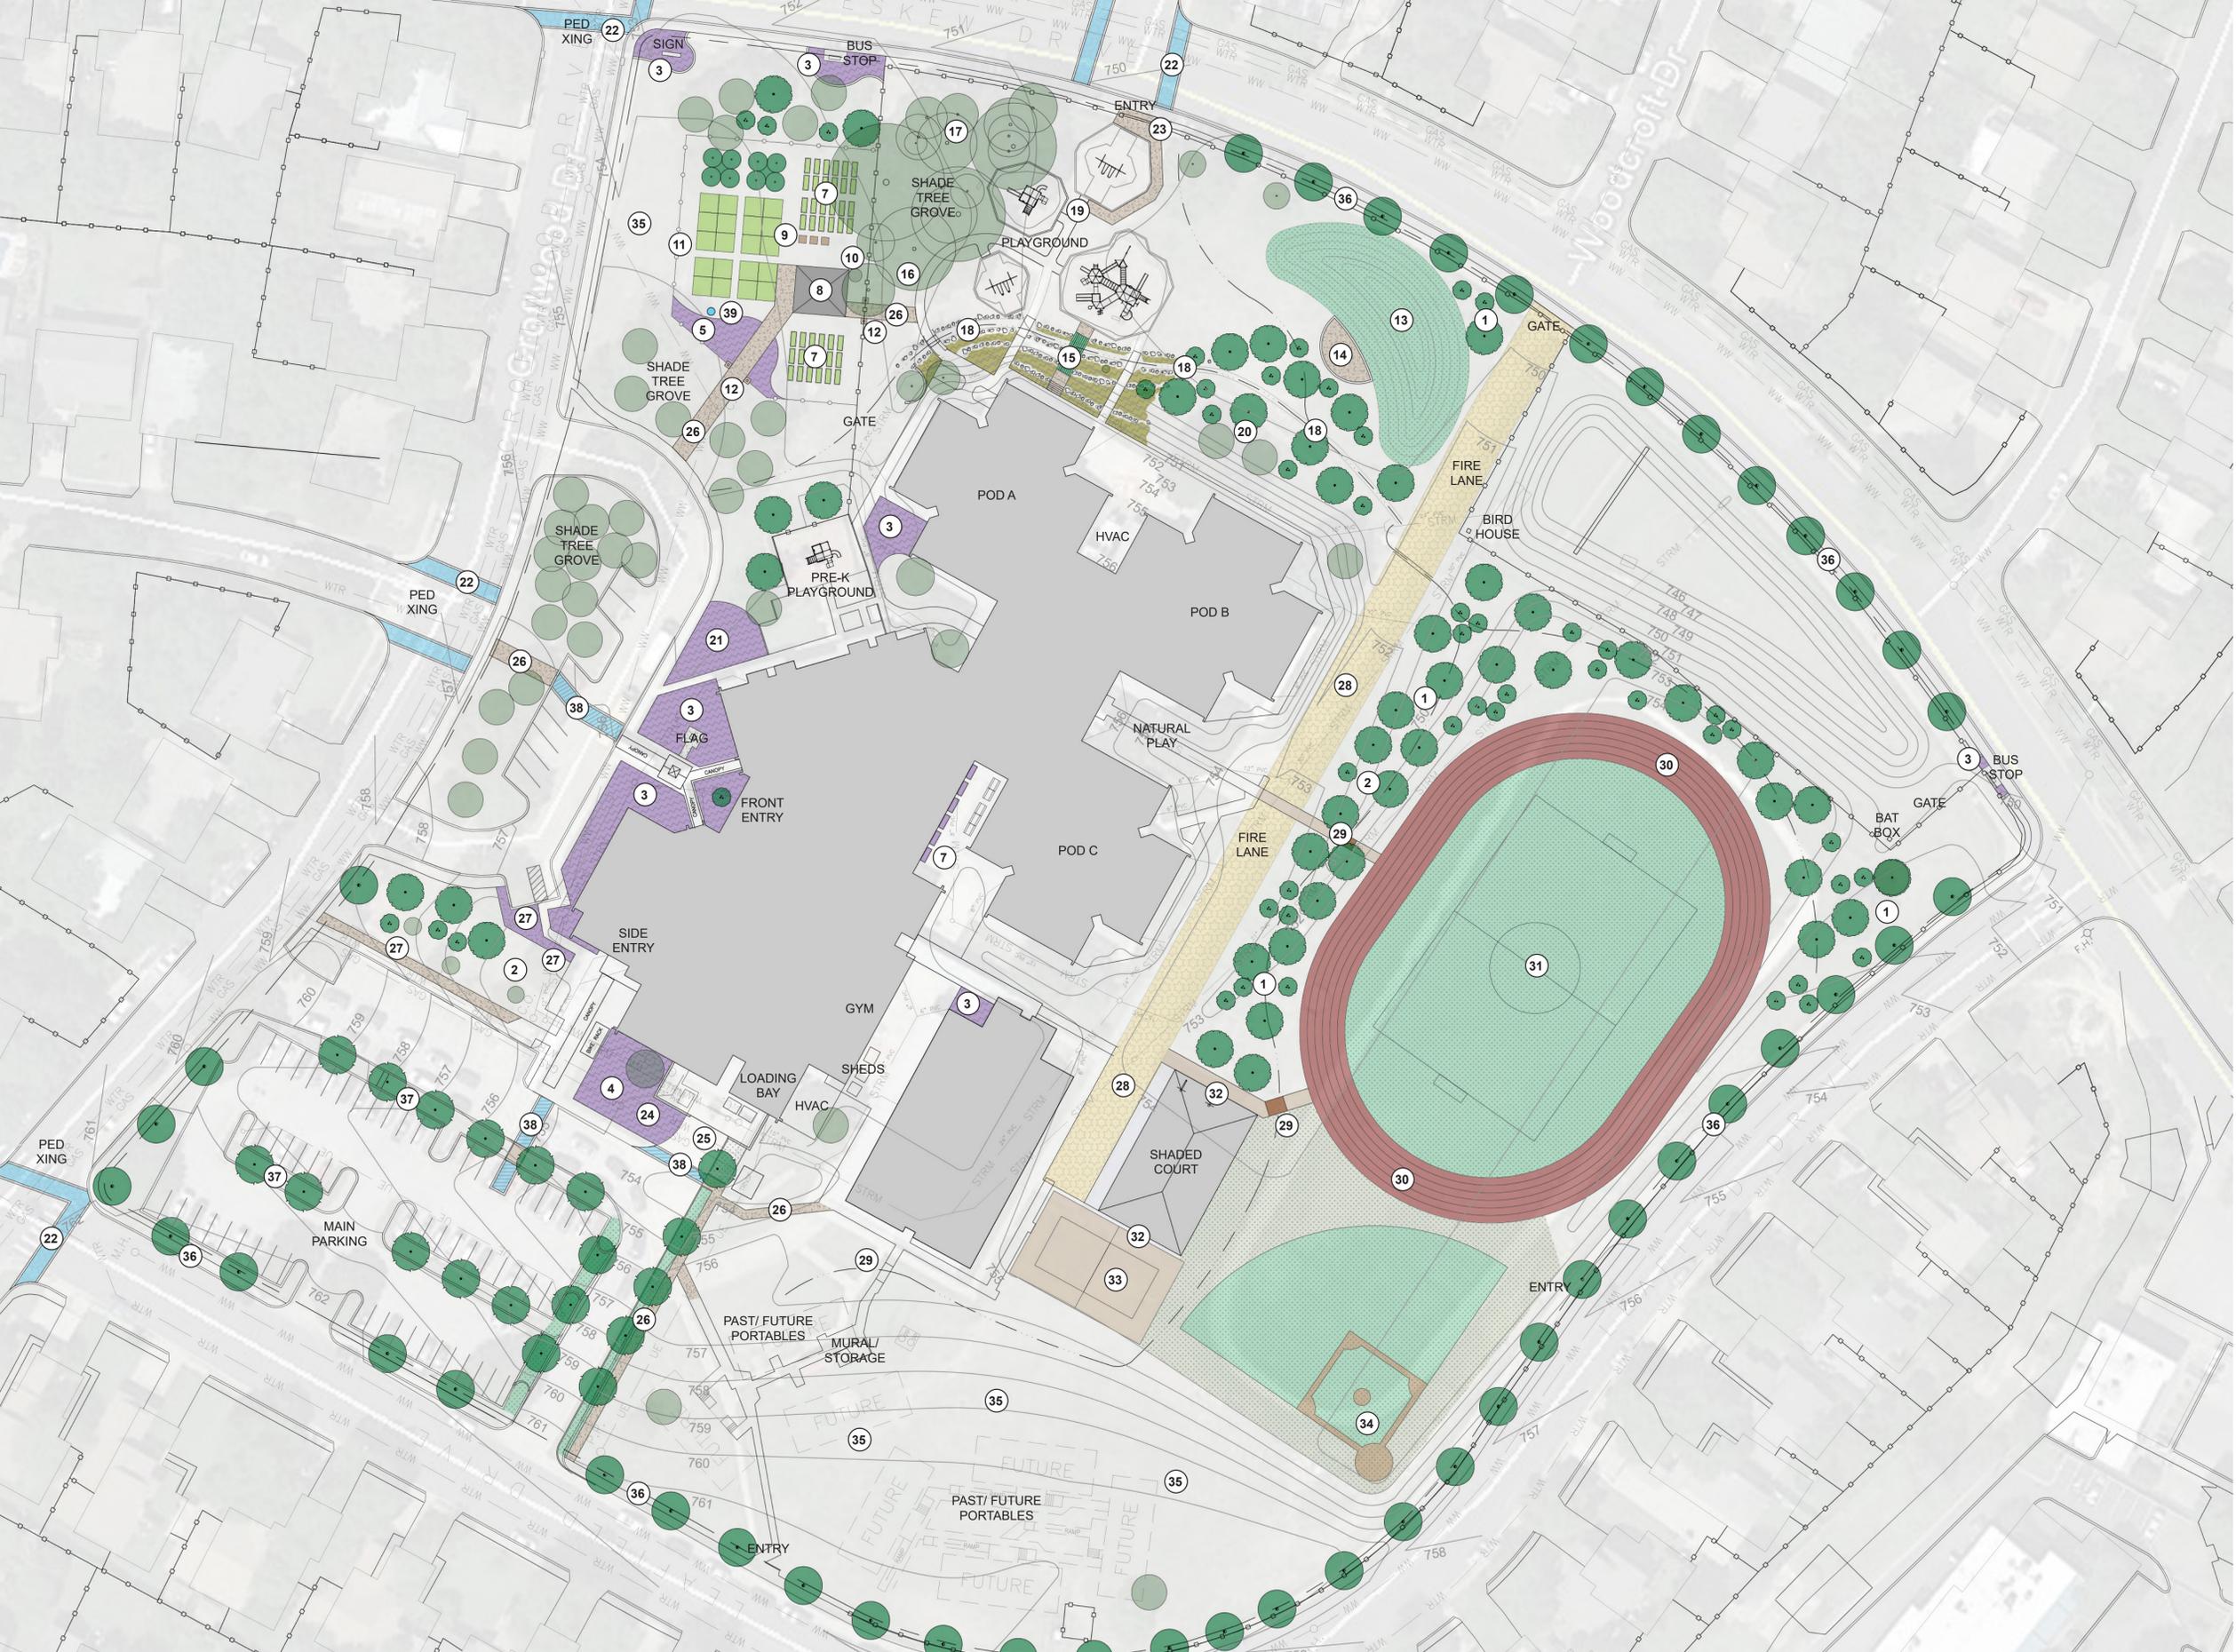
DRAFT - BOONE ELEMENTARY - SCHOOLYARD MASTER PLAN

- 1 Shade Trees
- 2 Rain Garden
- 3 Native Plant Garden
- 4 Native Color Garden
- 5 Pollinator Garden
- 6 Community Plots
- 7 Raised Planter Beds
- 8 Outdoor Classroom
- 9 Compost
- 10 Rainwater Collection
- 11 Garden Fence
- 12 Garden Gate
- 13 Amphitheater Hill
- 14 Play Stage
- 15 Vine Tunnel
- 16 Buddy Bench
- 17 Streamer Tree
- 18 Dry Creek Terrace Play
- 19 Peace Path
- 20 Log Tee-Pees
- 21 Refreshed Butterfly Garden
- 22 Painted Crosswalk
- 23 Playground Gate
- 24 Mural Screen Wall
- 25 Rolling Gate
- 26 Concrete Sidewalk
- 27 Crushed Granite Walk
- 28 Play Striping
- 29 Pedestrian Bridge
- 30 200m Track
- 31 Artificial Turf Soccer Field (U10 Size)
- 32 Combo Basketball/Soccer Goals
- 33 Volleyball Court
- 34 Baseball Diamond (Pinto League Size)
- 35 Wildflowers
- 36 Street Trees
- 37 Parking Lot Trees
- 38 Improved Crossing
- 39 Container Pond

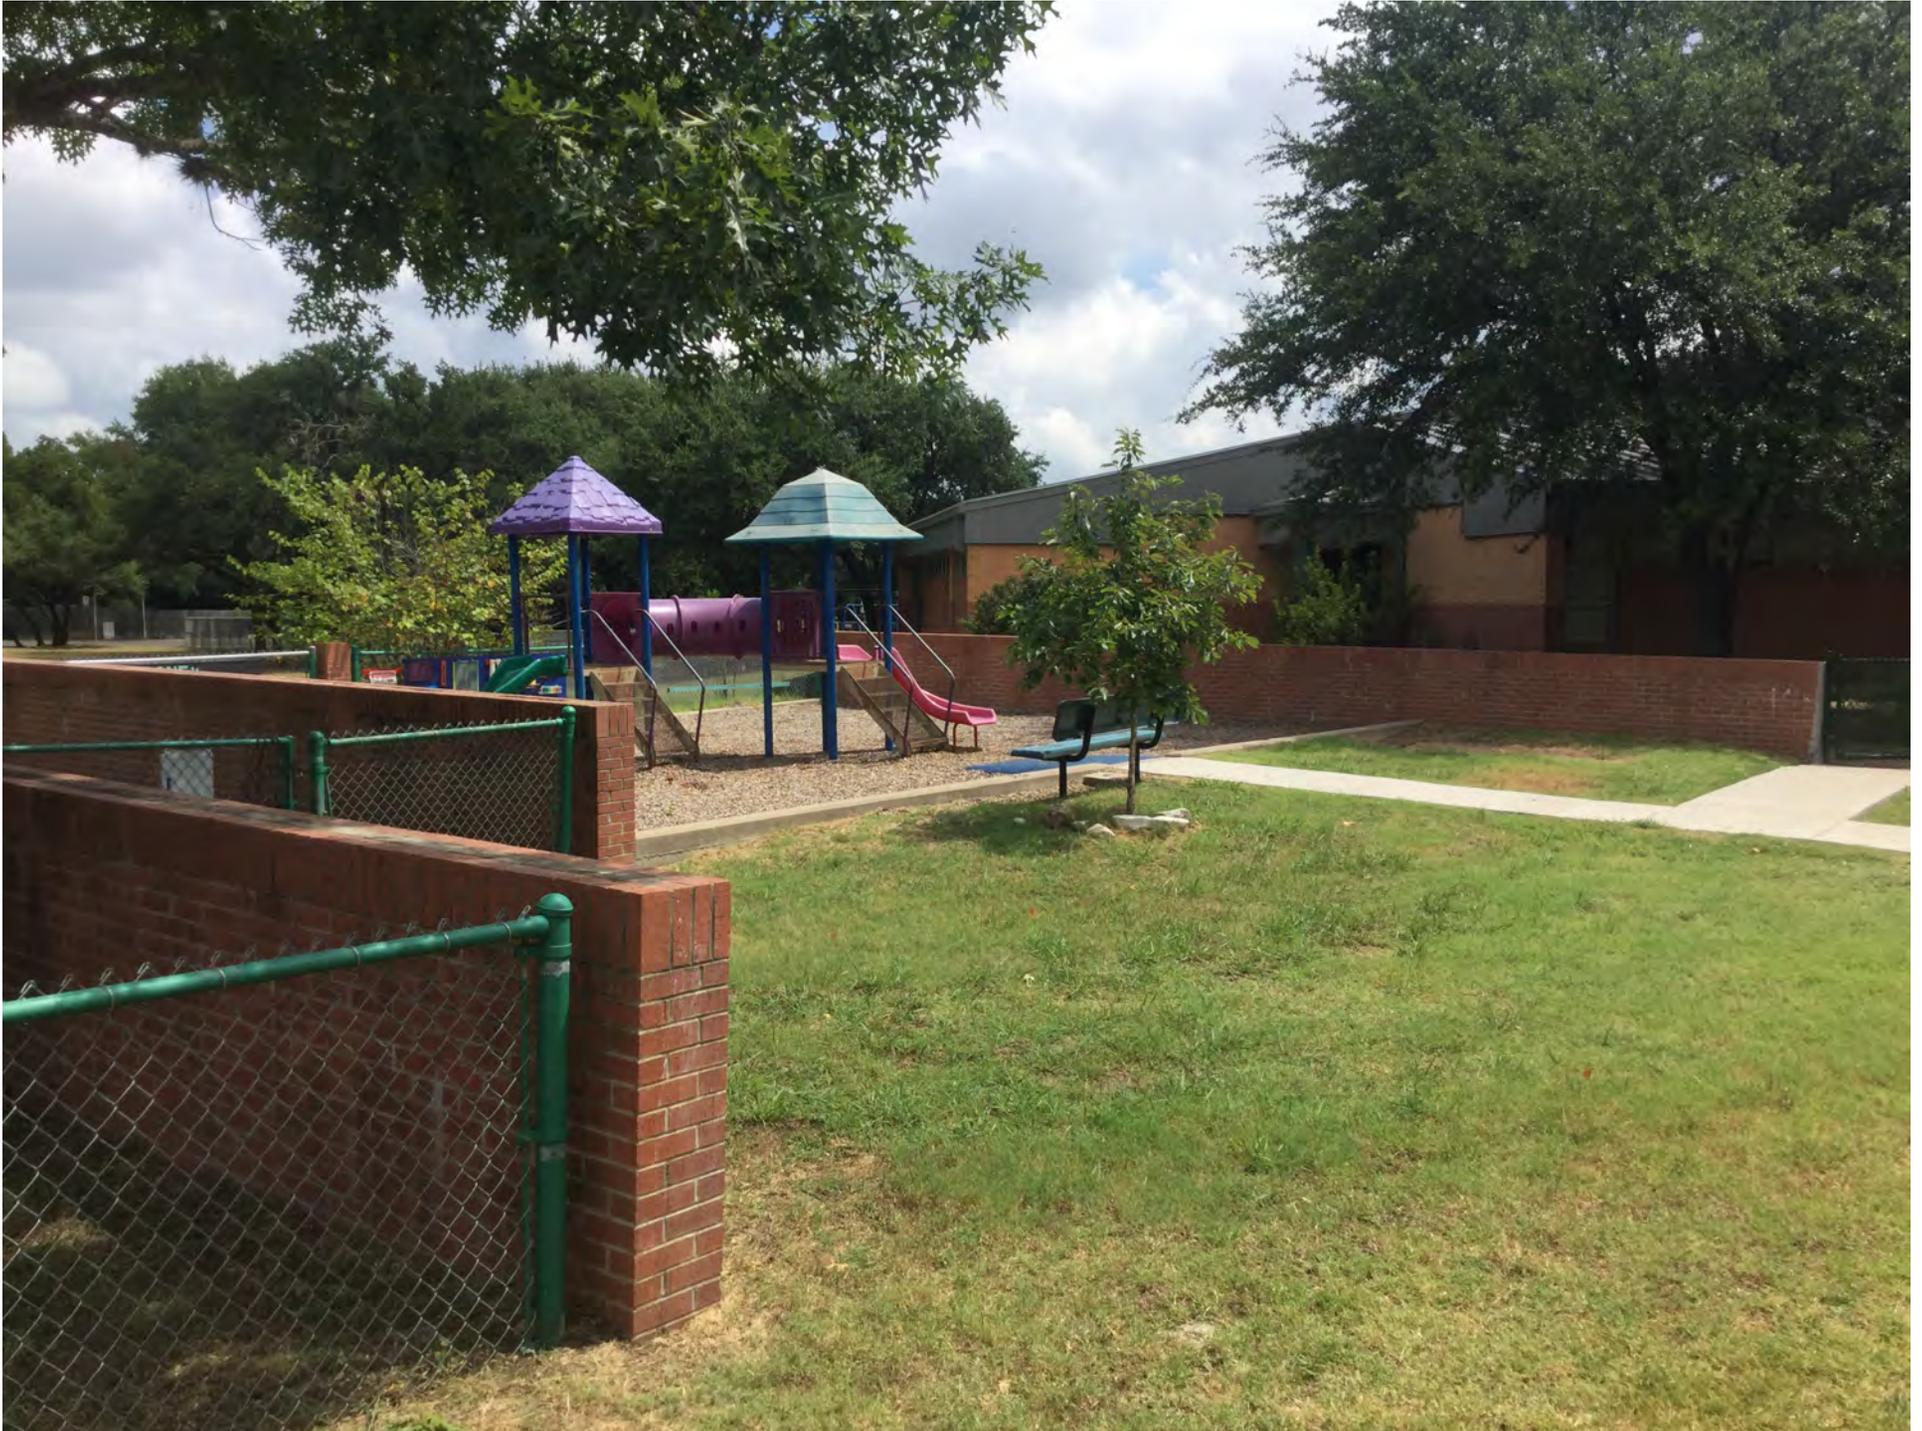
Photo 1.
1.3 Plaufields

1.3	Are outdoor play spaces and playfields adequate in size and configuration?			3				Comments	1.00	3.00
1) Outdoor play space exists, not developed 2)Outdoor play space exists but is not connected to gym or other athletic support areas or is too small. 3. Outdoor play spaces exist, are connected to other athletic areas, are the right size, but are not in good condition. 4. Outdoor play spaces need minor improvements to function well. 5. Outdoor play spaces are in excellent condition. N/A) Does not apply.		The playgrounds need more shade and updated equipment.								
		see photo 1

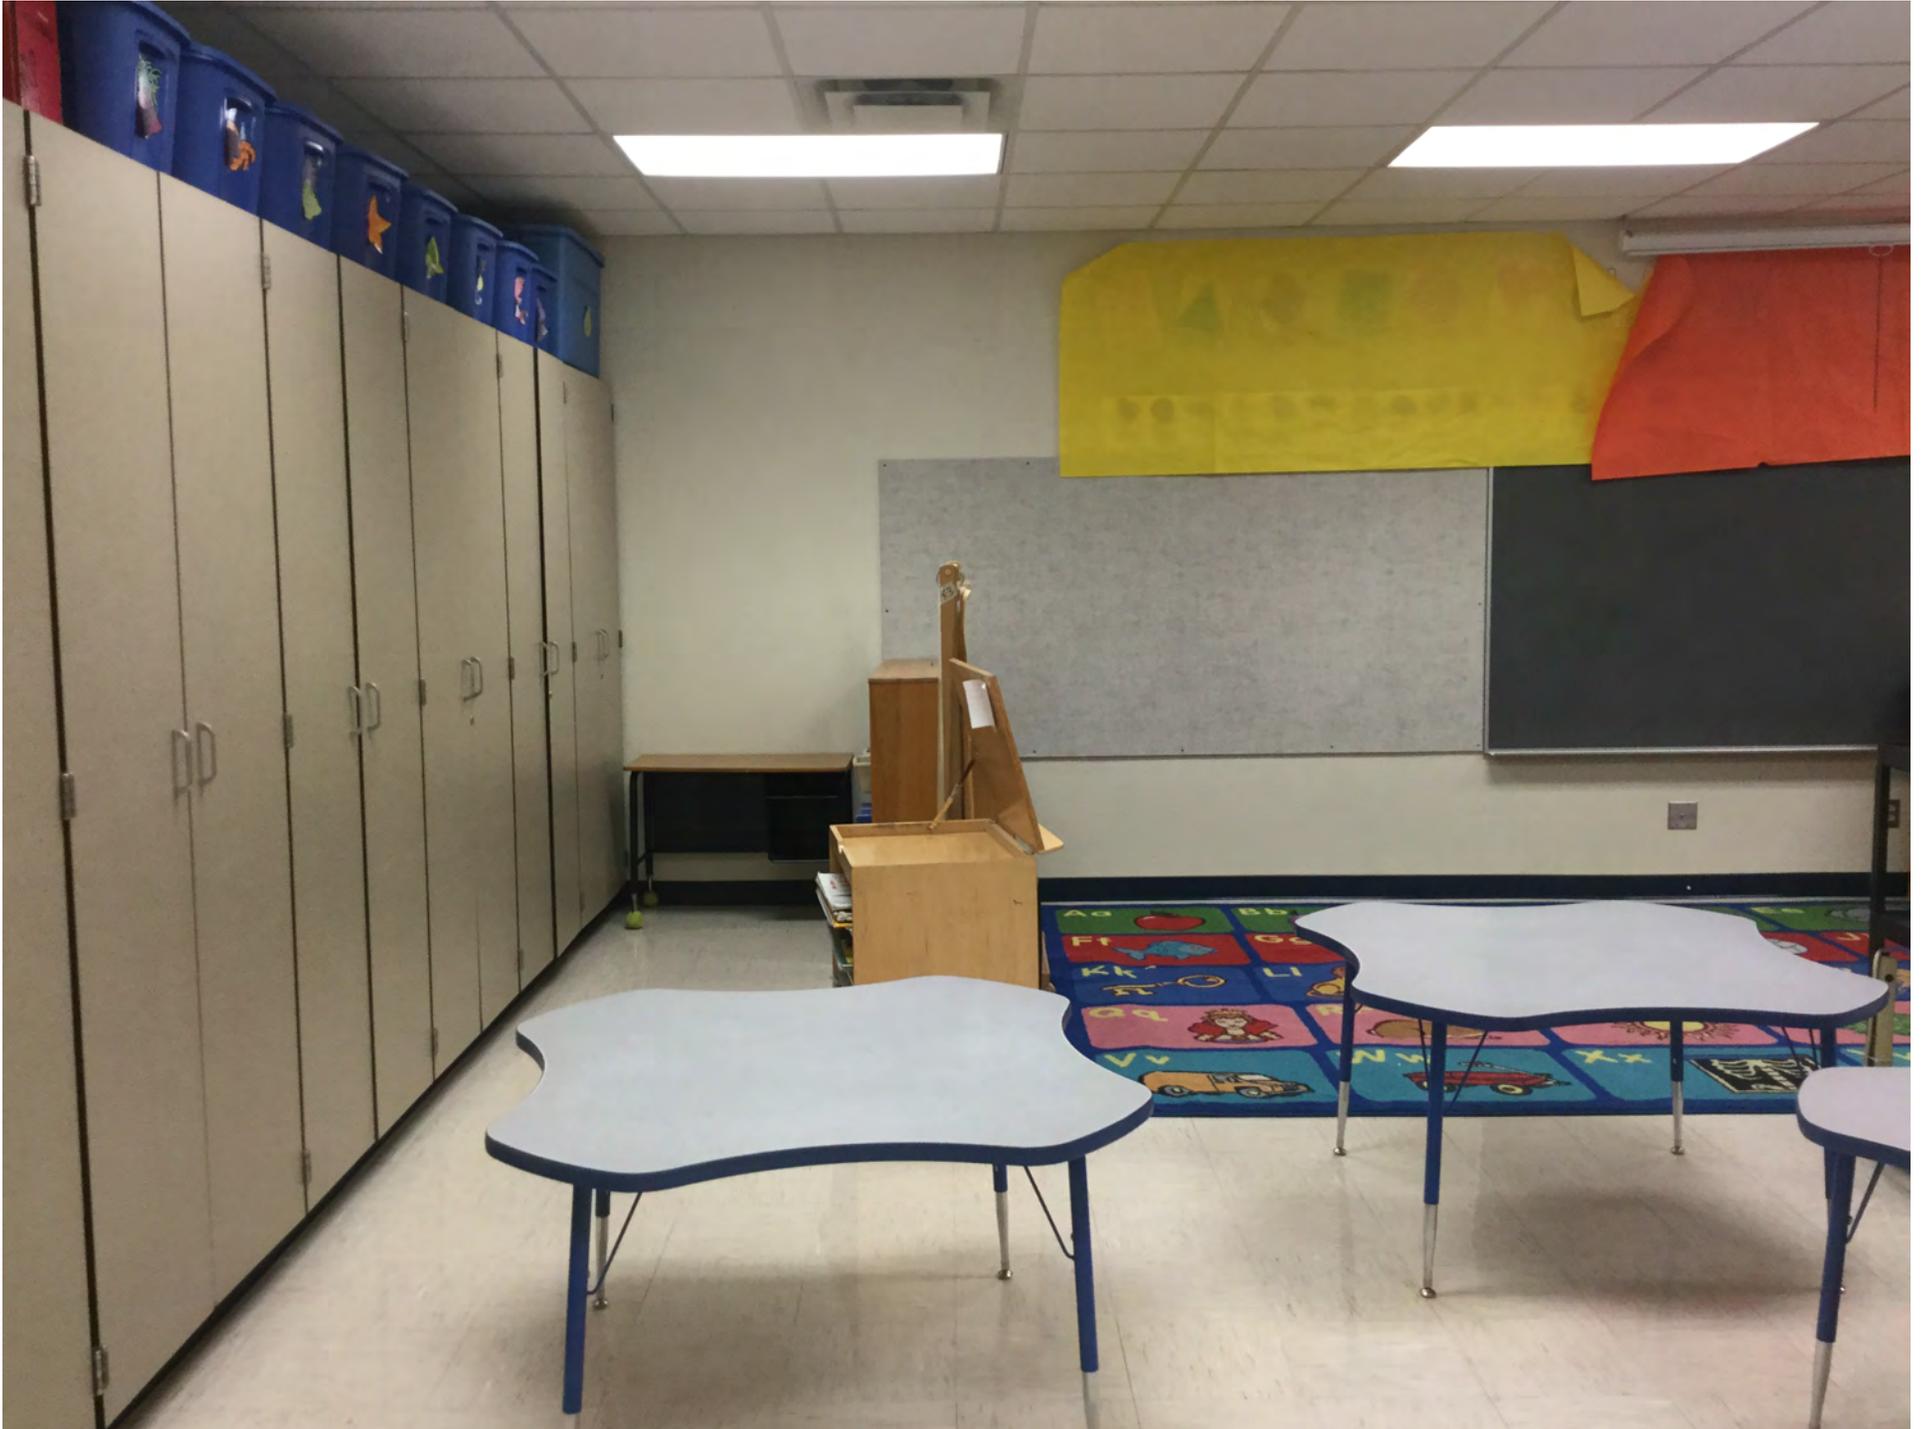
Photo 2.
3.2 Pre-K Space

1) Very unsatisfactory - Too small, awkward layout, does not meet needs 2) Unsatisfactory - Too small, only one area for all teaching methods, limited flexibility 3) Neutral - Moderate size, two areas for different teaching methods, some flexibility, access to student storage/casework 4) Satisfactory - Good size, at least two zones for different teaching methods, flexibility and student storage, not new 5) Very Satisfactory - Good size, two zones for different teaching methods, flexibility and student storage/casework, adequate display area and visual teaching tools N/A) Does not apply.										
		see photo 2

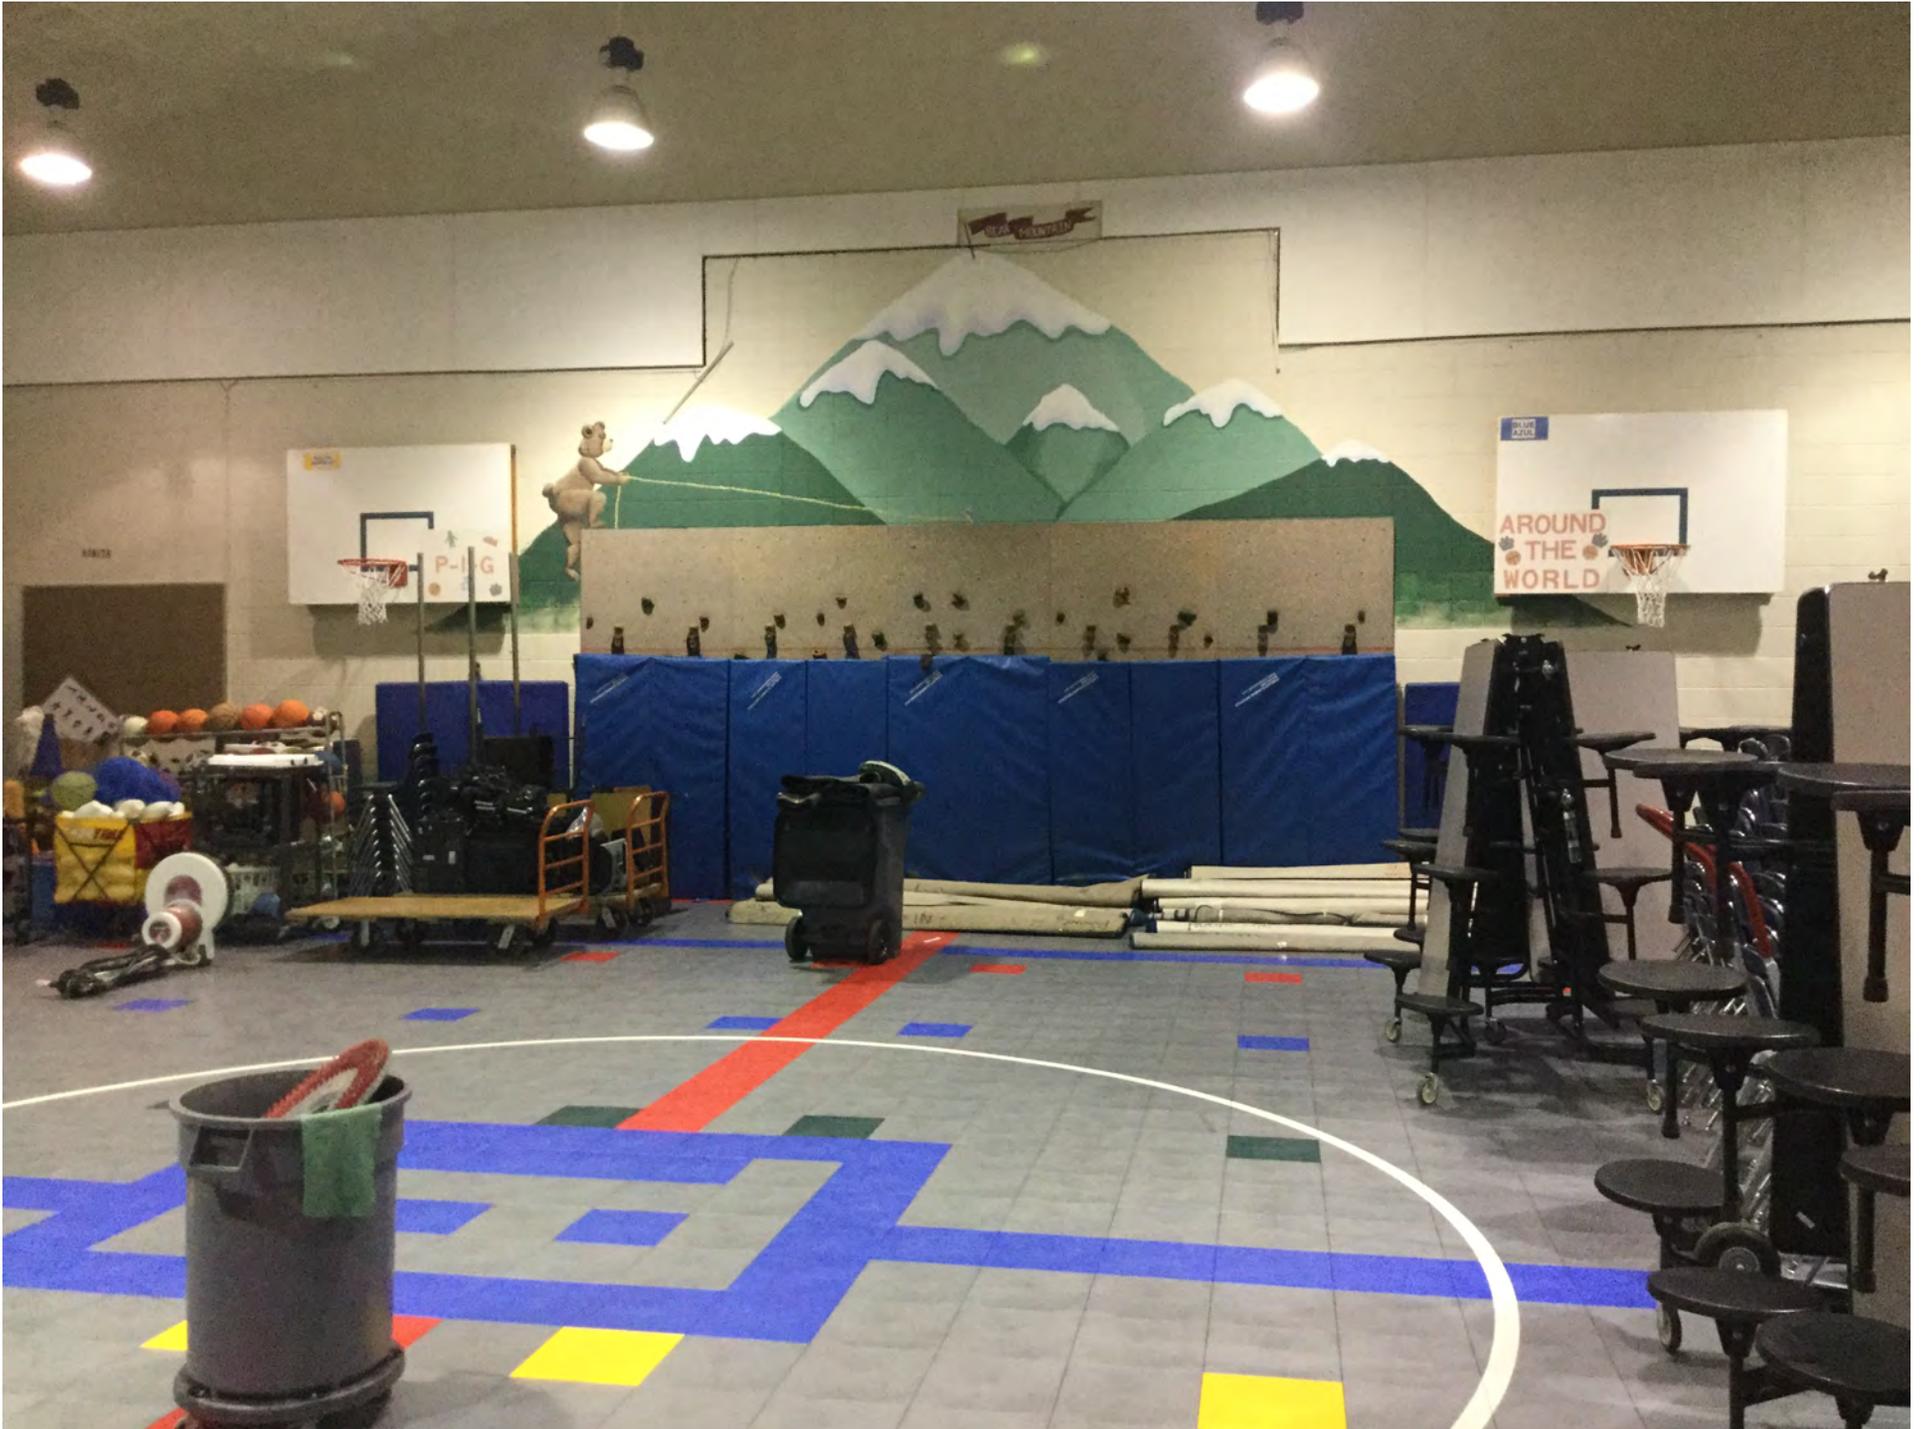
Photo 3.
3.6 Gym

1) Very unsatisfactory 2) Unsatisfactory 3) Average 4) Good 5) Very good N/A) Does not apply.								The gym lacks natural light but is in good condition.	
								see photo 3

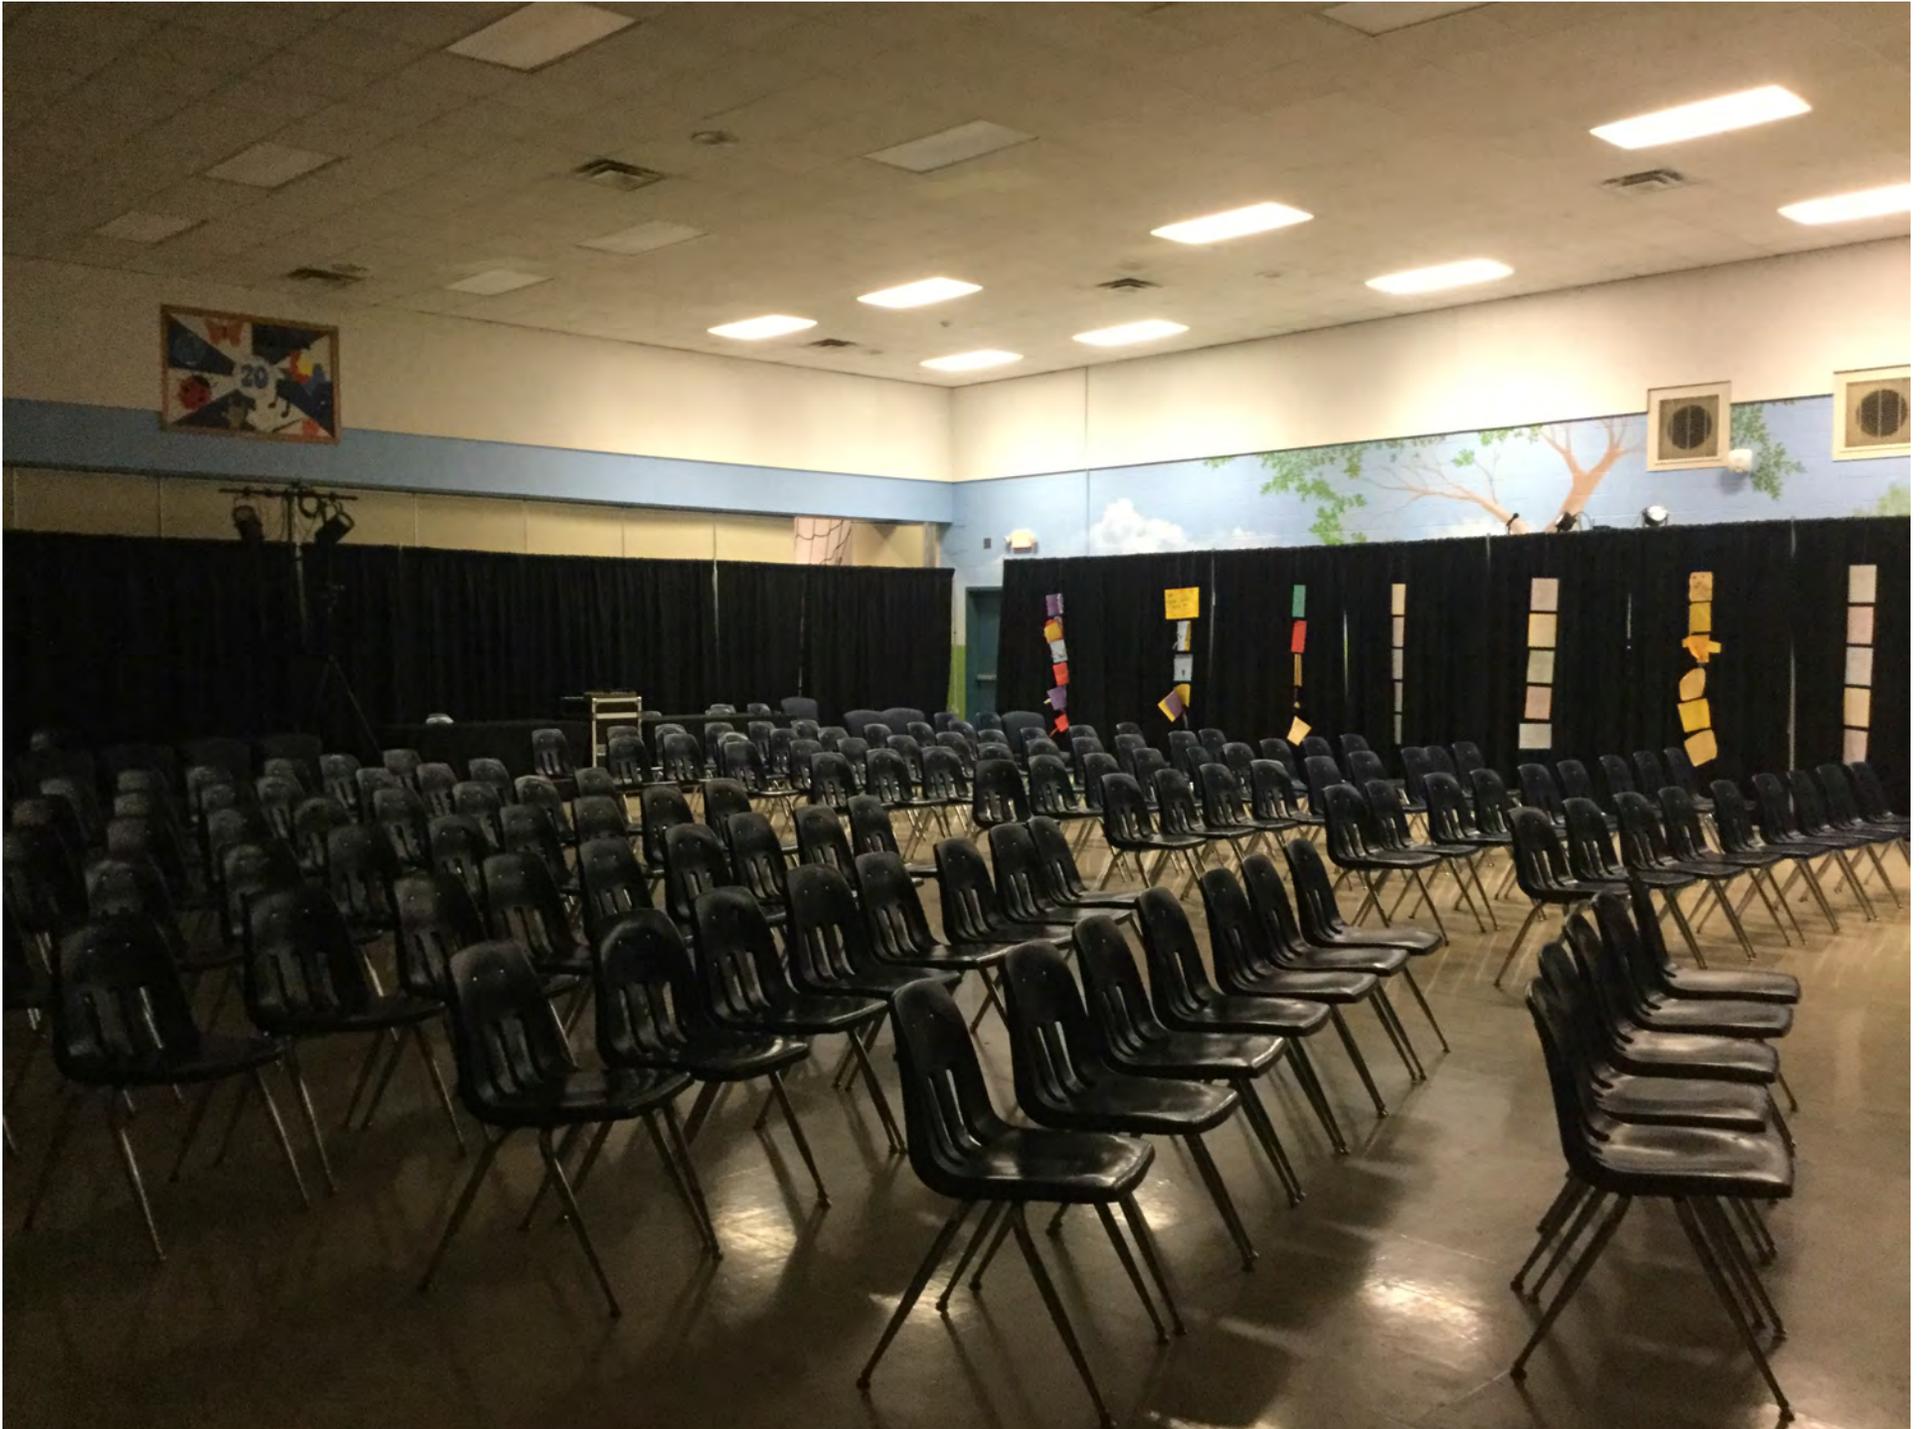
Photo 5.
3.16 Cafetorium

3.16	Are the student dining facilities appropriately configured?				4			Comments	1.00 4.00
1) Very unsatisfactory - Too small, poor circulation, inflexible seating in poor condition 2) Unsatisfactory - Too small or inadequate circulation, seating in poor condition 3) Average - moderate size, with adequate circulation, seating in okay condition 4) Good - good size, adequate circulation, seating in good condition 5) Very good - good size, adequate circulation, seating in good condition, with more than one option for eating space (ex: connection to outdoor eating space) N/A) Does not apply.									
		see photo 5

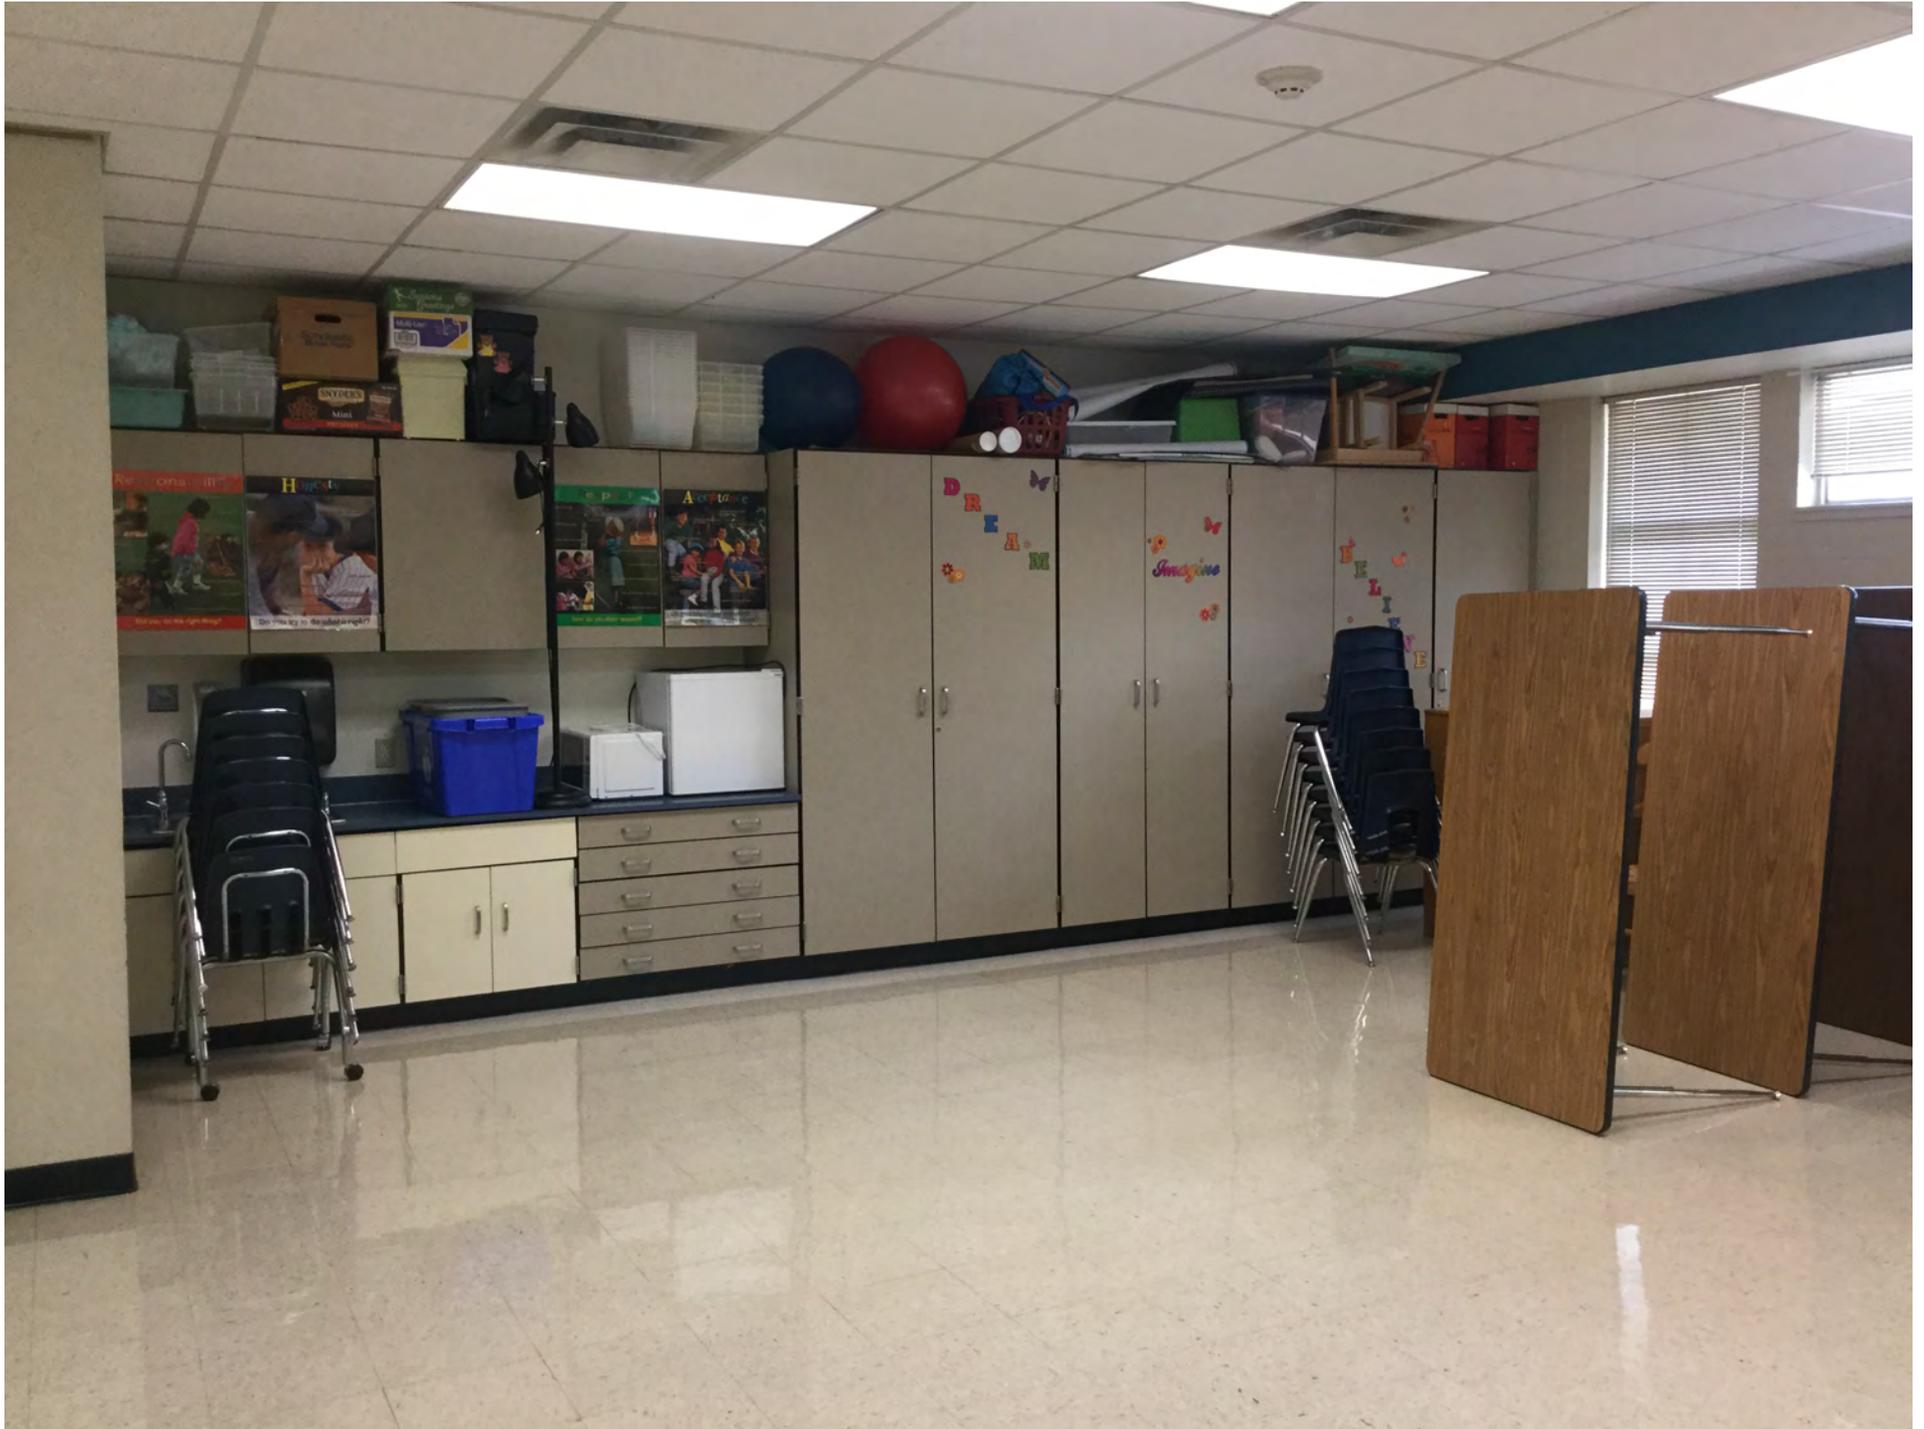
Photo 6.
4.2 Standard Classroom

4.2	Are general classrooms large enough to support project-based learning and multiple teaching modalities?				4			Comments	1.00	4.00
1) Very unsatisfactory -too small to move, set for lecture only, no connectivity, no flexibility 2) Unsatisfactory - adequate size but set for lecture only, no connectivity, no flexibility 3) Neutral - have flexibility and space for hands on or project based learning 4) Satisfactory - have flexibility and space for hands on or project based learning and connectivity for global learning 5) Very Satisfactory - space for hands on learning, flexibility for different groupings, and connectivity for global classrooms N/A) Does not apply.

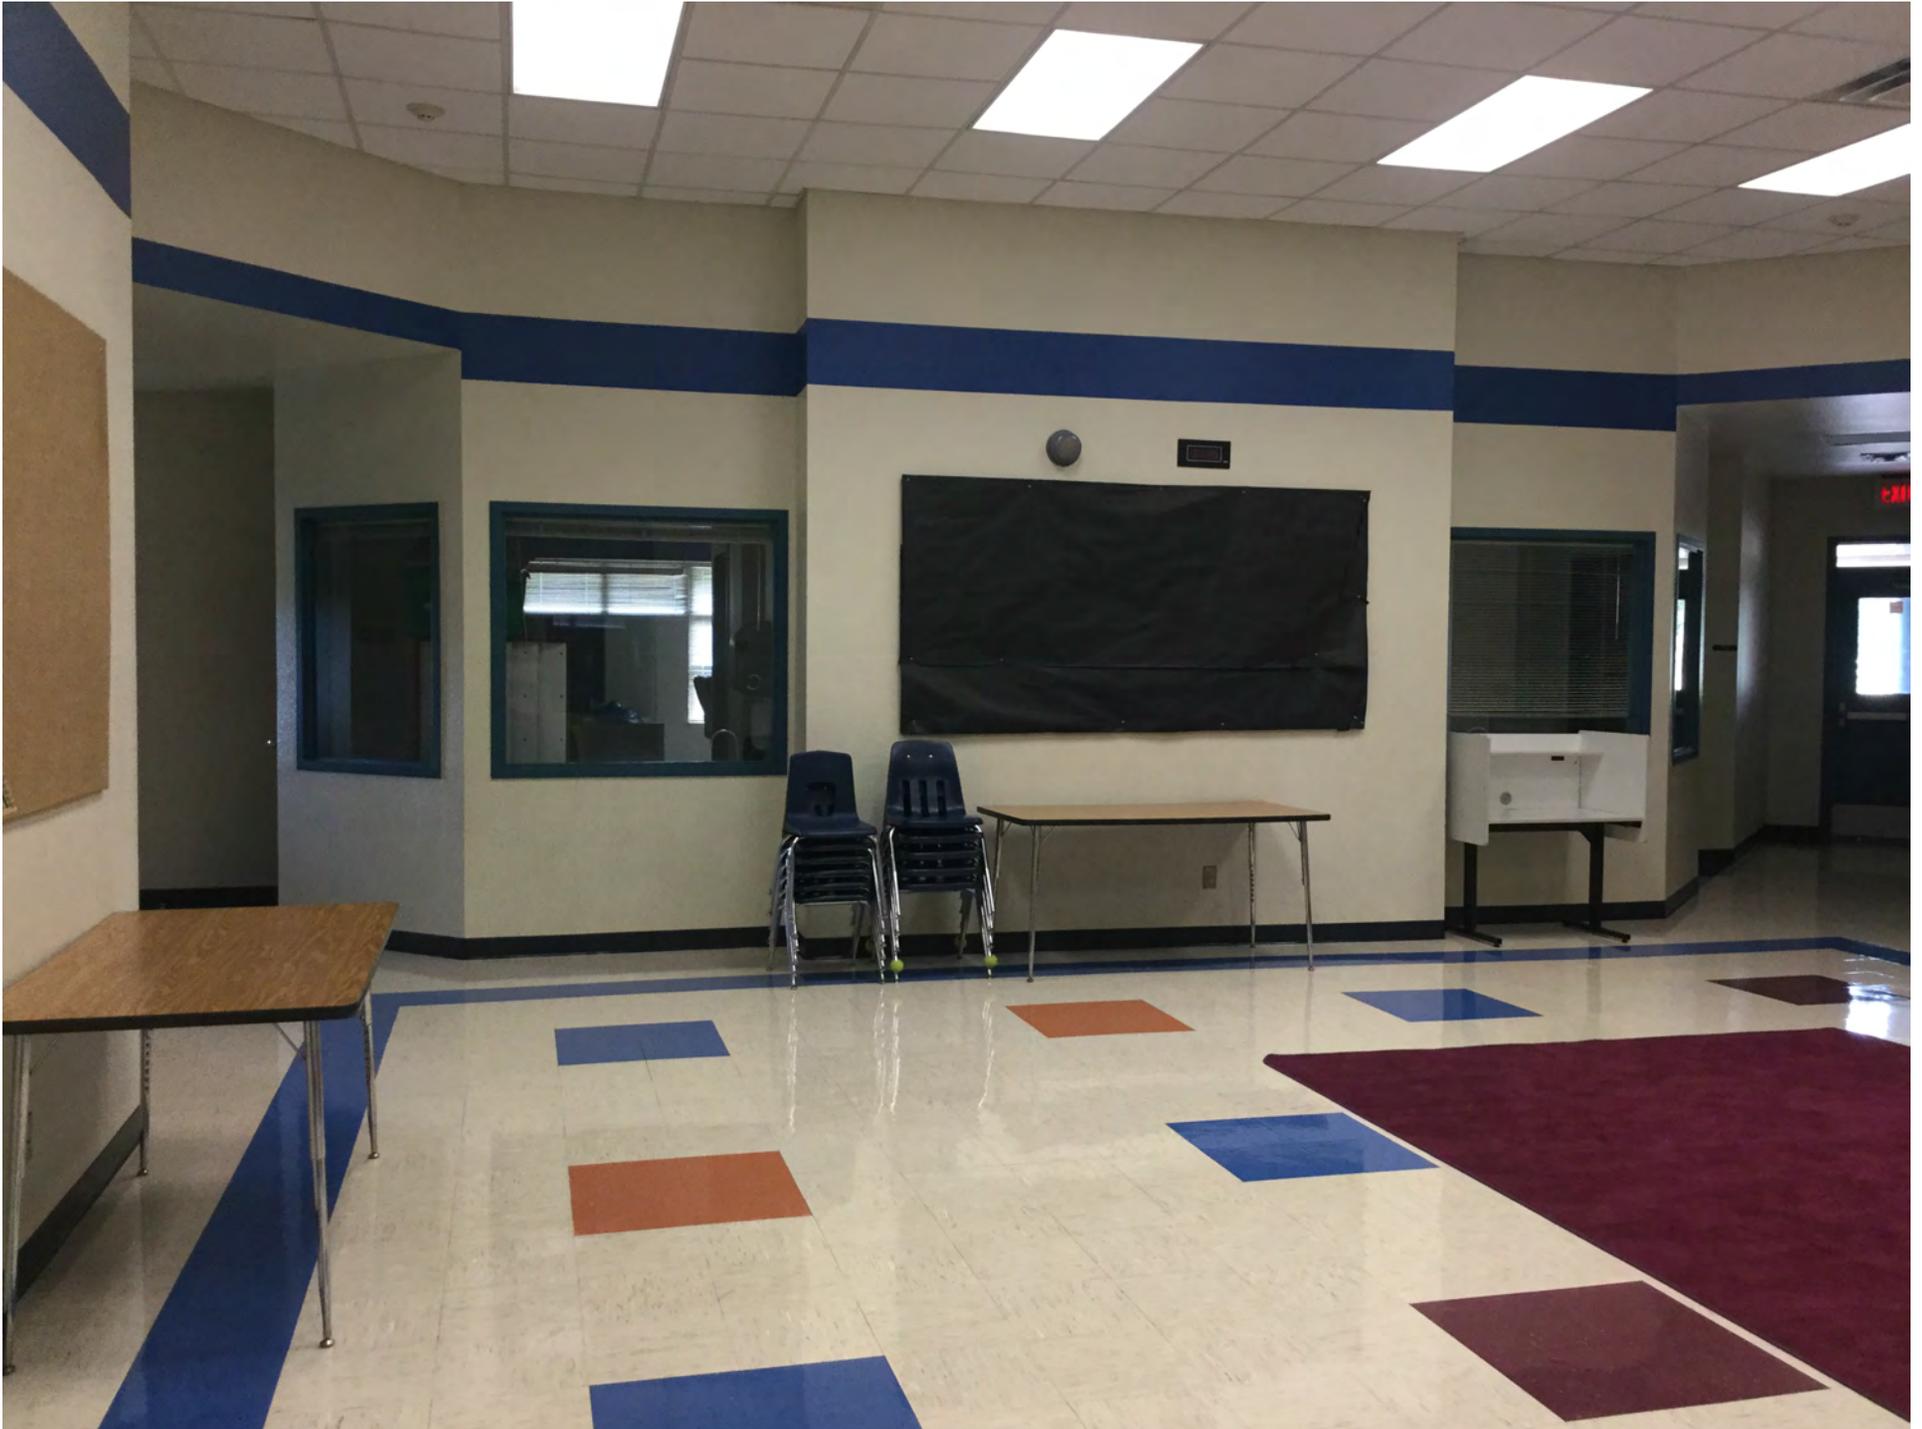
Photo 7.
4.5 Collaborative Space

1) Very unsatisfactory - no common spaces or meeting rooms or in very poor condition 2) Unsatisfactory - a few common spaces or meeting rooms in unsatisfactory condition 3) Average - a few common spaces and meeting areas needing updates 4) Good - multiple common spaces and meeting rooms in good condition 5) Very good - adequate common spaces and meeting rooms of excellent quality N/A) Does not apply.								There are multiple "pod" spaces, or commons areas, that can be used for break-out spaces and group collaborations. The administration meeting space needs increasing.	
see photo 7
