Educational Suitability Summary Report

Boone Elementary School

Date: 10/31/2016 (REV1 - 11/3/2016)

Austin ISD Educational Suitability Assessment Criteria

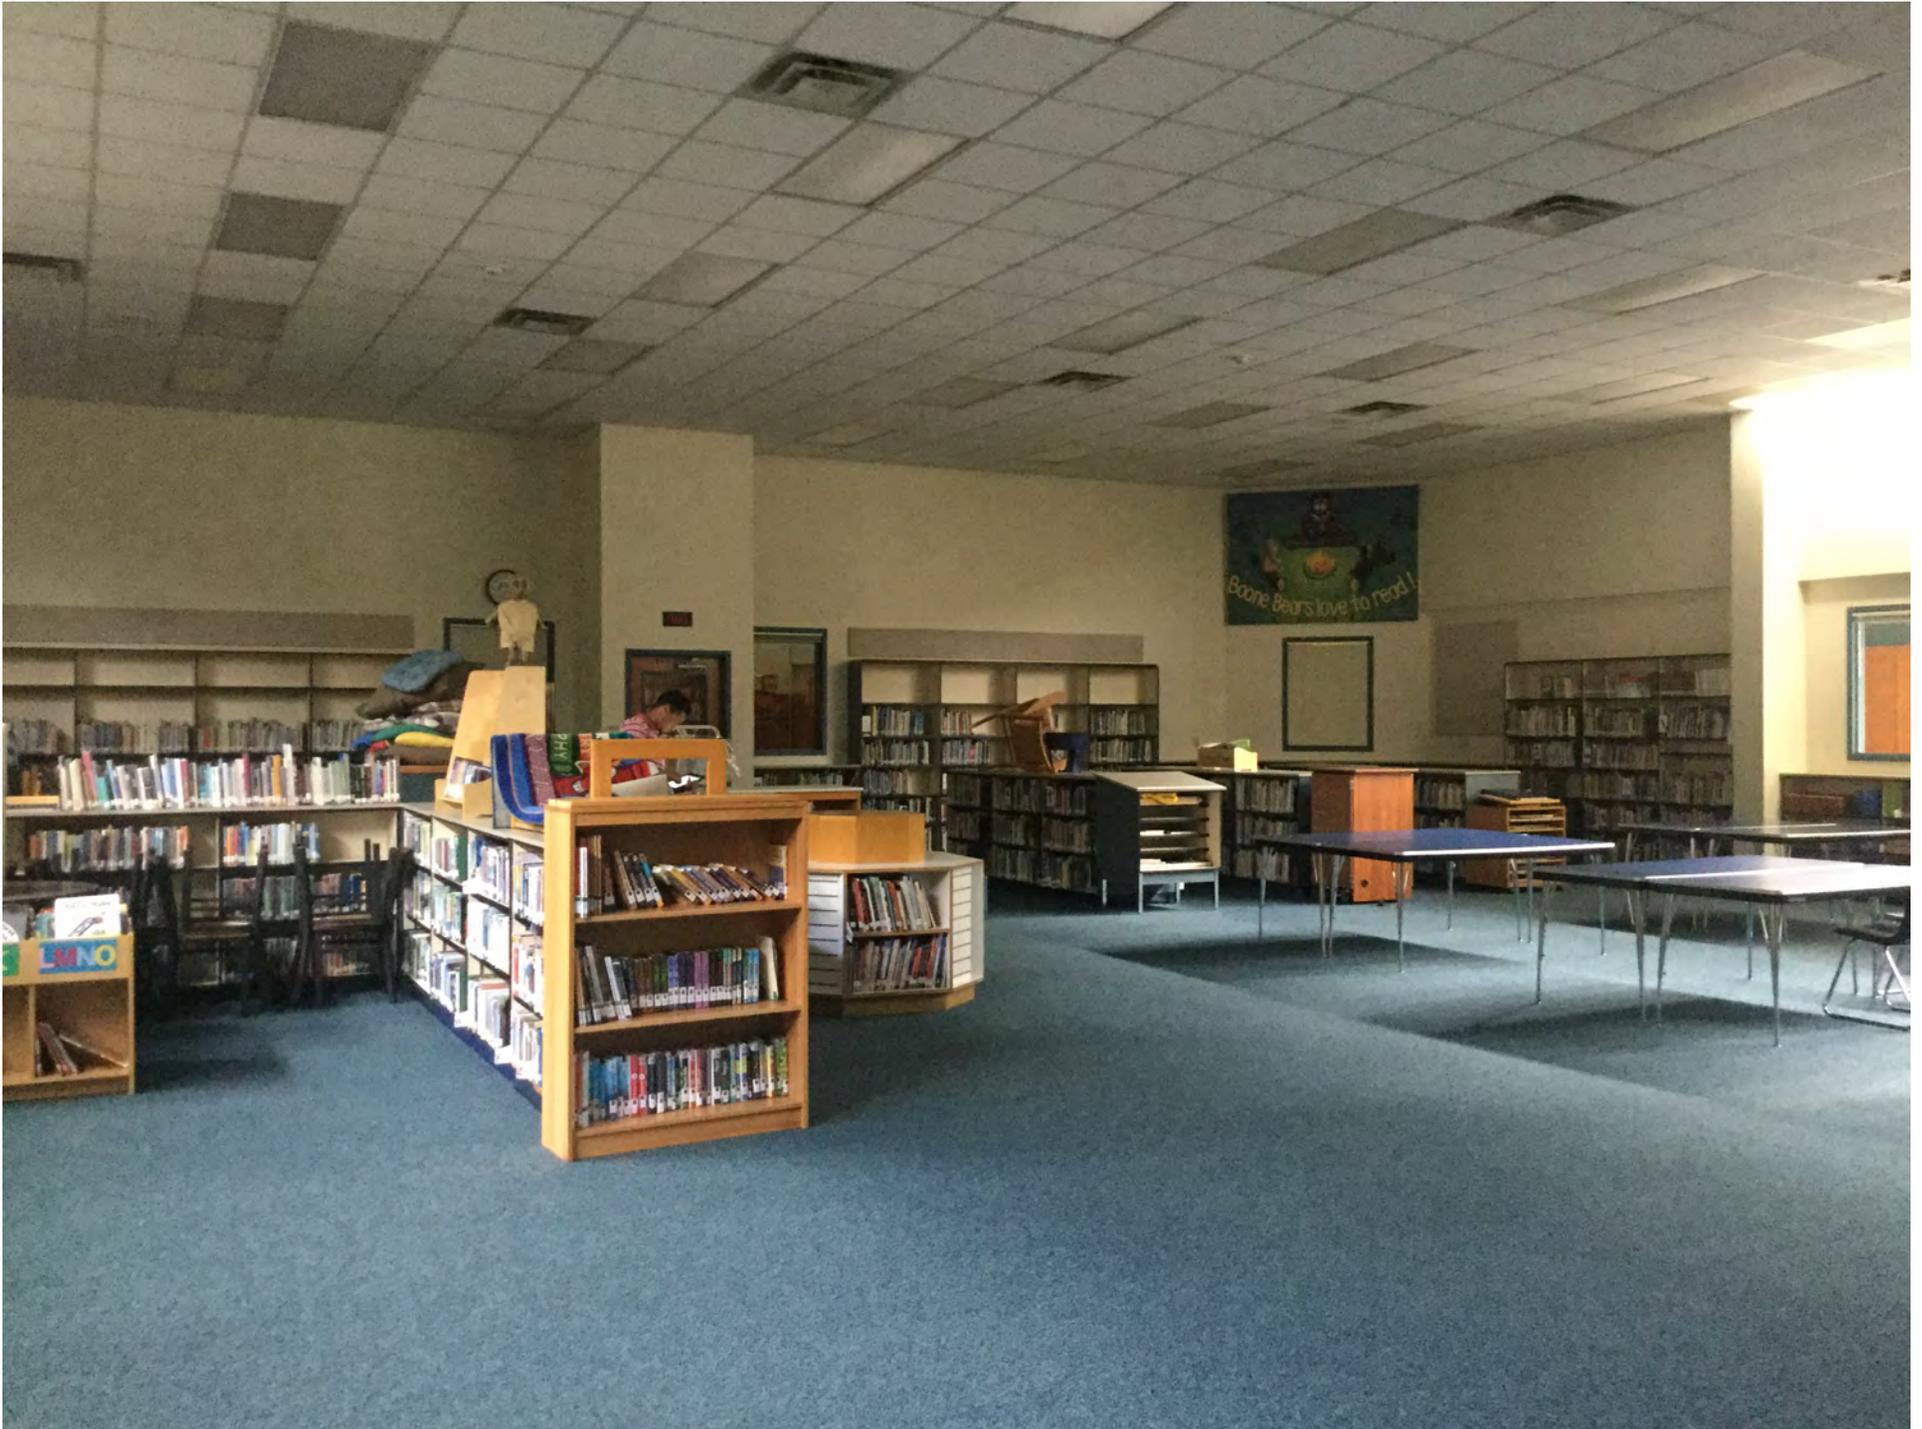
Photo 8.
5.3 Library

5.3	How well does the Library/Media Center support social interaction?					5		Comments	1.00	5.00
1) Very unsatisfactory 2) Unsatisfactory 3) Average 4) Good 5) Very good N/A) Does not apply.		see photo 8

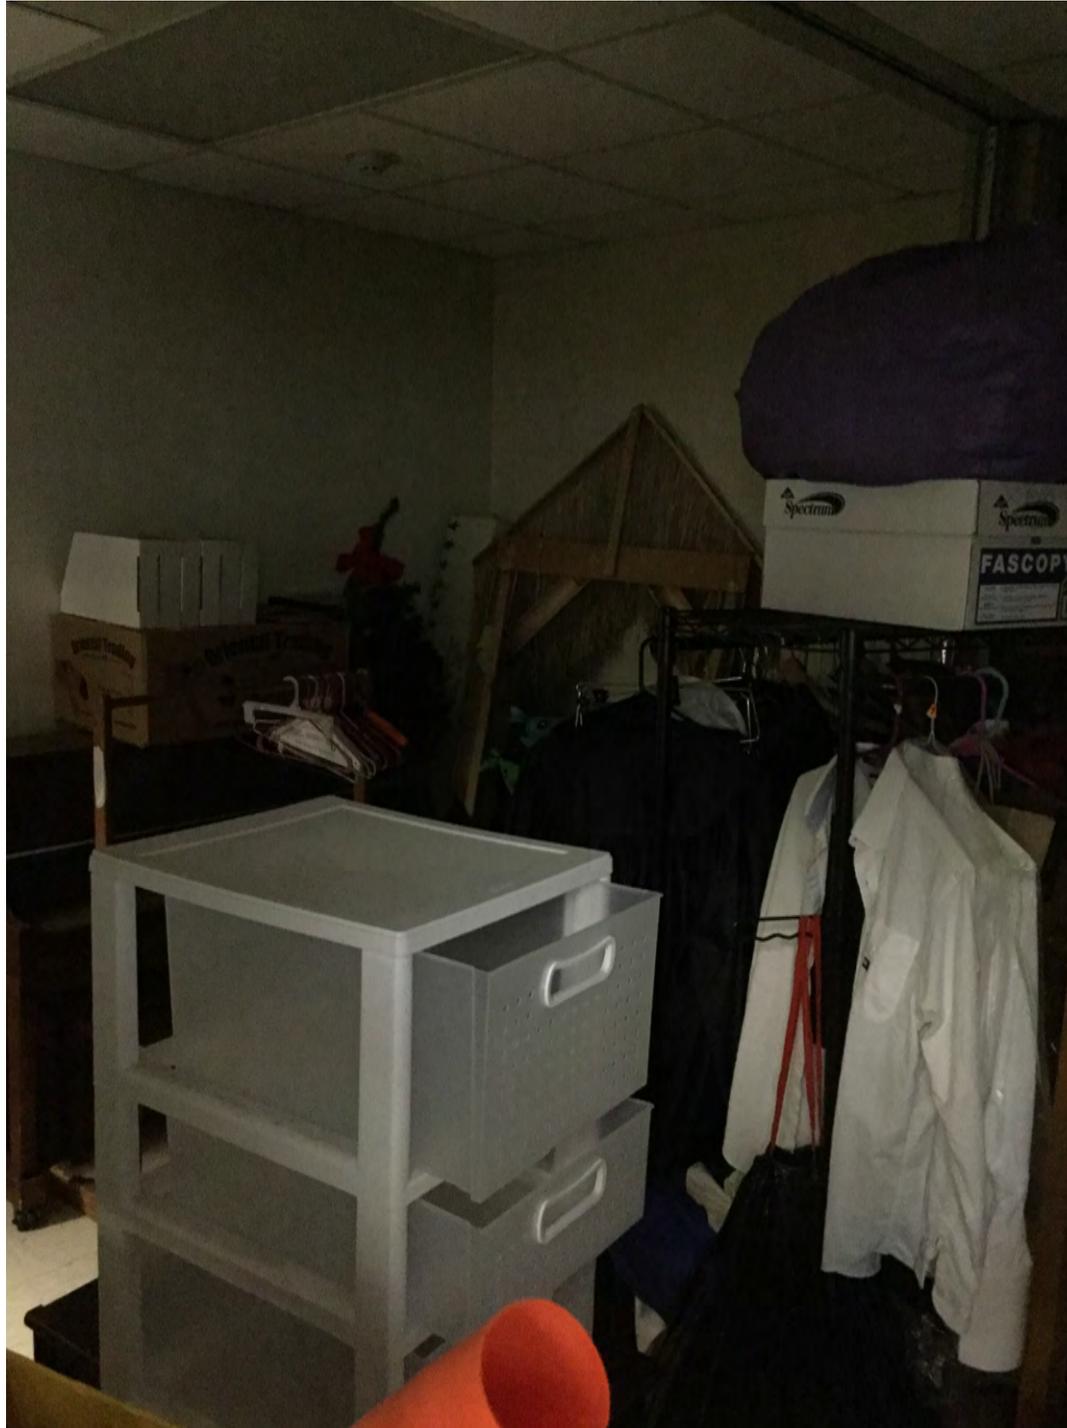
Photo 9.
8.1 Storage

The general building storage is almost non-existent. The classrooms feature tall built-in cabinets that are somewhat dated but are functioning well in most spaces. Student storage is limited in the school.

8 - Storage		1	2	3	4	5	N/A		7.00
8.1	Is there adequate general storage in the building?	1						Comments	1.00 1.00
1) Very unsatisfactory 2) Unsatisfactory 3) Average 4) Good 5) Very good N/A) Does not apply.								The general building storage is extremely lacking.	see photo 9
8.2	Is there adequate classroom storage?				4			Comments	1.00 4.00
1) Very unsatisfactory 2) Unsatisfactory 3) Average 4) Good 5) Very good N/A) Does not apply.								There is a full wall of large storage cabinets in most classroom spaces.	
8.3	Is there adequate student storage?		2					Comments	1.00 2.00
1) Very unsatisfactory 2) Unsatisfactory 3) Average 4) Good 5) Very good N/A) Does not apply.								There is limited student storage.
