## Educational Suitability Summary Report

Brentwood Elementary School

Date: 8/8/2016

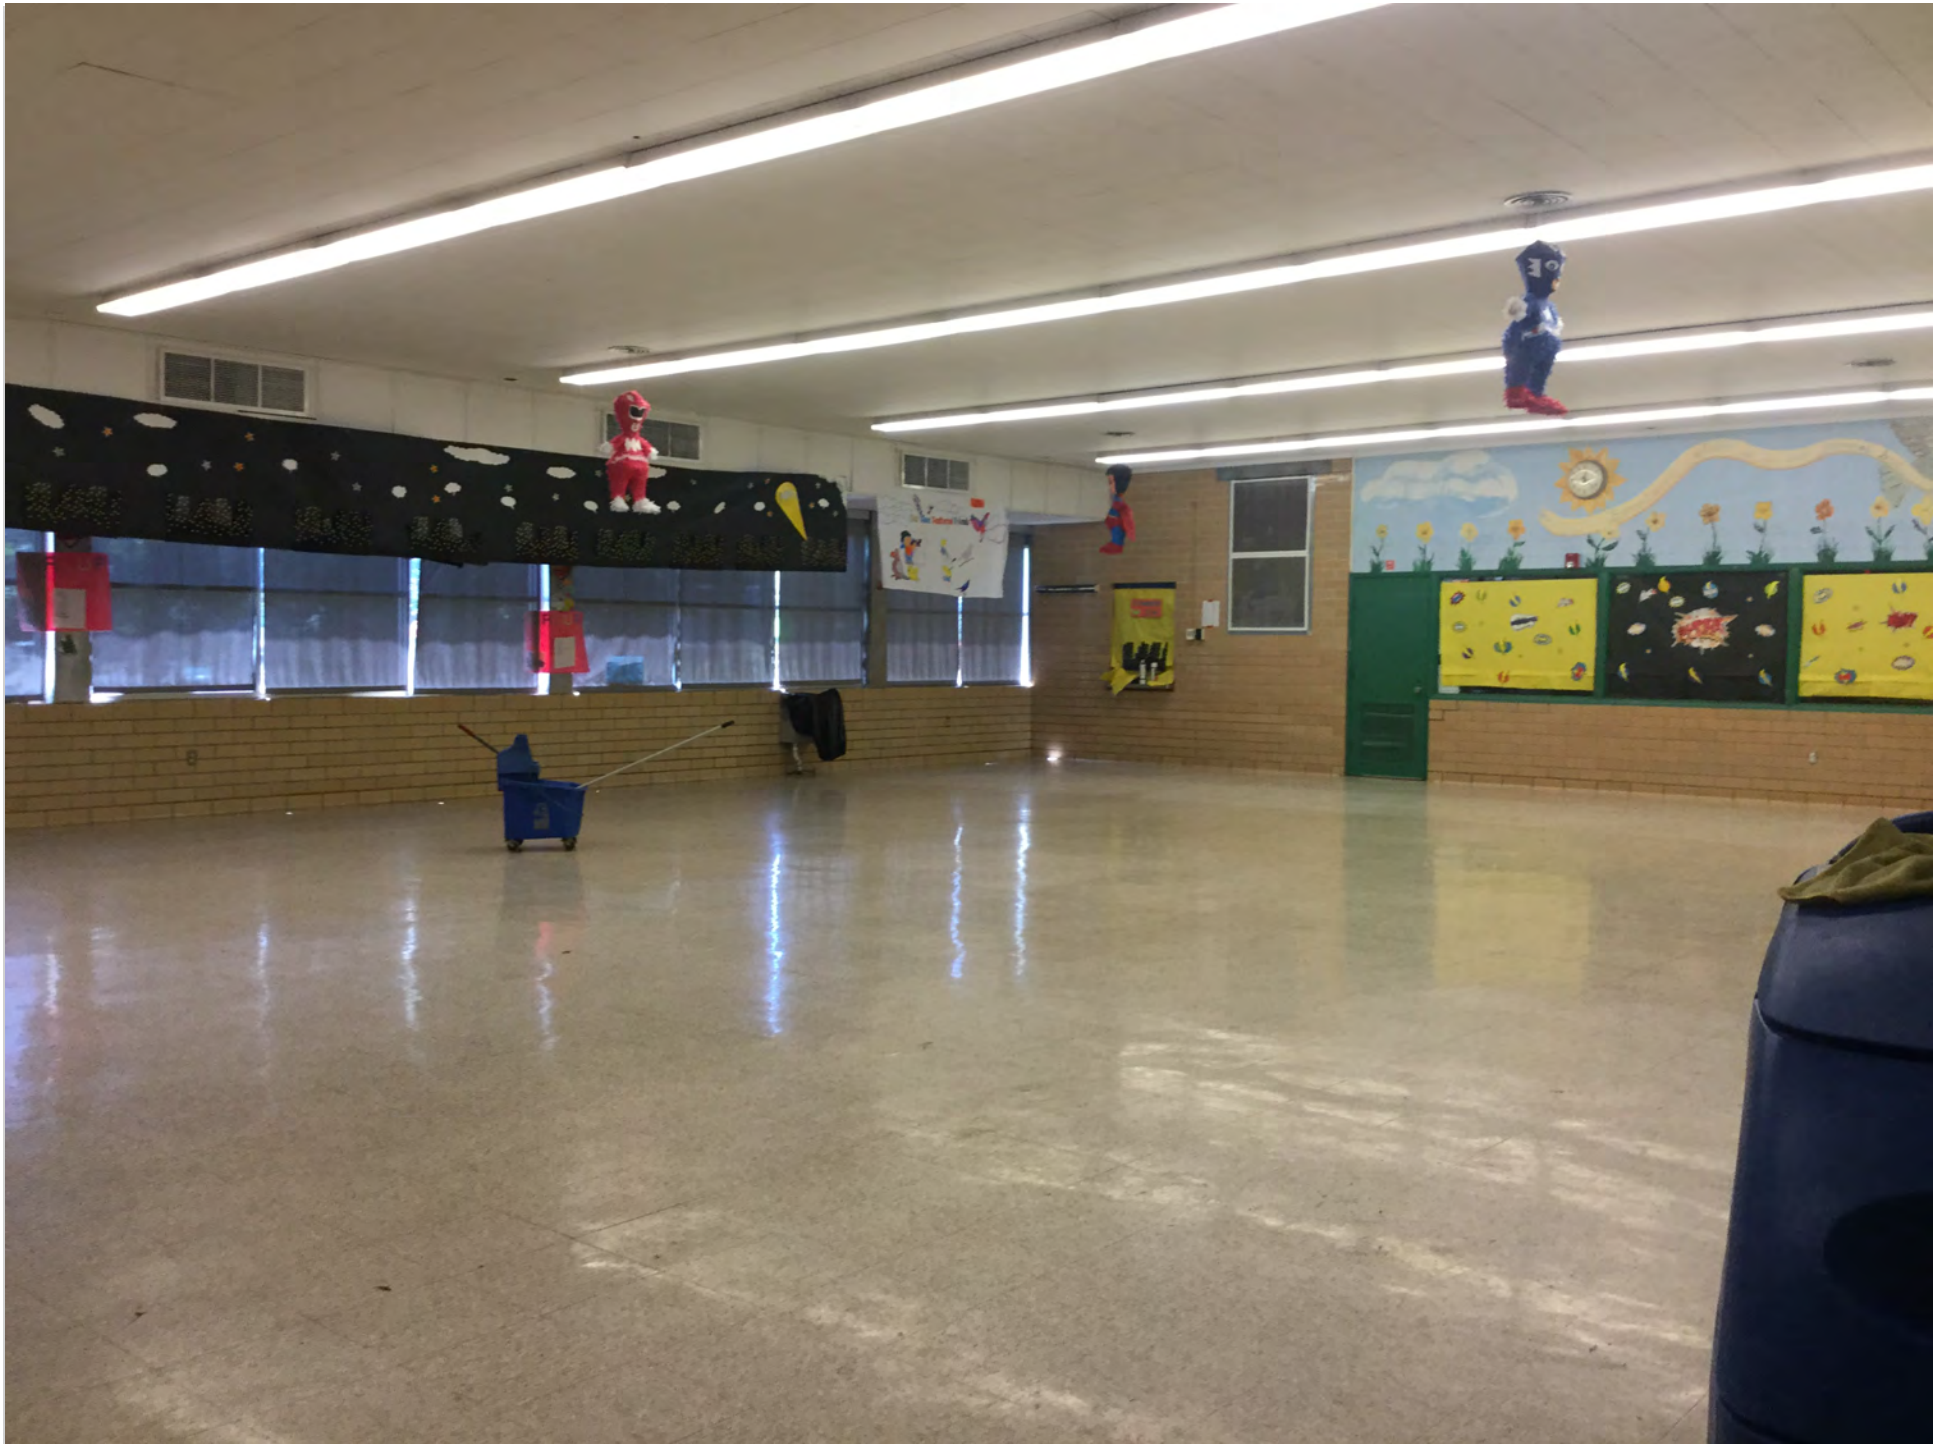
Cafetorium

3.16	Are the student dining facilities appropriately configured?		2					Comments	1.00 <b>2.00</b>
							1) Very unsatisfactory - Too small, poor circulation, inflexible seating in poor condition 2) Unsatisfactory - Too small or inadequate circulation, seating in poor condition 3) Average - moderate size, with adequate circulation, seating in okay condition 4) Good - good size, adequate circulation, seating in good condition 5) Very good - good size, adequate circulation, seating in good condition, with more than one option for eating space (ex: connection to outdoor eating space) N/A) Does not apply.		
								The stage is not ADA compliant. There are no stairs present at the front of stage, the primary access is only through the back of the stage via the corridor. There's no stage lighting system. The projector and screen used for assembly was made by a faculty member. The cafeteria line processes slowly and doesn't accommodate enough seating. Disposable plates used as a dishwasher can't handle the demand. A full assembly isn't possible. The lighting conditions are poor. The furniture is old and not flexible.

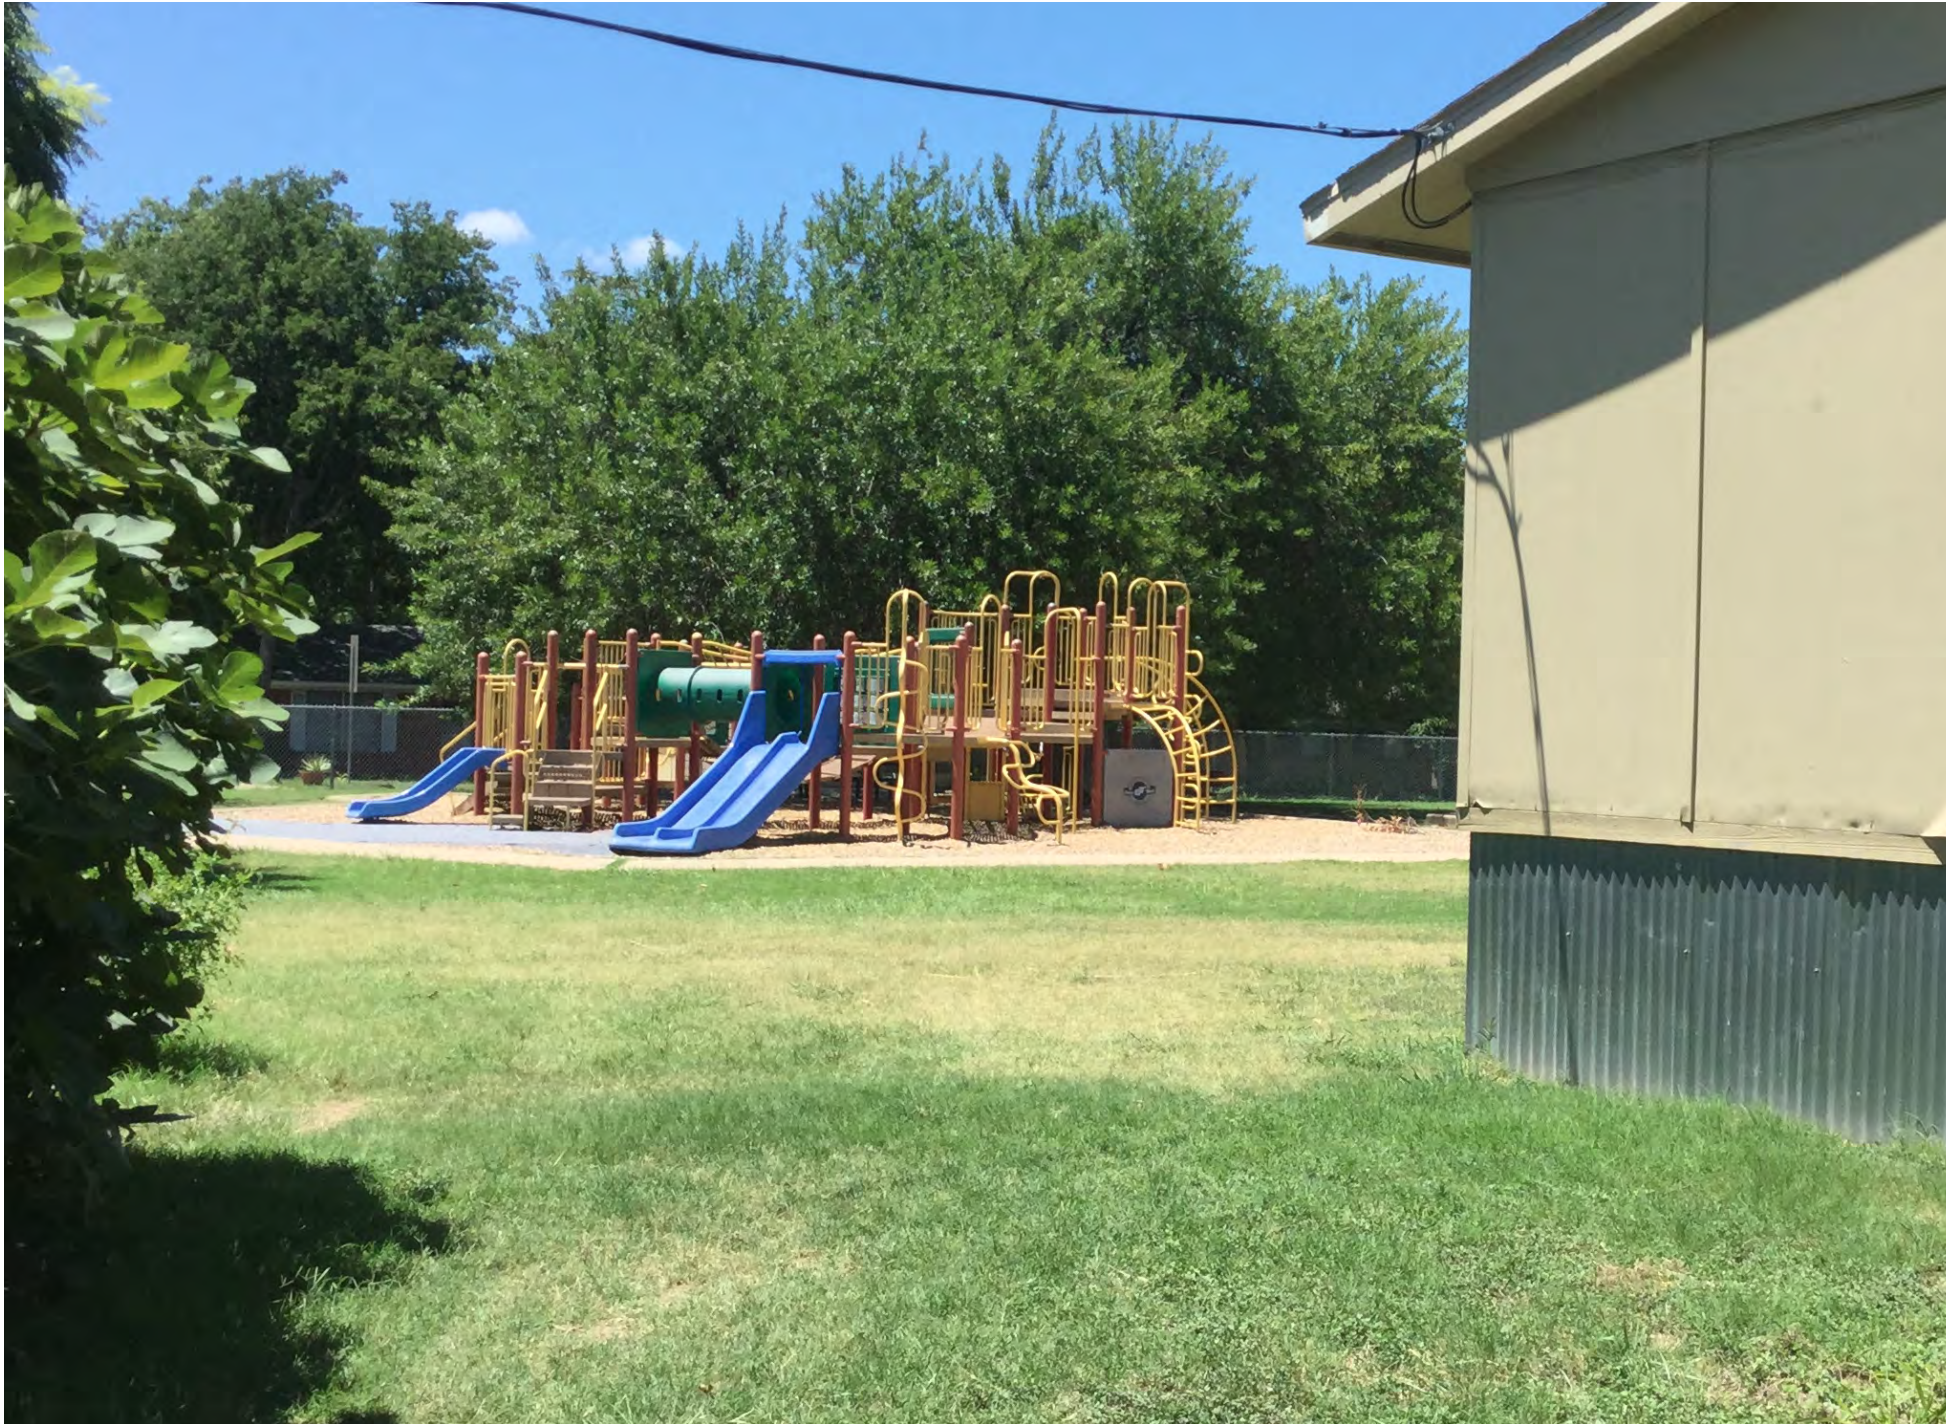
Playground

1.3	Are outdoor play spaces and playfields adequate in size and configuration?		2					Comments	1.00 2.00
	1) Outdoor play space exists, not developed 2) Outdoor play space exists but is not connected to gym or other athletic support areas or is too small. 3. Outdoor play spaces exist, are connected to other athletic areas, are the right size, but are not in good condition. 4. Outdoor play spaces need minor improvements to function well. 5. Outdoor play spaces are in excellent condition. N/A) Does not apply.							The existing playscapes are in poor condition. The low mulch and perimeter concrete cause tripping hazards and injuries. There is a general lack of shade.

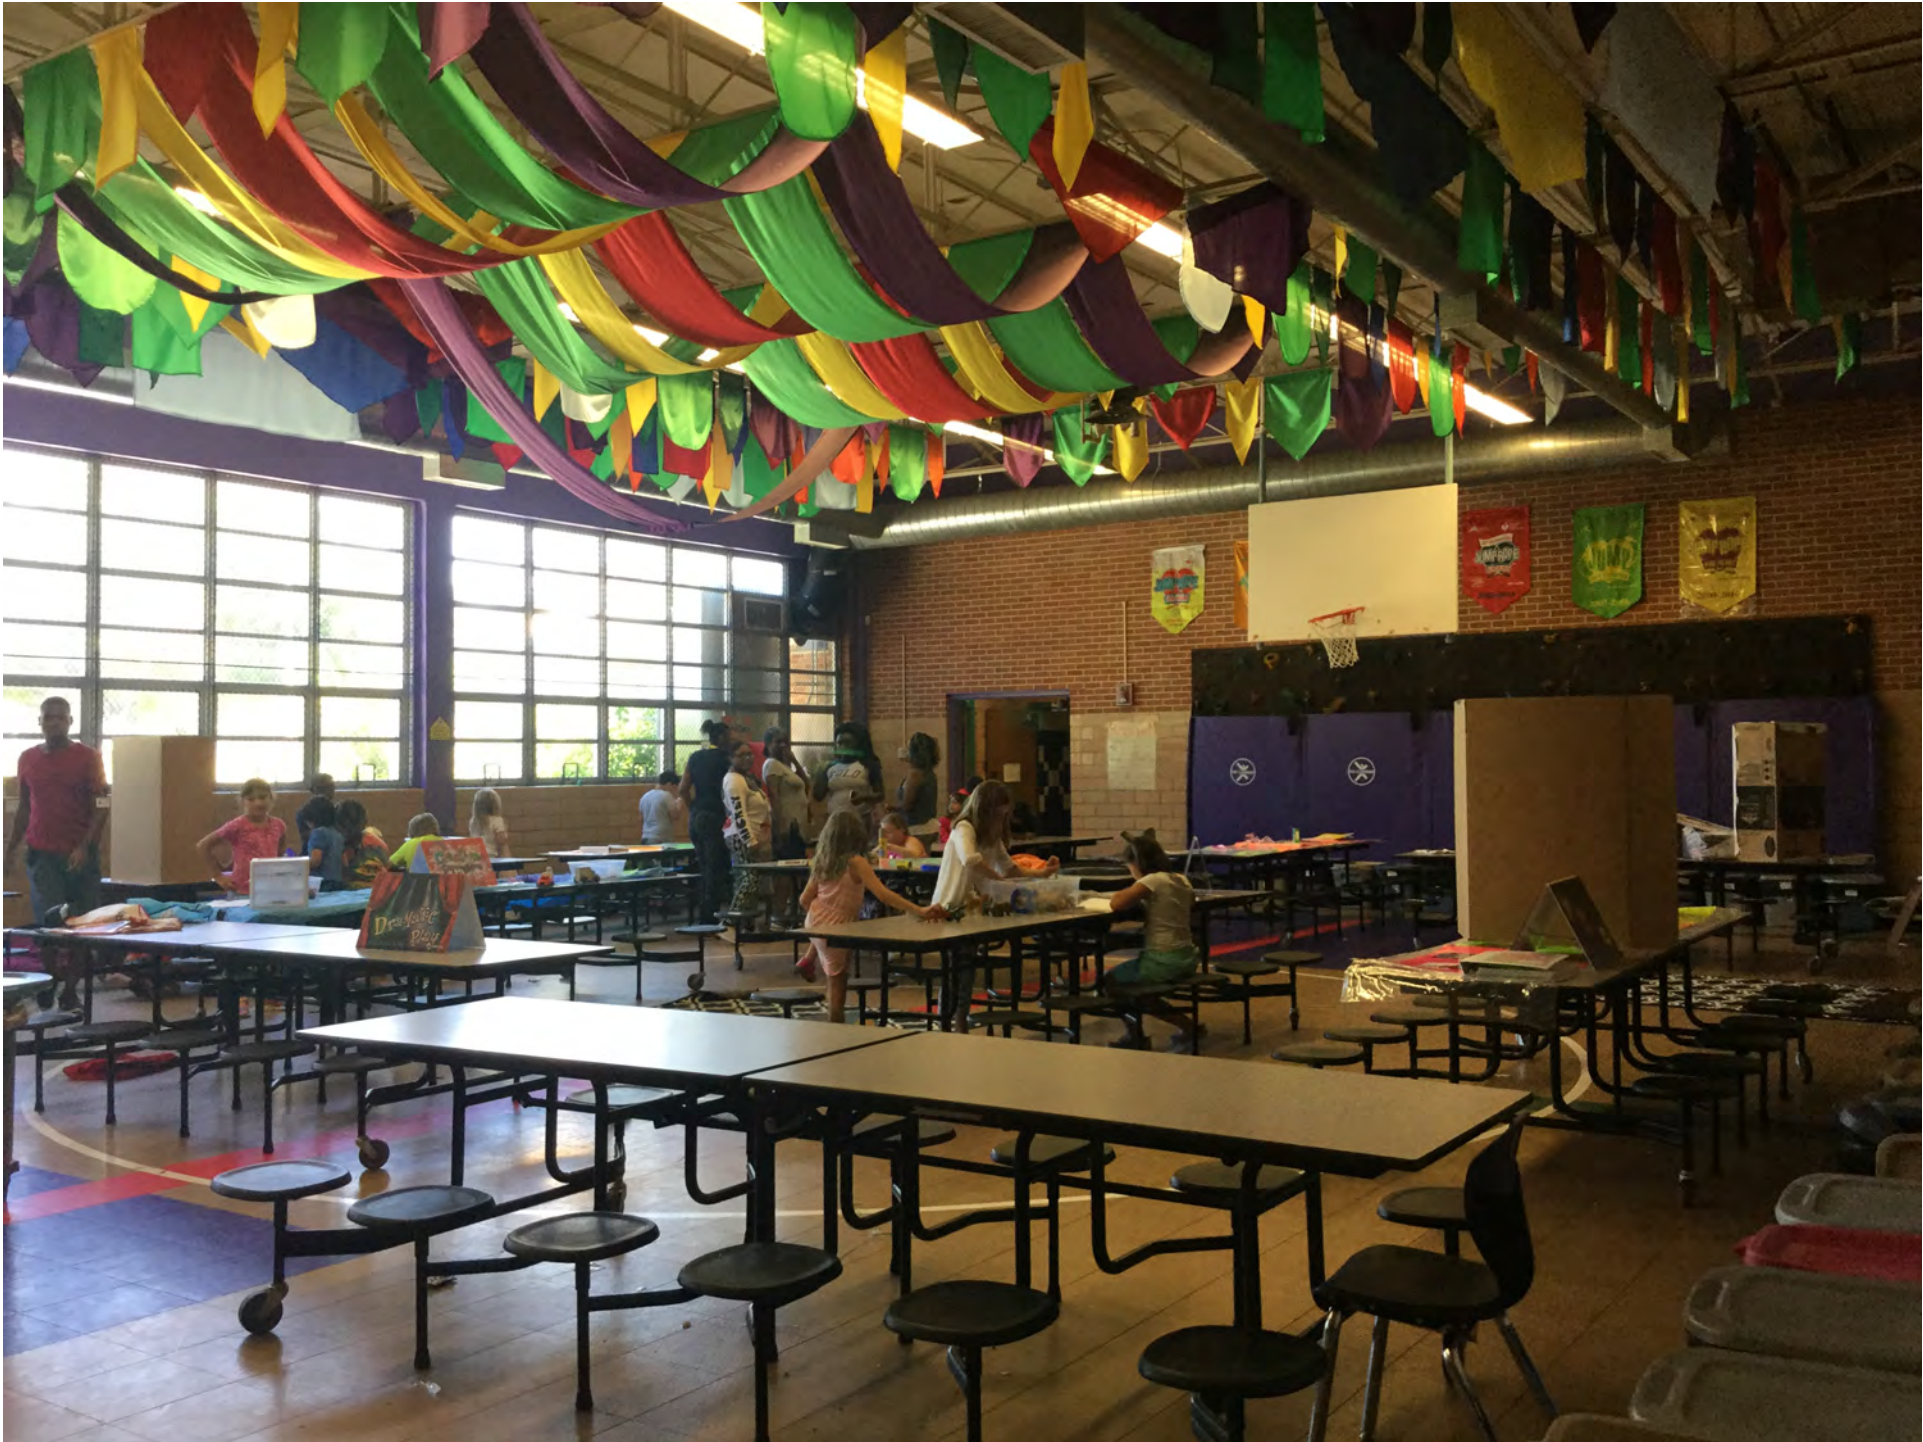
Gym

1) Very unsatisfactory 2) Unsatisfactory 3) Average 4) Good 5) Very good N/A) Does not apply.								The athletic storage space is undersized. Staff requests two gyms to meet student current demand. A standard classroom is utilized as second gym.

3.7	Are Physical Education and Athletic <b>support</b> spaces appropriately configured per the ed spec?	1						Comments	1.00 1.00
1) Very unsatisfactory - Support spaces are disconnected from served spaces, too small, do not meet needs 2) Unsatisfactory - Support spaces are connected, but too small, inadequate for needs 3) Average - Connected, moderate size, but need some renovations or updates to function well 4) Good - Connected, good size/layout, meets needs/functions well 5) Very good - connected, generous size, nice condition, functions appropriately N/A) Does not apply.								The only storage space was converted into a utility closet for electrical. Doors into the space do not function well.

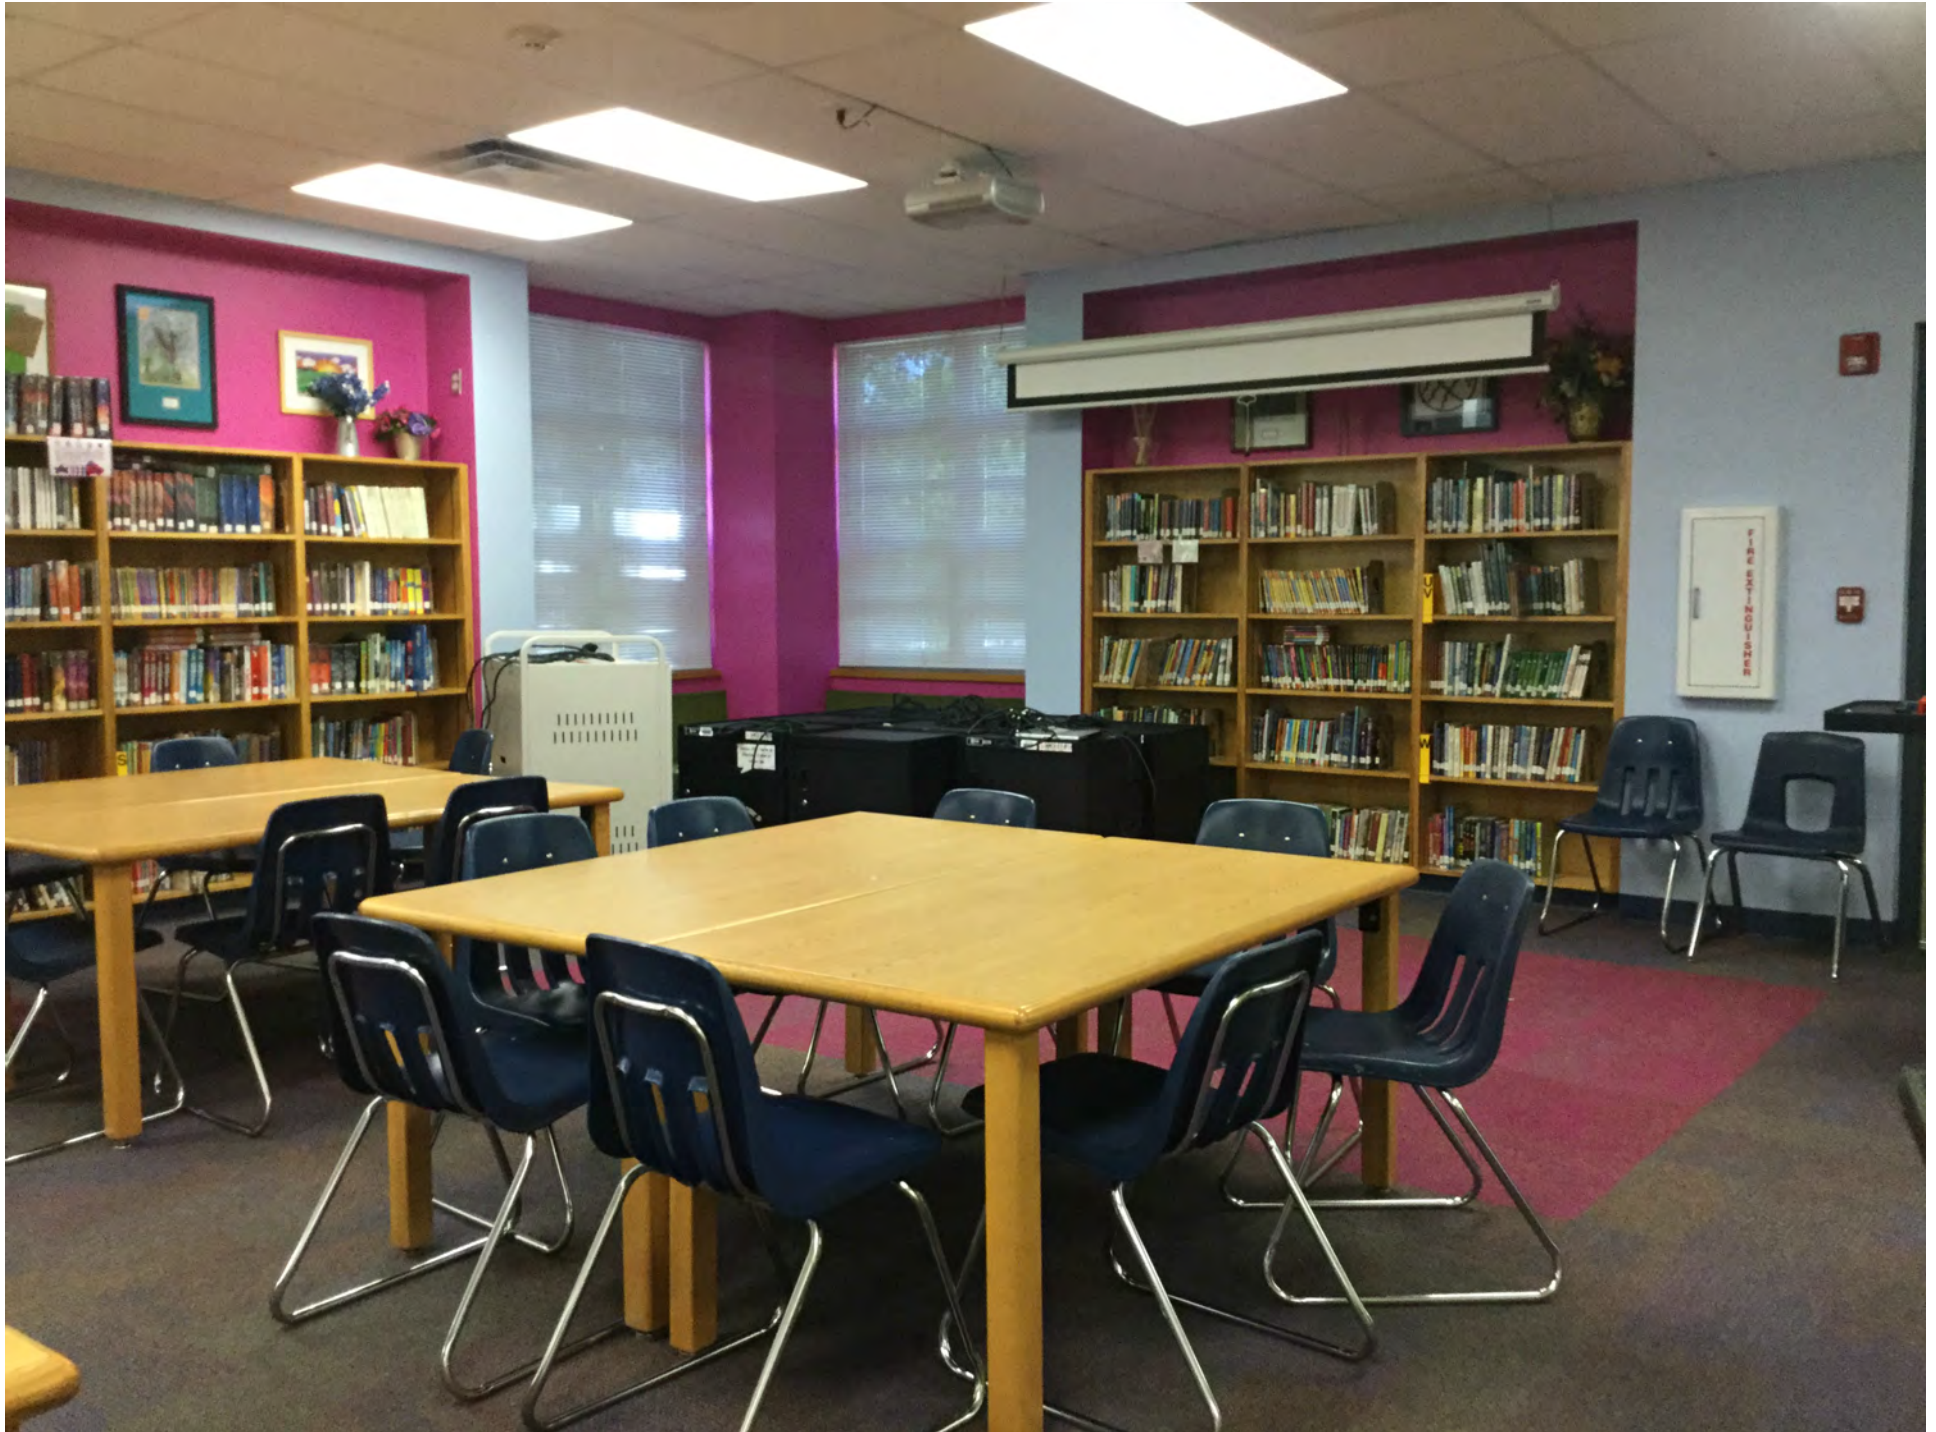
Library Furniture

5.4	How well does the Library/Media Center support collaborative work in small groups (4-8 students)?				4			Comments	1.004.00
1) Very unsatisfactory 2) Unsatisfactory 3) Average 4) Good 5) Very good N/A) Does not apply.								A grouping of furniture presents limited opportunities for this use.

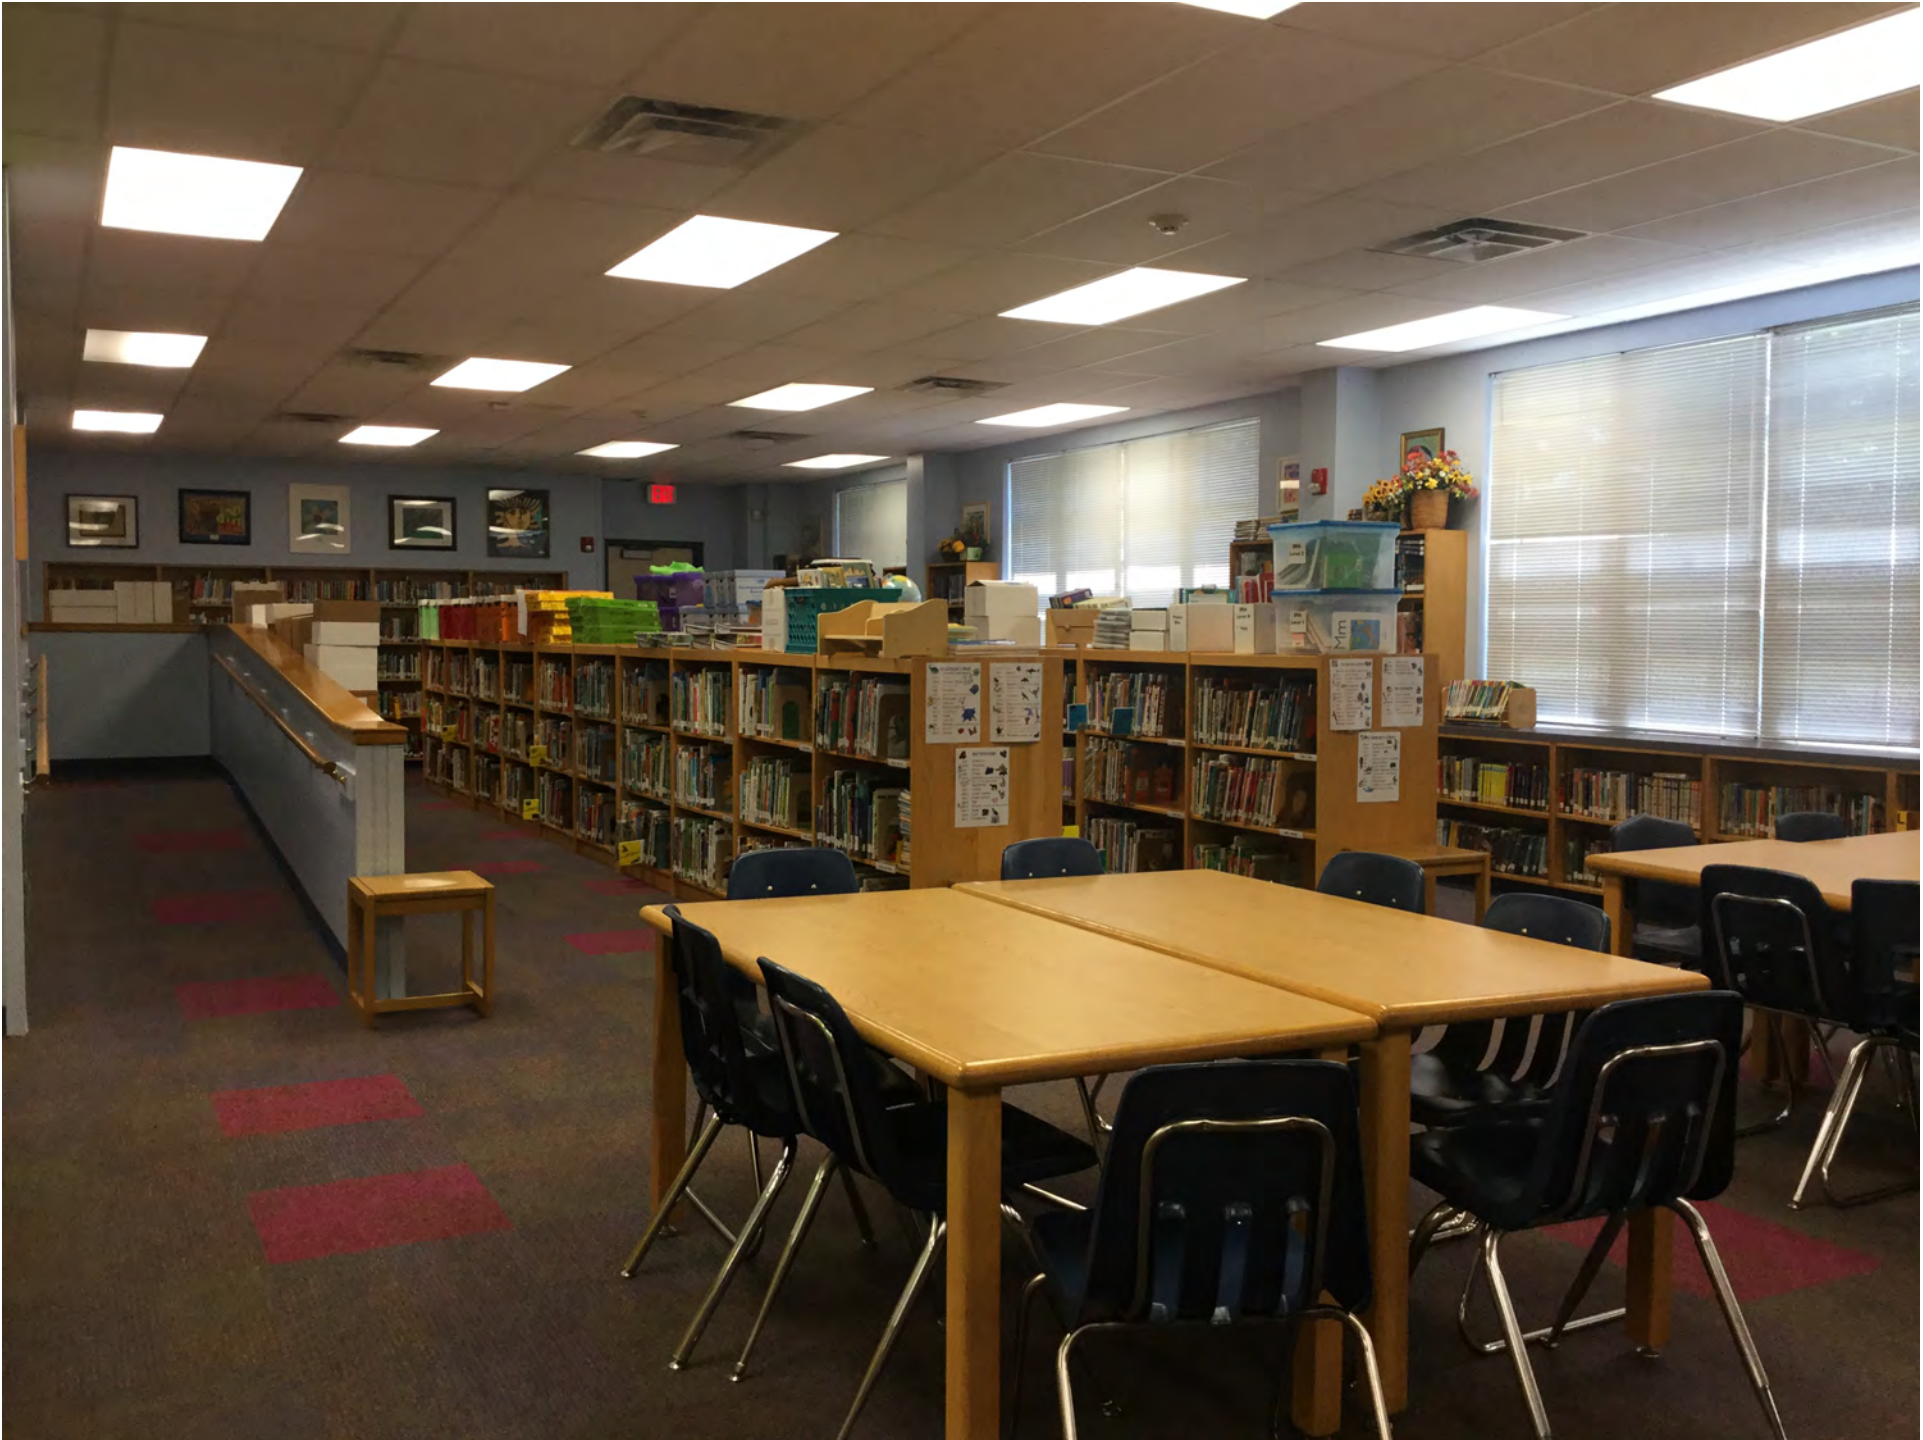
independent study. The reading amphitheater accommodates larger groups. Library technologies are minimally served as there is very limited space for computer access. A dedicated computer lab is not present and mobile computer storage is limited.
