Educational Suitability Summary Report

Bryker Woods Elementary School – BLDG #110

Date: 8/9/2016

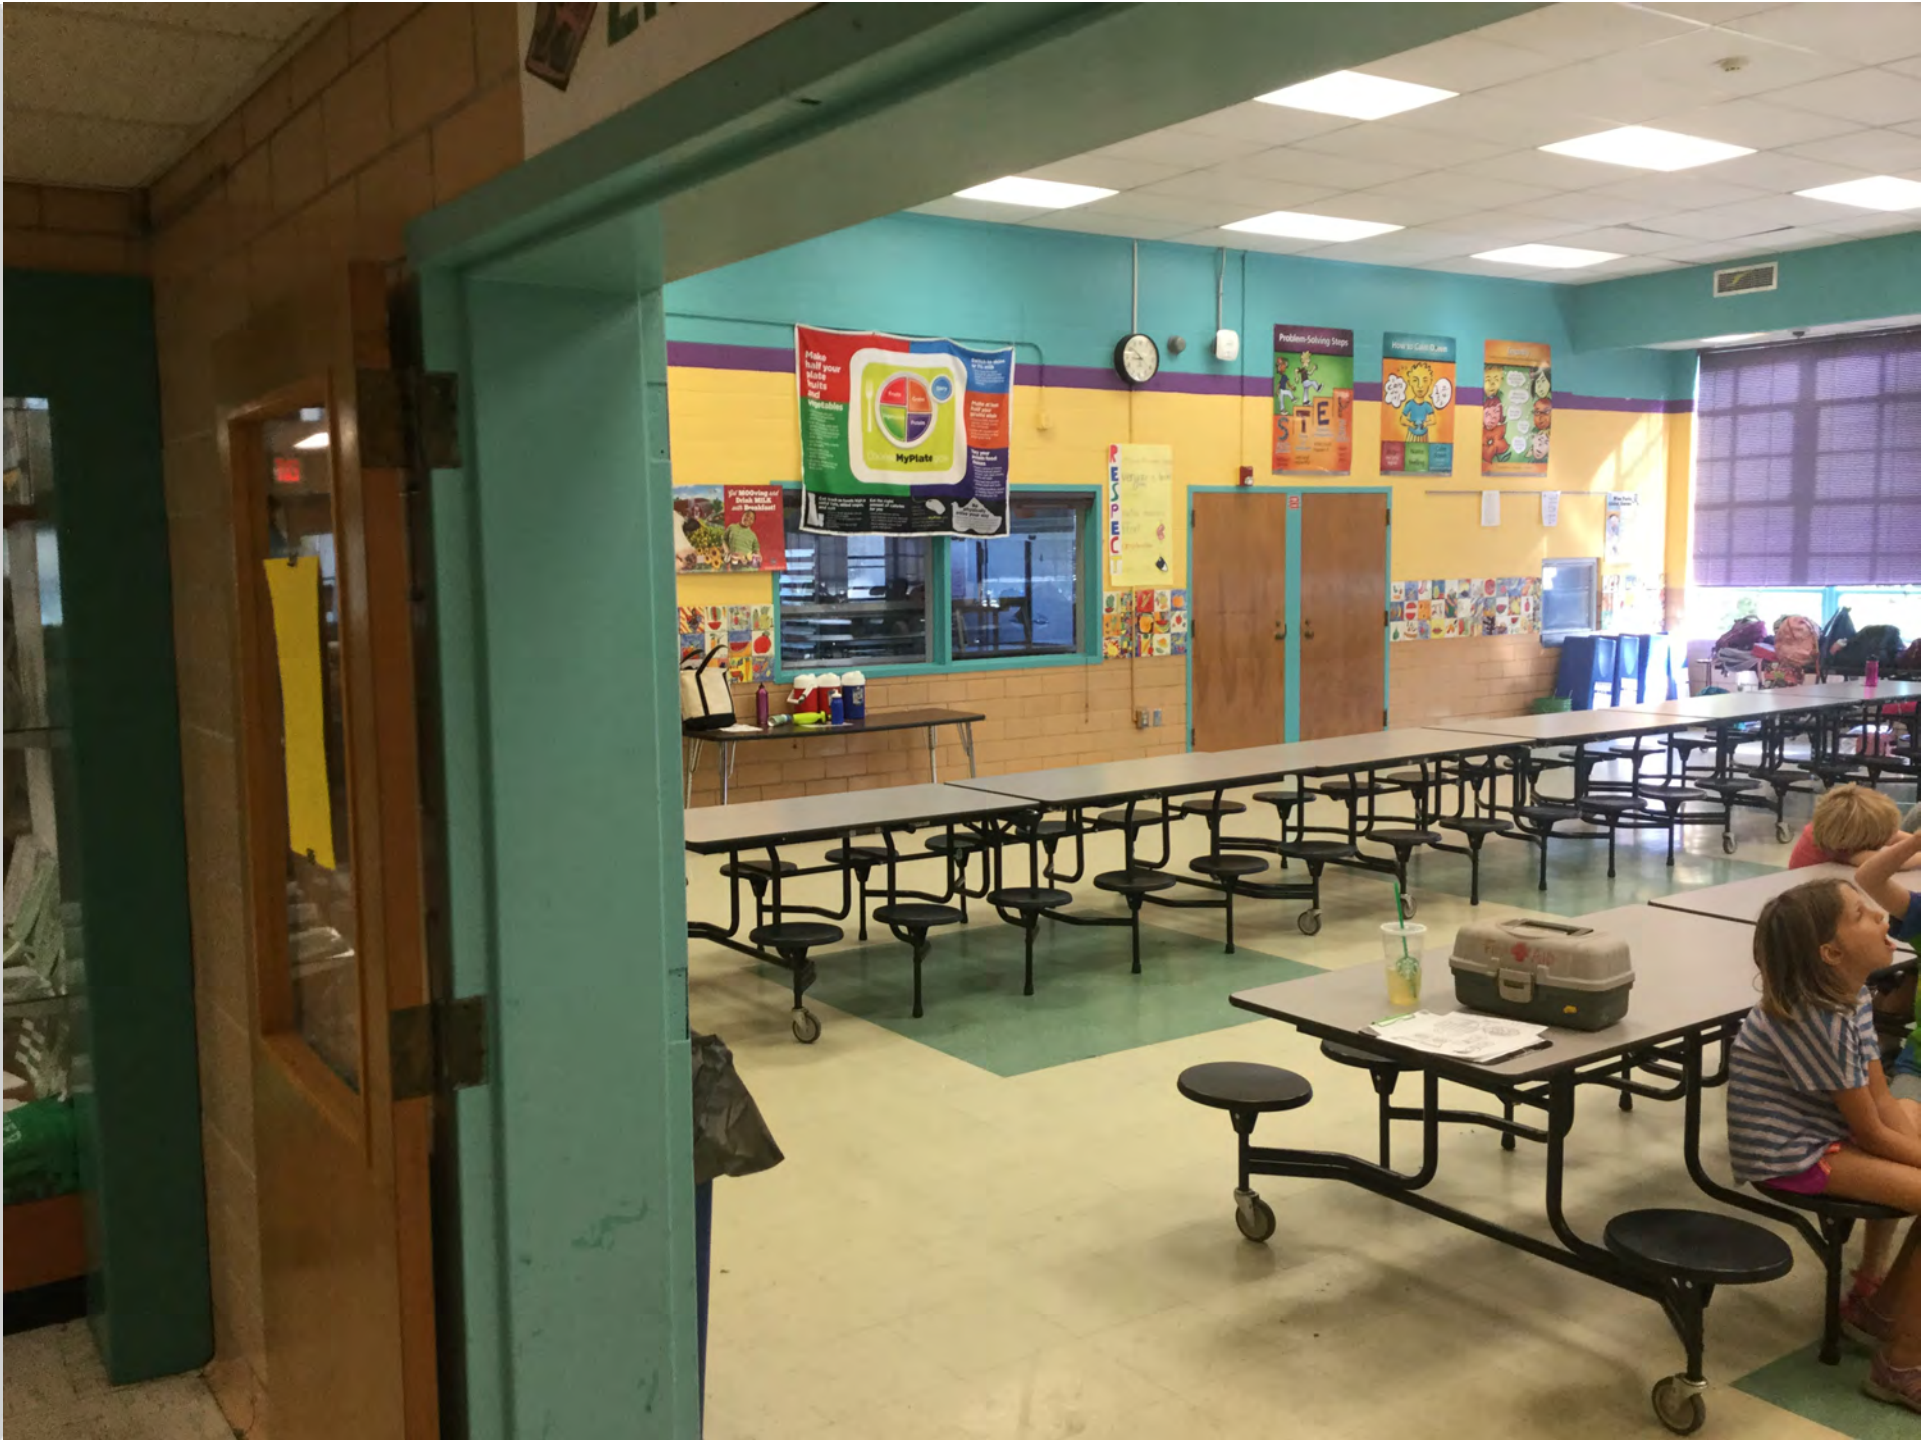
Photo 2. Cafetorium

The cafeteria is currently sized to accommodate student capacity, but is already at maximum capacity (440 of 450 seats are typically full). Seating capacity and the number of serving lines will need to increase if the school continues to grow. Acoustics and lighting quality are reportedly problems in the space and should be addressed. Additionally, the sound system for the stage functions poorly. The principal also mentions that as the cafetorium is the primary public use space, cosmetic improvements should be made in order to make the space more presentable.

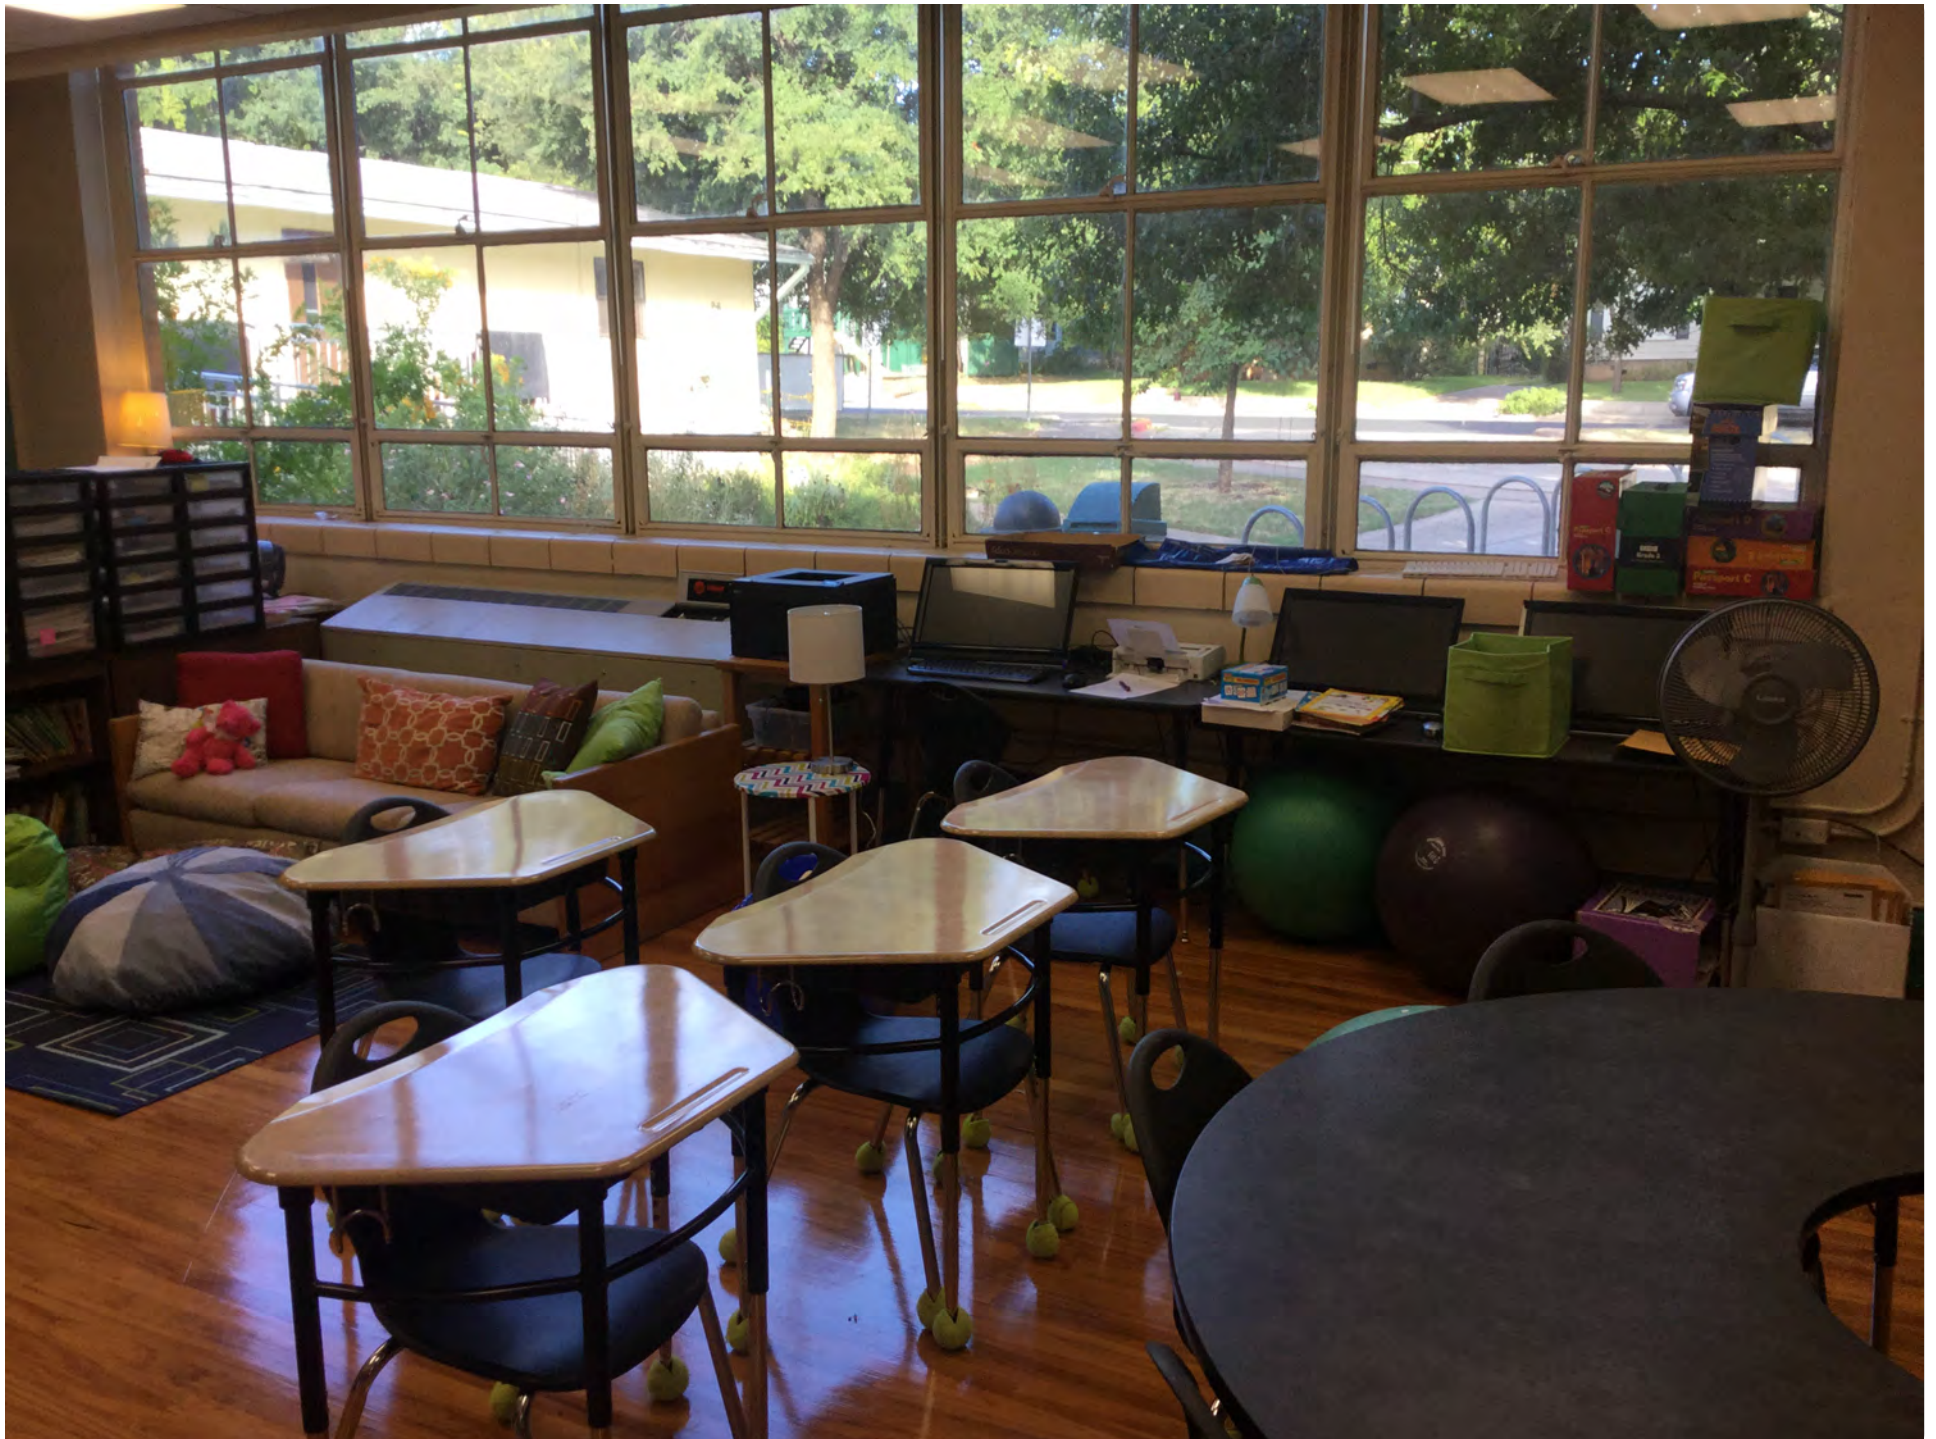
Photo 3. Classroom Furniture

A mix of adequate and aged furniture is present throughout the building. It appears that most furniture is appropriate for student age groups. Staff request more flexible furniture types to better promote collaborative working environments. There is also a request for nesting cafeteria seating and tables that will allow more open space for public events.

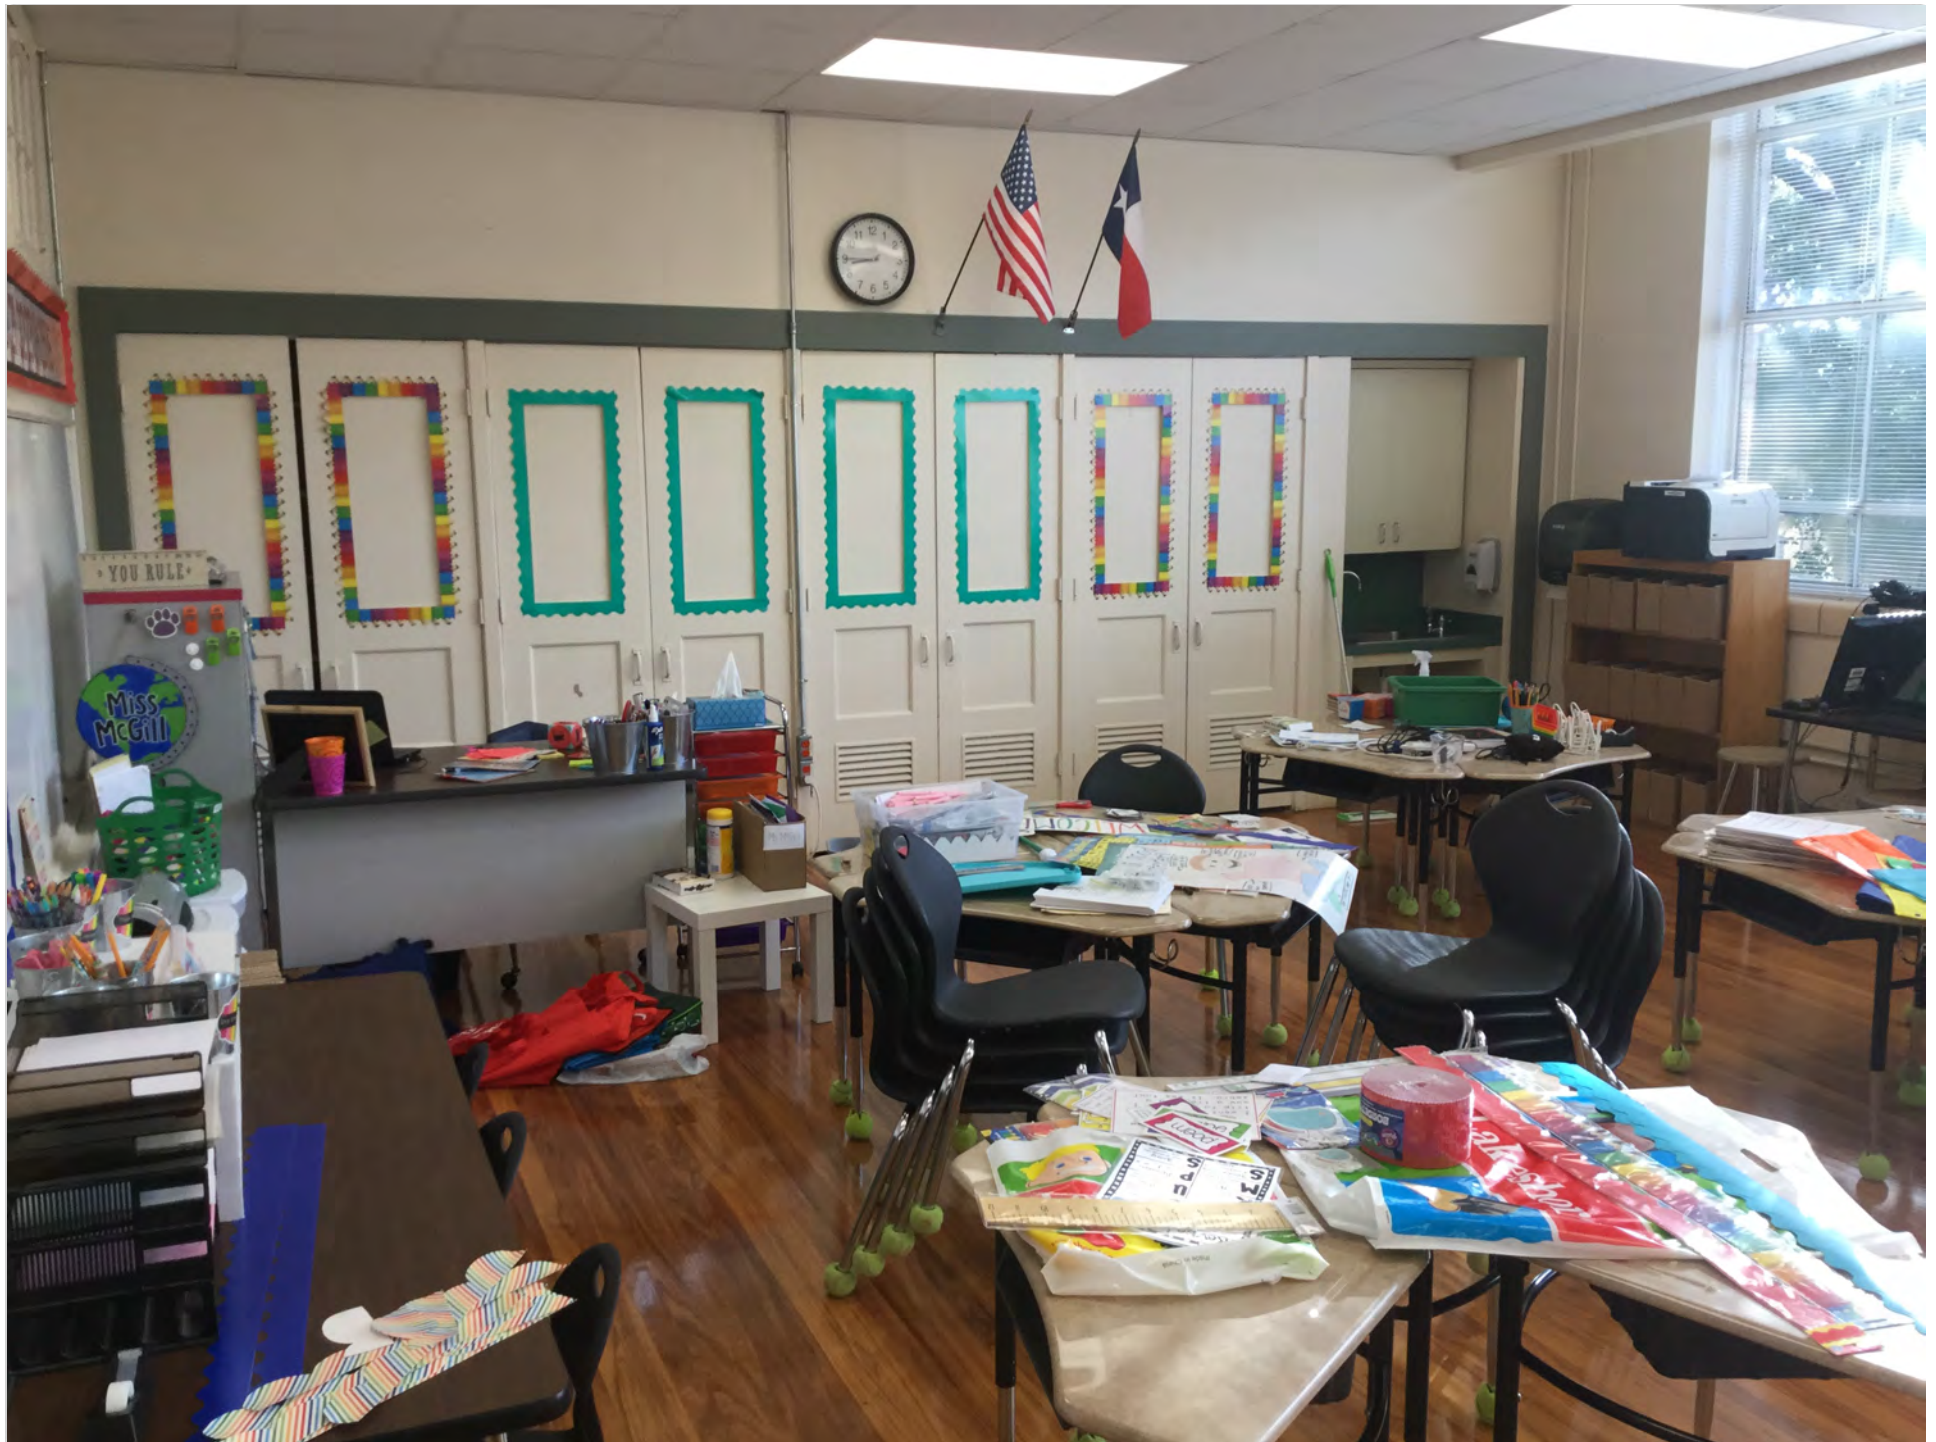
Photo 4. Classroom Storage

4.3	Is there adequate storage and or support space to support project-based learning?		2					Comments	1.00 2.00
1) Very unsatisfactory - none 2) Unsatisfactory-minimal casework/storage 3) Average - moderately sized casework 4) Good - large casework/cabinets/support 5) Very good - walk-in storage/ample support space N/A) Does not apply.								Storage space is minimal and depends on built-in casework and shallow closets.

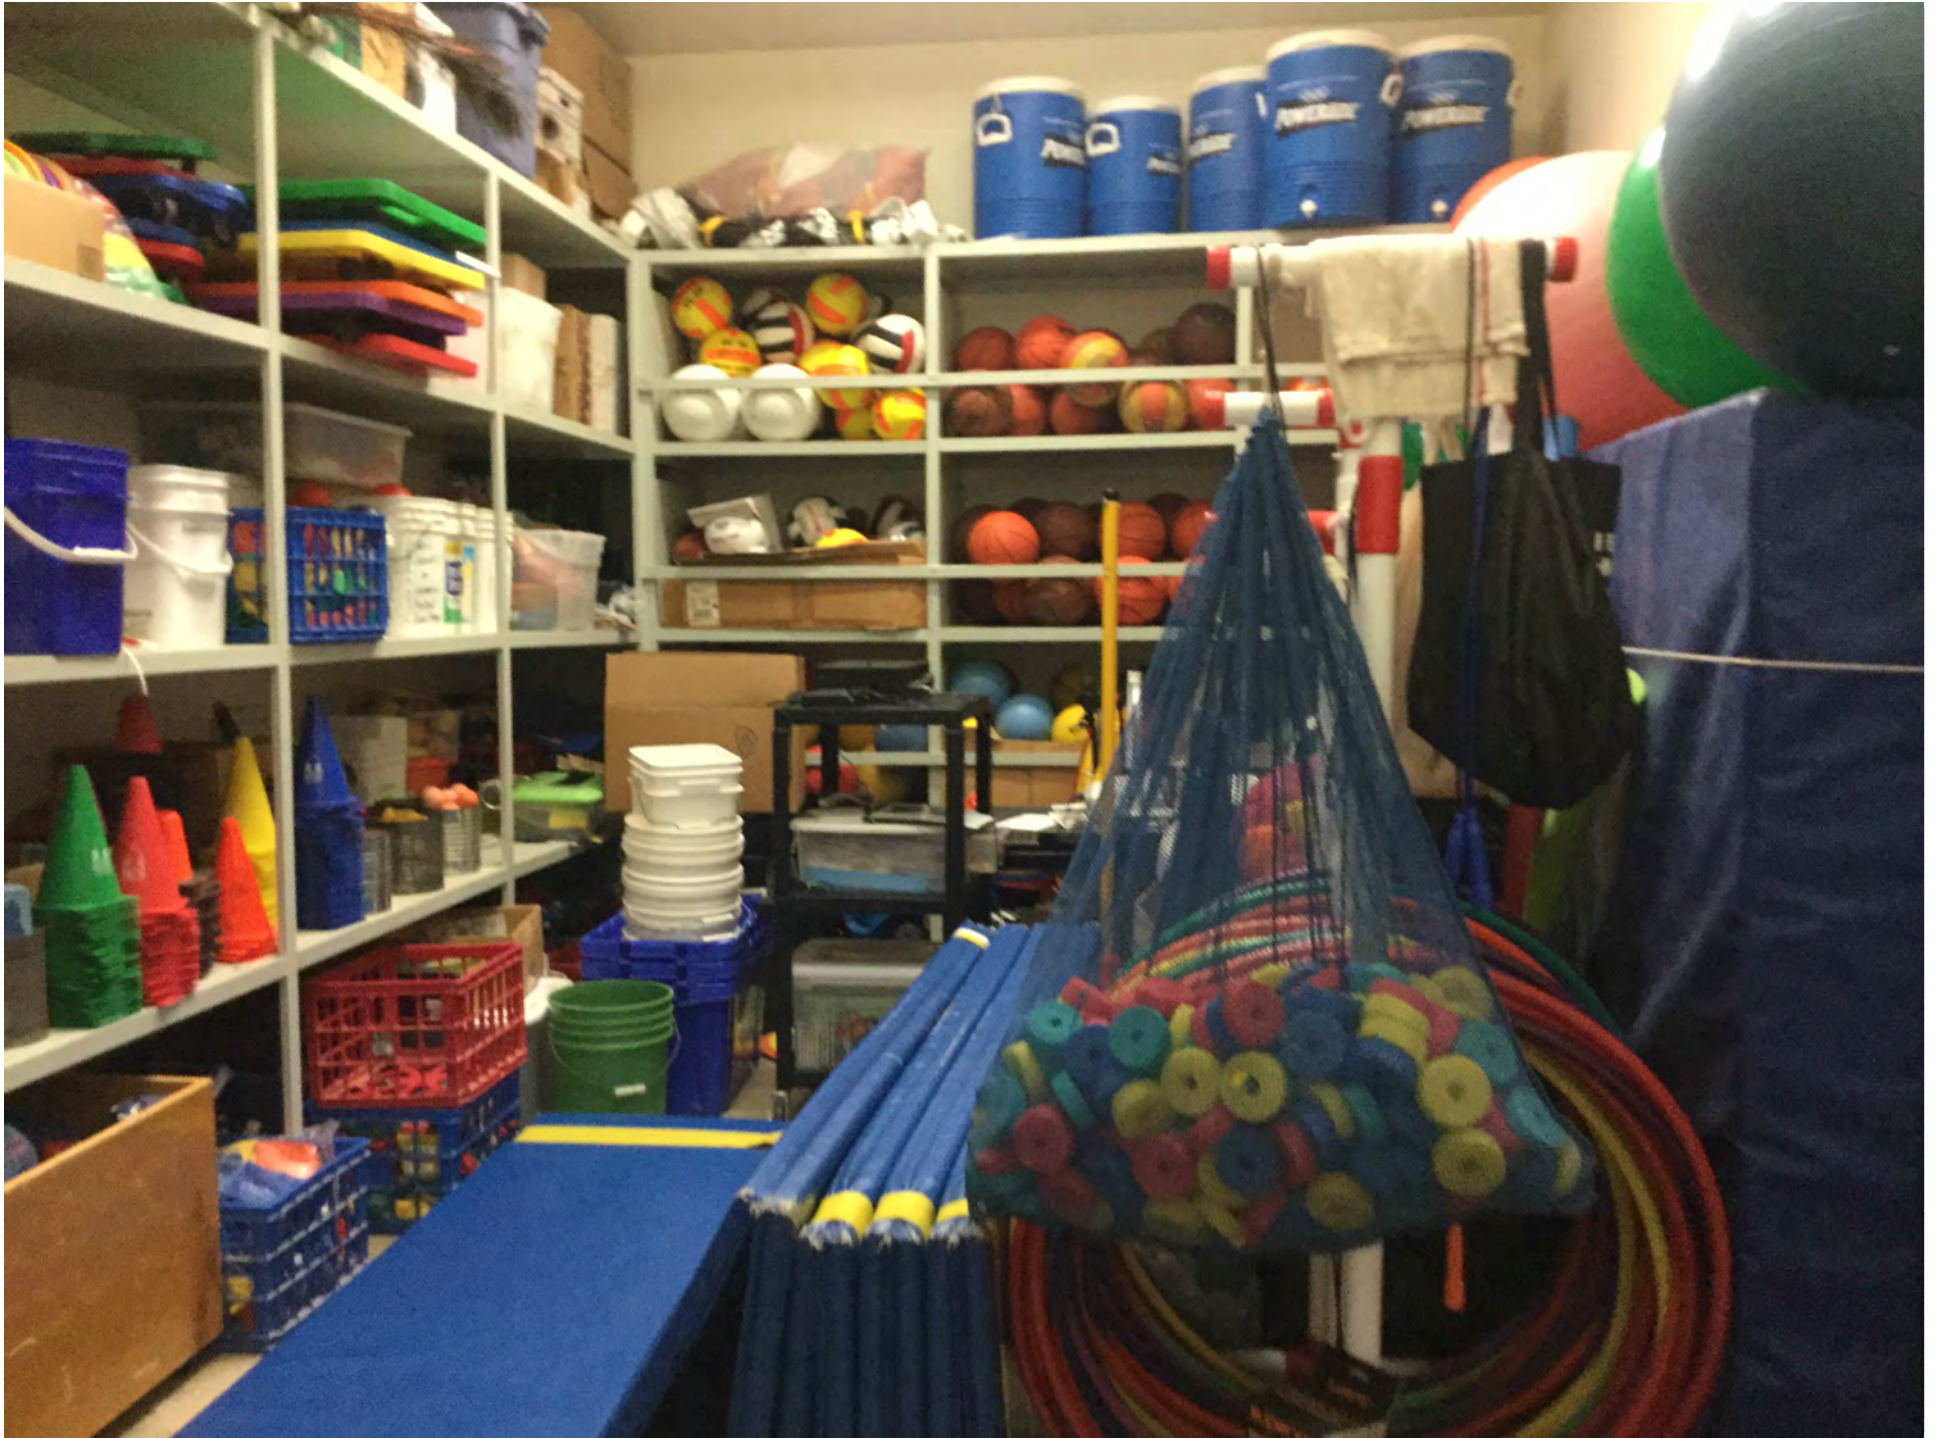
Photo 7. Gym Storage

3.7	Are Physical Education and Athletic support spaces appropriately configured per the ed spec?				4			Comments	1.004.00
1) Very unsatisfactory - Support spaces are disconnected from served spaces, too small, do not meet needs 2) Unsatisfactory - Support spaces are connected, but too small, inadequate for needs 3) Average - Connected, moderate size, but need some renovations or updates to function well 4) Good - Connected, good size/layout, meets needs/functions well 5) Very good - connected, generous size, nice condition, functions appropriately N/A) Does not apply.								The gym has its own restroom, storage, and support spaces.

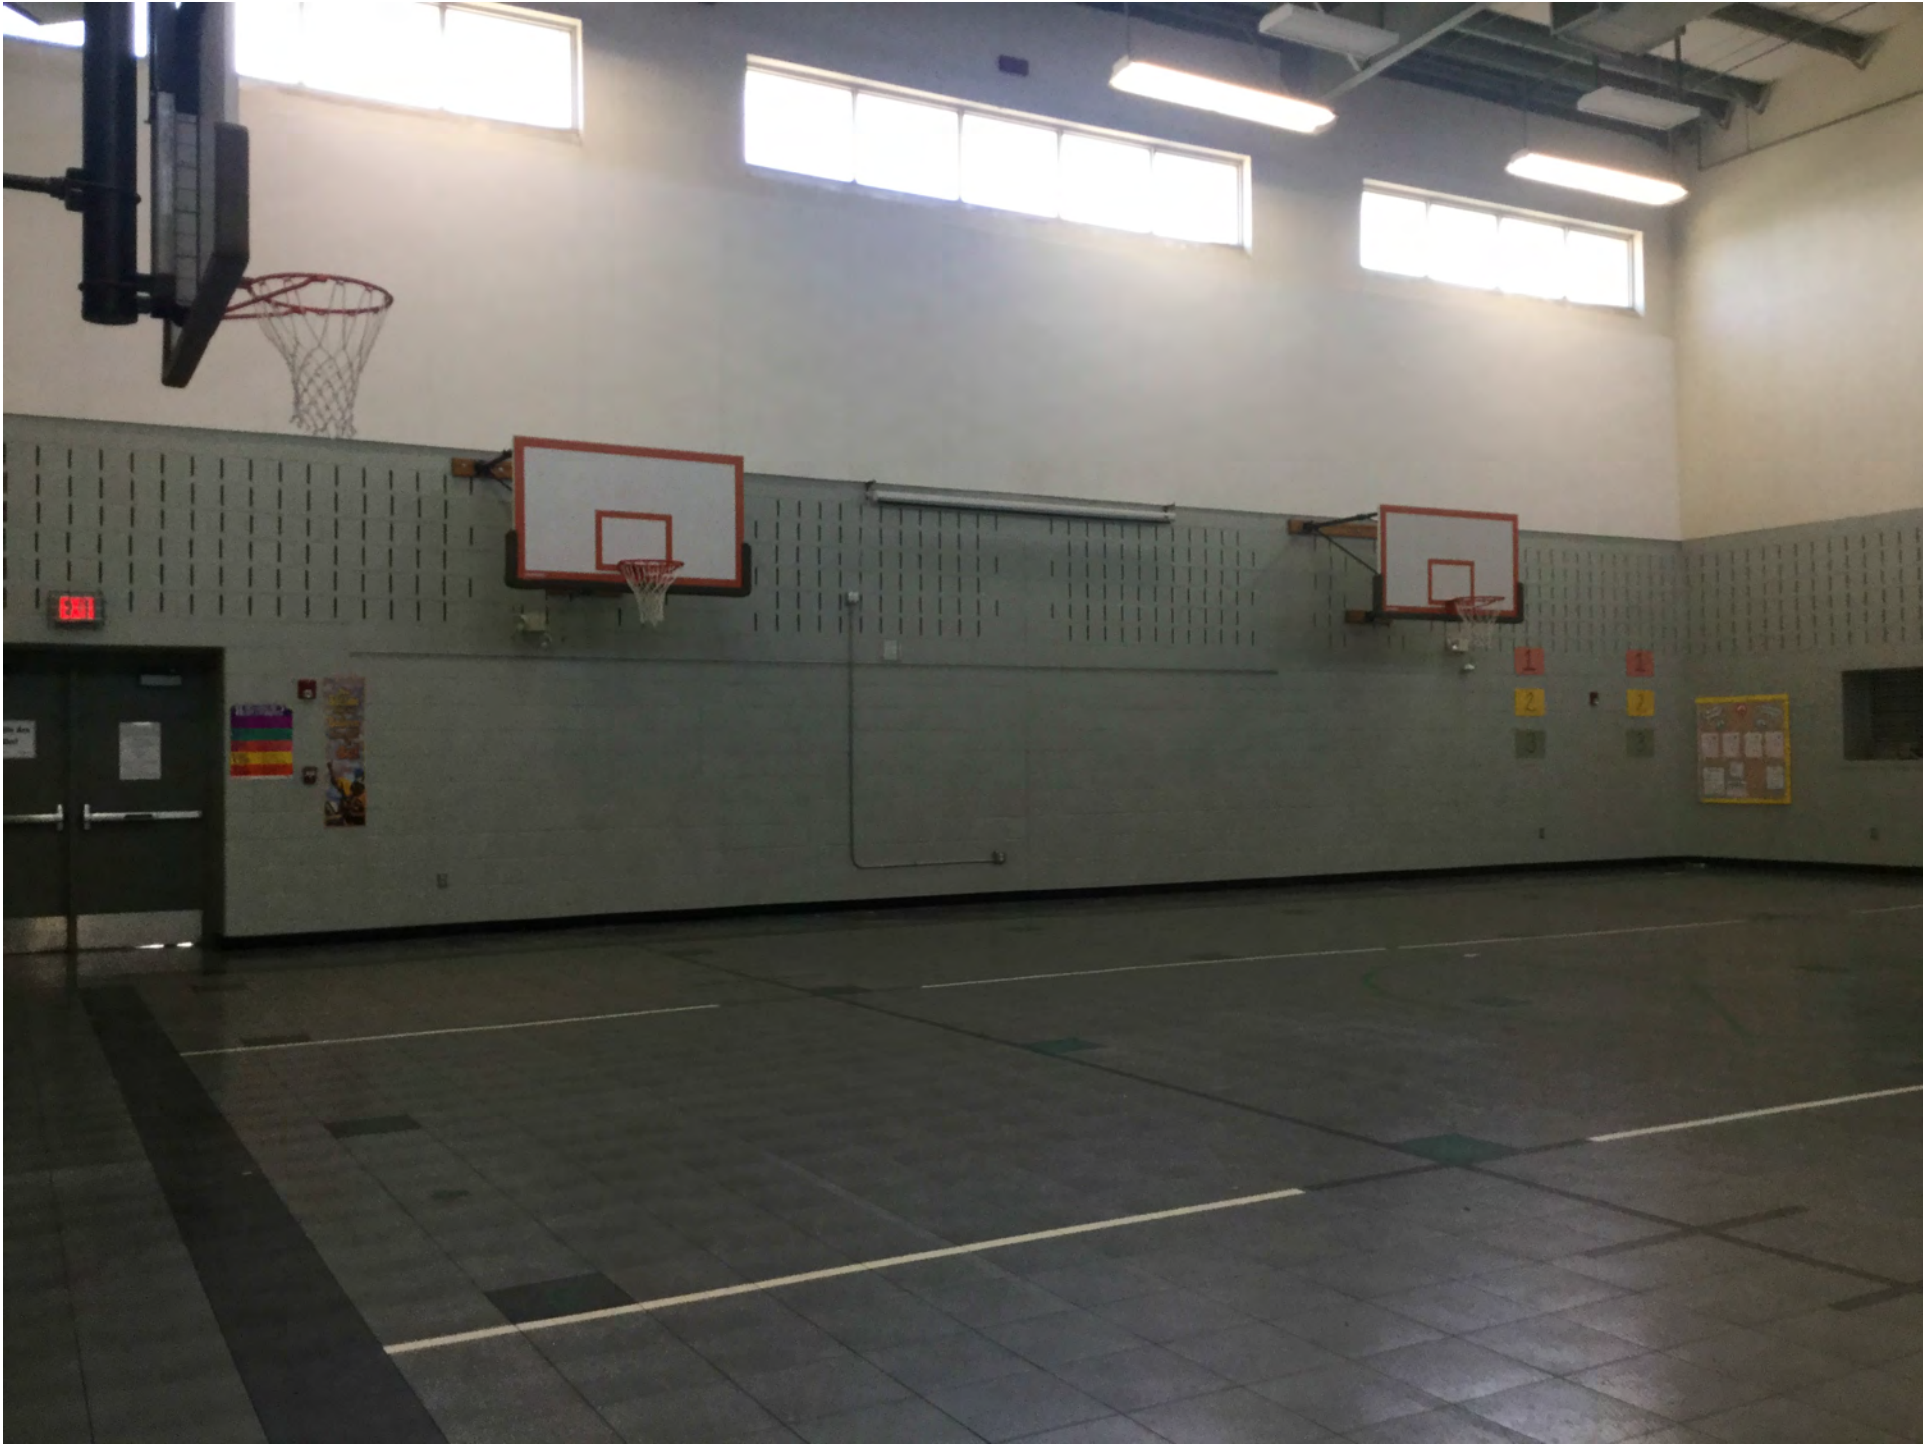
Photo 8. Gym

The gym is appropriately sized and equipped. The only issue present is that the flooring may need to be replaced due to extended age and miscellaneous damages.

1) Very unsatisfactory 2) Unsatisfactory 3) Average 4) Good 5) Very good N/A) Does not apply.								The gym is appropriately sized and configured. The gym is aged and would benefit from minor cosmetic updates.

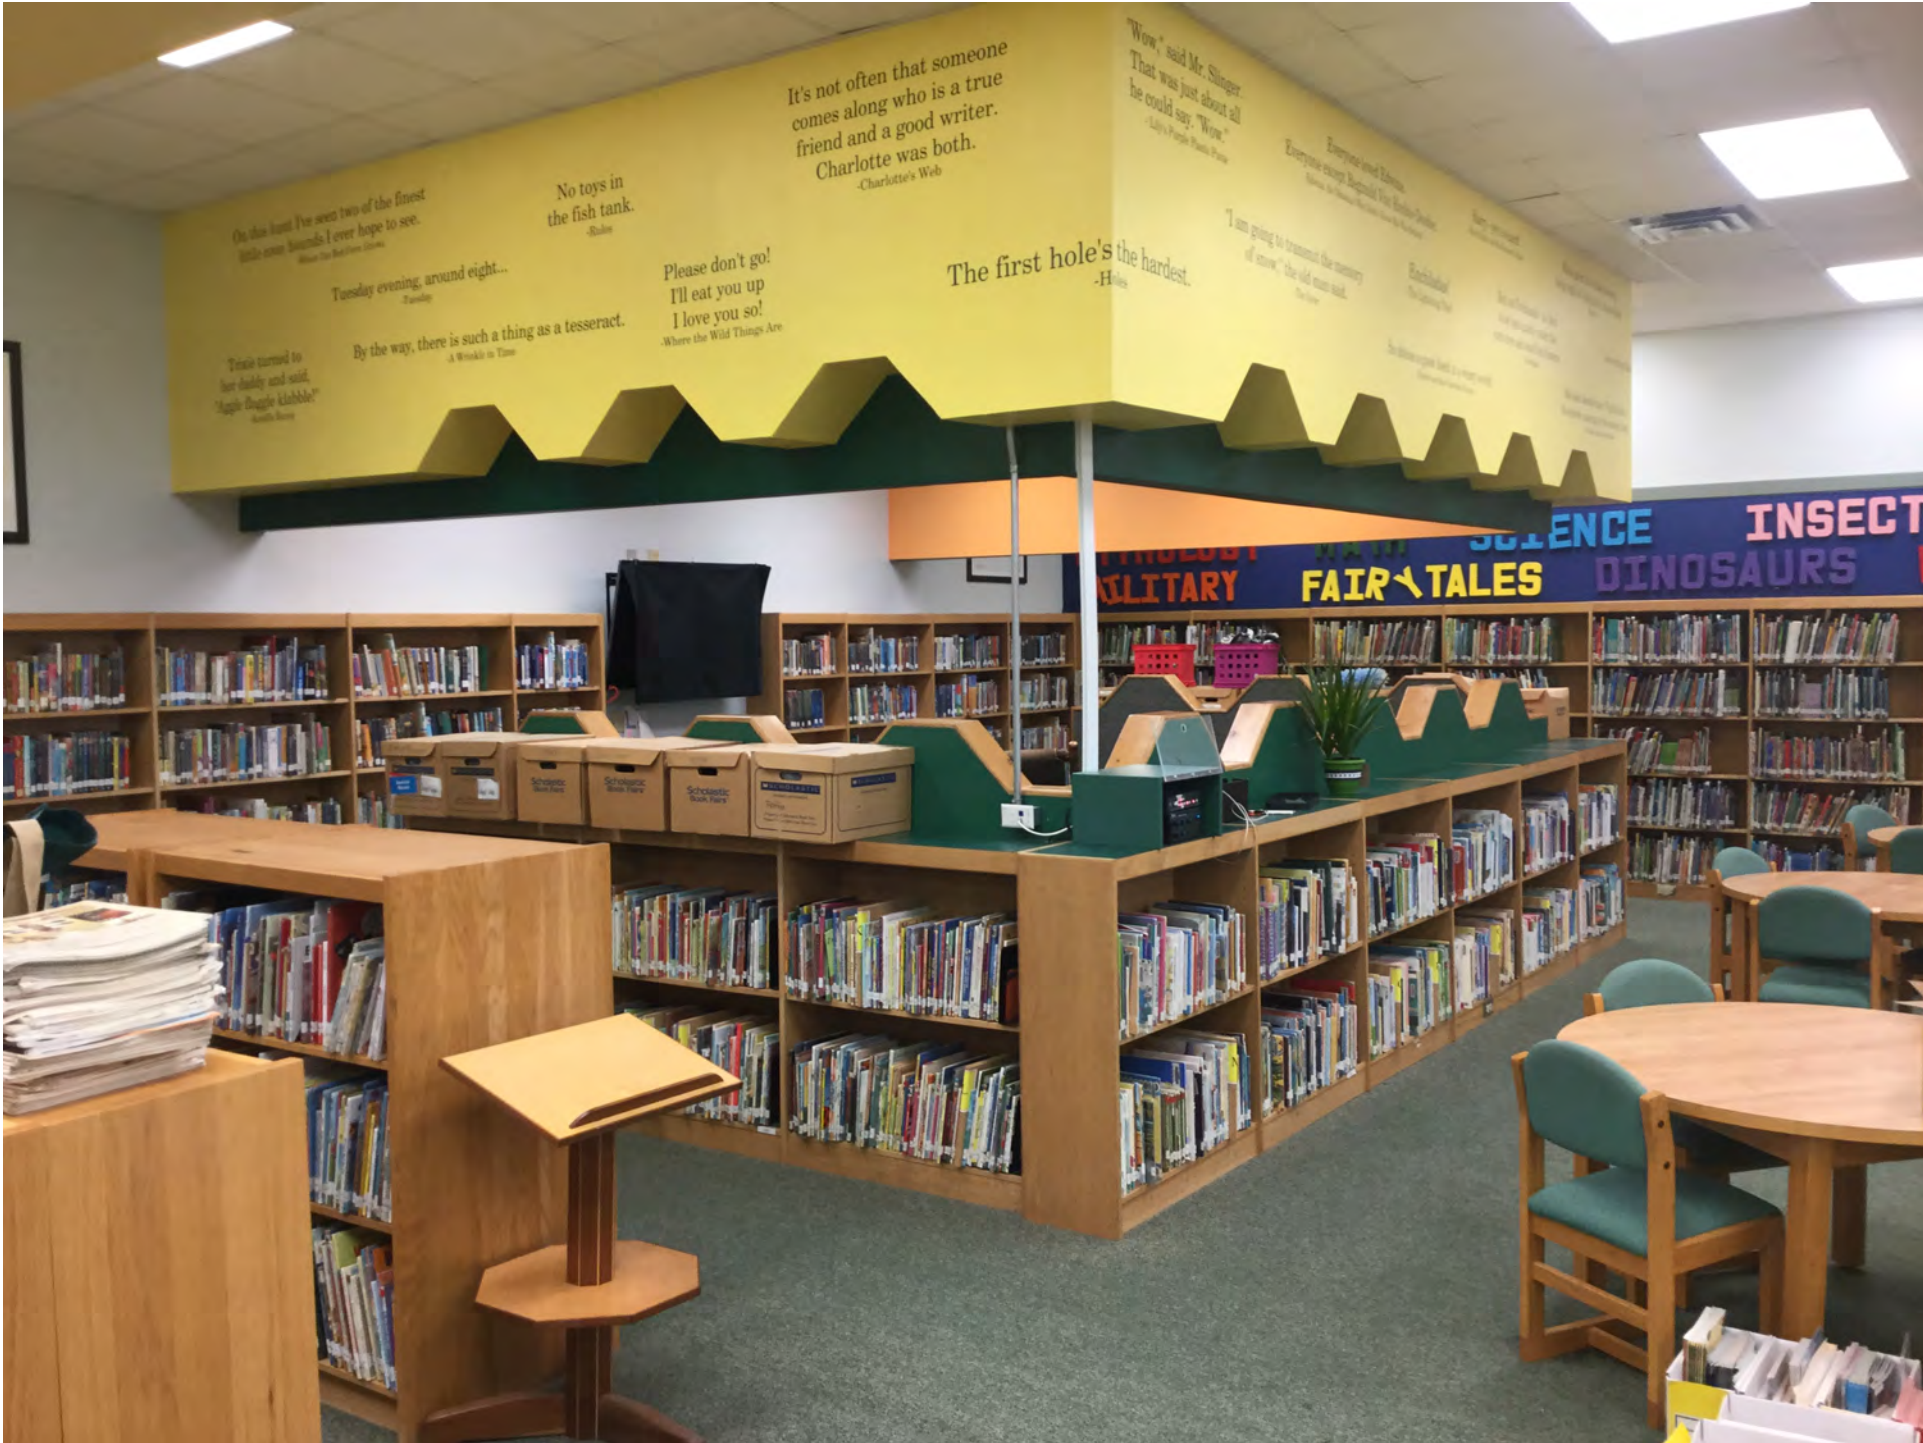
Photo 10. Library

The library is adequately sized for current enrollment, but needs additional space for secondary functions. Additional storage is needed for the literature library and storage is needed for instruments as the space is regularly used by the orchestra class.

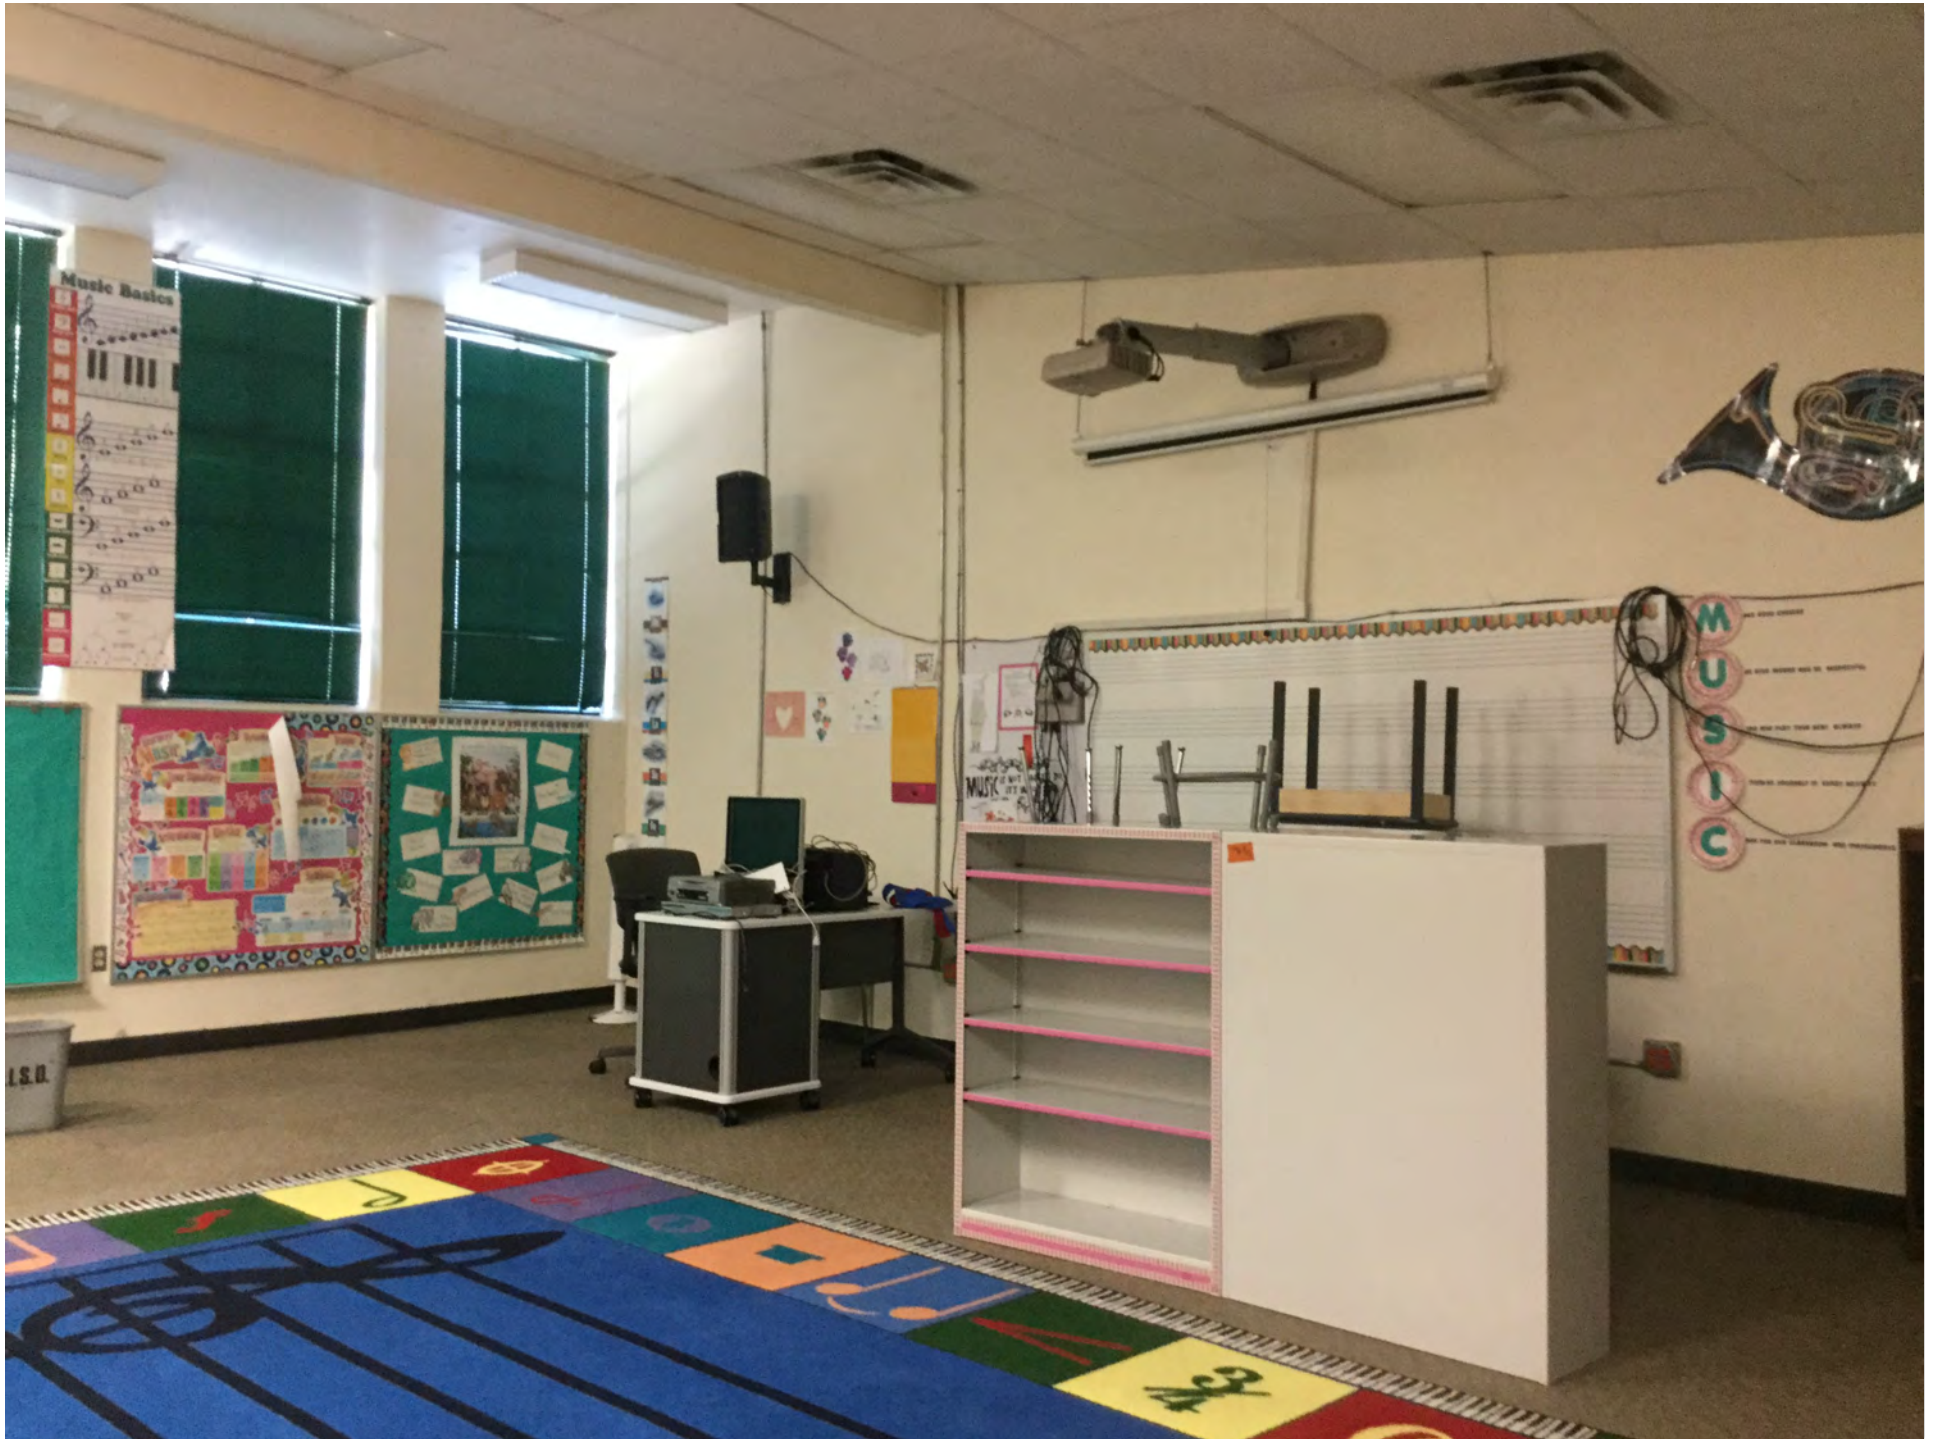
Photo 11. Music Room

Music and art room spaces have had problems with flooding in the past. Flooring has been recently replaced and additional work is scheduled within the next year. It is noted that neither space is especially attractive and that cosmetic improvements would brighten the spaces and make them more presentable. Lastly, new blinds and improved lighting quality are requested.
