Educational Suitability Summary Report

Bryker Woods Elementary School – BLDG #110

Date: 8/9/2016

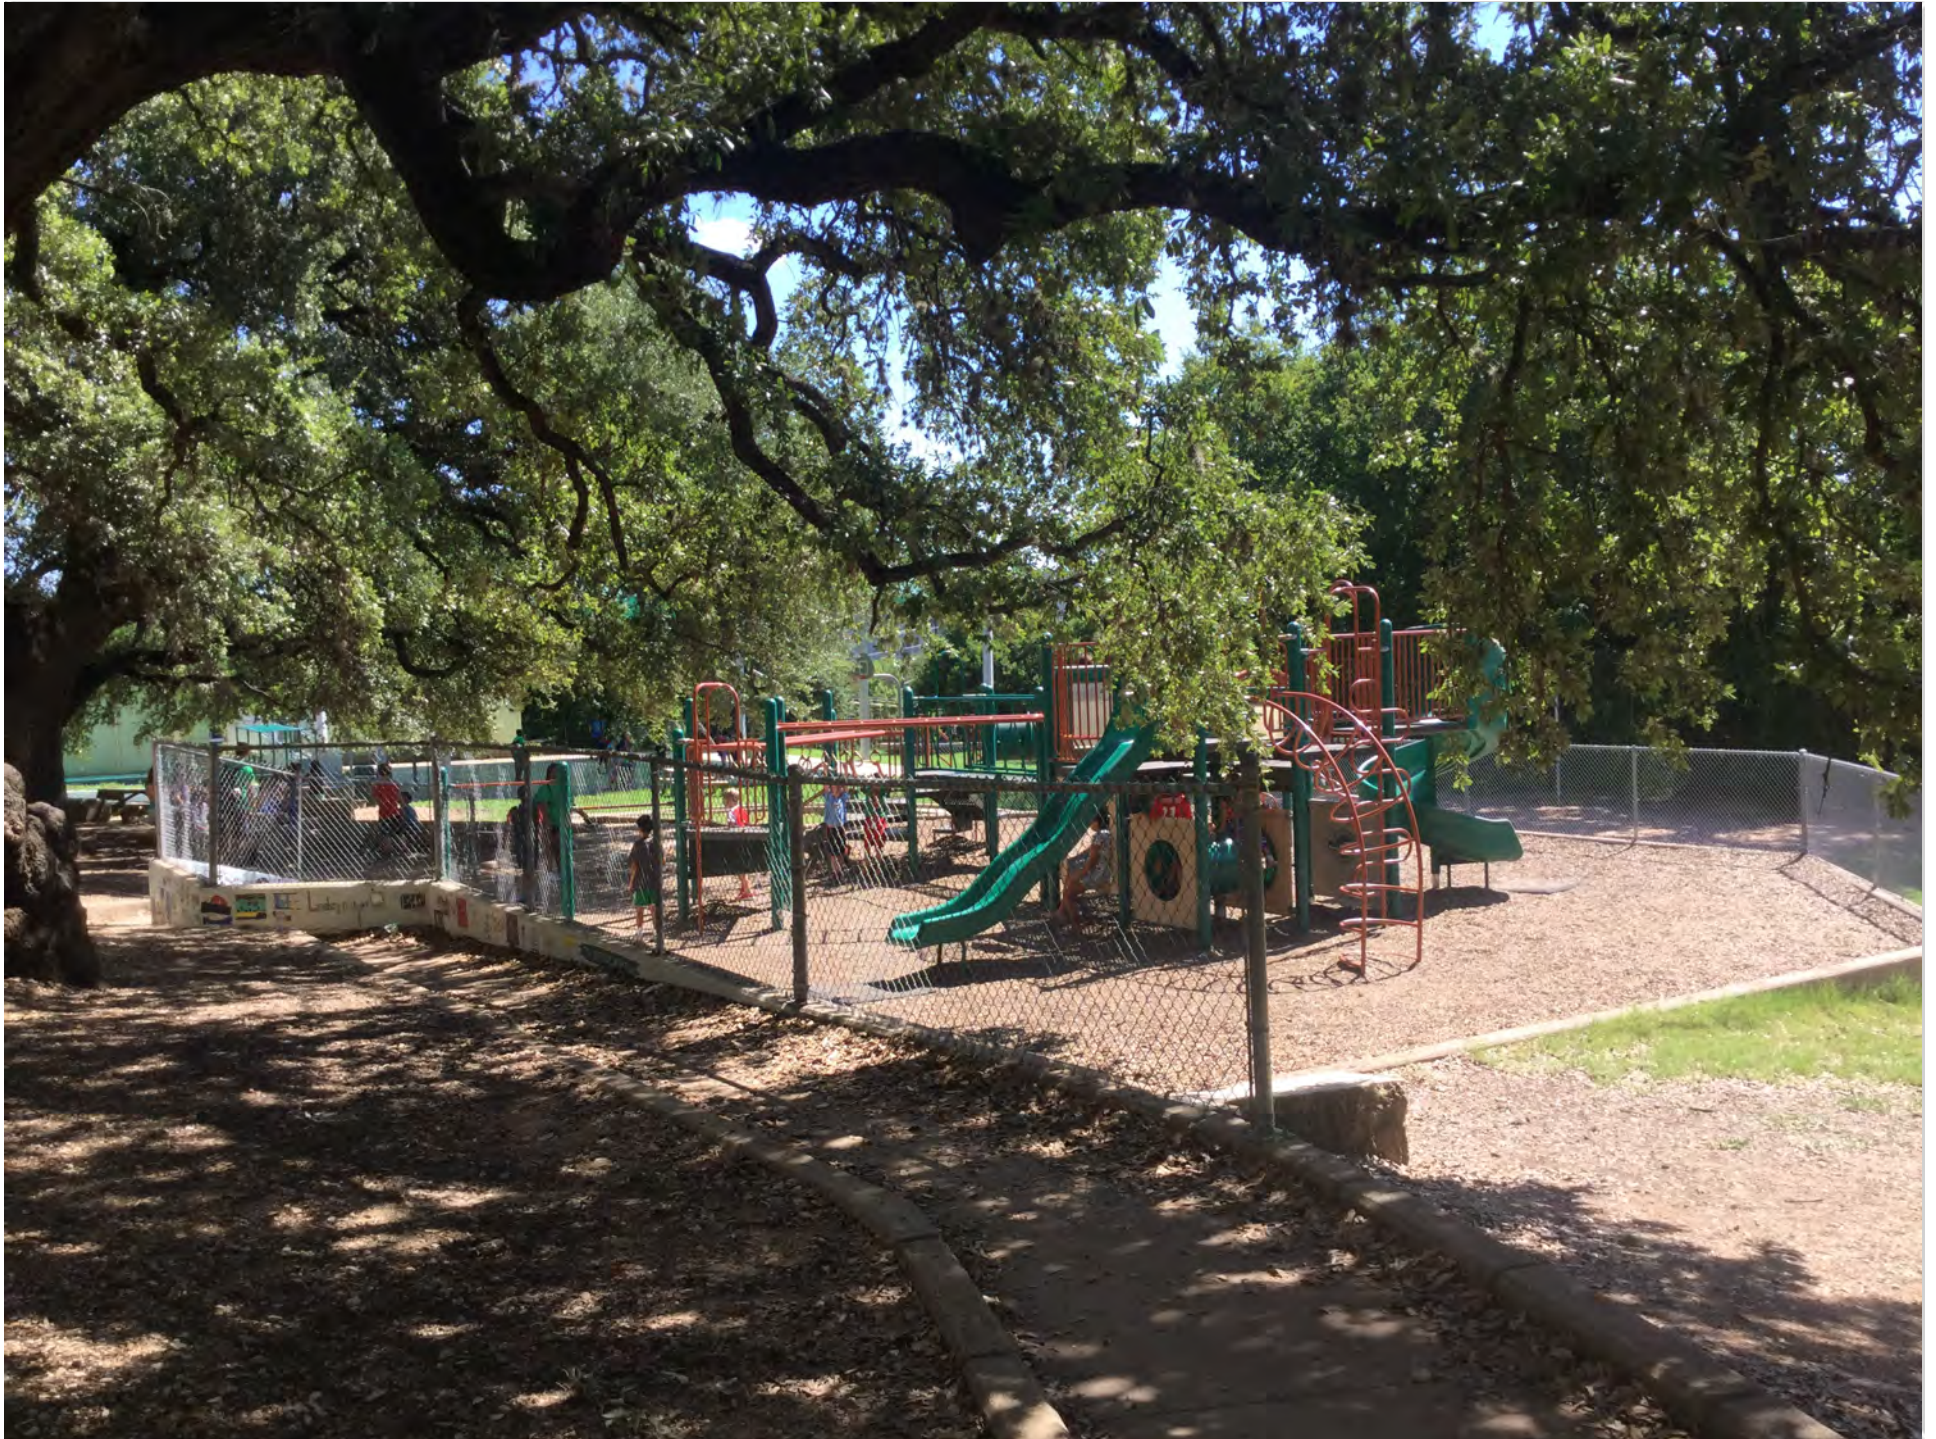
Photo 12. Playground

1.3	Are outdoor play spaces and playfields adequate in size and configuration?				4			Comments	1.00 4.00
	1) Outdoor play space exists, not developed 2) Outdoor play space exists but is not connected to gym or other athletic support areas or is too small. 3. Outdoor play spaces exist, are connected to other athletic areas, are the right size, but are not in good condition. 4. Outdoor play spaces need minor improvements to function well. 5. Outdoor play spaces are in excellent condition. N/A) Does not apply.							The topography causes challenges for playscapes and fields. The lower field undulates more than is desired. Potholes from washout and erosion occur. The track requires a lot of maintenance due to crushed stone surfacing. The playgrounds are in good condition. Murals are spread throughout the site.

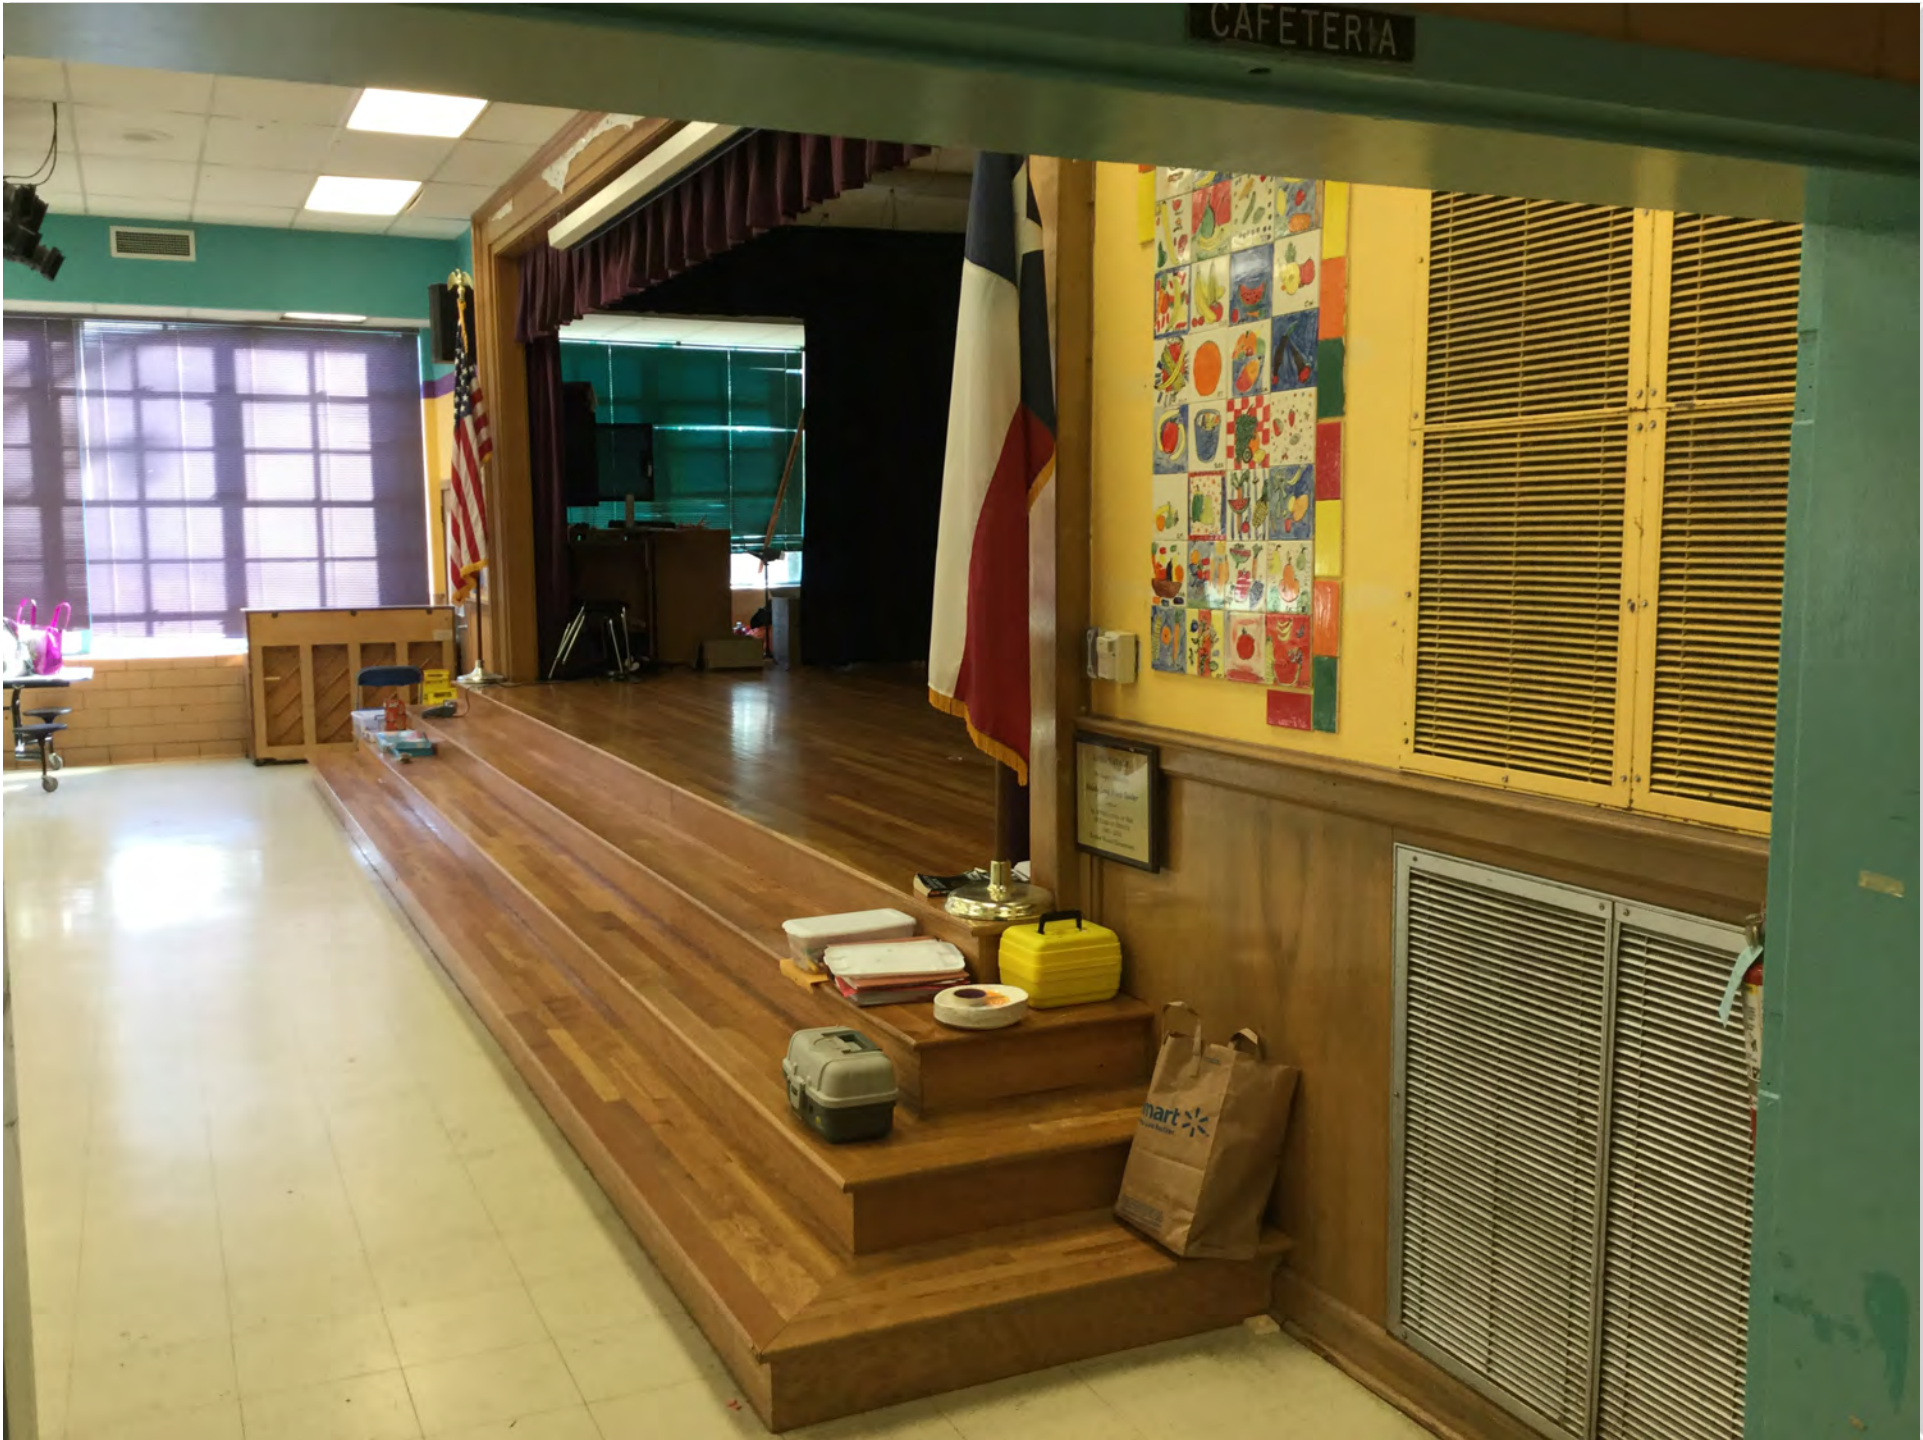
Photo 13. Stage Access

3.16	Are the student dining facilities appropriately configured?								3					Comments	1.00	3.00
1) Very unsatisfactory - Too small, poor circulation, inflexible seating in poor condition 2) Unsatisfactory - Too small or inadequate circulation, seating in poor condition 3) Average - moderate size, with adequate circulation, seating in okay condition 4) Good - good size, adequate circulation, seating in good condition 5) Very good - good size, adequate circulation, seating in good condition, with more than one option for eating space (ex: connection to outdoor eating space) N/A) Does not apply.													The cafetorium is appropriately sized, seats maximum of 450 (440 students enrolled), and is used heavily for public functions. The flooring is dated, the acoustics and lighting are poor, and the blinds are in poor condition. The stage has no storage capabilities. The stage is currently not ADA accessible.
