Educational Suitability Summary Report

Casey Elementary School

Date: 8/8/2016

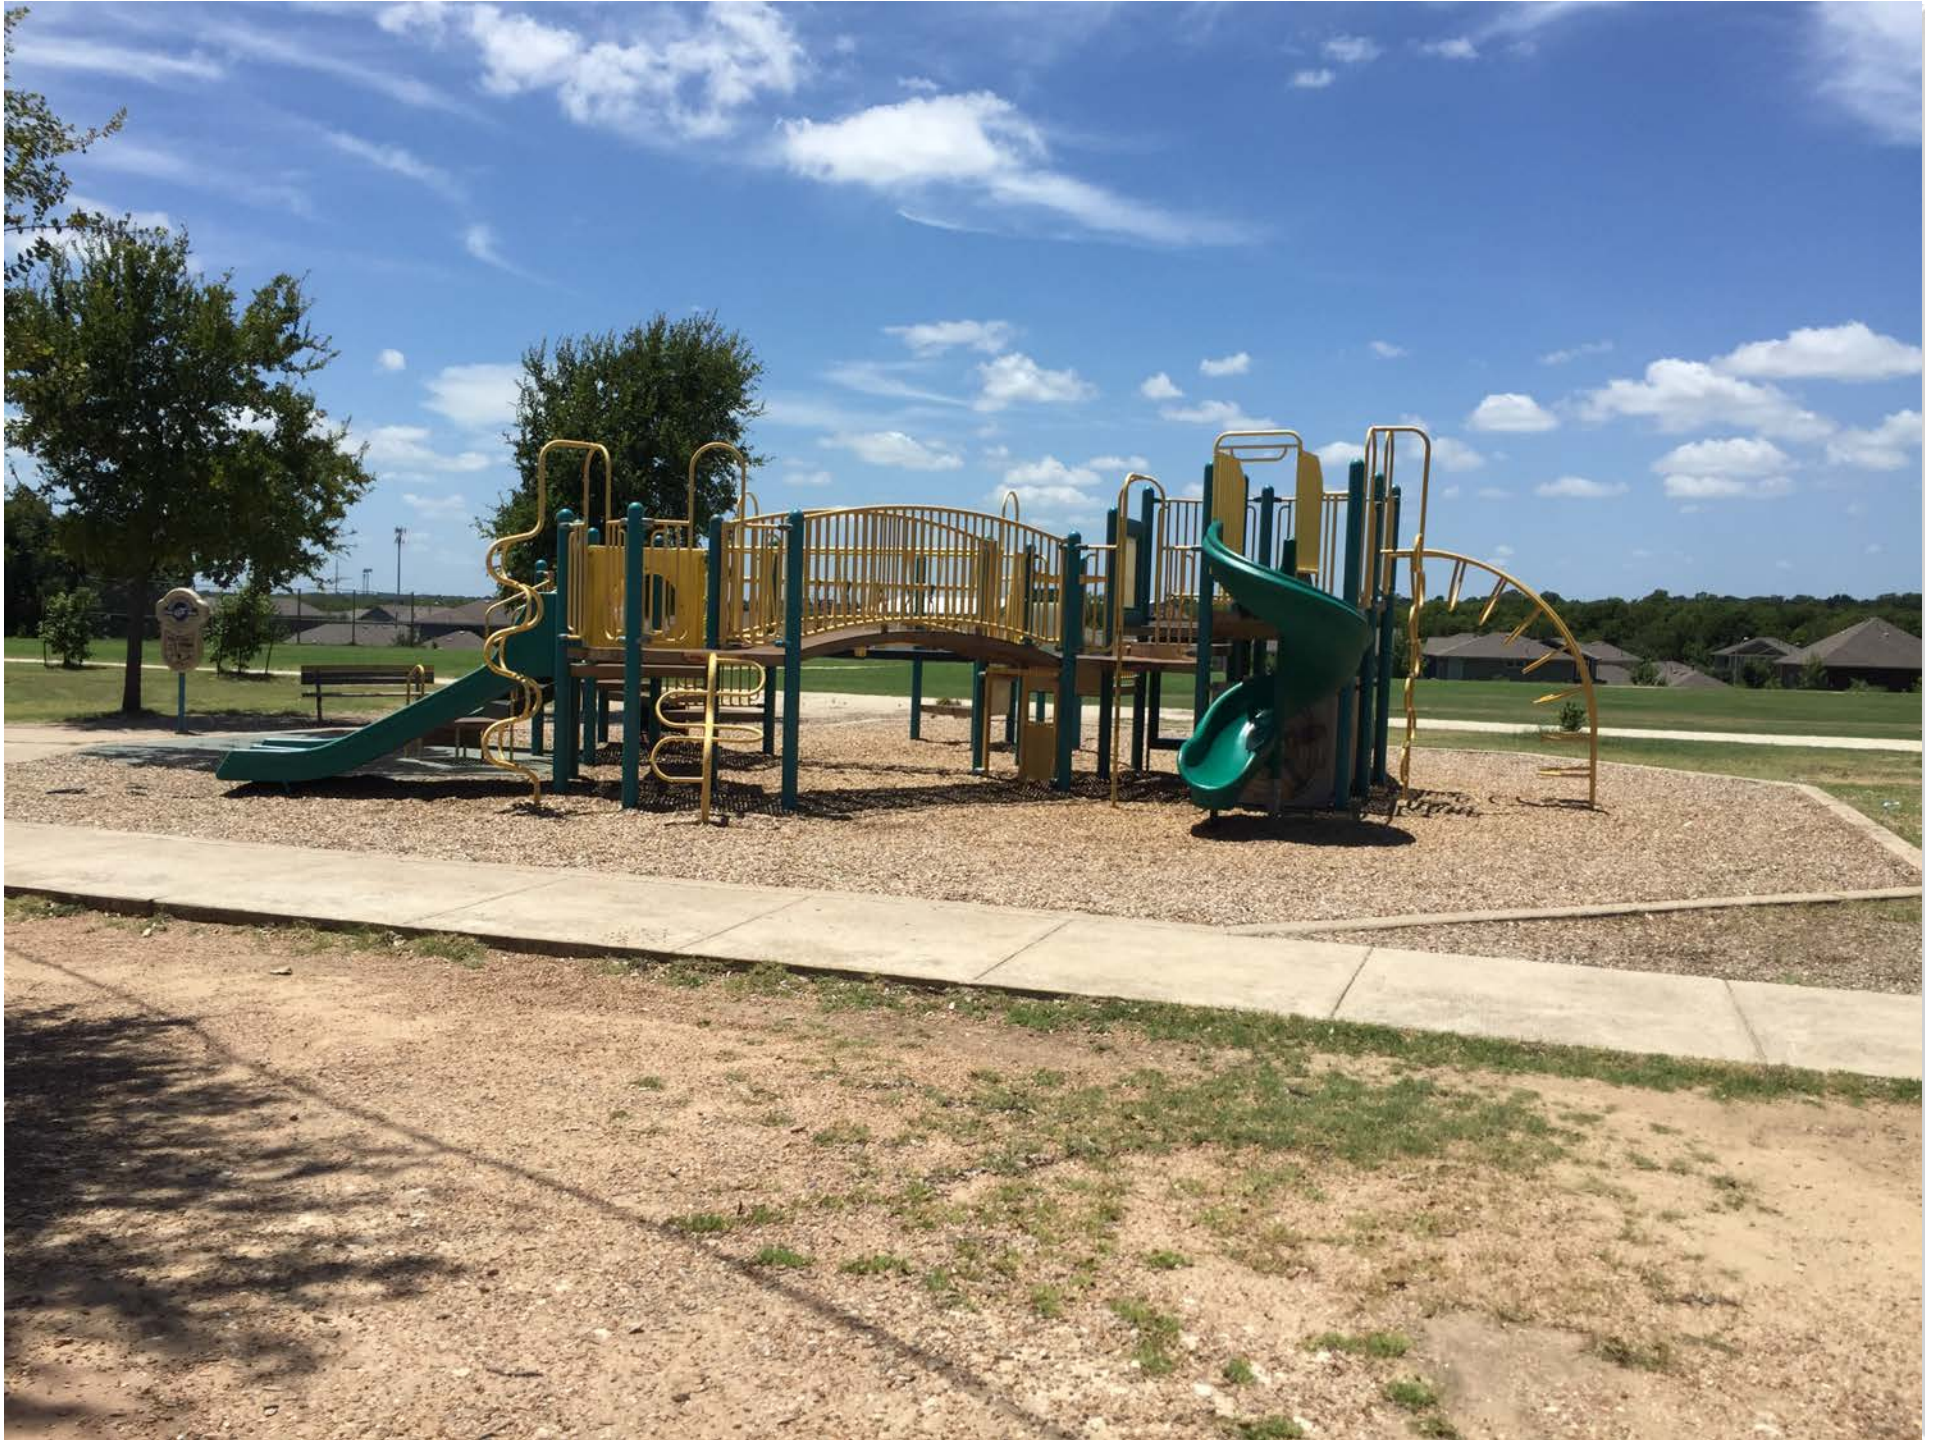
Photo 1. Playground

1.3	Are outdoor play spaces and playfields adequate in size and configuration?			3				Comments	1.00 3.00
1) Outdoor play space exists, not developed 2)Outdoor play space exists but is not connected to gym or other athletic support areas or is too small. 3. Outdoor play spaces exist, are connected to other athletic areas, are the right size, but are not in good condition. 4. Outdoor play spaces need minor improvements to function well. 5. Outdoor play spaces are in excellent condition. N/A) Does not apply.		See Photo 1

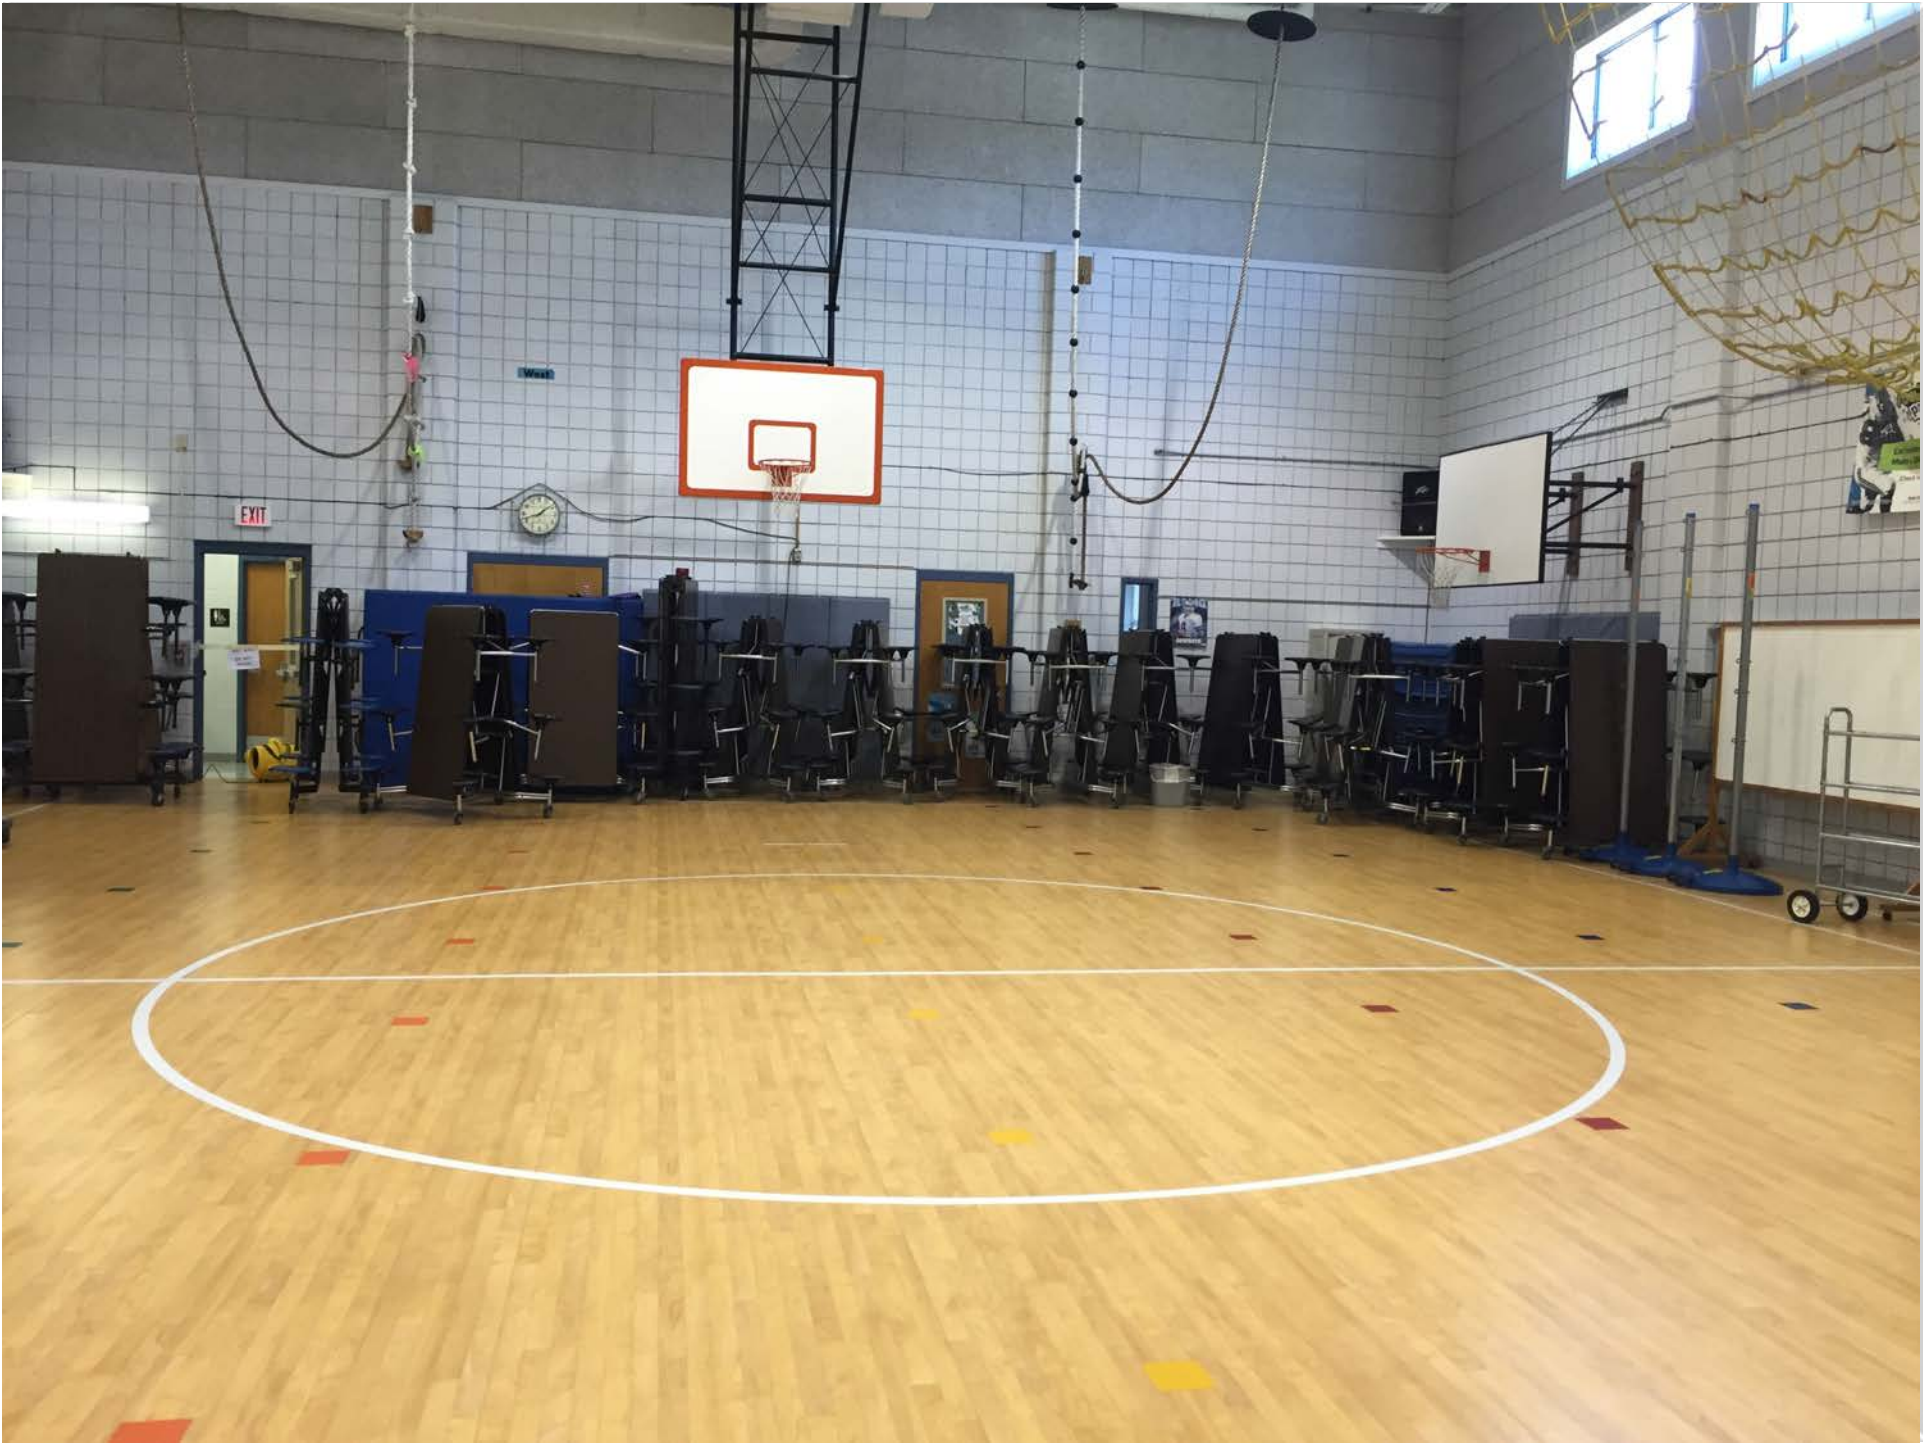
Photo 2. Gym

3 - Academic & Co-Curricular Support - Continued		1	2	3	4	5	N/A		
3.6	Are Physical Education and Athletic spaces appropriately configured per the ed spec?					5		Comments	1.005.00

1) Very unsatisfactory 2) Unsatisfactory 3) Average 4) Good 5) Very good N/A) Does not apply.								See Photo 2	
3.7	Are Physical Education and Athletic support spaces appropriately configured per the ed spec?		2					Comments	1.002.00

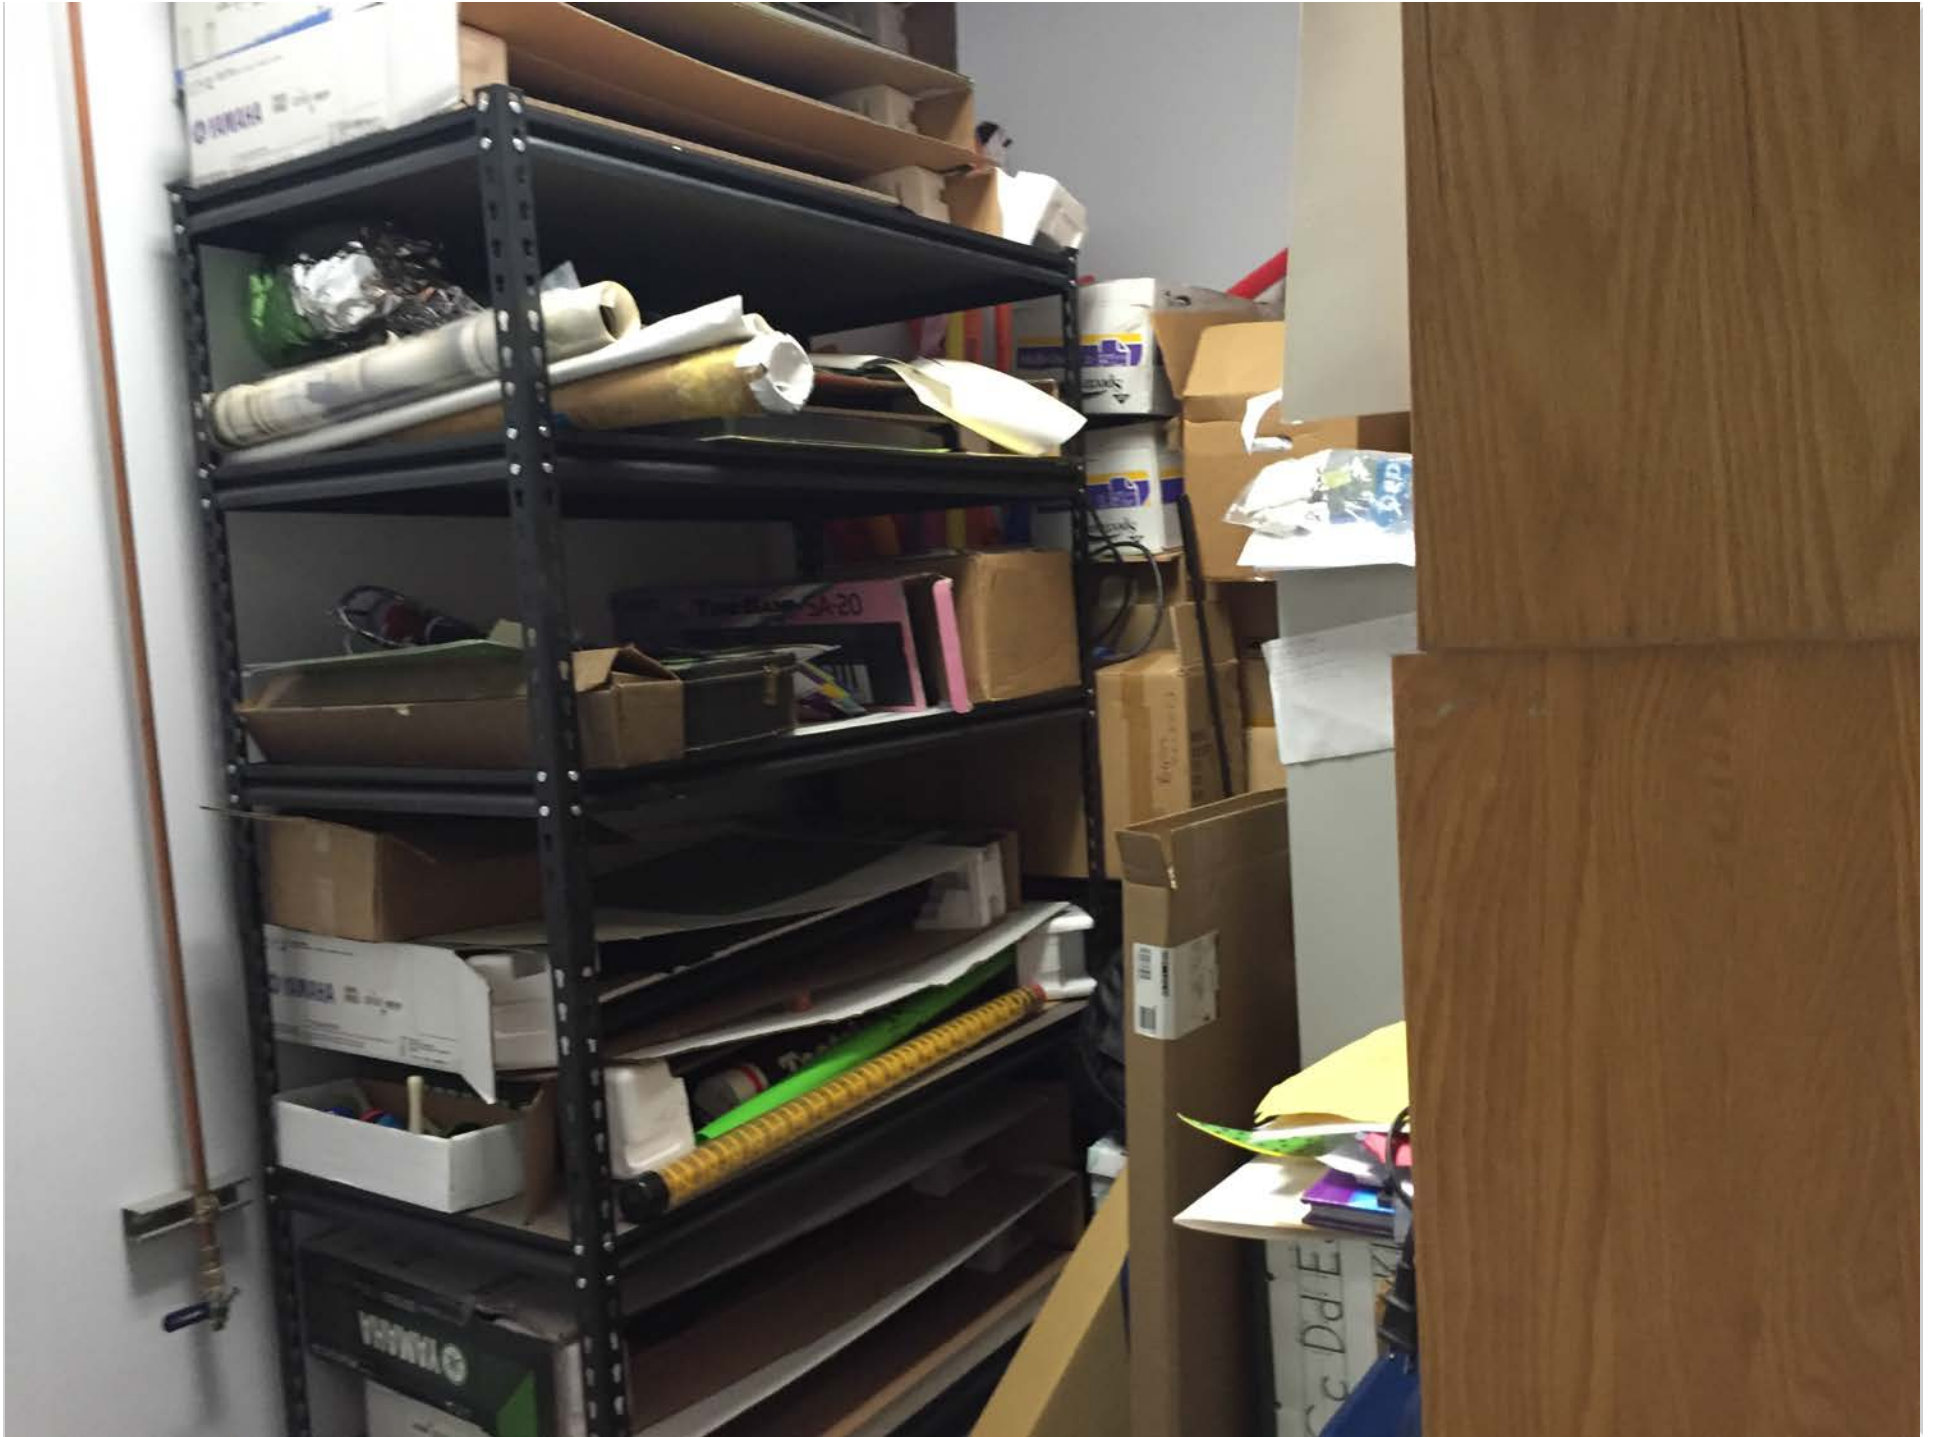
Photo 3. Band Storage

3.9	Are music, drama, or performance support spaces appropriately configured per the ed spec?			3				Comments	1.003.00
1) Very unsatisfactory - Support spaces are disconnected from served spaces, too small, do not meet needs 2) Unsatisfactory - Support spaces are connected, but too small, inadequate for needs 3) Average - Connected, moderate size, but need some renovations or updates to function well 4) Good - Connected, good size/layout, meets needs/functions well 5) Very good - connected, generous size, nice condition, functions appropriately N/A) Does not apply.								See Photo 3

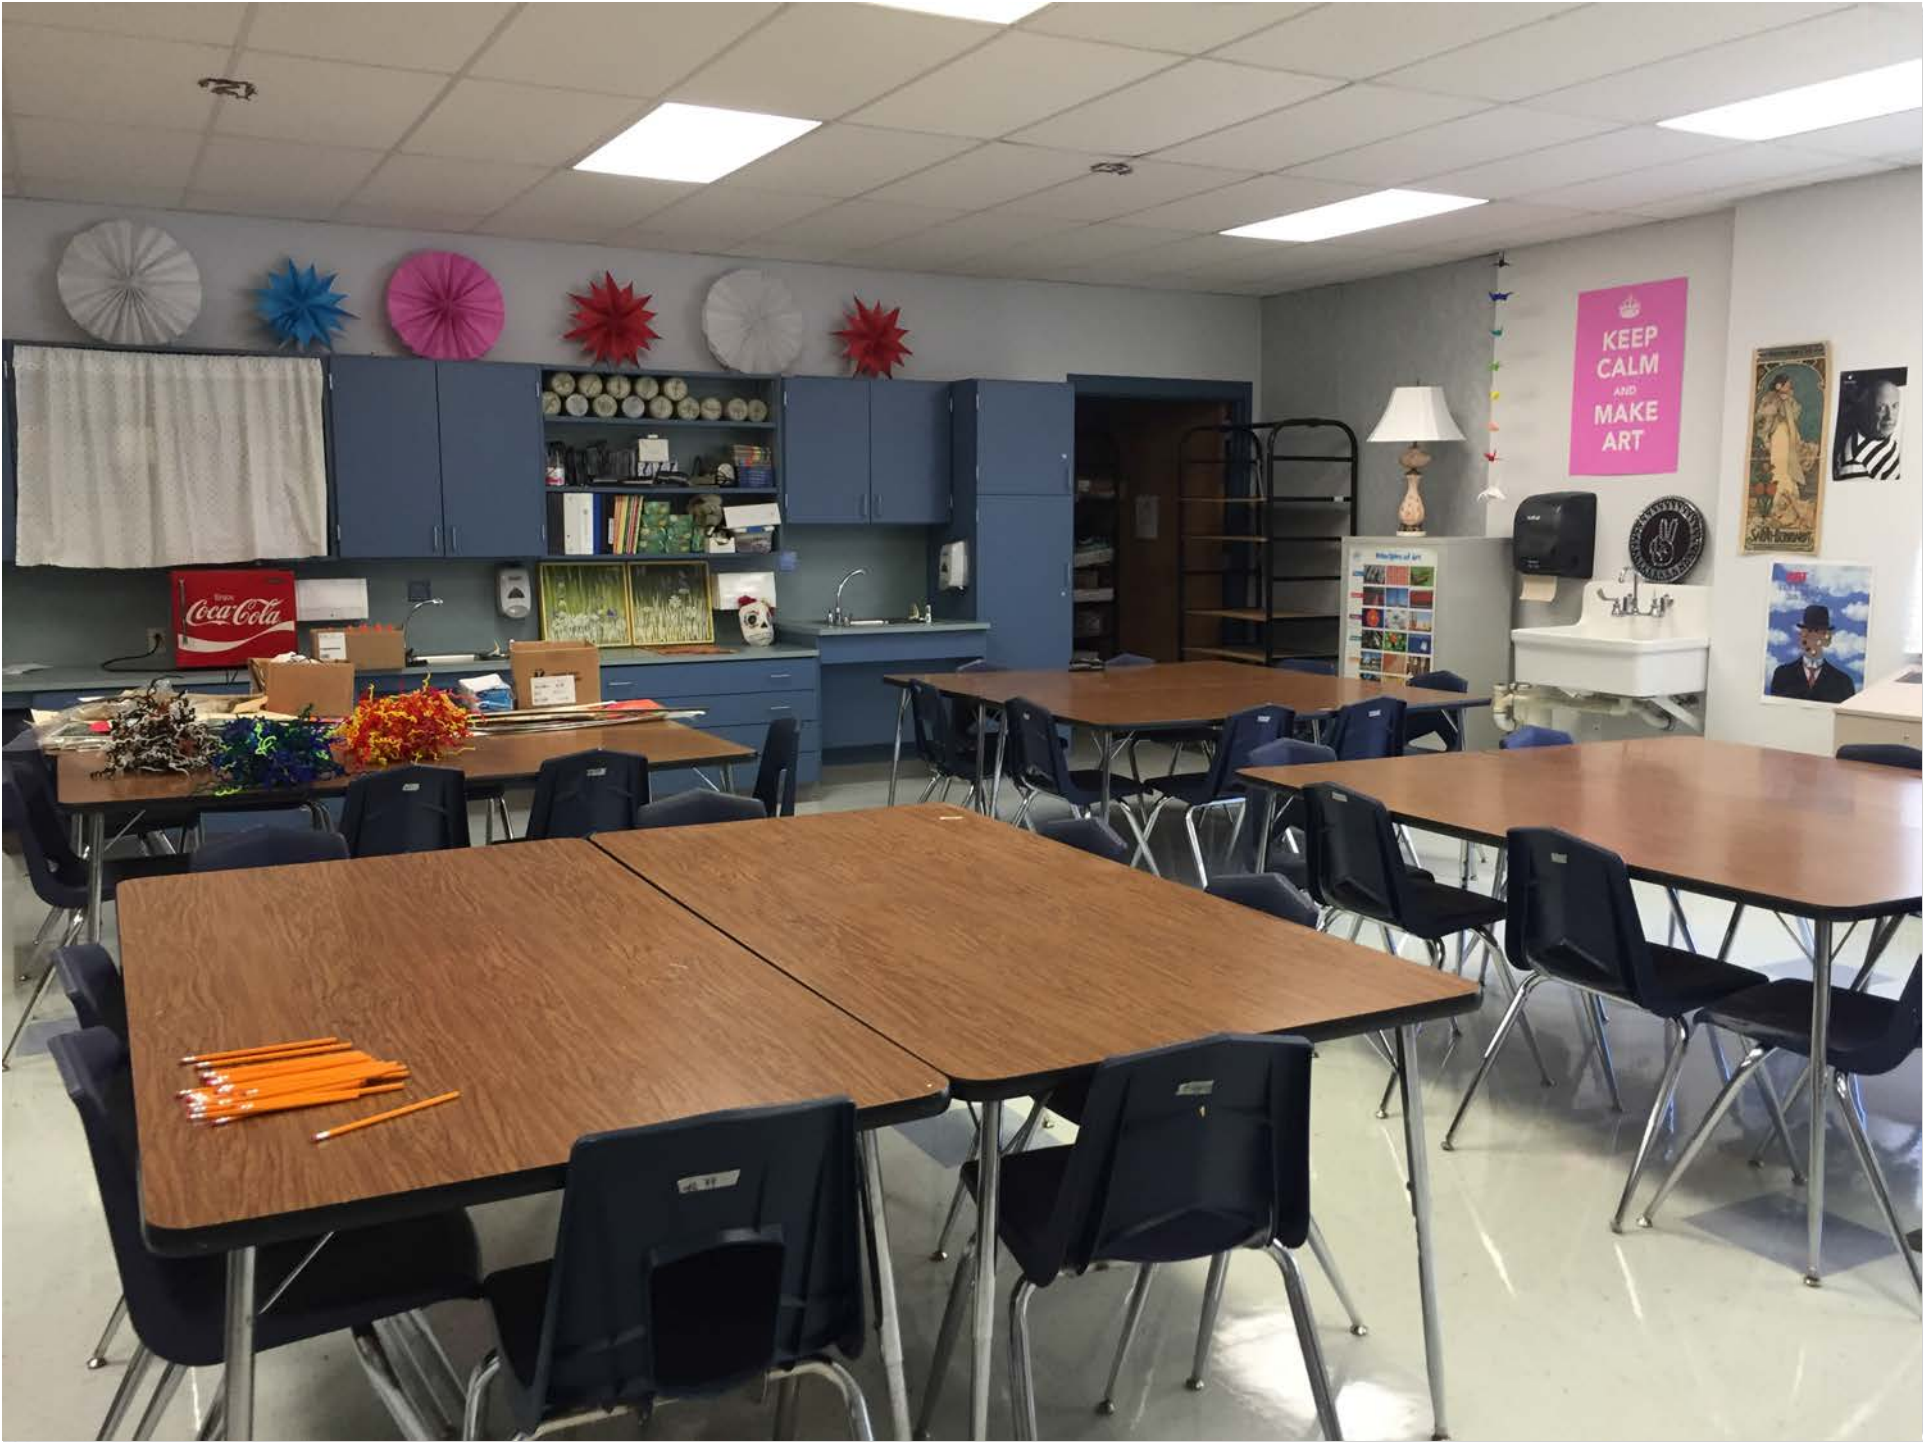
Photo 4. Art

3 - Academic & Co-Curricular Support - Continued								1	2	3	4	5	N/A		
3.10	Are Visual Arts spaces appropriately configured per the ed spec?				4			Comments				1.00	4.00

1) Very unsatisfactory 2) Unsatisfactory 3) Average 4) Good 5) Very good N/A) Does not apply.								See Photo 4							
3.11	Are Visual Arts support spaces appropriately configured per the ed spec?			3				Comments				1.00	3.00

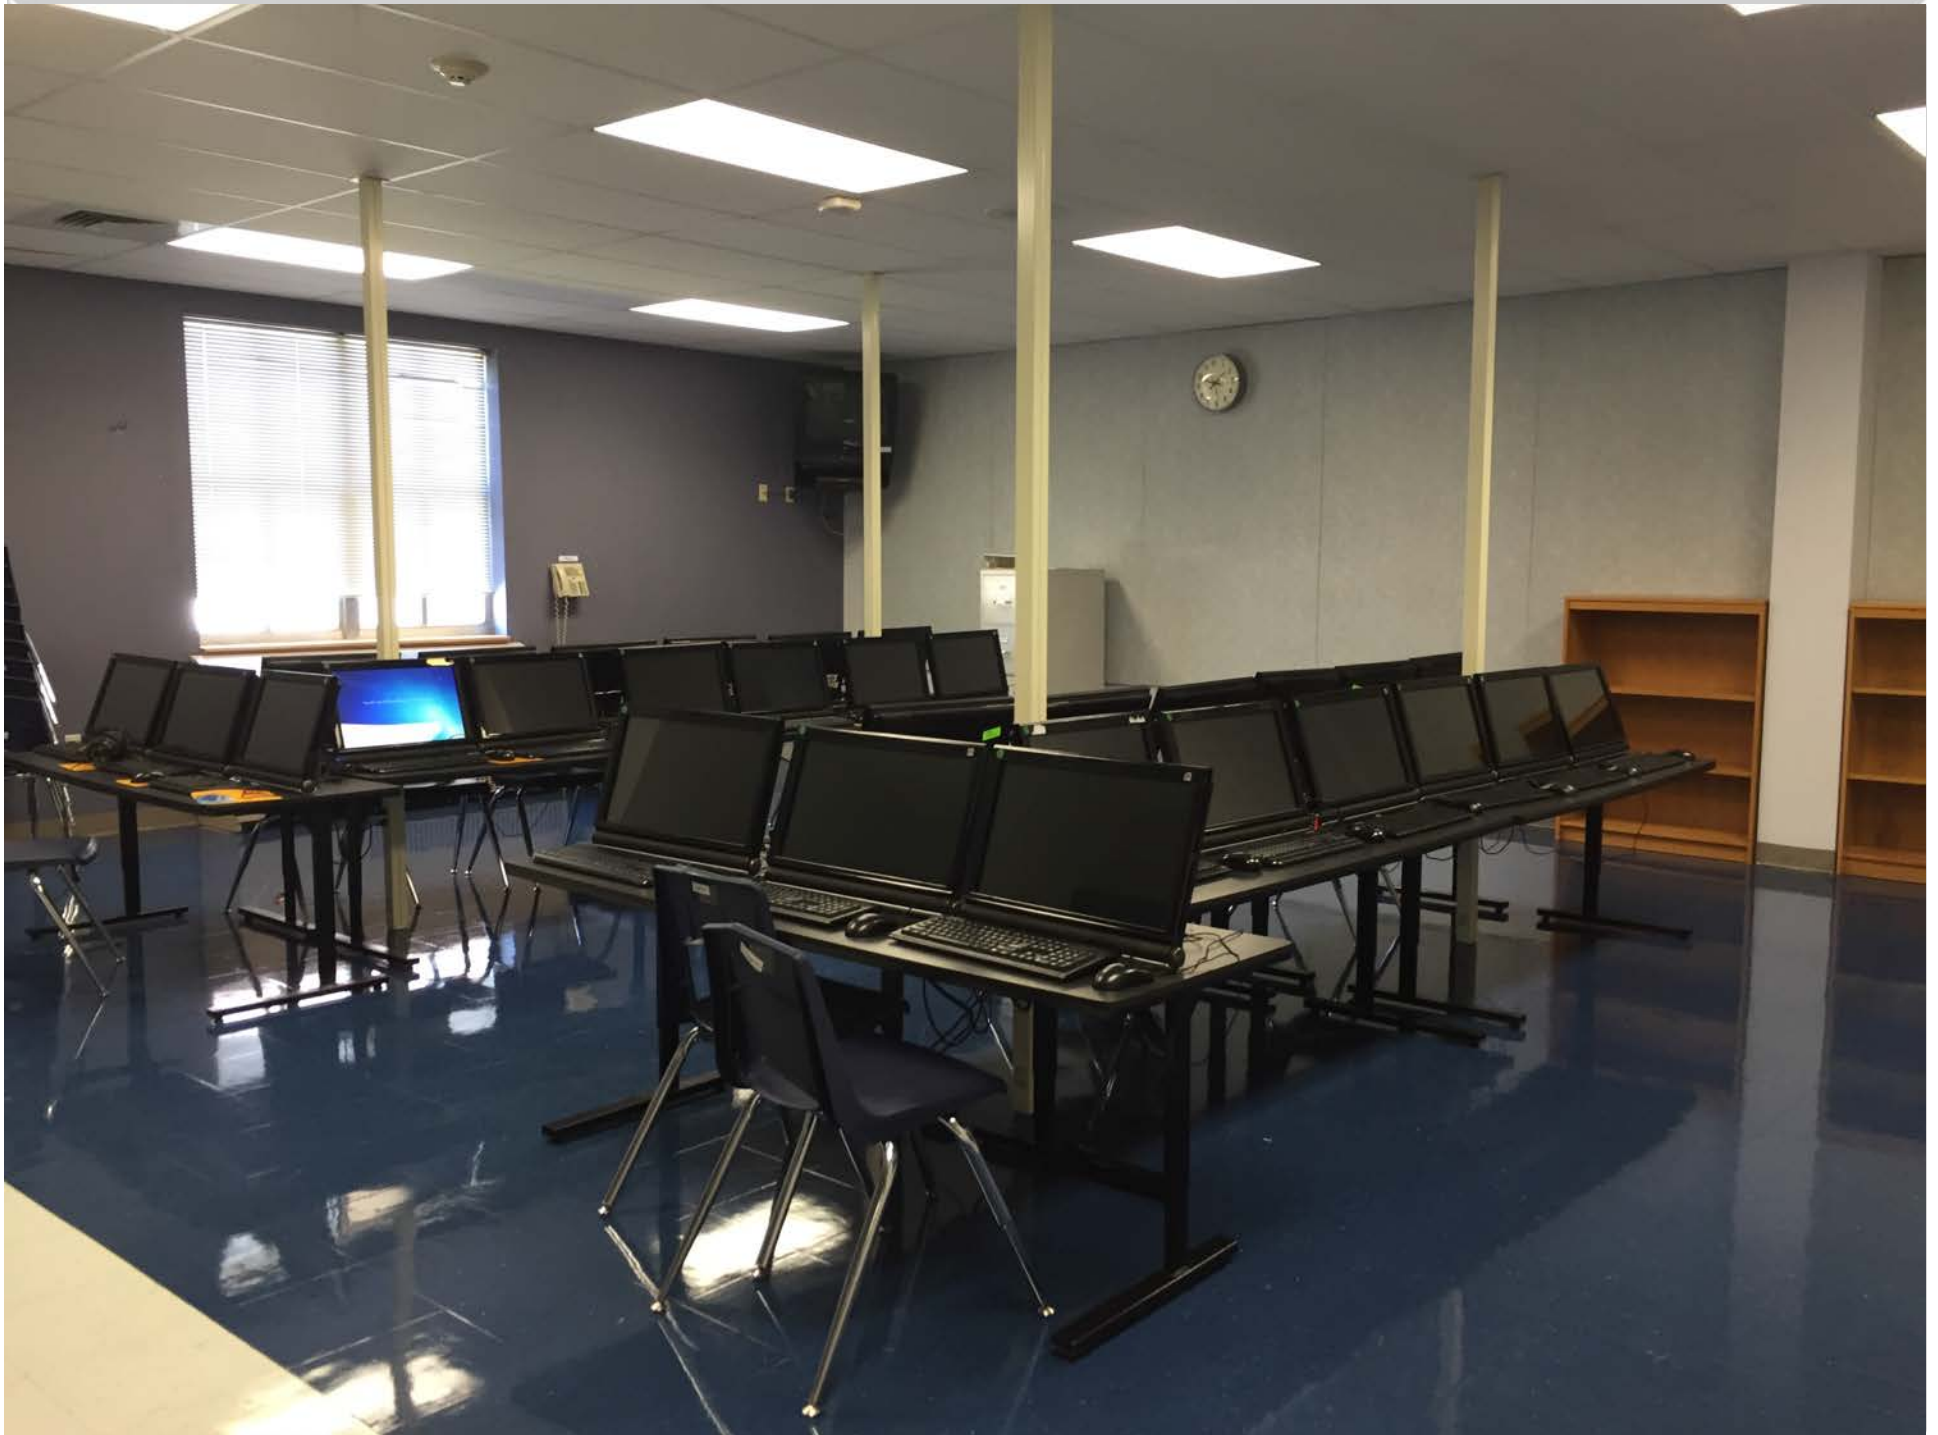
Photo 5. Computer lab

3.12	Are computer lab spaces appropriately configured?				4			Comments				1.00	4.00		
1) Very unsatisfactory 2) Unsatisfactory 3) Average 4) Good 5) Very good N/A) Does not apply.								See Photo 5

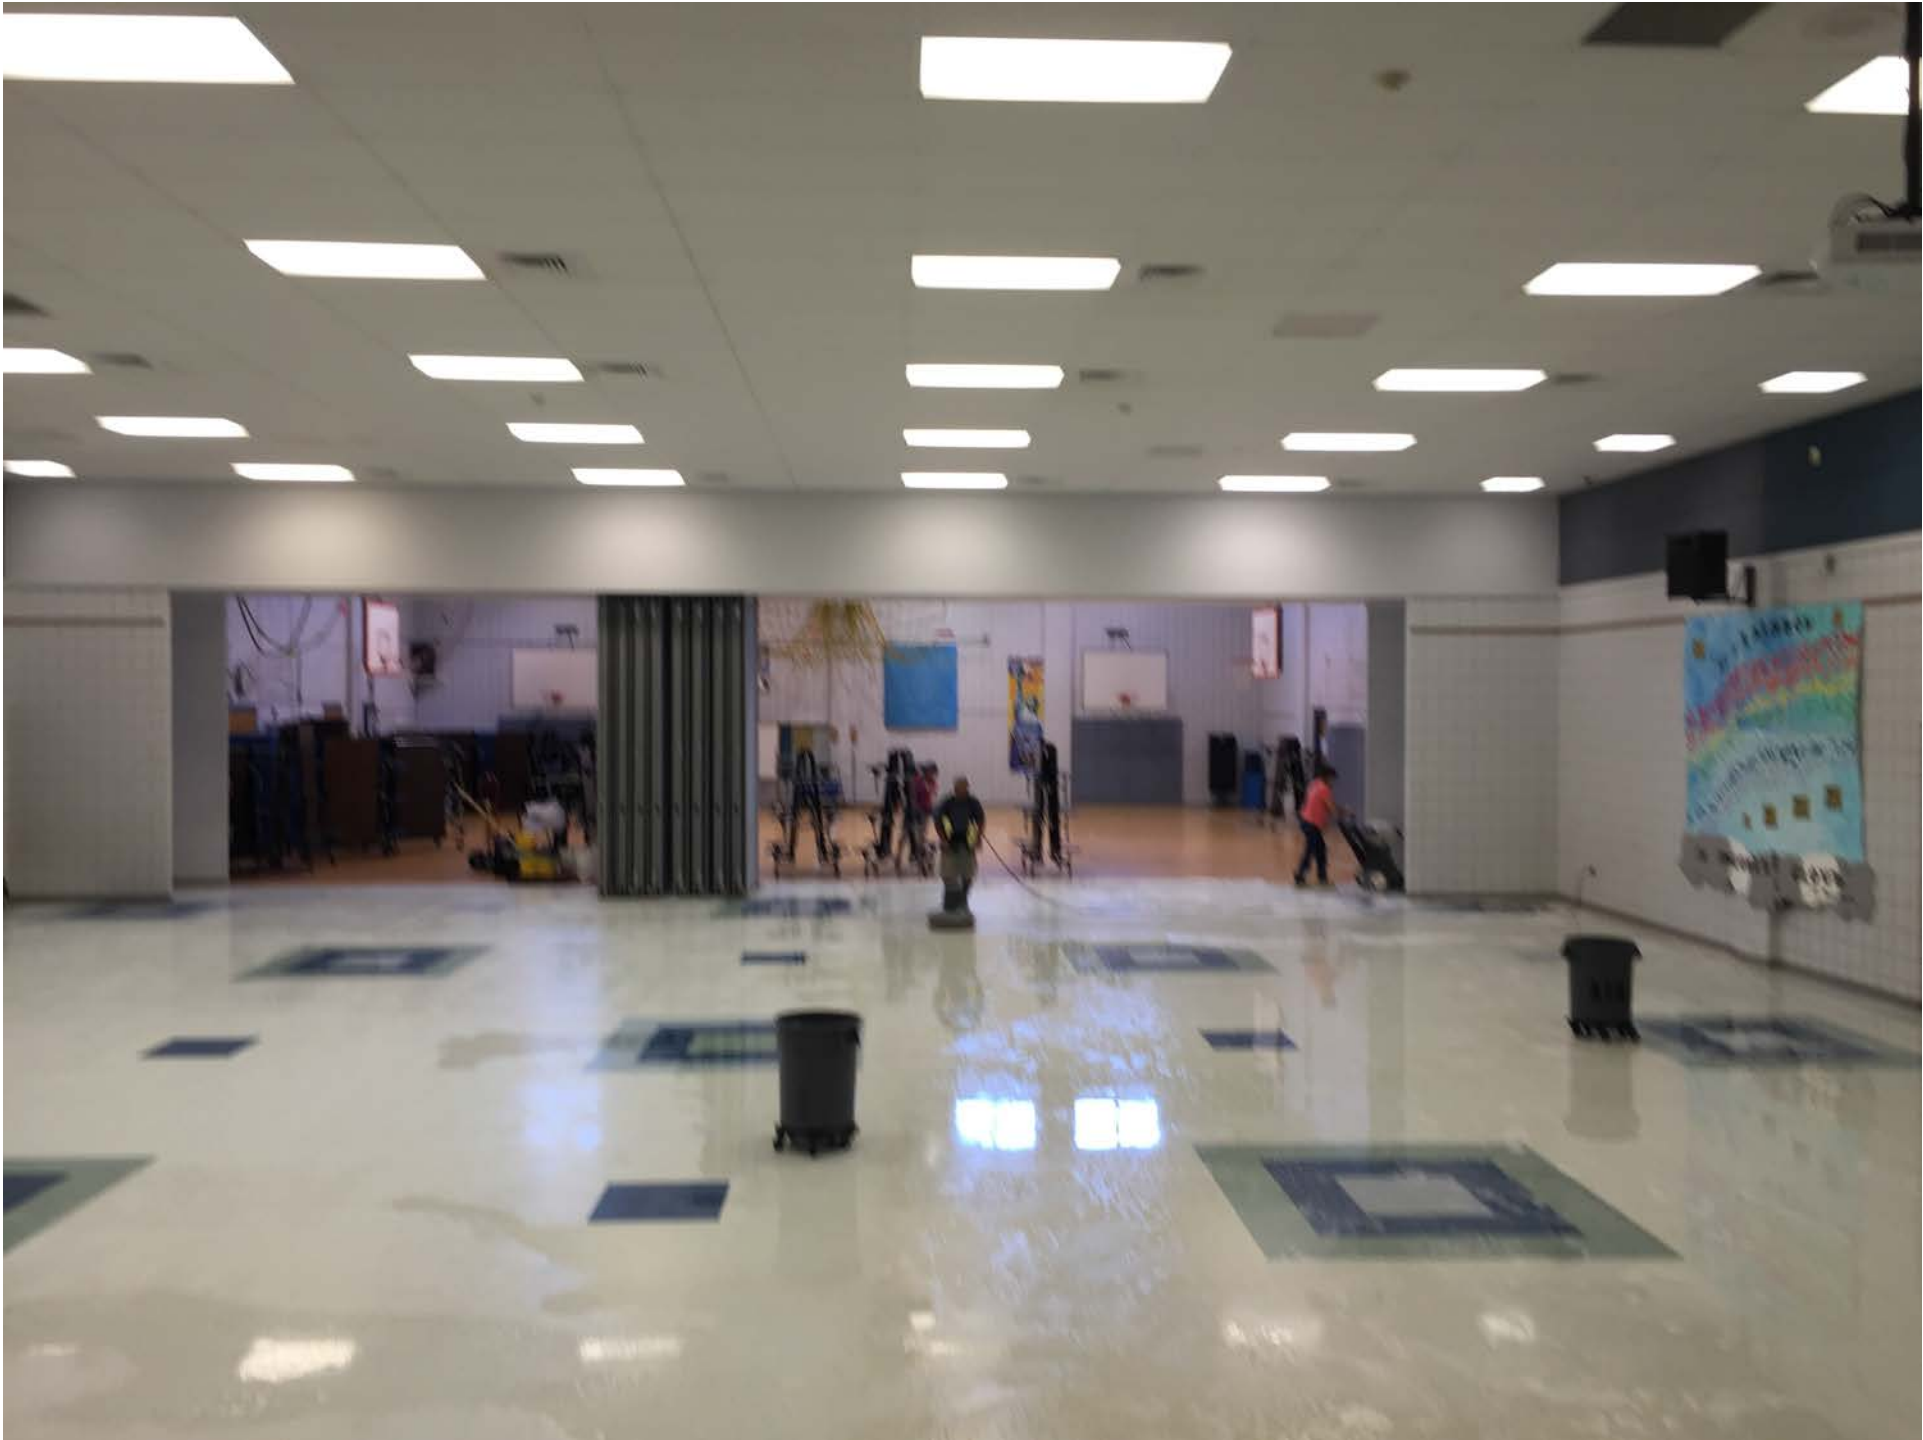
Photo 6. Cafeteria

3.16	Are the student dining facilities appropriately configured?				4			Comments	1.00 4.00
1) Very unsatisfactory - Too small, poor circulation, inflexible seating in poor condition 2) Unsatisfactory - Too small or inadequate circulation, seating in poor condition 3) Average - moderate size, with adequate circulation, seating in okay condition 4) Good - good size, adequate circulation, seating in good condition 5) Very good - good size, adequate circulation, seating in good condition, with more than one option for eating space (ex: connection to outdoor eating space) N/A) Does not apply.							Some of the dining tables do not latch properly.

See Photo 6

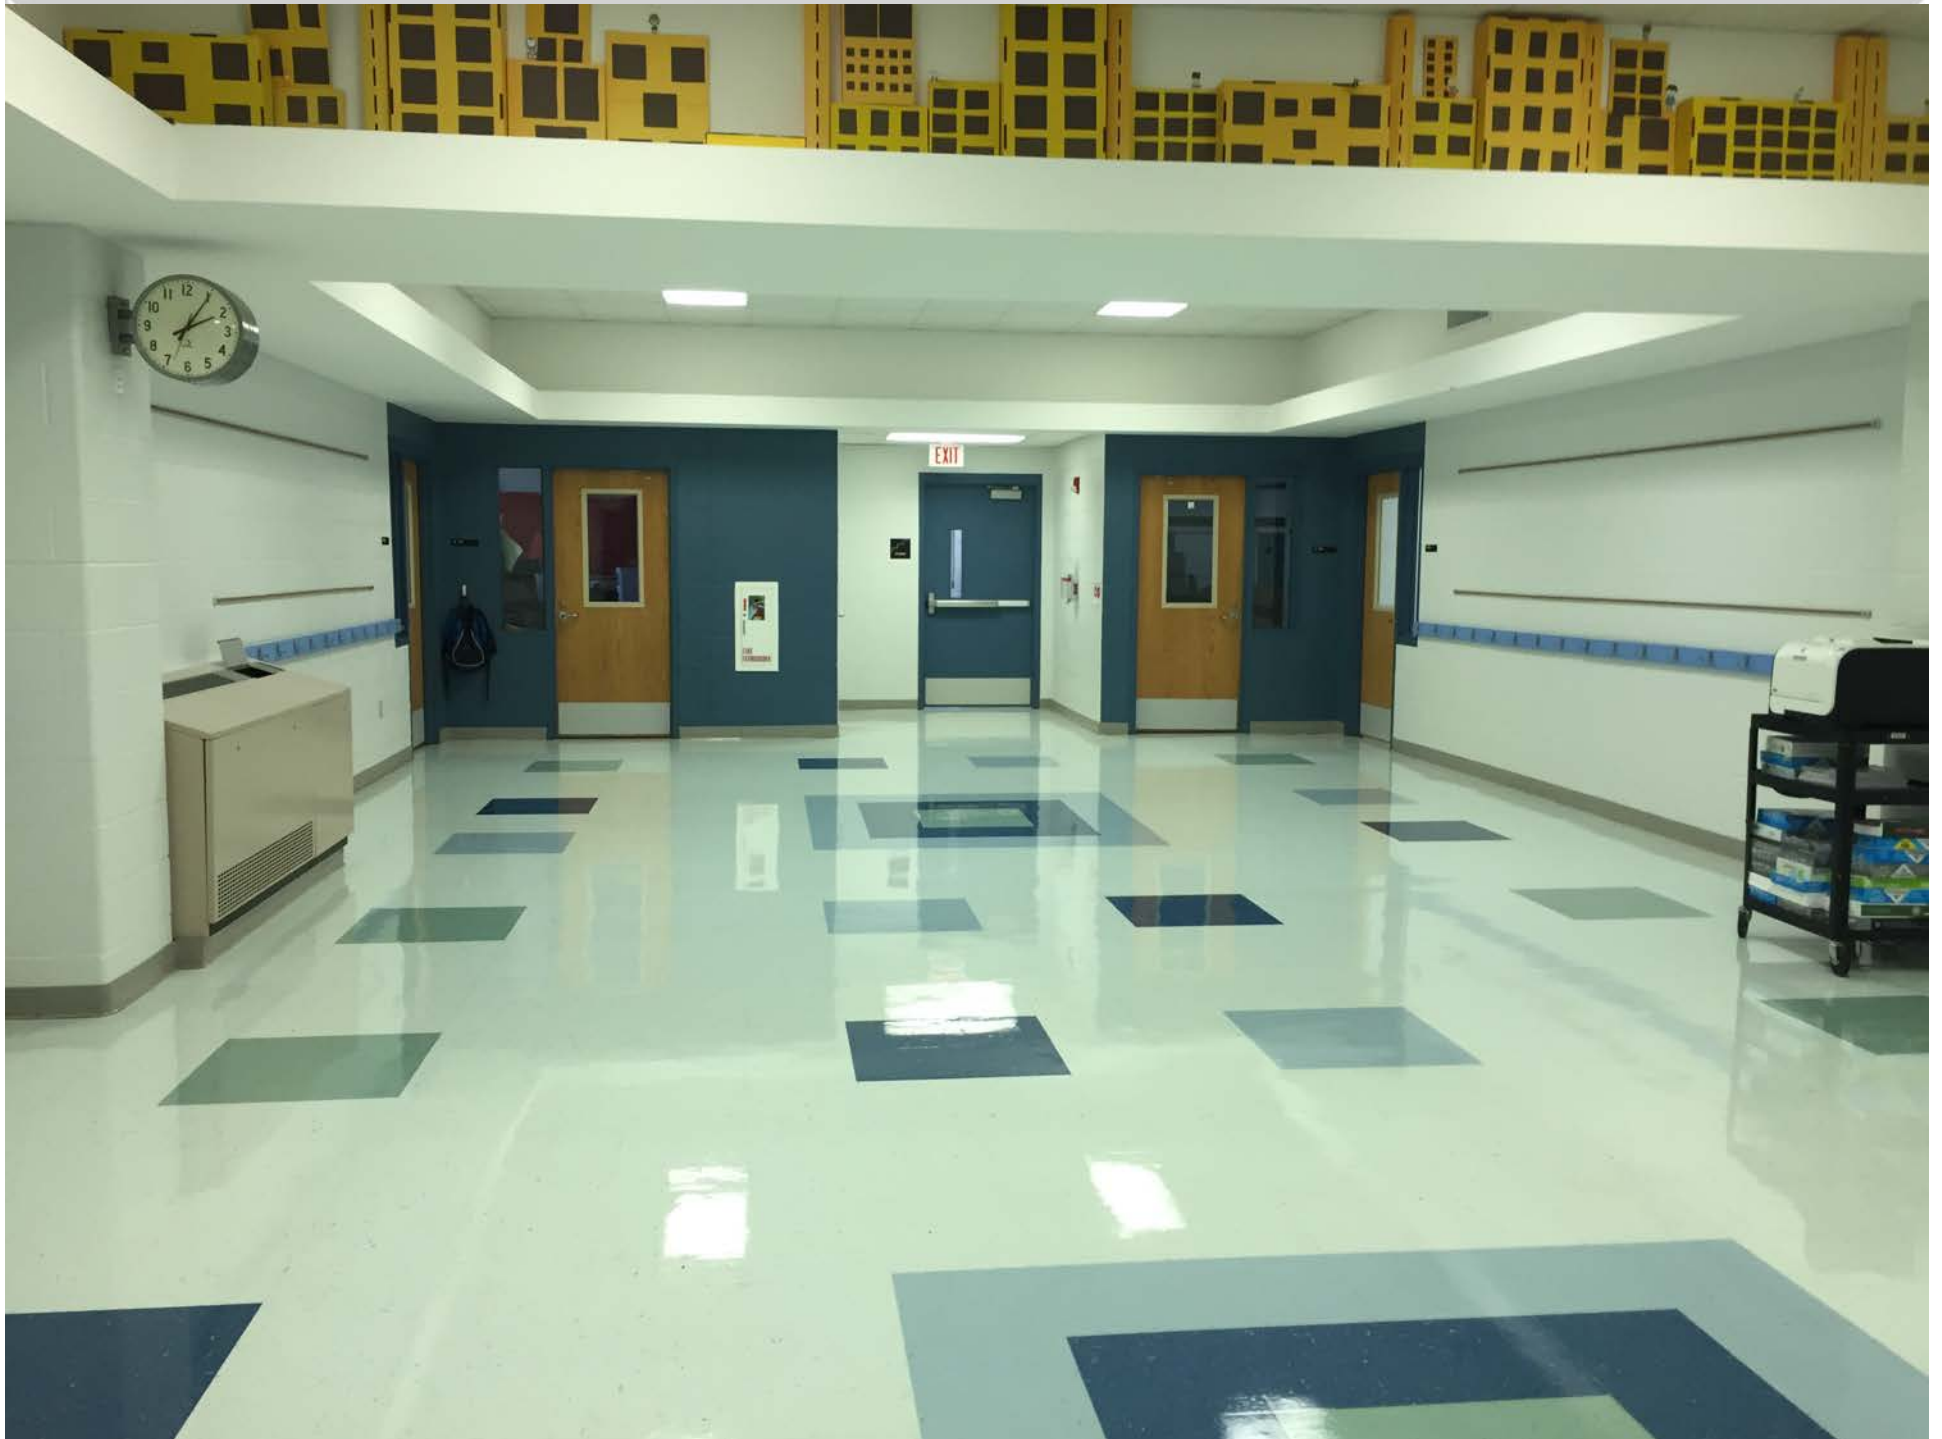
Photo 7. Common Space

1) Very unsatisfactory - no common spaces or meeting rooms or in very poor condition 2) Unsatisfactory - a few common spaces or meeting rooms in unsatisfactory condition 3) Average - a few common spaces and meeting areas needing updates 4) Good - multiple common spaces and meeting rooms in good condition 5) Very good - adequate common spaces and meeting rooms of excellent quality N/A) Does not apply.								See Photo 7
