Educational Suitability Summary Report

Casey Elementary School

Date: 8/8/2016

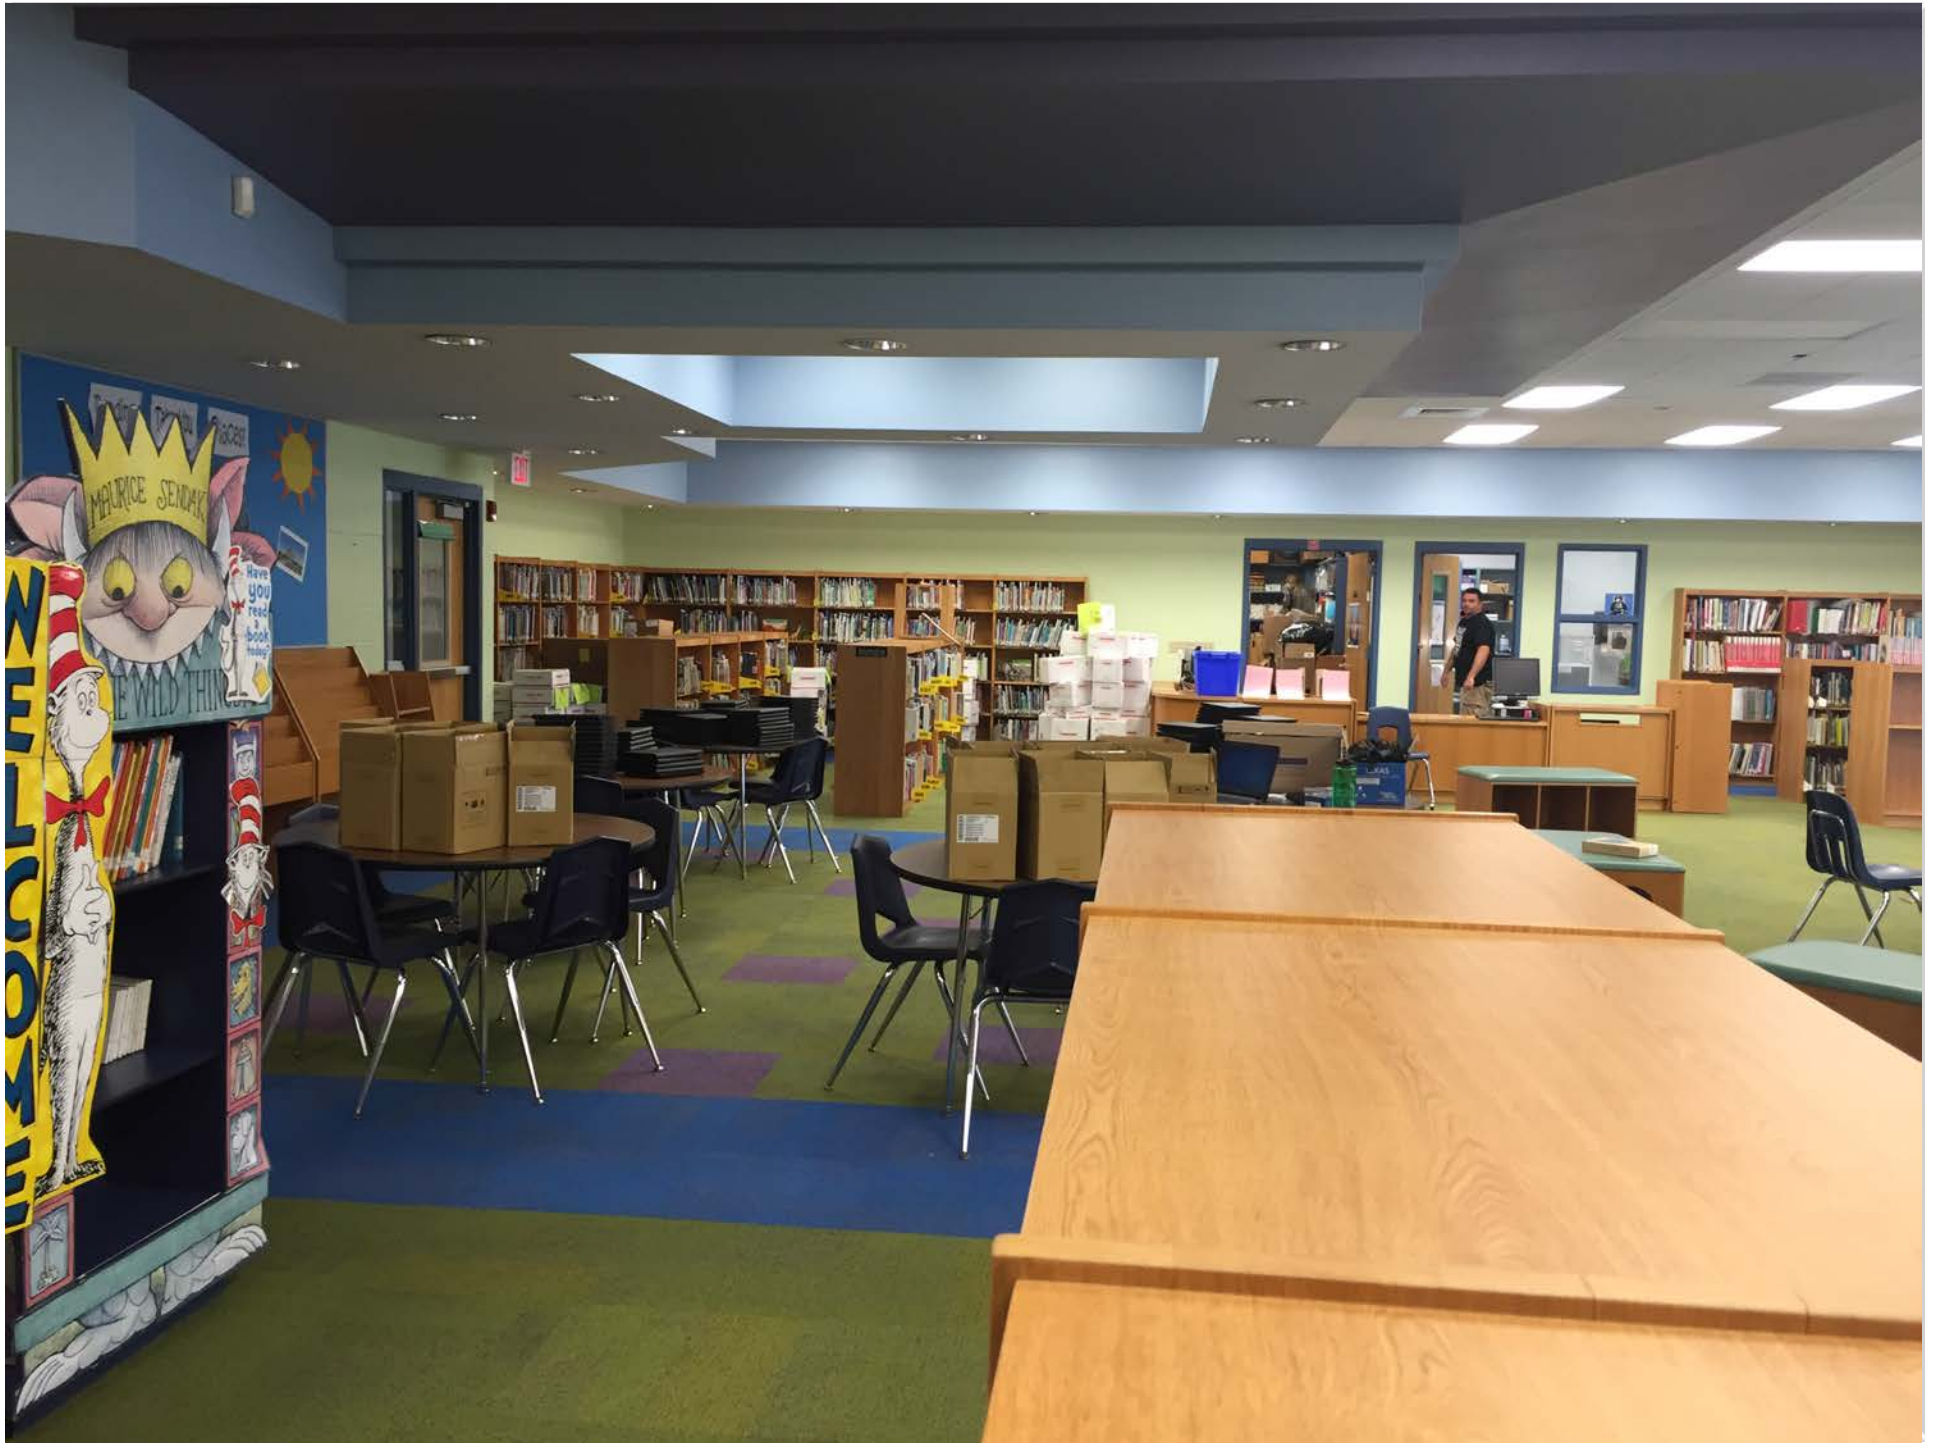
Photo 8. Library

5.3	How well does the Library/Media Center support social interaction?			3				Comments	1.003.00
1) Very unsatisfactory 2) Unsatisfactory 3) Average 4) Good 5) Very good N/A) Does not apply.								The library needs a different area and furniture to support social interaction. It is too small and lacks sufficient areas for various groups sizes.	
								See Photo 8

5.4	How well does the Library/Media Center support collaborative work in small groups (4-8 students)?			3				Comments	1.003.00
1) Very unsatisfactory 2) Unsatisfactory 3) Average 4) Good 5) Very good N/A) Does not apply.									
								See Photo 8

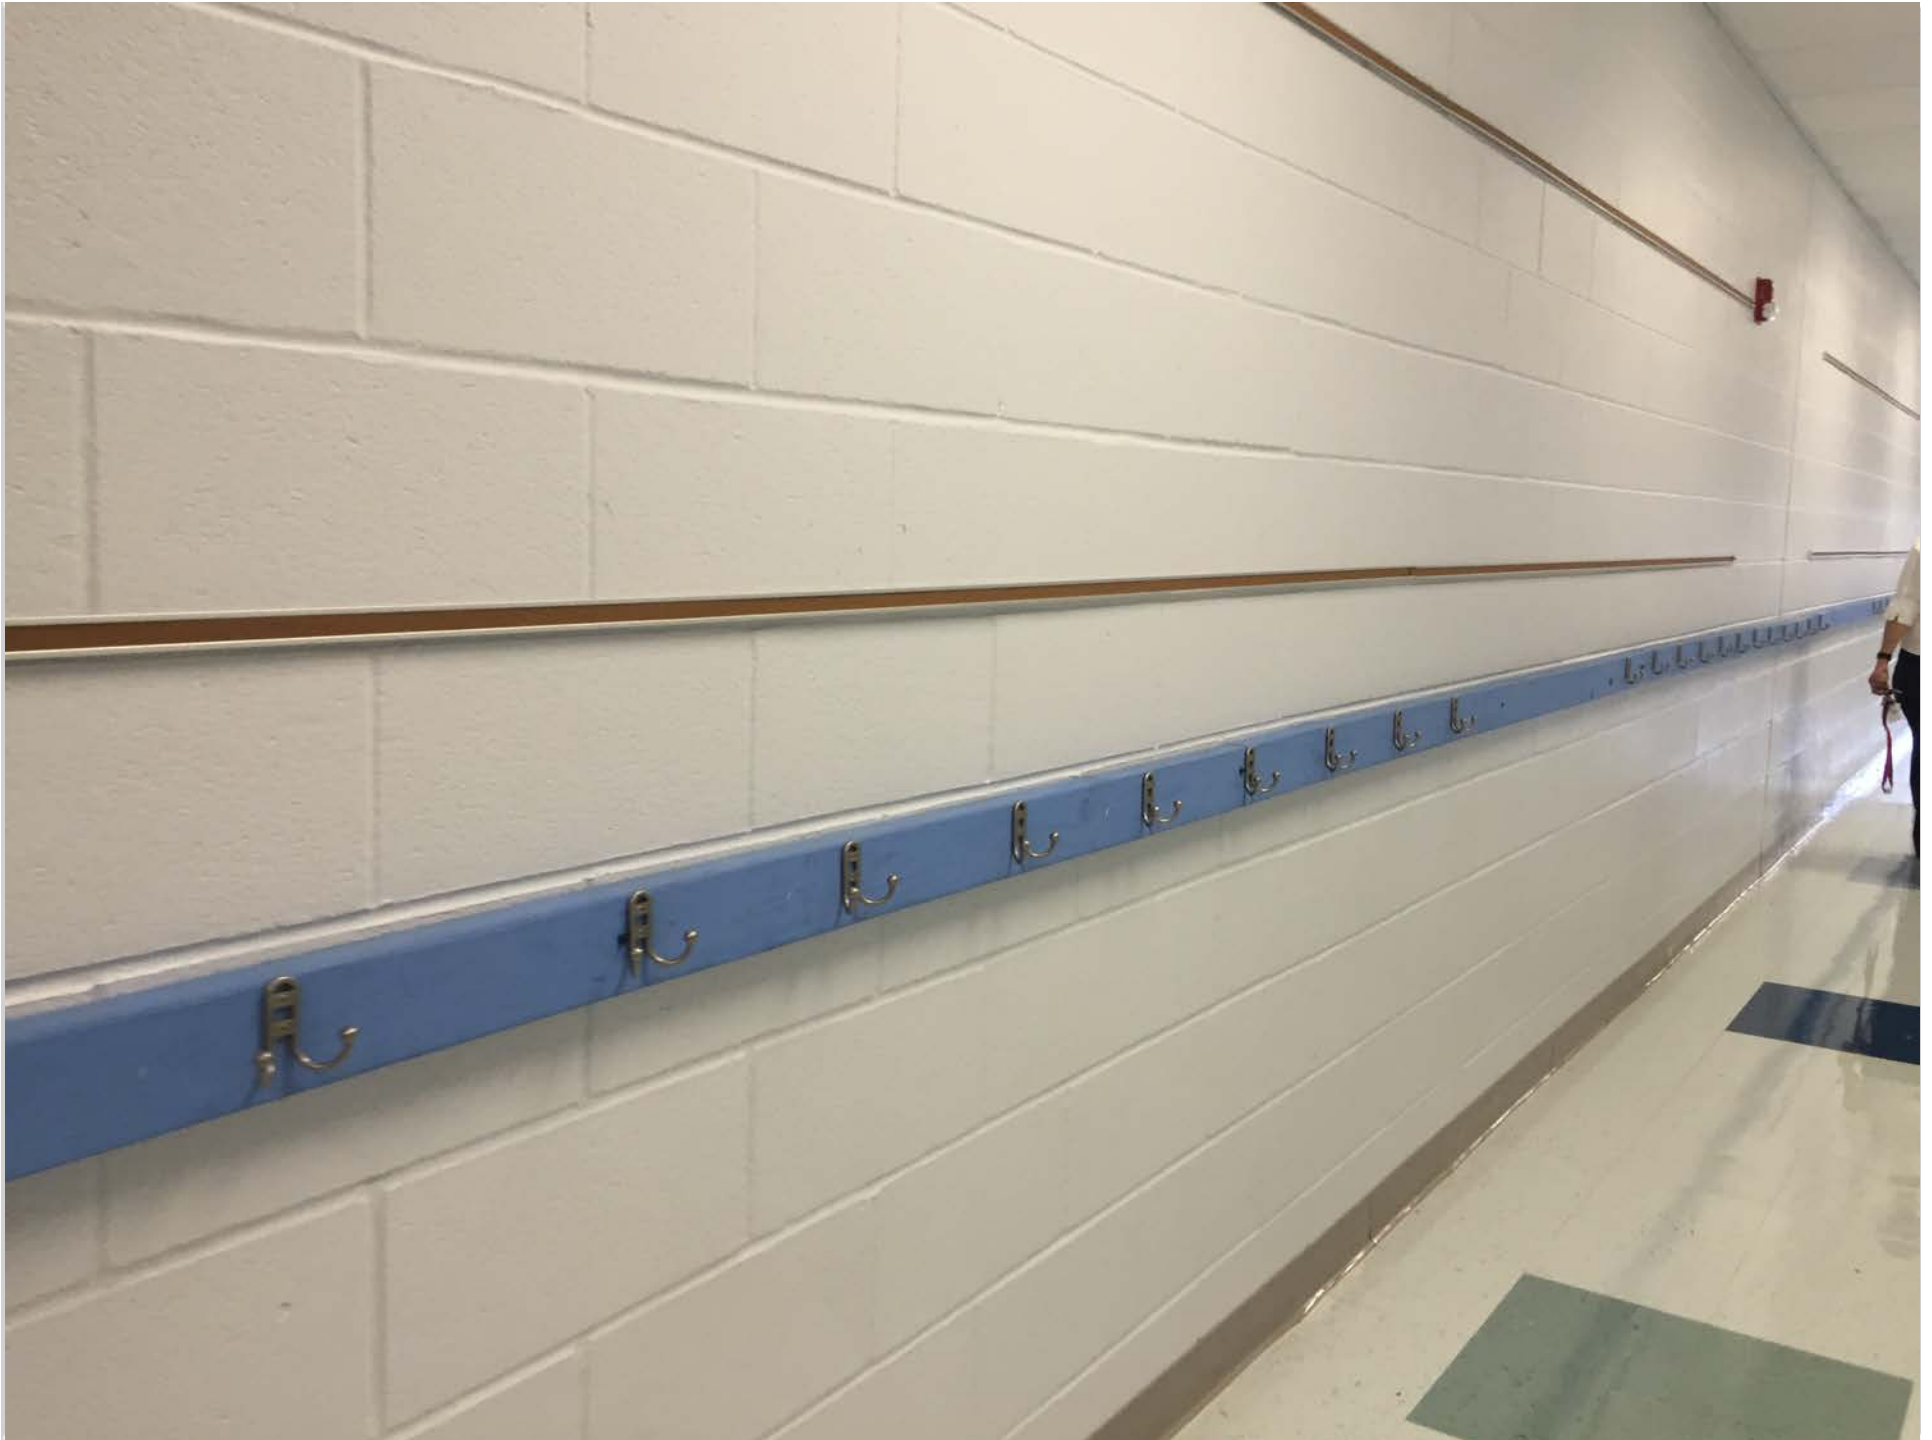
Photo 9. Student Storage

General building storage is inadequate. Classroom storage spaces are equipped with built-in cabinets but appear to be filled to capacity. Student storage consists of hooks in corridors.

See Photo 9
