Educational Suitability Summary Report

Cook Elementary School – BLDG #161

Date: 08/04/2016

Score 56% Average

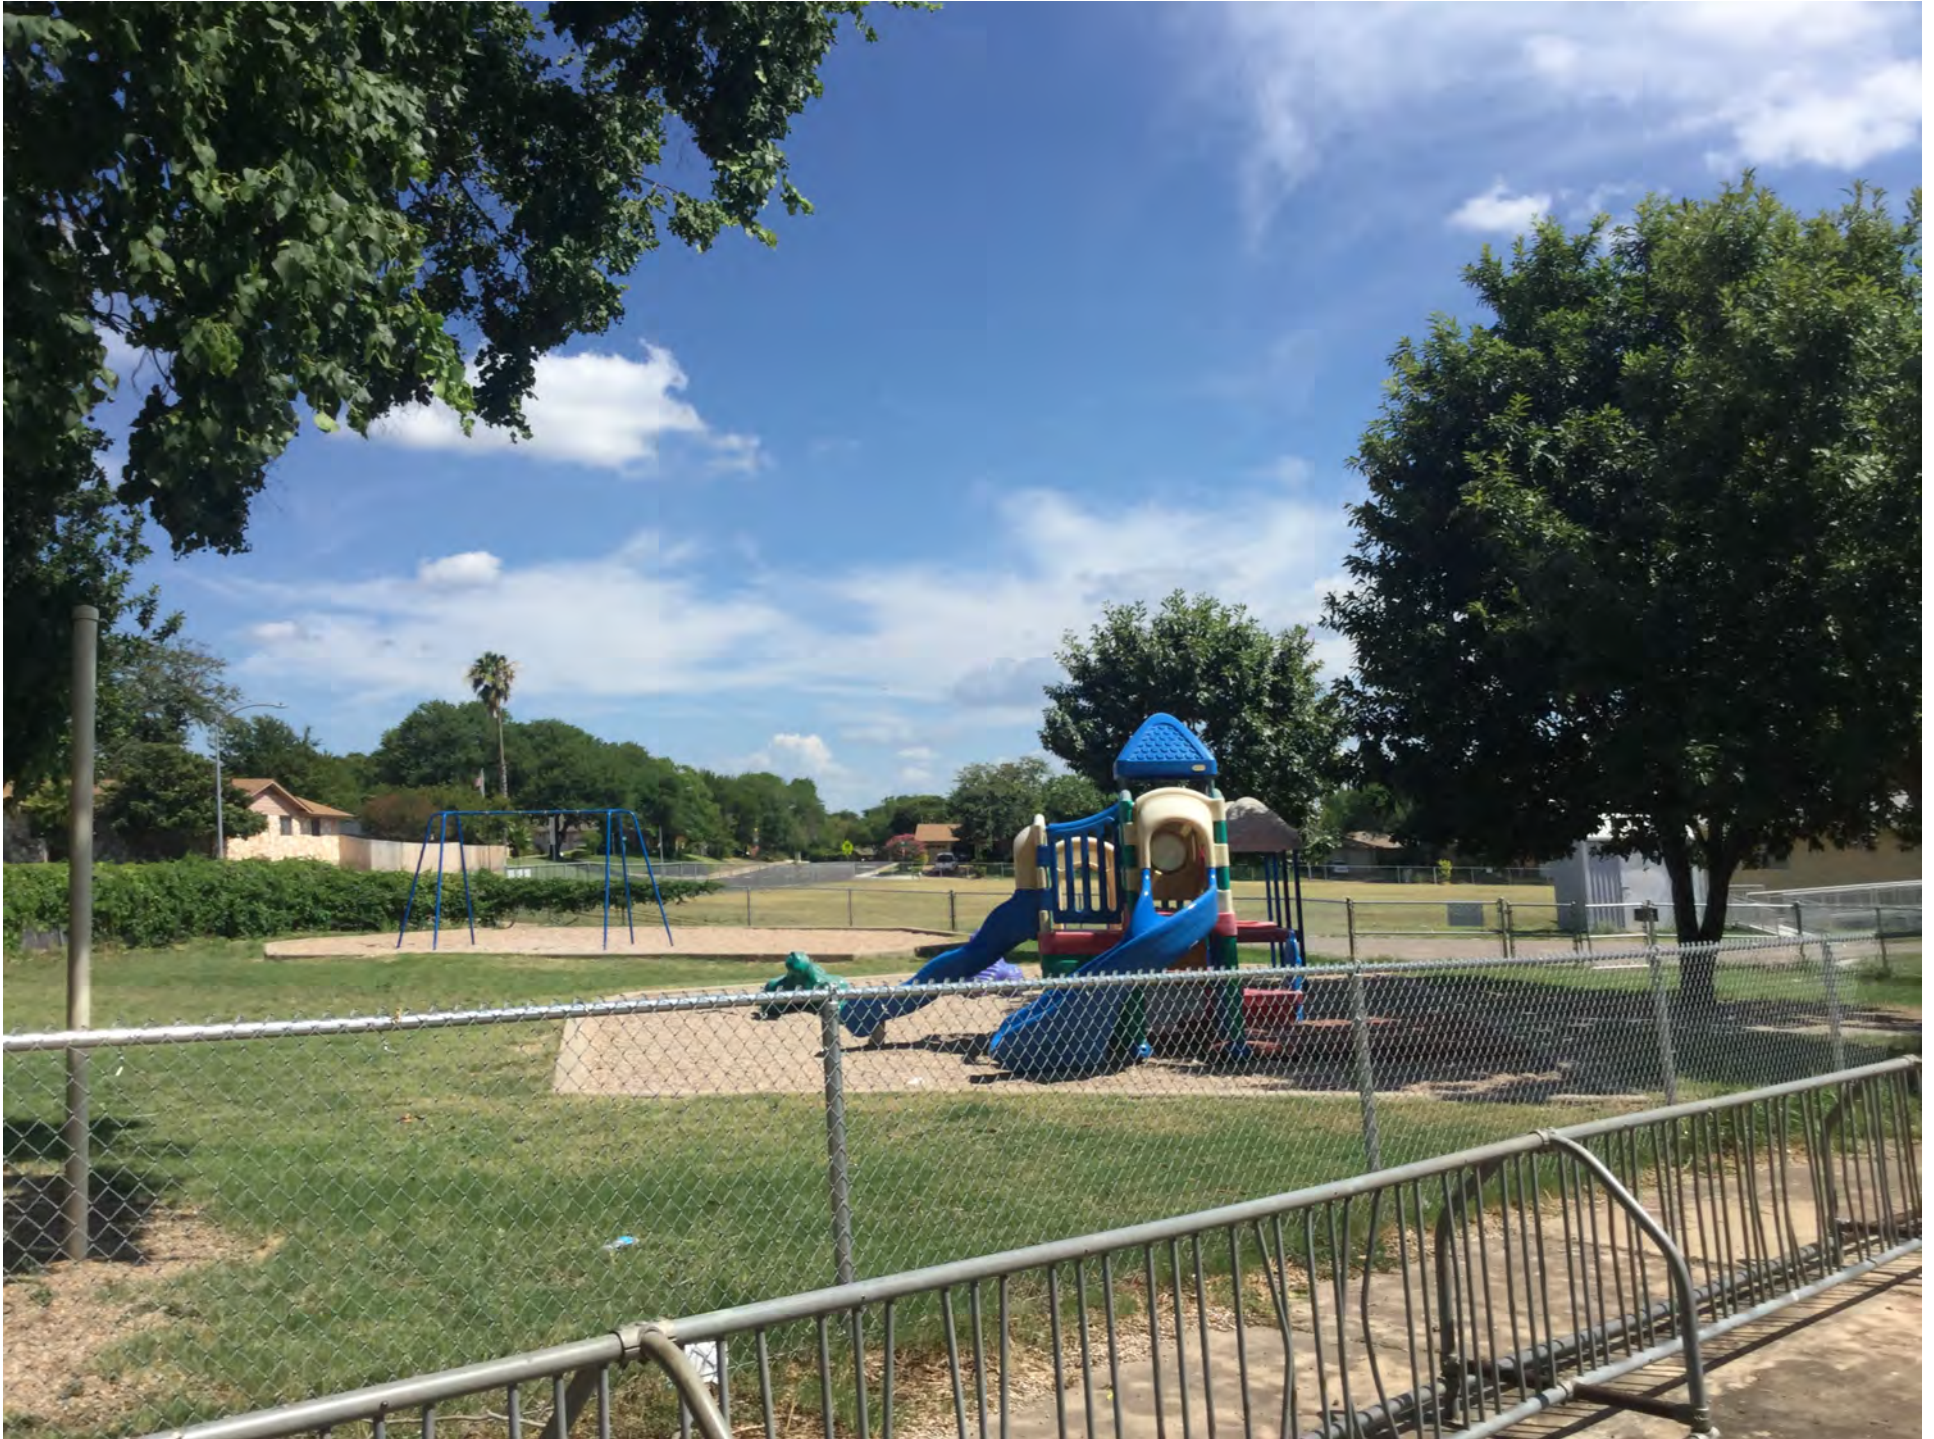
Photo 1.
1.3 Playfields

1.3	Are outdoor play spaces and playfields adequate in size and configuration?			3				Comments	1.00 3.00
	1) Outdoor play space exists, not developed 2)Outdoor play space exists but is not connected to gym or other athletic support areas or is too small. 3. Outdoor play spaces exist, are connected to other athletic areas, are the right size, but are not in good condition. 4. Outdoor play spaces need minor improvements to function well. 5. Outdoor play spaces are in excellent condition. N/A) Does not apply.								see photo 1

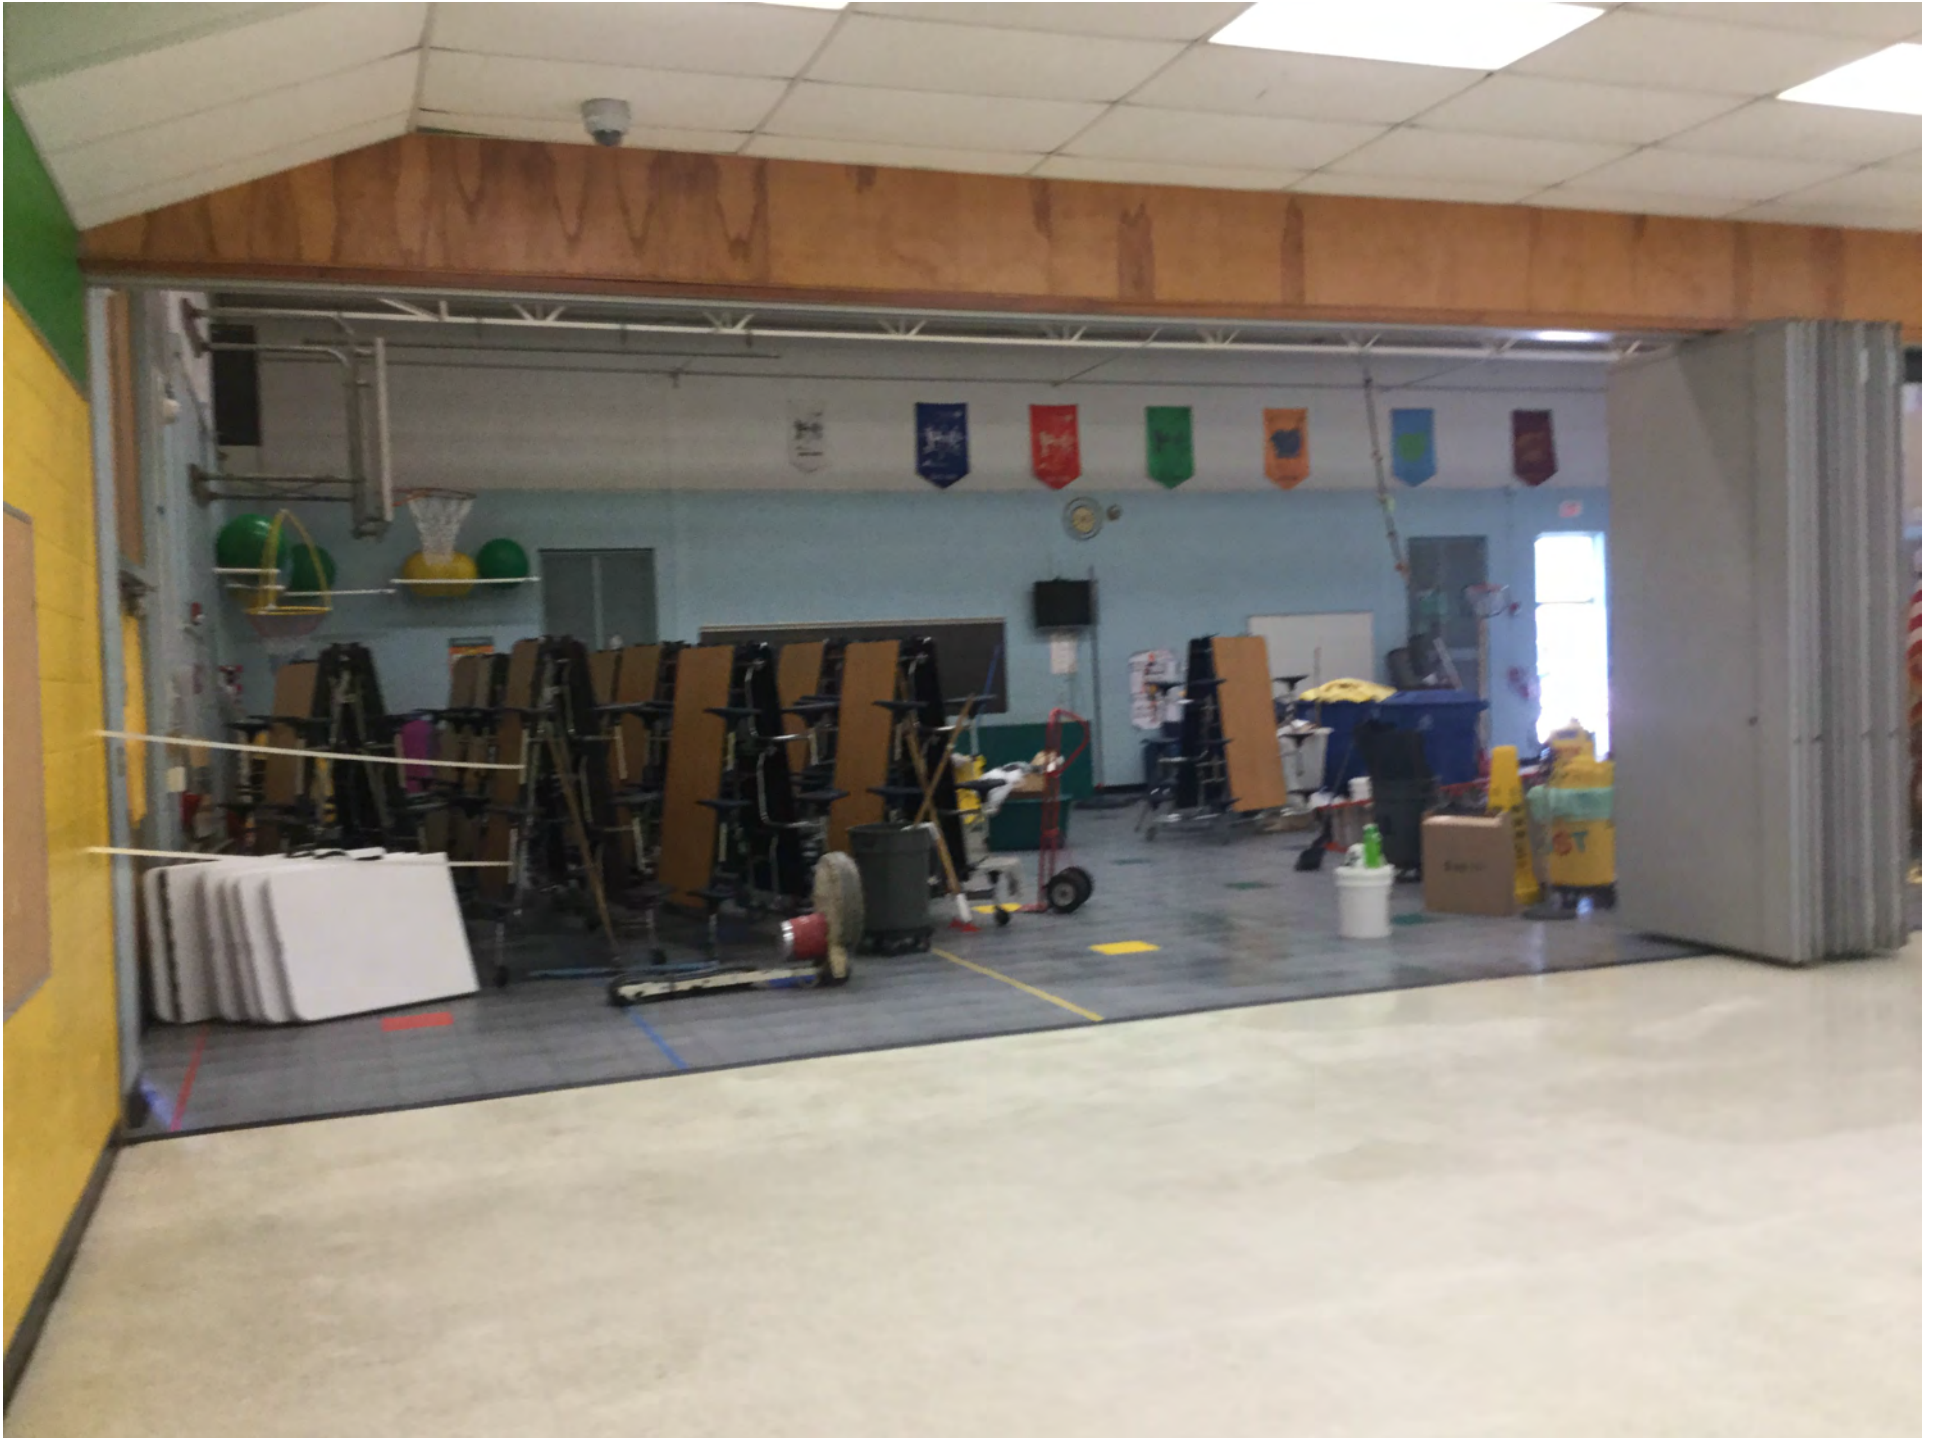
Photo 2.
3.6 Gym

1) Very unsatisfactory 2) Unsatisfactory 3) Average 4) Good 5) Very good N/A) Does not apply.								The gym is in poor condition and undersized.			
see photo 2

3.7	Are Physical Education and Athletic support spaces appropriately configured per the ed spec?	1						Comments		1.00	1.00
1) Very unsatisfactory - Support spaces are disconnected from served spaces, too small, do not meet needs 2) Unsatisfactory - Support spaces are connected, but too small, inadequate for needs 3) Average - Connected, moderate size, but need some renovations or updates to function well 4) Good - Connected, good size/layout, meets needs/functions well 5) Very good - connected, generous size, nice condition, functions appropriately N/A) Does not apply.								The office is located across the hallway from the gym, and there is an inadequate amount of storage.

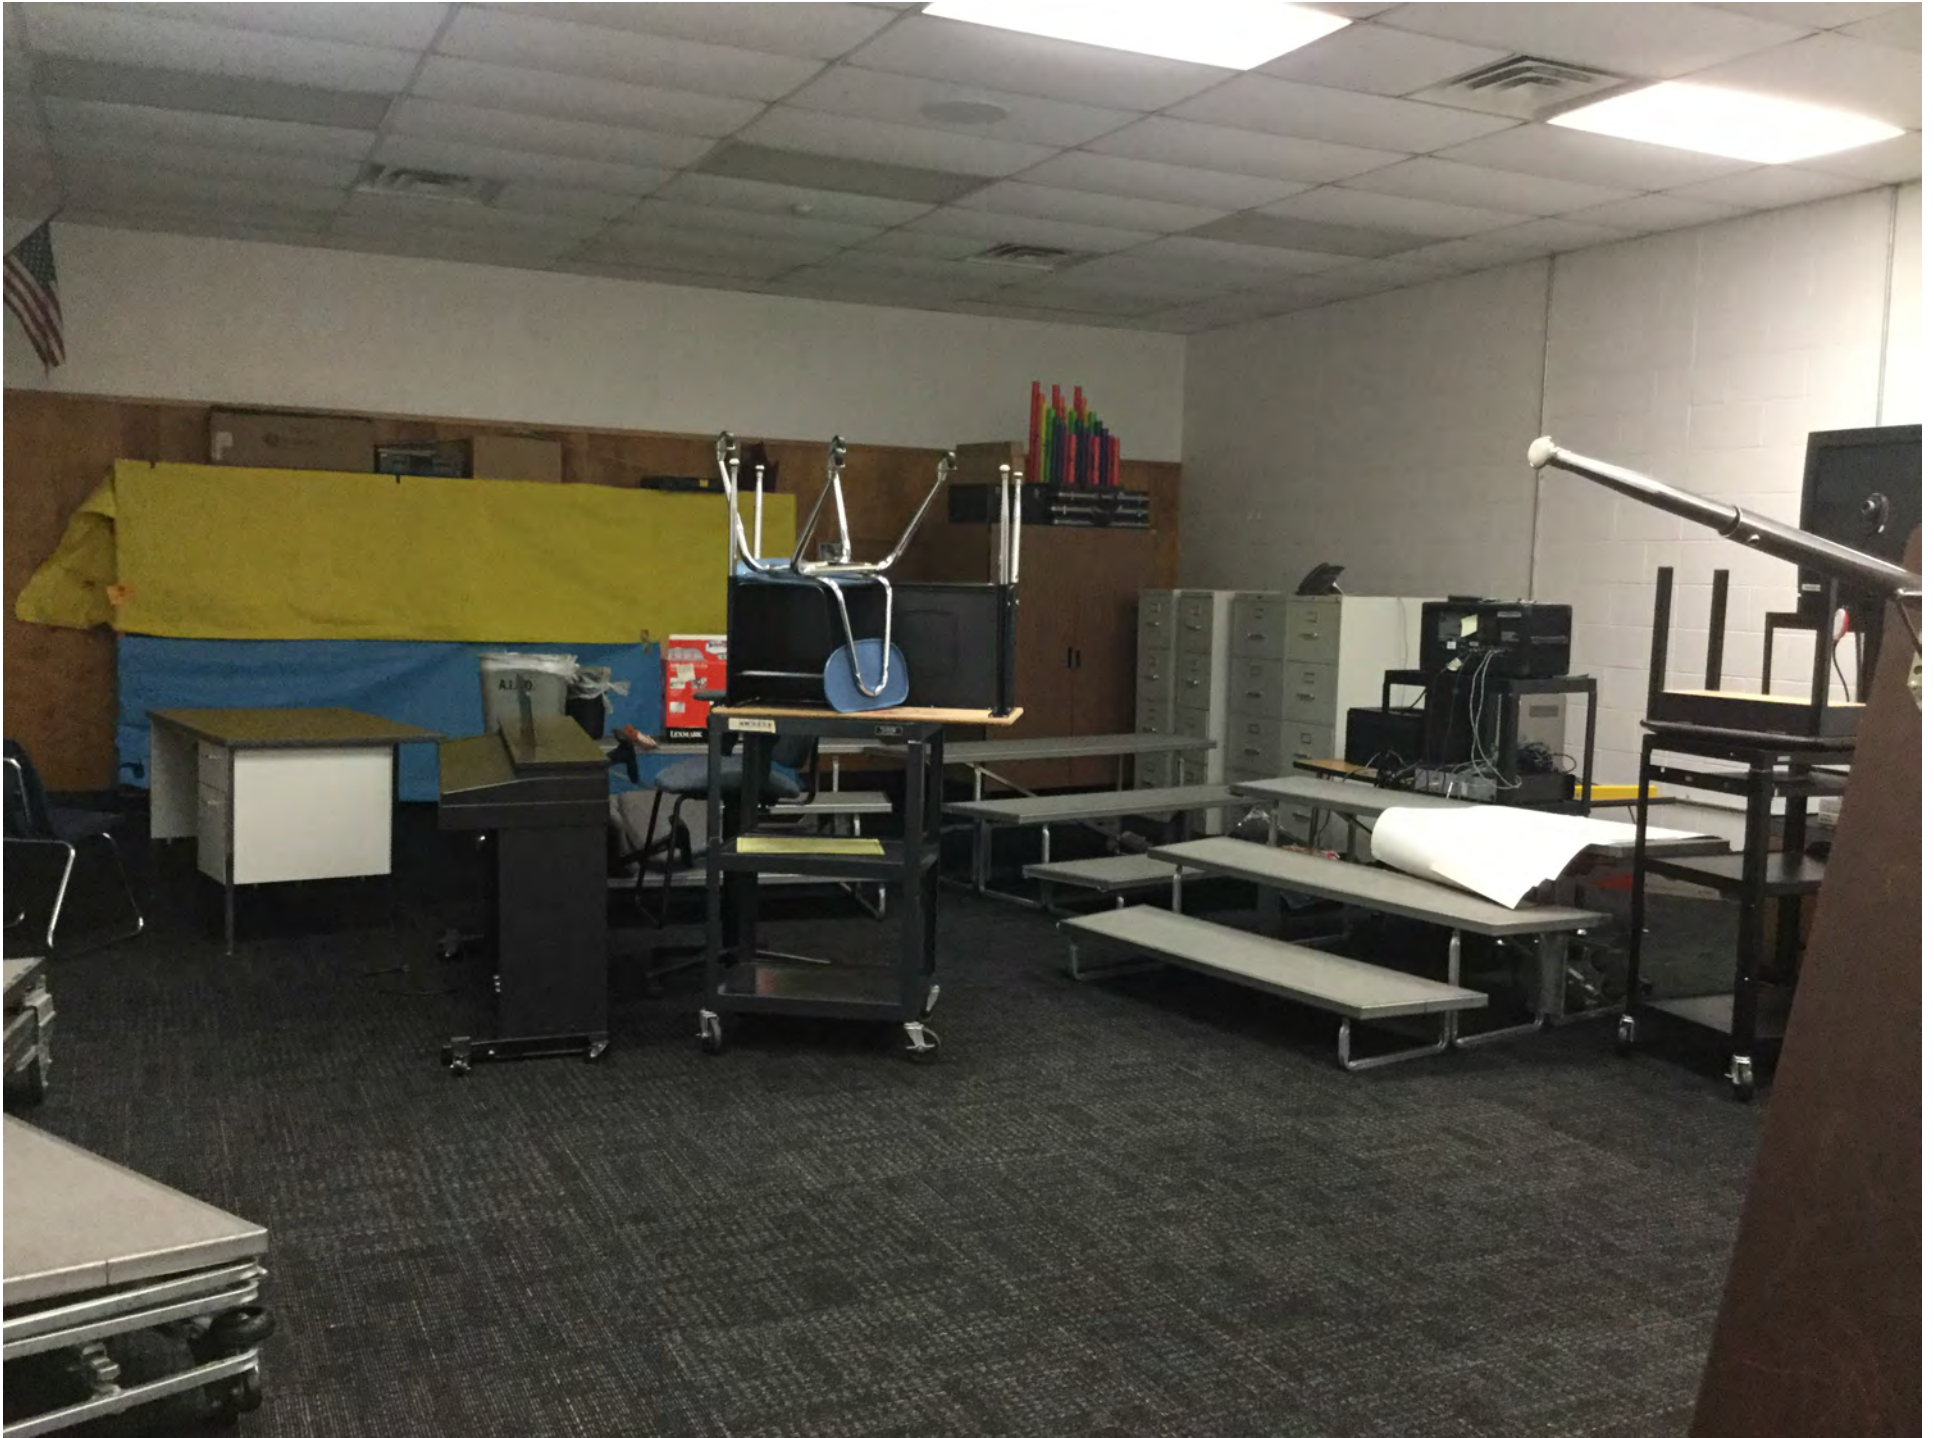
Photo 3.
3.8 Music Room

3.8	Are music, drama, or performance spaces appropriately configured per the ed spec?	1						Comments		1.00	1.00
1) Very unsatisfactory 2) Unsatisfactory 3) Average 4) Good 5) Very good N/A) Does not apply.								There is one music room in the building and a part-time music room in a portable. The main building music room is small and has no storage, casework, or office space.			
see photo 3

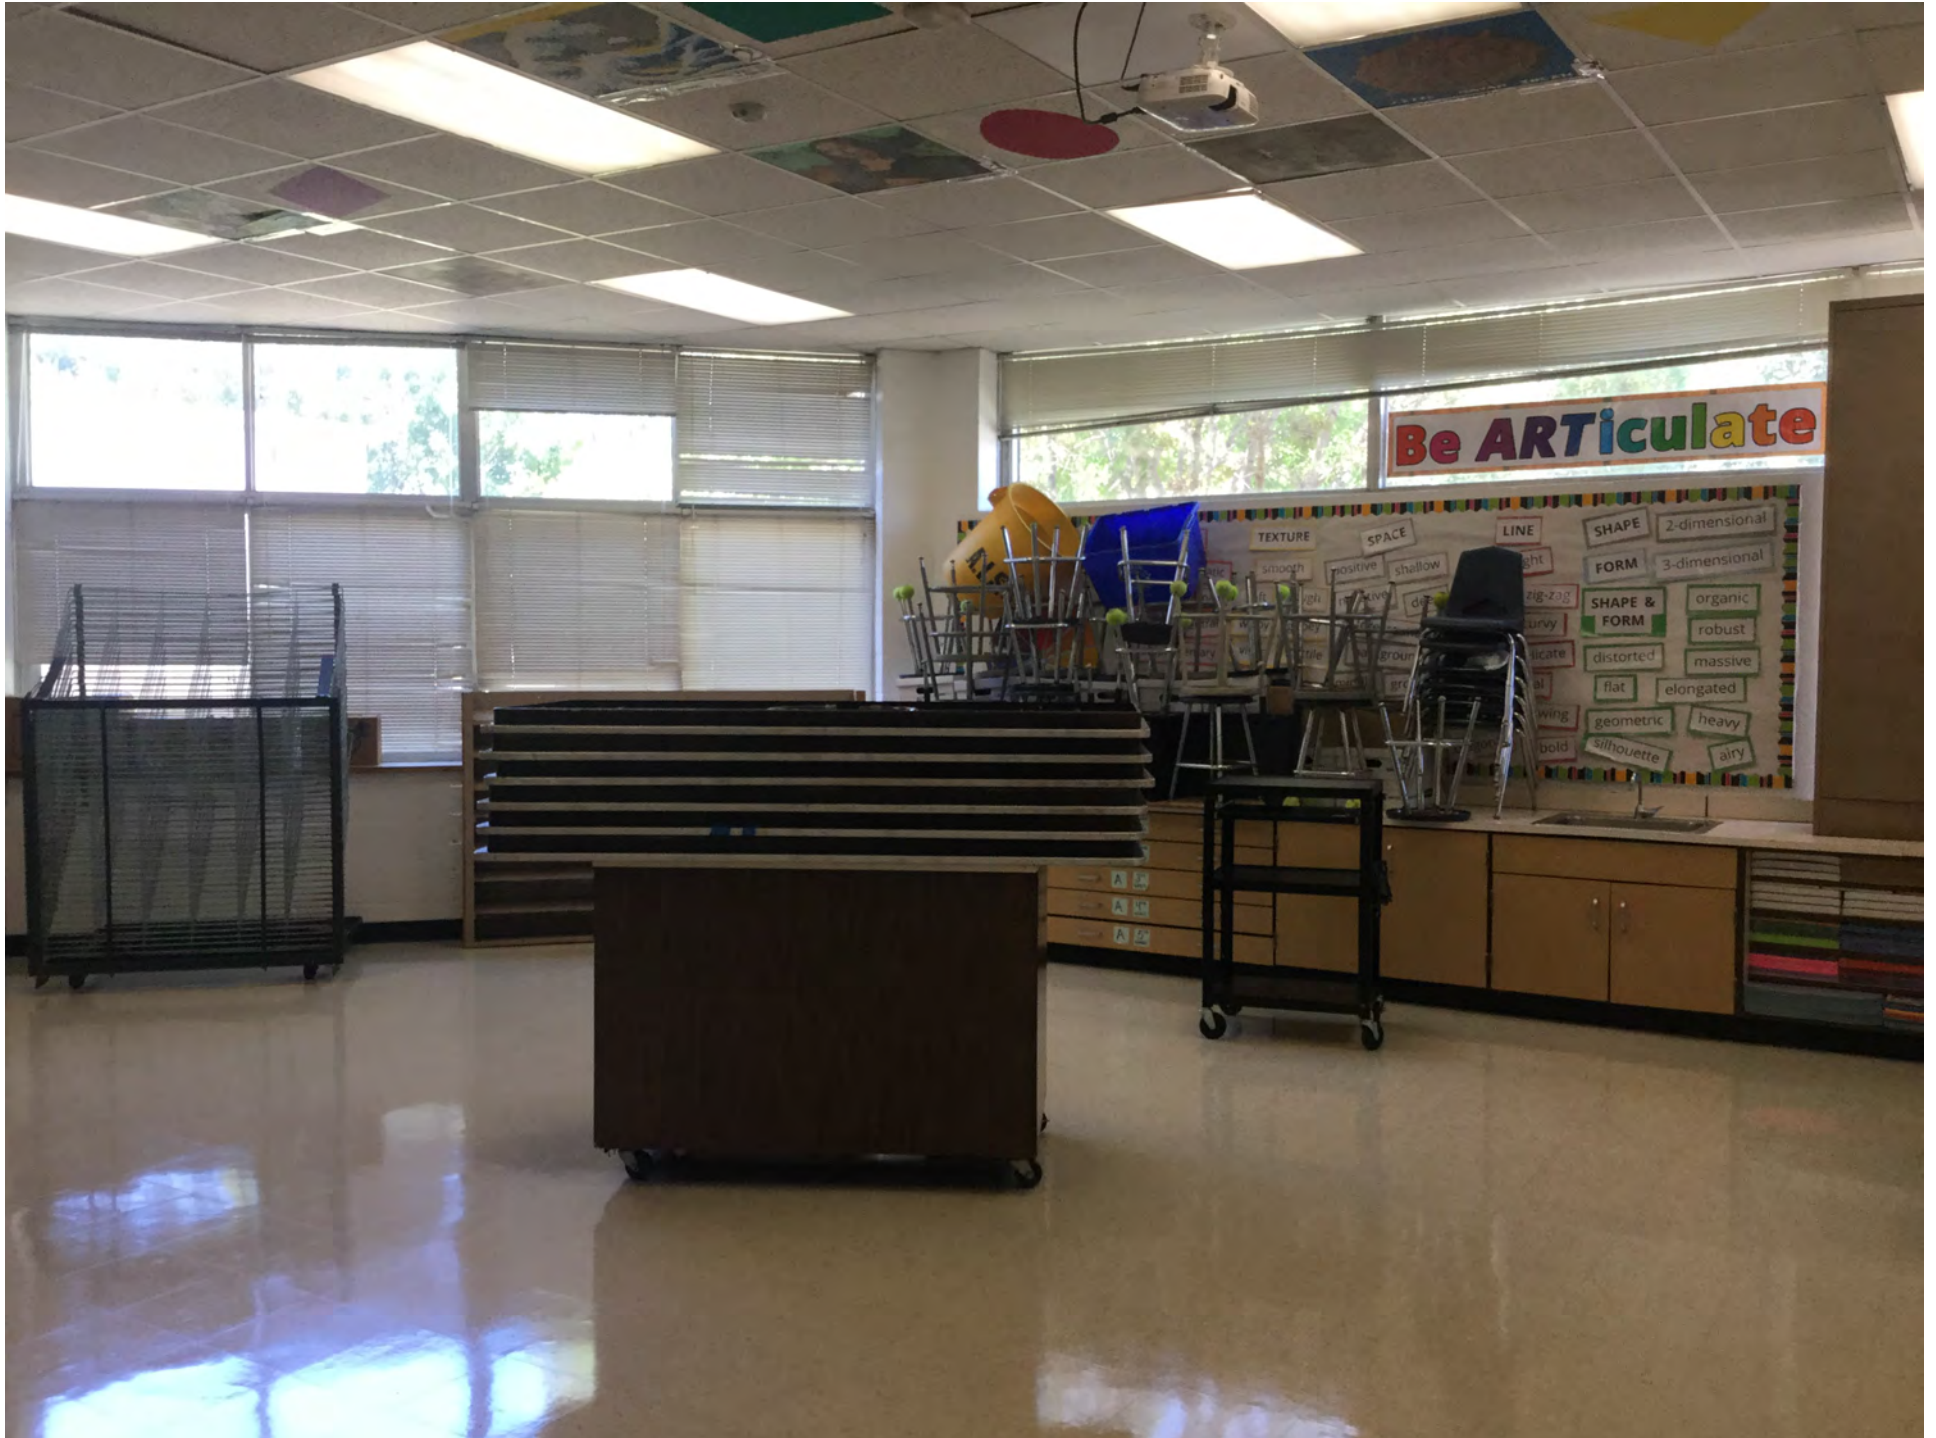
Photo 4.
3.10 Art Room

1) Very unsatisfactory 2) Unsatisfactory 3) Average 4) Good 5) Very good N/A) Does not apply.								There is one adequate art room located in the main building and a part time art room located in a portable .							
see photo 4

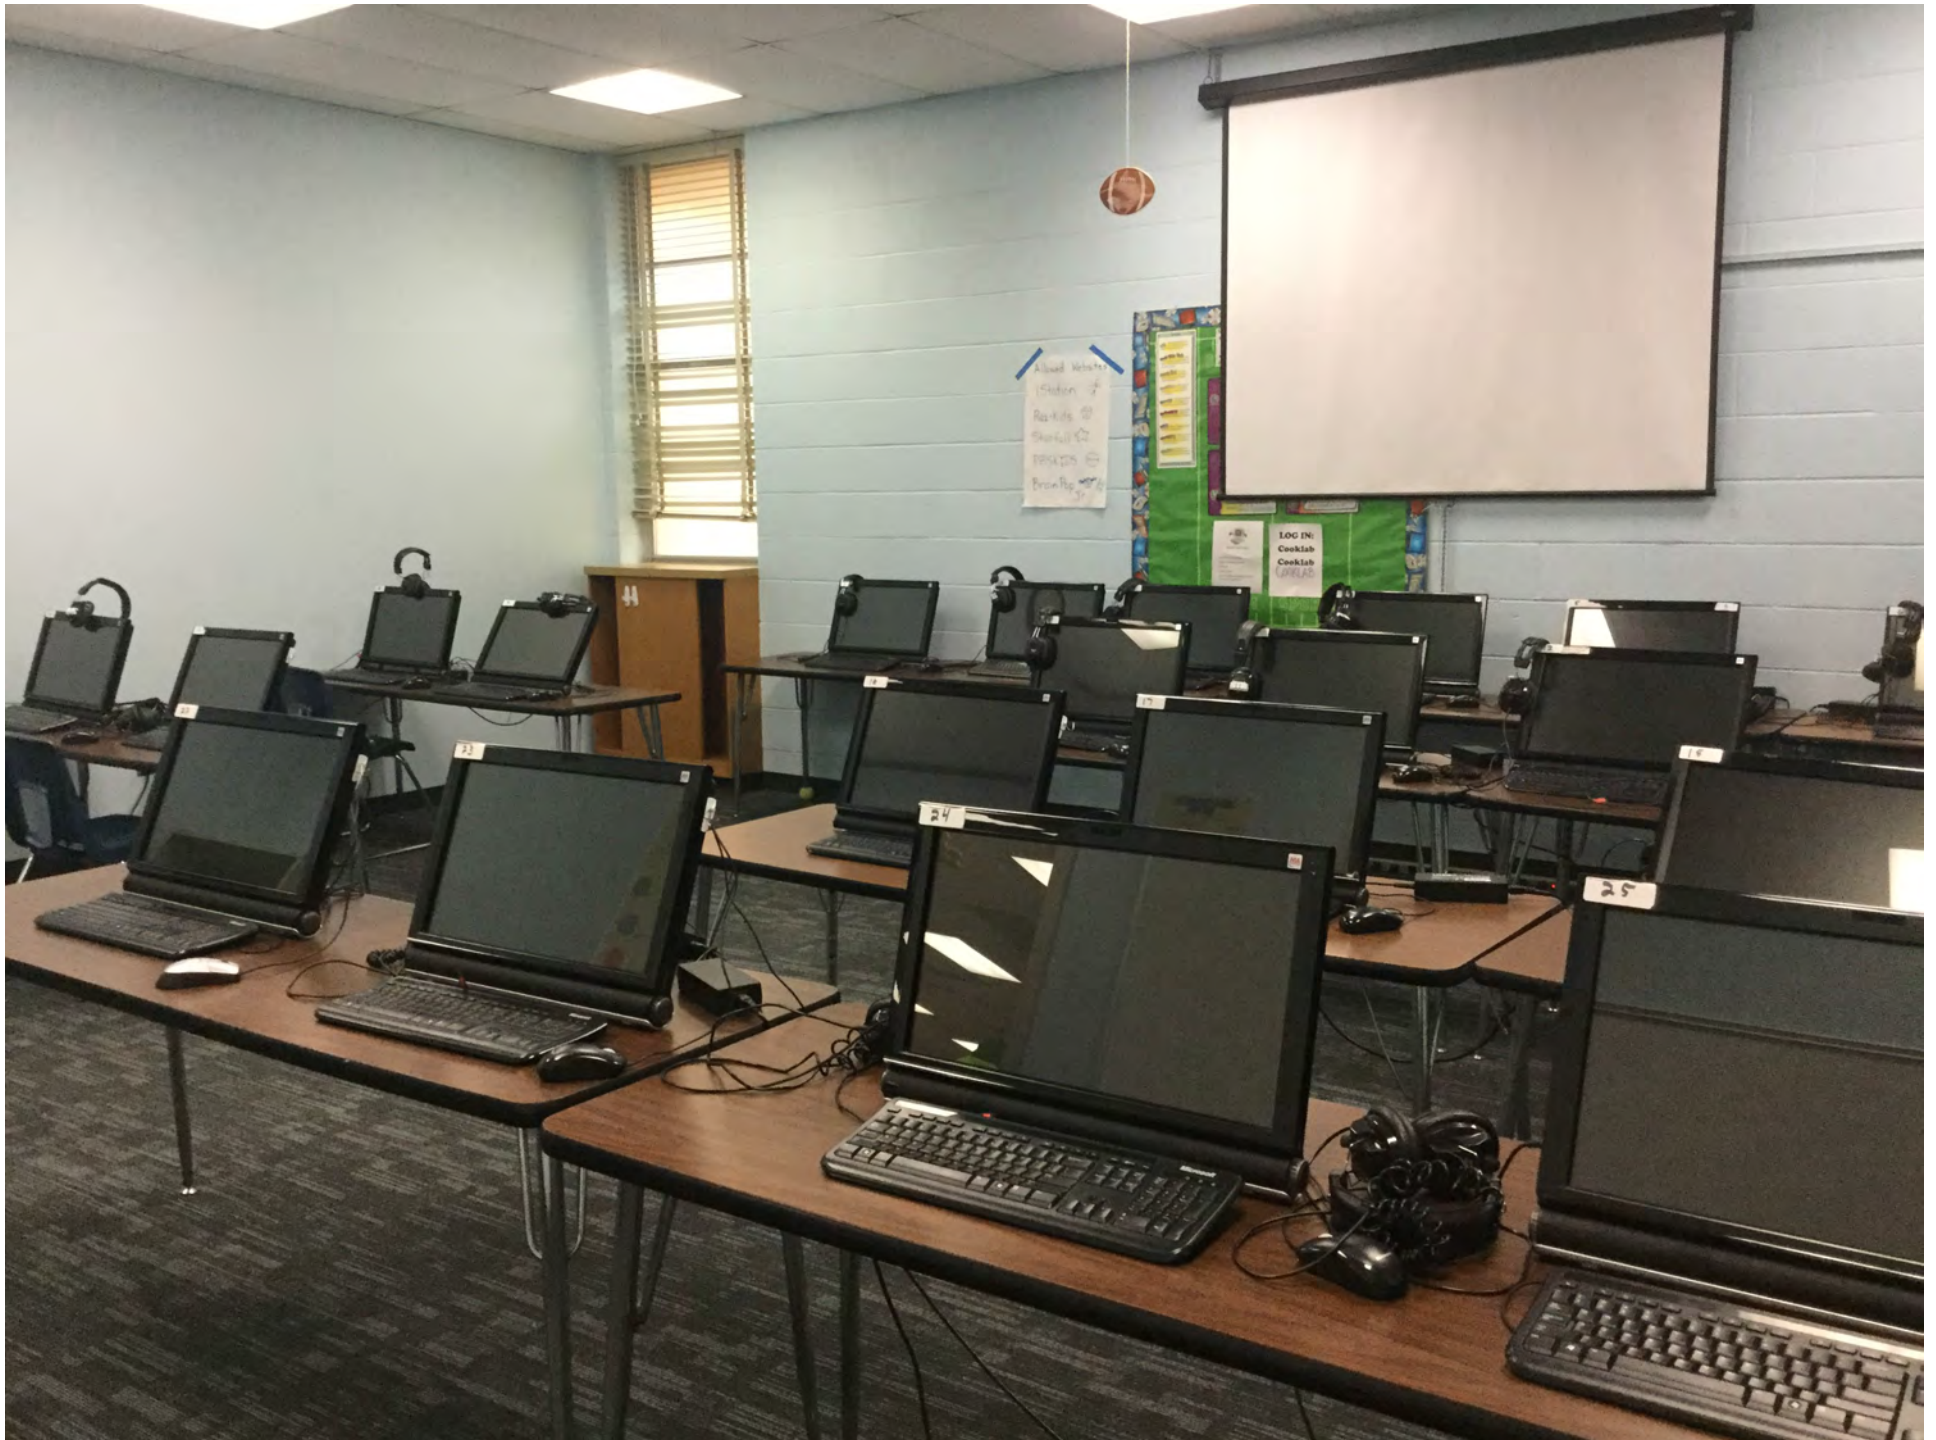
Photo 5.
3.12 Computer Lab

3.12	Are computer lab spaces appropriately configured?		2					Comments						1.00	2.00
1) Very unsatisfactory 2) Unsatisfactory 3) Average 4) Good 5) Very good N/A) Does not apply.								The computer lab could use more space and devices.							
see photo 5

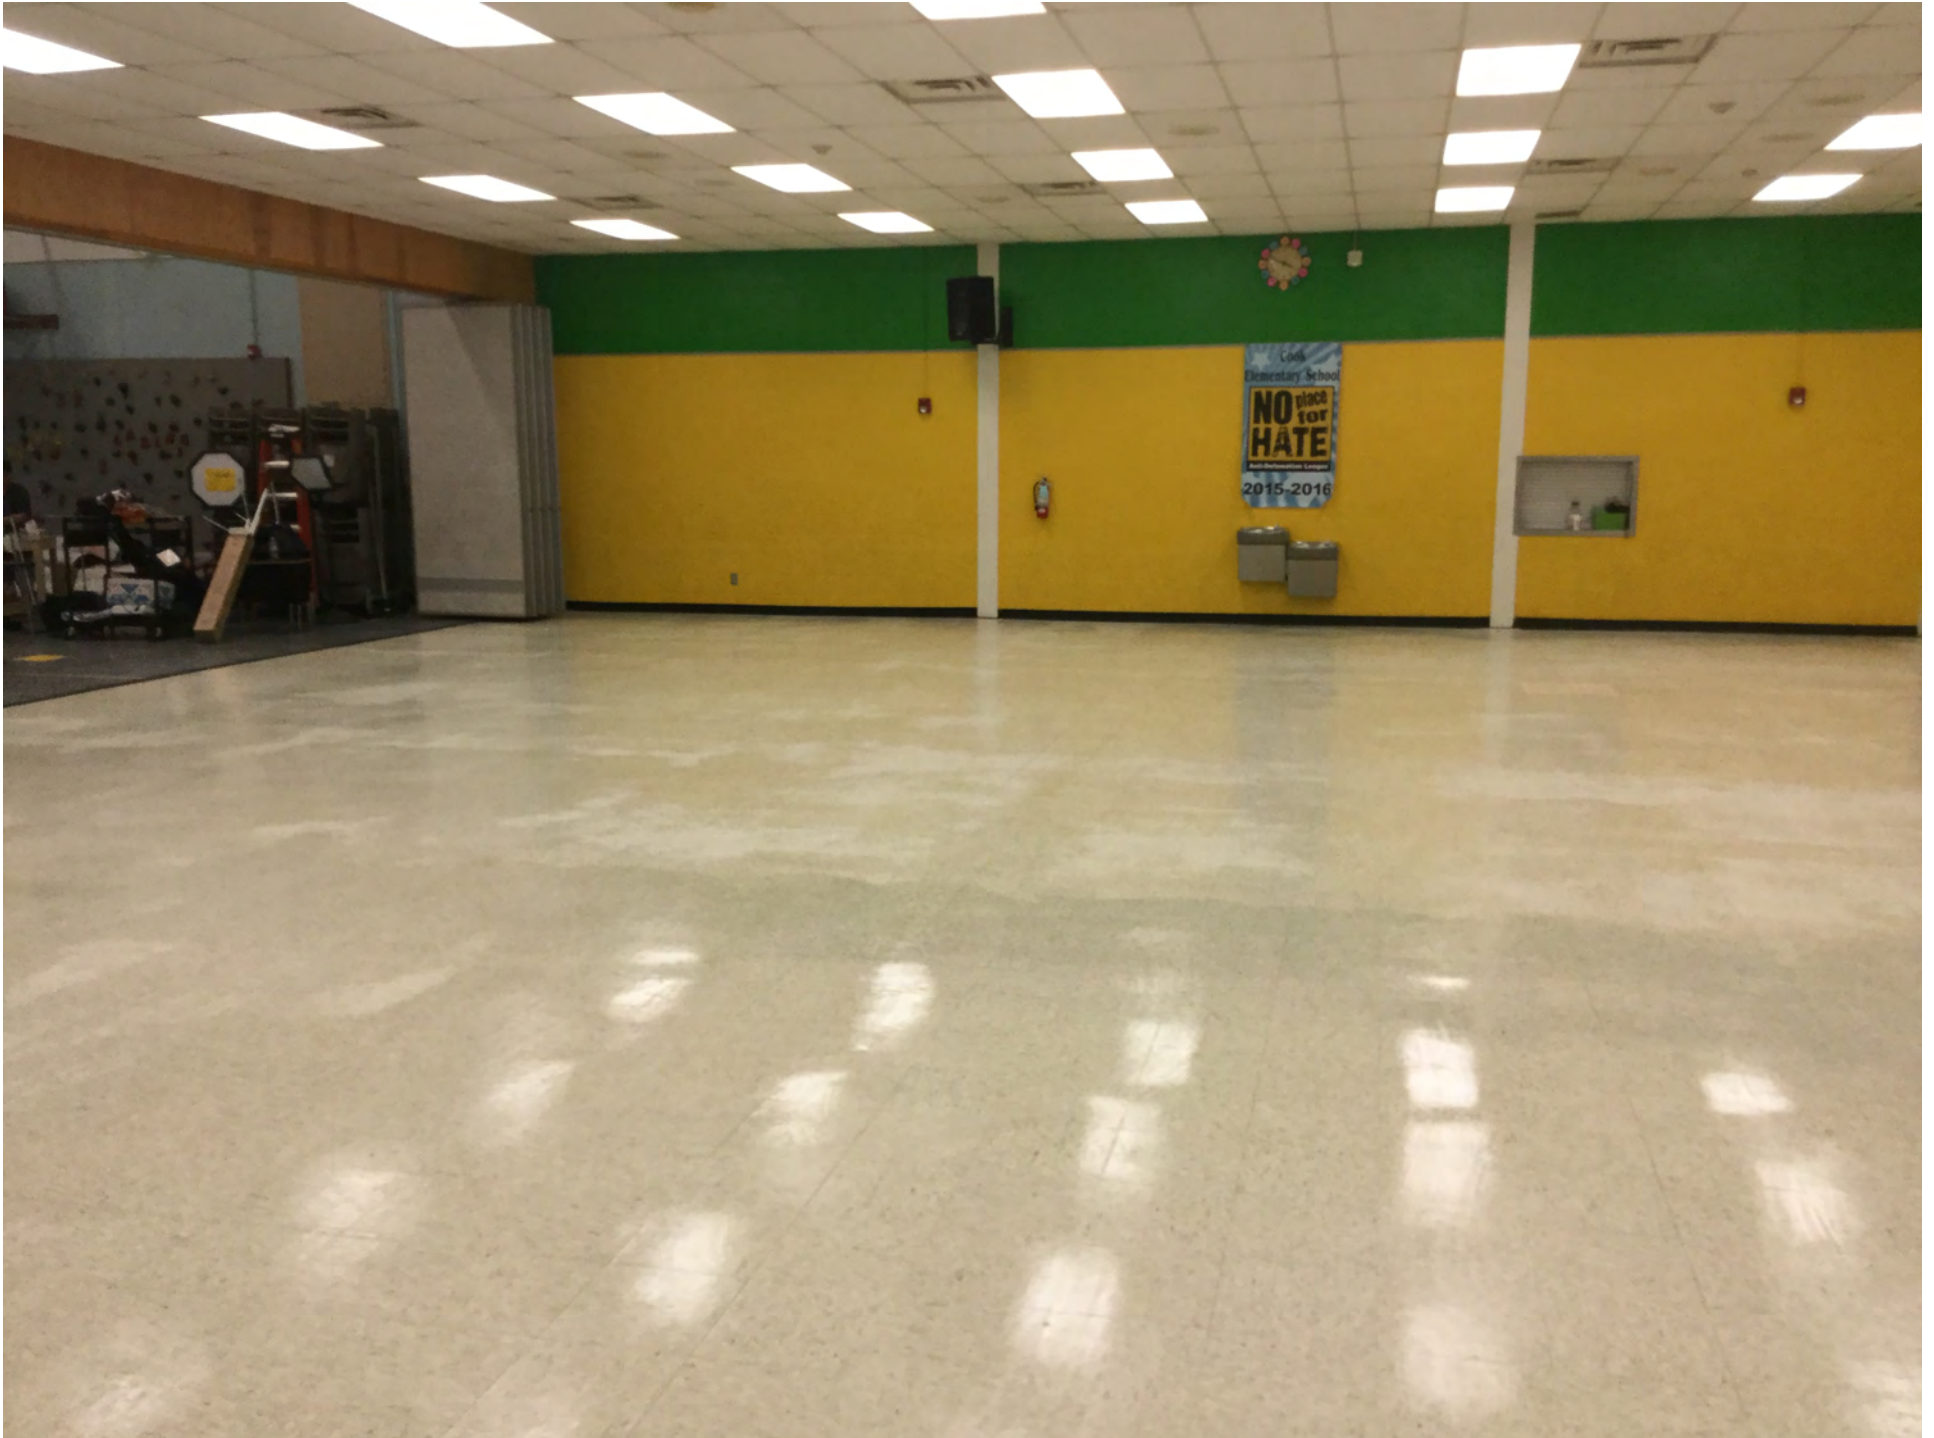
Photo 6.
3.16 Cafetorium

3.16	Are the student dining facilities appropriately configured?			3				Comments				1.00	3.00
1) Very unsatisfactory - Too small, poor circulation, inflexible seating in poor condition 2) Unsatisfactory - Too small or inadequate circulation, seating in poor condition 3) Average - moderate size, with adequate circulation, seating in okay condition 4) Good - good size, adequate circulation, seating in good condition 5) Very good - good size, adequate circulation, seating in good condition, with more than one option for eating space (ex: connection to outdoor eating space) N/A) Does not apply.								Due to the current campus enrollment, the cafeteria size is not adequate. <

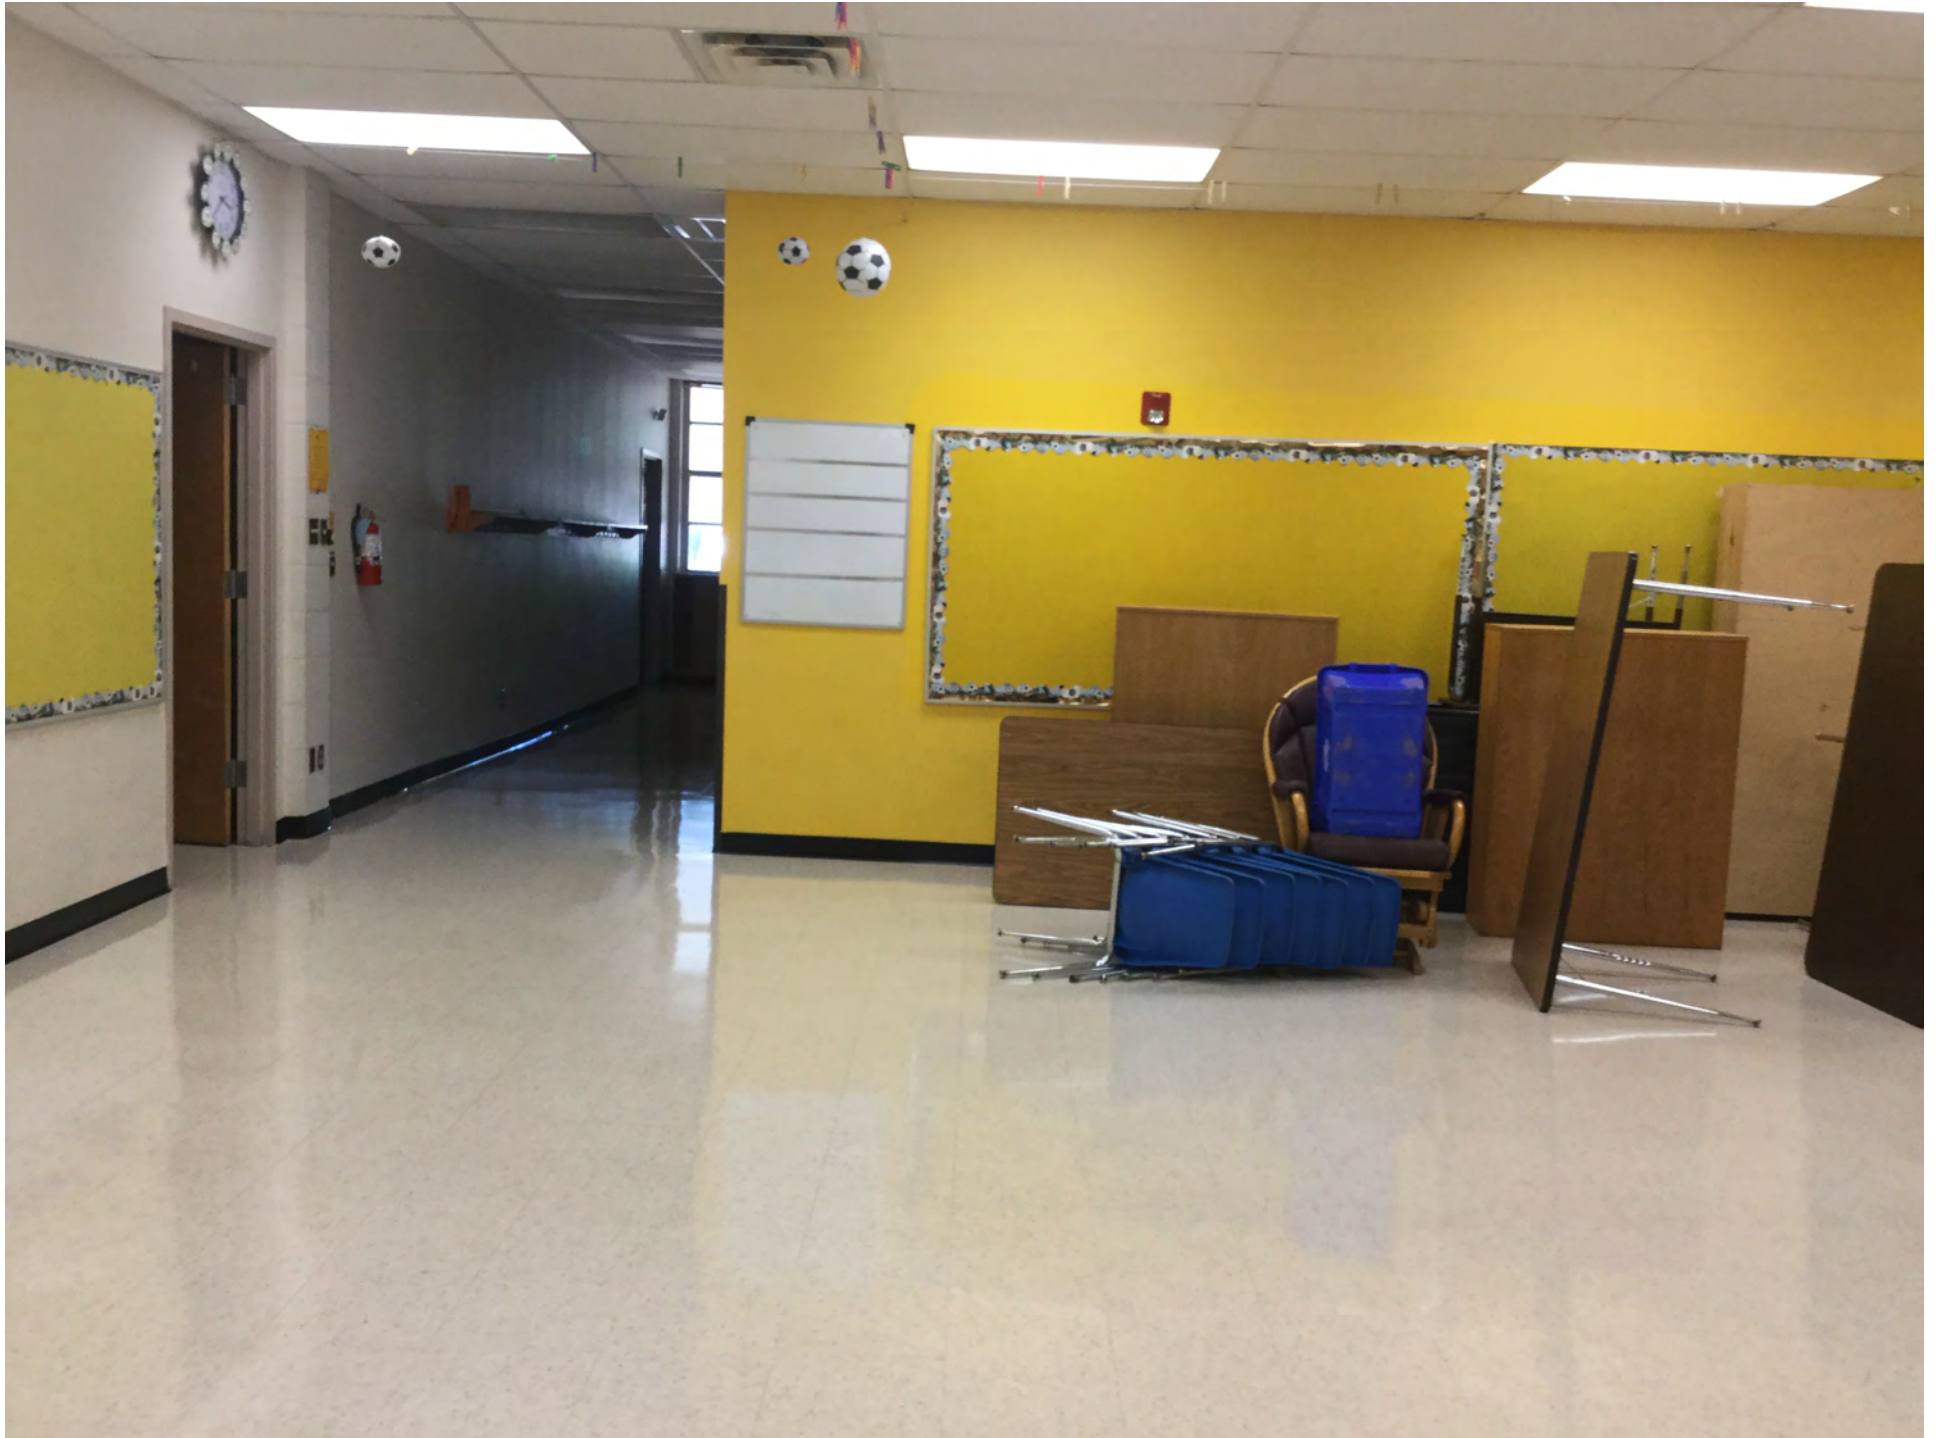
Photo 7.
4.2 Standard Classroom

4.2	Are general classrooms large enough to support project-based learning and multiple teaching modalities?	1						Comments	1.00	1.00
1) Very unsatisfactory -too small to move, set for lecture only, no connectivity, no flexibility 2) Unsatisfactory - adequate size but set for lecture only, no connectivity, no flexibility 3) Neutral - have flexibility and space for hands on or project based learning 4) Satisfactory - have flexibility and space for hands on or project based learning and connectivity for global learning 5) Very Satisfactory - space for hands on learning, flexibility for different groupings, and connectivity for global classrooms N/A) Does not apply.								Due to the circulation pattern that forces students to walk through adjacent classrooms to get to their classroom, this section recieved the lowest score.		
		see photo 7
