Educational Suitability Summary Report

Cook Elementary School – BLDG #161

Date: 08/04/2016

Score 56% Average

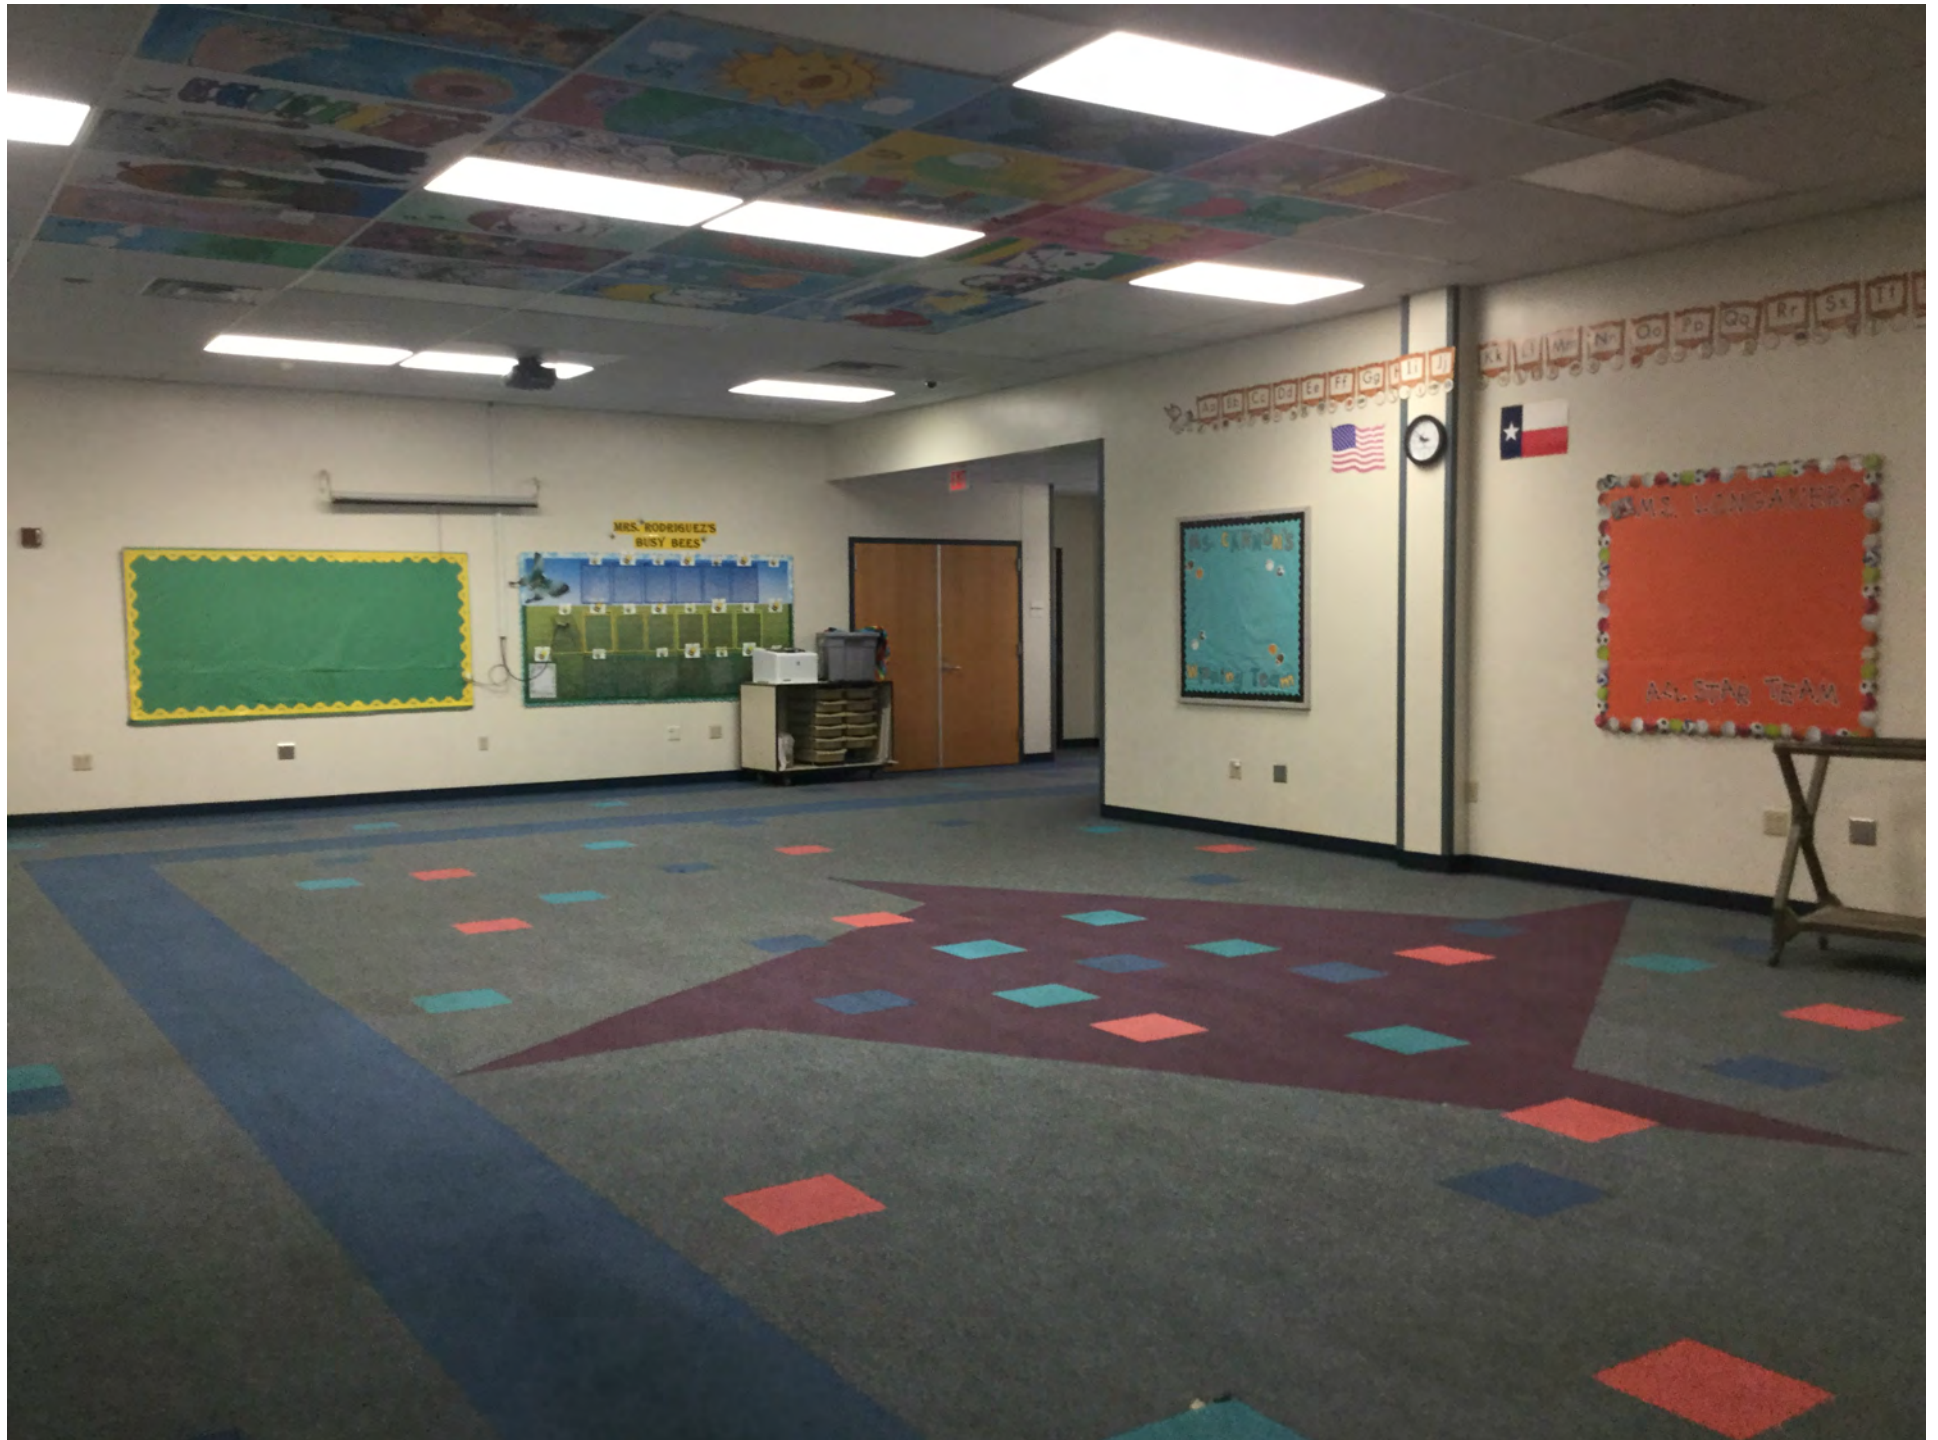
Photo 8.
4.5 Collaborative Space

1) Very unsatisfactory - no common spaces or meeting rooms or in very poor condition 2) Unsatisfactory - a few common spaces or meeting rooms in unsatisfactory condition 3) Average - a few common spaces and meeting areas needing updates 4) Good - multiple common spaces and meeting rooms in good condition 5) Very good - adequate common spaces and meeting rooms of excellent quality N/A) Does not apply.								see photo 8

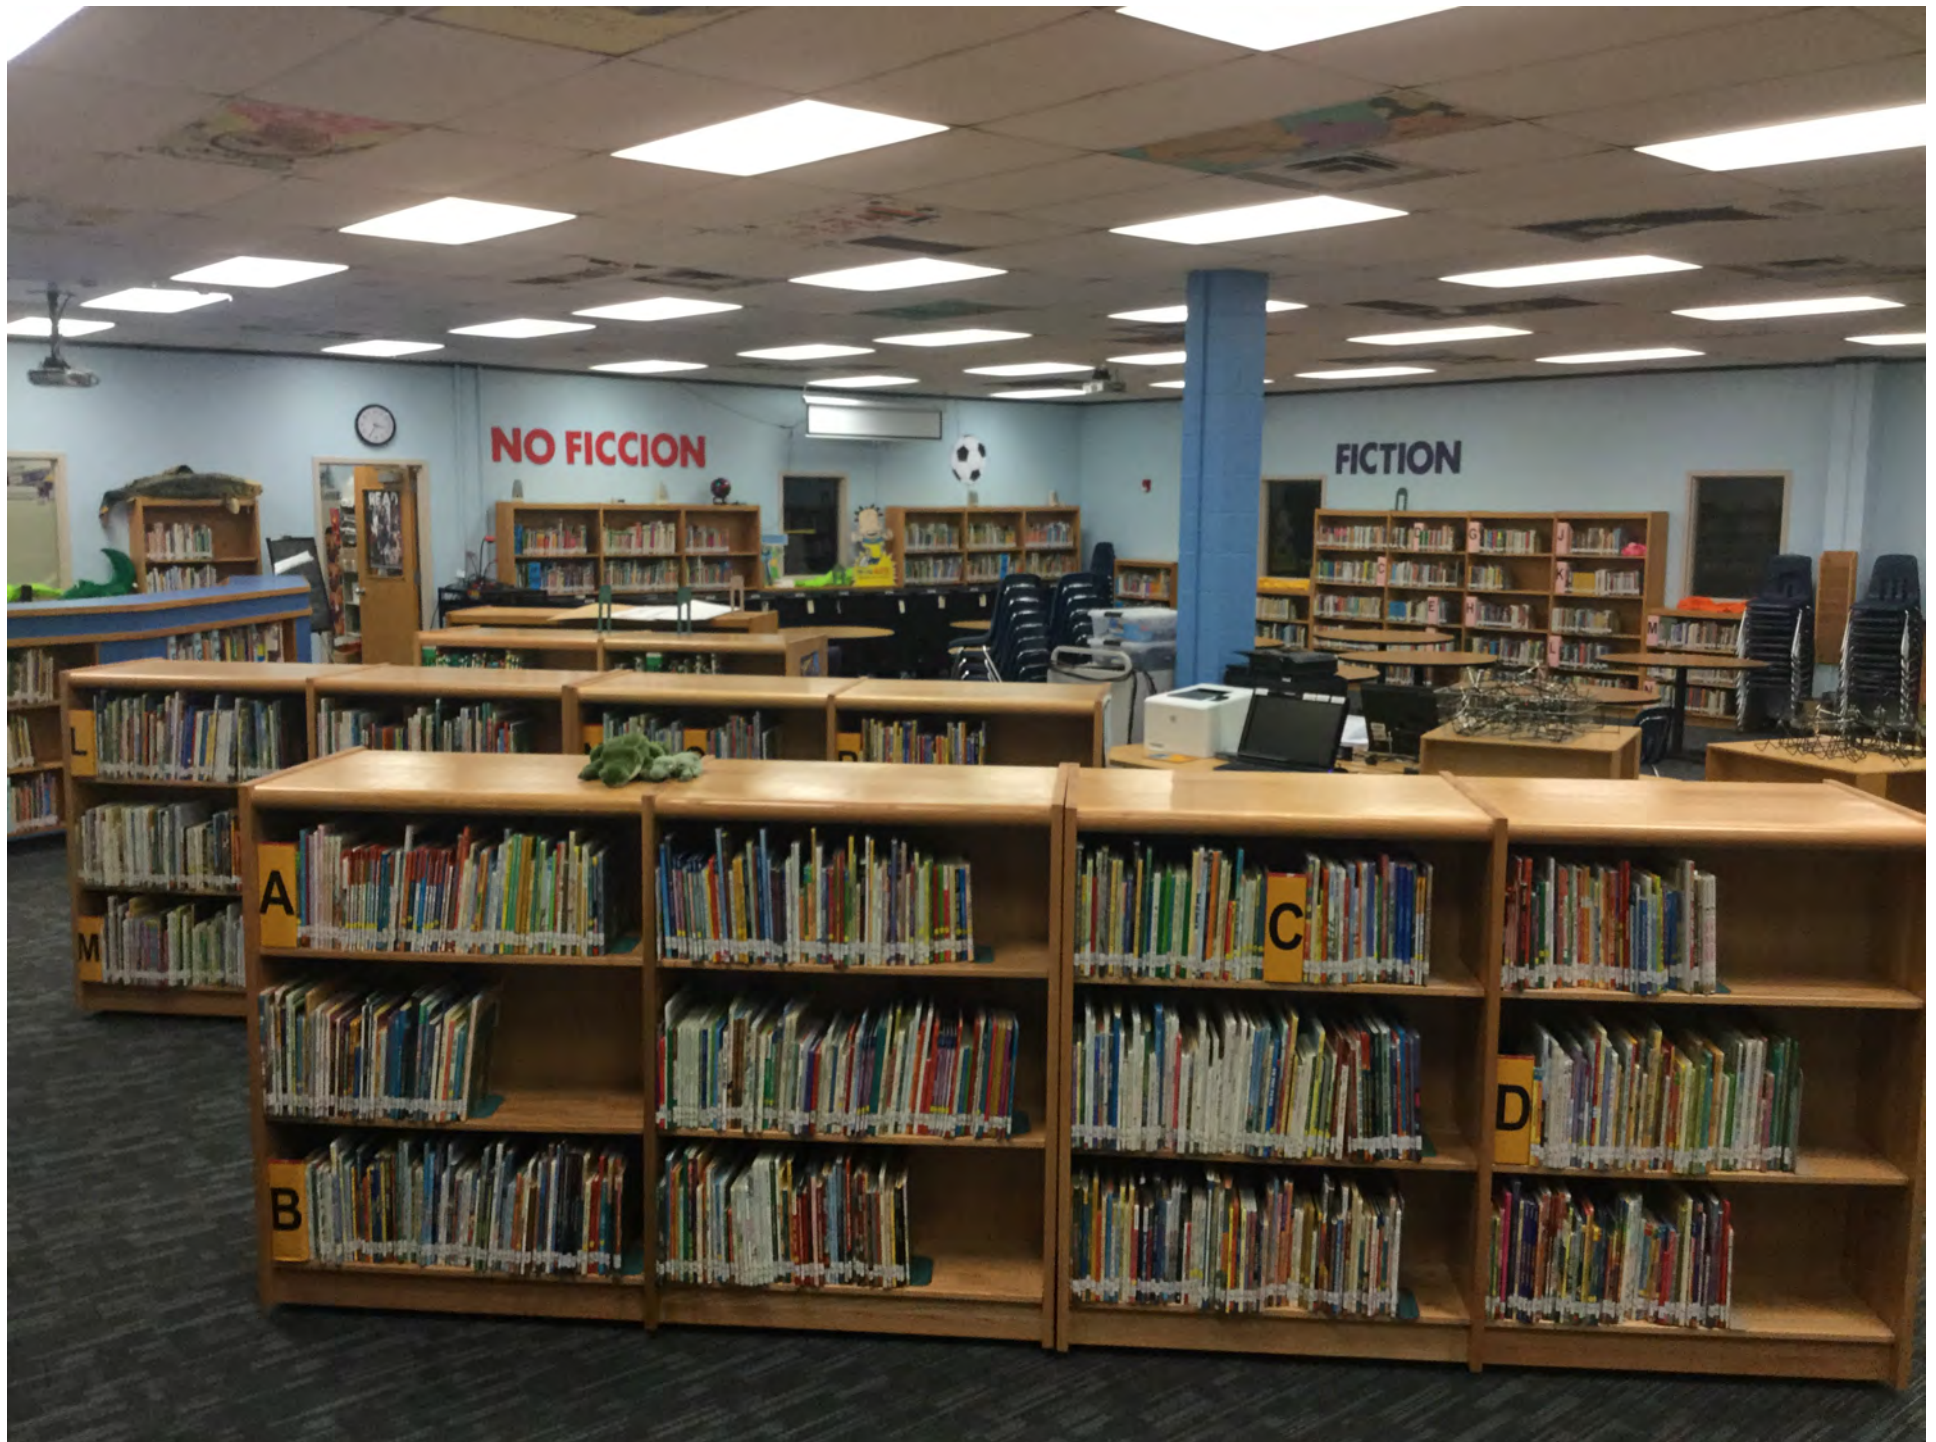
Photo 9.
5.4 Library

5.4	How well does the Library/Media Center support collaborative work in small groups (4-8 students)?					5		Comments	1.005.00
1) Very unsatisfactory 2) Unsatisfactory 3) Average 4) Good 5) Very good N/A) Does not apply.								see photo 9
