Educational Suitability Summary Report

Cowan Elementary School

Date: 07/19/2016

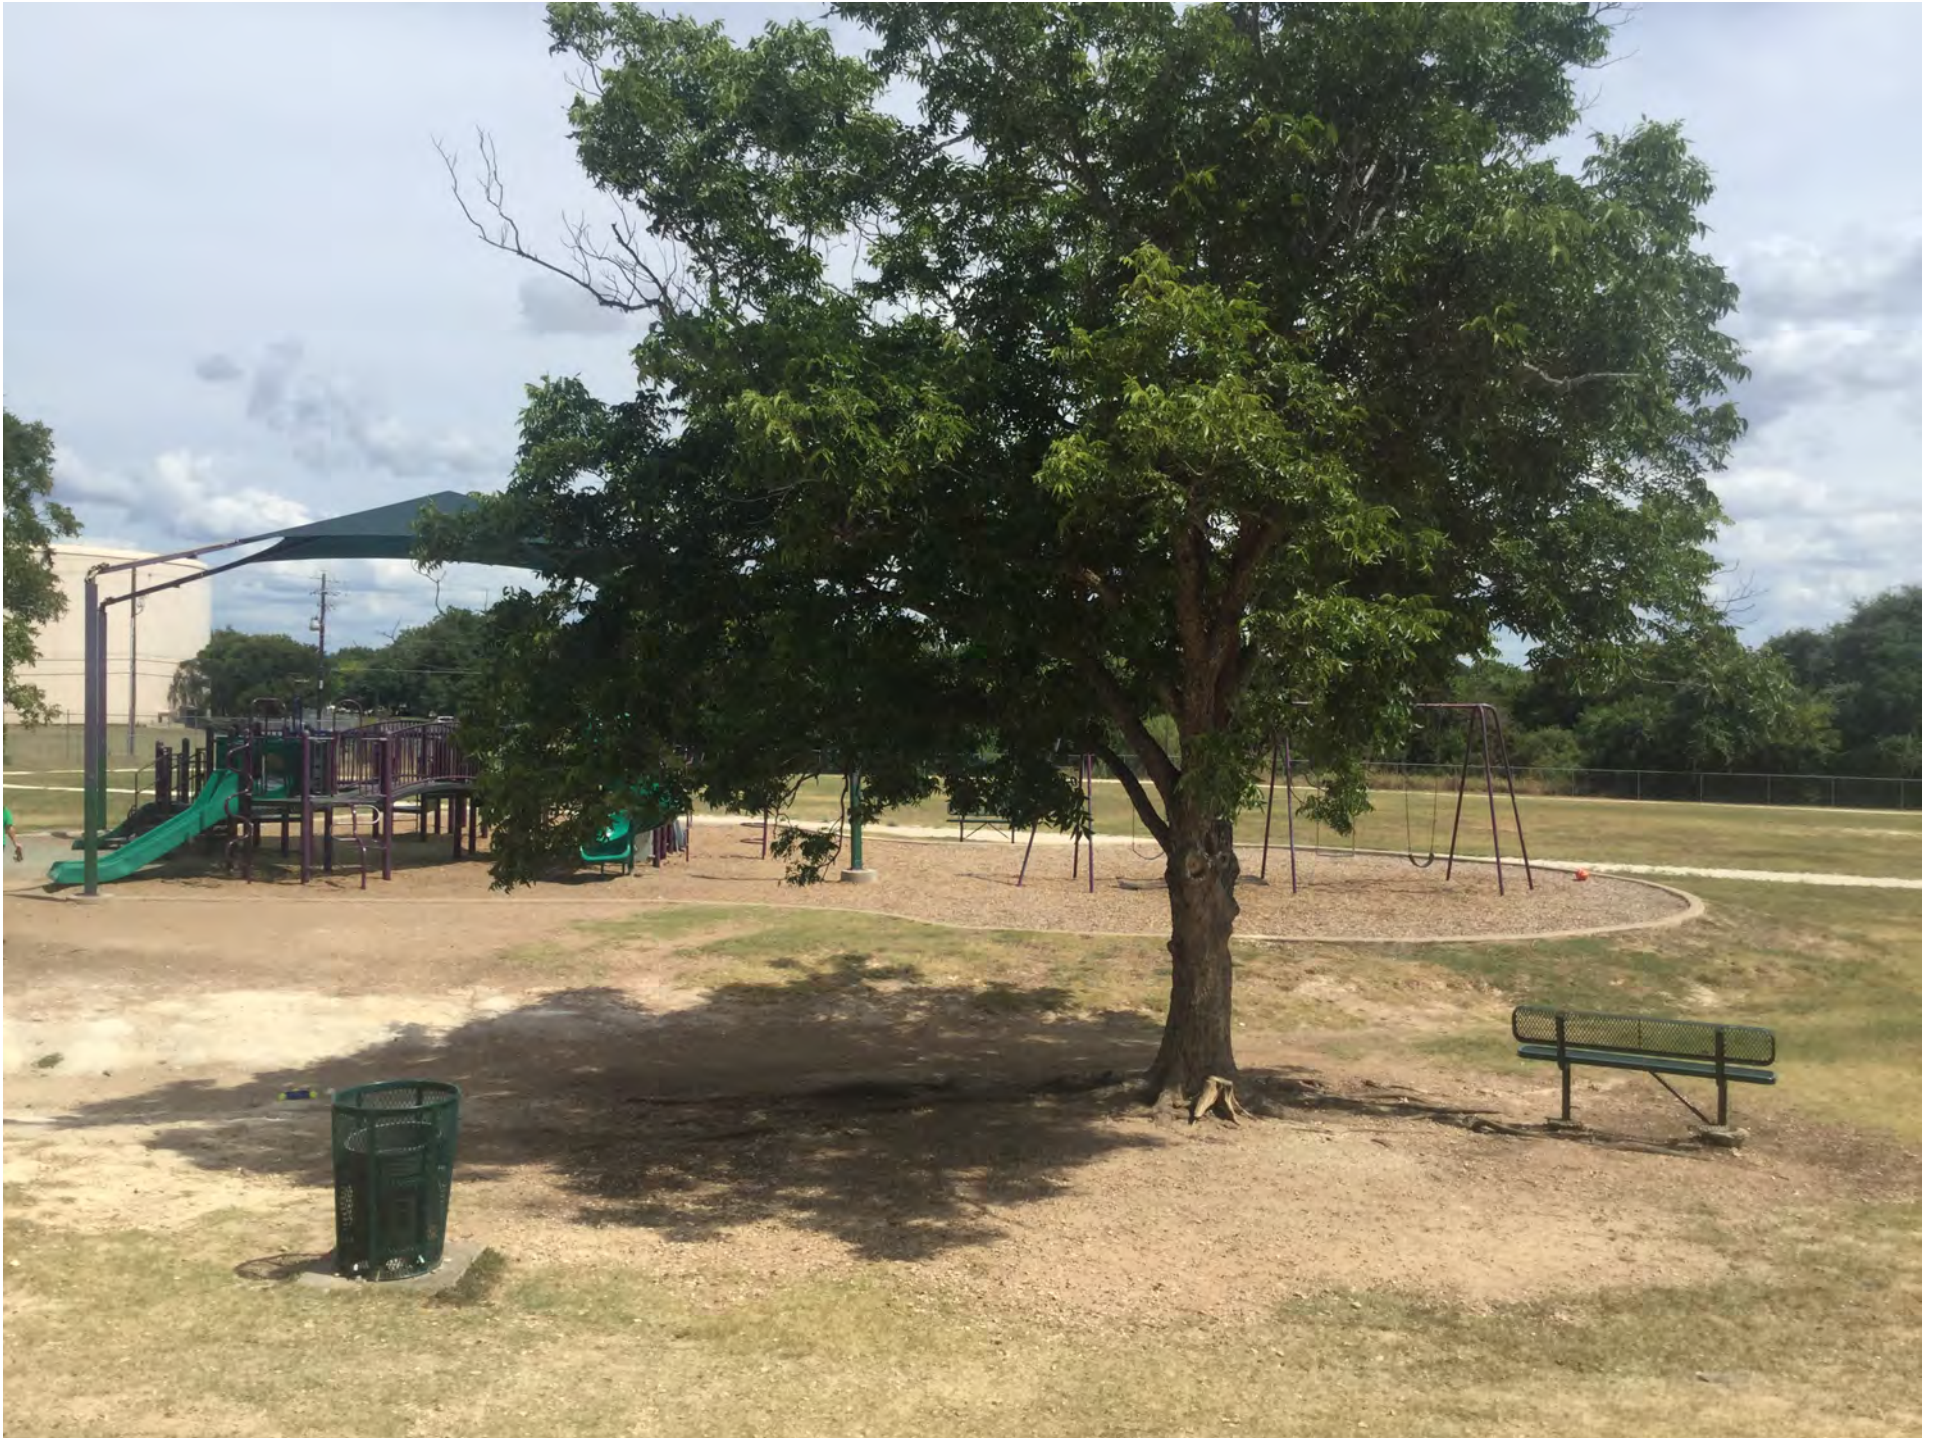
Photo 1.
1.3 Outdoor Playfields

1.3	Are outdoor play spaces and playfields adequate in size and configuration?					5		Comments	1.00 5.00
	1) Outdoor play space exists, not developed 2) Outdoor play space exists but is not connected to gym or other athletic support areas or is too small. 3. Outdoor play spaces exist, are connected to other athletic areas, are the right size, but are not in good condition. 4. Outdoor play spaces need minor improvements to function well. 5. Outdoor play spaces are in excellent condition. N/A) Does not apply.							Play spaces in great condition and shaded.	see photo 1

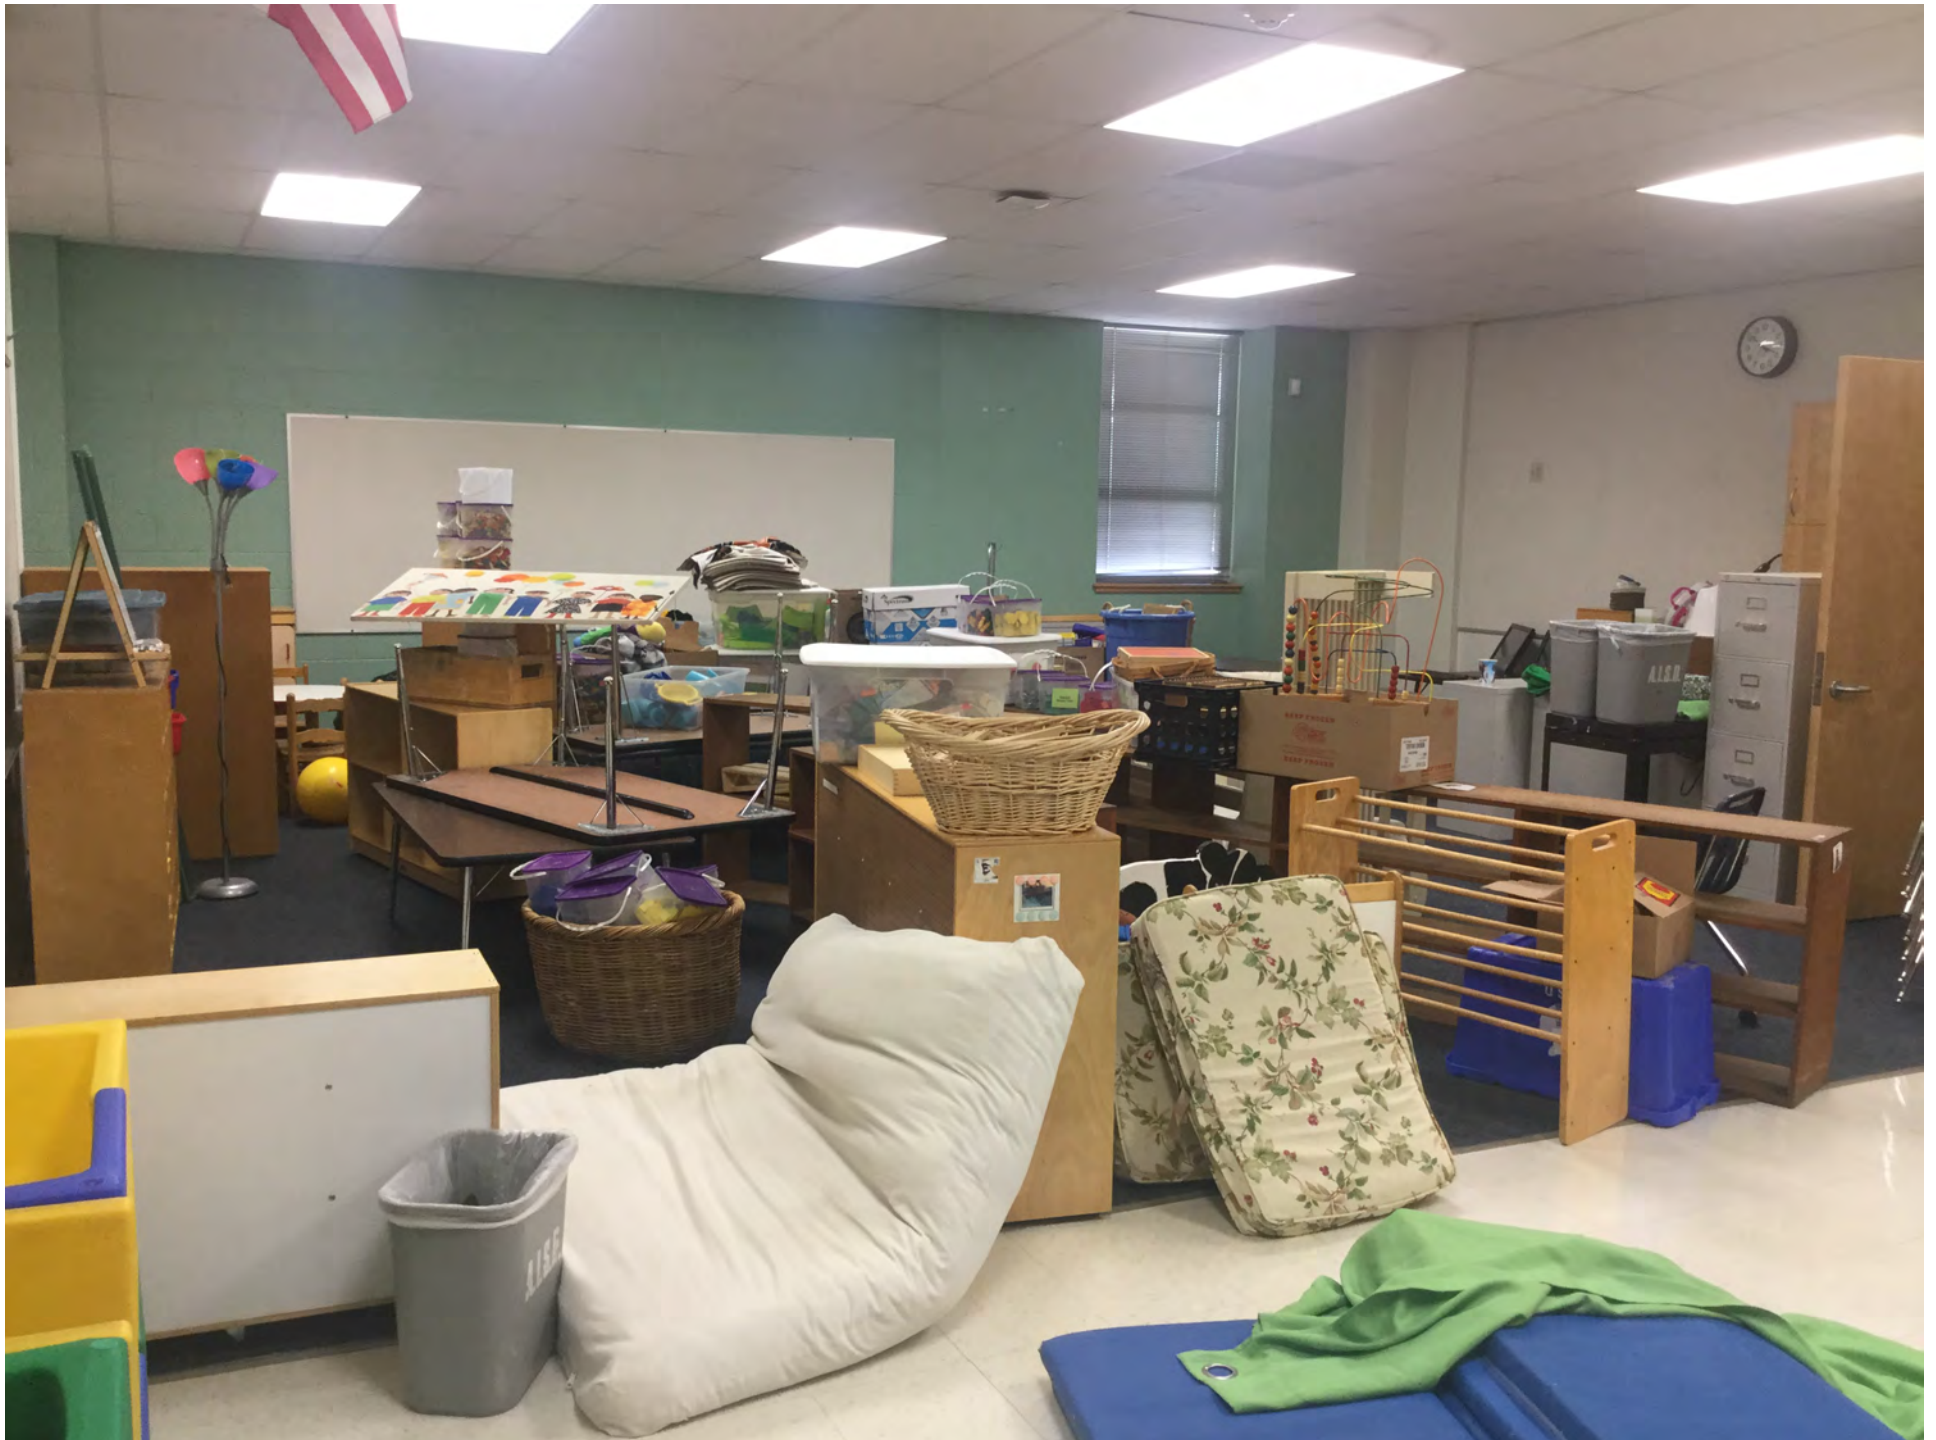
Photo 2.
3.2 Pre-K Space

3 - Academic & Co-Curricular Support		1	2	3	4	5	N/A	48.00	
3.2	Are Pre-K and Kinder classrooms appropriately configured per the ed spec? (elementary school only)				4			Comments	1.00 4.00

1) Very unsatisfactory - Too small, awkward layout, does not meet needs 2) Unsatisfactory - Too small, only one area for all teaching methods, limited flexibility 3) Neutral - Moderate size, two areas for different teaching methods, some flexibility, access to student storage/casework 4) Satisfactory - Good size, at least two zones for different teaching methods, flexibility and student storage, not new 5) Very Satisfactory - Good size, two zones for different teaching methods, flexibility and student storage/casework, adequate display area and visual teaching tools N/A) Does not apply.									
		see photo 2

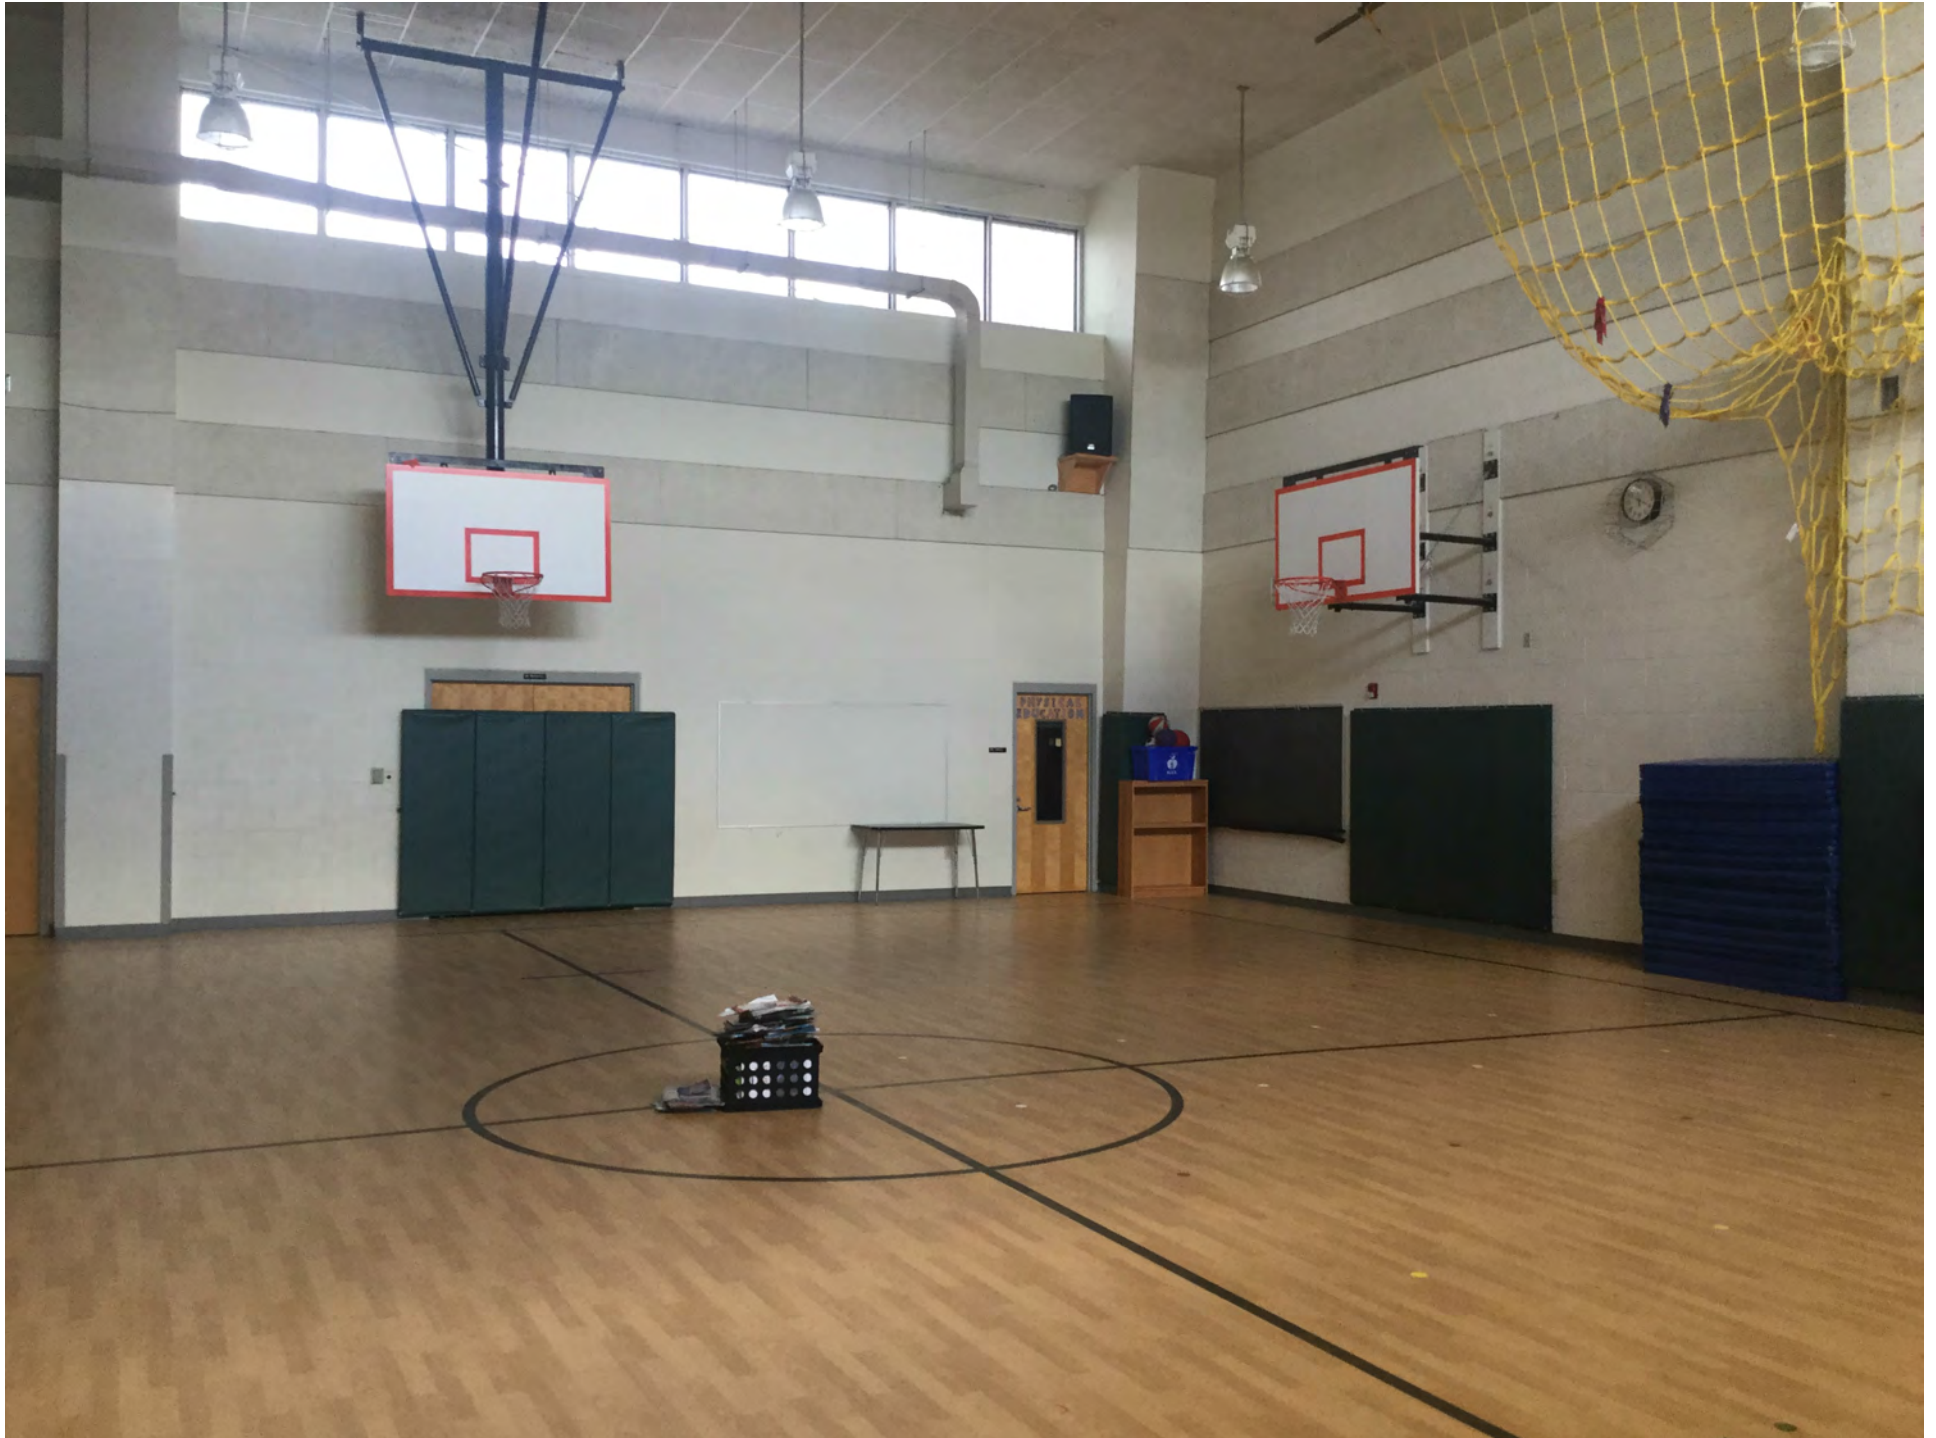
Photo 3.
3.6 Gym

1) Very unsatisfactory 2) Unsatisfactory 3) Average 4) Good 5) Very good N/A) Does not apply.						Gym needs to be closer to the playfield and play spaces.				
see photo 3

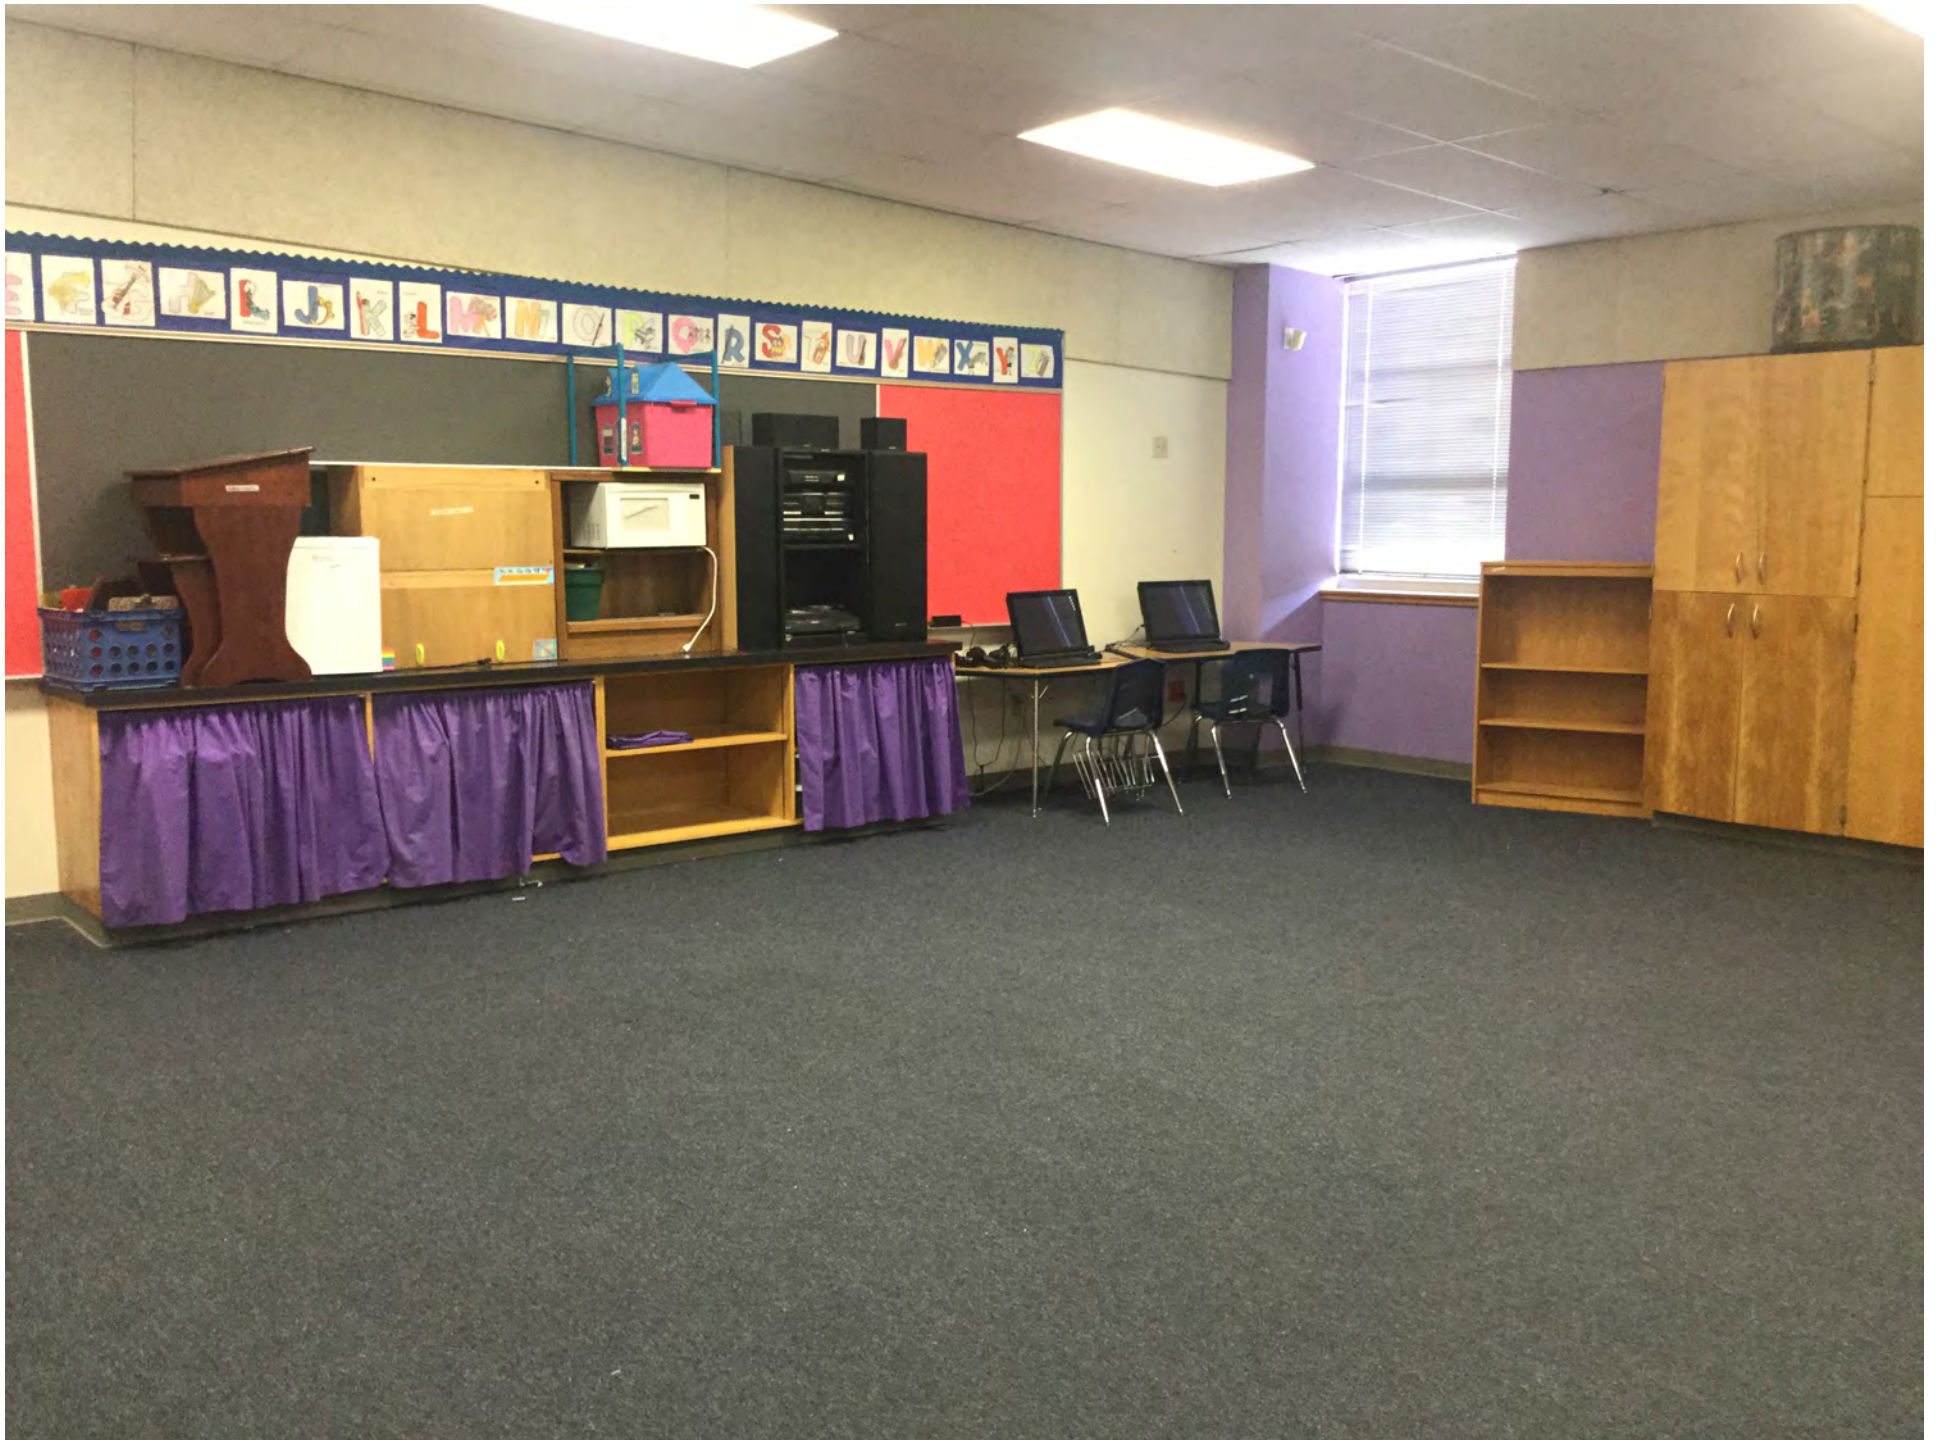
Photo 4.
3.8 Music Room

3.8	Are music, drama, or performance spaces appropriately configured per the ed spec?				4			Comments			1.00	4.00
		1) Very unsatisfactory 2) Unsatisfactory 3) Average 4) Good 5) Very good N/A) Does not apply.						Music Room is in excellent condition but there is also a music room in a portable.				
see photo 4

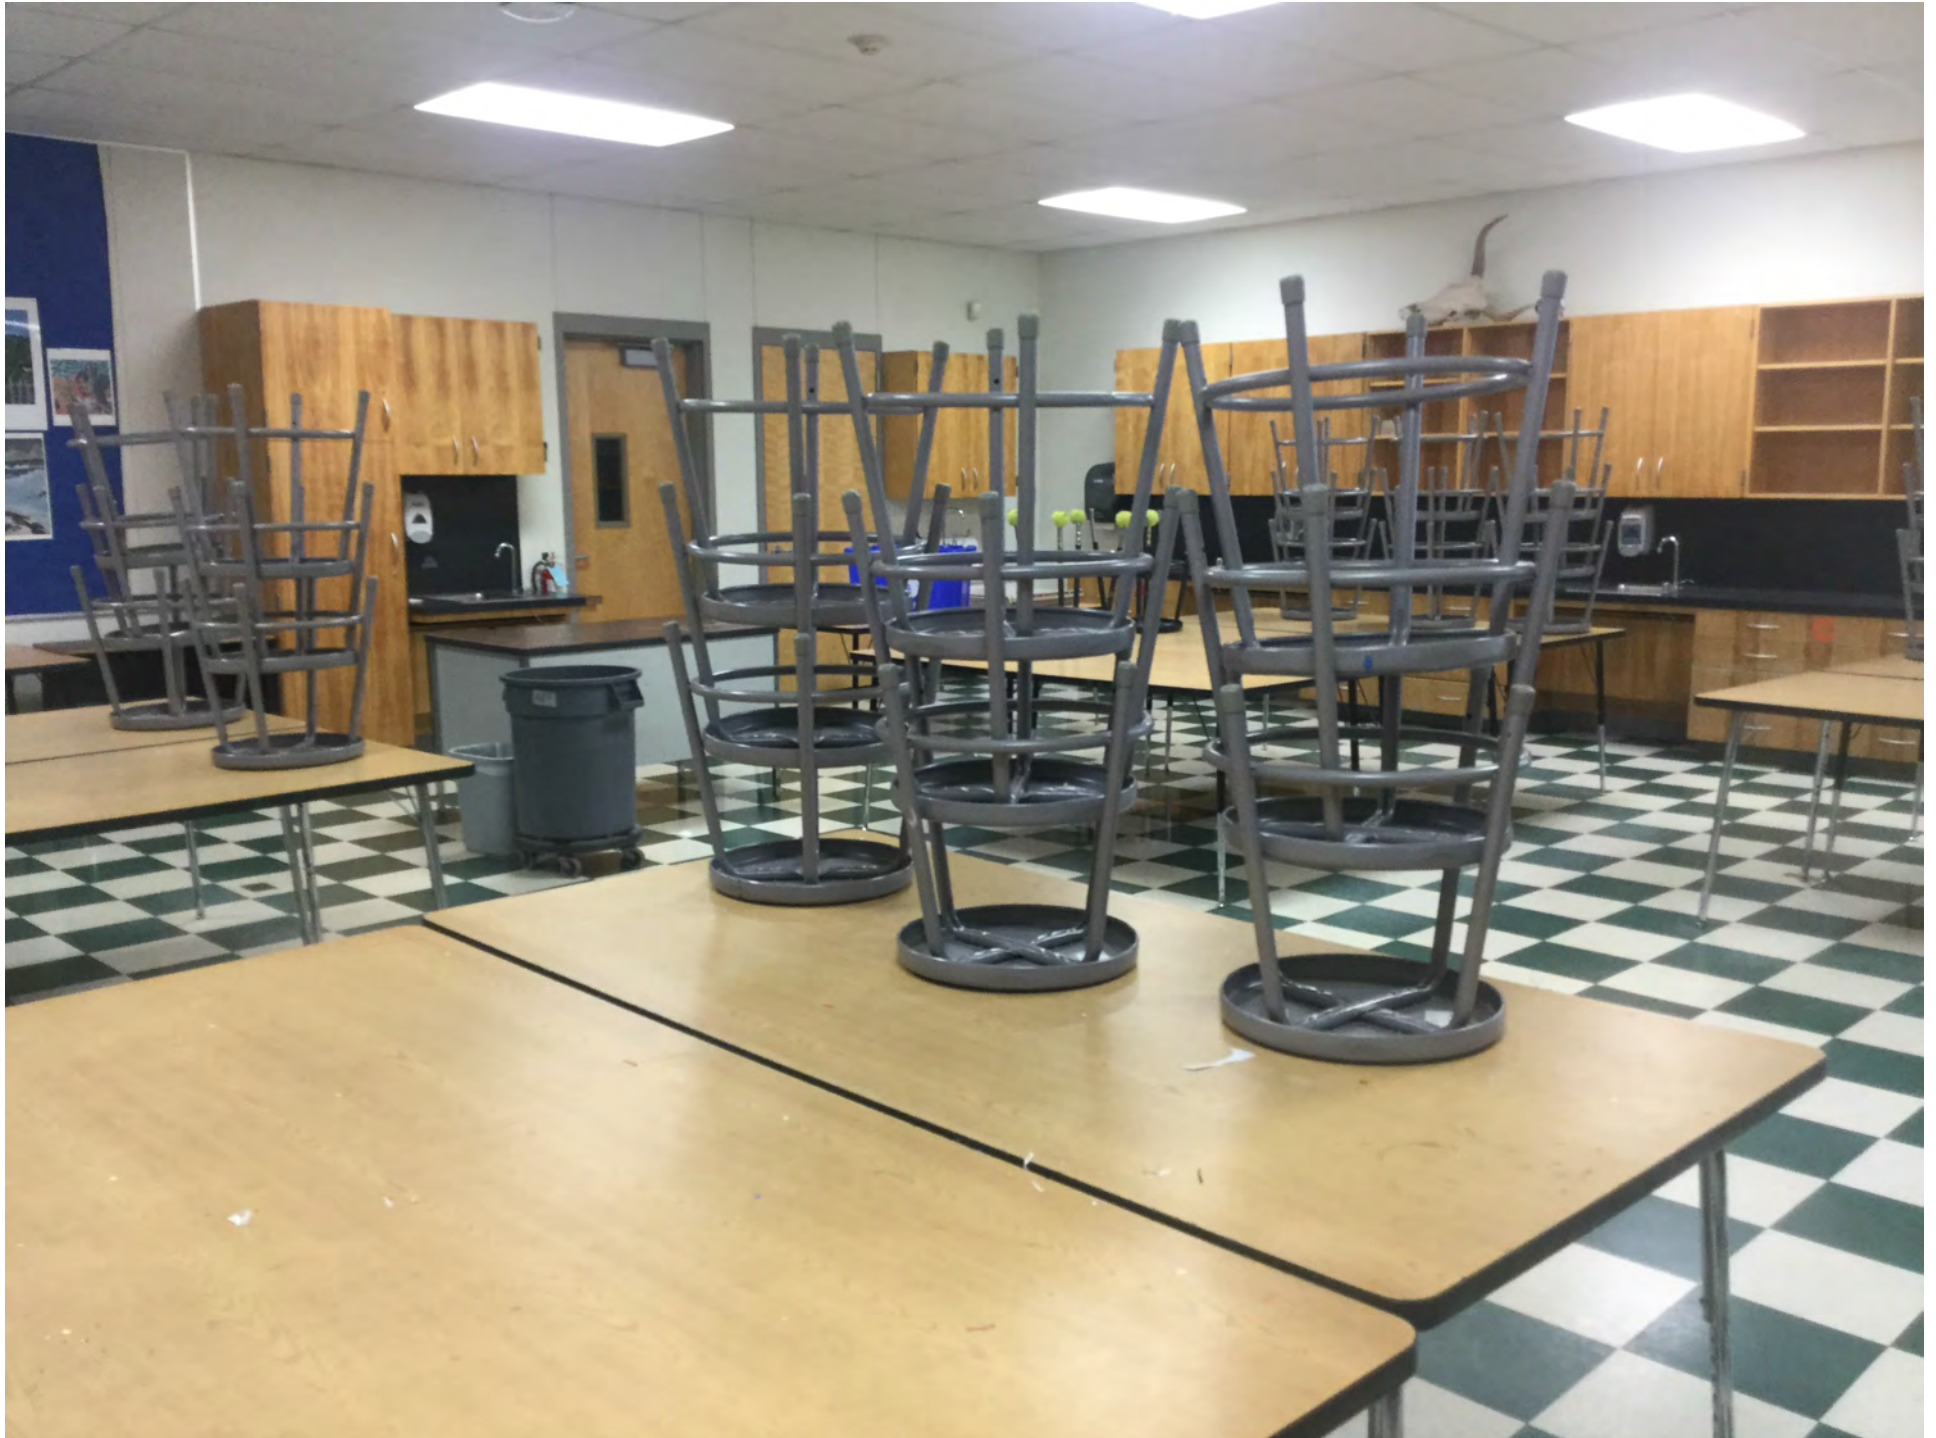
Photo 5.
Art Room

1) Very unsatisfactory 2) Unsatisfactory 3) Average 4) Good 5) Very good N/A) Does not apply.													Main Art Room is in excellent condition but there is also an art room in a portable.

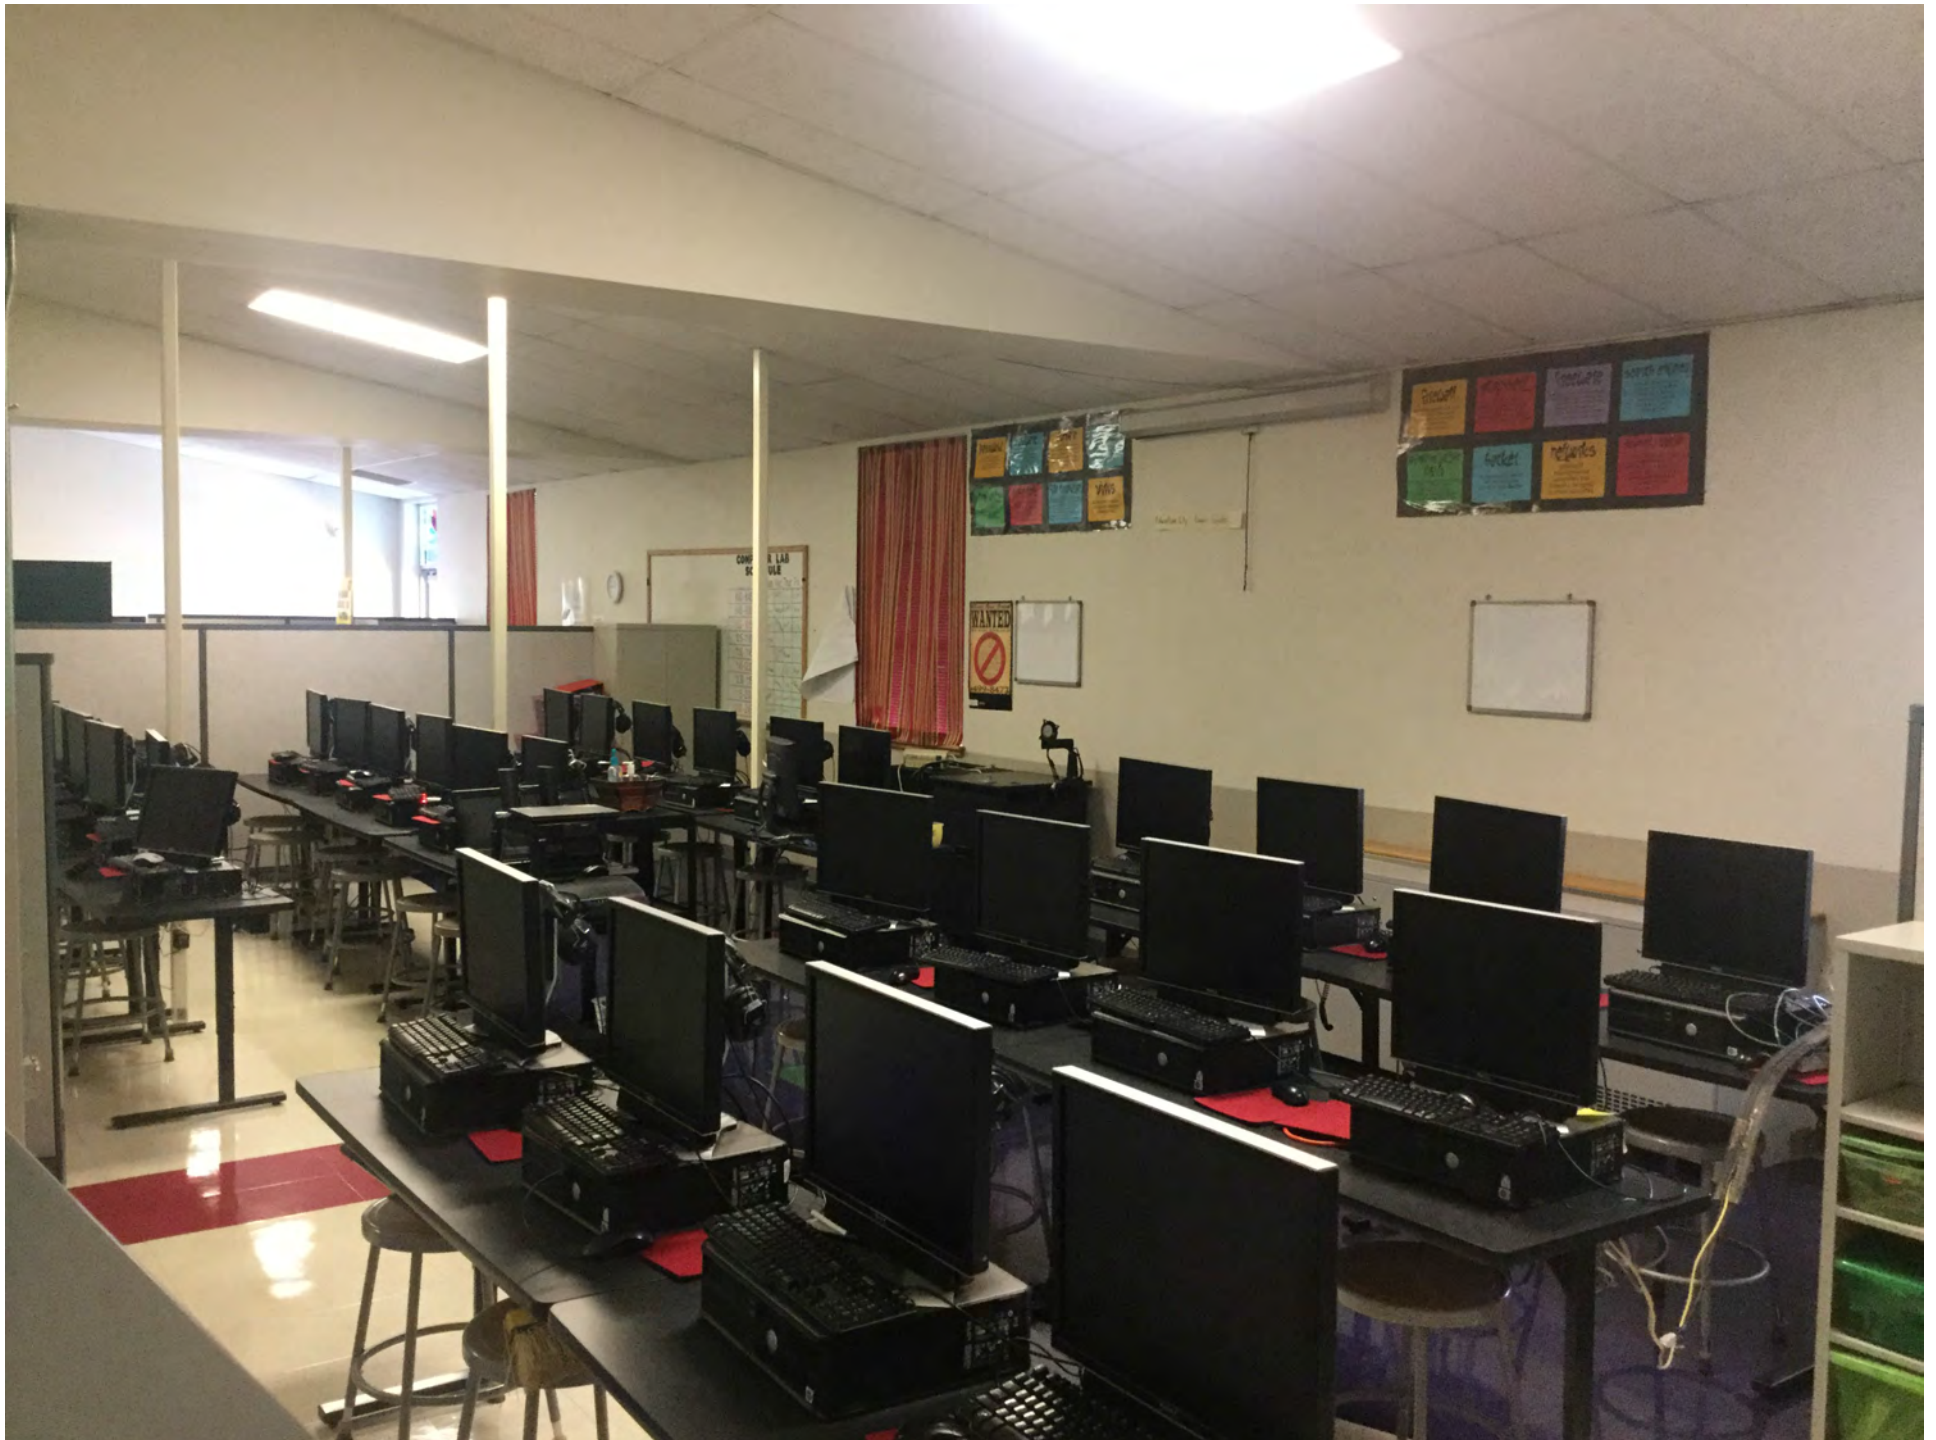
Photo 6.
3.12 Computer Lab

3.12	Are computer lab spaces appropriately configured?													3				Comments		1.00	3.00
1) Very unsatisfactory 2) Unsatisfactory 3) Average 4) Good 5) Very good N/A) Does not apply.													Plenty of technology is available but the computer lab has no real secure space. The lab is in an open hallway with partition walls.

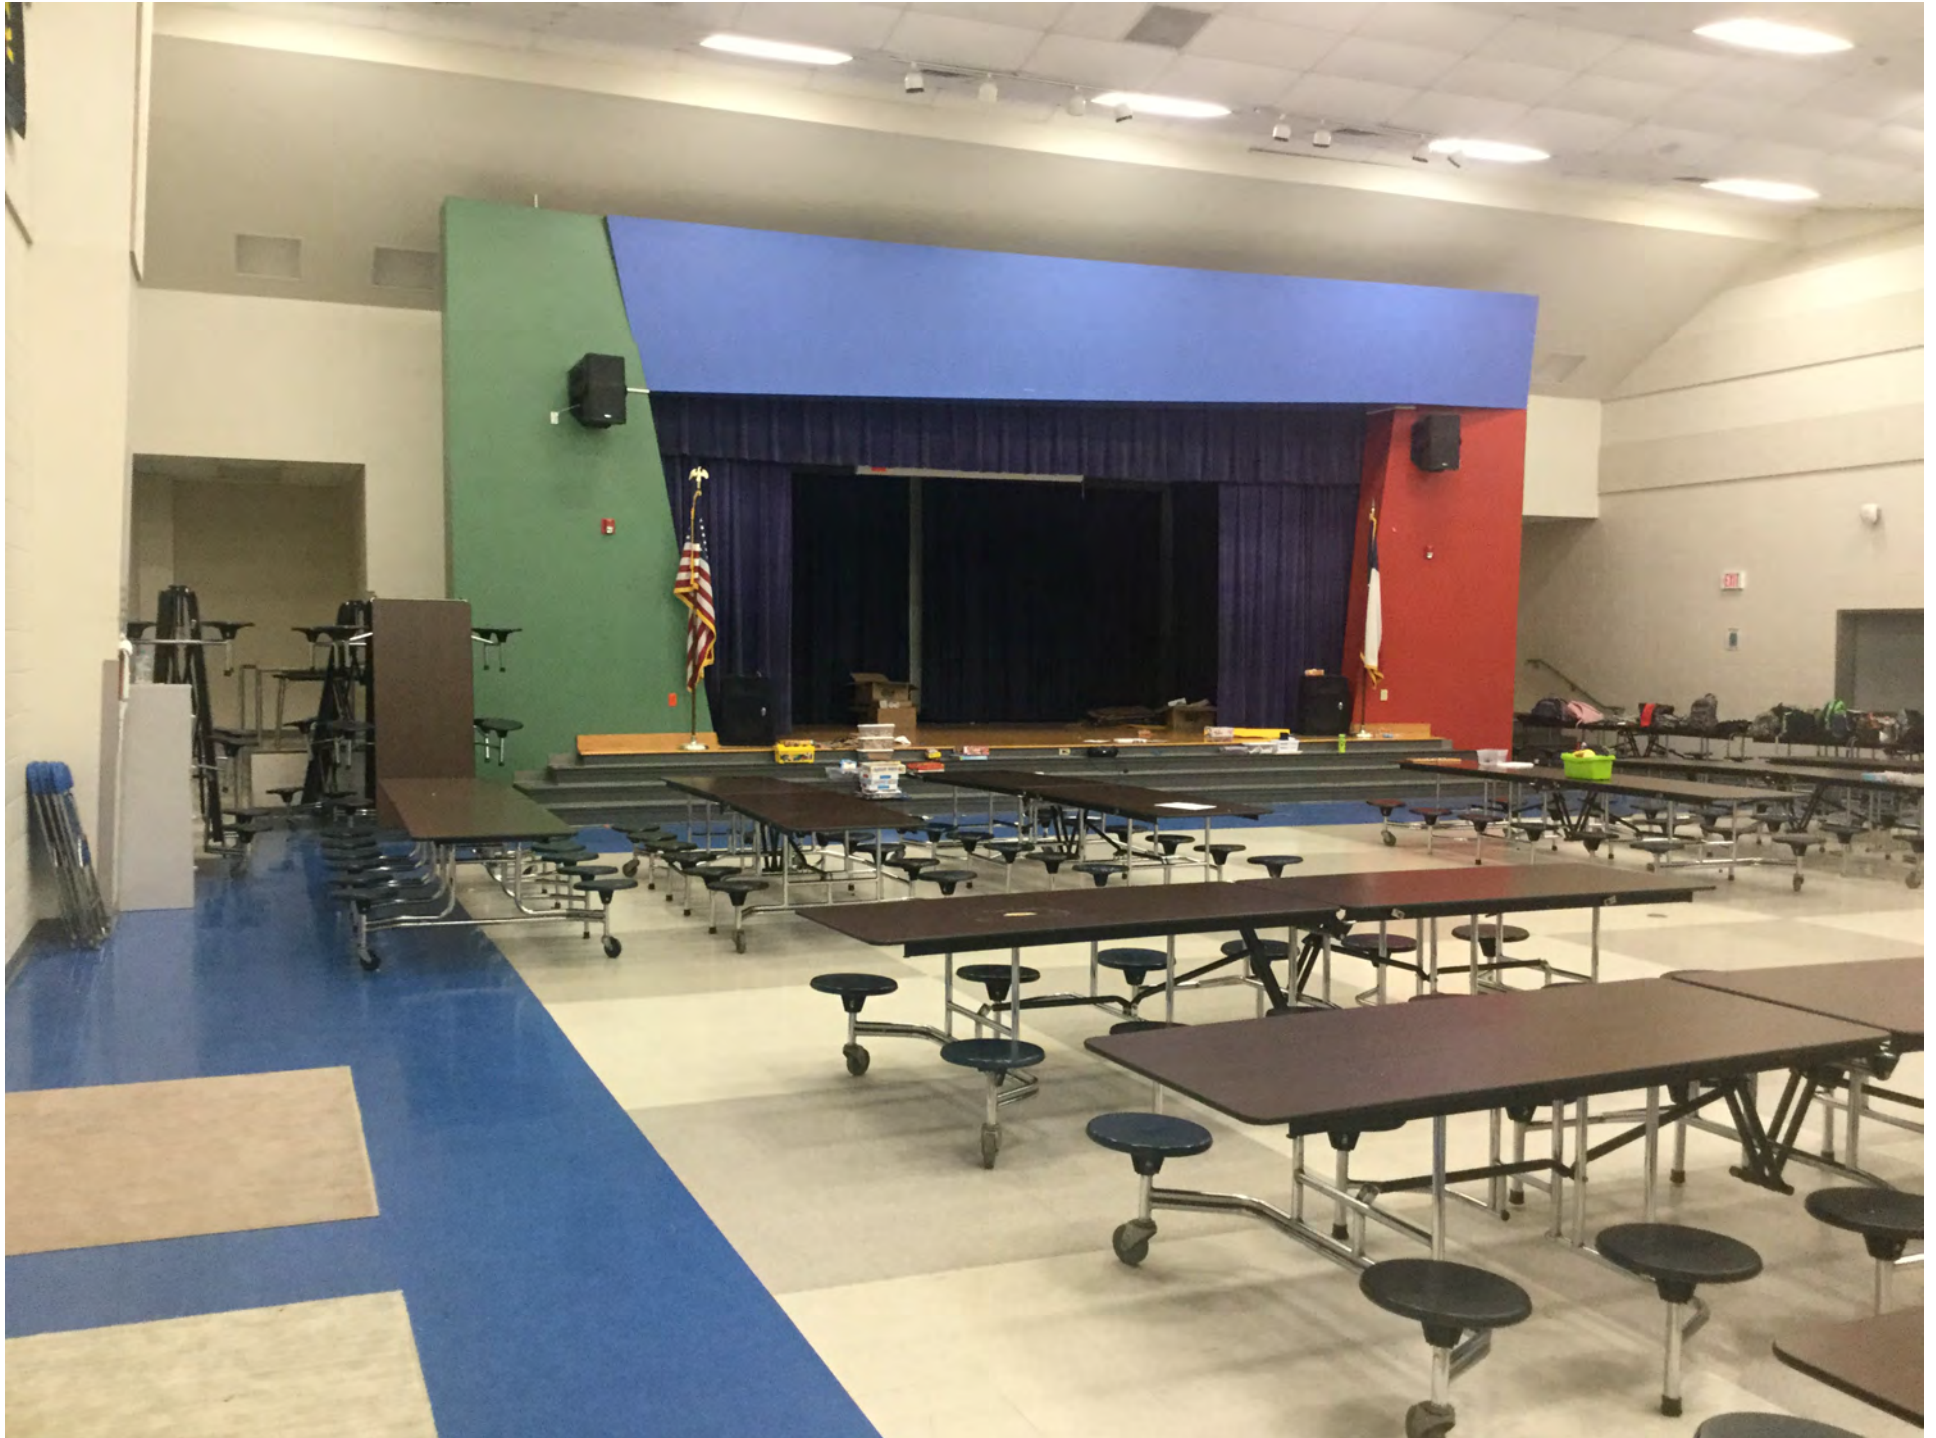
Photo 7.
3.16 Cafetorium

3.16	Are the student dining facilities appropriately configured?				4			Comments	1.00 4.00
1) Very unsatisfactory - Too small, poor circulation, inflexible seating in poor condition 2) Unsatisfactory - Too small or inadequate circulation, seating in poor condition 3) Average - moderate size, with adequate circulation, seating in okay condition 4) Good - good size, adequate circulation, seating in good condition 5) Very good - good size, adequate circulation, seating in good condition, with more than one option for eating space (ex: connection to outdoor eating space) N/A) Does not apply.							<div>see photo 7</div>
