Educational Suitability Summary Report

Cowan Elementary School

Date: 07/19/2016

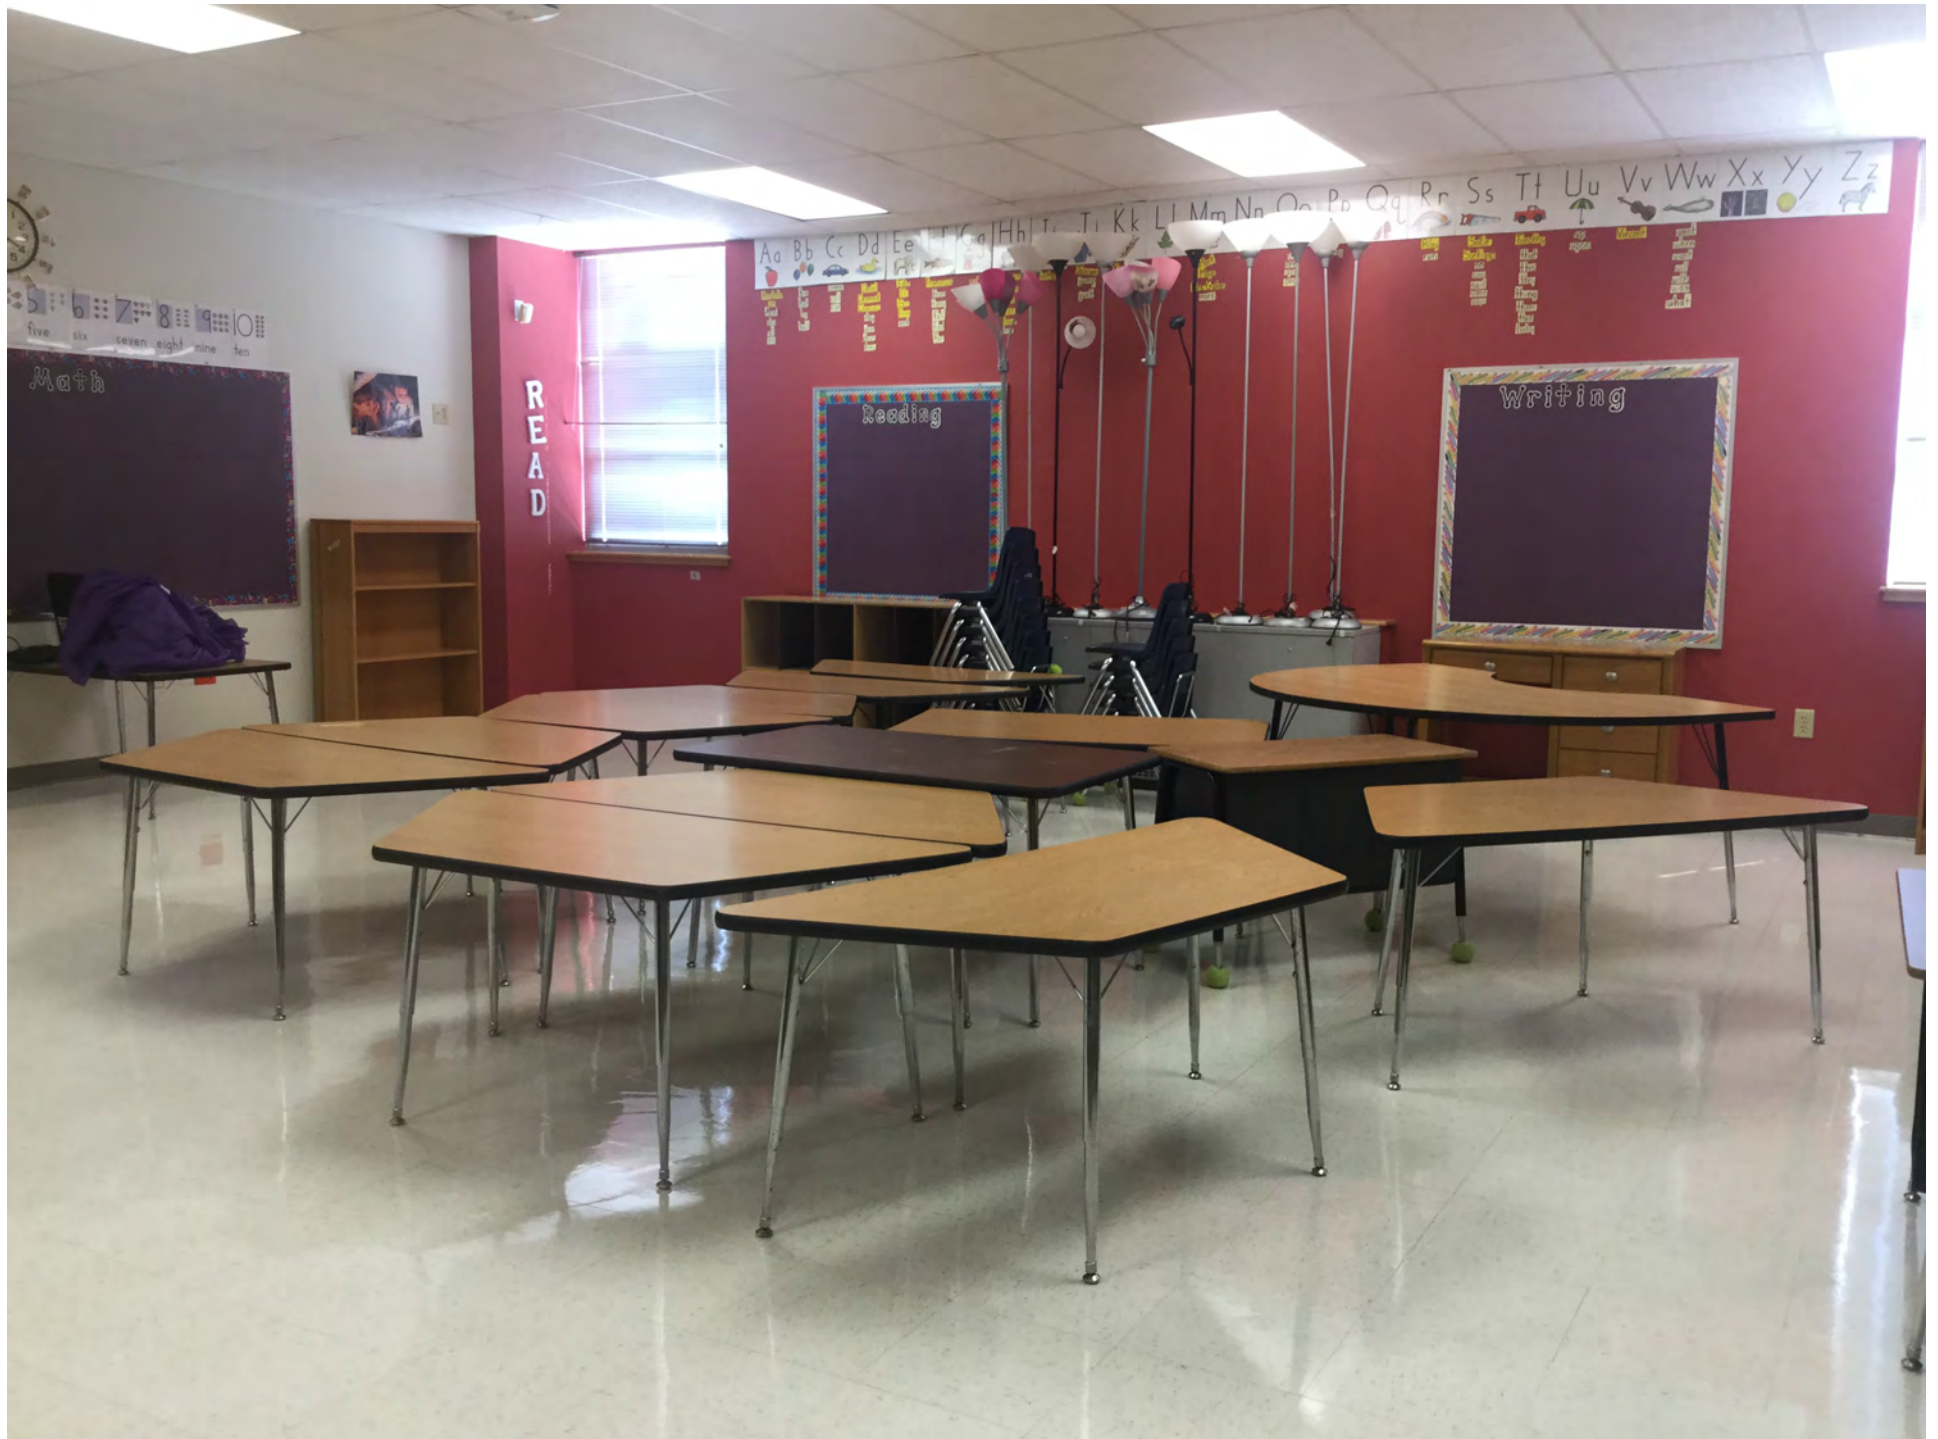
Photo 8.
4.2 Standard Classroom

4.2	Are general classrooms large enough to support project-based learning and multiple teaching modalities?				4			Comments	1.00	4.00
1) Very unsatisfactory -too small to move, set for lecture only, no connectivity, no flexibility 2) Unsatisfactory - adequate size but set for lecture only, no connectivity, no flexibility 3) Neutral - have flexibility and space for hands on or project based learning 4) Satisfactory - have flexibility and space for hands on or project based learning and connectivity for global learning 5) Very Satisfactory - space for hands on learning, flexibility for different groupings, and connectivity for global classrooms N/A) Does not apply.									see photo 8

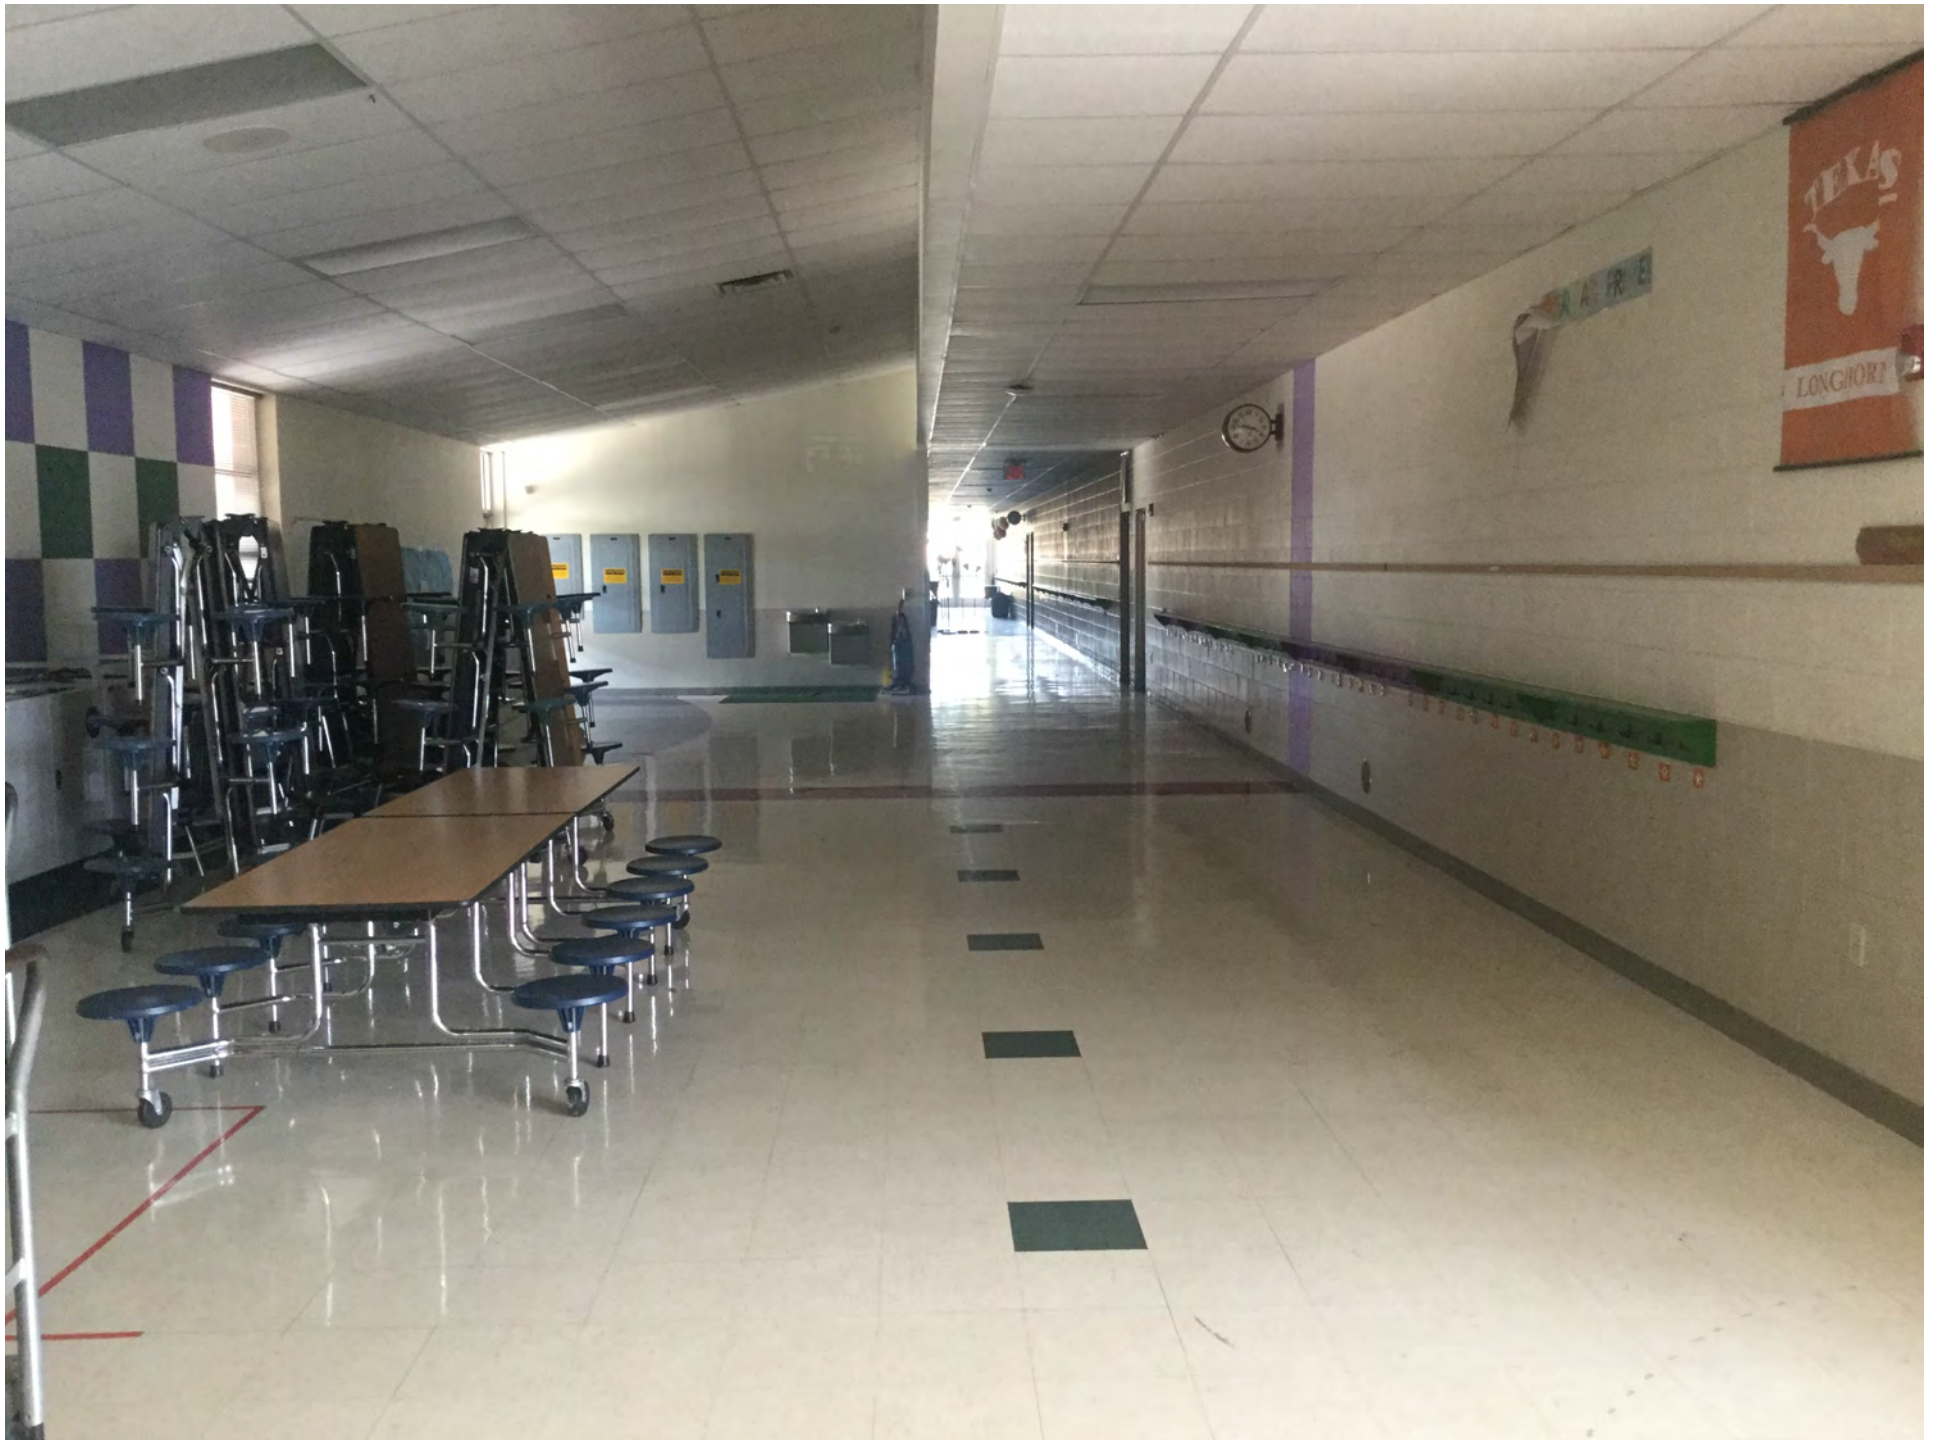
Photo 9.
4.5 Collaborative Space

1) Very unsatisfactory - no common spaces or meeting rooms or in very poor condition 2) Unsatisfactory - a few common spaces or meeting rooms in unsatisfactory condition 3) Average - a few common spaces and meeting areas needing updates 4) Good - multiple common spaces and meeting rooms in good condition 5) Very good - adequate common spaces and meeting rooms of excellent quality N/A) Does not apply.							There is a lack of adequate conference room space. There is only one real student pod area which is appropriated for morning assemblies.		
see photo 9

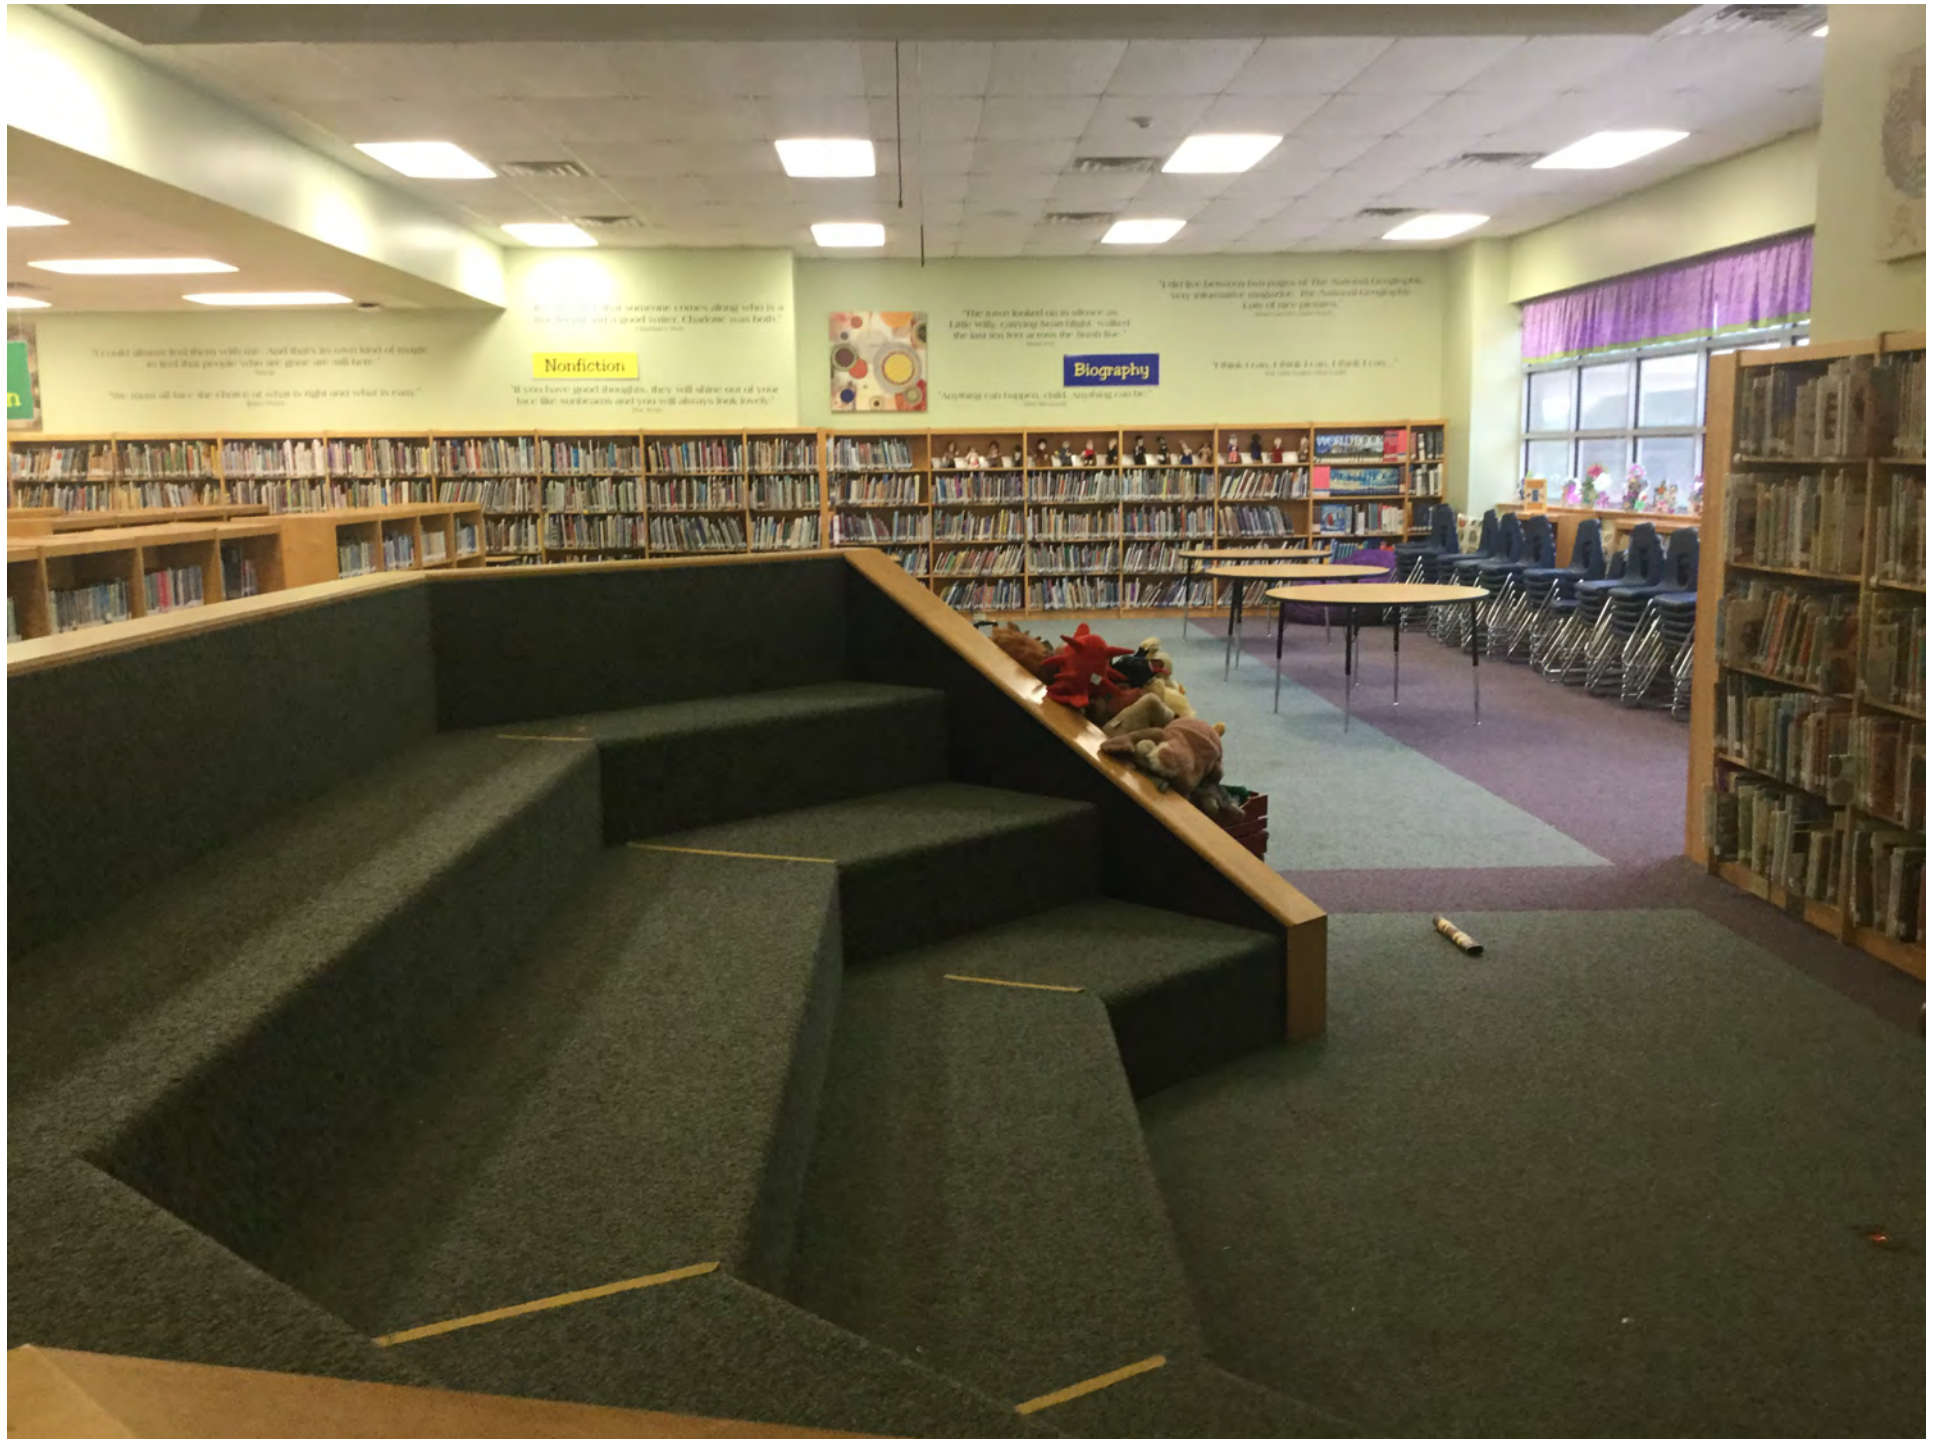
Photo 10.
5.3 Library

1) Very unsatisfactory 2) Unsatisfactory 3) Average 4) Good 5) Very good N/A) Does not apply.								see photo 10	
5.4	How well does the Library/Media Center support collaborative work in small groups (4-8 students)?					5		Comments	1.005.00
