Educational Suitability Summary Report

Cunningham Elementary School – BLDG # 113

Date: 07/26/2016

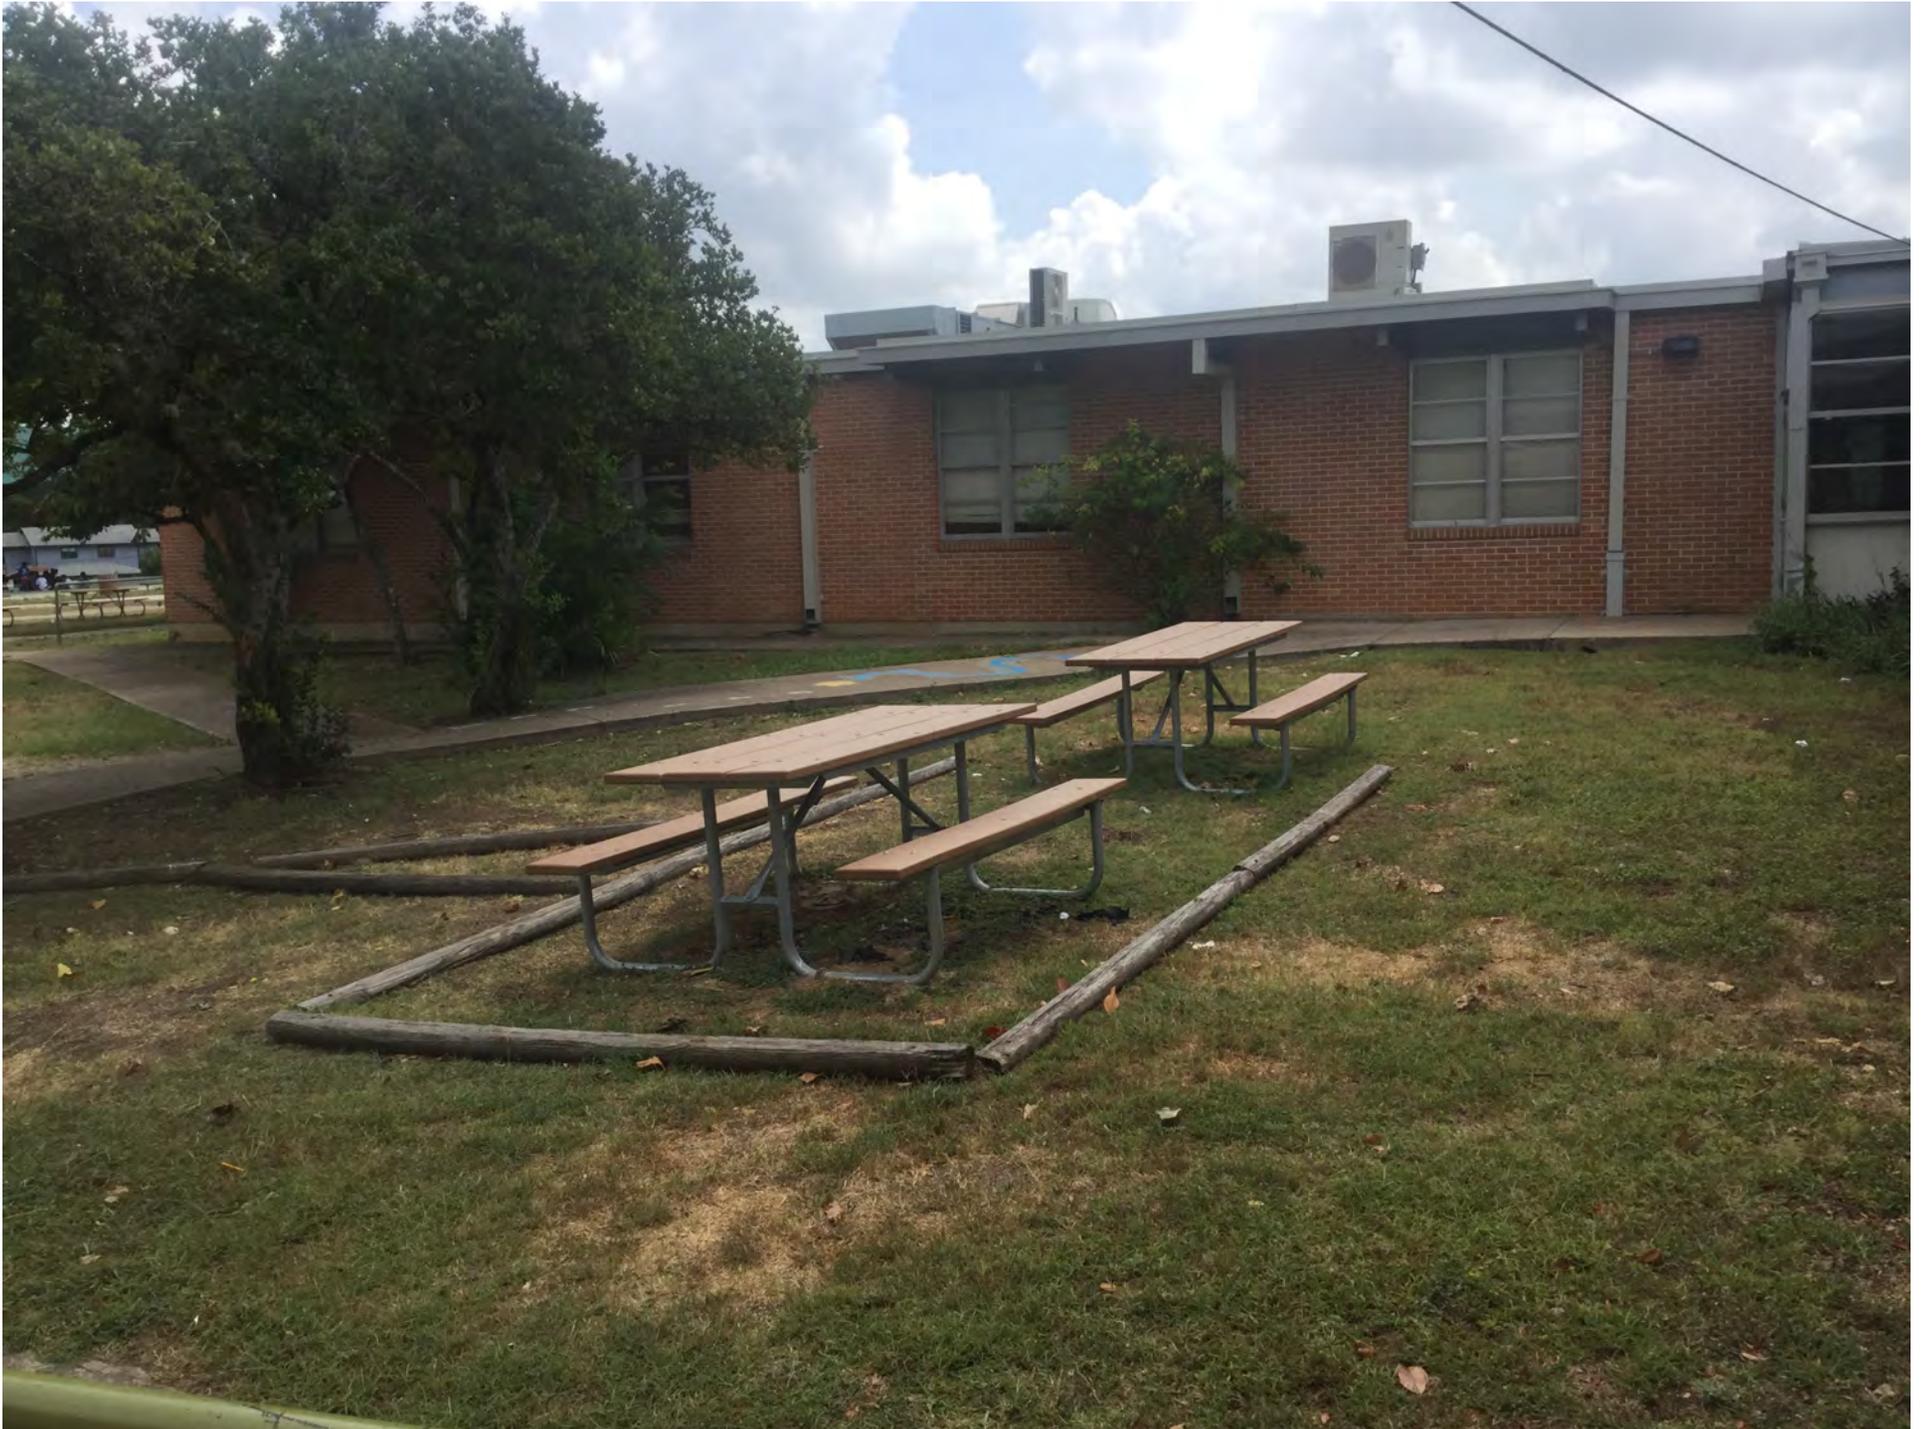
Photo 1. outdoor spaces

1.2	Are opportunities provided for outdoor learning (outdoor classrooms, gardens, etc.)?				4			Comments	1.00	4.00
1) Outdoor space exists is not developed 2)Outdoor space for learning exists but not connected to classroom learning areas. 3. Outdoor learning spaces exist and are accessible but not in good condition. 4. Outdoor learning spaces need minor improvements to function well. 5. Outdoor learning spaces are in excellent condition. N/A) Does not apply.								There is good access to the exterior.	See Image 1

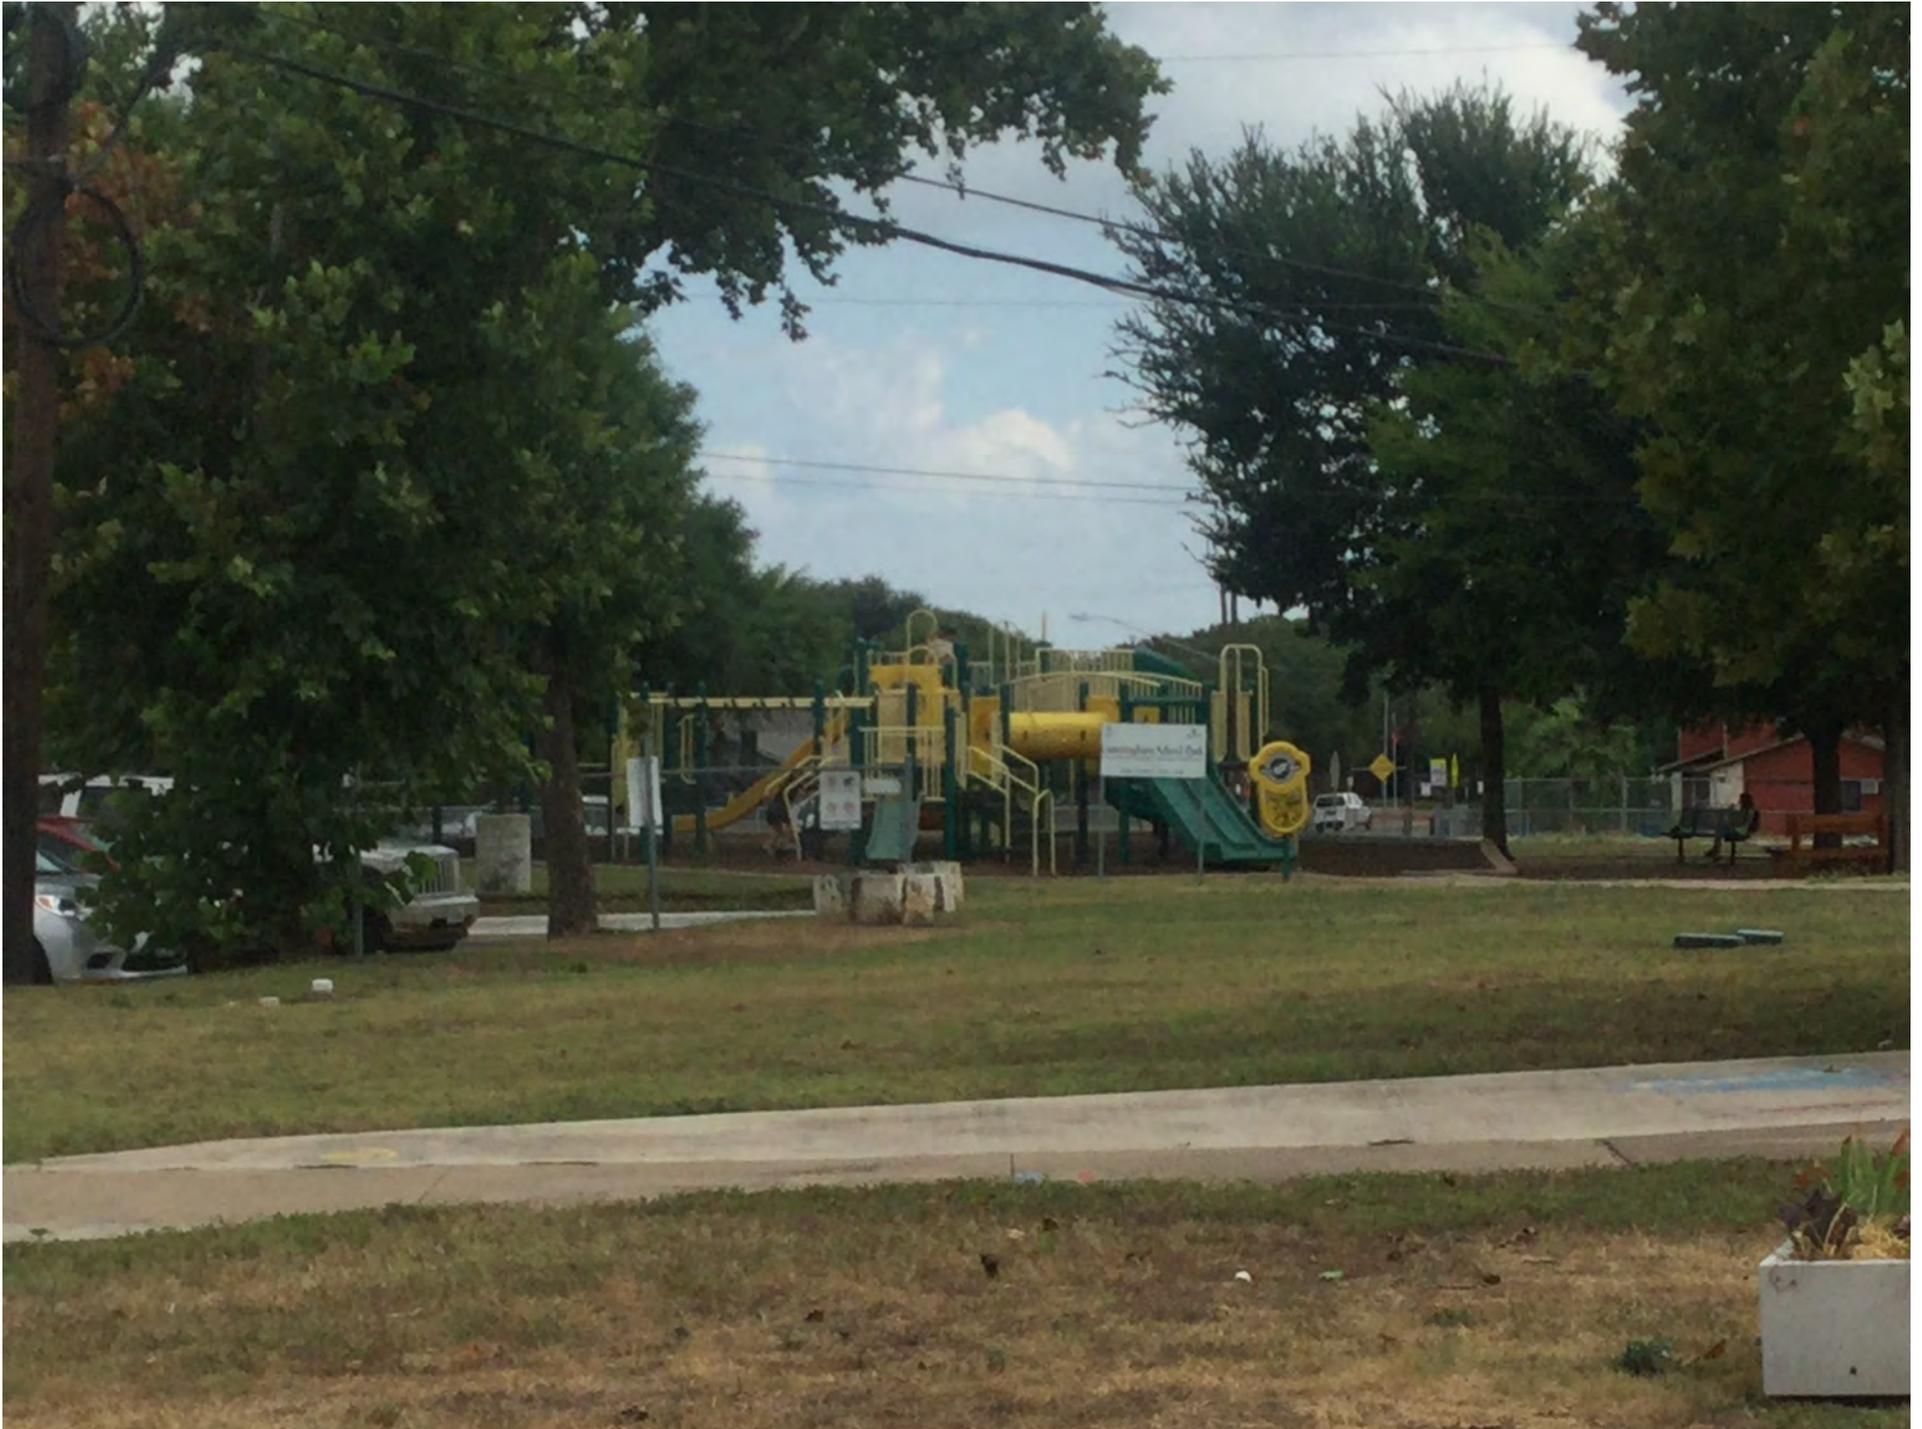
Photo 2. Playground

1.3	Are outdoor play spaces and playfields adequate in size and configuration?			3				Comments	1.00	3.00
1) Outdoor play space exists, not developed 2)Outdoor play space exists but is not connected to gym or other athletic support areas or is too small. 3. Outdoor play spaces exist, are connected to other athletic areas, are the right size, but are not in good condition. 4. Outdoor play spaces need minor improvements to function well. 5. Outdoor play spaces are in excellent condition. N/A) Does not apply.								The playgrounds are too from the classroom, and additional equipment is needed for the playground.	See image 2

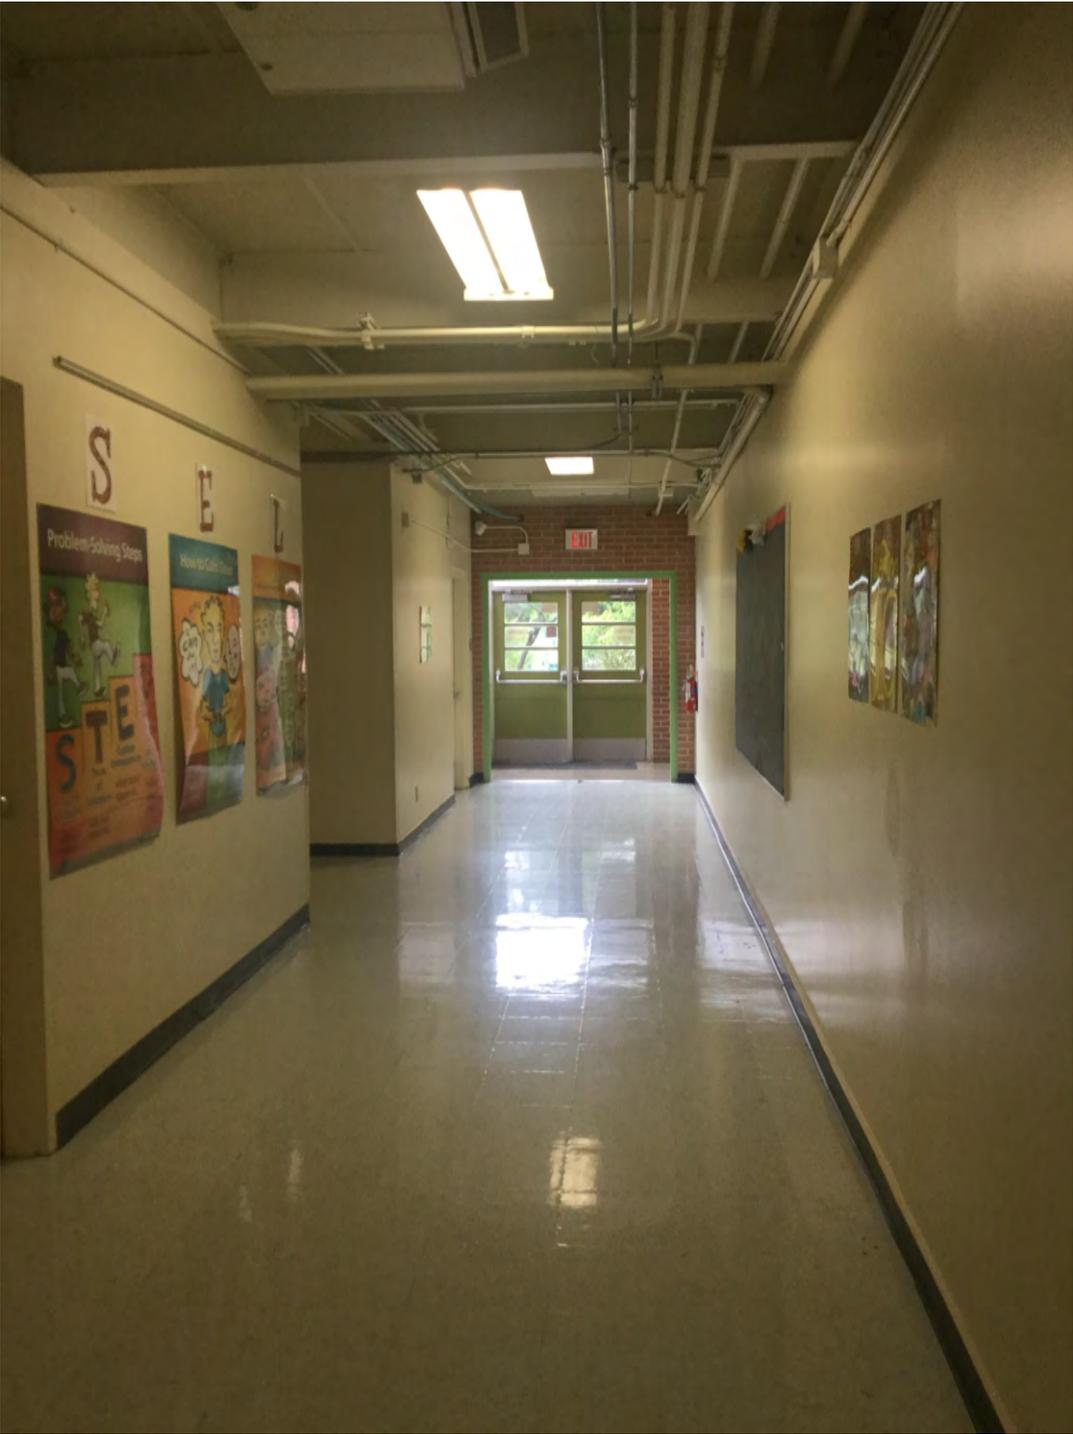
Photo 3. Hallway

1) Primary circulation is 5'-0" to 6'-0" wide. 2) Primary circulation is 6'-0" to 7'-0" wide 3) Primary circulation is 7'-0" to 8'-0" wide 4) Primary circulation is 8'-0"-10'-0" wide 5) Primary circulation is 10'-0"+ wide N/A) Does not apply.		See Image 3

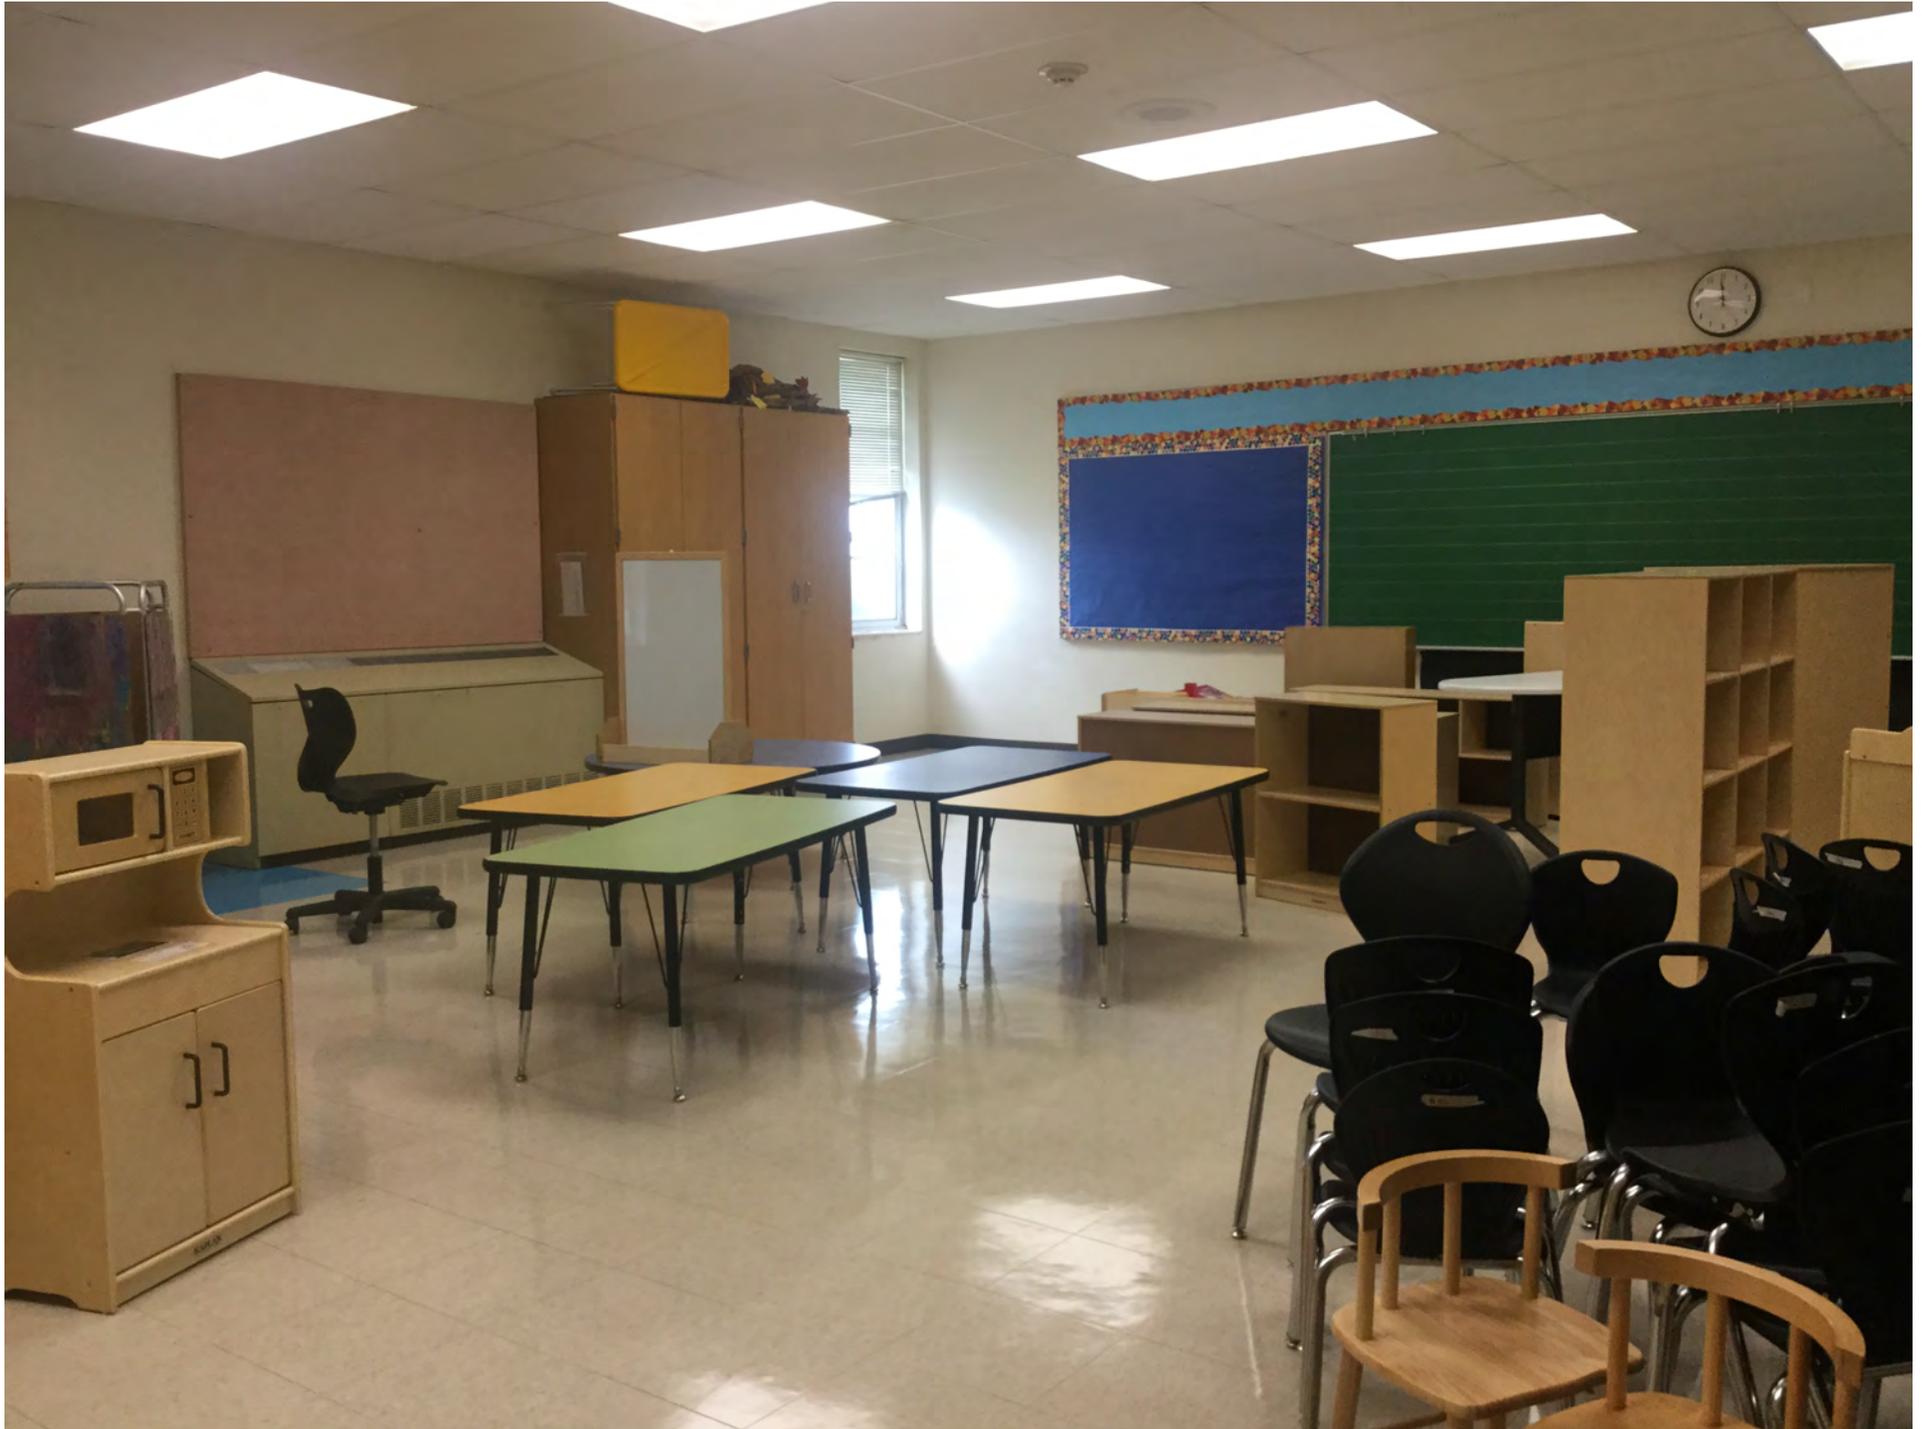
Photo 4. Pre-K Classroom

1) Very unsatisfactory - Too small, awkward layout, does not meet needs 2) Unsatisfactory - Too small, only one area for all teaching methods, limited flexibility 3) Neutral - Moderate size, two areas for different teaching methods, some flexibility, access to student storage/casework 4) Satisfactory - Good size, at least two zones for different teaching methods, flexibility and student storage, not new 5) Very Satisfactory - Good size, two zones for different teaching methods, flexibility and student storage/casework, adequate display area and visual teaching tools N/A) Does not apply.								The classrooms are of sufficient size.	See Image 4

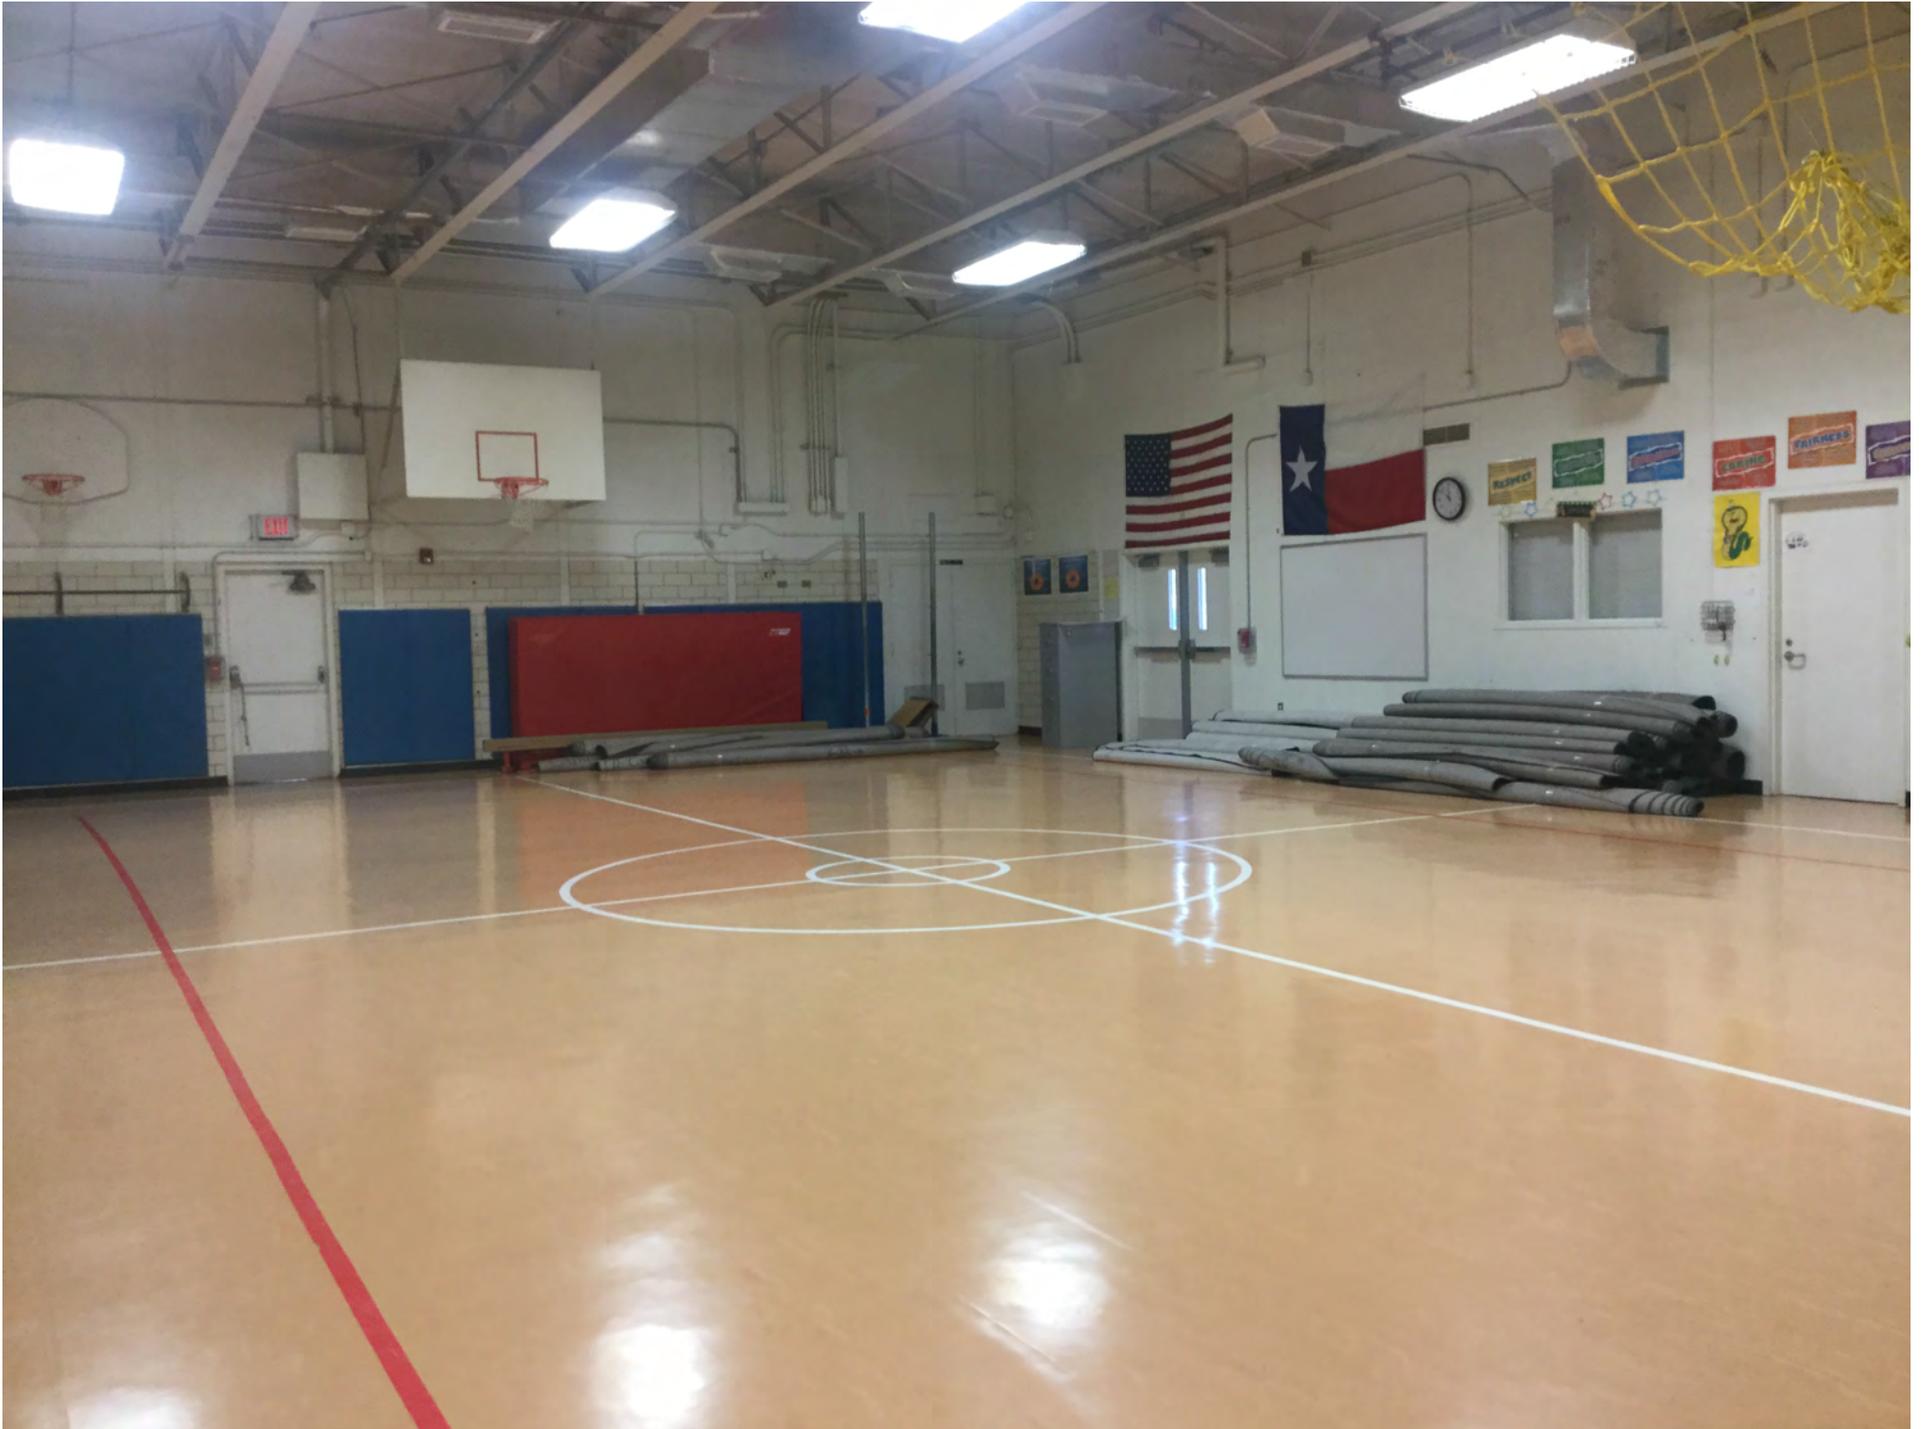
Photo 5. Gym

1) Very unsatisfactory 2) Unsatisfactory 3) Average 4) Good 5) Very good N/A) Does not apply.								The physical education spaces are undersized and not built to Ed spec. They would like to turn this into a multipurpose room and an extension of the cafeteria. A new gym building is needed.		
								See Image 5

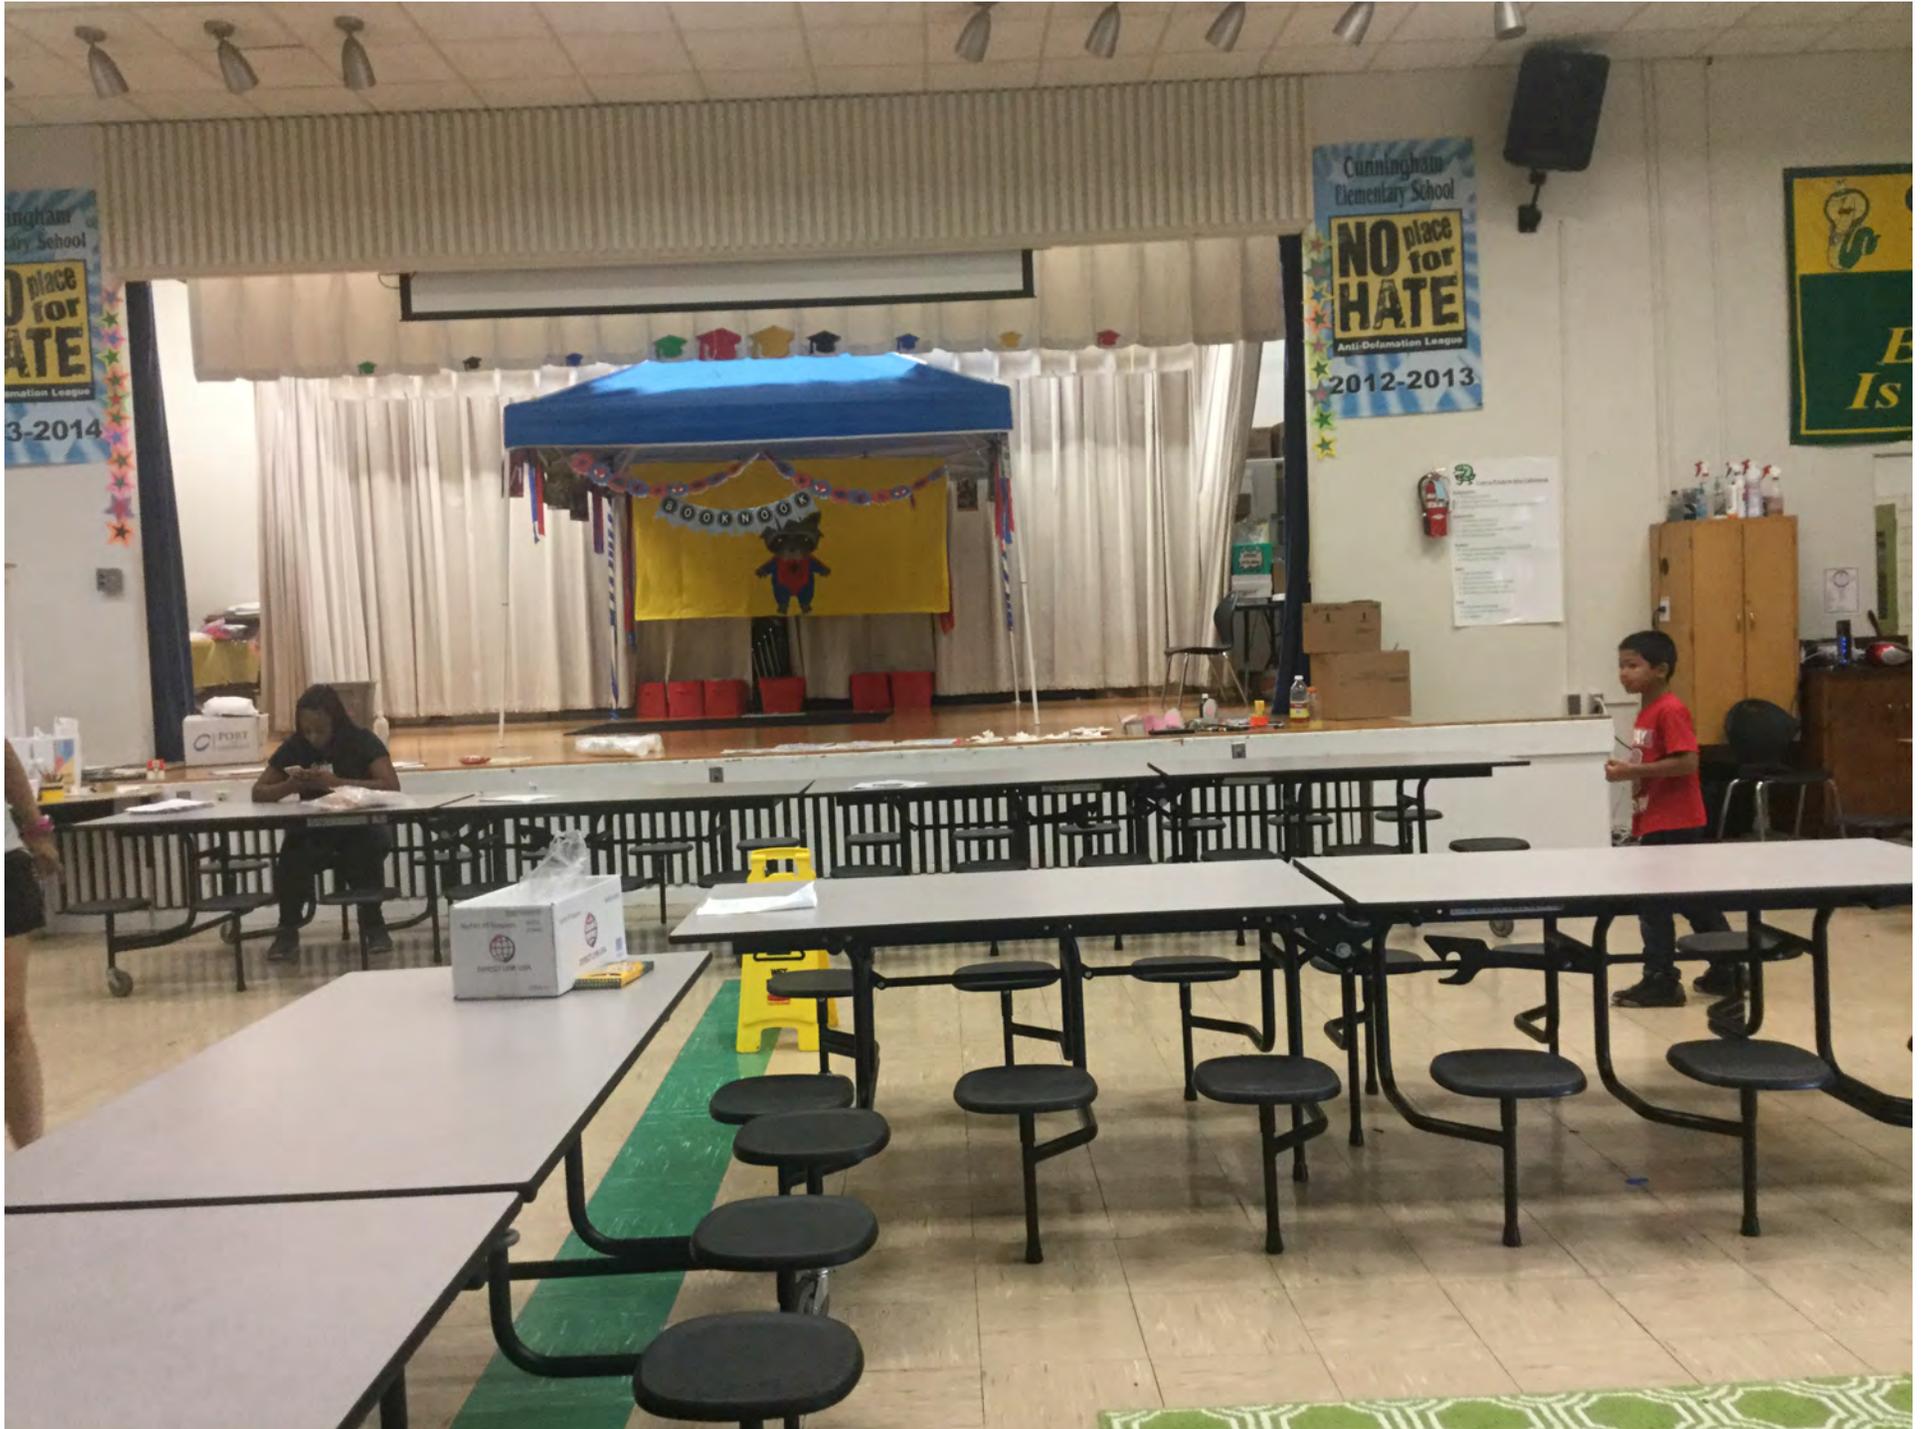
Photo 6. cafeteria

3.16	Are the student dining facilities appropriately configured?				4			Comments	1.00	4.00
1) Very unsatisfactory - Too small, poor circulation, inflexible seating in poor condition 2) Unsatisfactory - Too small or inadequate circulation, seating in poor condition 3) Average - moderate size, with adequate circulation, seating in okay condition 4) Good - good size, adequate circulation, seating in good condition 5) Very good - good size, adequate circulation, seating in good condition, with more than one option for eating space (ex: connection to outdoor eating space) N/A) Does not apply.								The furniture is insufficient and needs to be flexible to be able to set up smaller groups to foster group development, especially with the special needs students.		
								See image 6

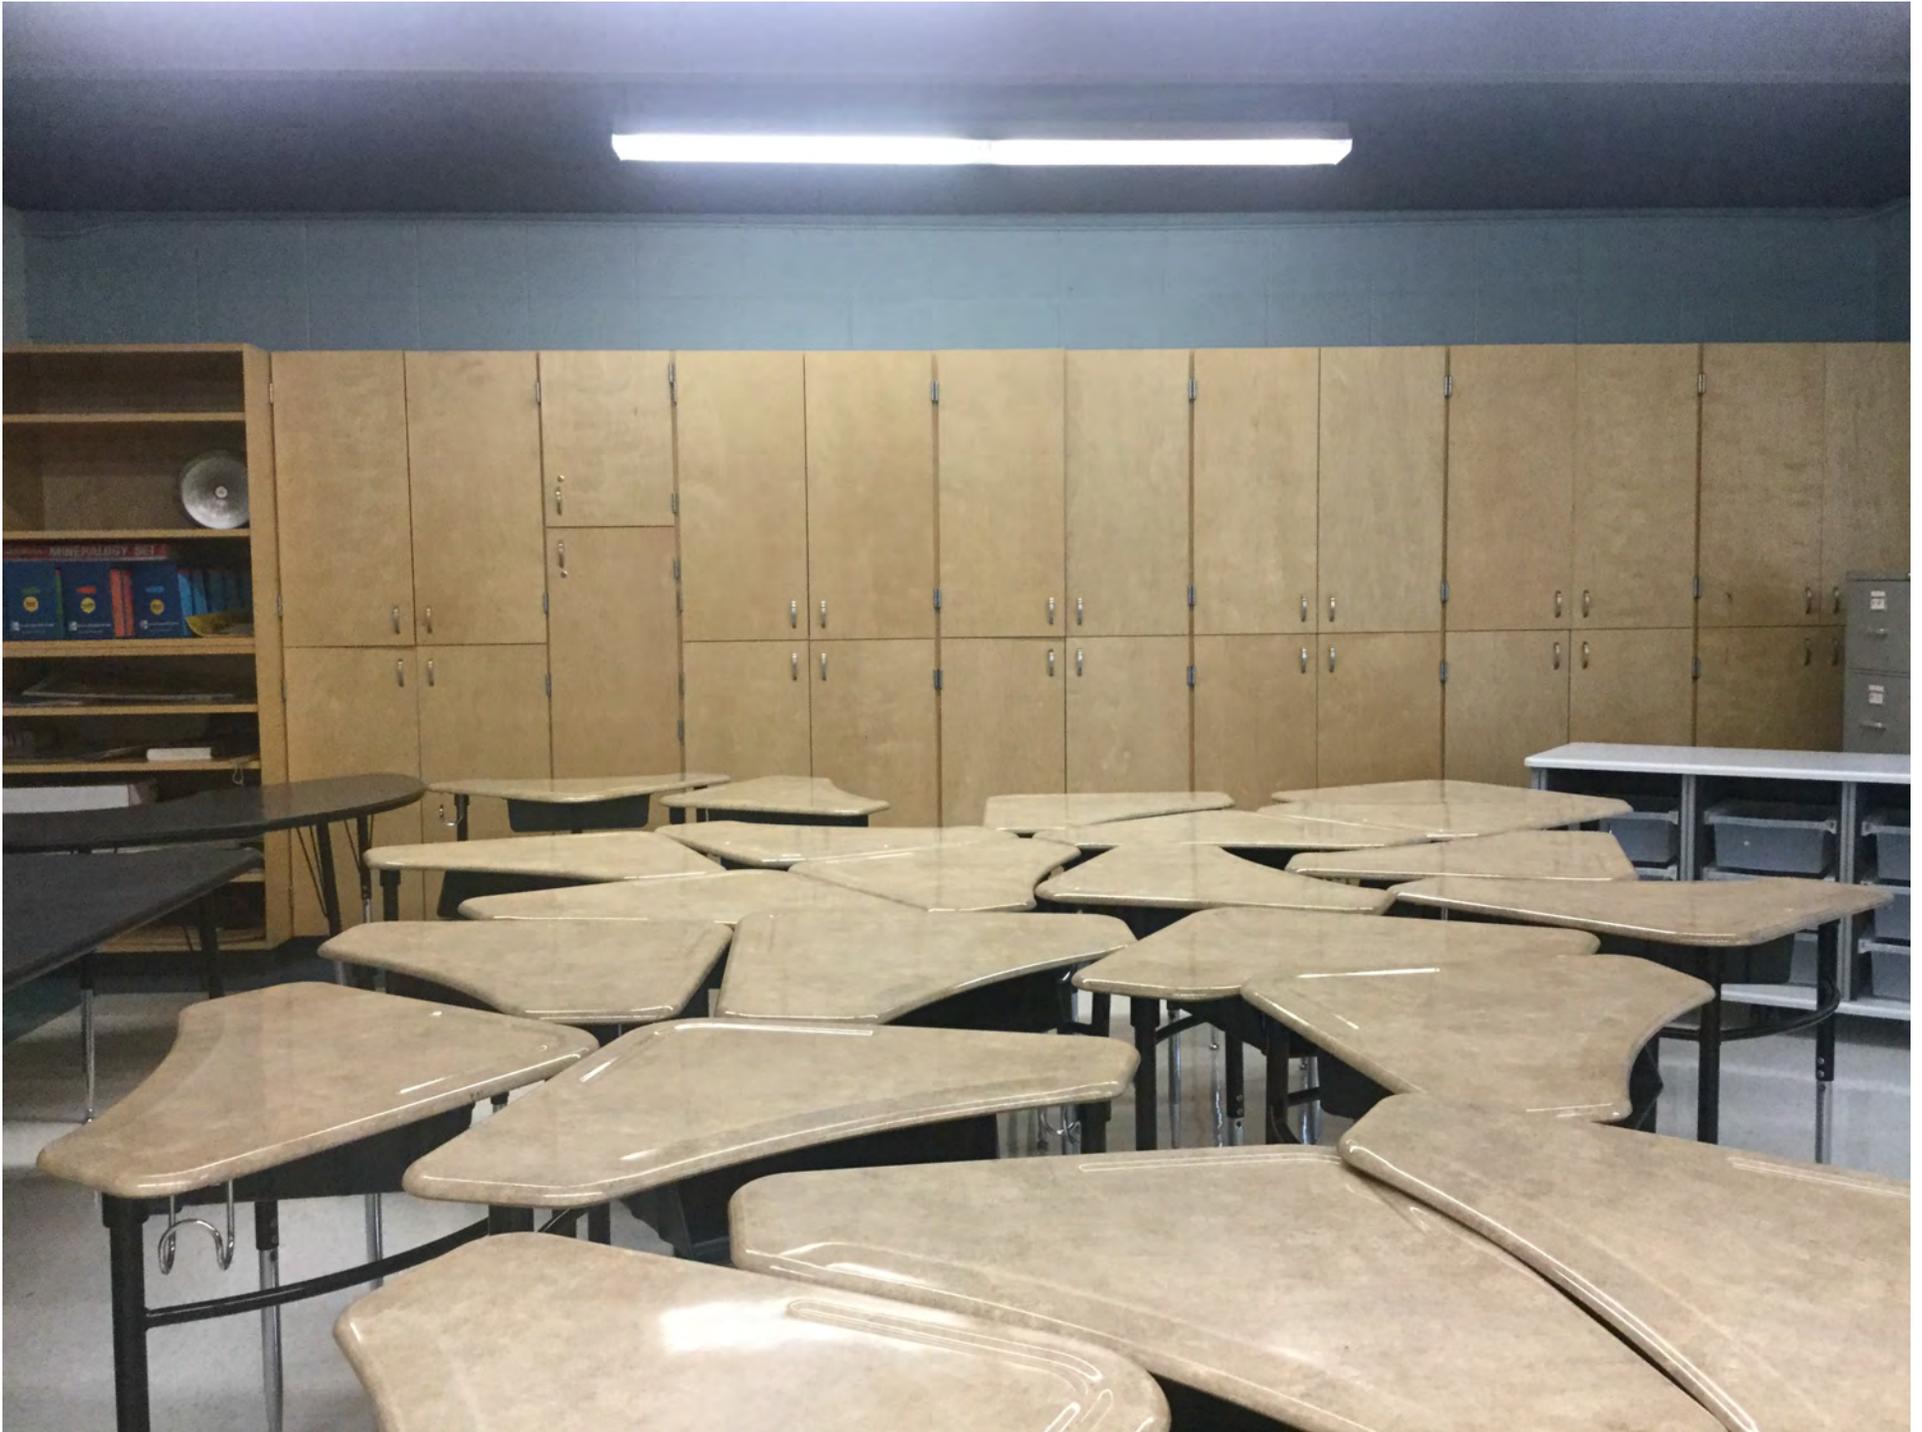
Photo 7. Classroom

4.2	Are general classrooms large enough to support project-based learning and multiple teaching modalities?					5		Comments	1.00	5.00
1) Very unsatisfactory -too small to move, set for lecture only, no connectivity, no flexibility 2) Unsatisfactory - adequate size but set for lecture only, no connectivity, no flexibility 3) Neutral - have flexibility and space for hands on or project based learning 4) Satisfactory - have flexibility and space for hands on or project based learning and connectivity for global learning 5) Very Satisfactory - space for hands on learning, flexibility for different groupings, and connectivity for global classrooms N/A) Does not apply.		See large 7

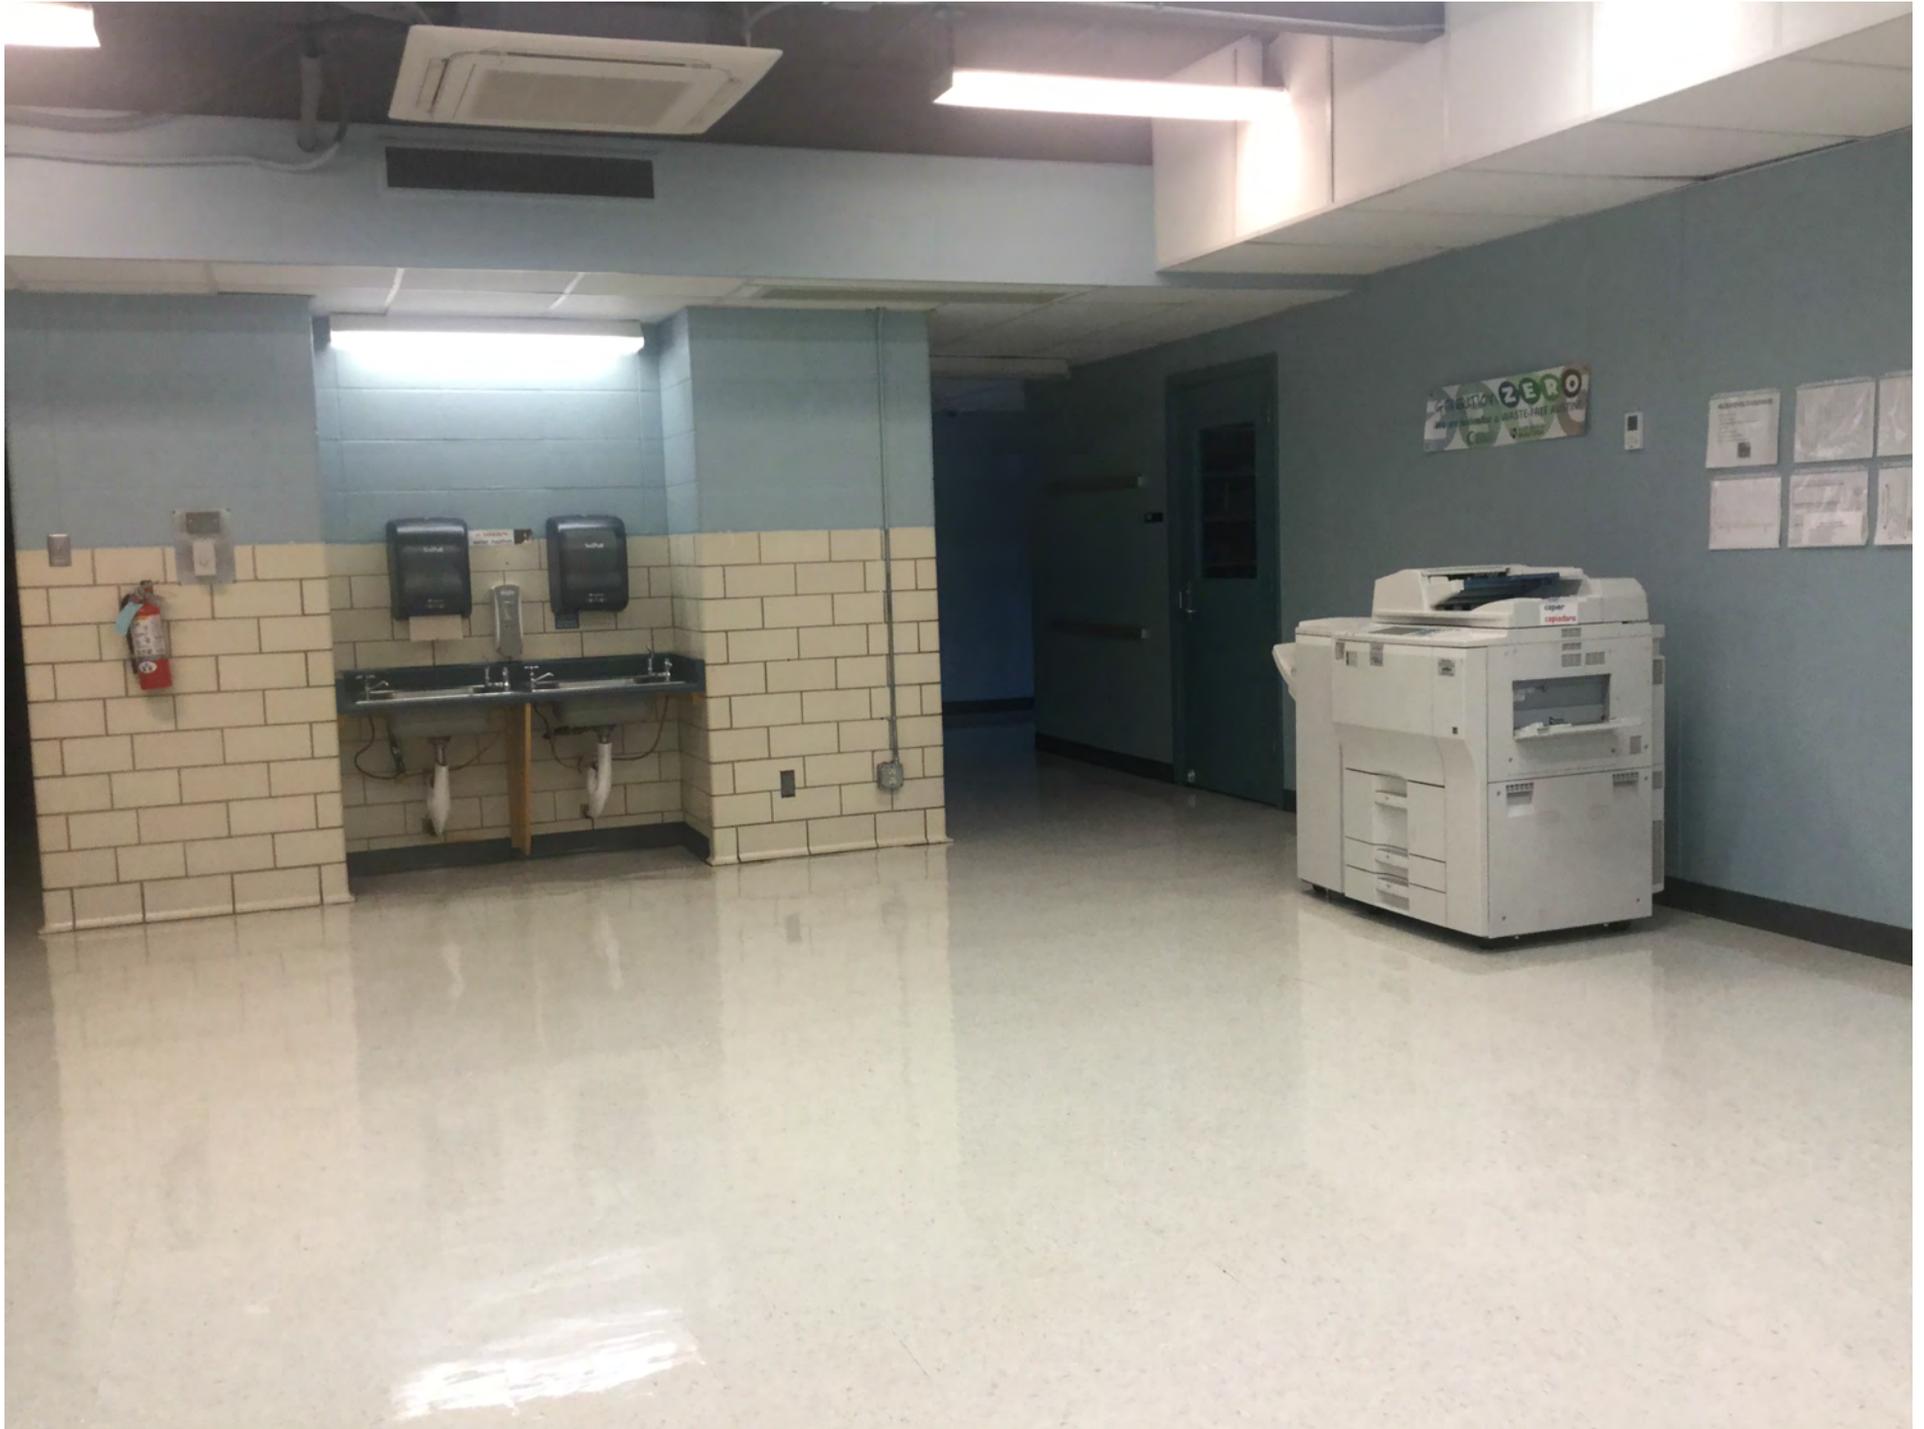
Photo 8. flex space

1) Very unsatisfactory - no common spaces or meeting rooms or in very poor condition 2) Unsatisfactory - a few common spaces or meeting rooms in unsatisfactory condition 3) Average - a few common spaces and meeting areas needing updates 4) Good - multiple common spaces and meeting rooms in good condition 5) Very good - adequate common spaces and meeting rooms of excellent quality N/A) Does not apply.								There are very few dedicated spaces for such collaboration.	
								See Image 8
