Educational Suitability Summary Report

Cunningham Elementary School – BLDG # 113

Date: 07/26/2016

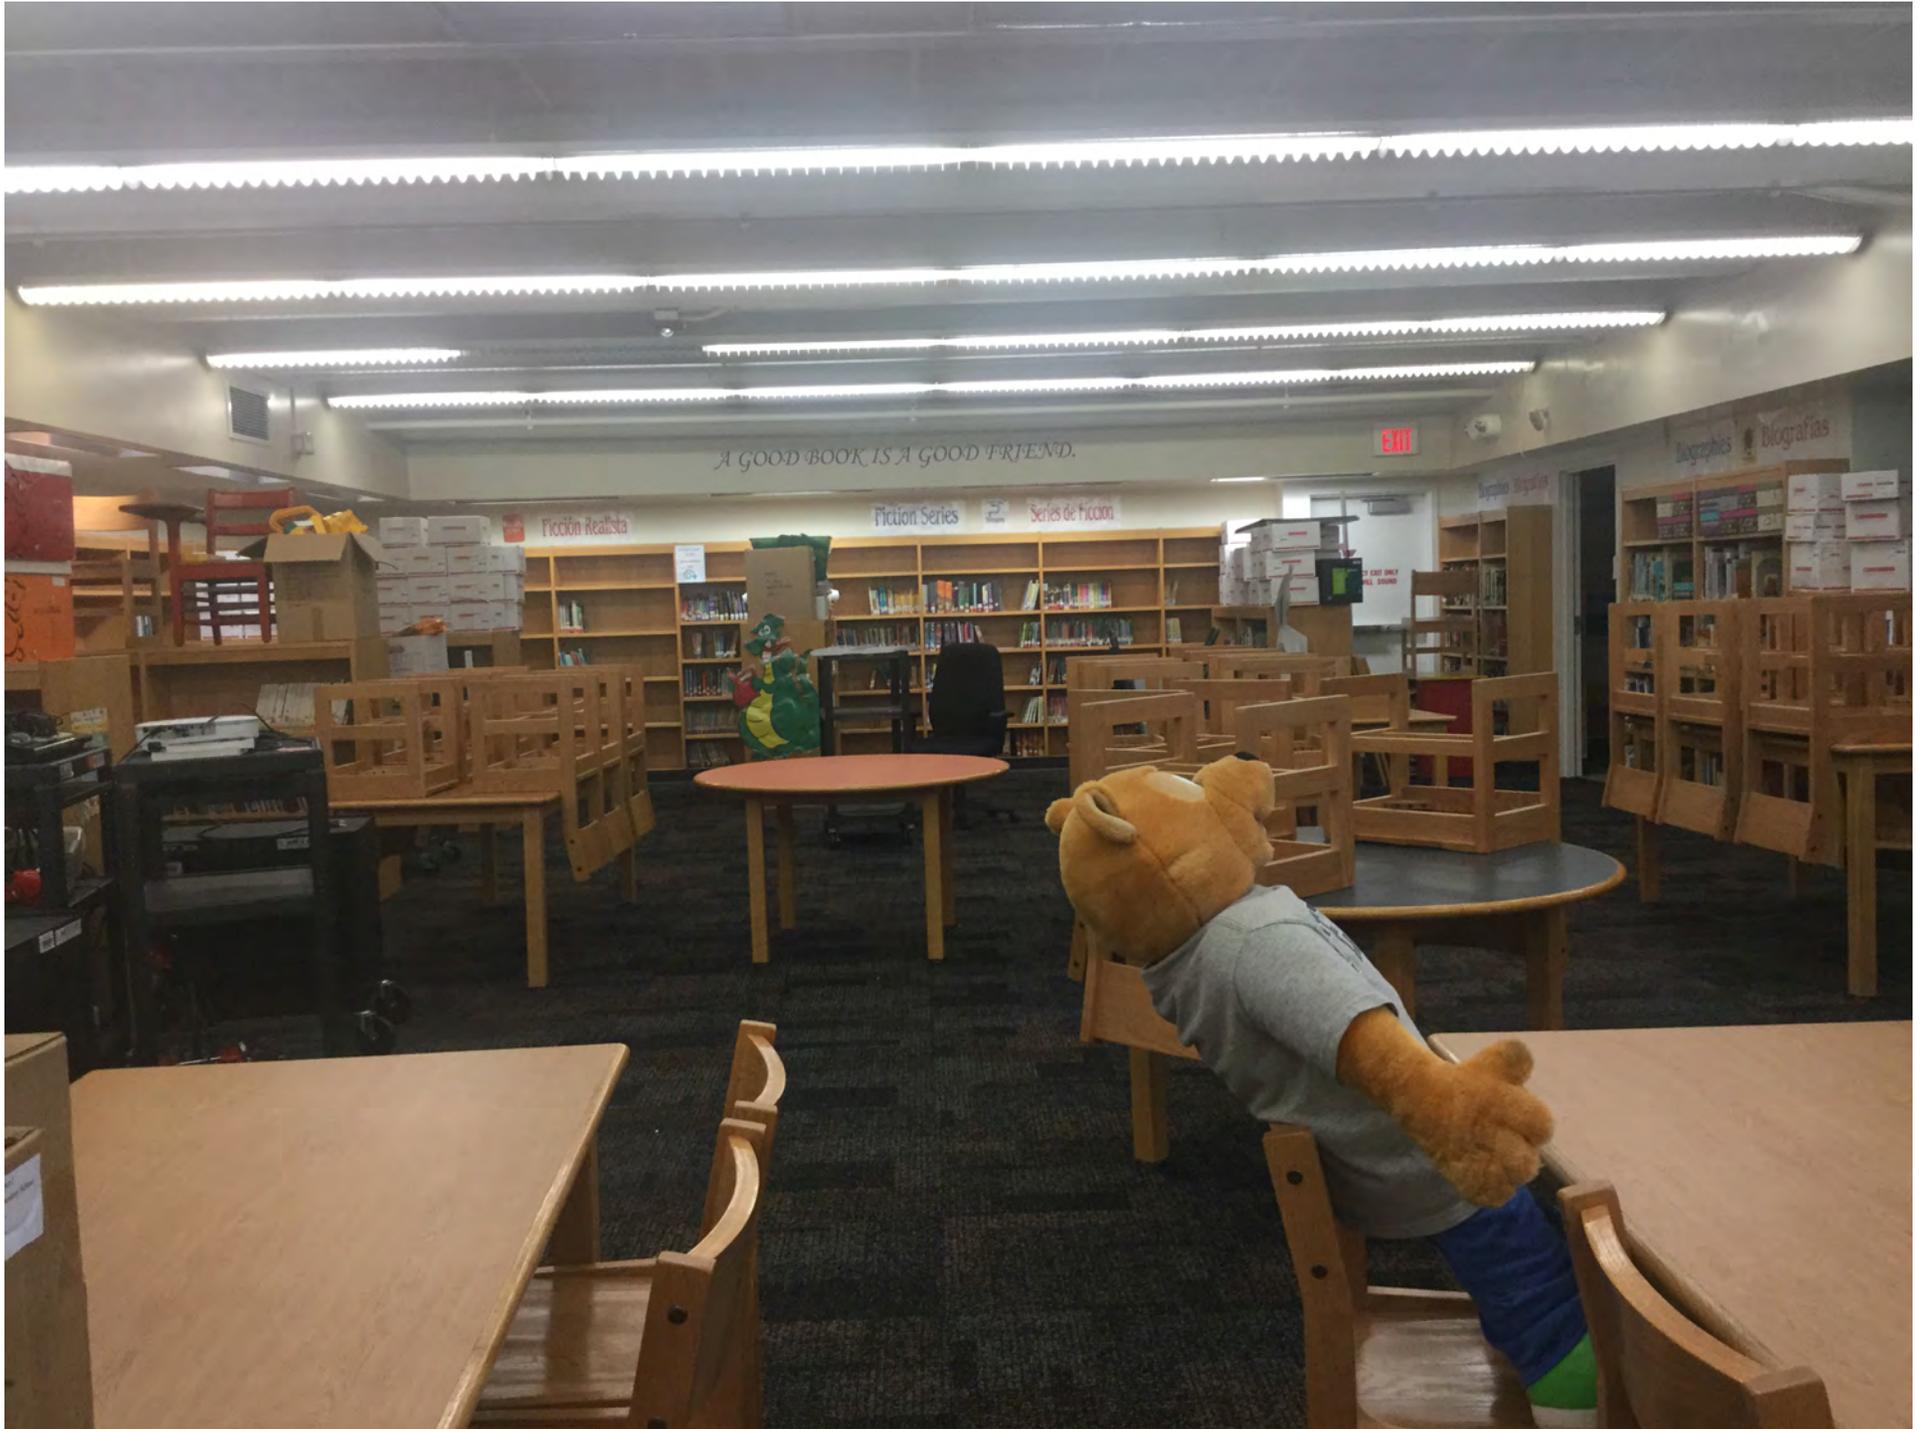
Photo 9. Library

5.3	How well does the Library/Media Center support social interaction?			3				Comments	1.00	3.00
1) Very unsatisfactory 2) Unsatisfactory 3) Average 4) Good 5) Very good N/A) Does not apply.		See Image 9
