Educational Suitability Summary Report

Dawson Elementary School – BLDG # 114

Date: 06/20/2016 (Rev 1 – 12/19/16 – Added Survey Responses)

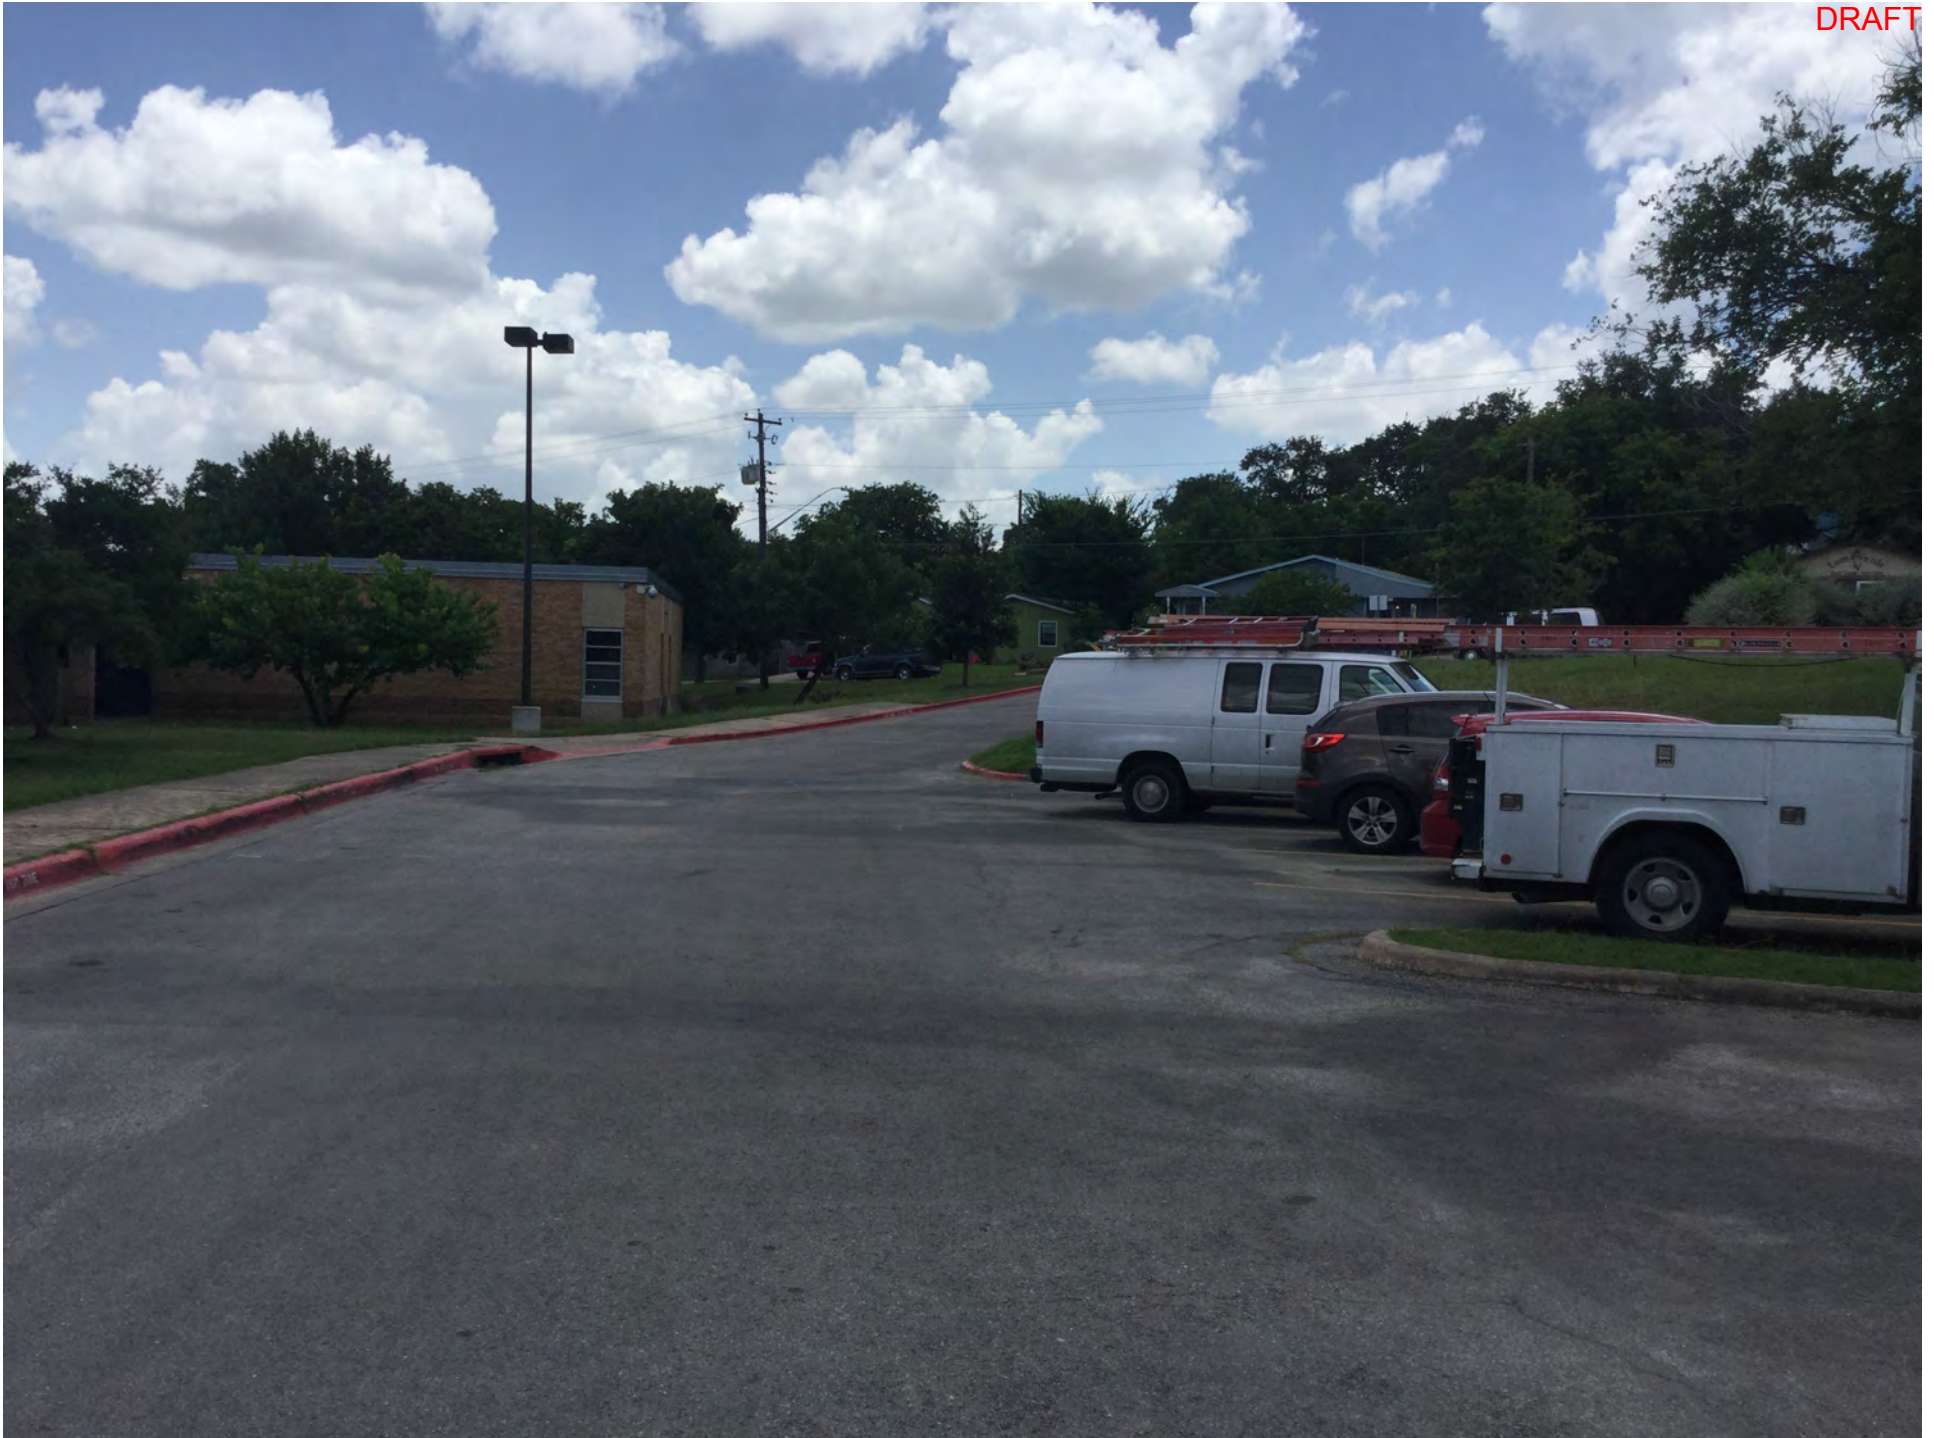
Photo 1.
1.1 Building Entry

1 - Exterior		1	2	3	4	5	N/A	11.00	
1.1	Does the site permit desirable separation of vehicular, bus and pedestrian traffic?			3				Comments	1.00 3.00
	1) Bus , car and pedestrian all happen at the same location. 2) Cars and buses mix, pedestrians are separated. 3) Buses, cars, and pedestrians are separate but stack space is small. 4) Buses, cars, and pedestrians are separate but drop off does not have a canopy or a holding place like a commons or cafeteria. 5) Buses, cars, and pedestrians are separate and drop off area has a canopy and destination. N/A) Does not apply.							The traffic circle in the front is reserved for staff parking and special needs drop off, but is abused by parents dropping off in the morning. Arrivals are more of an issue than departures.	see photo 1

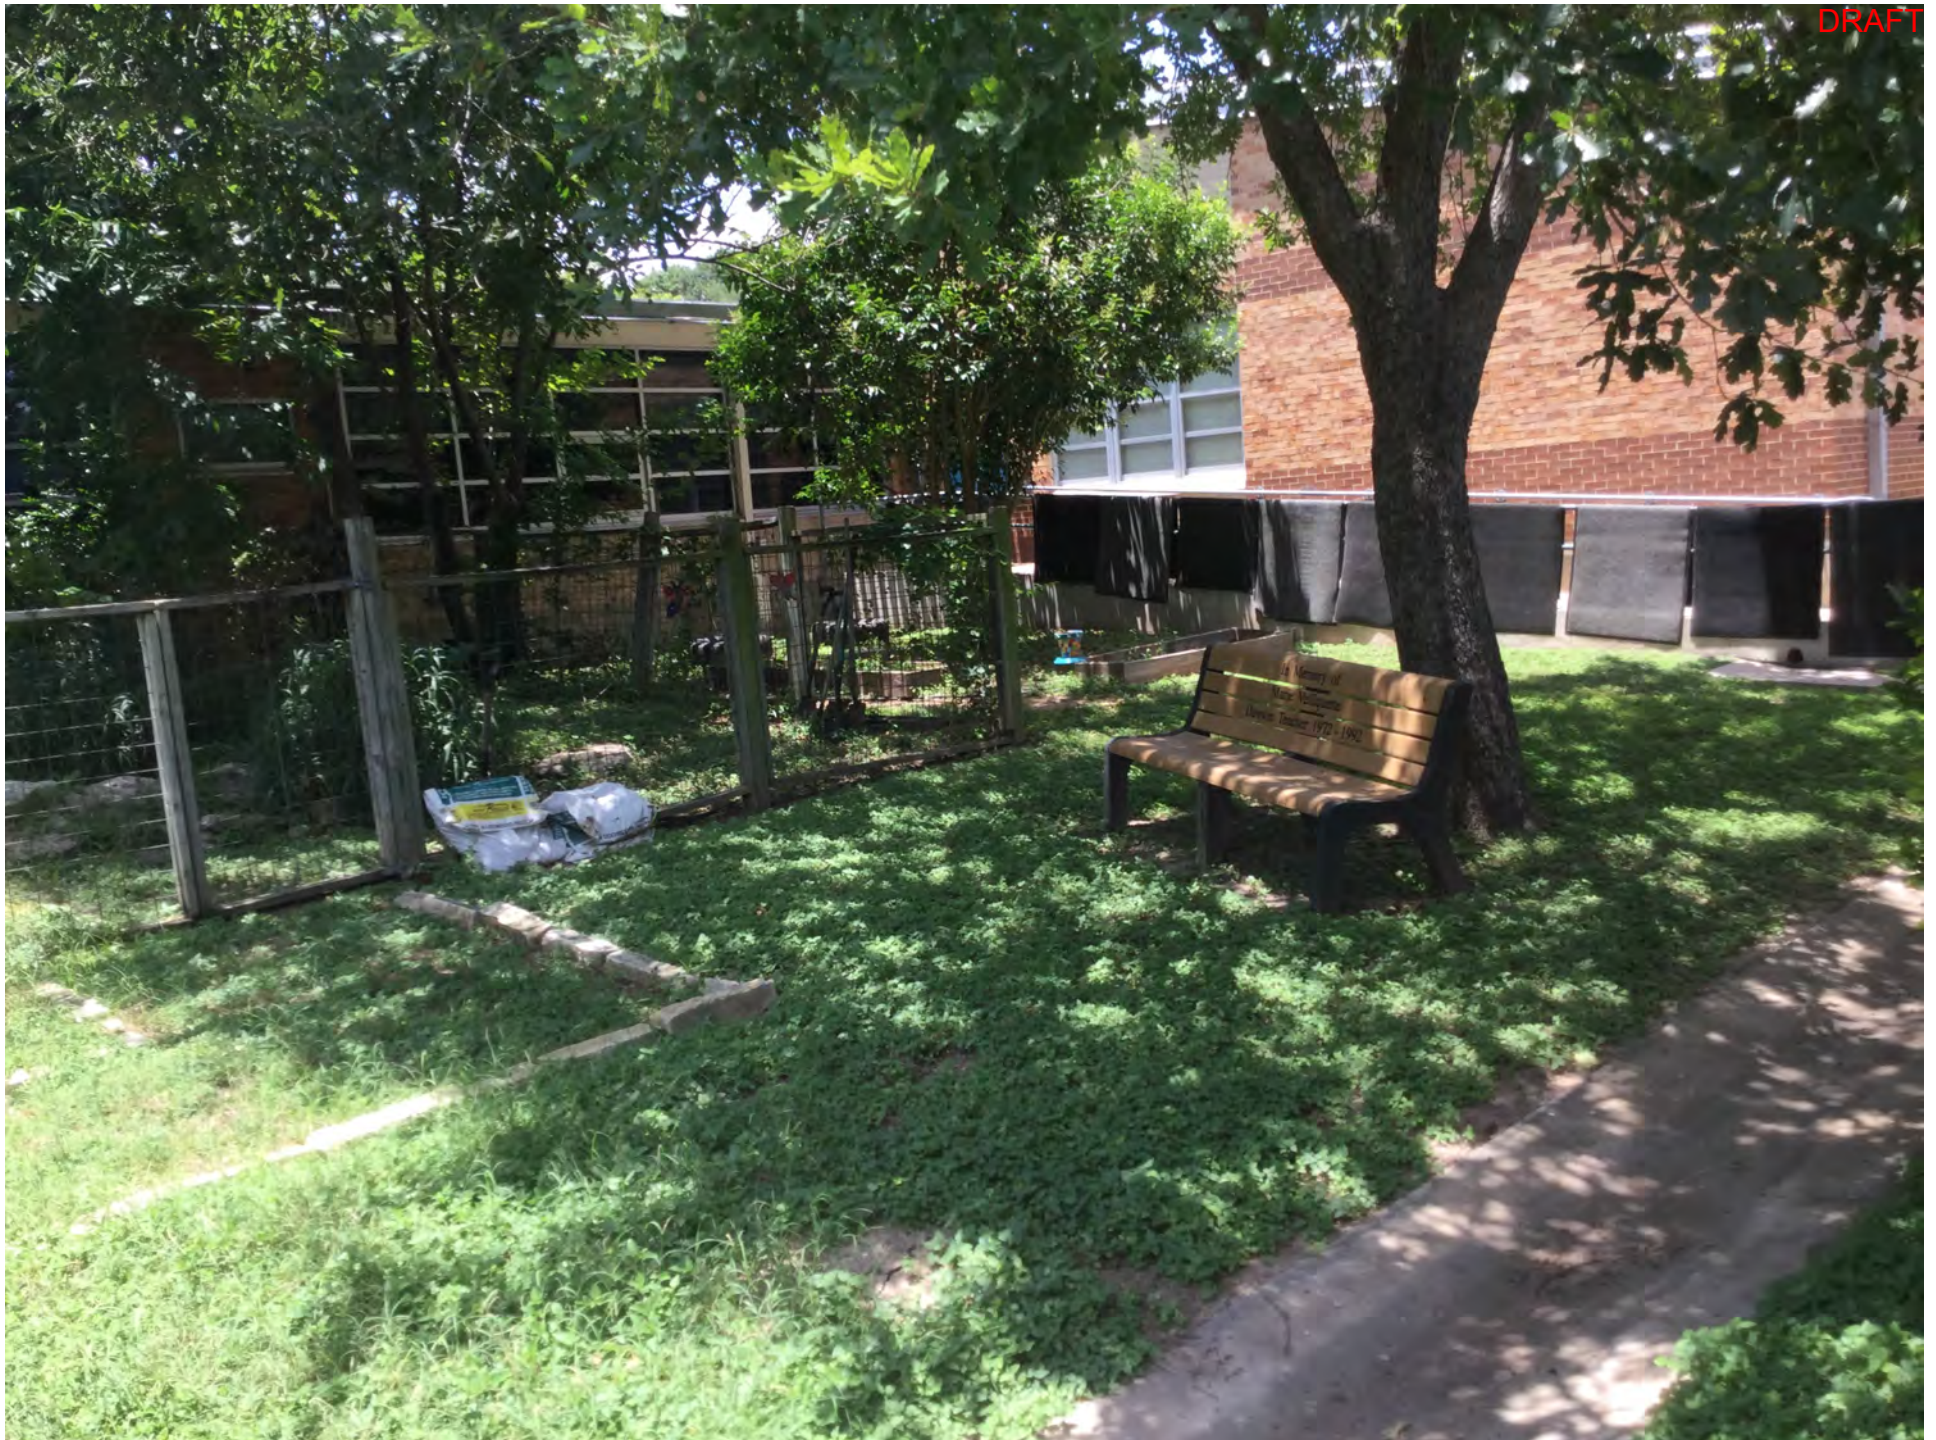
Photo 2.
1.2 Outdoor Space

1.2	Are opportunities provided for outdoor learning (outdoor classrooms, gardens, etc.)?				4			Comments	1.00 4.00
	1) Outdoor space exists is not developed 2) Outdoor space for learning exists but not connected to classroom learning areas. 3. Outdoor learning spaces exist and are accessible but not in good condition. 4. Outdoor learning spaces need minor improvements to function well. 5. Outdoor learning spaces are in excellent condition. N/A) Does not apply.							There is plenty of outdoor seating, tables, and gardens.	see photo 2

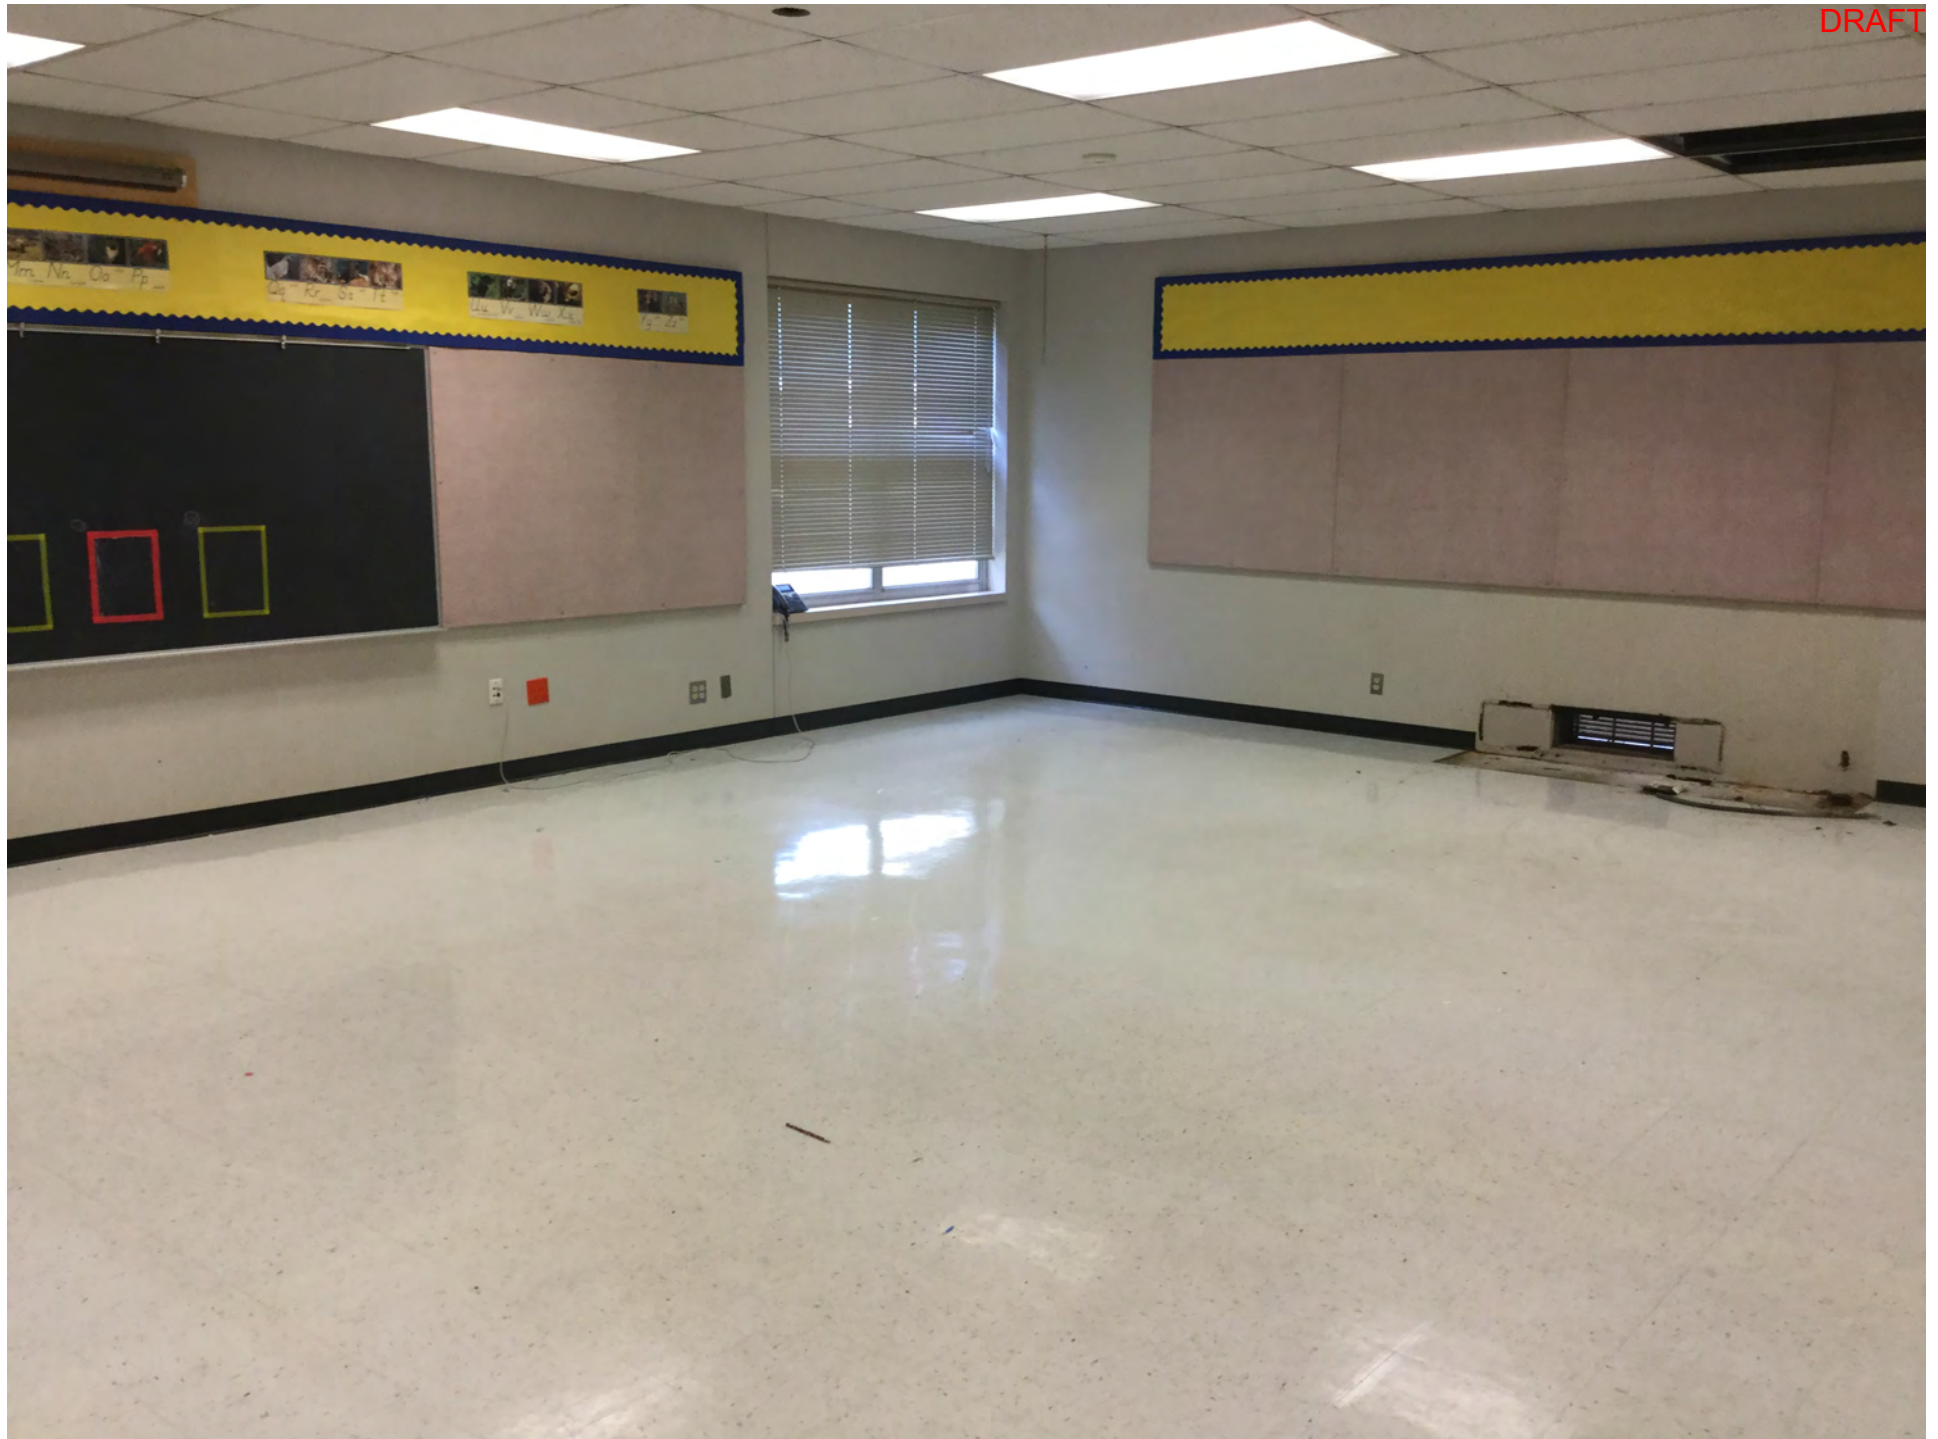
Photo 3.
3.1 Pre-K Space

1) Very unsatisfactory - Too small, awkward layout, does not meet needs 2) Unsatisfactory - Too small, only one area for all teaching methods, limited flexibility 3) Neutral - Moderate size, two areas for different teaching methods, some flexibility, access to student storage/casework 4) Satisfactory - Good size, at least two zones for different teaching methods, flexibility and student storage, not new 5) Very Satisfactory - Good size, two zones for different teaching methods, flexibility and student storage/casework, adequate display area and visual teaching tools N/A) Does not apply.								The classroom is very spacious but lacks idea flexibility.	
									see photo 3

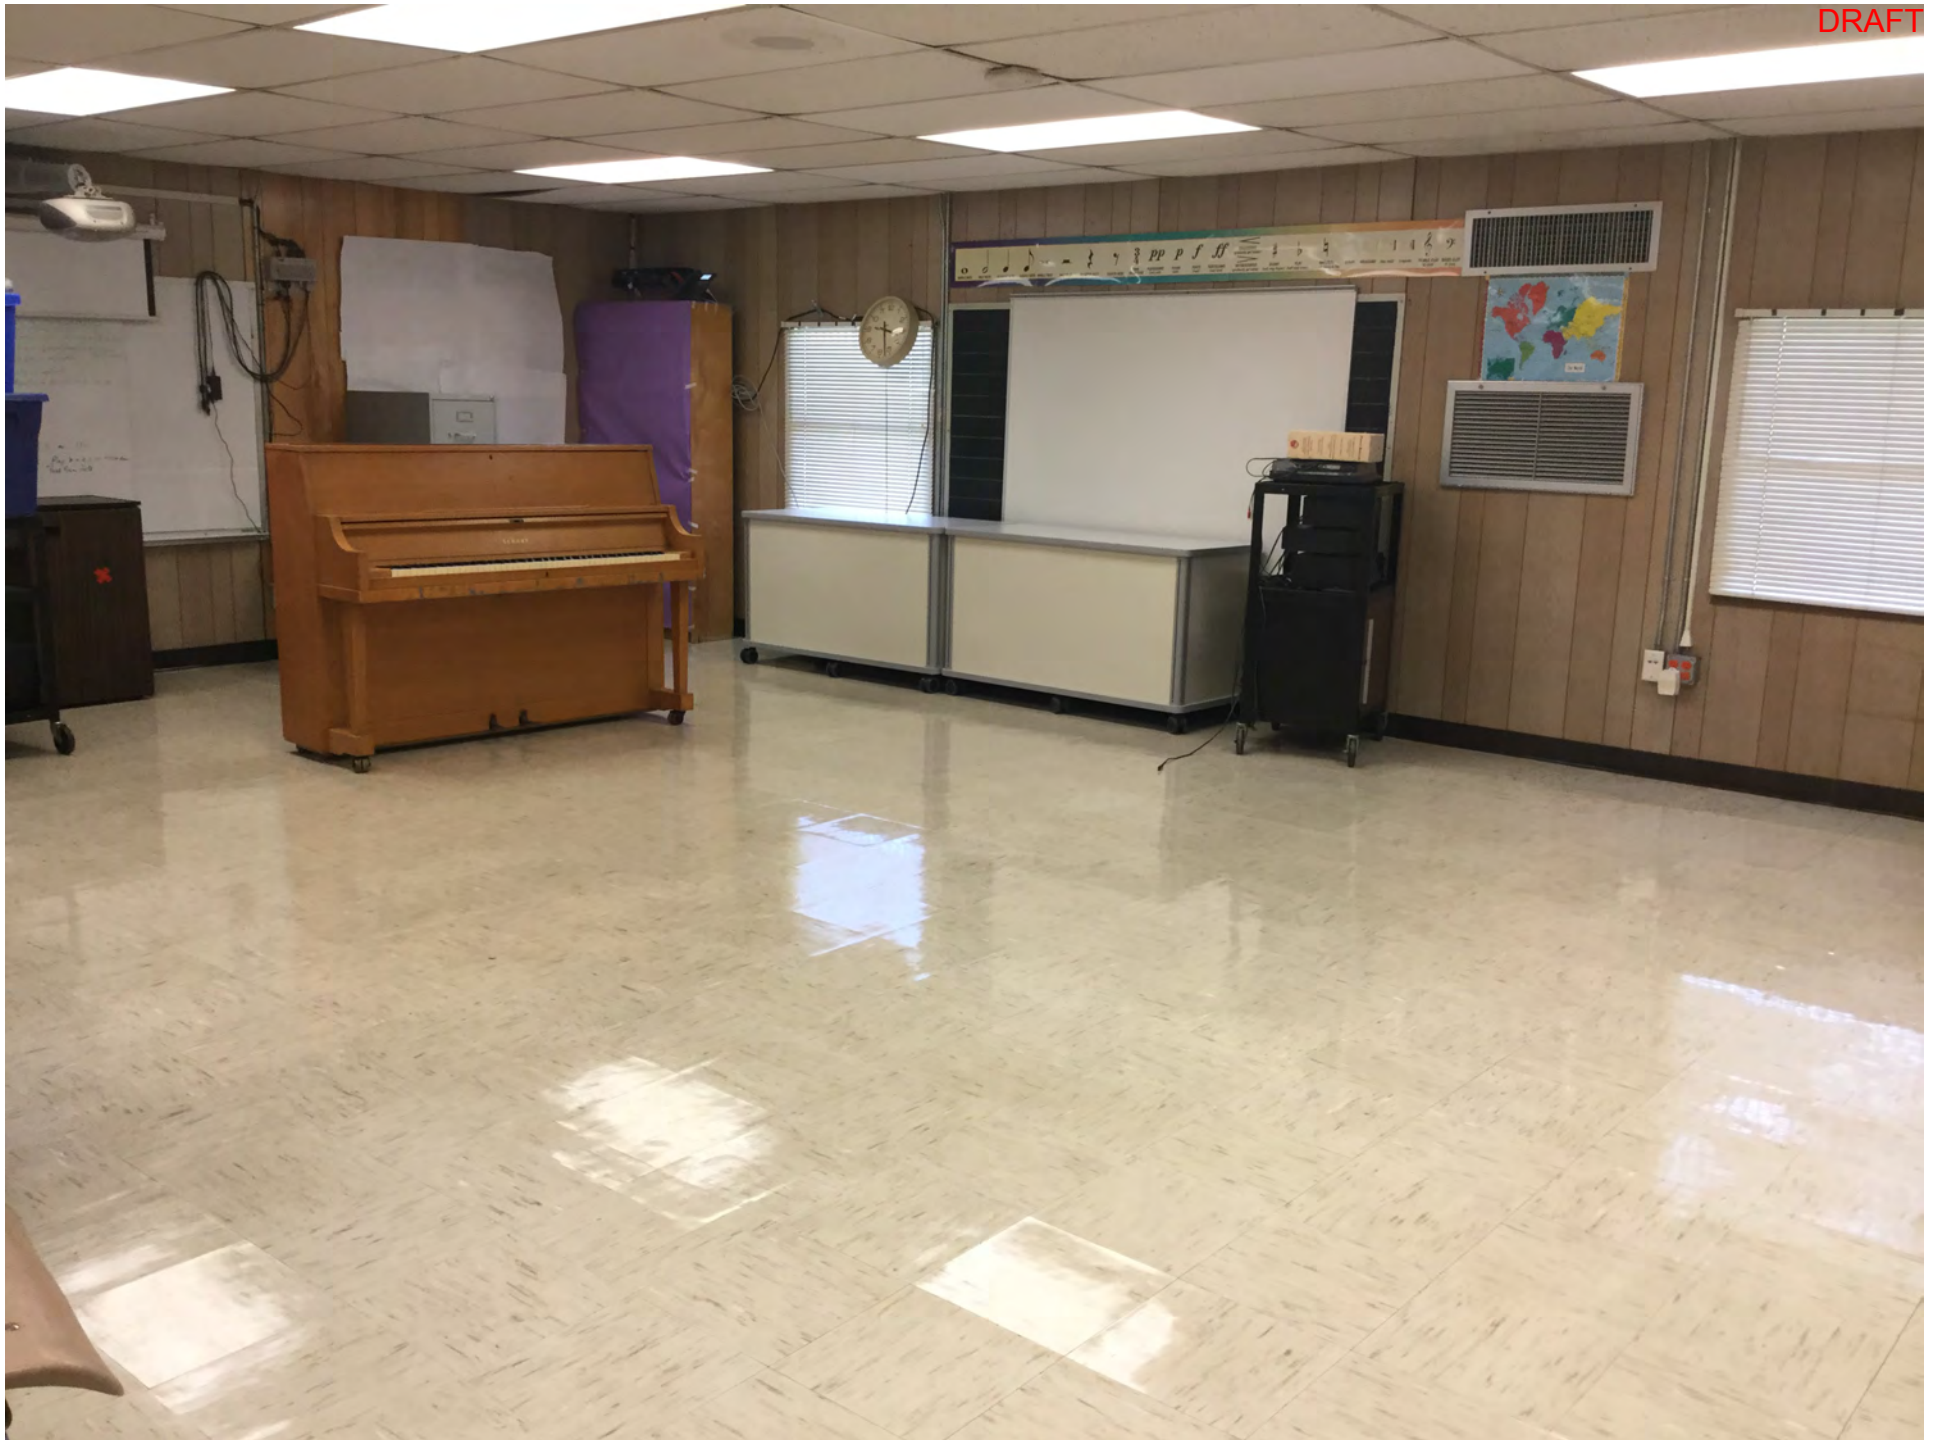
Photo 4.
3.8 Music Room

3.8	Are music, drama, or performance spaces appropriately configured per the ed spec?			3				Comments	1.003.00
1) Very unsatisfactory 2) Unsatisfactory 3) Average 4) Good 5) Very good N/A) Does not apply.								The cafetorium and the stage are in good condition. The music room is inside of a portable.	
								see photo 4

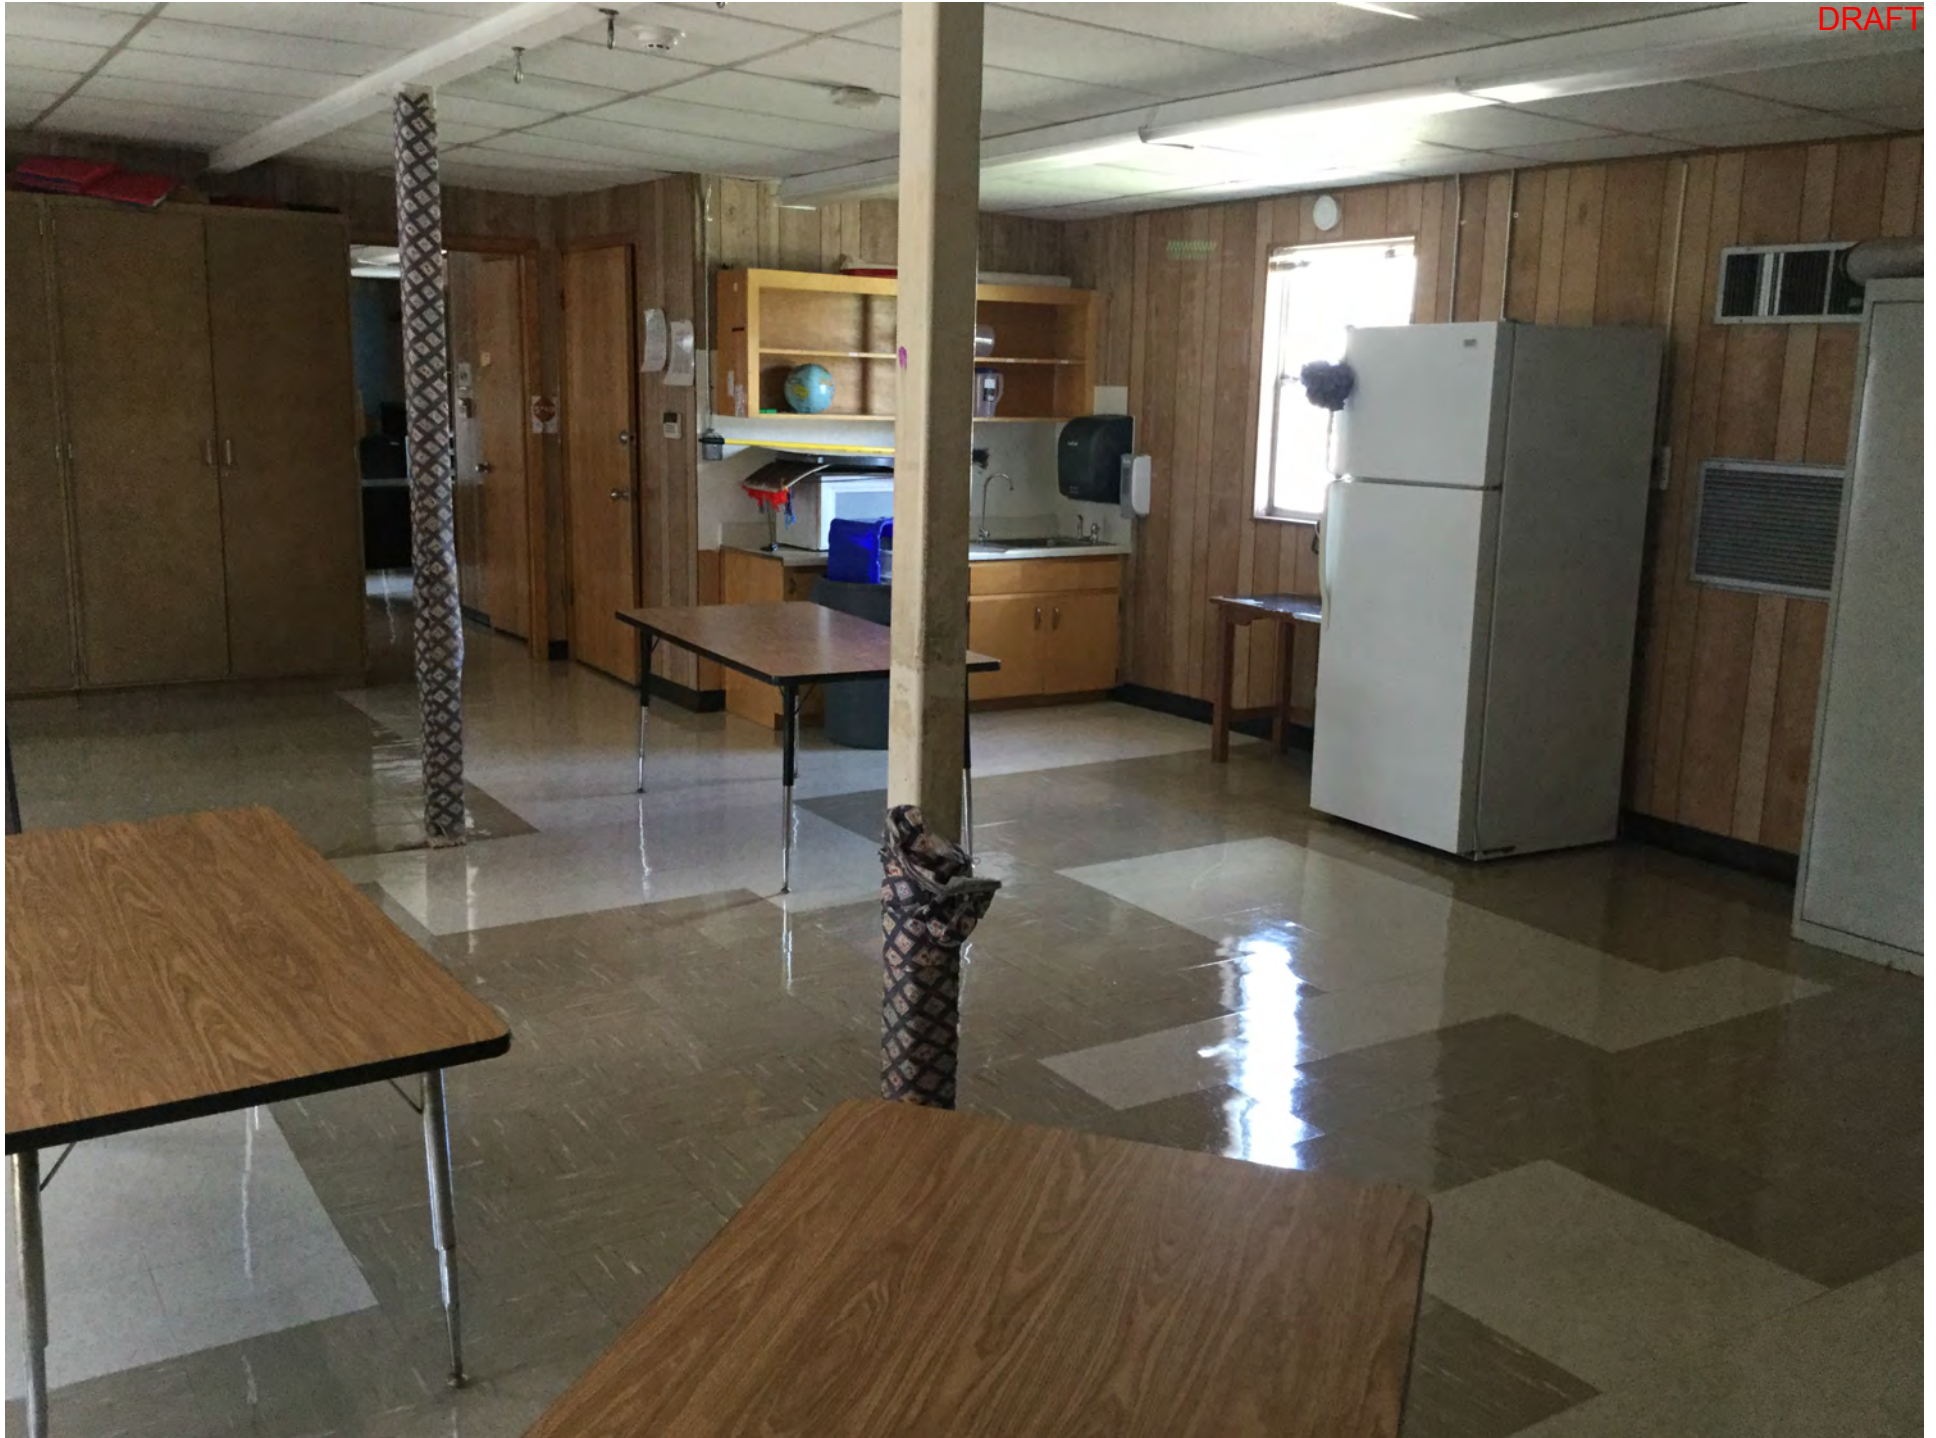
Photo 5.
3.14 Special Education Space

1) Very unsatisfactory 2) Unsatisfactory 3) Average 4) Good 5) Very good N/A) Does not apply.							The special ed pre-k spaces are nice but some of the classes are in portables. <i>SPED Dept Comments: The restrooms have rails, but not big enough for a wheelchair. No connections for washer and dryer.</i>		
							see photo 5

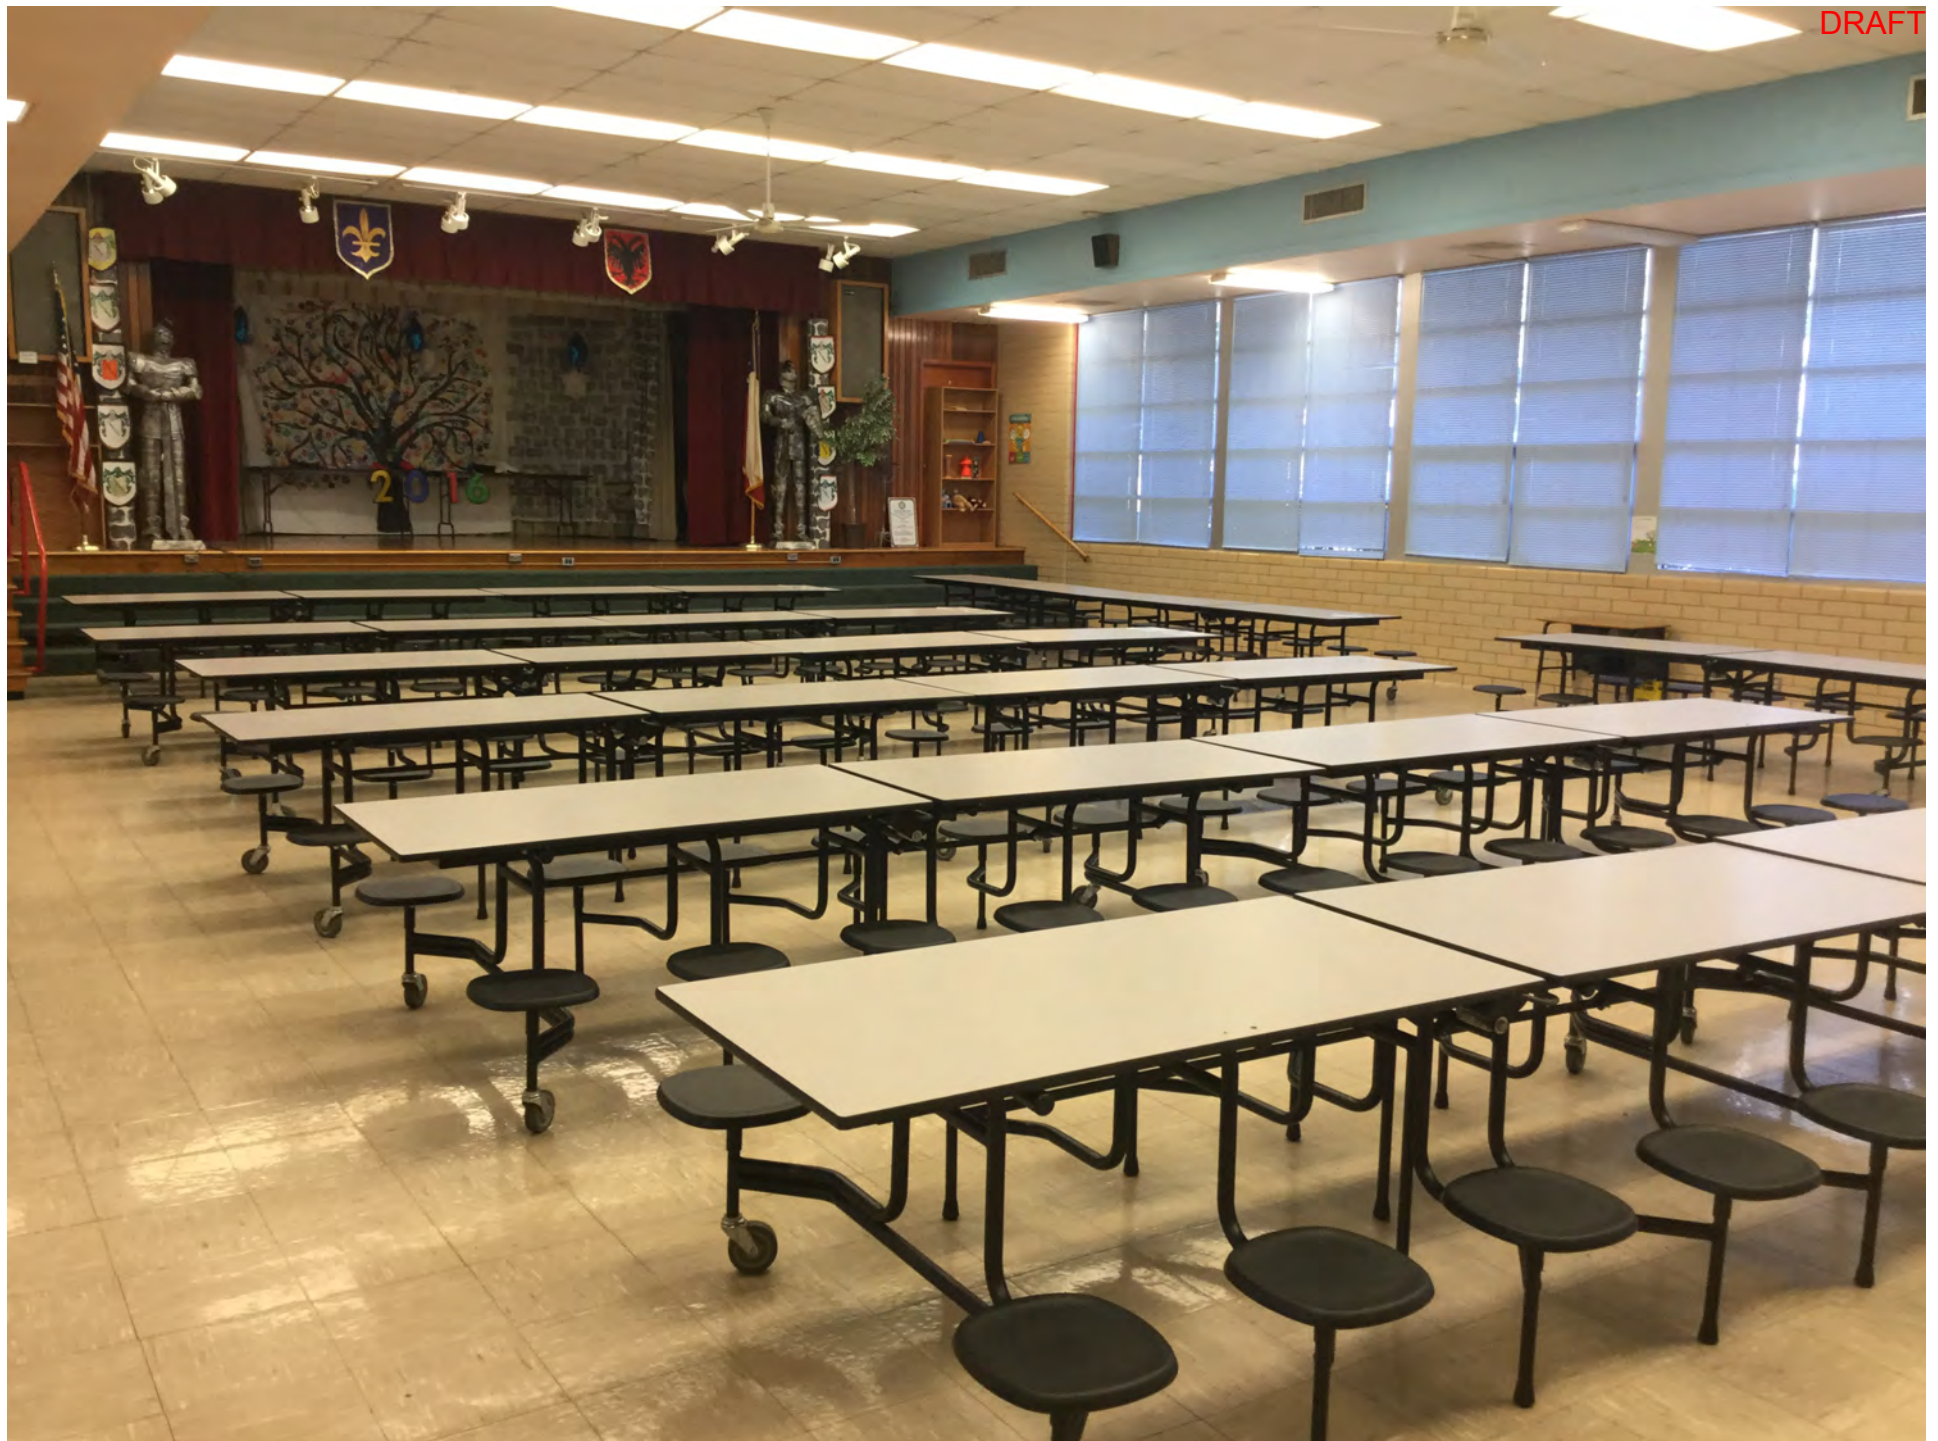
Photo 6.
3.16 Cafetorium

3.16	Are the student dining facilities appropriately configured?				4			Comments	1.00 4.00
1) Very unsatisfactory - Too small, poor circulation, inflexible seating in poor condition 2) Unsatisfactory - Too small or inadequate circulation, seating in poor condition 3) Average - moderate size, with adequate circulation, seating in okay condition 4) Good - good size, adequate circulation, seating in good condition 5) Very good - good size, adequate circulation, seating in good condition, with more than one option for eating space (ex: connection to outdoor eating space) N/A) Does not apply.							The cafetorium could be larger to support the entire student body. <i>SPED Dept Comments: Need some repair on ramps to portables. Need ramp to loading dock for recycling program.</i>		
							see photo 6

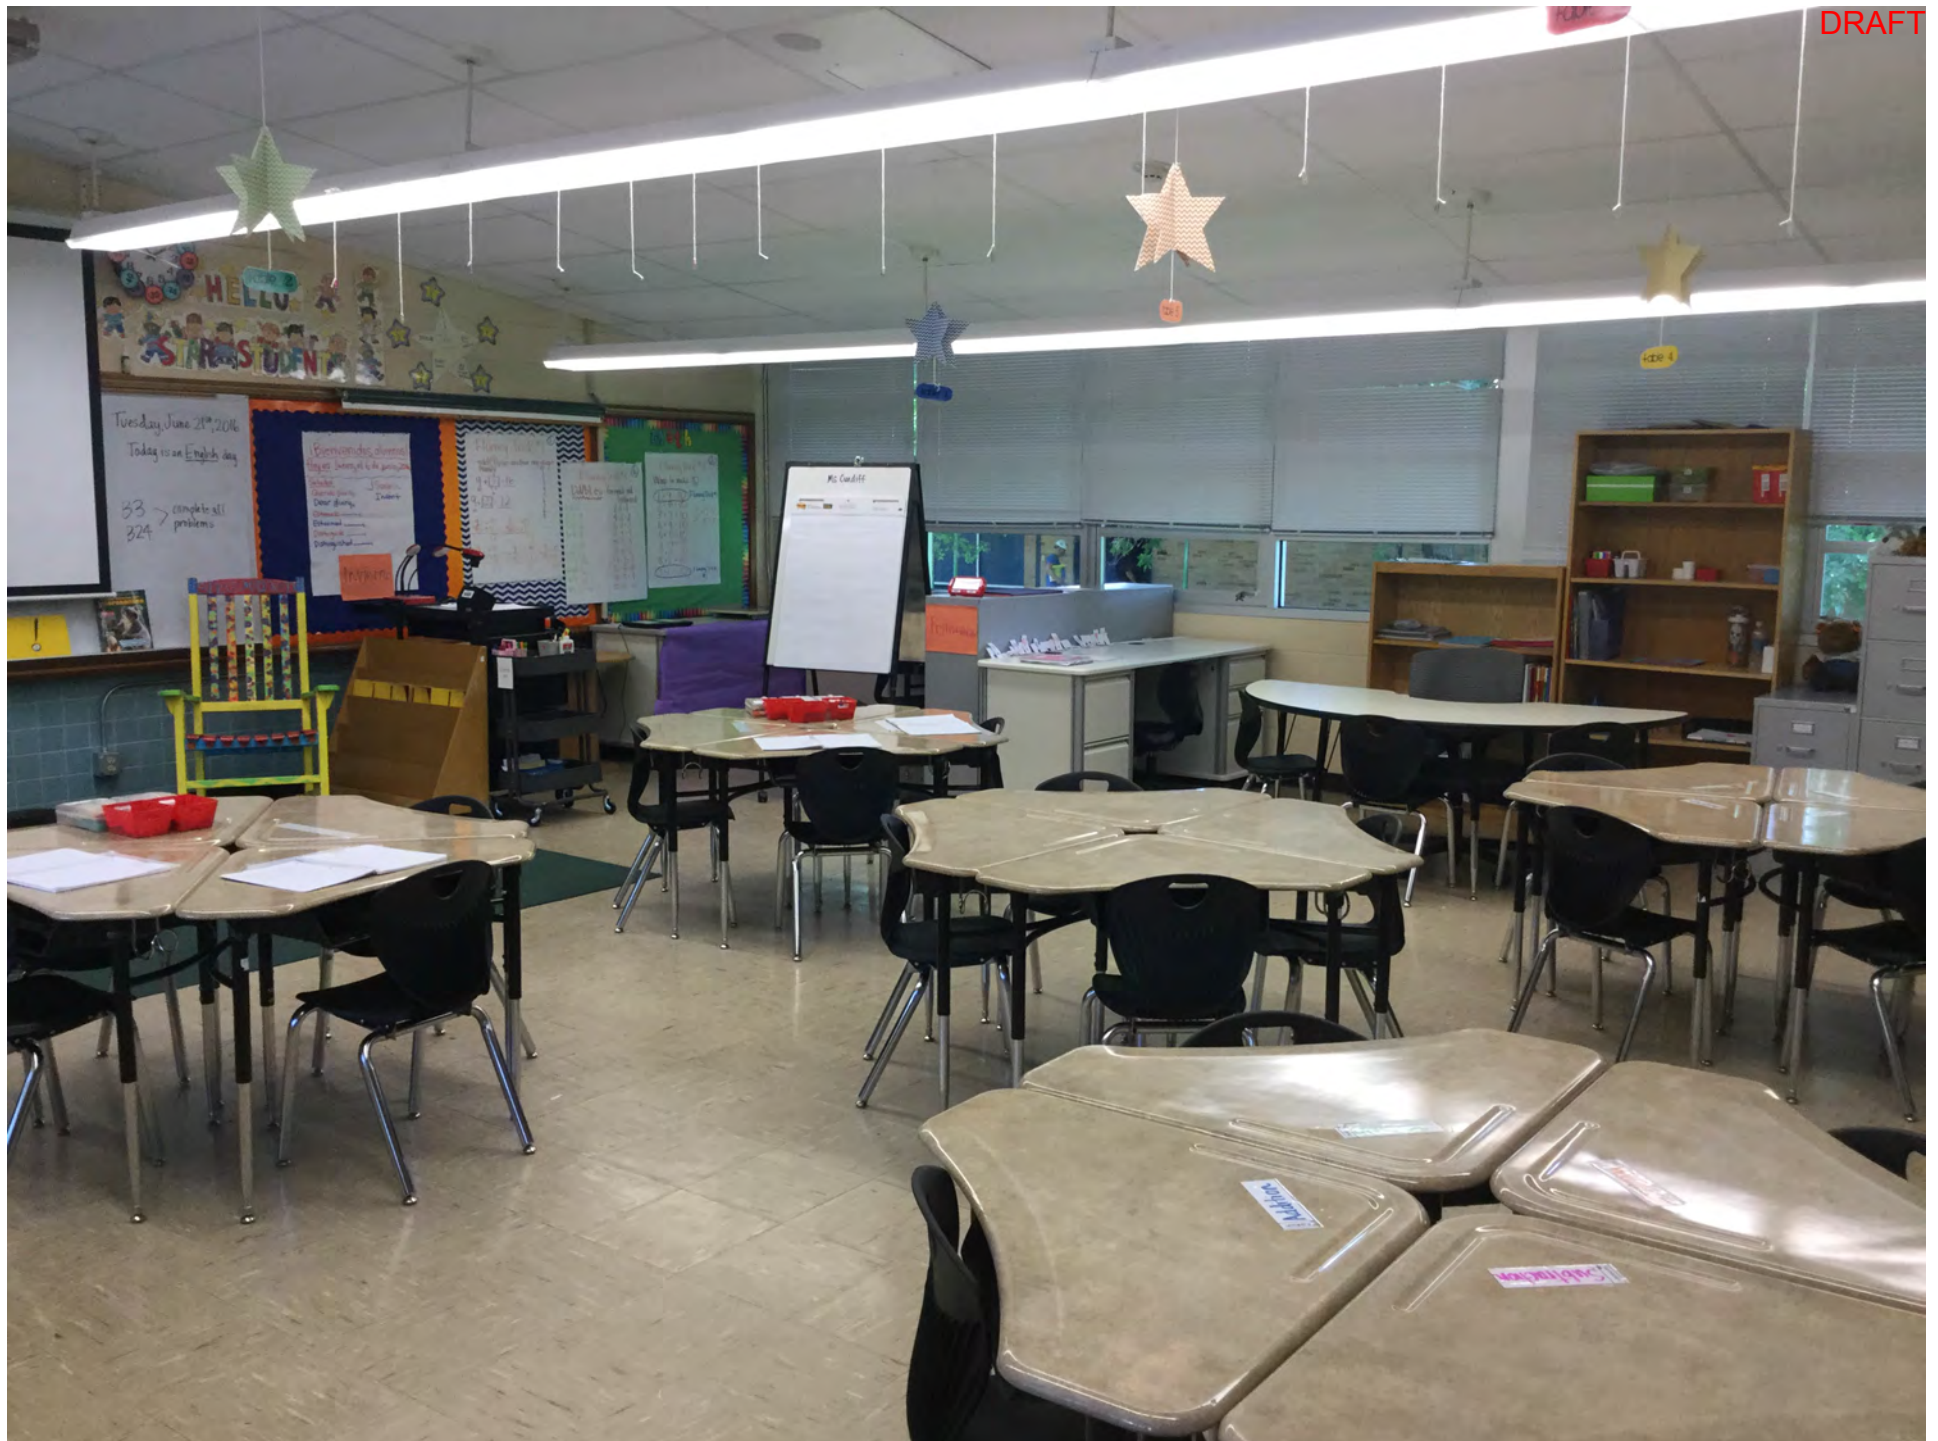
Photo 7.
4.2 Standard Classroom

4.2	Are general classrooms large enough to support project-based learning and multiple teaching modalities?				4			Comments	1.00	4.00
1) Very unsatisfactory -too small to move, set for lecture only, no connectivity, no flexibility 2) Unsatisfactory - adequate size but set for lecture only, no connectivity, no flexibility 3) Neutral - have flexibility and space for hands on or project based learning 4) Satisfactory - have flexibility and space for hands on or project based learning and connectivity for global learning 5) Very Satisfactory - space for hands on learning, flexibility for different groupings, and connectivity for global classrooms N/A) Does not apply.
