Educational Suitability Summary Report

Dawson Elementary School – BLDG # 114

Date: 06/20/2016 (Rev 1 – 12/19/16 – Added Survey Responses)

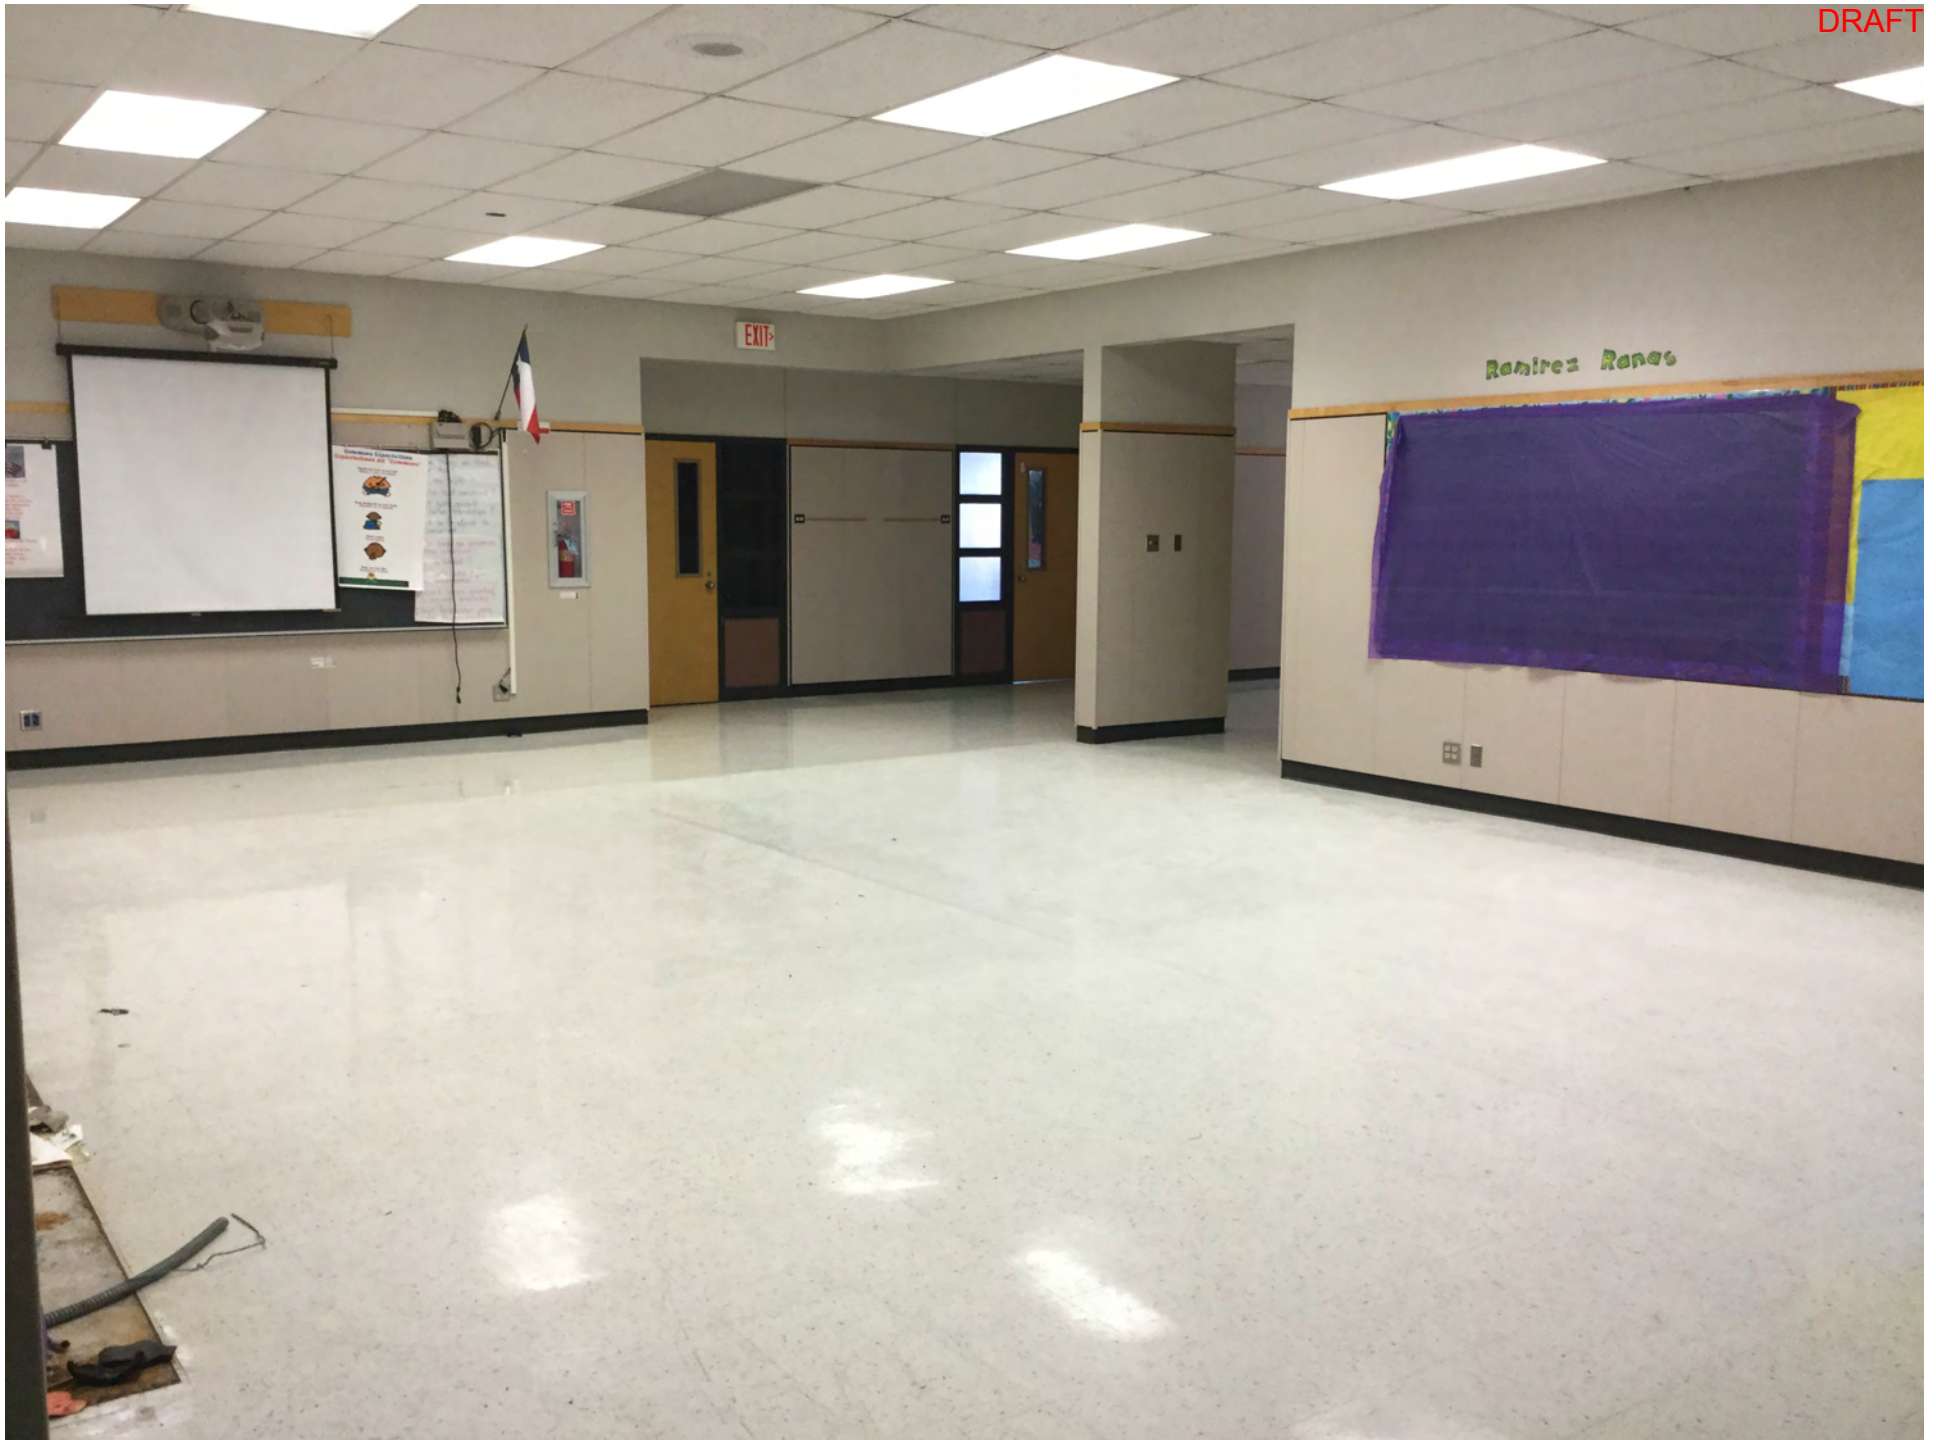
Photo 8.
4.5 Collaborative Space

1) Very unsatisfactory - no common spaces or meeting rooms or in very poor condition 2) Unsatisfactory - a few common spaces or meeting rooms in unsatisfactory condition 3) Average - a few common spaces and meeting areas needing updates 4) Good - multiple common spaces and meeting rooms in good condition 5) Very good - adequate common spaces and meeting rooms of excellent quality N/A) Does not apply.								There is a central room in the Pre-K wing as well as plenty of exterior seating for collaboration.	
see photo 7

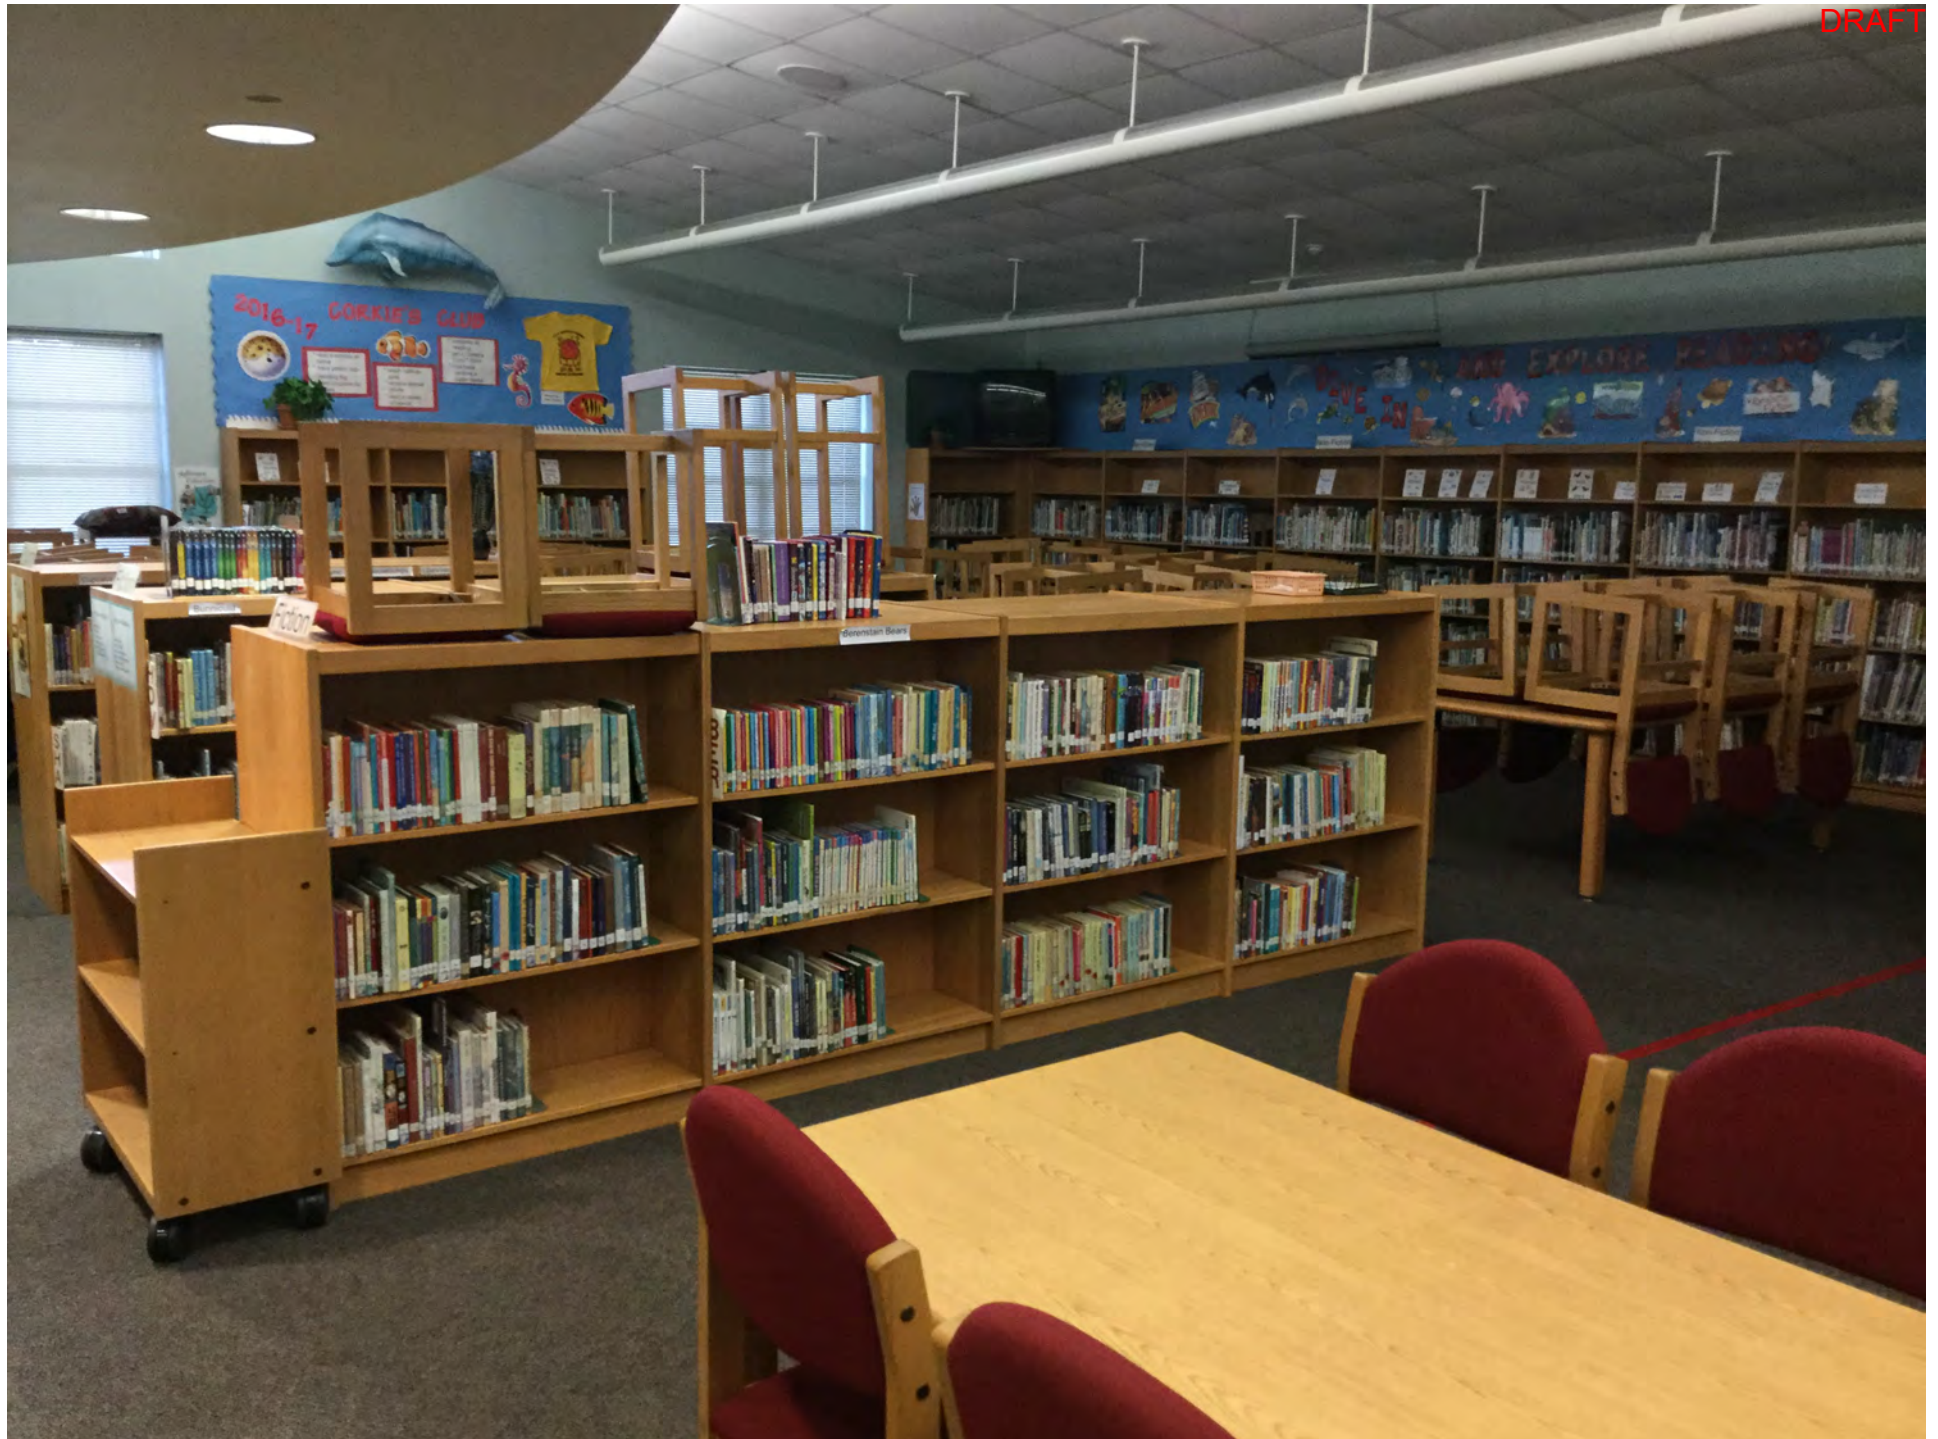
Photo 9.
5.4 Library

5.4	How well does the Library/Media Center support collaborative work in small groups (4-8 students)?				4			Comments	1.004.00
1) Very unsatisfactory 2) Unsatisfactory 3) Average 4) Good 5) Very good N/A) Does not apply.								It could use more spaces to support more of the student body at any given time.	
								see photo 8

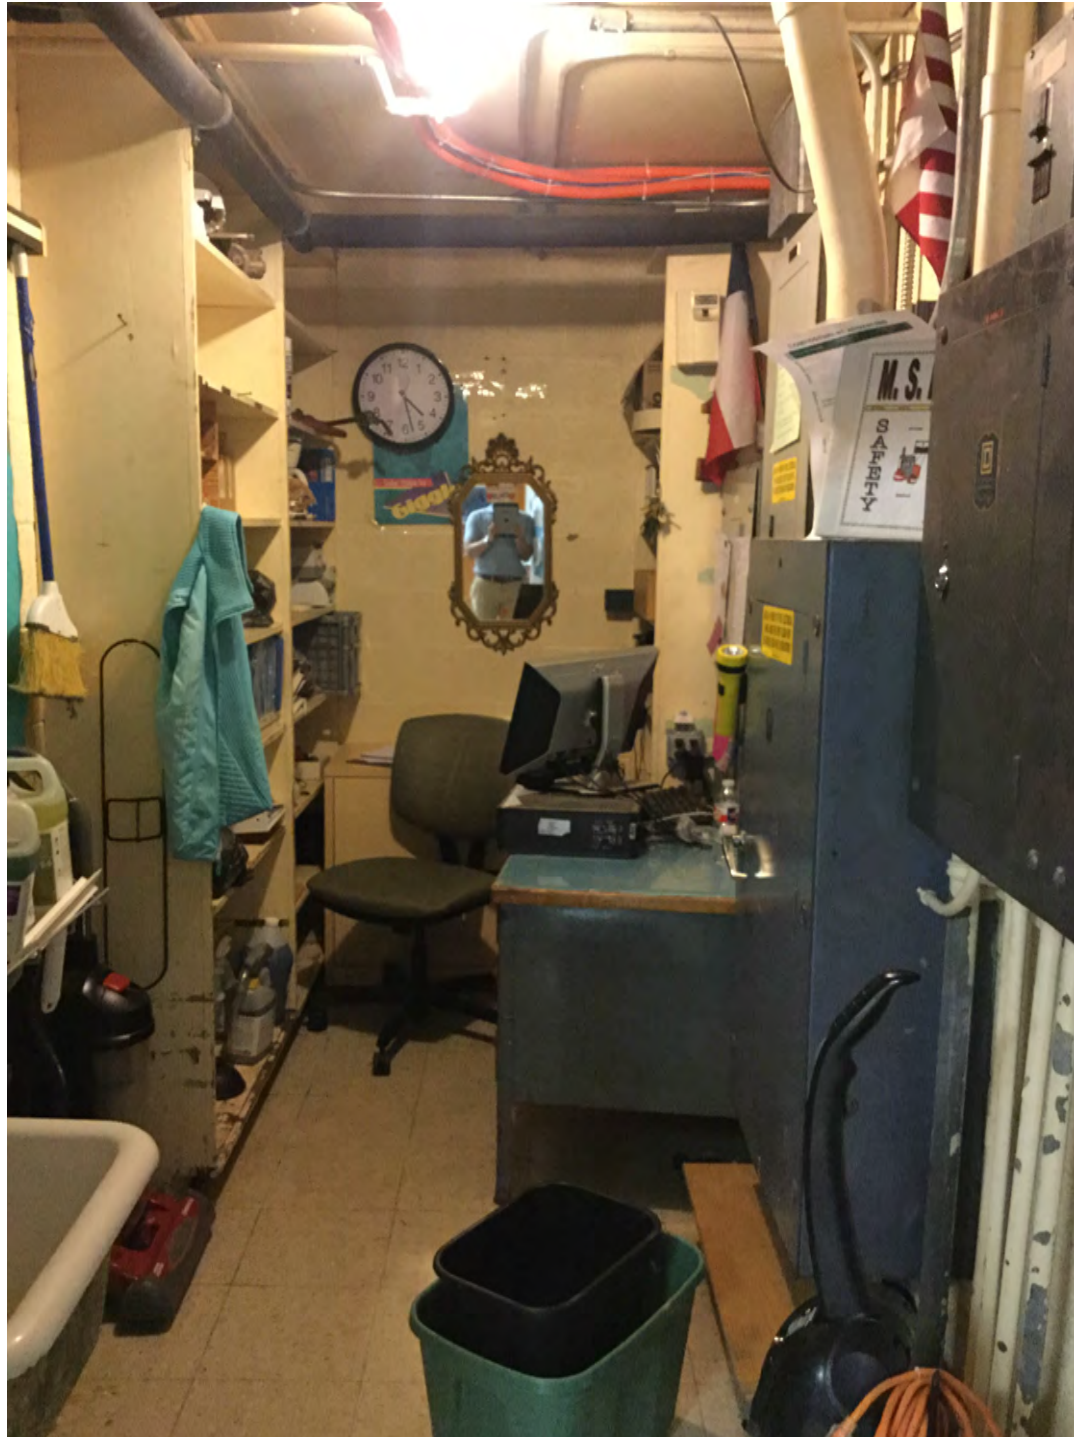
Photo 10.
8.1 Storage

8 - Storage		1	2	3	4	5	N/A	8.00	
8.1	Is there adequate general storage in the building?		2					Comments	1.00 2.00
1) Very unsatisfactory 2) Unsatisfactory 3) Average 4) Good 5) Very good N/A) Does not apply.								General storage is an issue with many of the storage areas being electrical closets.	see photo 9
8.2	Is there adequate classroom storage?			3				Comments	1.00 3.00
1) Very unsatisfactory 2) Unsatisfactory 3) Average 4) Good 5) Very good N/A) Does not apply.								The teachers are storing science materials in separate classrooms.	
8.3	Is there adequate student storage?			3				Comments	1.00 3.00
1) Very unsatisfactory 2) Unsatisfactory 3) Average 4) Good 5) Very good N/A) Does not apply.								There is no real consideration for student storage.
