## Educational Suitability Summary Report

Dobie Pre-Kindergarten Center

Date: 08/09/2016

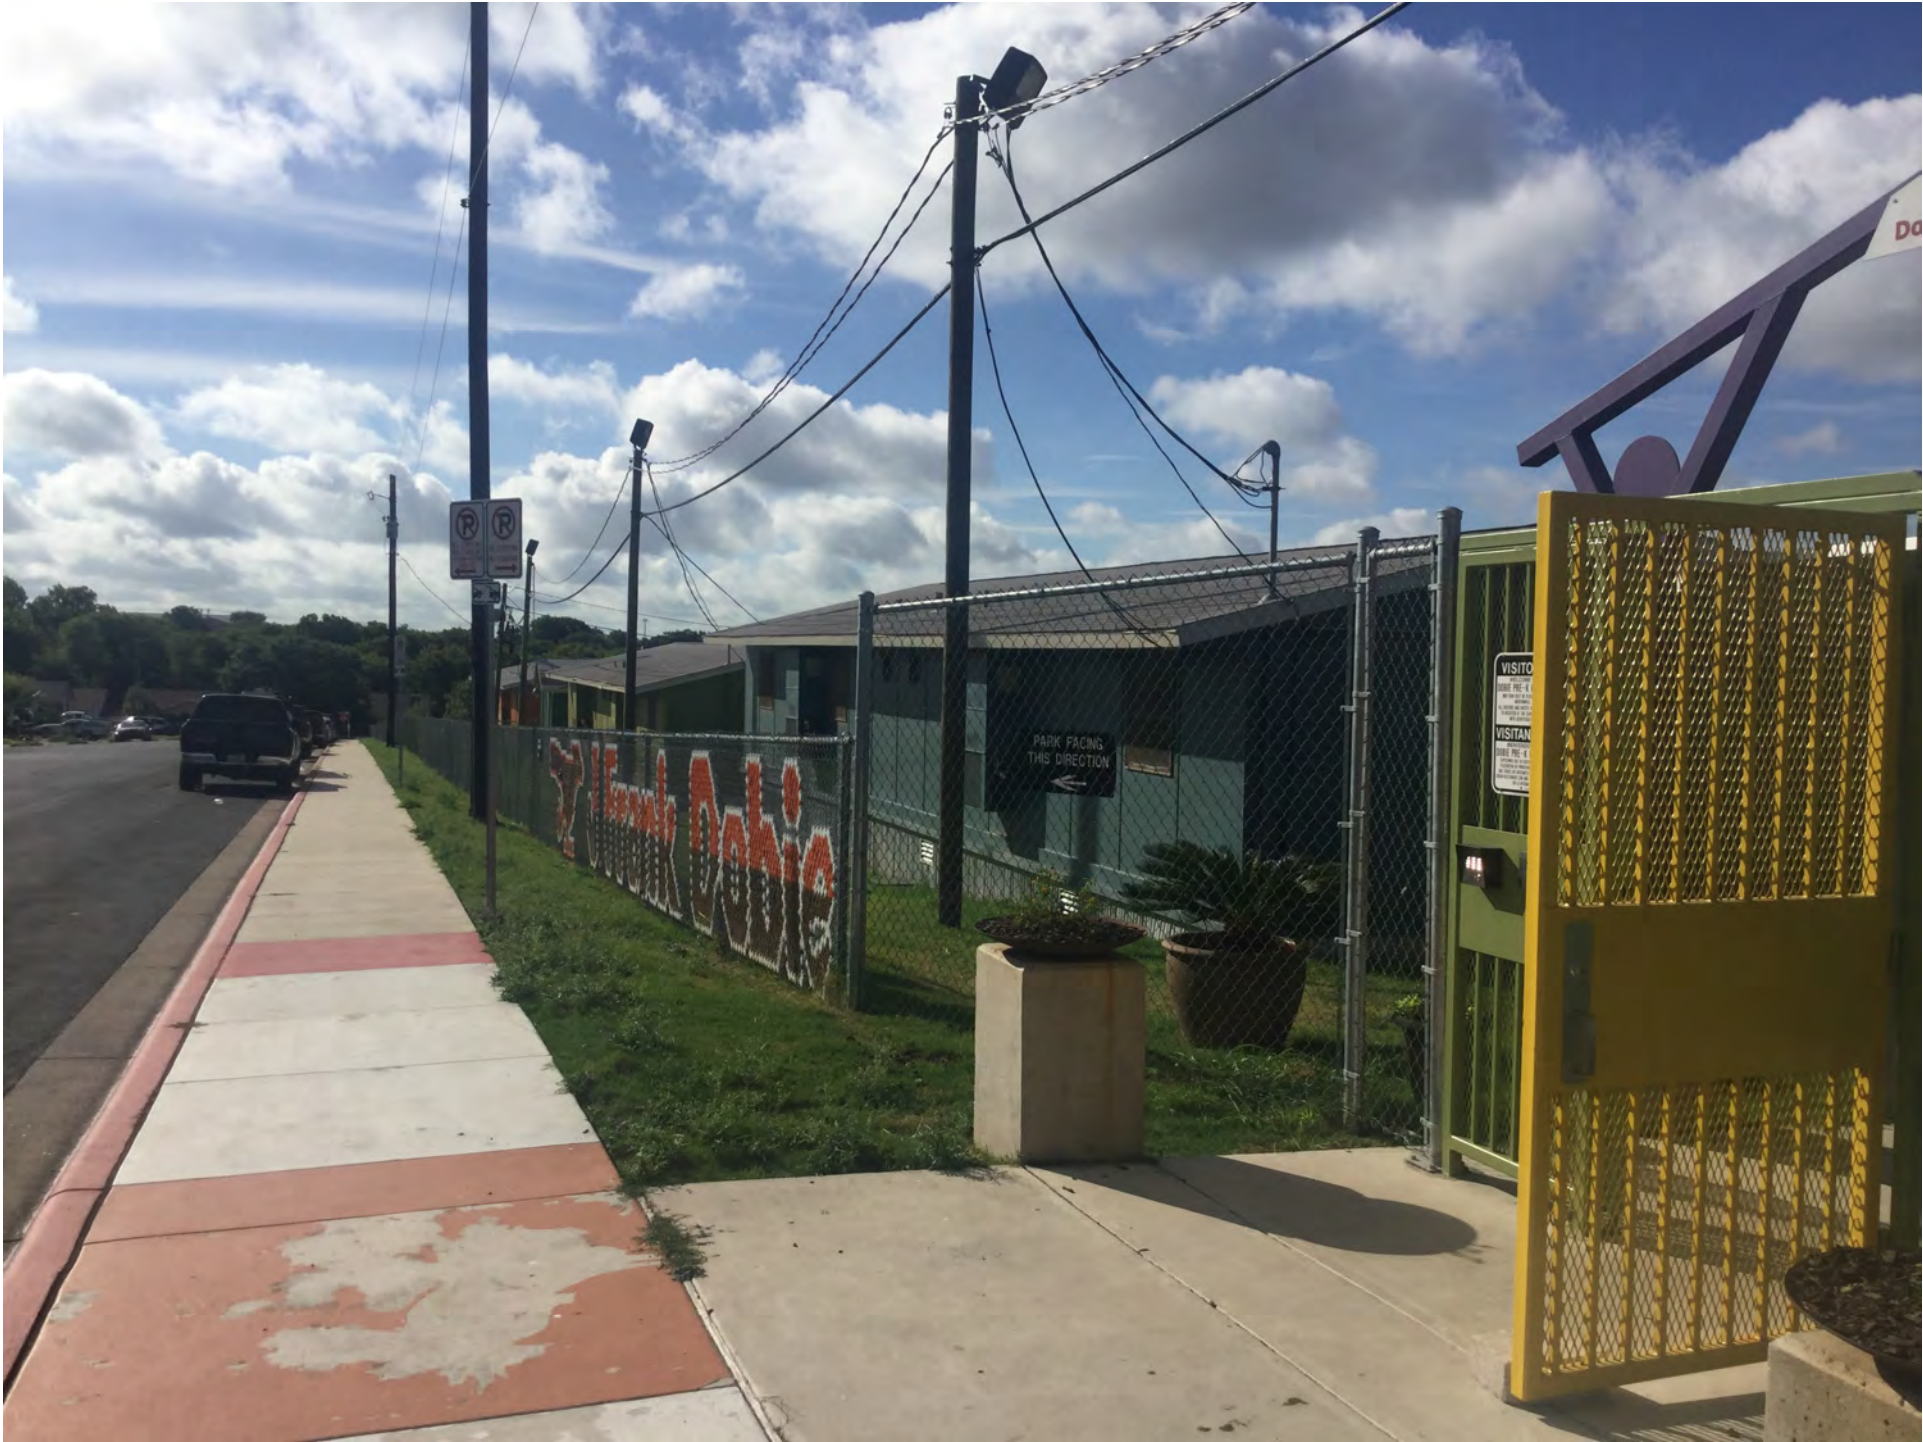
Photo 1. Pick Up and Drop Off

There is no separation of traffic. The drop off area is along a busy road across from private residences. Parking is limited to on-street parking which creates conflicts with the neighbors.

1 - Exterior		1	2	3	4	5	N/A	4.75	
1.1	Does the site permit desirable separation of vehicular, bus and pedestrian traffic?	1						Comments	1.00 1.00
	1) Bus , car and pedestrian all happen at the same location. 2) Cars and buses mix, pedestrians are separated. 3) Buses, cars, and pedestrians are separate but stack space is small. 4) Buses, cars, and pedestrians are separate but drop off does not have a canopy or a holding place like a commons or cafeteria. 5) Buses, cars, and pedestrians are separate and drop off area has a canopy and destination. N/A) Does not apply.							There is no separation of traffic. The drop off area is along a busy road across from private residences. Parking is limited to on-street parking which creates conflicts with the neighbors. The pick-up procedure involves parents walking to their children's classrooms to receive them, but there is no covered area for parents to wait to pick up children. There are reports of parents passing out from the heat while waiting to get their children.

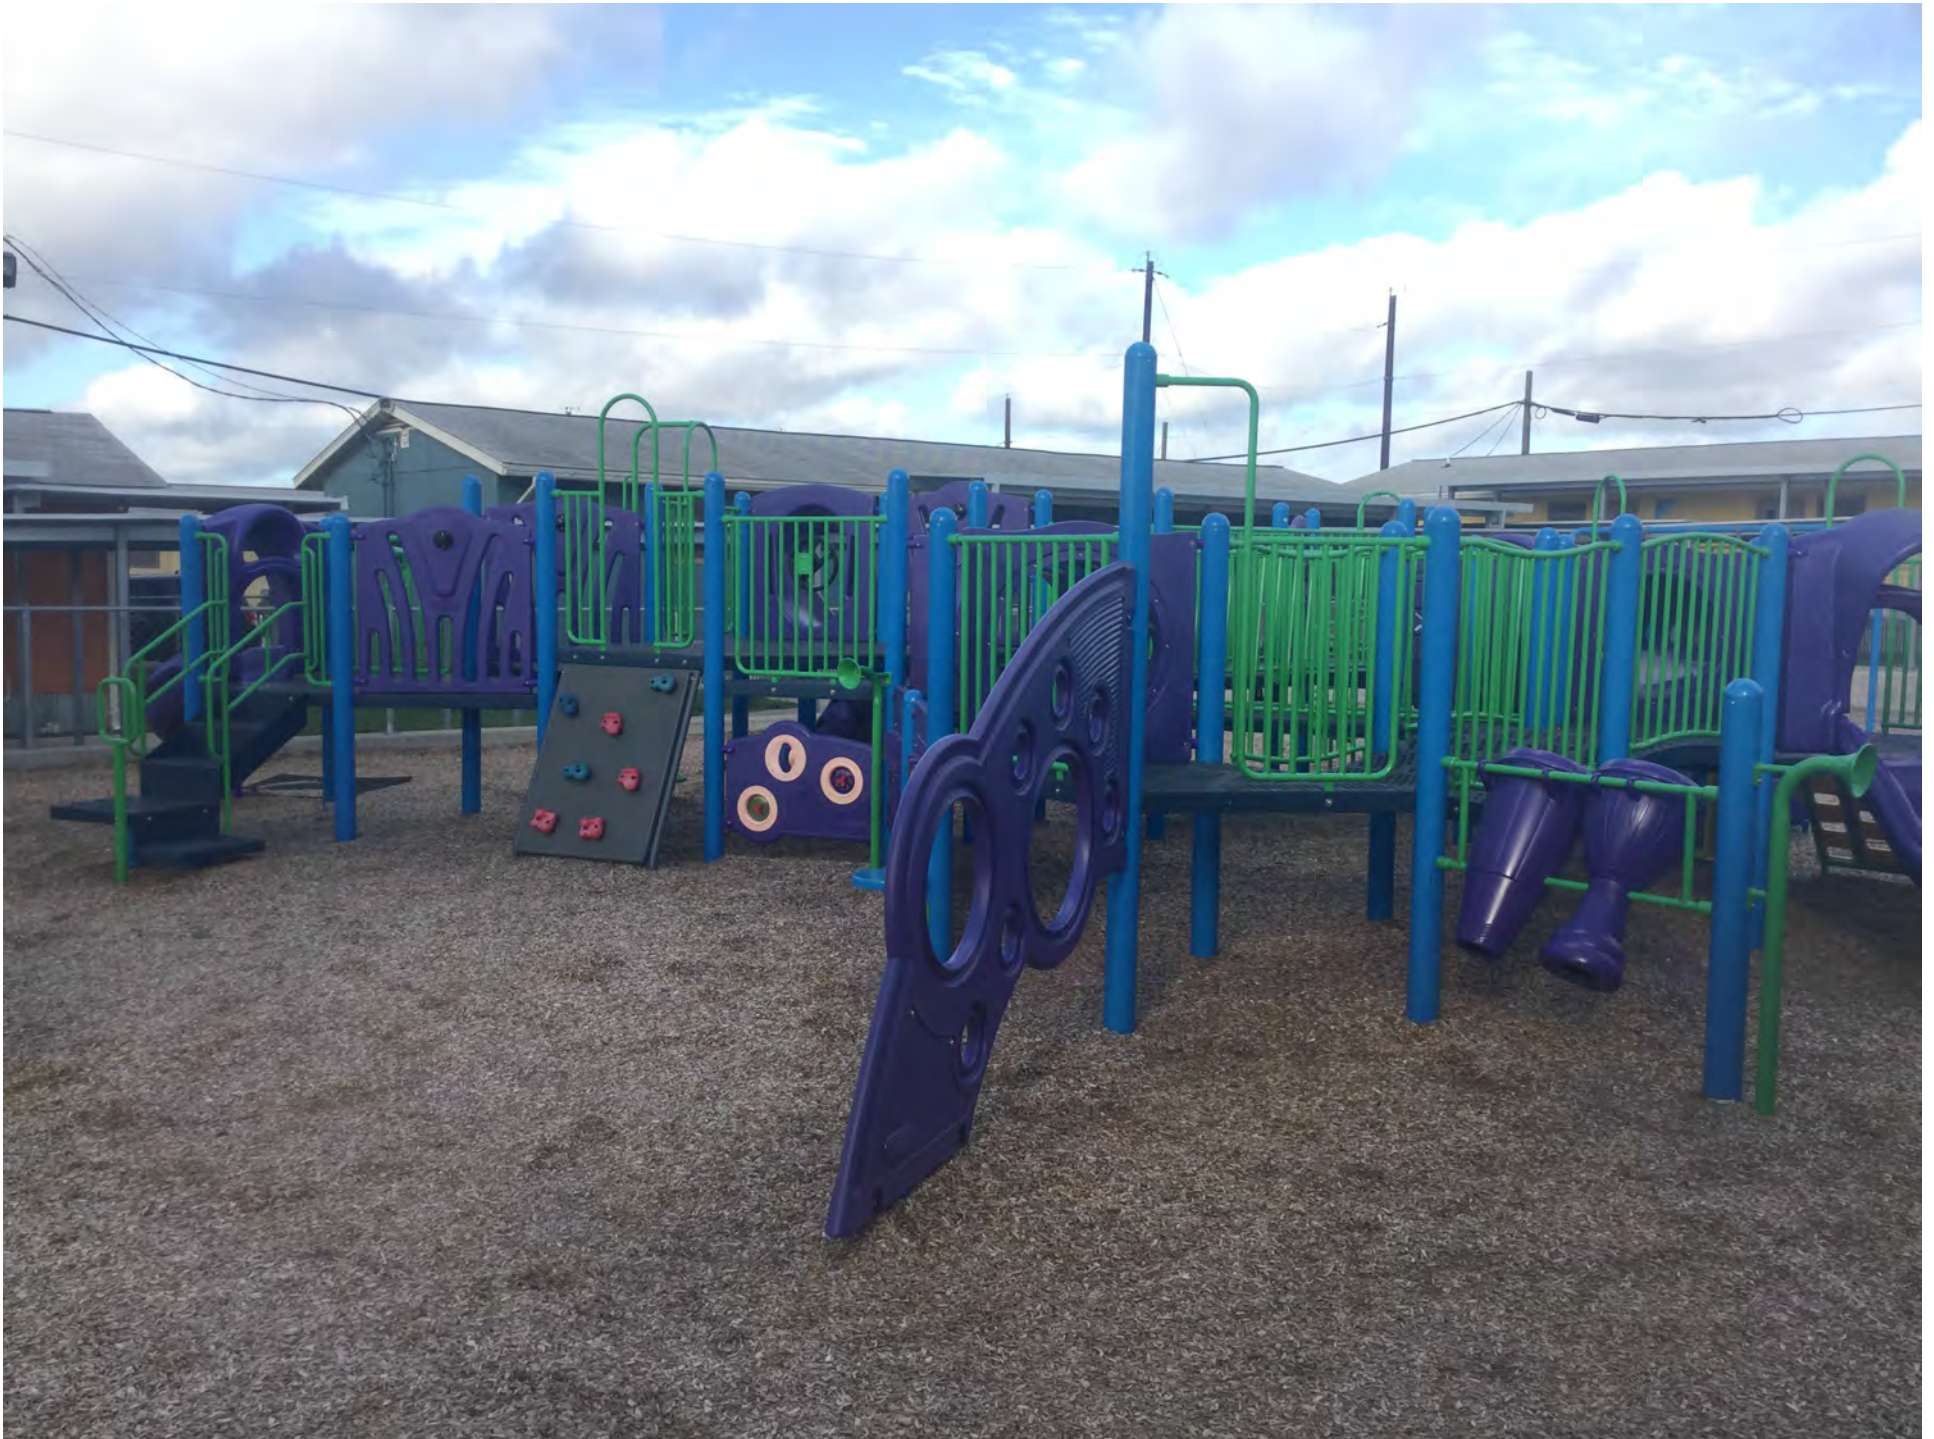
Photo 2. Playground

1.3	Are outdoor play spaces and playfields adequate in size and configuration?		2					Comments	1.00 2.00
	1) Outdoor play space exists, not developed 2) Outdoor play space exists but is not connected to gym or other athletic support areas or is too small. 3. Outdoor play spaces exist, are connected to other athletic areas, are the right size, but are not in good condition. 4. Outdoor play spaces need minor improvements to function well. 5. Outdoor play spaces are in excellent condition. N/A) Does not apply.							The outdoor play space is undersized and needs additional shade.

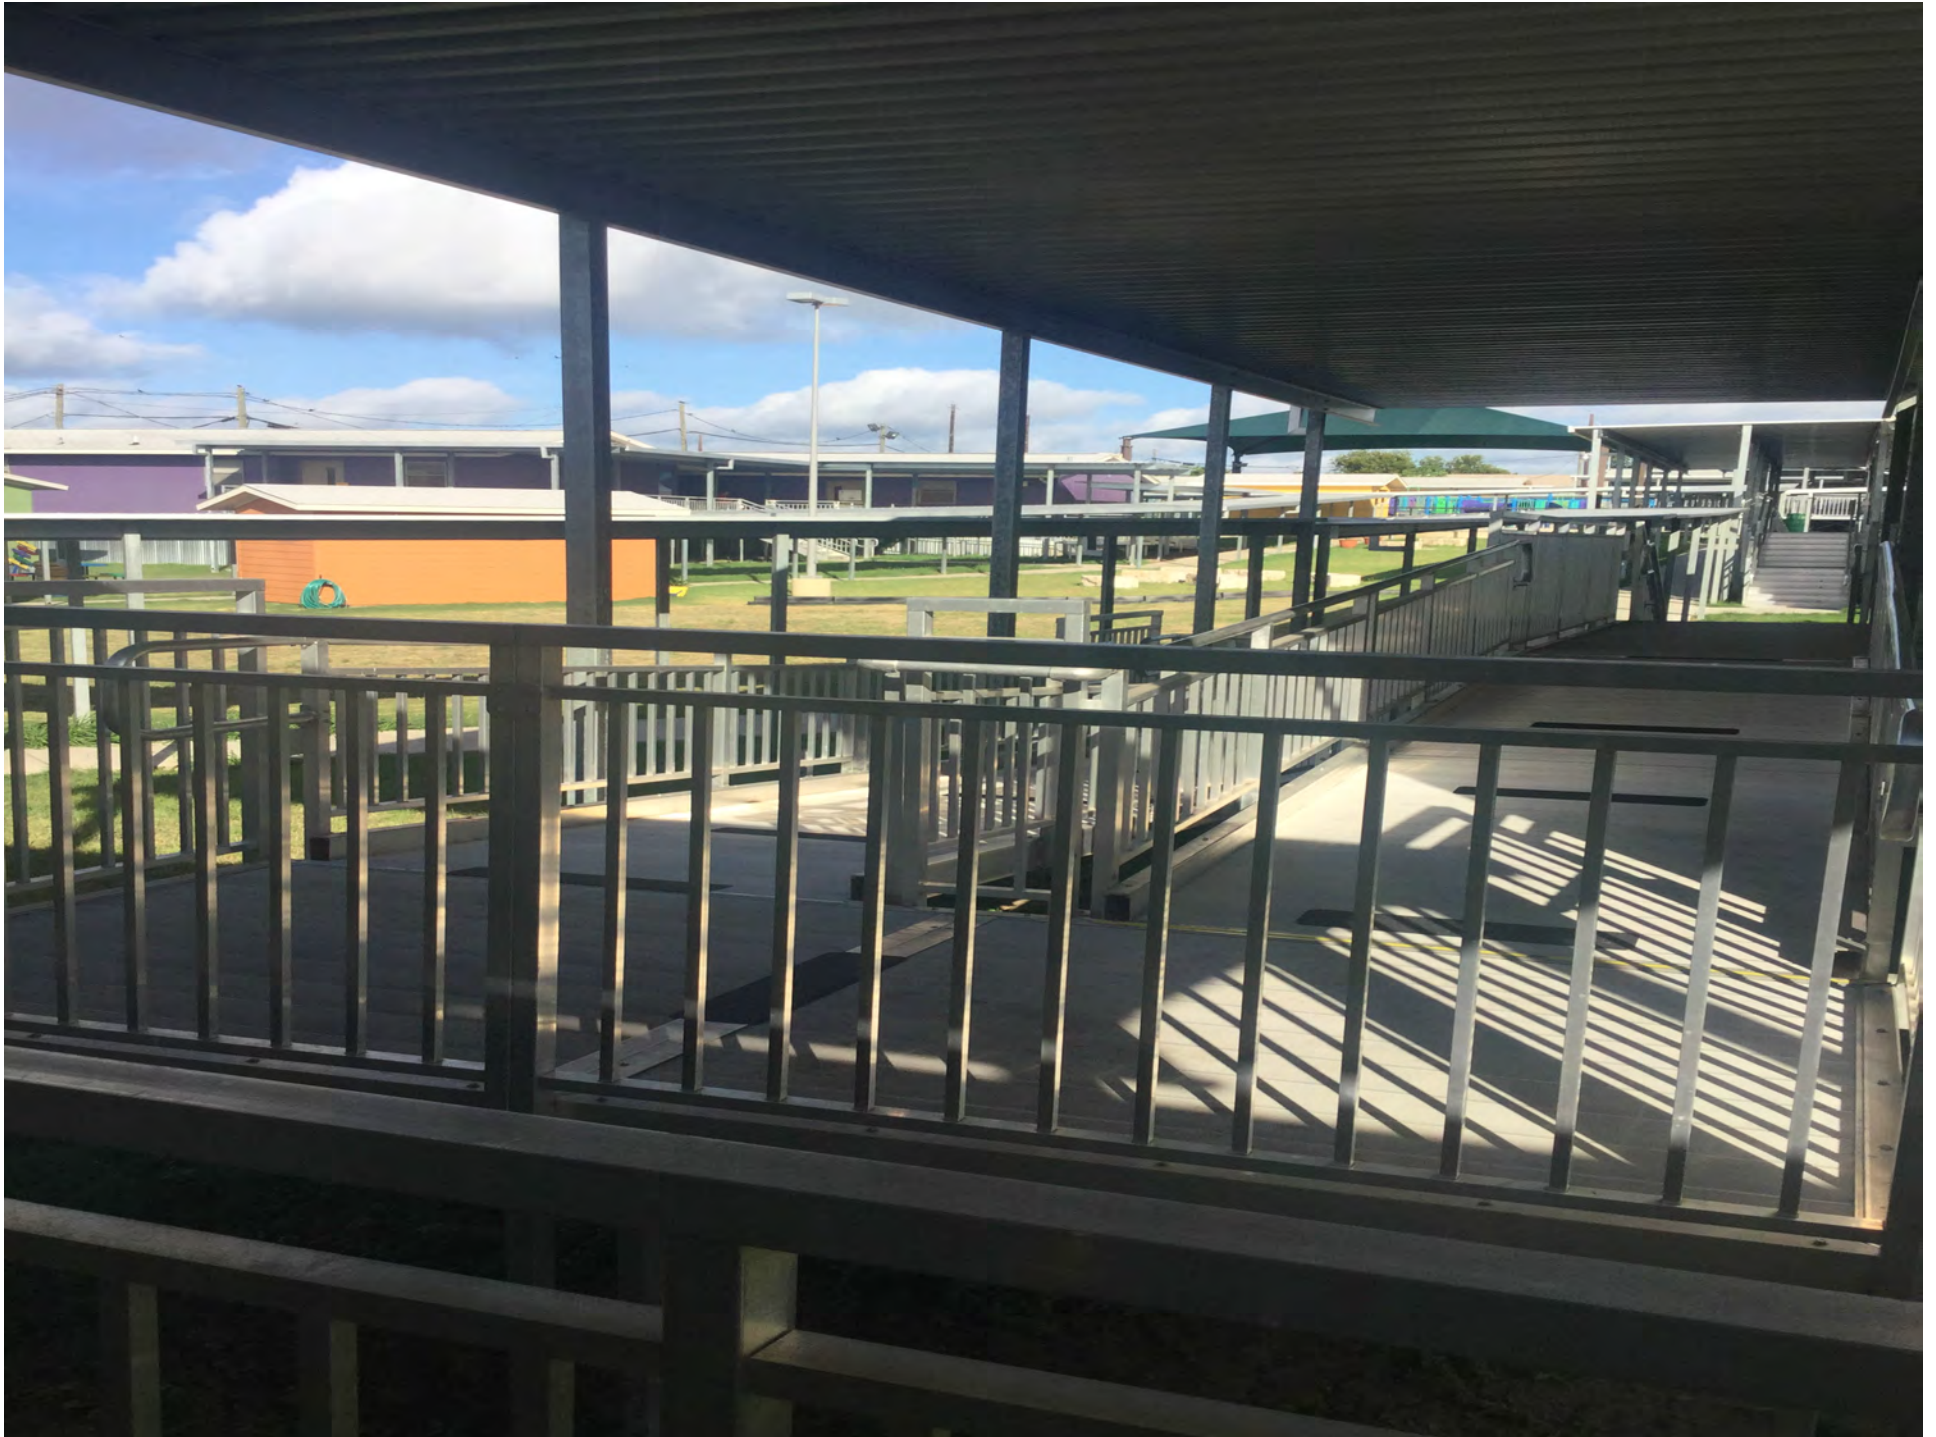
Photo 3. Walkways

The walkways are narrow and they are a mix of covered exterior walkways and uncovered exterior walkways. The metal ramps ice in cold weather and can burn students in warm weather. The school consists entirely of portables. There are no large assembly spaces for

1) Primary circulation is 5'-0" to 6'-0" wide. 2) Primary circulation is 6'-0" to 7'-0" wide 3) Primary circulation is 7'-0" to 8'-0" wide 4) Primary circulation is 8'-0"-10'-0" wide 5) Primary circulation is 10'-0"+ wide N/A) Does not apply.							The walkways are narrow and they are a mix of covered exterior walkways and uncovered exterior walkways. The metal ramps ice in cold weather and can burn students in warm weather.

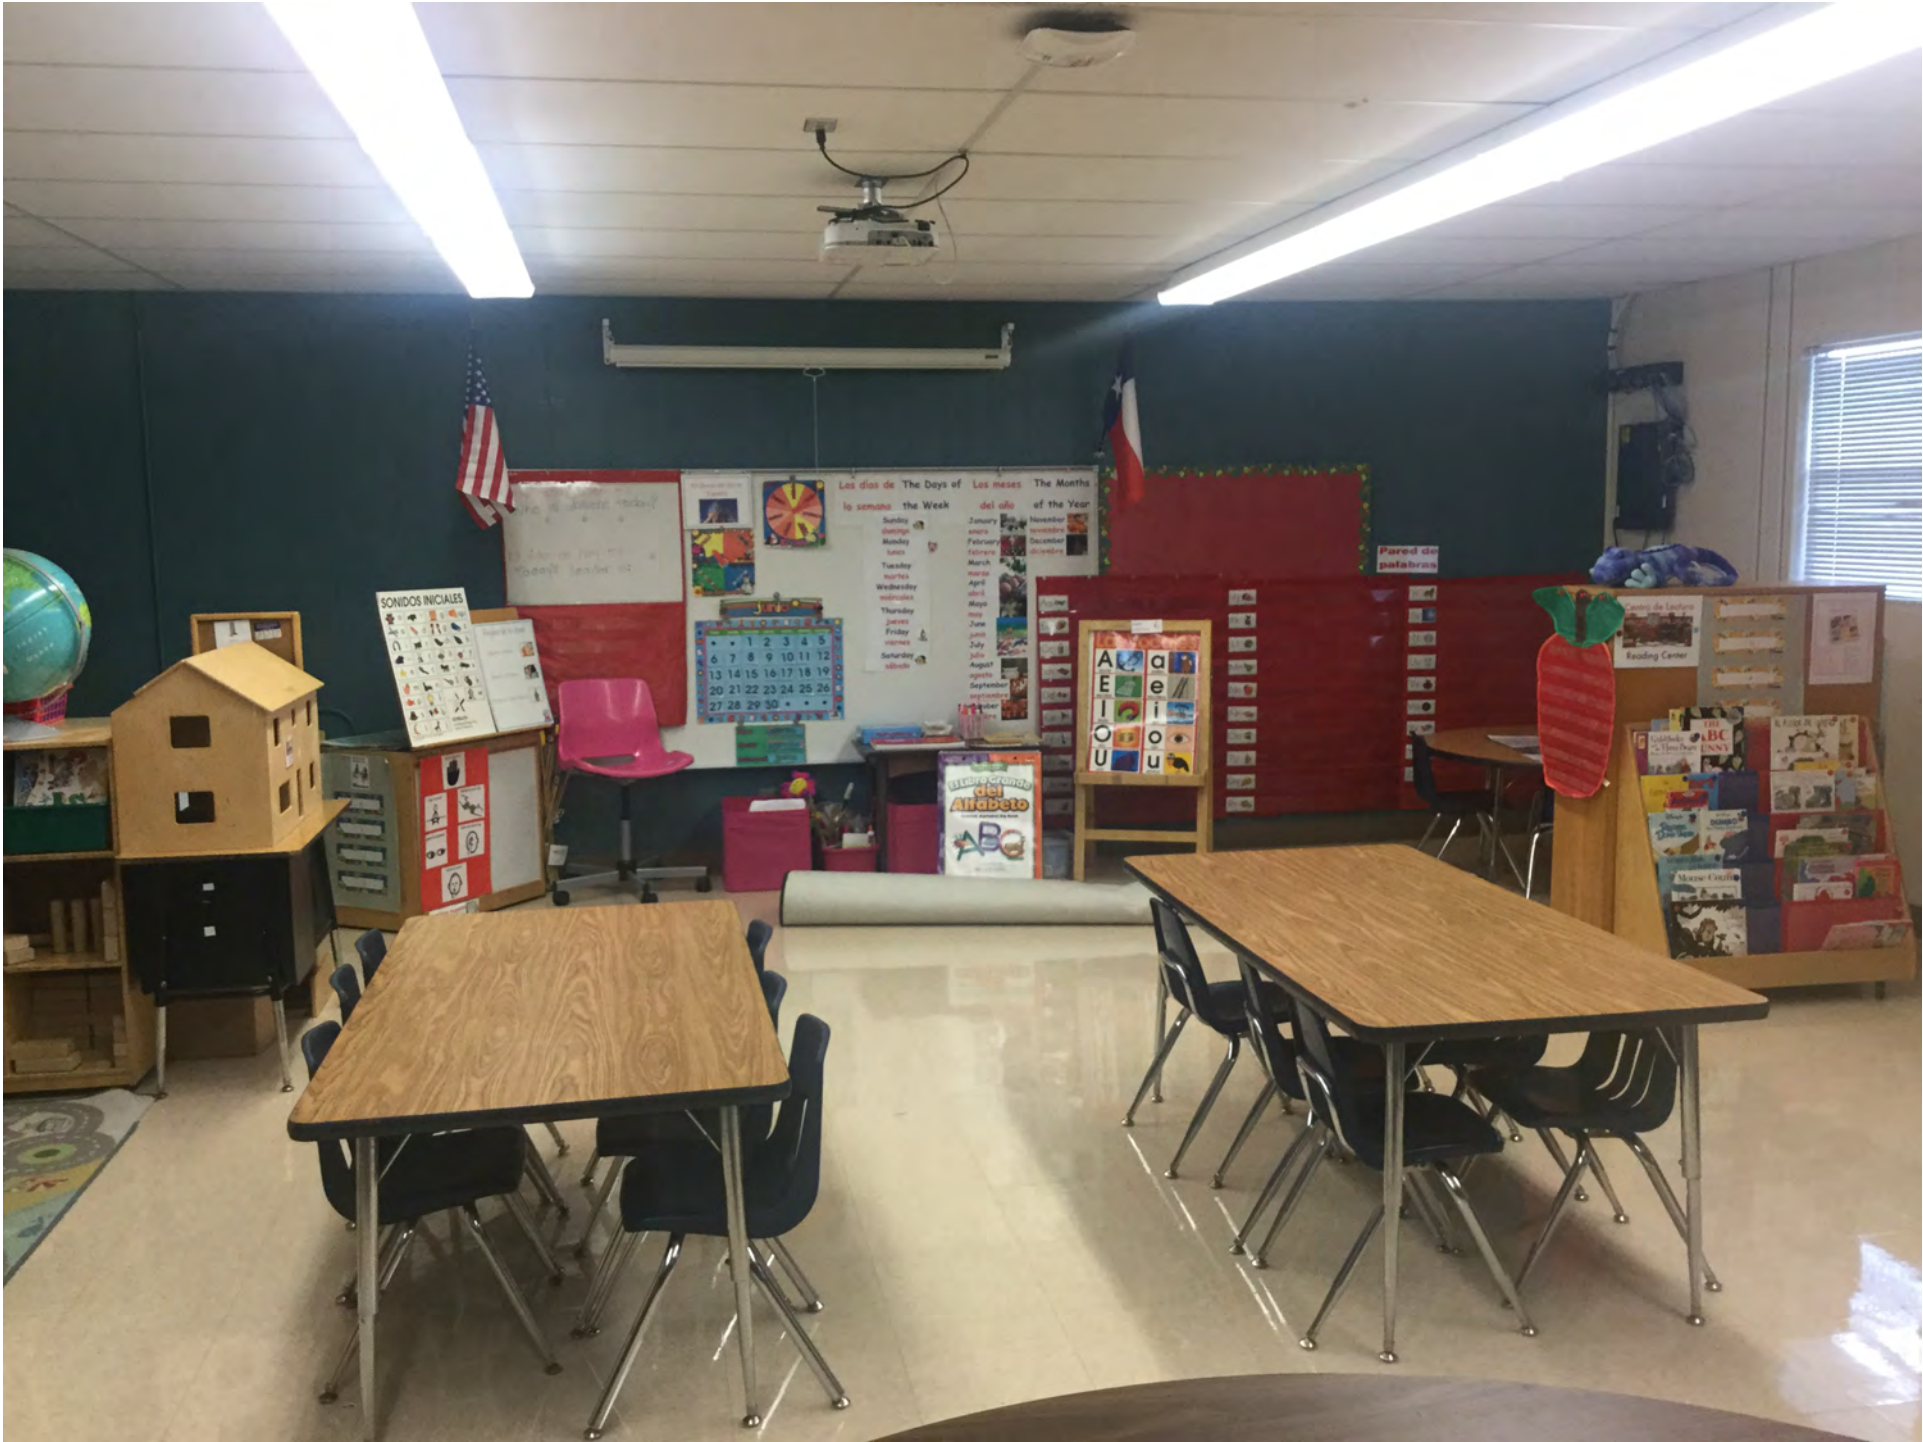
Photo 4. Typical Classroom

1) Very unsatisfactory - Too small, awkward layout, does not meet needs 2) Unsatisfactory - Too small, only one area for all teaching methods, limited flexibility 3) Neutral - Moderate size, two areas for different teaching methods, some flexibility, access to student storage/casework 4) Satisfactory - Good size, at least two zones for different teaching methods, flexibility and student storage, not new 5) Very Satisfactory - Good size, two zones for different teaching methods, flexibility and student storage/casework, adequate display area and visual teaching tools N/A) Does not apply.								The spaces are portable classrooms. They are undersized and packed full of furniture.

4.2	Are general classrooms large enough to support project-based learning and multiple teaching modalities?	1						Comments	1.00 1.00
1) Very unsatisfactory -too small to move, set for lecture only, no connectivity, no flexibility 2) Unsatisfactory - adequate size but set for lecture only, no connectivity, no flexibility 3) Neutral - have flexibility and space for hands on or project based learning 4) Satisfactory - have flexibility and space for hands on or project based learning and connectivity for global learning 5) Very Satisfactory - space for hands on learning, flexibility for different groupings, and connectivity for global classrooms N/A) Does not apply.									The classrooms are undersized for normal instruction.

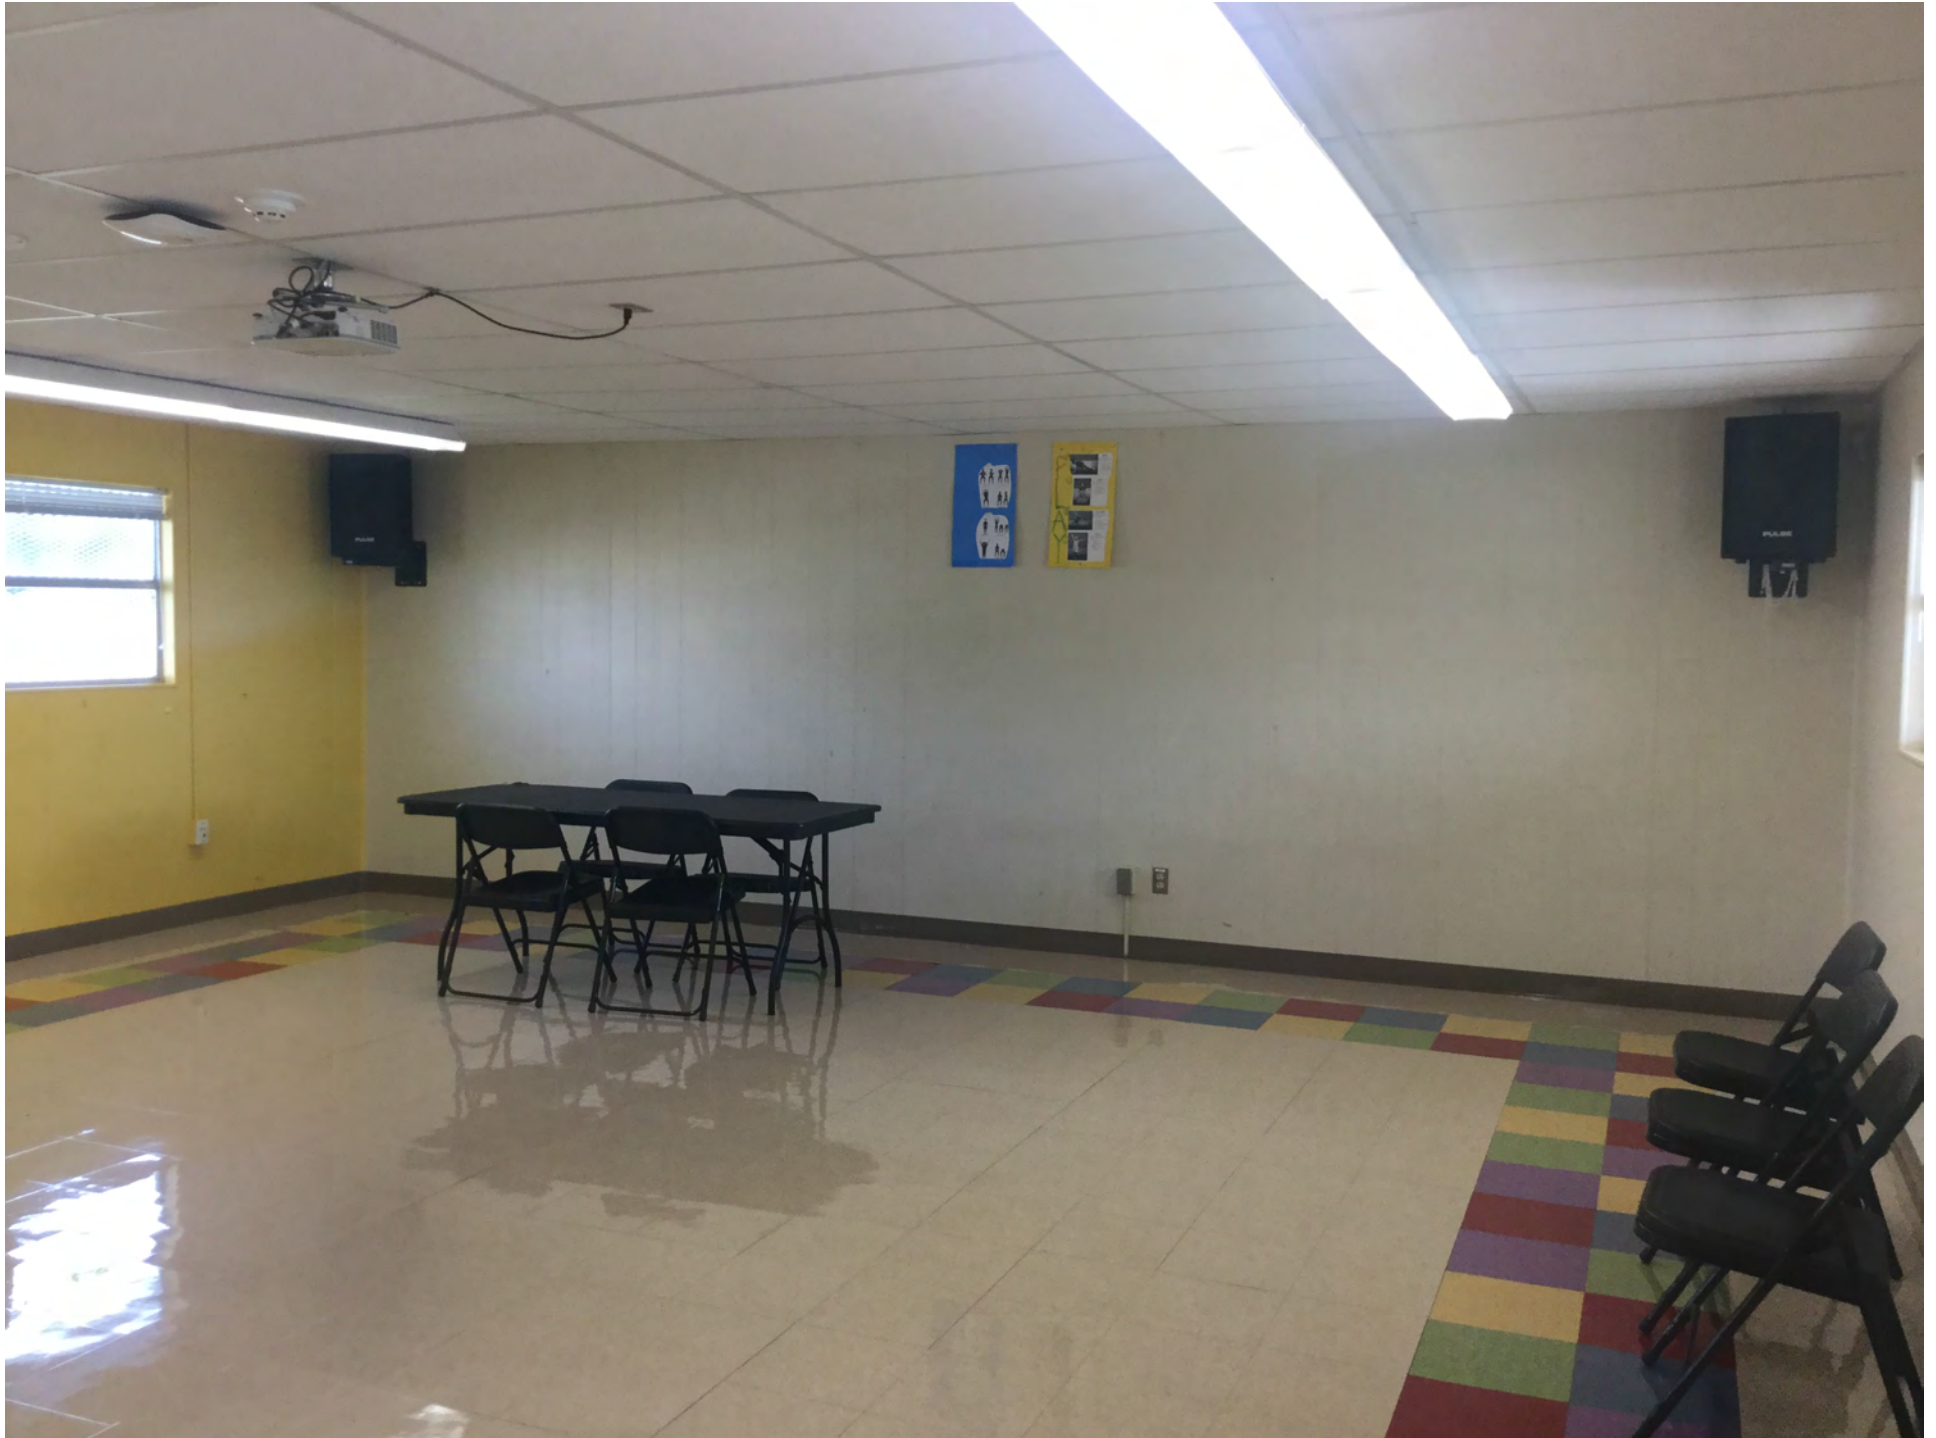
Photo 5. Gym Space

The gymnasium is in a portable. There is a poorly functioning stereo and a restroom. There is no athletic flooring or equipment expected in a typical physical education space. There is no performance space for the campus. Because of this, the graduation ceremony has to be split into seven consecutive ceremonies. There are no dedicated special education spaces, but the support for special needs students is problematic. There are serious accessibility concerns at the campus. The emergency evacuation pathway for the campus is to the adjacent middle school along an ADA non-compliant path. The sidewalk is discontinuous and in poor condition. There is no ADA parking area on the campus either. The dining facilities are two portables. One of these has a restroom and nicer serving equipment, while the other has makeshift equipment and no restroom. This causes inefficiencies and challenges for teachers.

1) Very unsatisfactory 2) Unsatisfactory 3) Average 4) Good 5) Very good N/A) Does not apply.								The gymnasium is in a portable. There is a poorly functioning stereo and a restroom. There is no athletic flooring or any conventional indications of a physical education space.

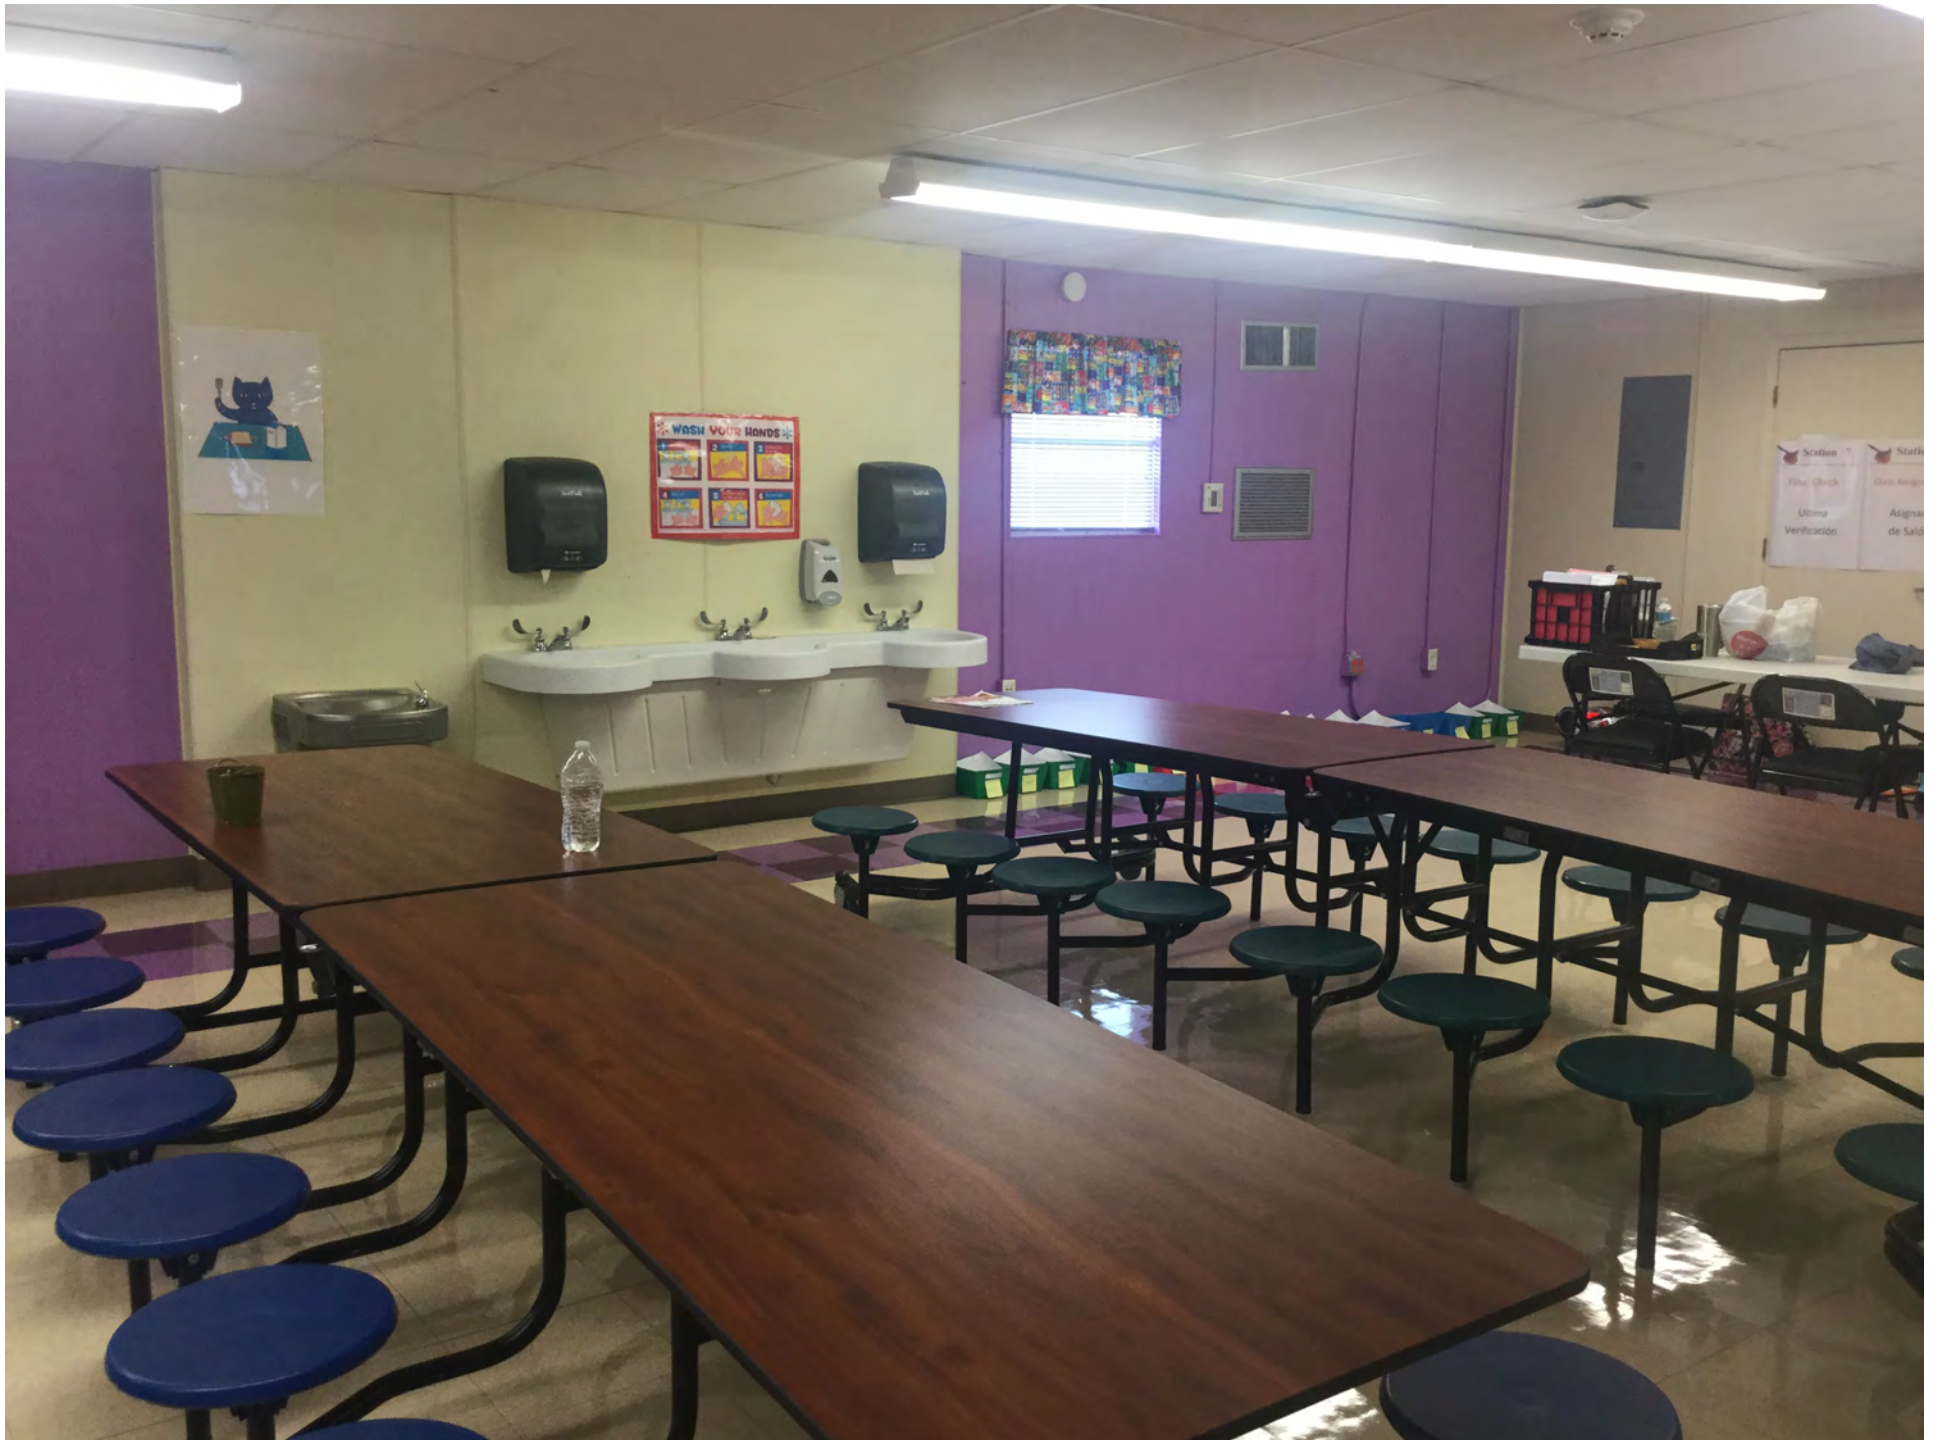
Photo 6.  
Cafeteria Portable

3.16	Are the student dining facilities appropriately configured?						1							Comments	1.00	1.00
1) Very unsatisfactory - Too small, poor circulation, inflexible seating in poor condition 2) Unsatisfactory - Too small or inadequate circulation, seating in poor condition 3) Average - moderate size, with adequate circulation, seating in okay condition 4) Good - good size, adequate circulation, seating in good condition 5) Very good - good size, adequate circulation, seating in good condition, with more than one option for eating space (ex: connection to outdoor eating space) N/A) Does not apply.													The dining facilities are two portables. One of these has a restroom and nicer serving equipment, while the other has makeshift equipment and no restroom. This causes dissatisfaction with instructors.

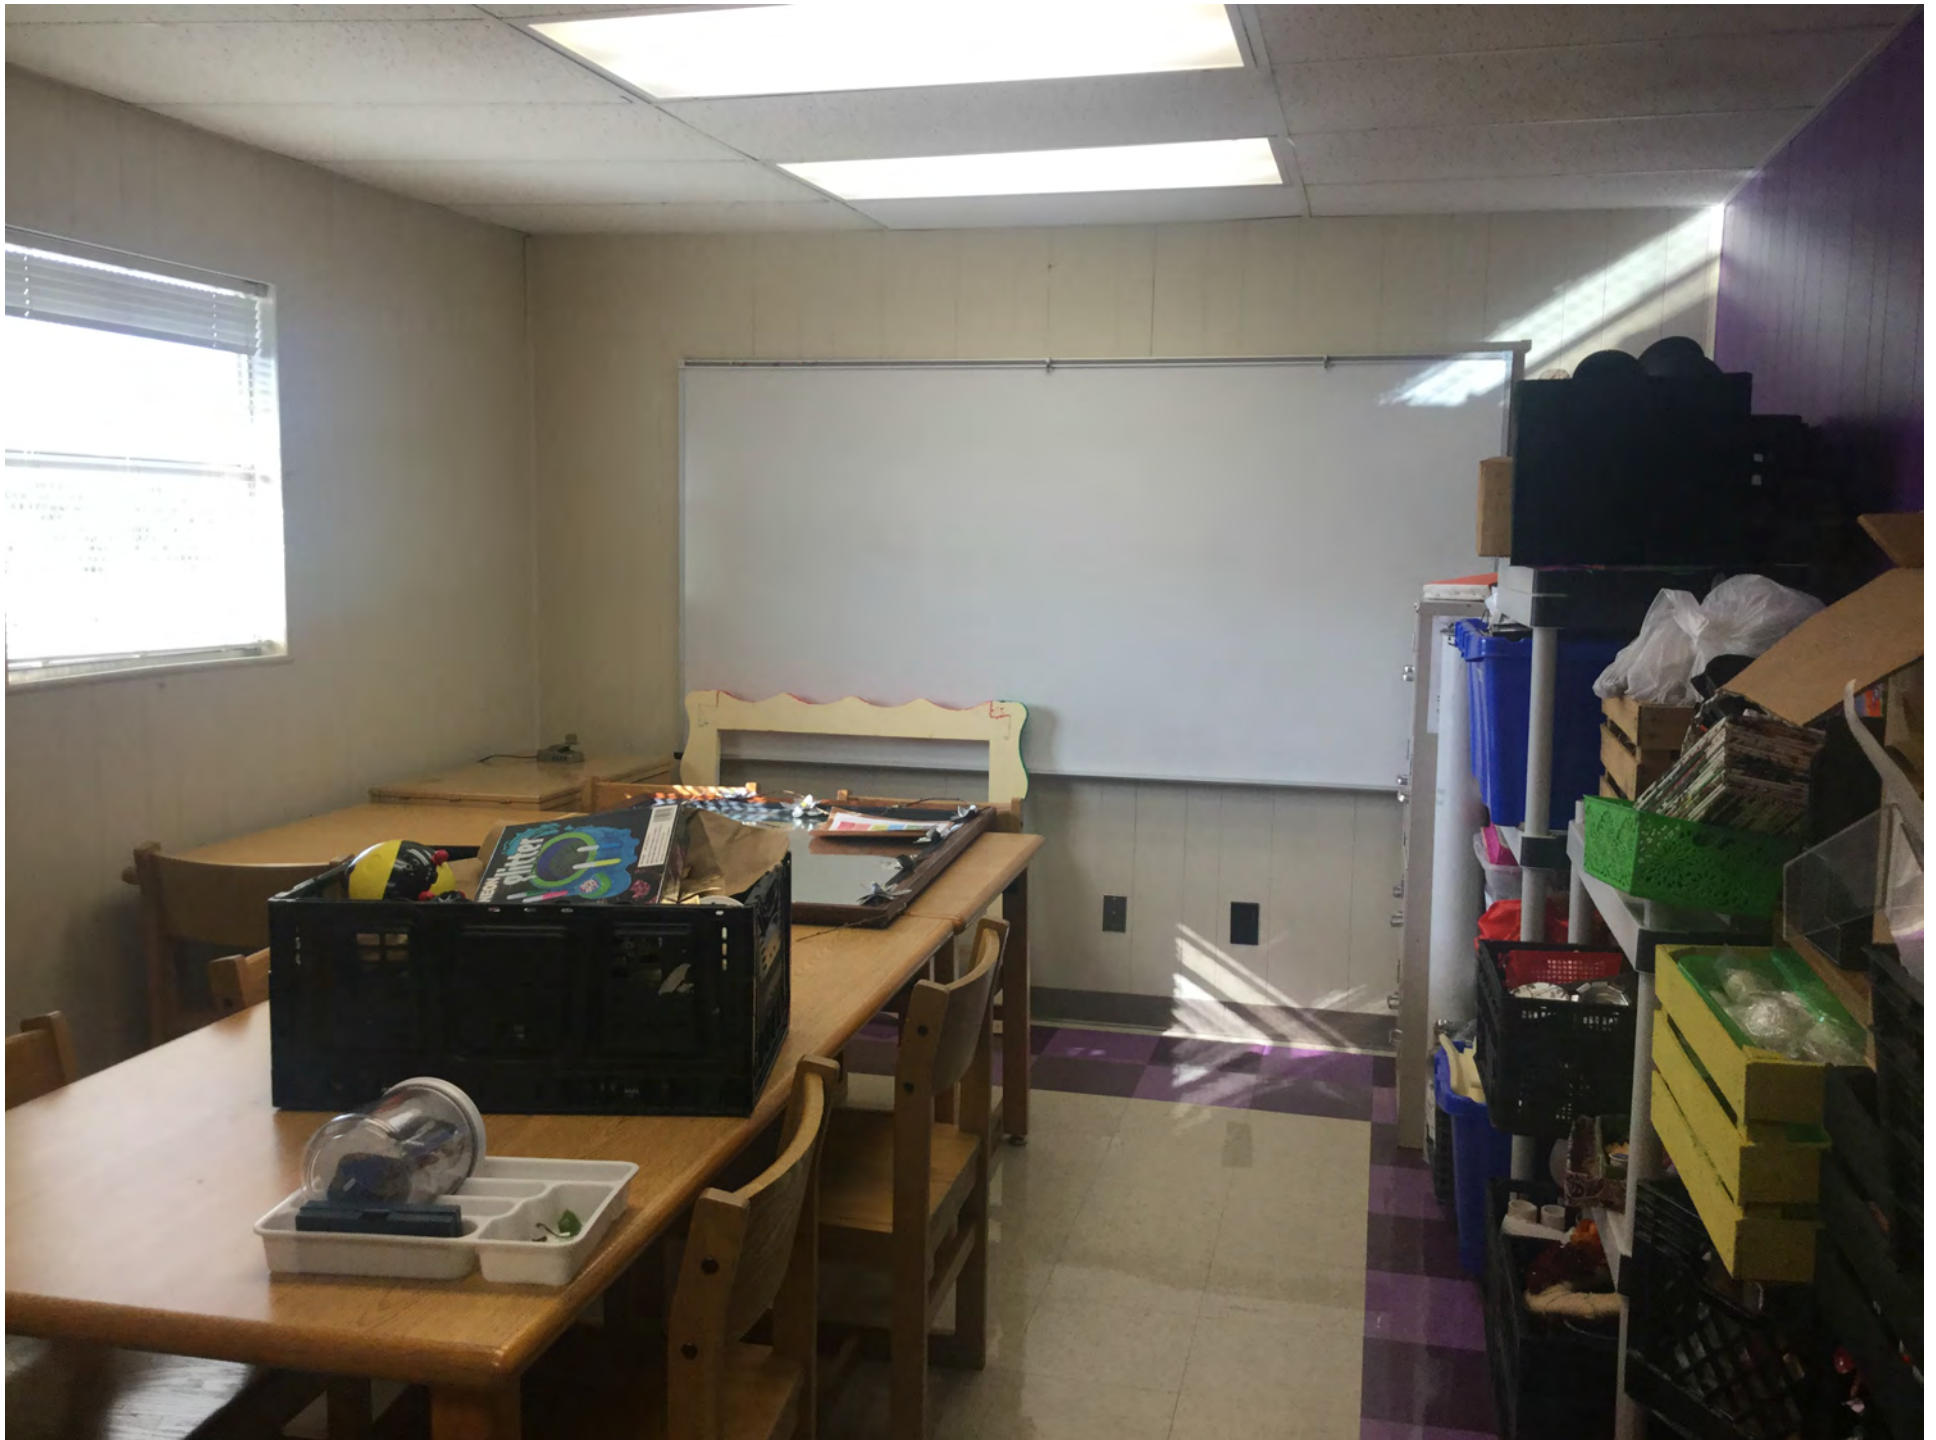
Photo 7. Meeting Space

1) Very unsatisfactory - no common spaces or meeting rooms or in very poor condition 2) Unsatisfactory - a few common spaces or meeting rooms in unsatisfactory condition 3) Average - a few common spaces and meeting areas needing updates 4) Good - multiple common spaces and meeting rooms in good condition 5) Very good - adequate common spaces and meeting rooms of excellent quality N/A) Does not apply.							The meeting space is located in a portable very far from the front office portable, actually outside of the boundary fence of the school. This portable has outdated, non-matching furniture and undersized meeting space. This area is shared by parent resource and the PTA.
