## Educational Suitability Summary Report

Dobie Pre-Kindergarten Center

Date: 08/09/2016

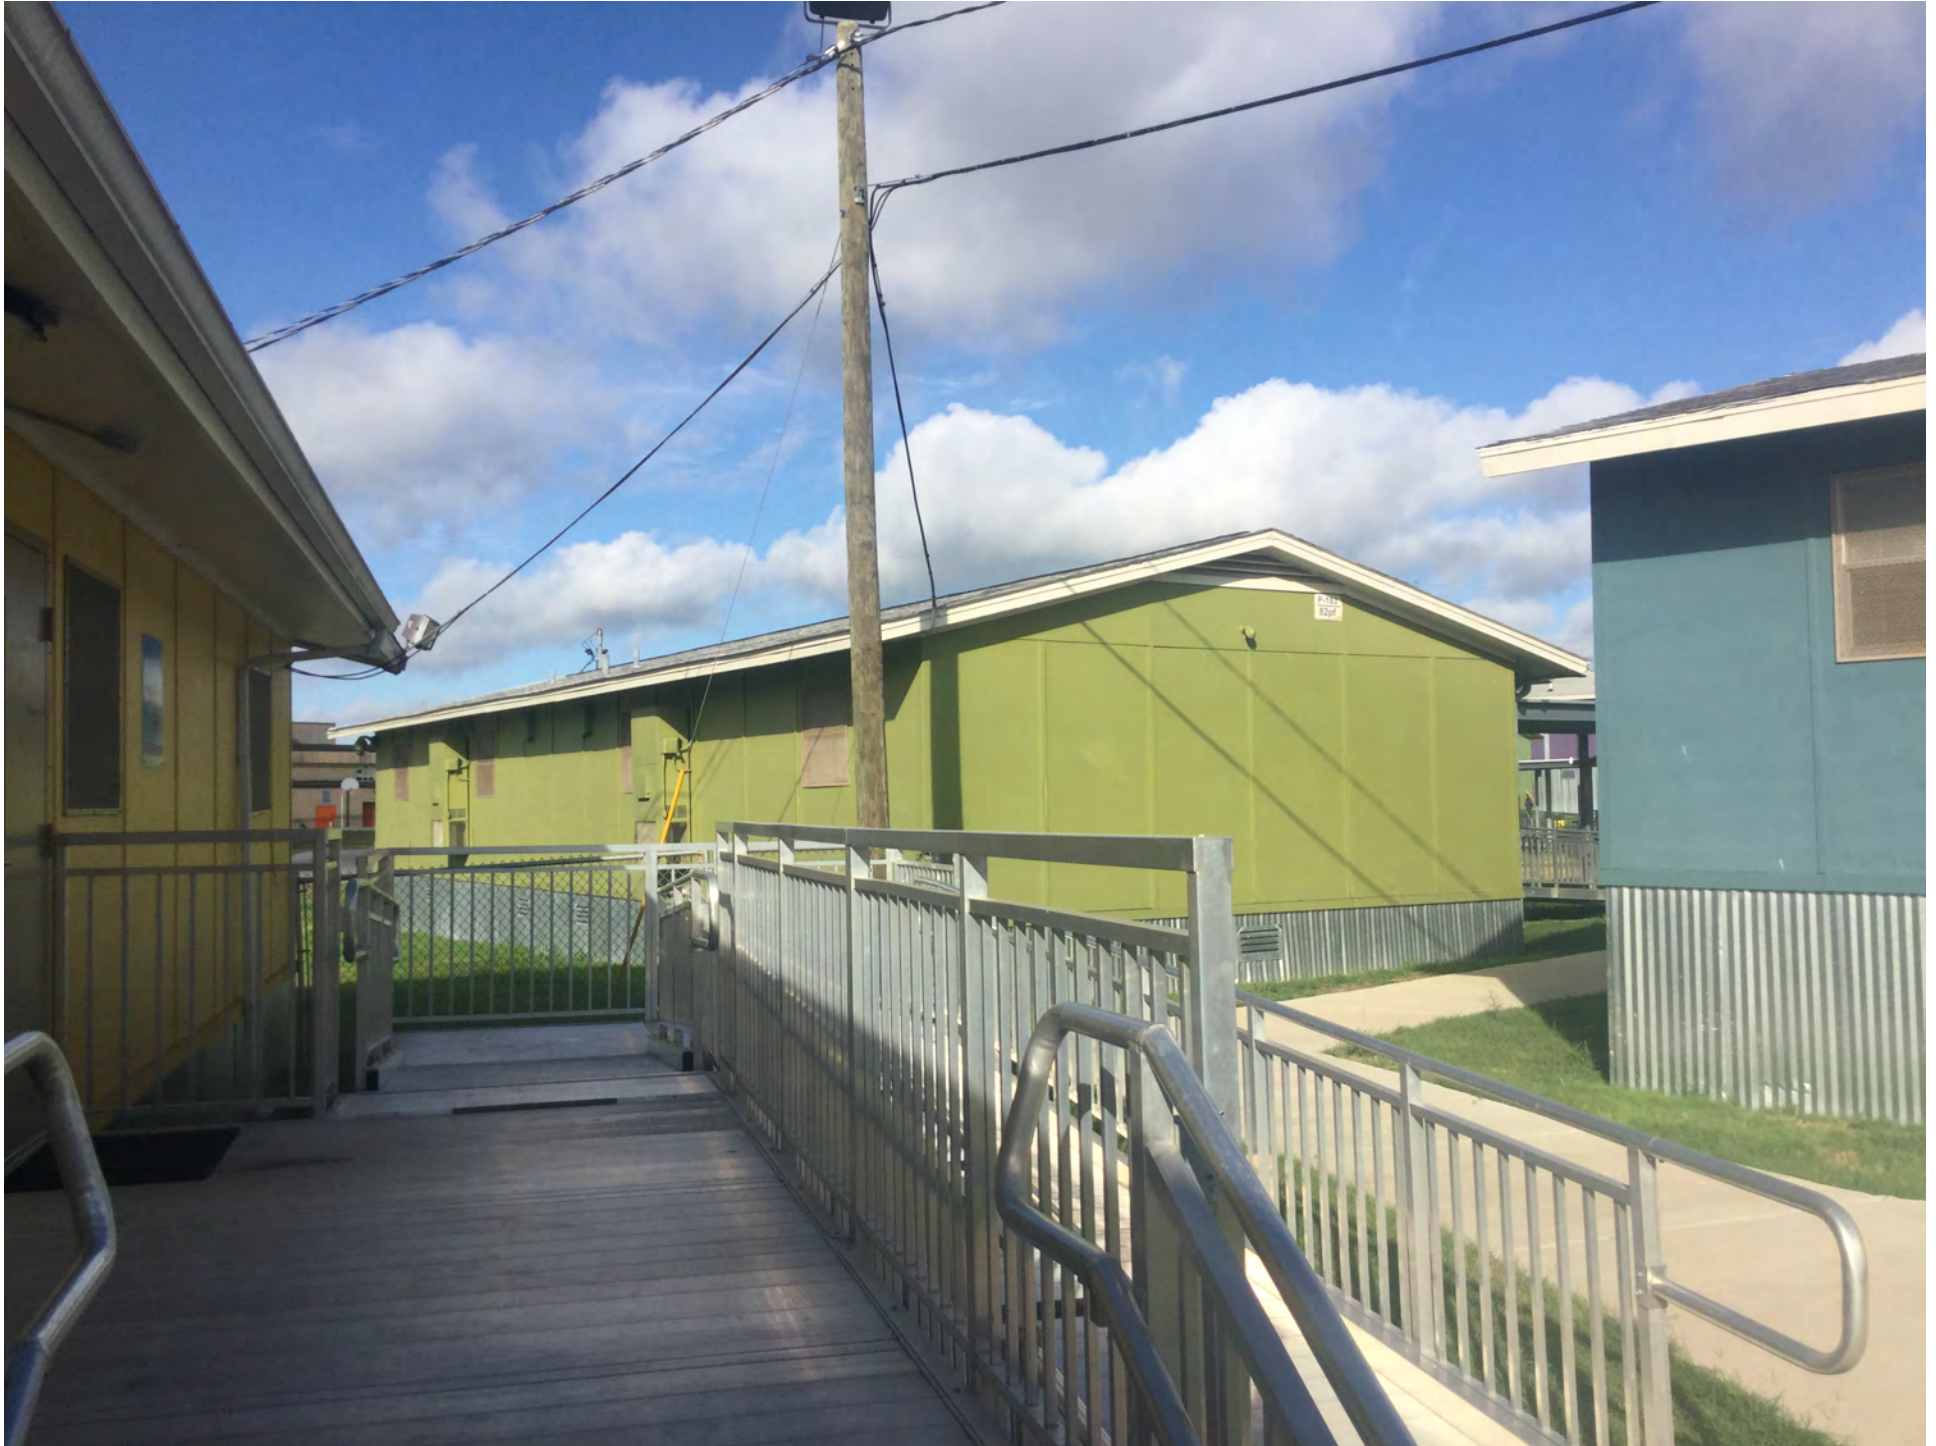
Photo 8. Lack of Visibility

6.4	Is there enough interior transparency for faculty to affectively supervise students who are not in classrooms?	1						Comments	1.00 1.00
1) Very unsatisfactory 2) Unsatisfactory 3) Average 4) Good 5) Very good N/A) Does not apply.								There is difficulty in supervising students in an all-portable campus because students are not in one, contained building. There are newer portables on the outskirts of the campus that are completely blocked from view from the rest of the school.

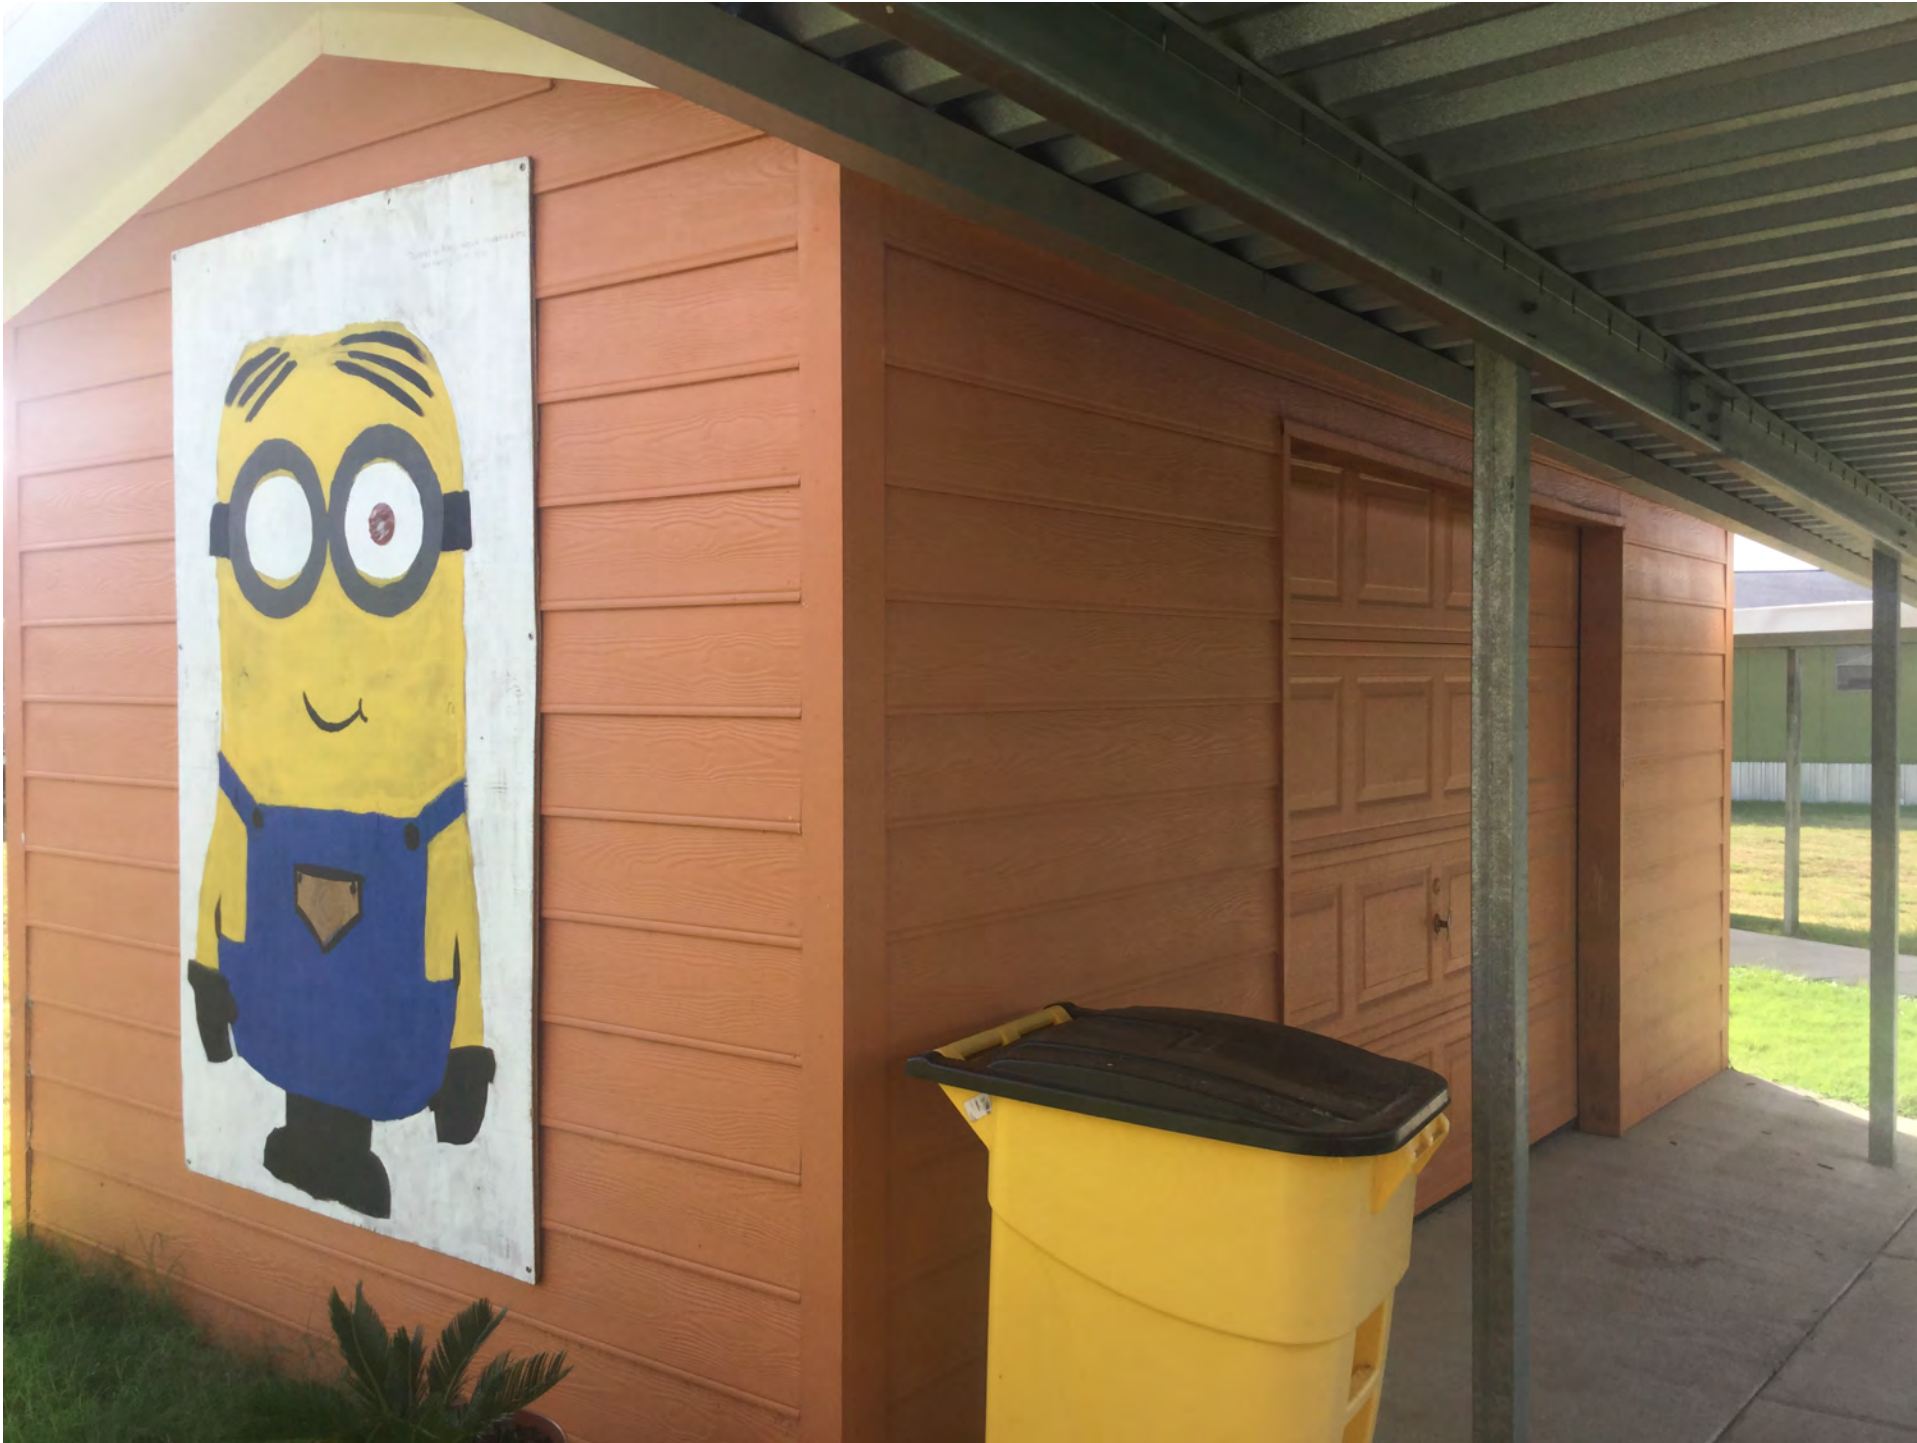
Photo 9. Storage

General building storage is in the form of exterior storage sheds and a few supply closets.

There is a lack of secure file storage as well. The classroom and student storage is limited and being supplemented by older bookcases and shelves.

8 - Storage		1	2	3	4	5	N/A	5.00	
8.1	Is there adequate general storage in the building?	1						Comments	1.00 1.00
1) Very unsatisfactory 2) Unsatisfactory 3) Average 4) Good 5) Very good N/A) Does not apply.								General building storage is being accommodated by exterior storage sheds. There is a lack of secure storage for important files.	
8.2	Is there adequate classroom storage?		2					Comments	1.00 2.00
1) Very unsatisfactory 2) Unsatisfactory 3) Average 4) Good 5) Very good N/A) Does not apply.								The classroom storage is limited. There are large, older bookcases and shelves being used to supplement storage.	
8.3	Is there adequate student storage?		2					Comments	1.00 2.00
1) Very unsatisfactory 2) Unsatisfactory 3) Average 4) Good 5) Very good N/A) Does not apply.								Student storage is limited to the classroom shelving or bookcases.
