Educational Suitability Summary Report

Doss Elementary School – BLDG 154

Date: 07/26/2016

Austin ISD Educational Suitability Assessment Criteria

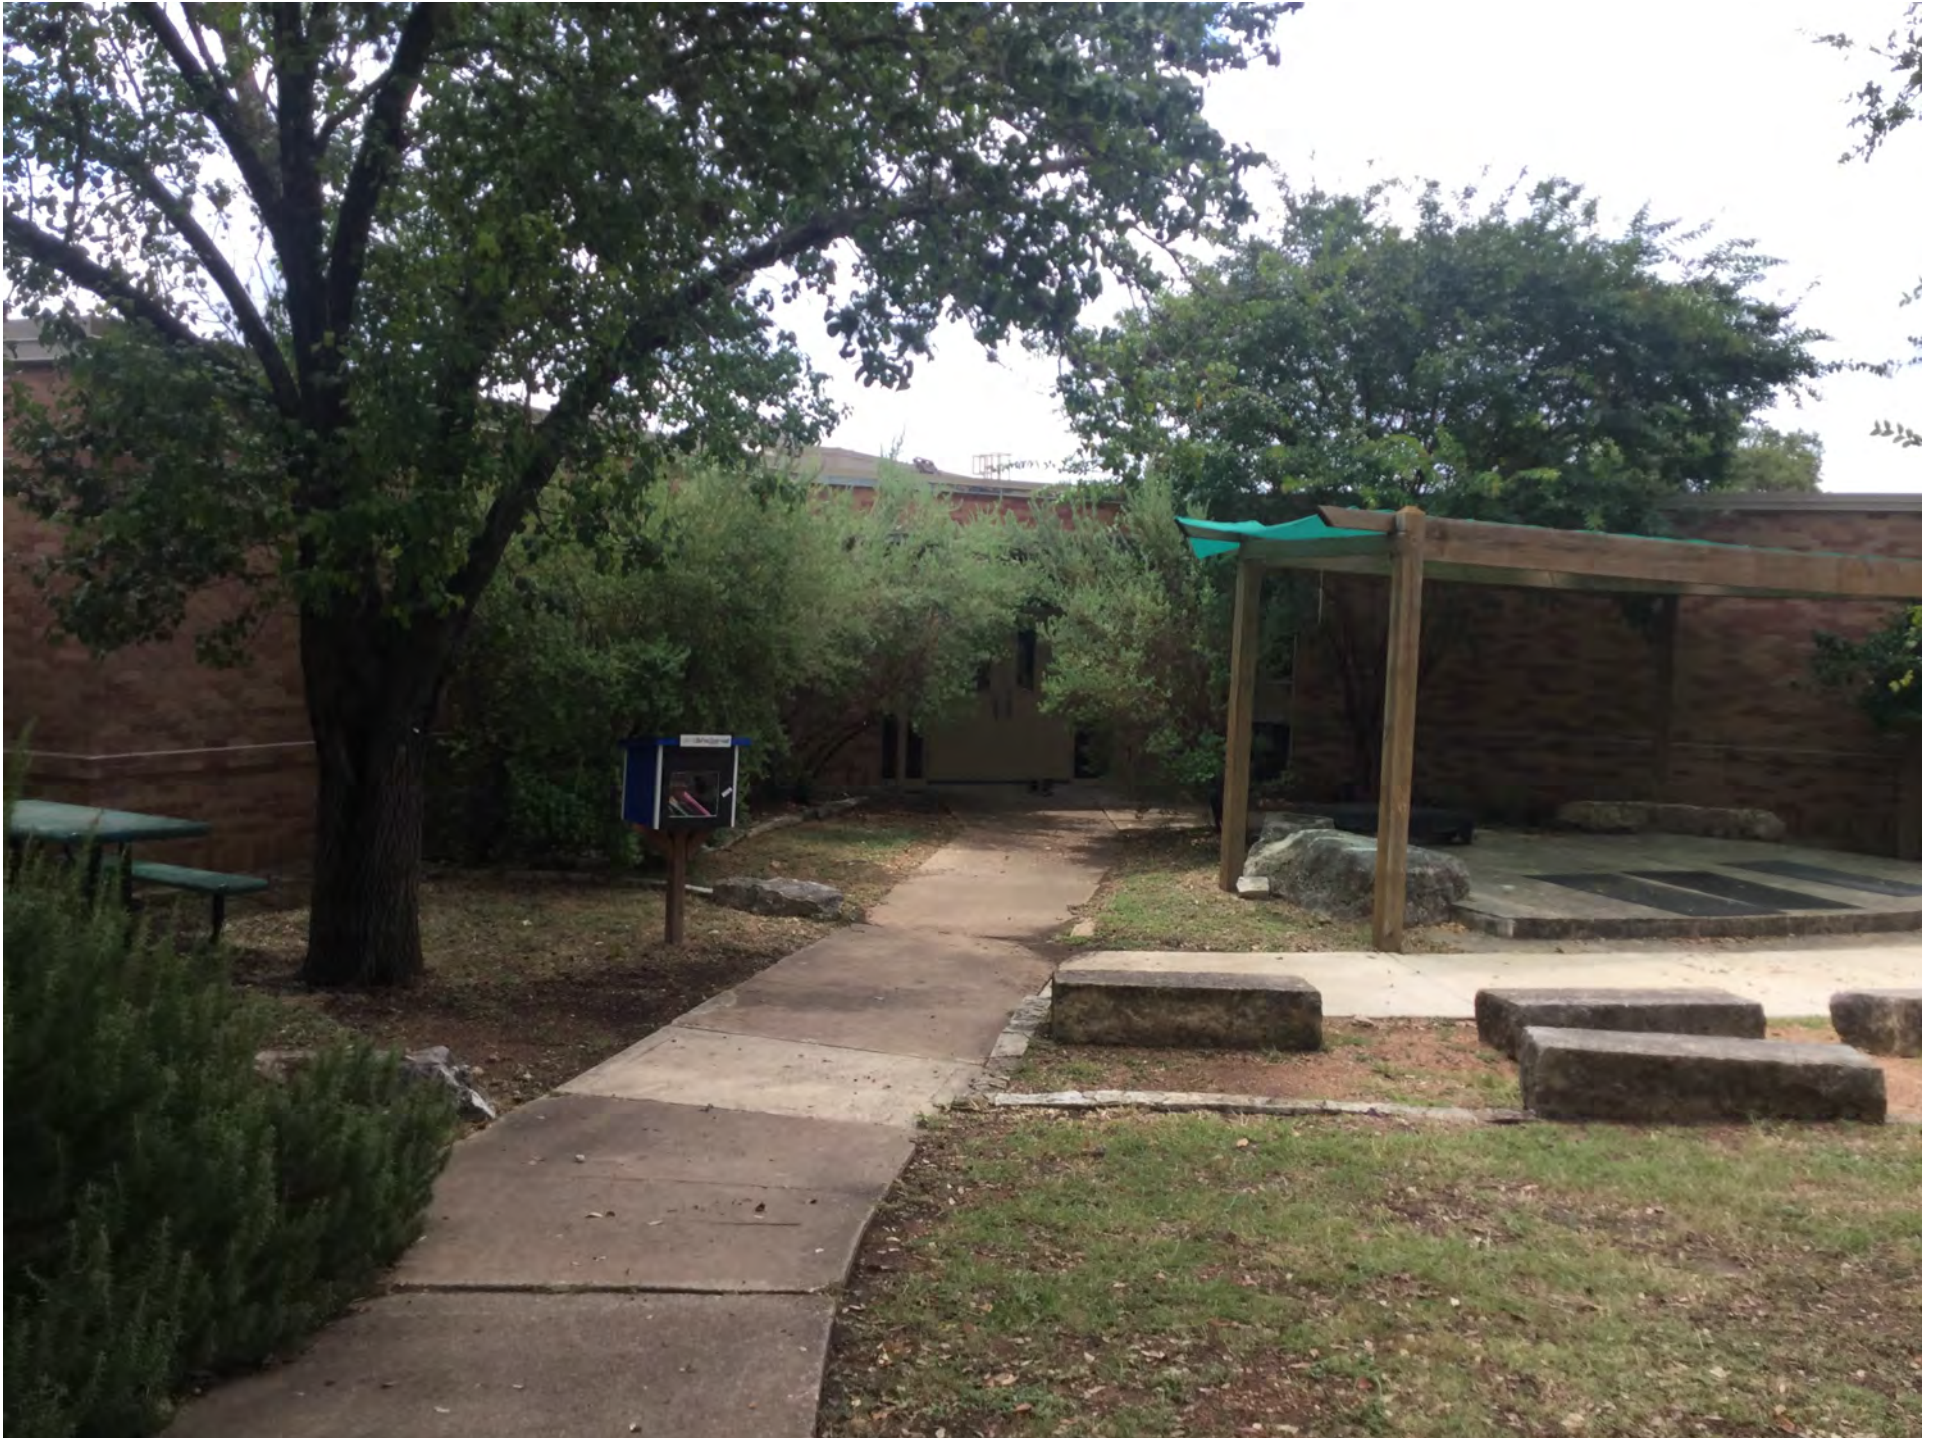
Photo 1. Outdoor Area

1.2	Are opportunities provided for outdoor learning (outdoor classrooms, gardens, etc.)?		2						Comments					1.00	2.00	
1) Outdoor space exists is not developed 2)Outdoor space for learning exists but not connected to classroom learning areas. 3. Outdoor learning spaces exist and are accessible but not in good condition. 4. Outdoor learning spaces need minor improvements to function well. 5. Outdoor learning spaces are in excellent condition. N/A) Does not apply.								The courtyards are nice outdoor learning spaces, but the outdoor furniture needs to be ugraded to function appropriately.								
See Image 1

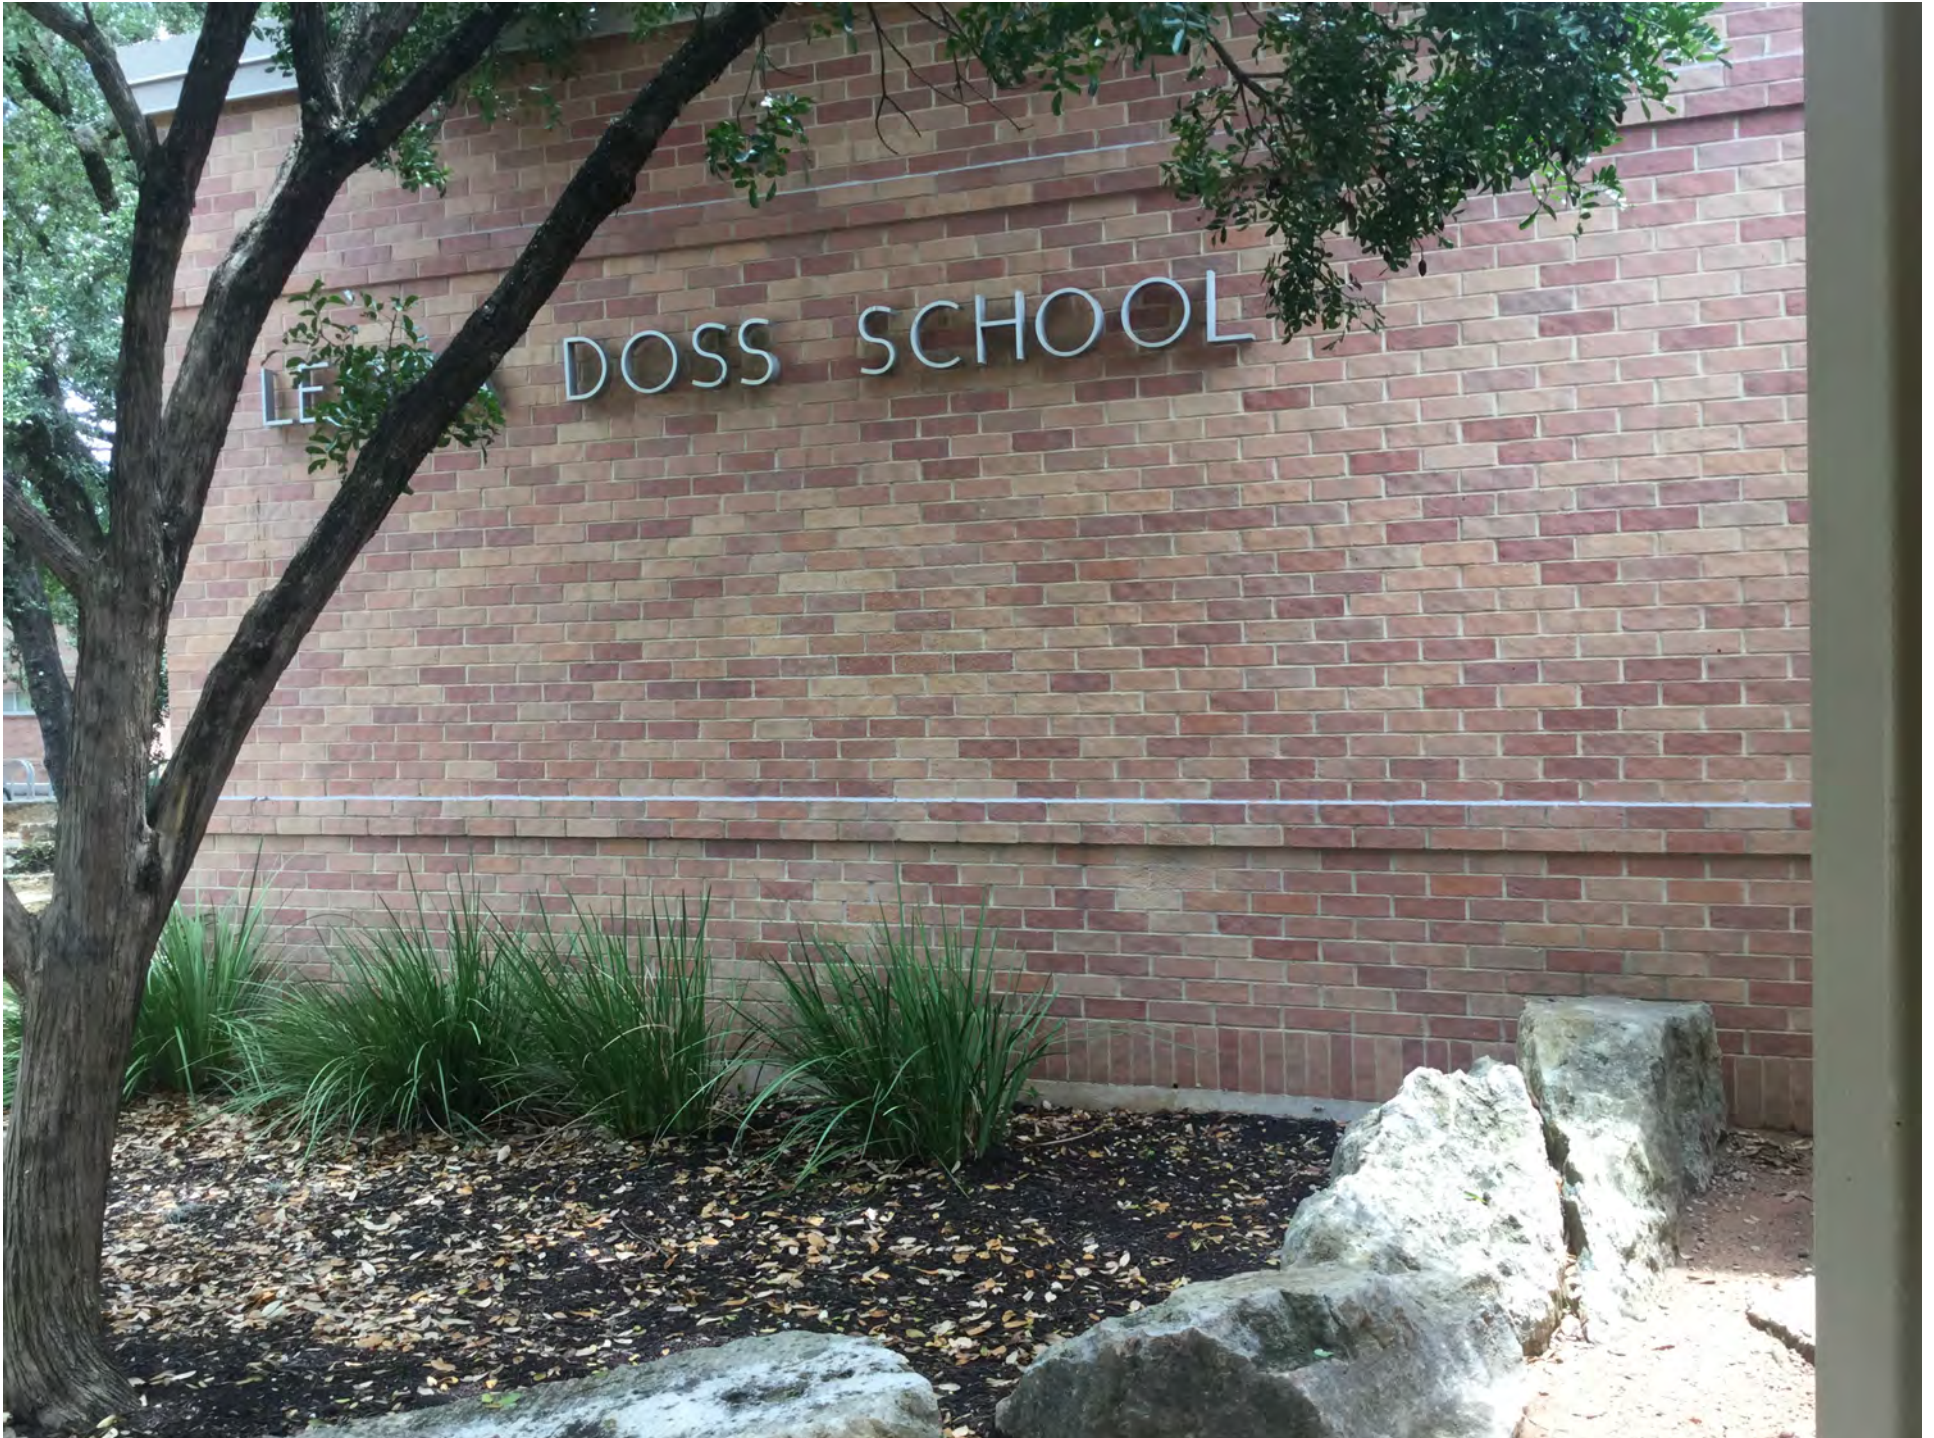
Photo 2. Signage

1.4	Is the building easily identified with appropriate signage and community wayfinding?		2						Comments					0.25	0.50	
1) Campus has no signage and no striping. 2) Signage is faded/hidden. 3) Signage & striping visible but not apparent. 4) Signage is visible but not good condition. 5. Signage and wayfinding is visible and easy to use. N/A) Does not apply.								The signage is not clearly visible.								
See Image 2

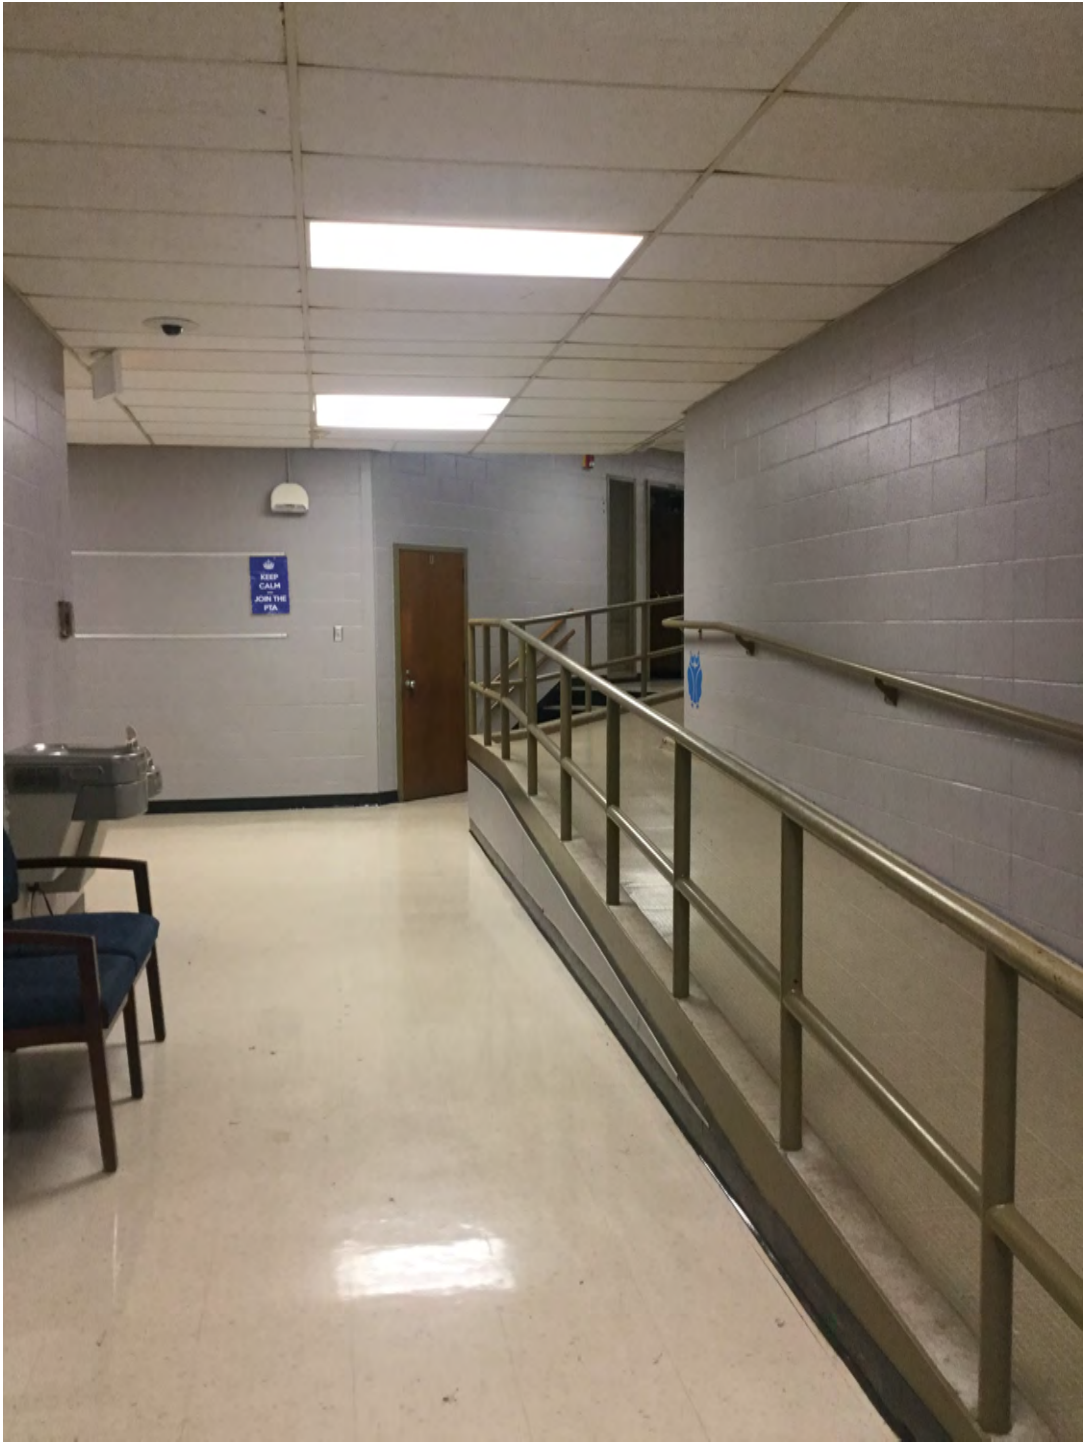
Photo 3. Hallway

1) Primary circulation is 5'-0" to 6'-0" wide. 2) Primary circulation is 6'-0" to 7'-0" wide 3) Primary circulation is 7'-0" to 8'-0" wide 4) Primary circulation is 8'-0"-10'-0" wide 5) Primary circulation is 10'-0"+ wide N/A) Does not apply.								See Image 3

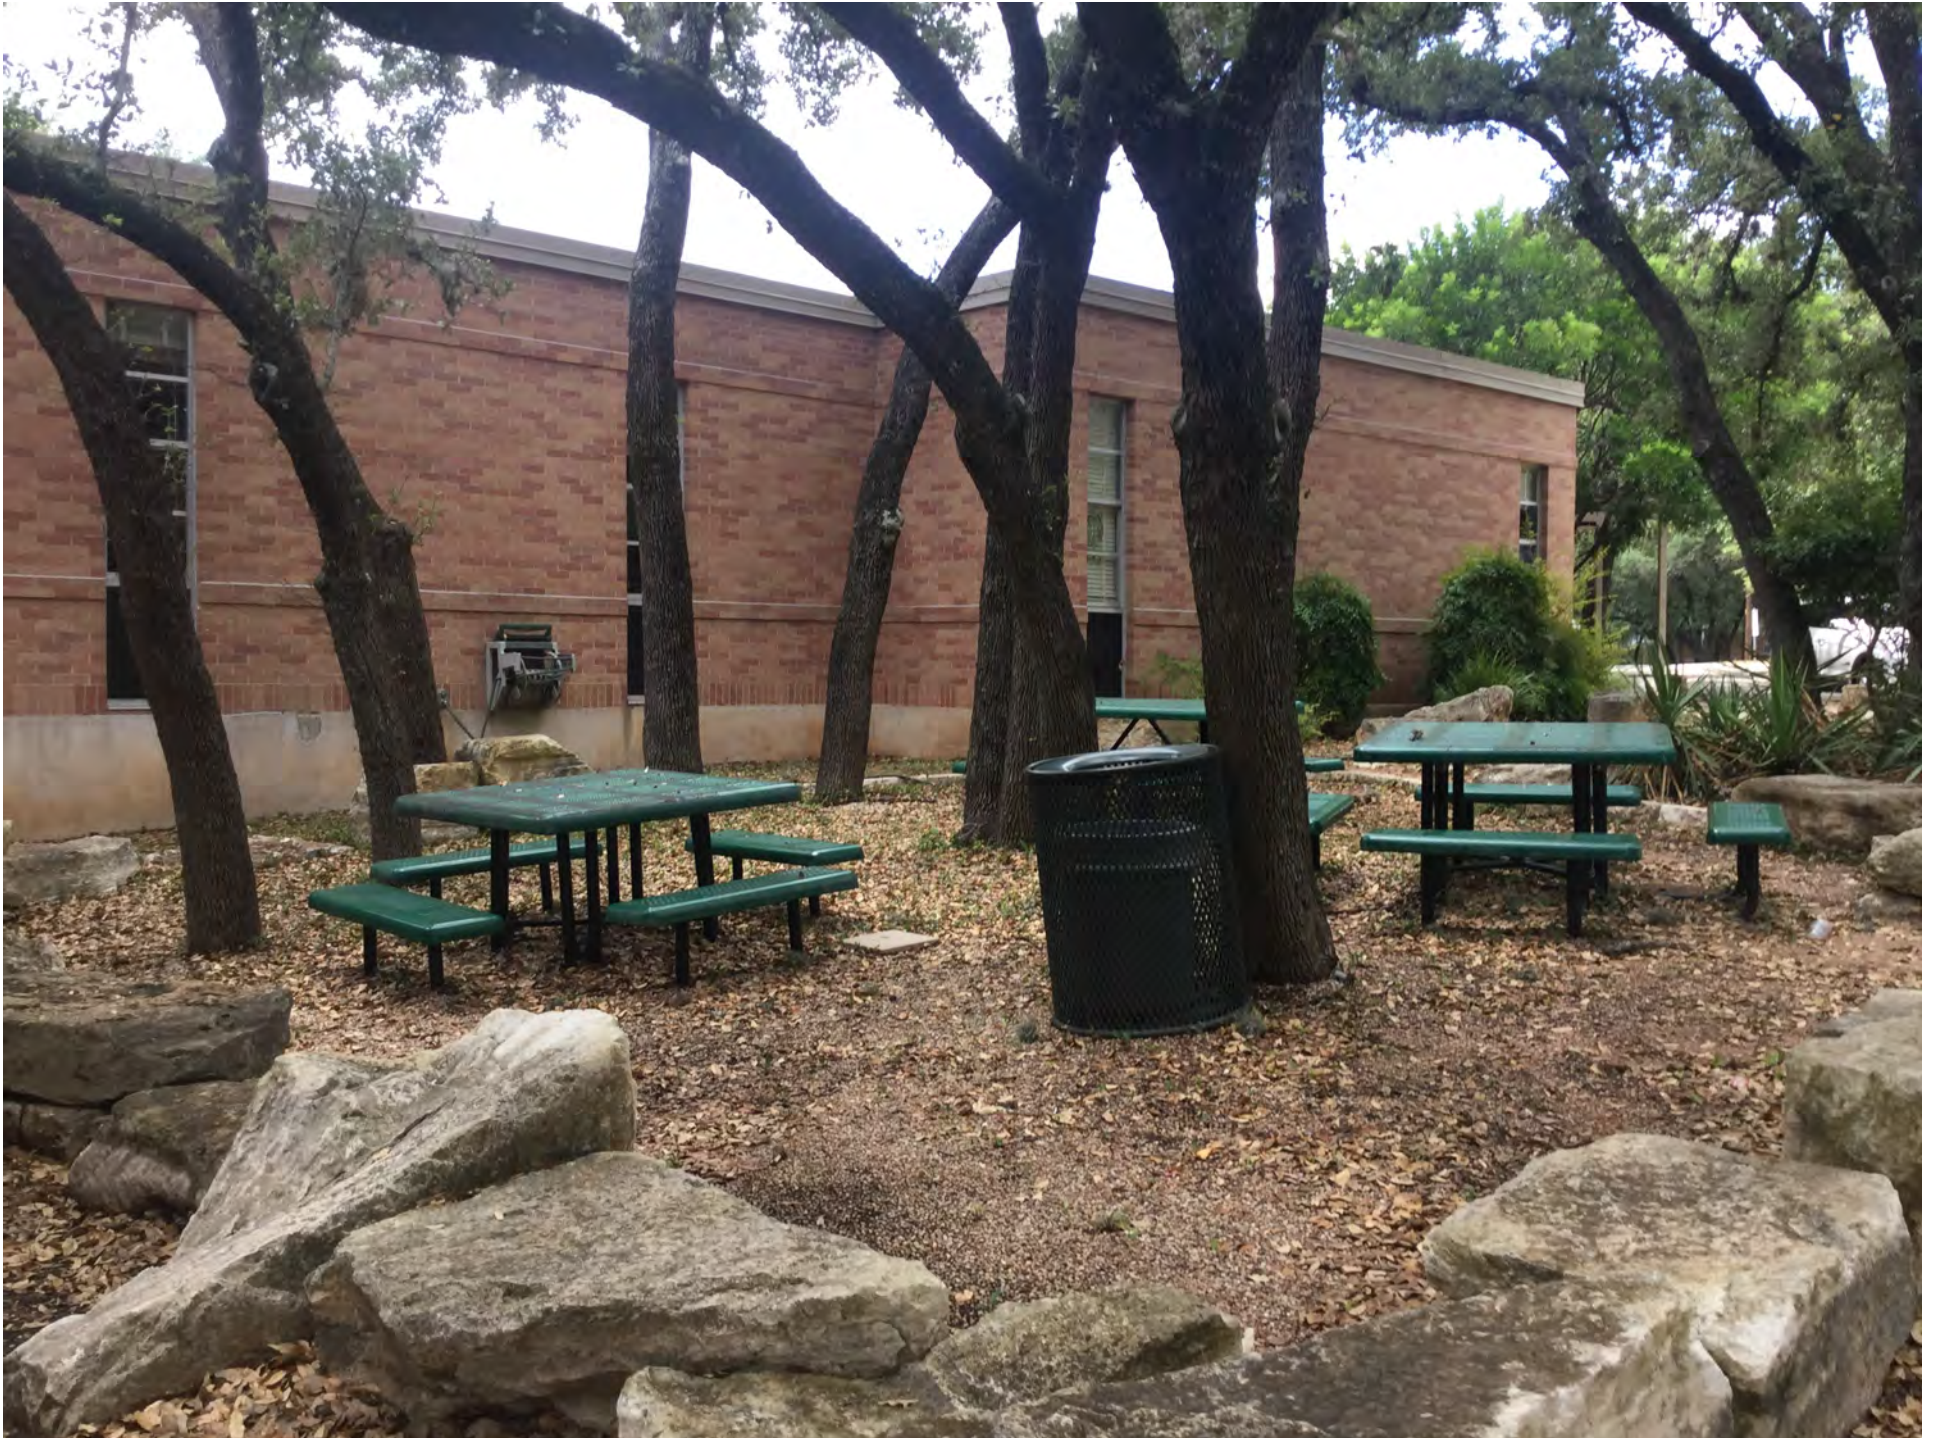
Photo 4. School Structure

2.3	Does the general appearance of the school evoke pride for the students and community?		2					Comments	0.25 0.50
1) General appearance is poor. 2) General appearance is aged but ok. 3) General appearance is good. 4) General appearance shows pride in campus and student works. 5) General appearance shows pride in campus and student works and is welcoming to the community. N/A) Does not apply.								See Image 4	
								The building has areas with some dated finishes. The campus needs some upgrades throughout.

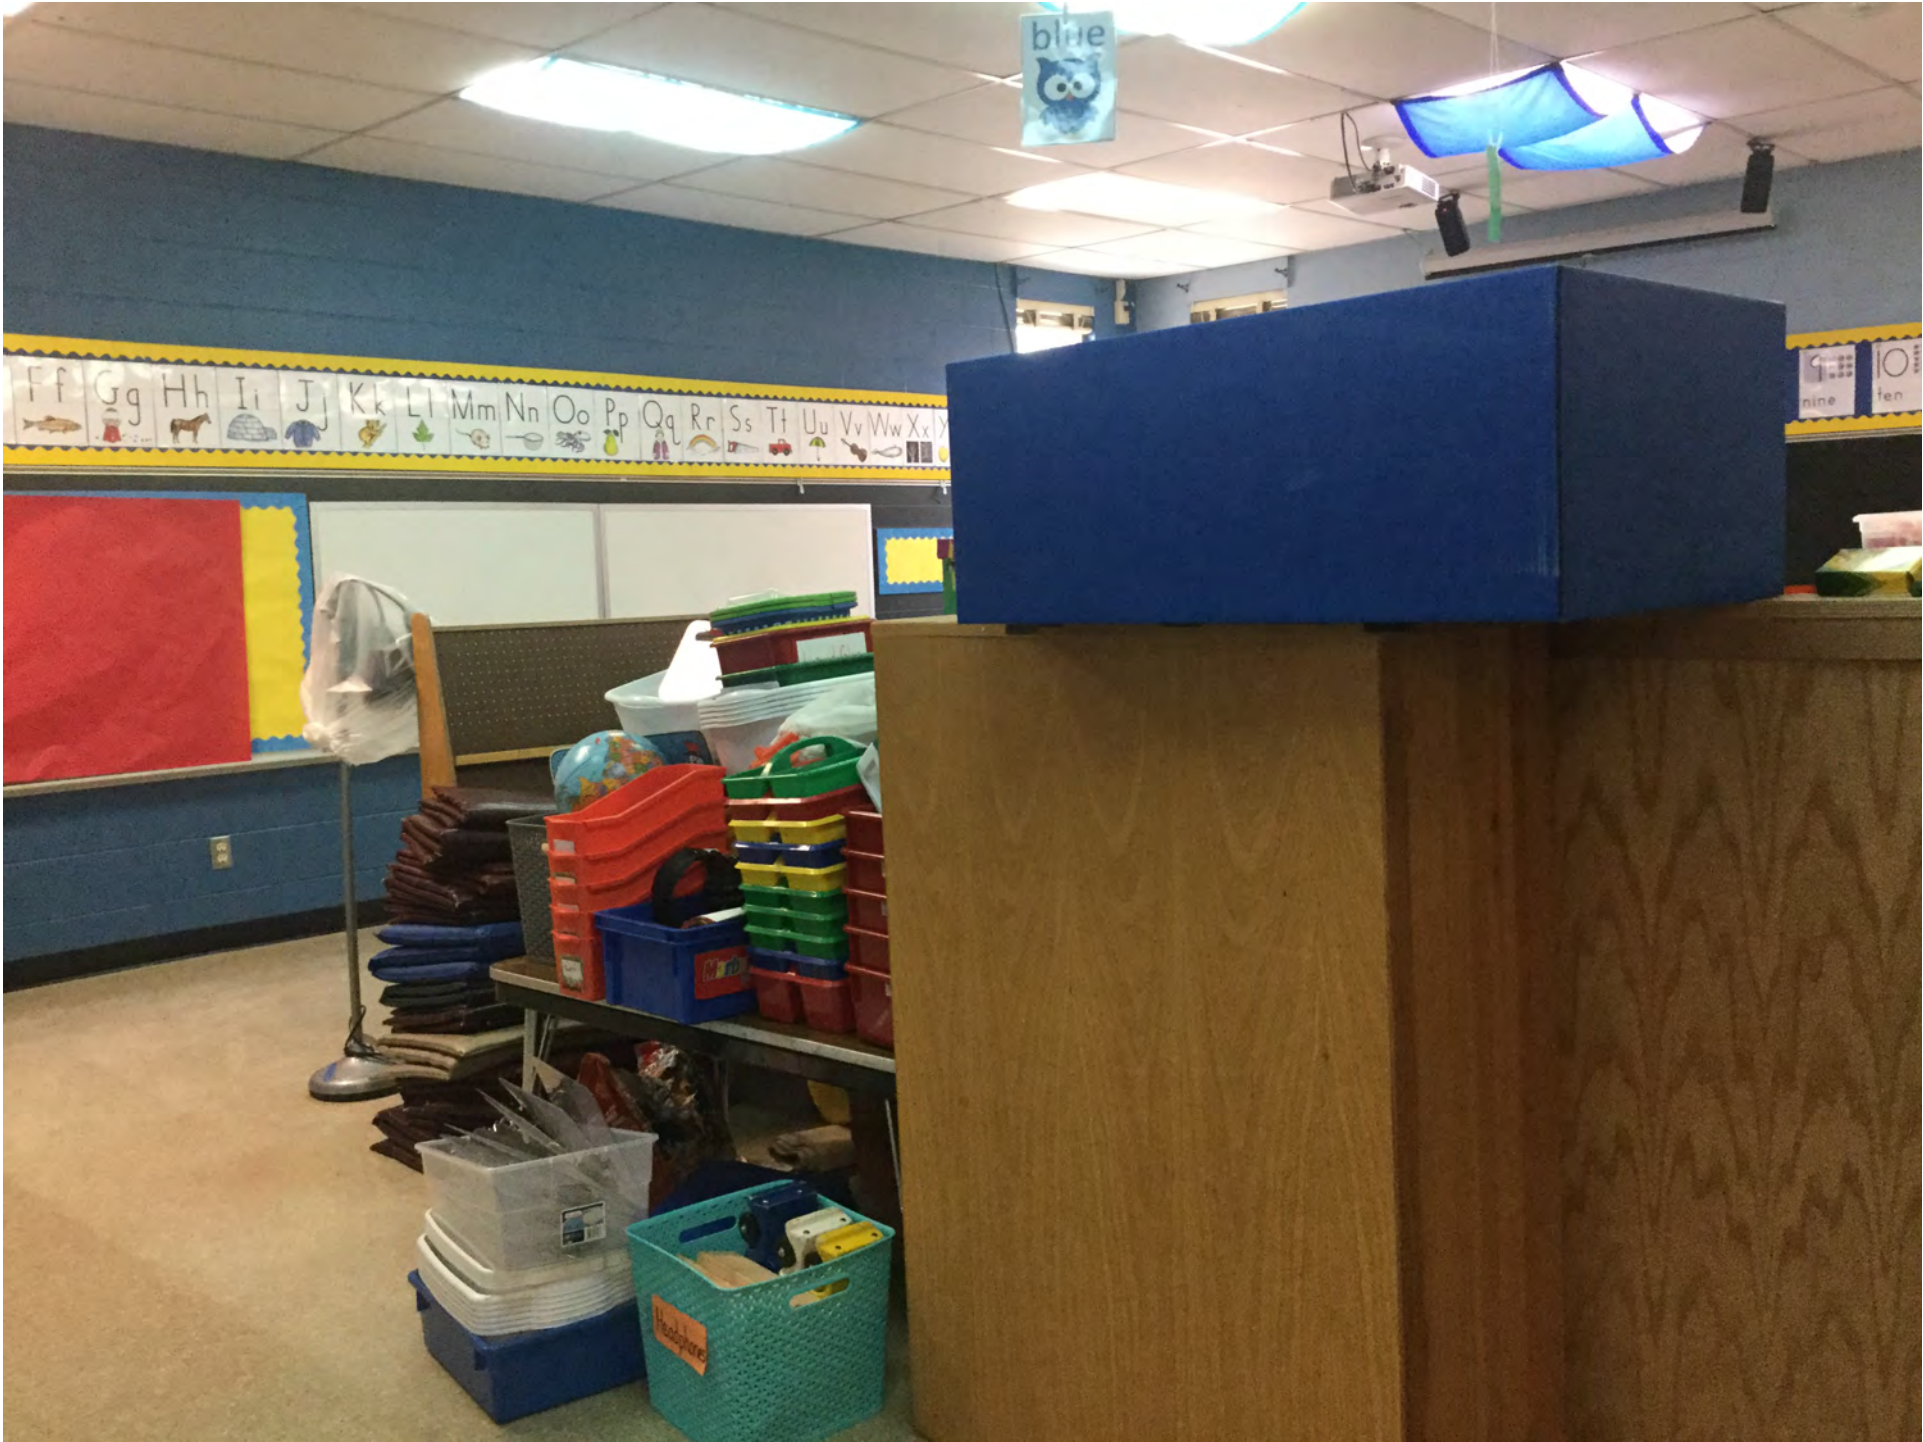
Photo 5. Classroom

1) Very unsatisfactory - Too small, awkward layout, does not meet needs 2) Unsatisfactory - Too small, only one area for all teaching methods, limited flexibility 3) Neutral - Moderate size, two areas for different teaching methods, some flexibility, access to student storage/casework 4) Satisfactory - Good size, at least two zones for different teaching methods, flexibility and student storage, not new 5) Very Satisfactory - Good size, two zones for different teaching methods, flexibility and student storage/casework, adequate display area and visual teaching tools N/A) Does not apply.							The classrooms are insufficient due to over capacity .									
See image 5

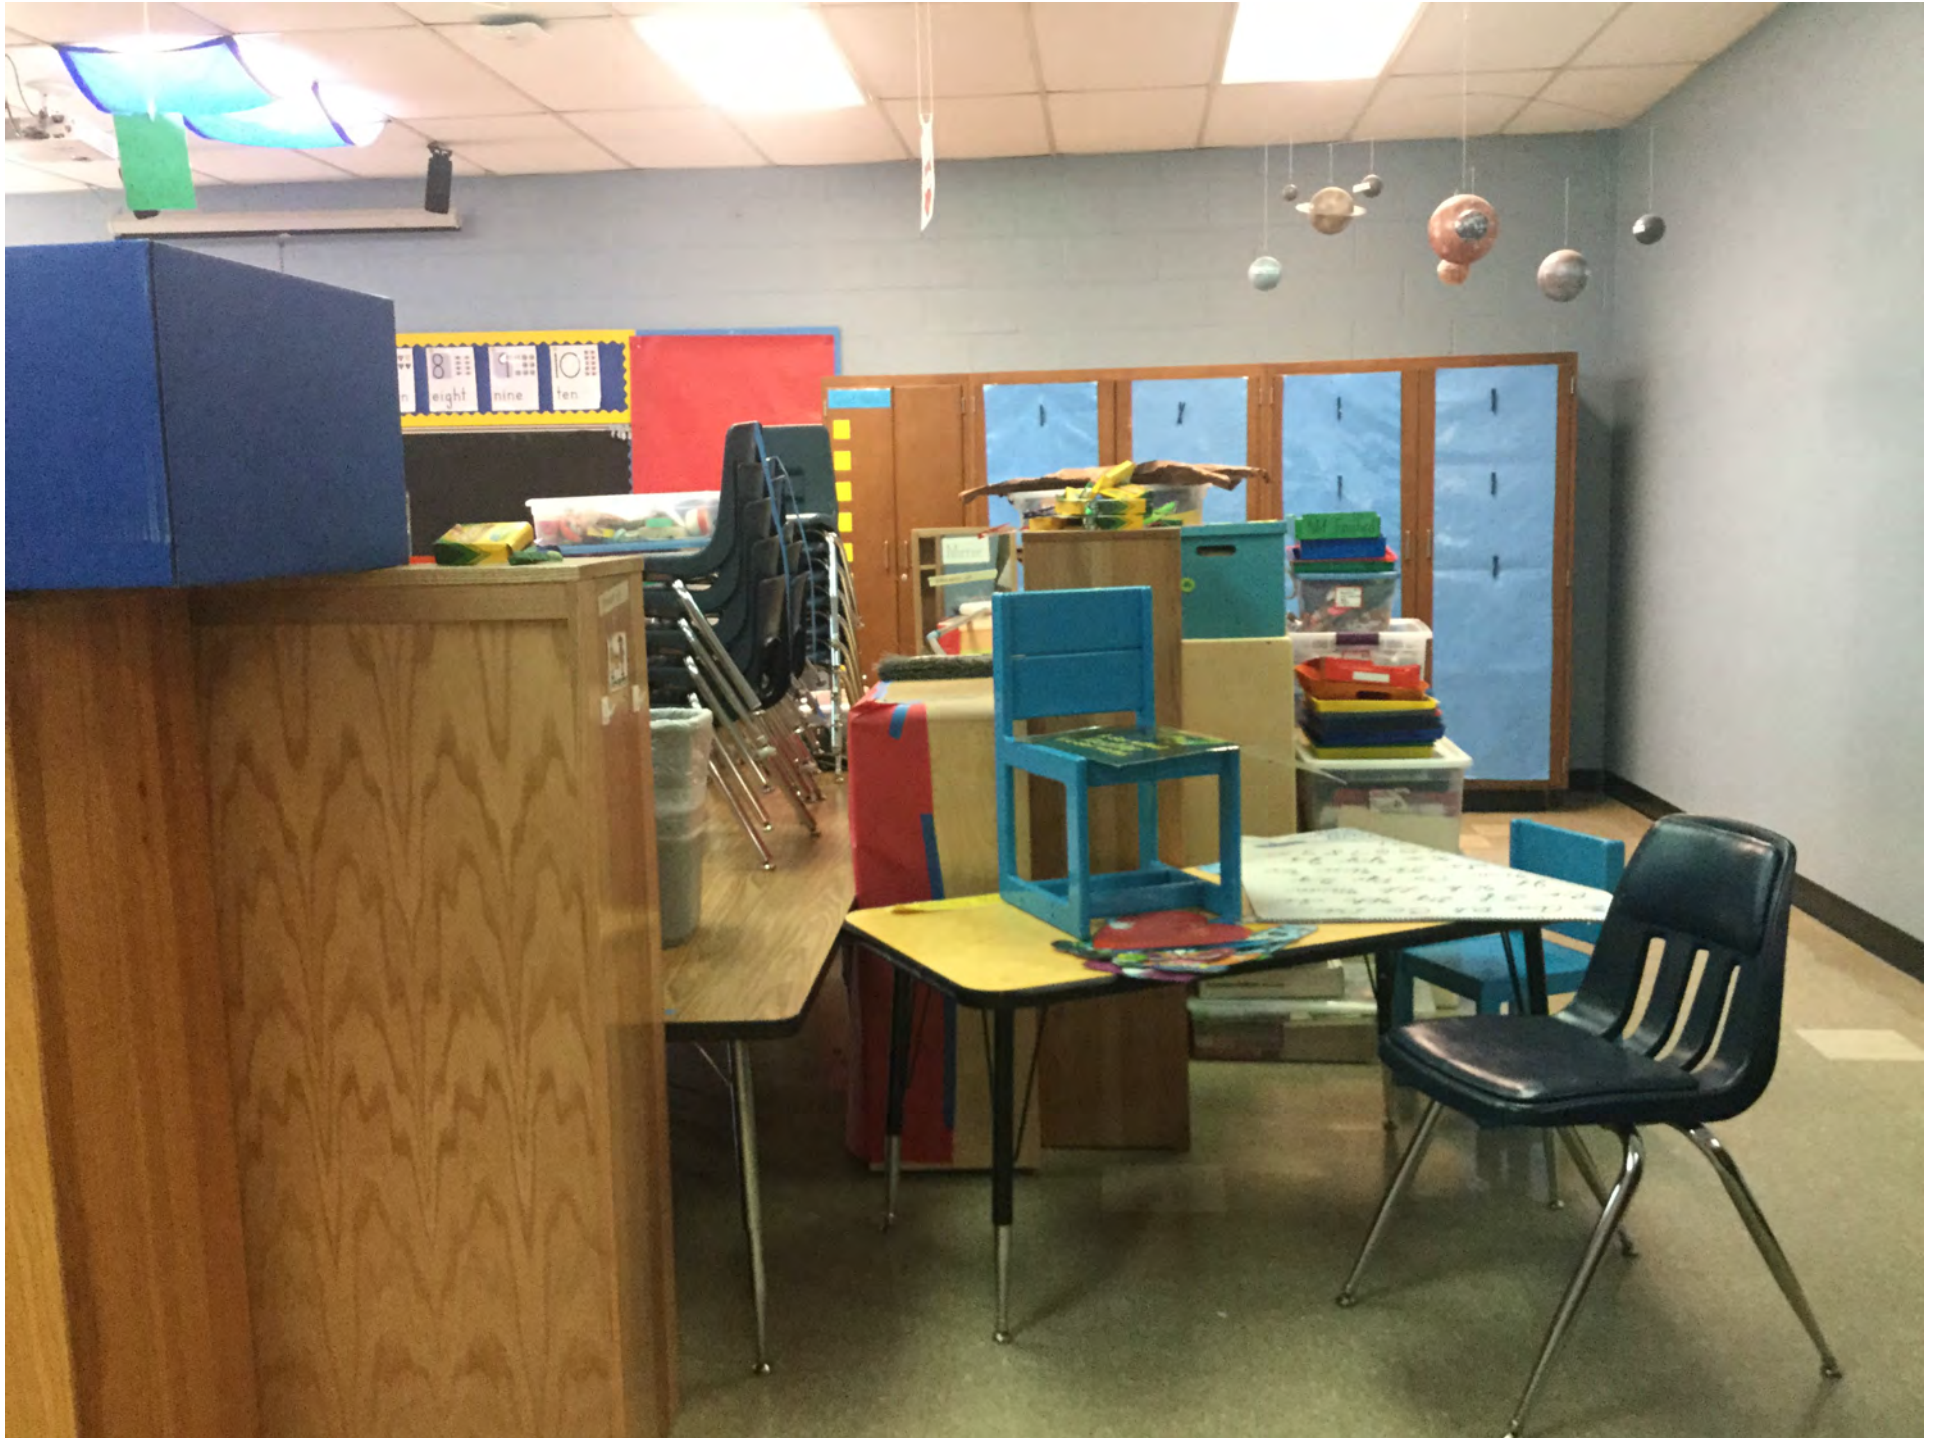
Photo 6. Classroom Storage

1) Very unsatisfactory - No storage, casework, or restrooms 2) Unsatisfactory - unsatisfactory size or condition of storage, casework, or restrooms 3) Neutral - Moderate size or moderate condition storage, casework, and restrooms 4) Satisfactory - Satisfies ed spec for storage, casework, and restrooms 5) Very Satisfactory - exceeds ed spec for storage, casework, and restrooms N/A) Does not apply.							The classrooms have insufficient storage and the restrooms are not ADA compliant.									
See Image 6

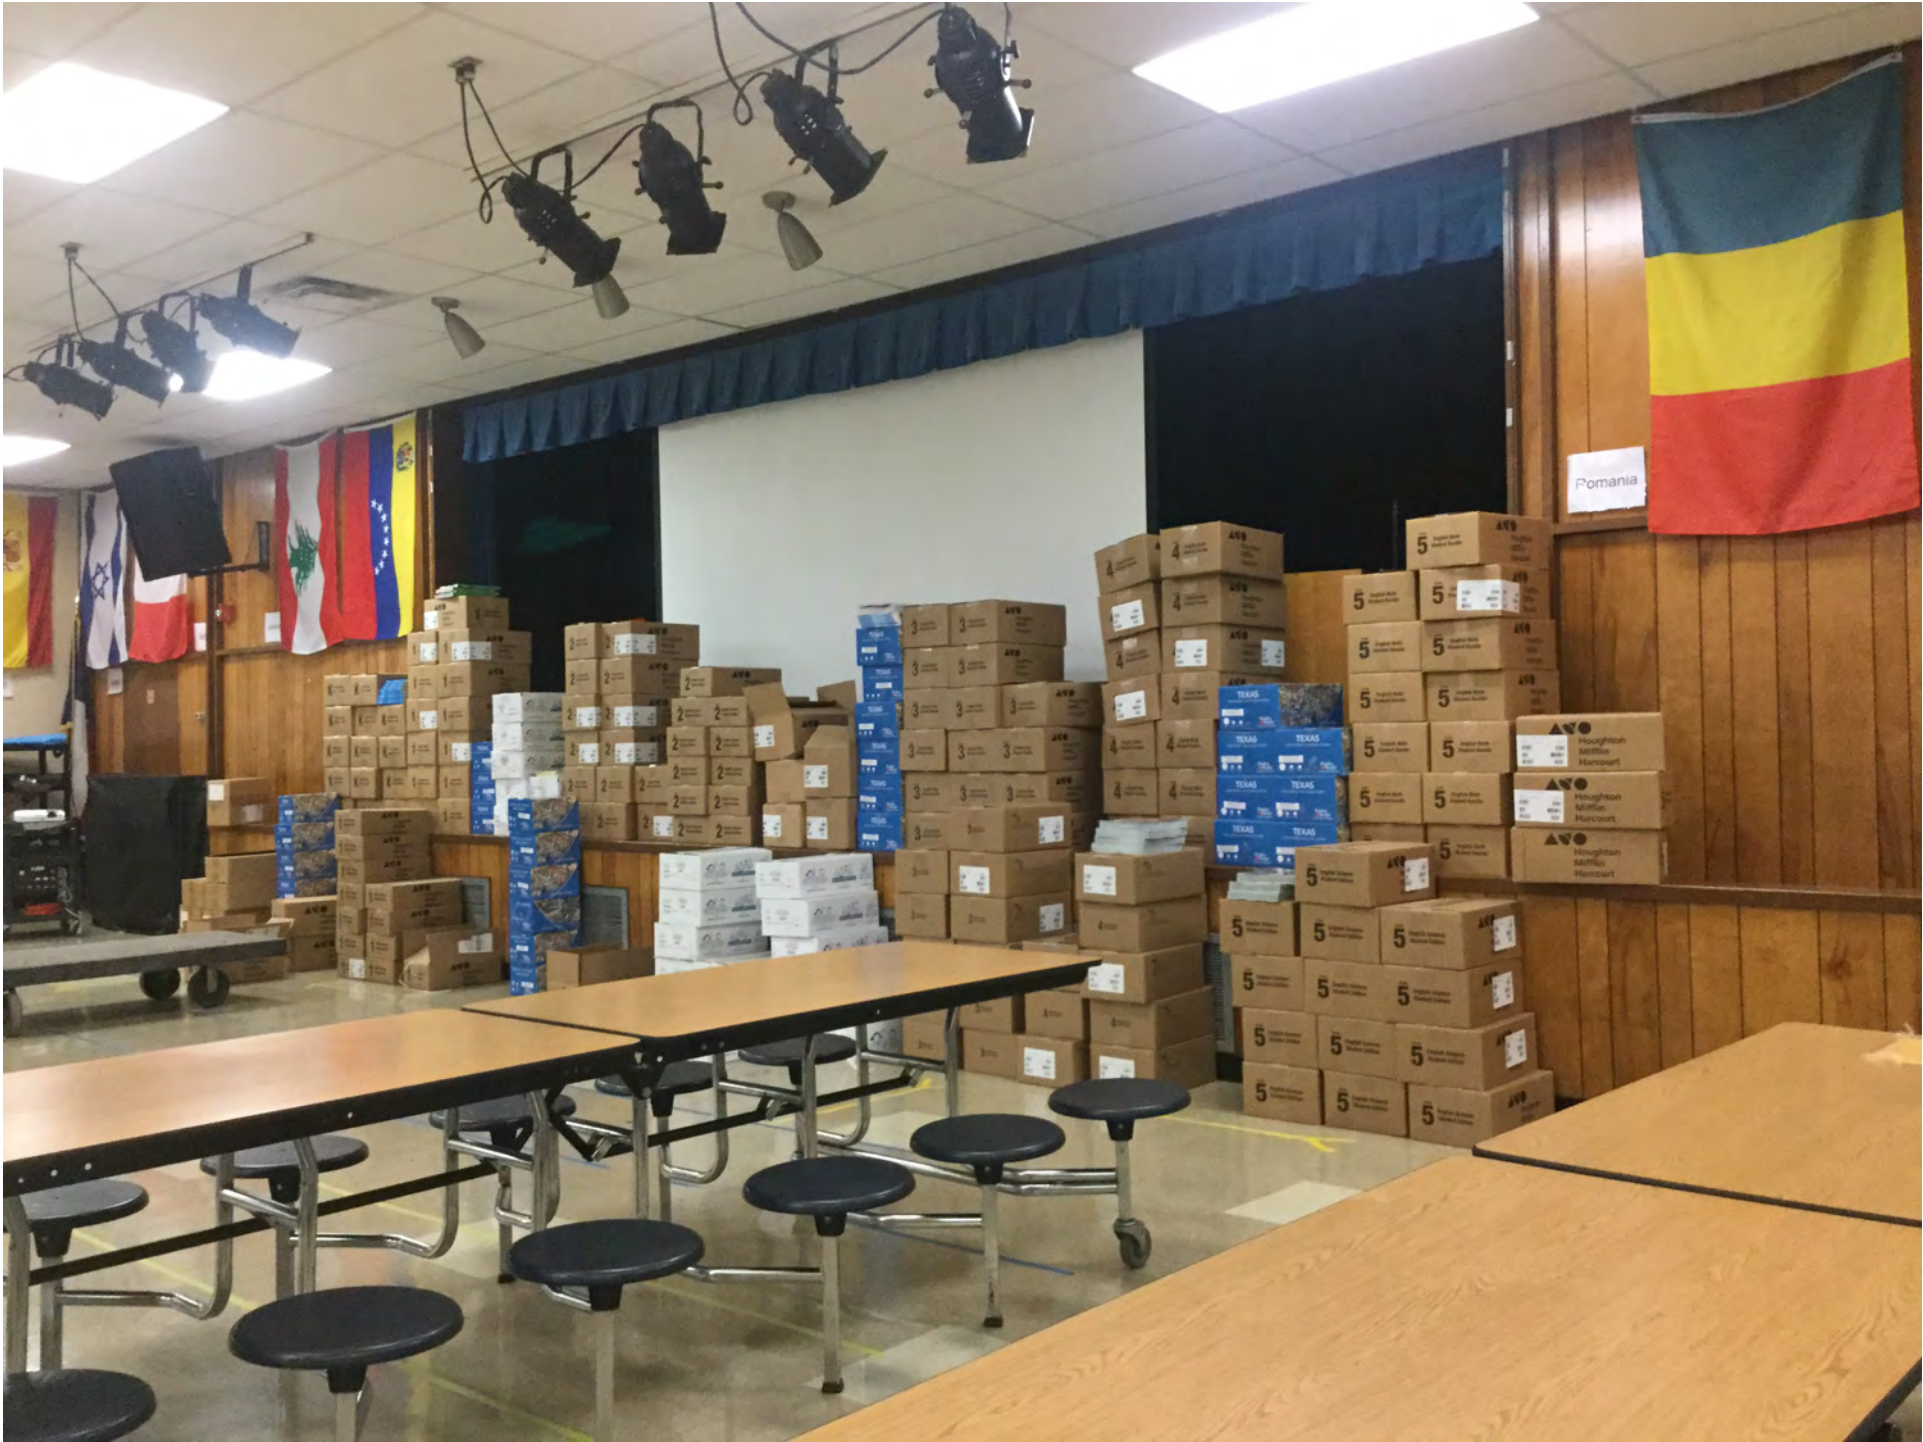
Photo 7. Stage

3.8	Are music, drama, or performance spaces appropriately configured per the ed spec?		2					Comments	1.00 2.00
1) Very unsatisfactory 2) Unsatisfactory 3) Average 4) Good 5) Very good N/A) Does not apply.								The stage is older and is not ADA accessible. One of the art room spaces is in a portable which is unsatisfactory for its needs. <i>CAC comment: The stage needs a new lighting system and sound system.</i>	
								See image 7

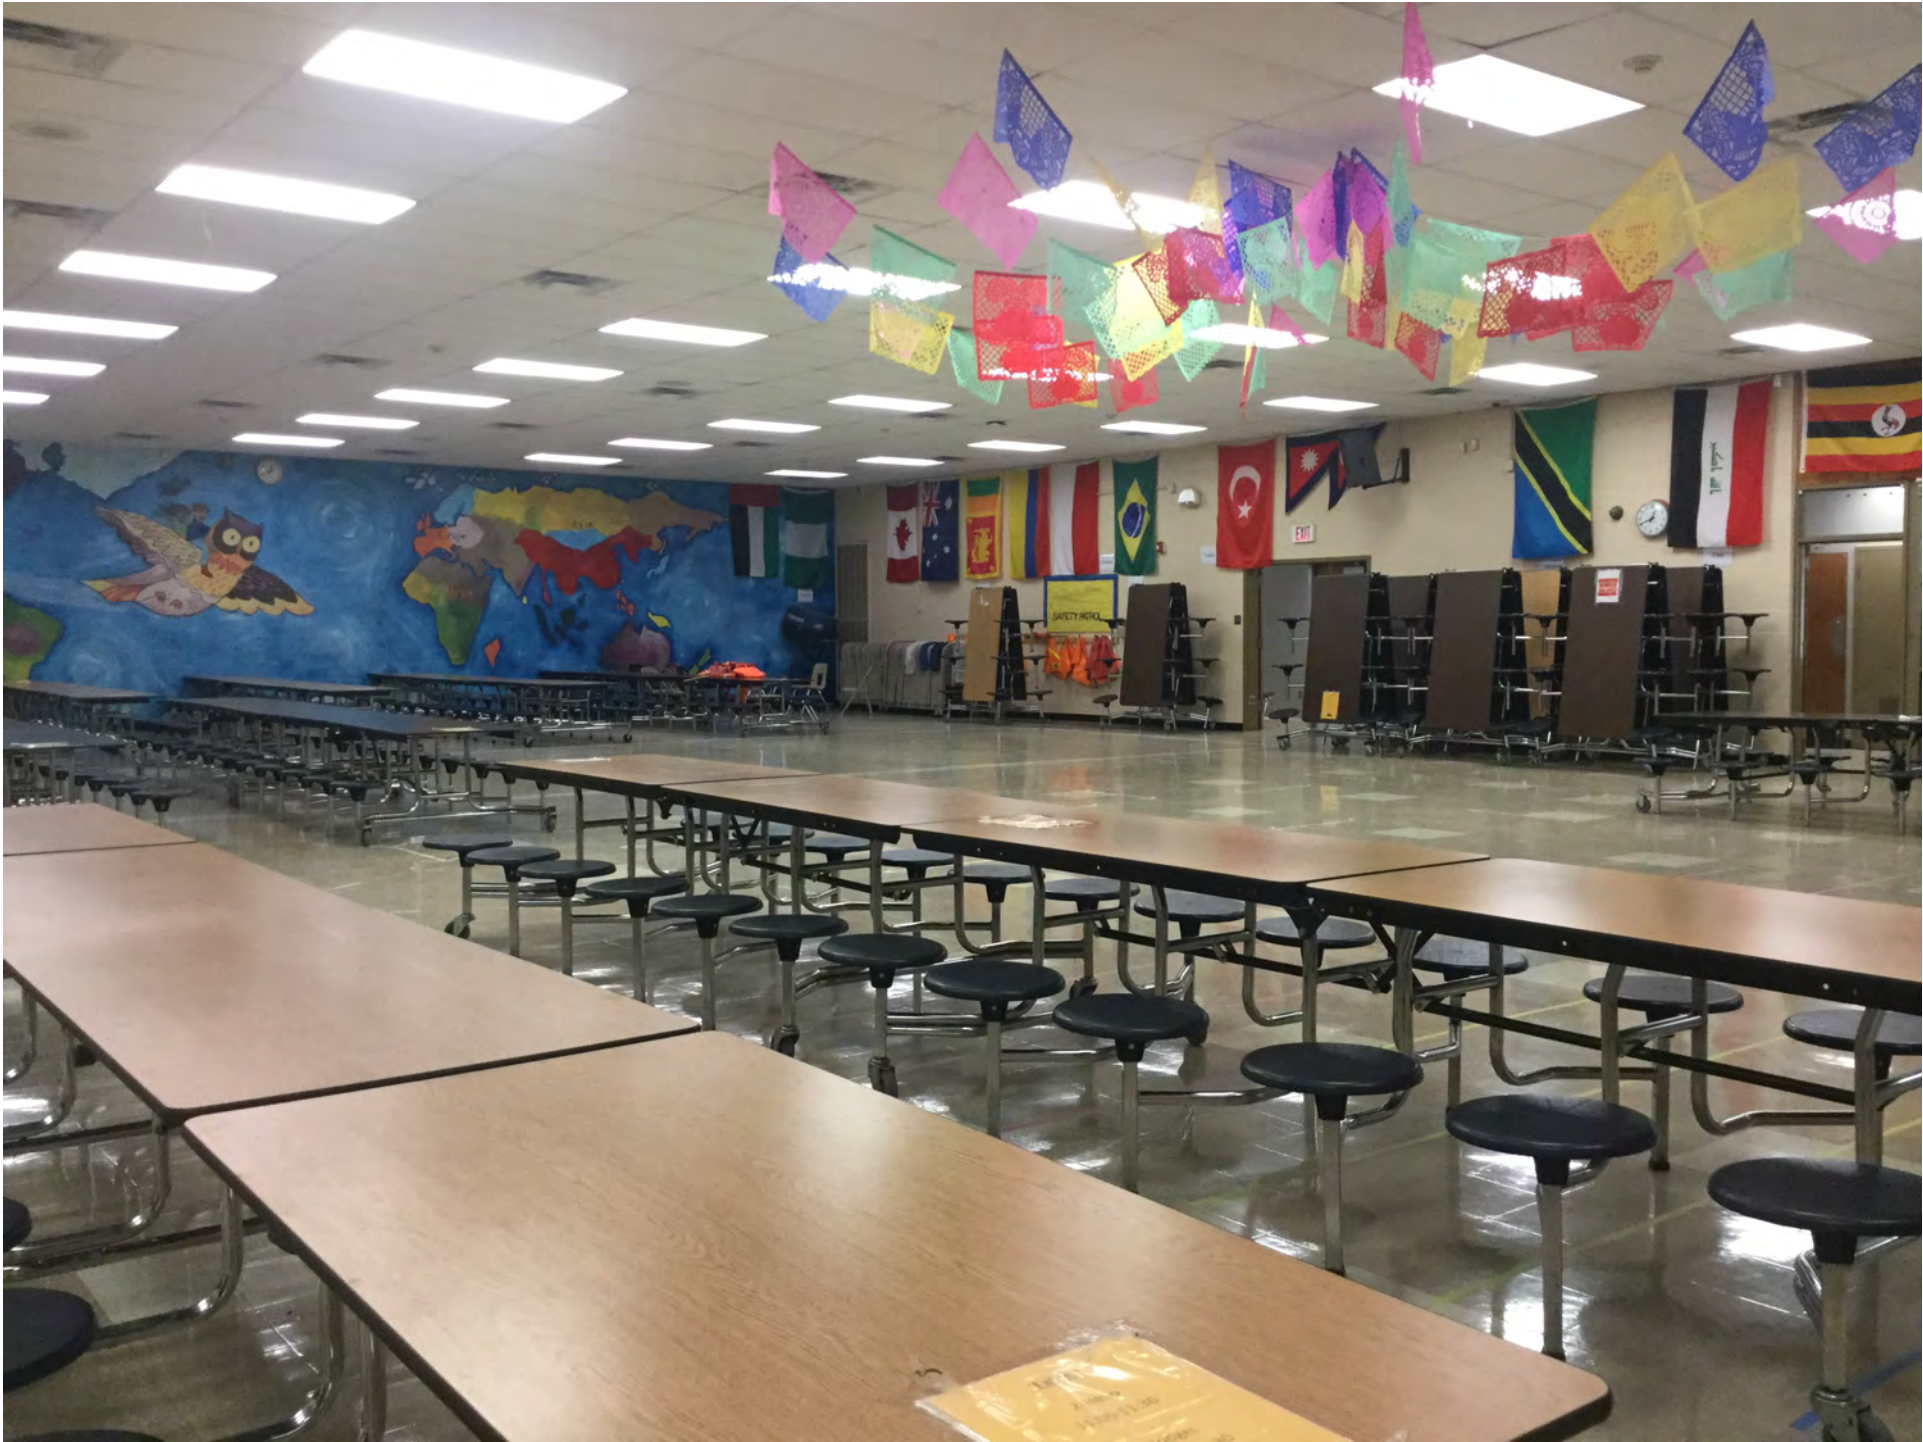
Photo 8. Cafeteria

3.16 Are the student dining facilities appropriately configured?				4			Comments 1.00 4.00
1) Very unsatisfactory - Too small, poor circulation, inflexible seating in poor condition 2) Unsatisfactory - Too small or inadequate circulation, seating in poor condition 3) Average - moderate size, with adequate circulation, seating in okay condition 4) Good - good size, adequate circulation, seating in good condition 5) Very good - good size, adequate circulation, seating in good condition, with more than one option for eating space (ex: connection to outdoor eating space) N/A) Does not apply.							Size is adequate but lunch periods extended. HVAC system does not keep up with the occupant load. <i>CAC comments: cafeteria need to be updated in order to serve 900+ students quickly. Two lines? Additional Options?</i>
