Educational Suitability Summary Report

Doss Elementary School – BLDG 154

Date: 07/26/2016

Austin ISD Educational Suitability Assessment Criteria

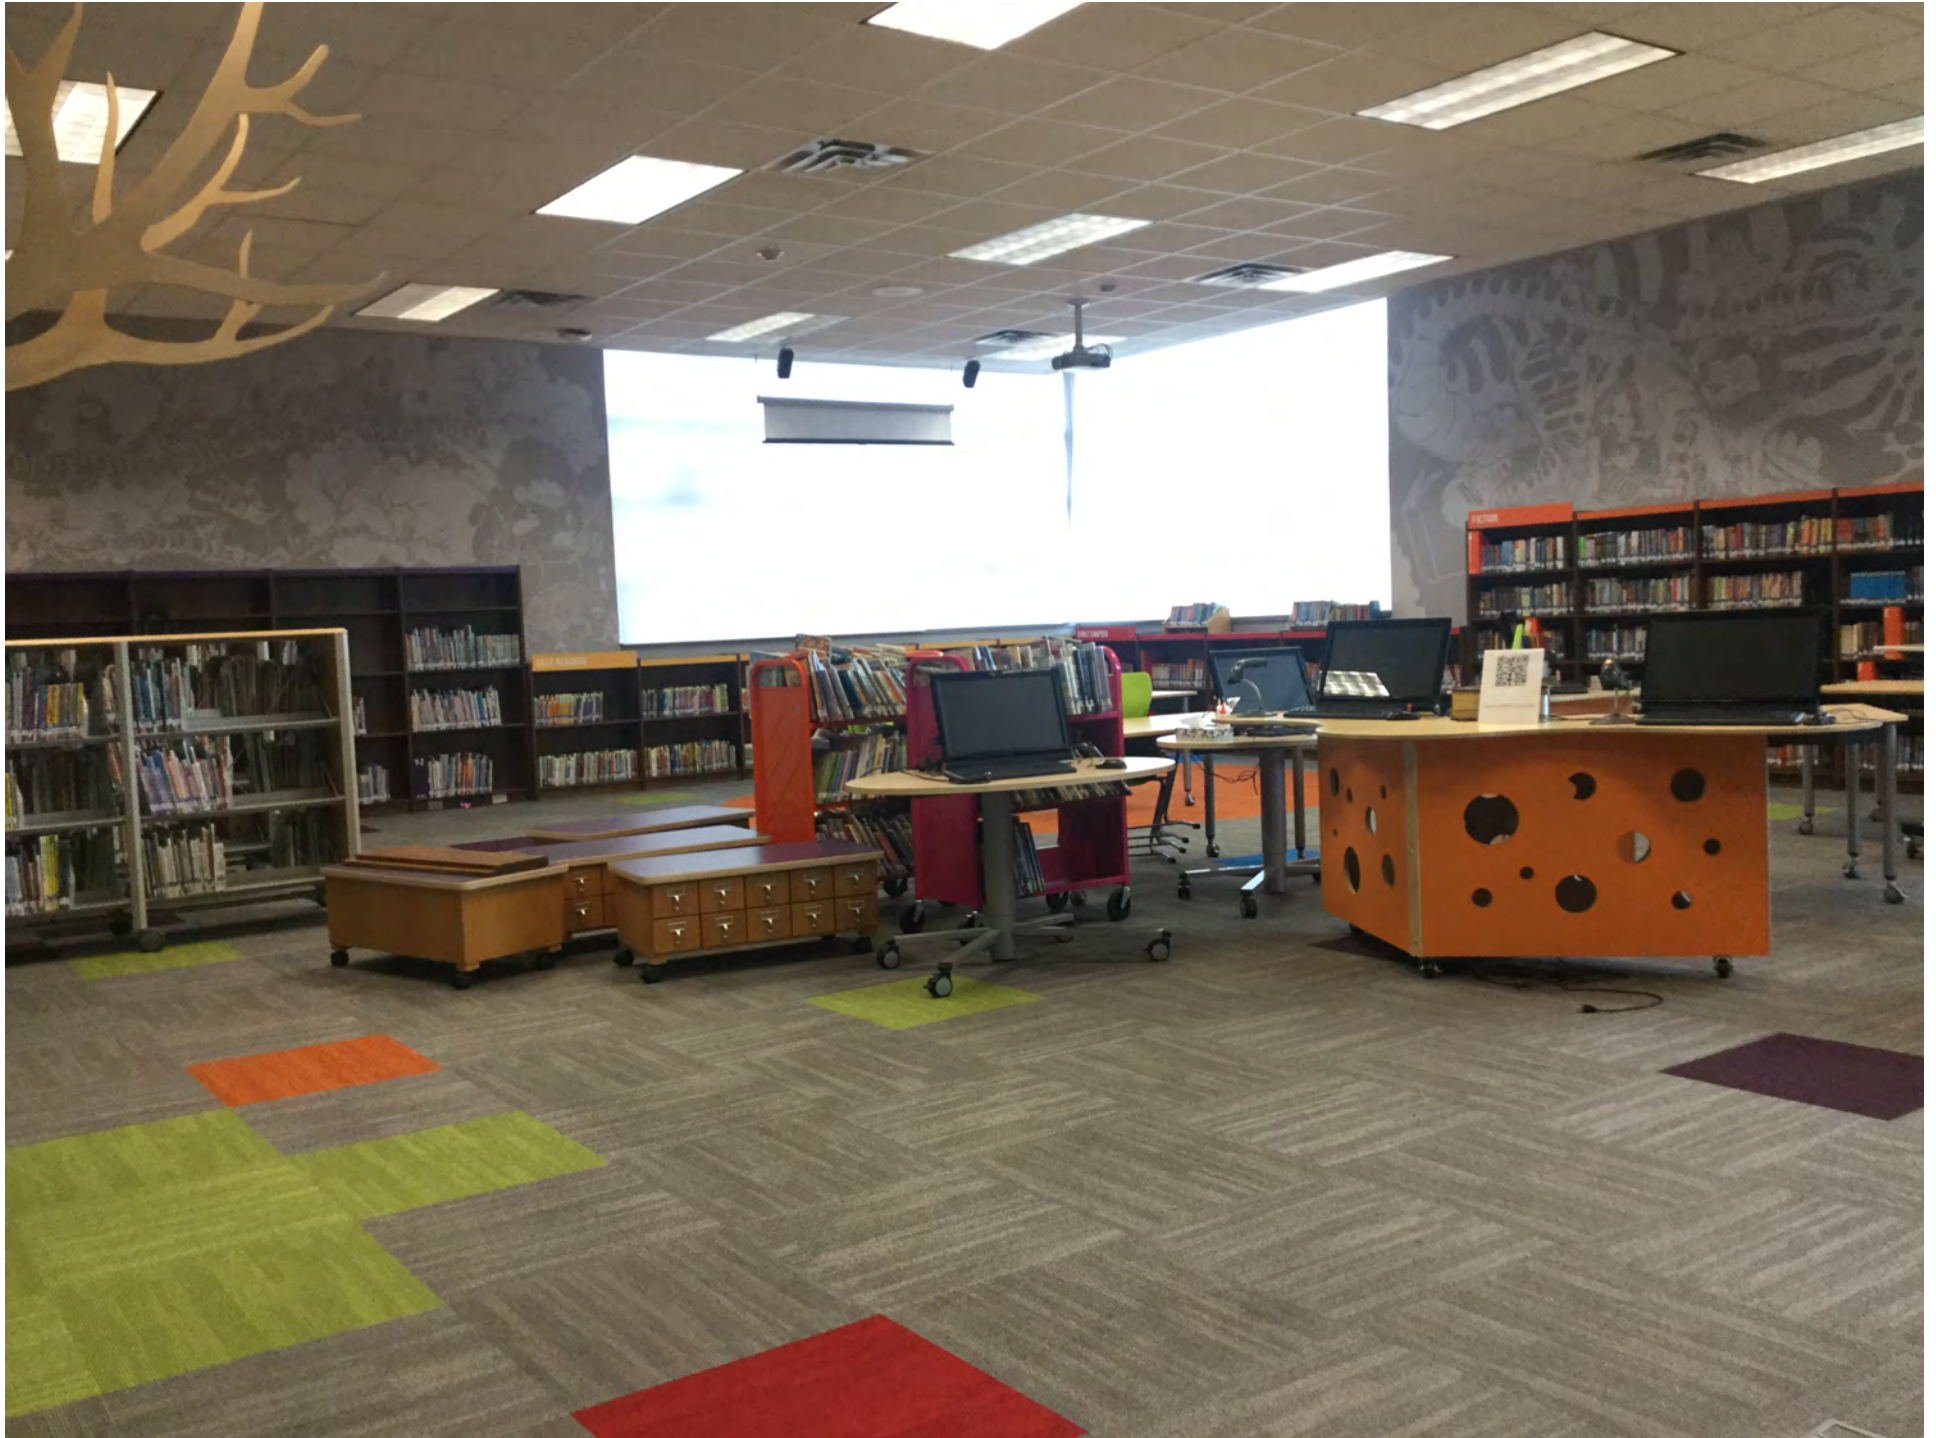
Photo 9. Library

1) Very unsatisfactory 2) Unsatisfactory 3) Average 4) Good 5) Very good N/A) Does not apply.								The library is small and only fits one grade level at the time.	
								See Image 9

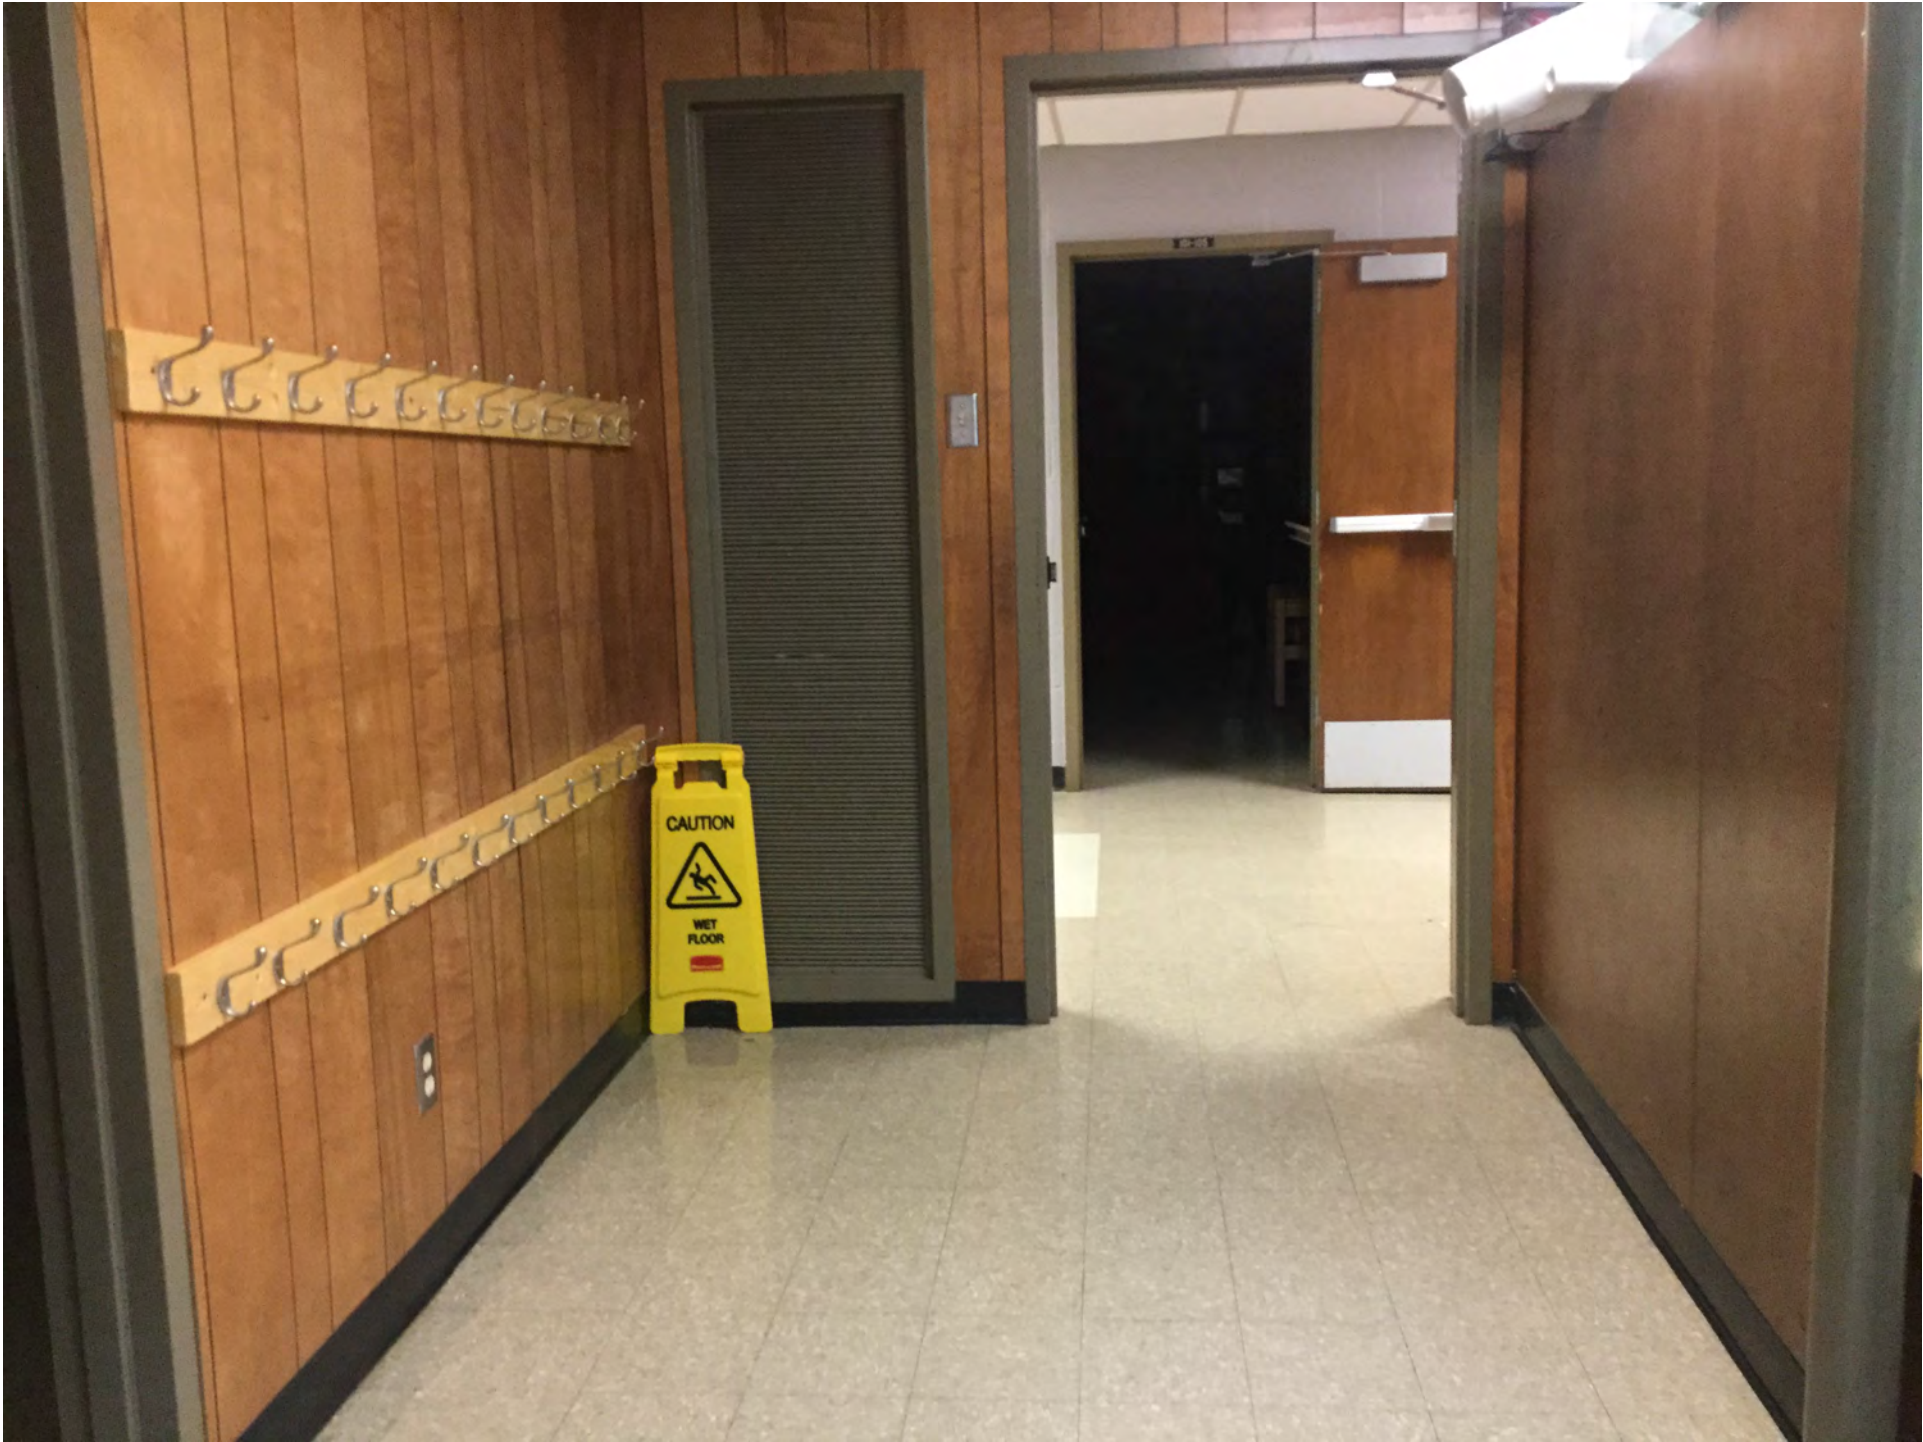
Photo 10. Student Storage

8 - Storage		1	2	3	4	5	N/A	8.00	
8.1	Is there adequate general storage in the building?		2					Comments	1.00 2.00
1) Very unsatisfactory 2) Unsatisfactory 3) Average 4) Good 5) Very good N/A) Does not apply.								The general building storage is very limited. The book storage is undersized.	
8.2	Is there adequate classroom storage?		2					Comments	1.00 2.00
1) Very unsatisfactory 2) Unsatisfactory 3) Average 4) Good 5) Very good N/A) Does not apply.								Classrooms have insufficient storage.	
8.3	Is there adequate student storage?				4			Comments	1.00 4.00
1) Very unsatisfactory 2) Unsatisfactory 3) Average 4) Good 5) Very good N/A) Does not apply.								Students use wall hooks to hang their bags.	
								See image 10
