## Educational Suitability Summary Report

Galindo Elementary School

Date: 08/01/2016 (Rev 1 – 12/20/16 – Updated Survey Responses)

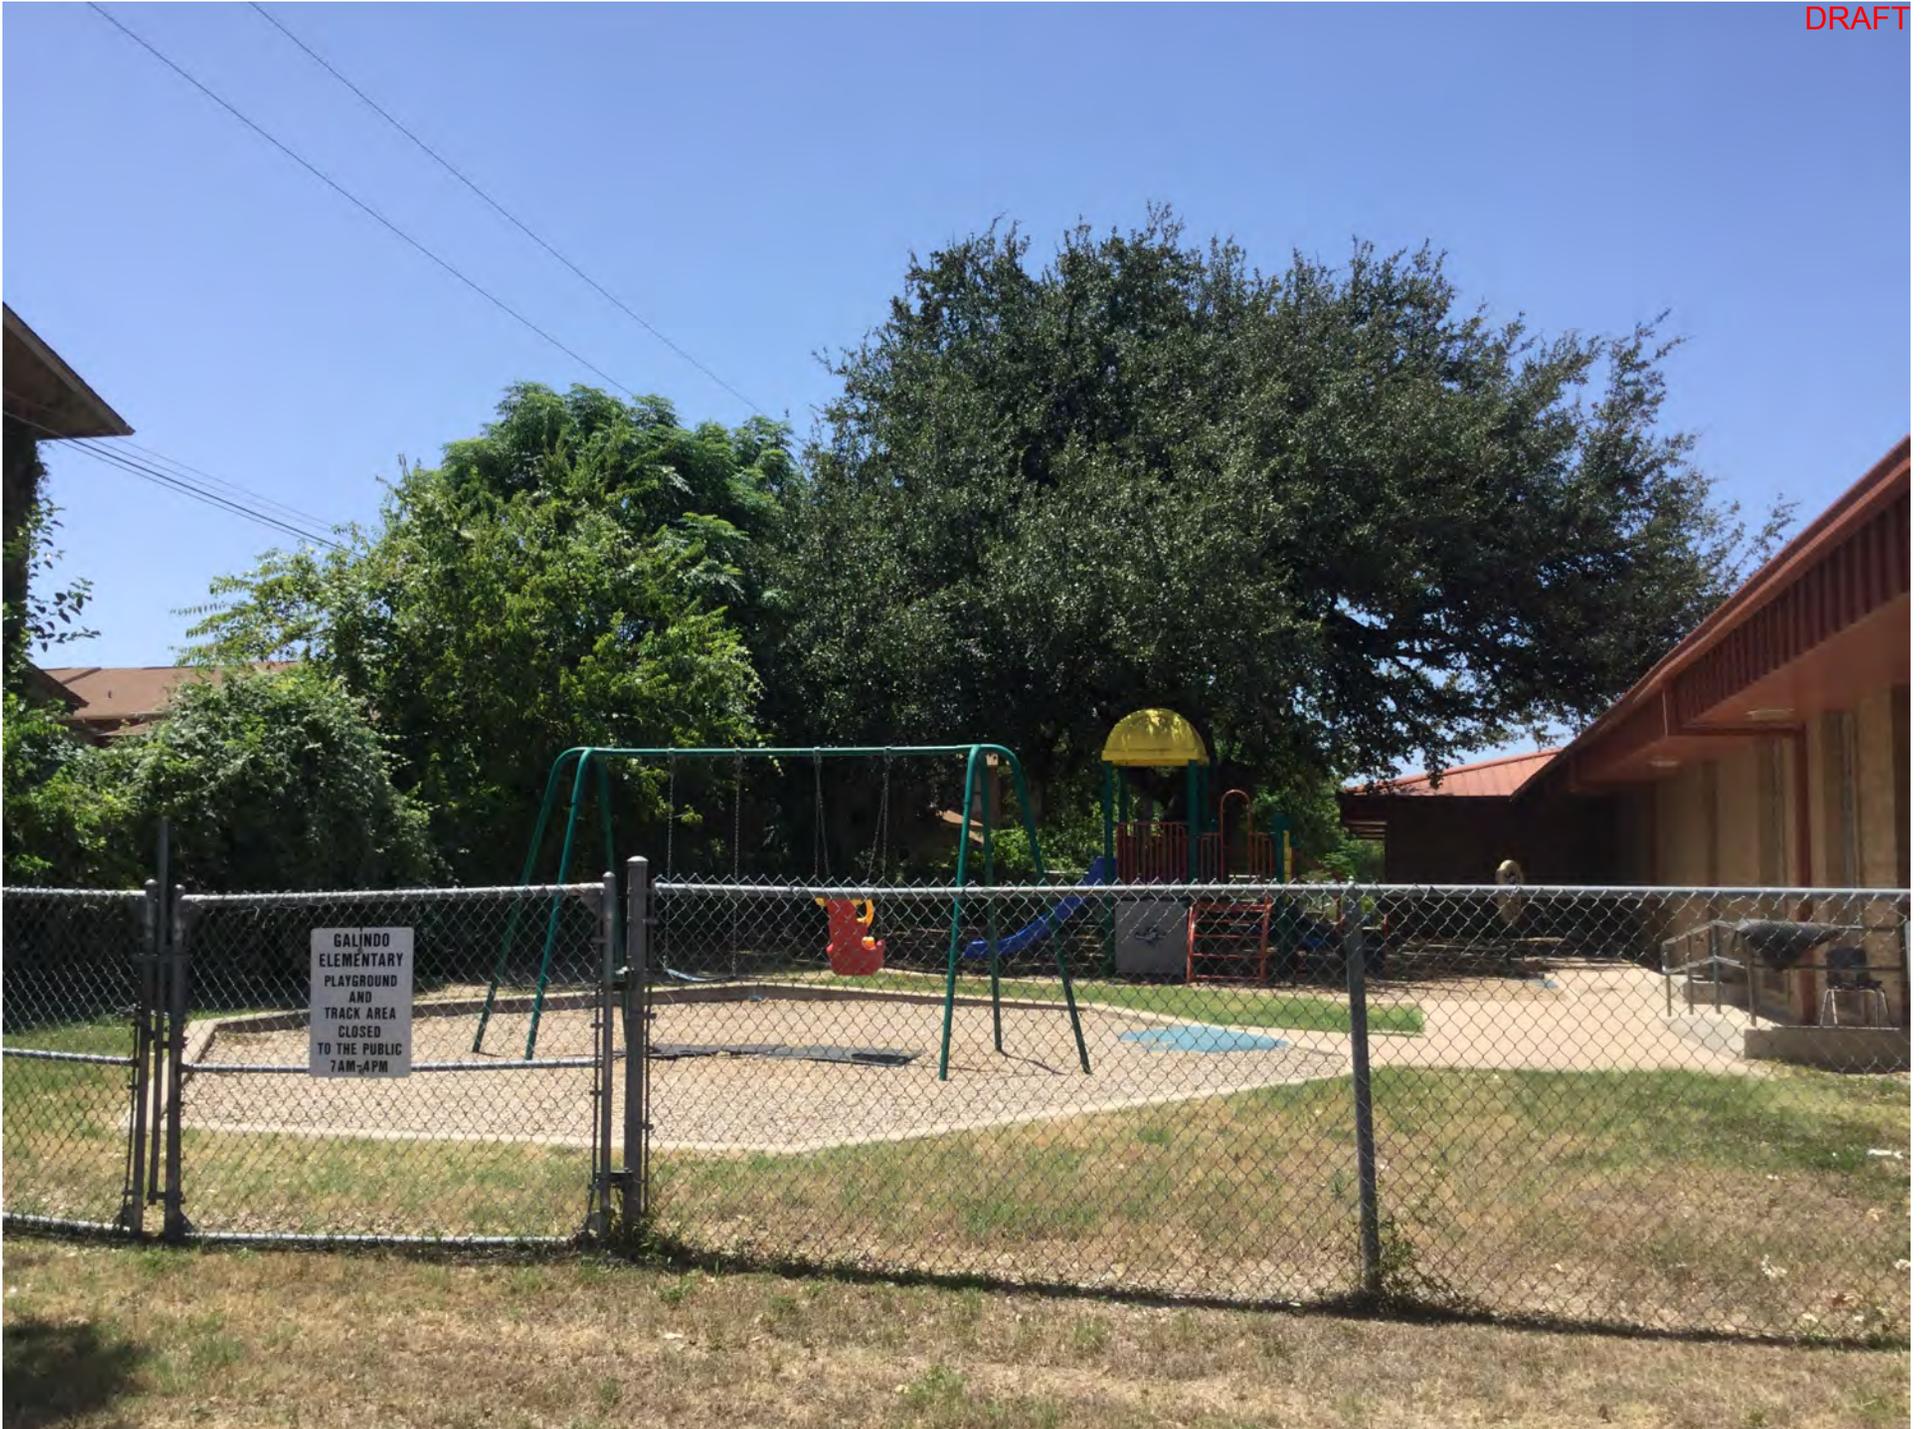
Photo 1.  
1.3 Outdoor Play Space

1.3	Are outdoor play spaces and playfields adequate in size and configuration?				4			Comments	1.00	4.00
1) Outdoor play space exists, not developed 2)Outdoor play space exists but is not connected to gym or other athletic support areas or is too small. 3. Outdoor play spaces exist, are connected to other athletic areas, are the right size, but are not in good condition. 4. Outdoor play spaces need minor improvements to function well. 5. Outdoor play spaces are in excellent condition. N/A) Does not apply.								Outdoor play spaces need more security. Due to the location of facilities in the area, the campus staff are having to remove graffiti from equipment almost daily. Trash, needles, alcohol bottles, etc are constantly being found on the site.	see photo 1

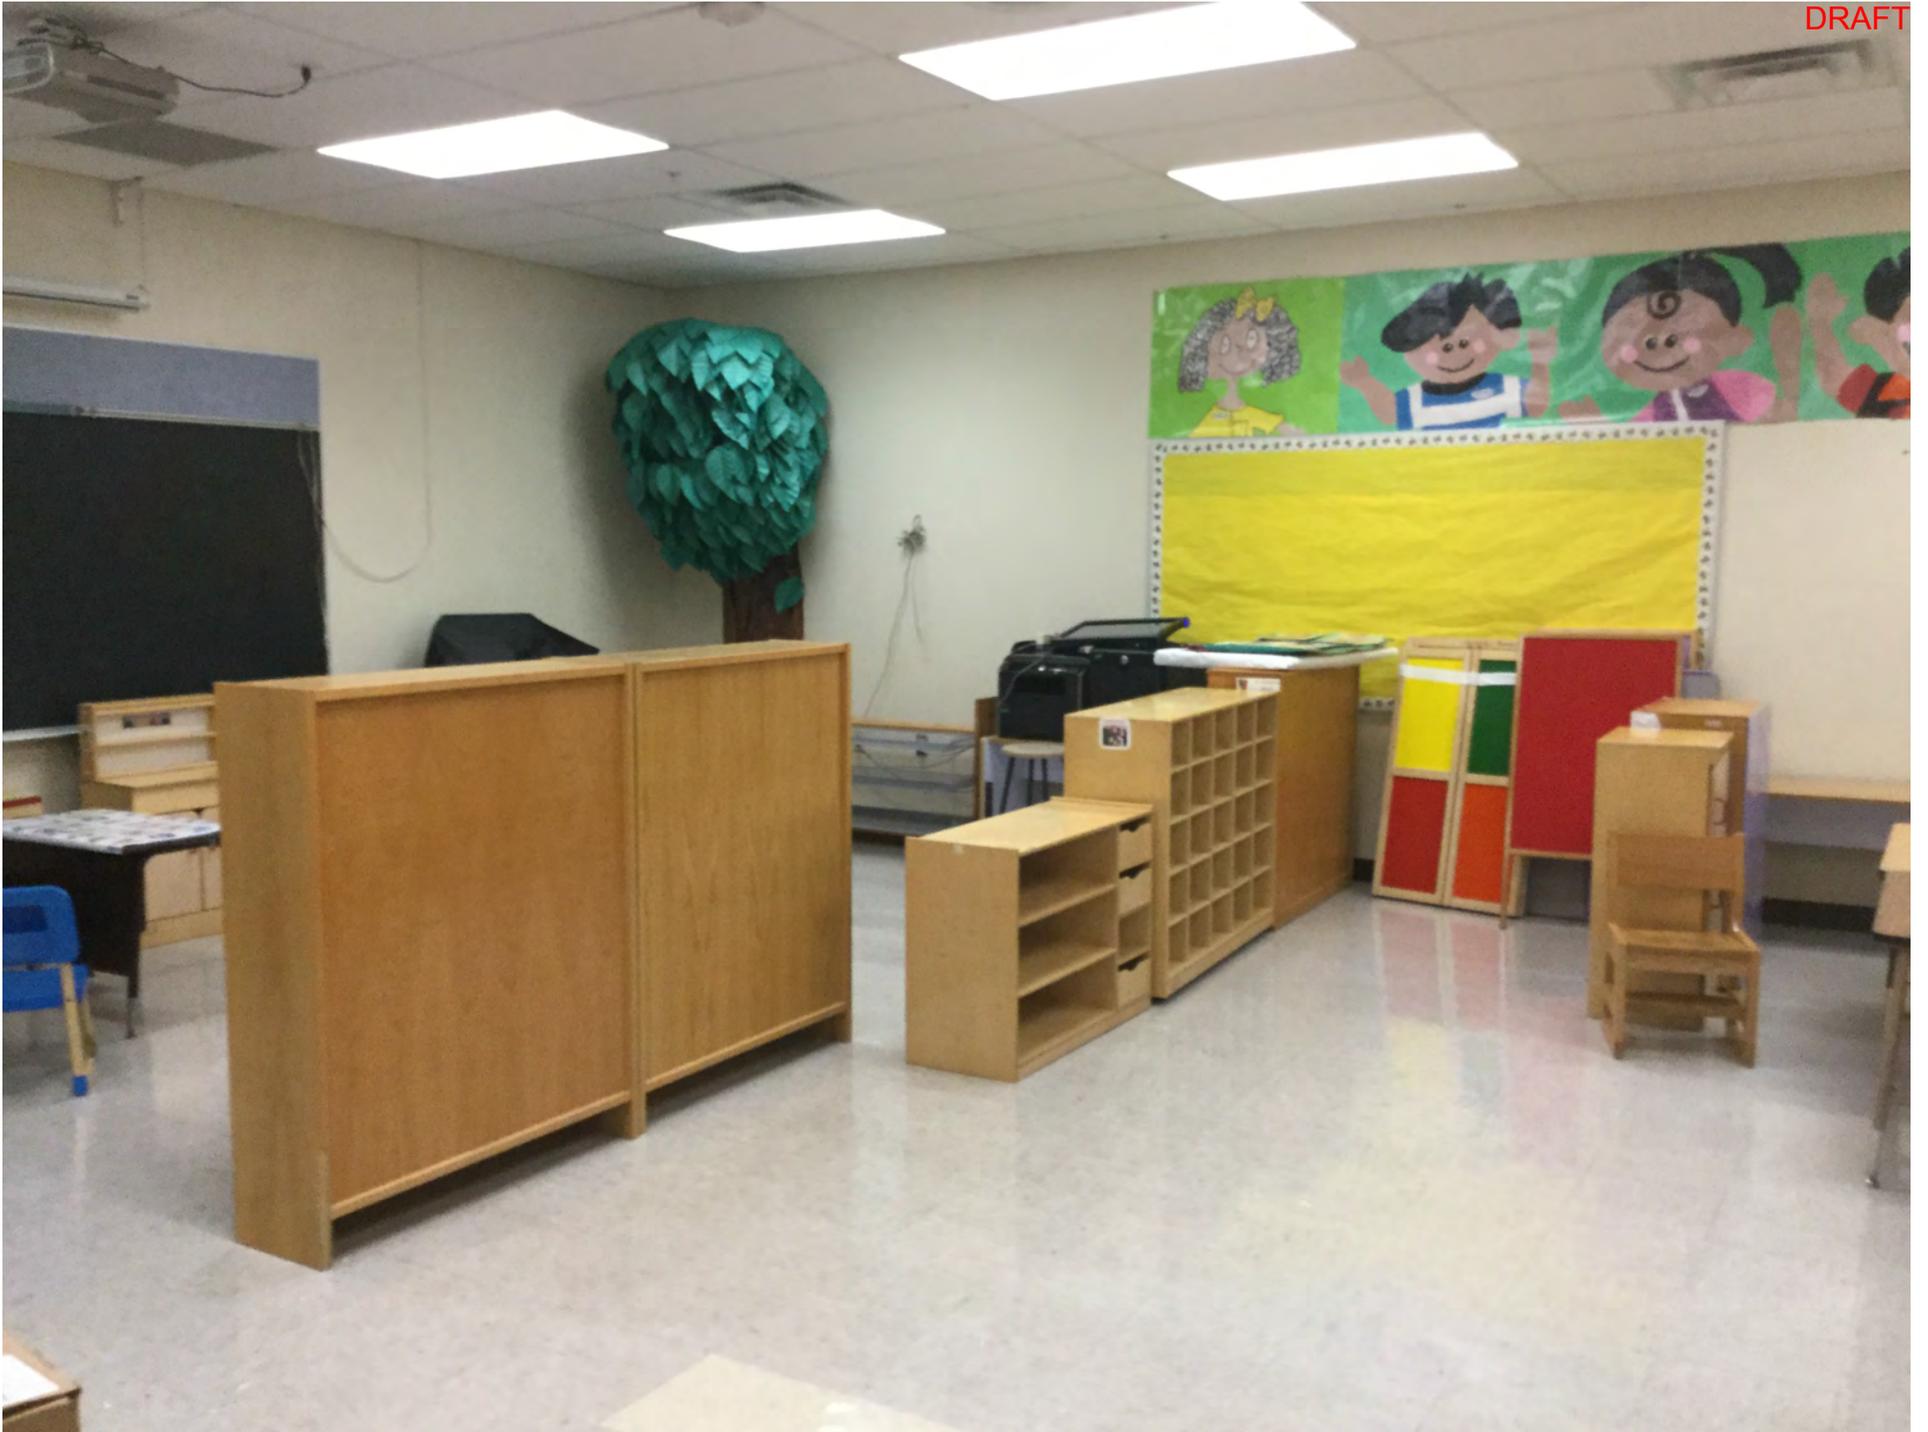
Photo 2.  
3.2 Pre-K Room

1) Very unsatisfactory - Too small, awkward layout, does not meet needs 2) Unsatisfactory - Too small, only one area for all teaching methods, limited flexibility 3) Neutral - Moderate size, two areas for different teaching methods, some flexibility, access to student storage/casework 4) Satisfactory - Good size, at least two zones for different teaching methods, flexibility and student storage, not new 5) Very Satisfactory - Good size, two zones for different teaching methods, flexibility and student storage/casework, adequate display area and visual teaching tools N/A) Does not apply.		see photo 2

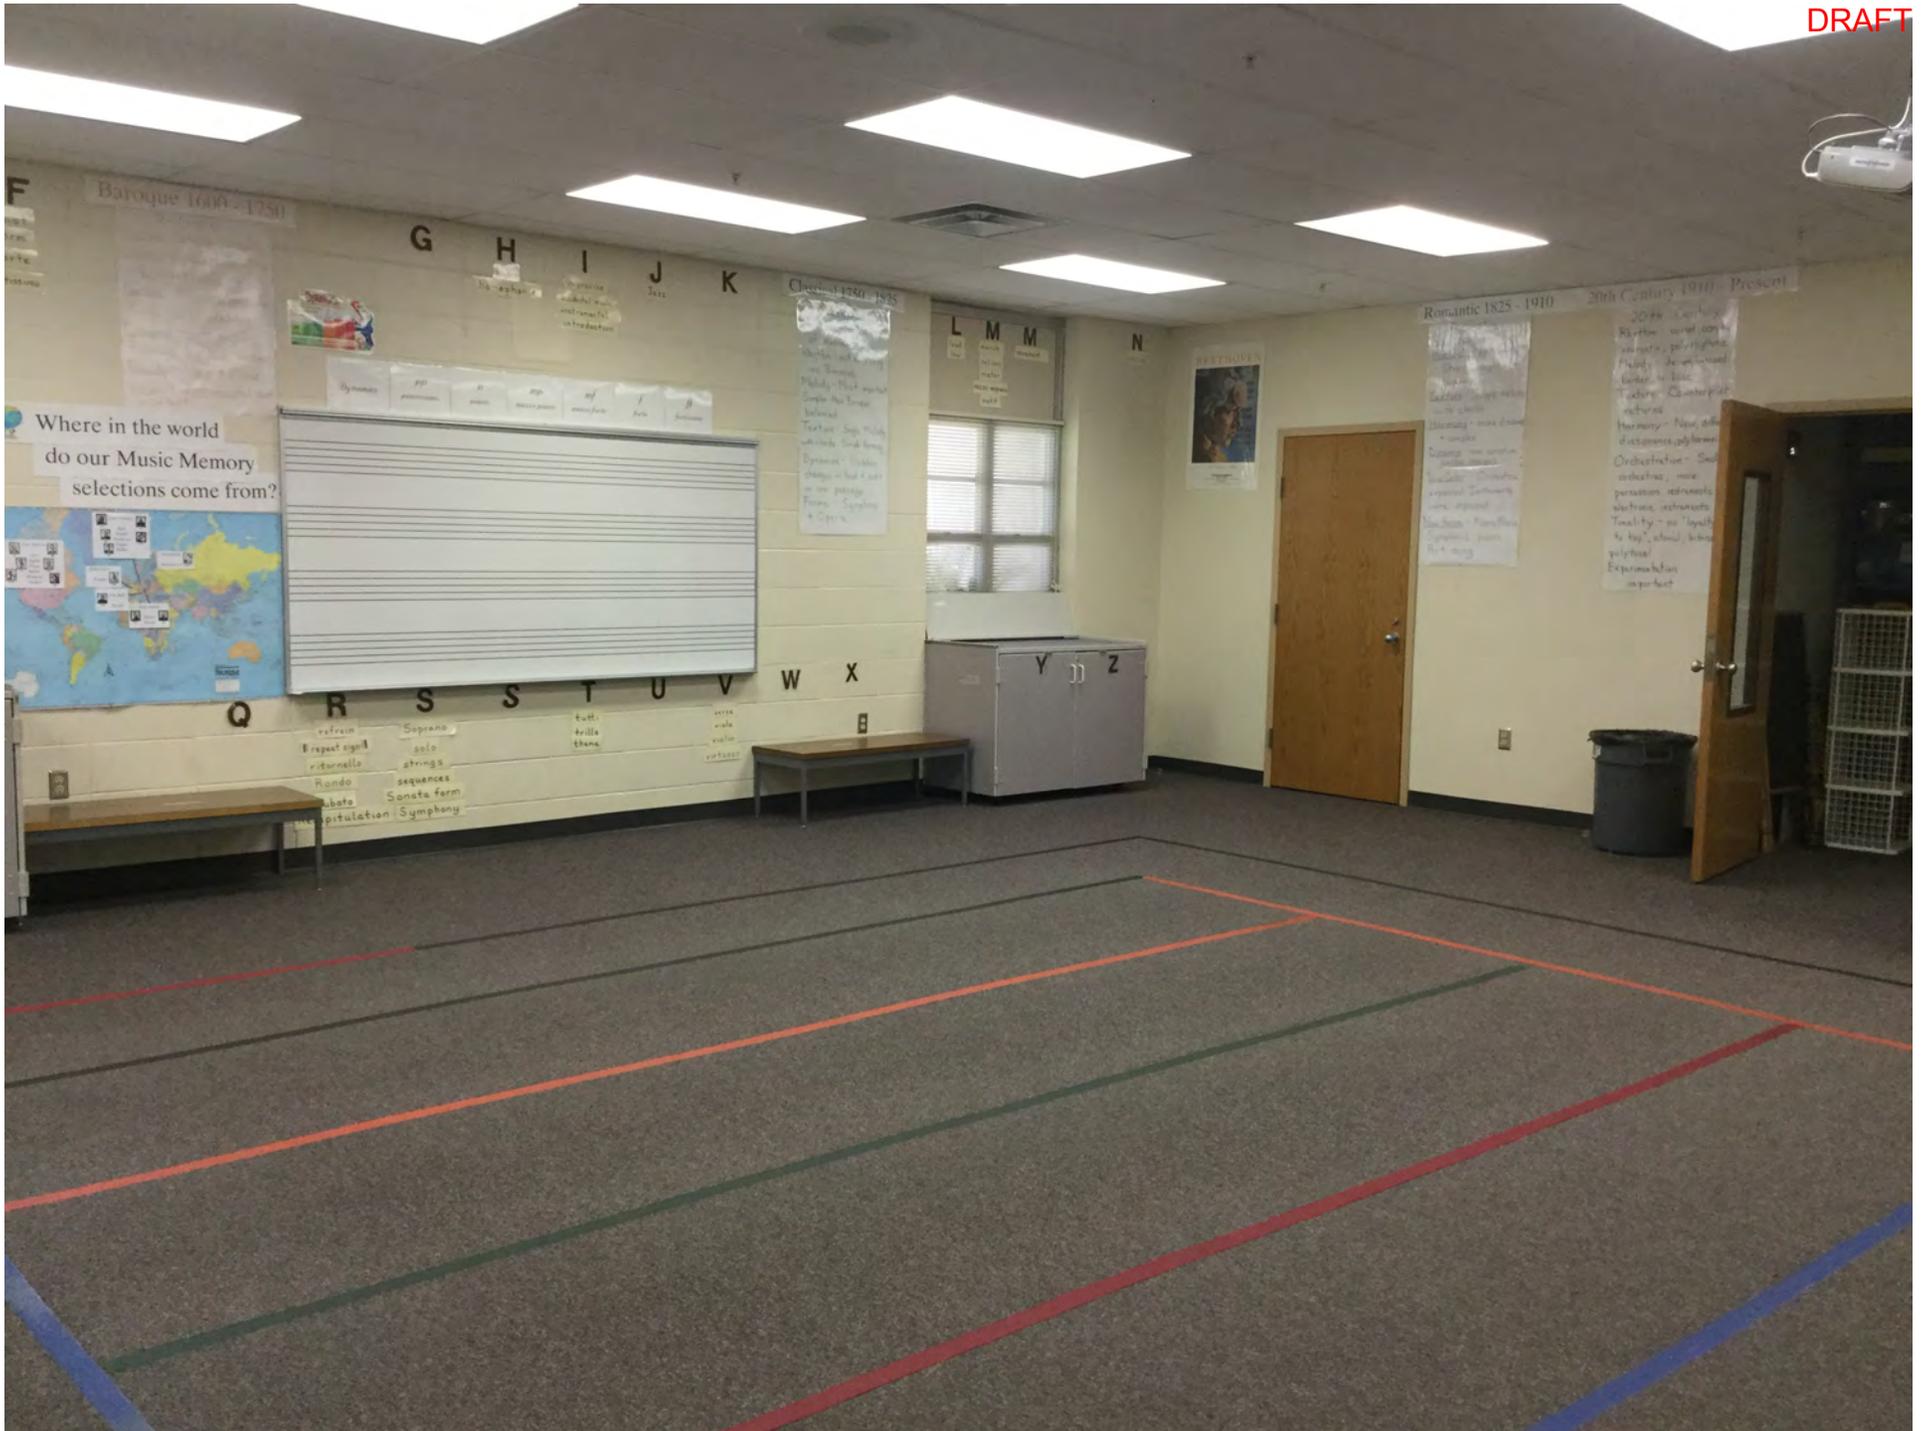
Photo 3.  
3.8 Music Room

3.8	Are music, drama, or performance spaces appropriately configured per the ed spec?				4			Comments	1.00 4.00
1) Very unsatisfactory 2) Unsatisfactory 3) Average 4) Good 5) Very good N/A) Does not apply.		The main art room is in good condition but the supplementary classes are poorly equipped. One supplementary class shares space with an art class. The campus staff could rearrange to align the music spaces to work with the original design intent of the school.							
		<b>see photo 3</b>

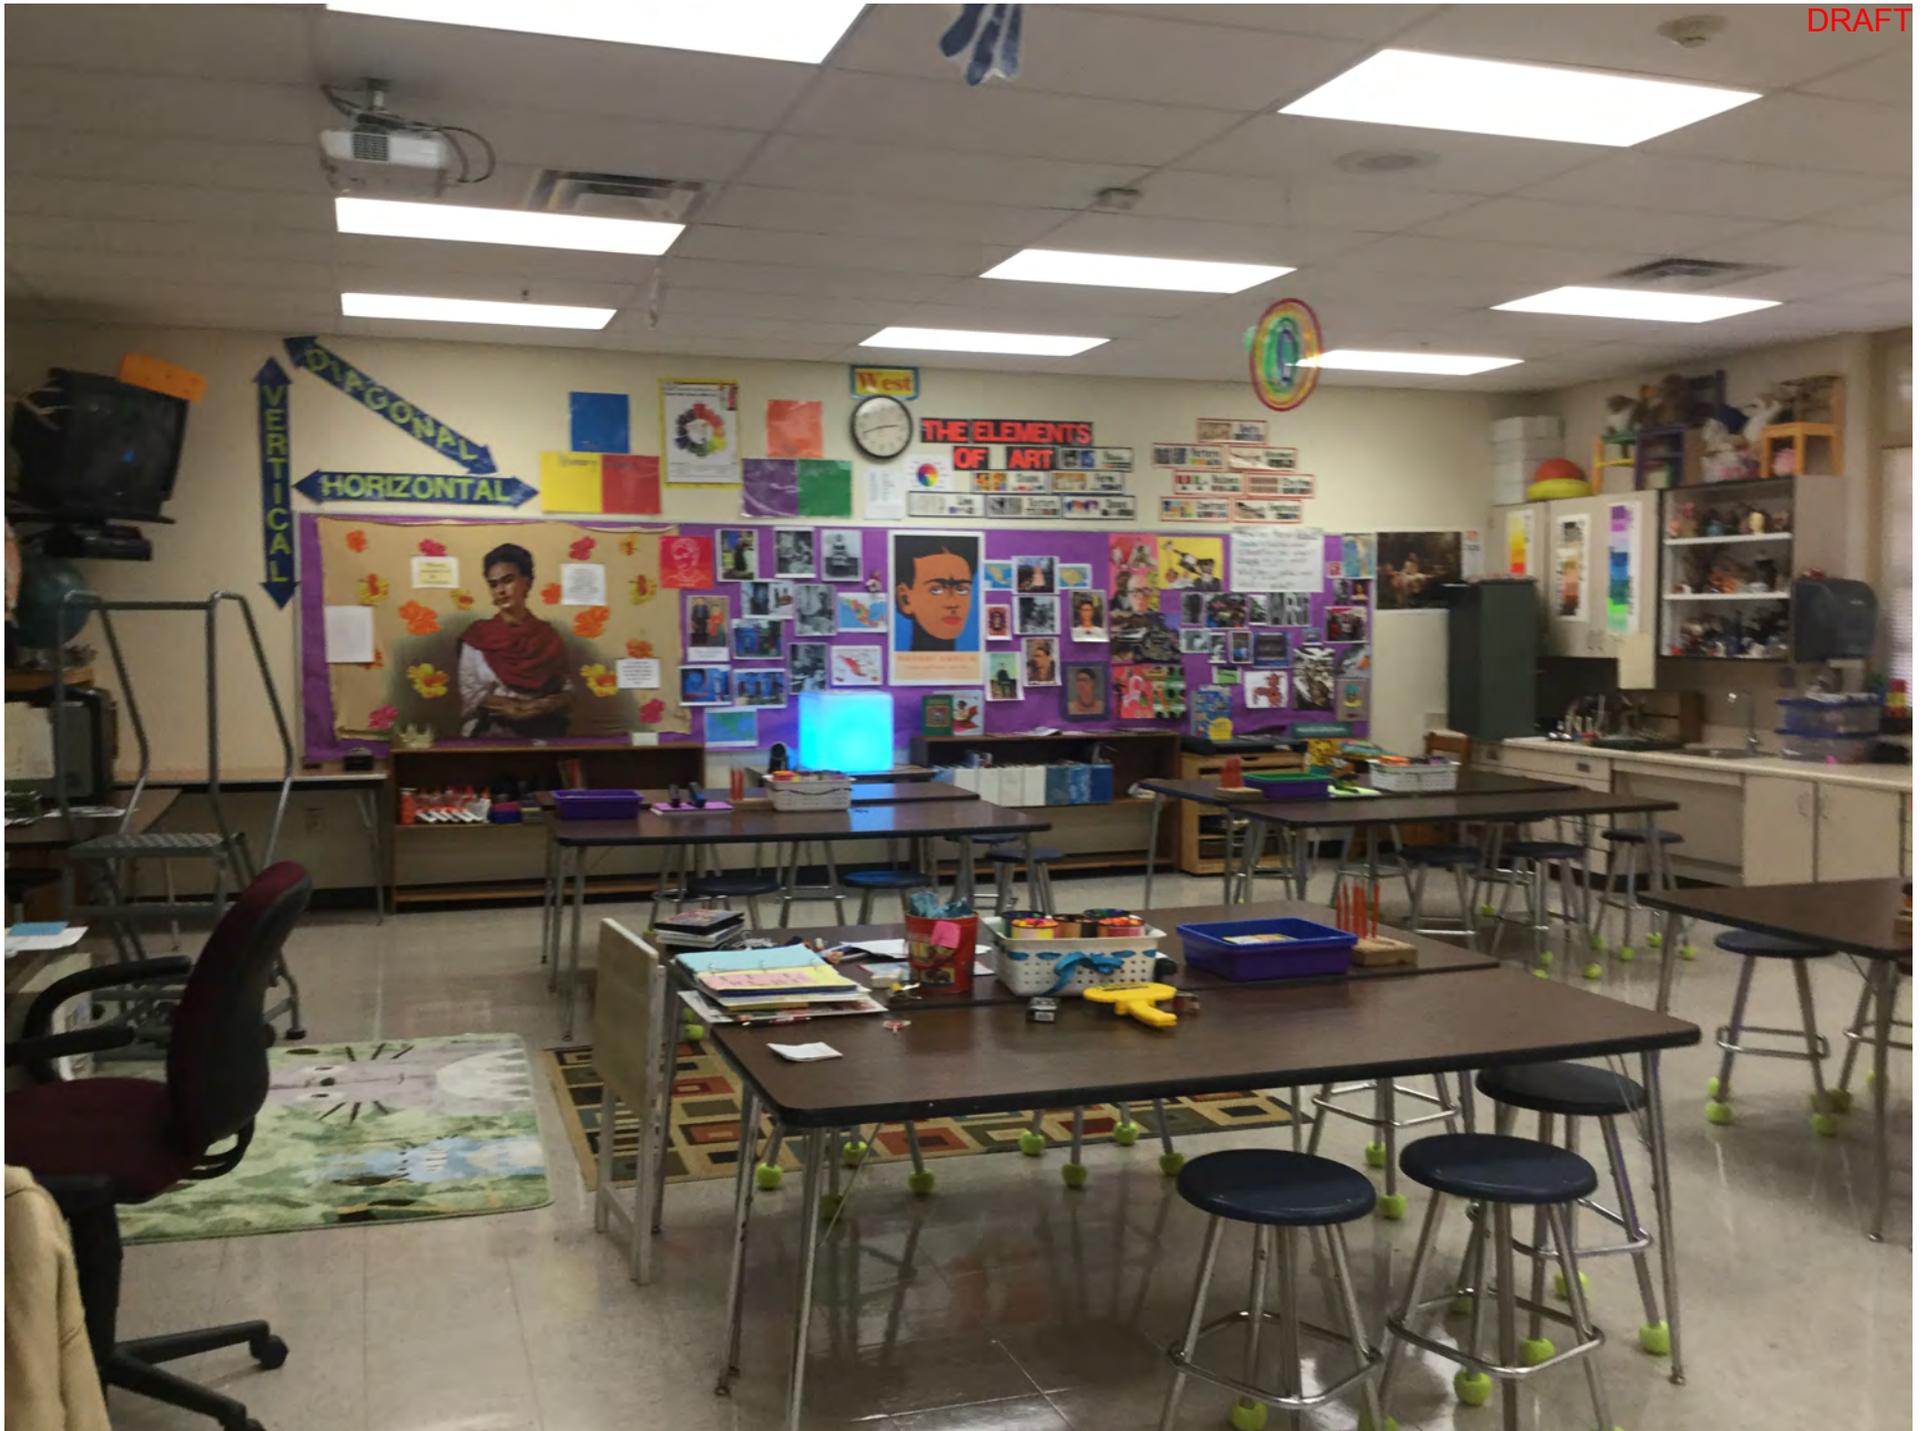
Photo 4.  
3.10 Art Room

1) Very unsatisfactory 2) Unsatisfactory 3) Average 4) Good 5) Very good N/A) Does not apply.								Two of the art rooms are in good condition and are well equipped . One art room space shares with a music class.	see photo 4

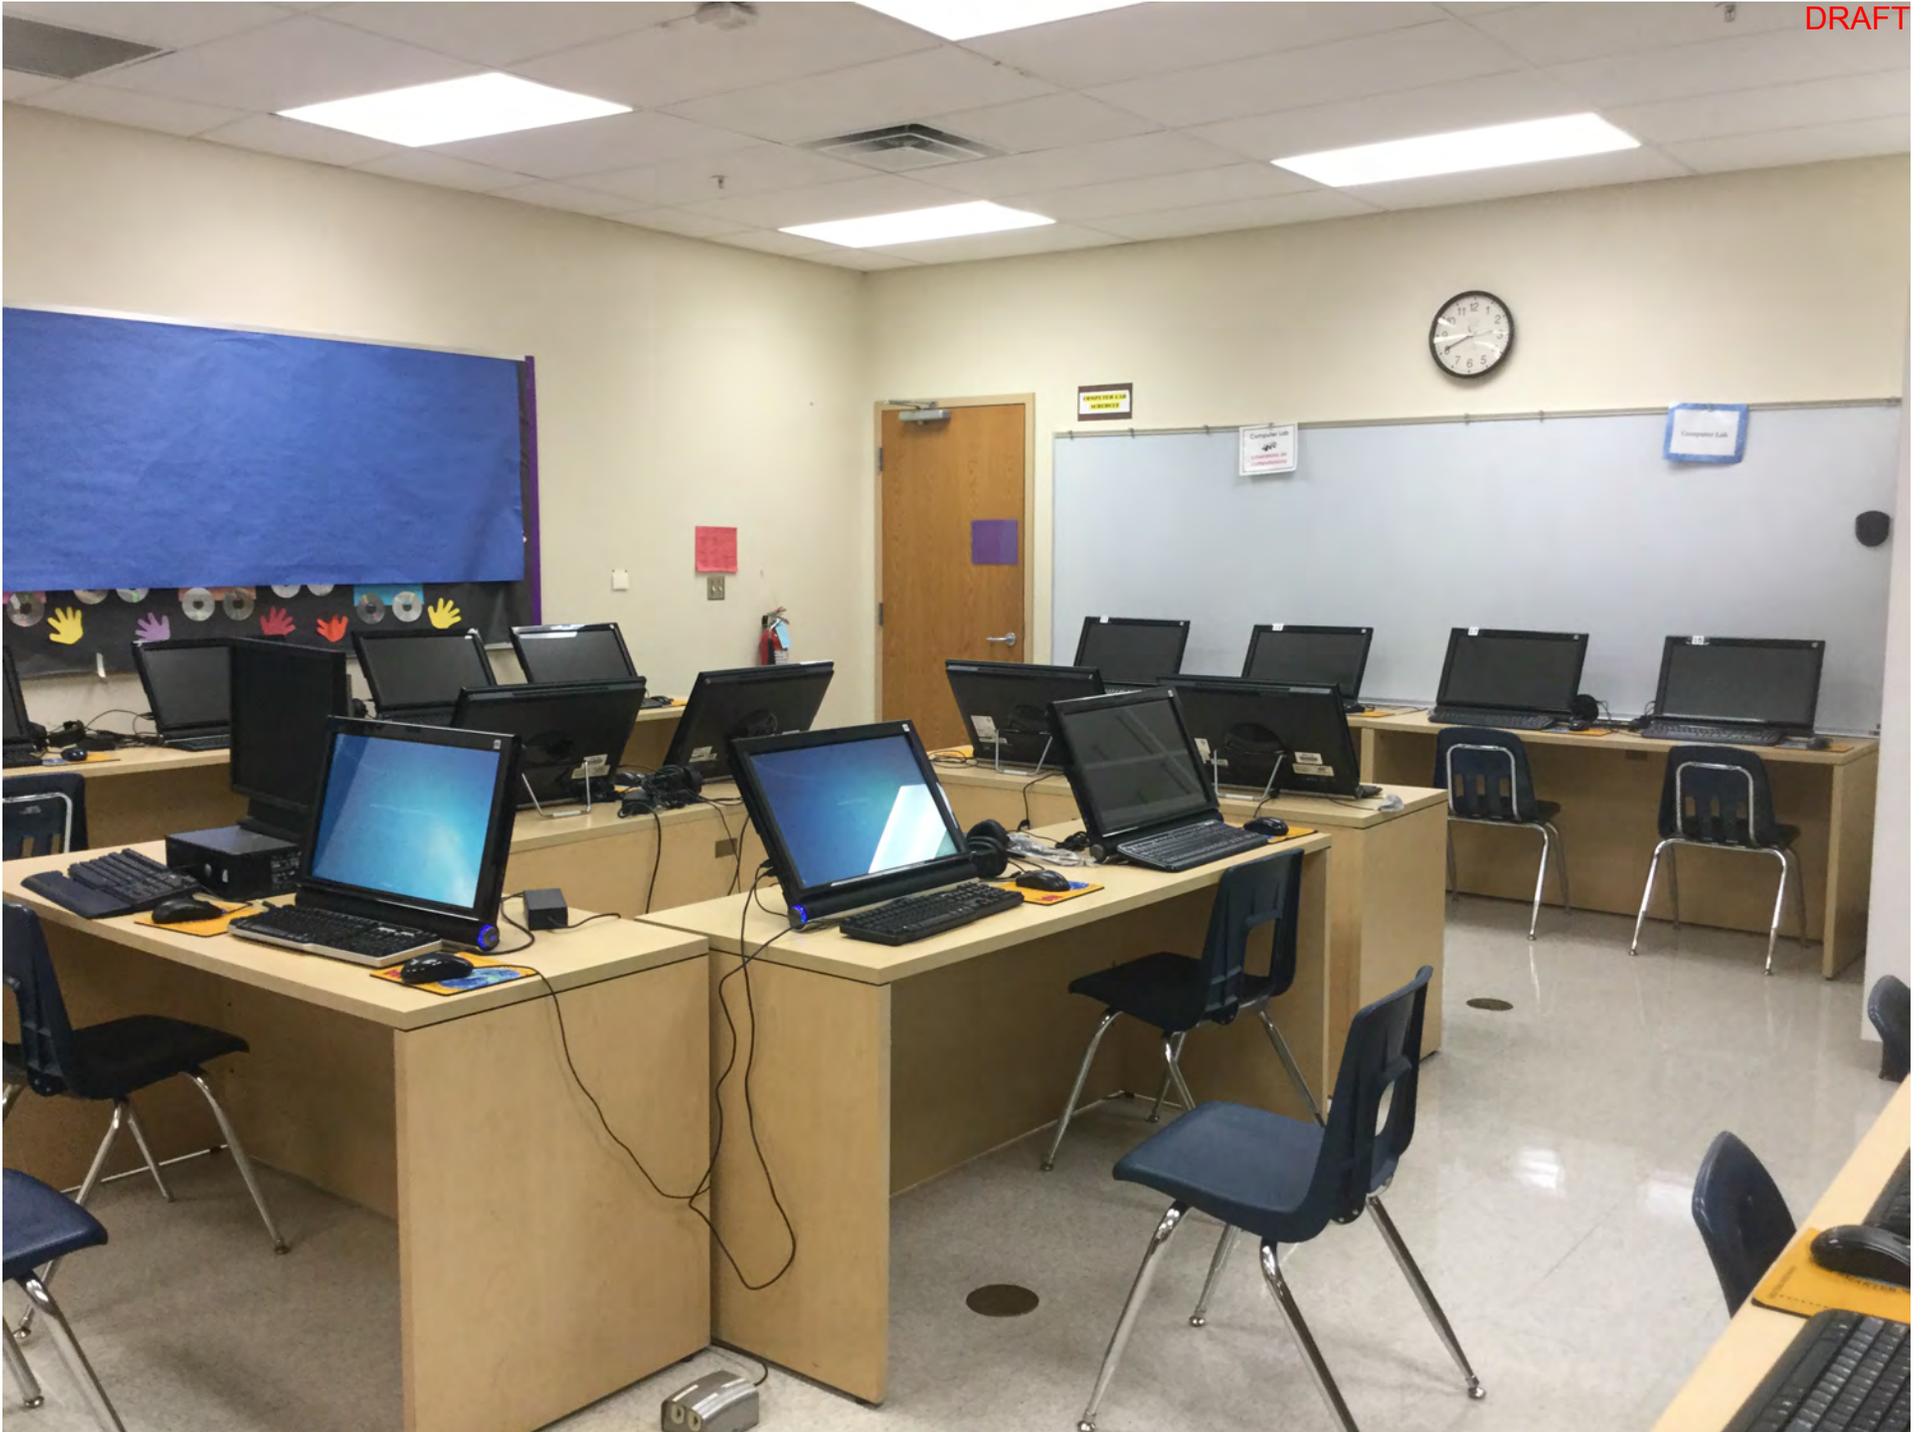
Photo 5.  
3.13 Computer Lab

3.12	Are computer lab spaces appropriately configured?				4			Comments	1.00 4.00
1) Very unsatisfactory 2) Unsatisfactory 3) Average 4) Good 5) Very good N/A) Does not apply.								The computer lab square footage may need to be increased. Due to the use of mobile devices, the lab is not used as much.

3.13	Are computer lab <b>support</b> spaces appropriately configured?					5		Comments	1.00 5.00
1) Very unsatisfactory - Support spaces are disconnected from served spaces, too small, do not meet needs 2) Unsatisfactory - Support spaces are connected, but too small, inadequate for needs 3) Average - Connected, moderate size, but need some renovations or updates to function well 4) Good - Connected, good size/layout, meets needs/functions well 5) Very good - connected, generous size, nice condition, functions appropriately N/A) Does not apply.									see photo 5

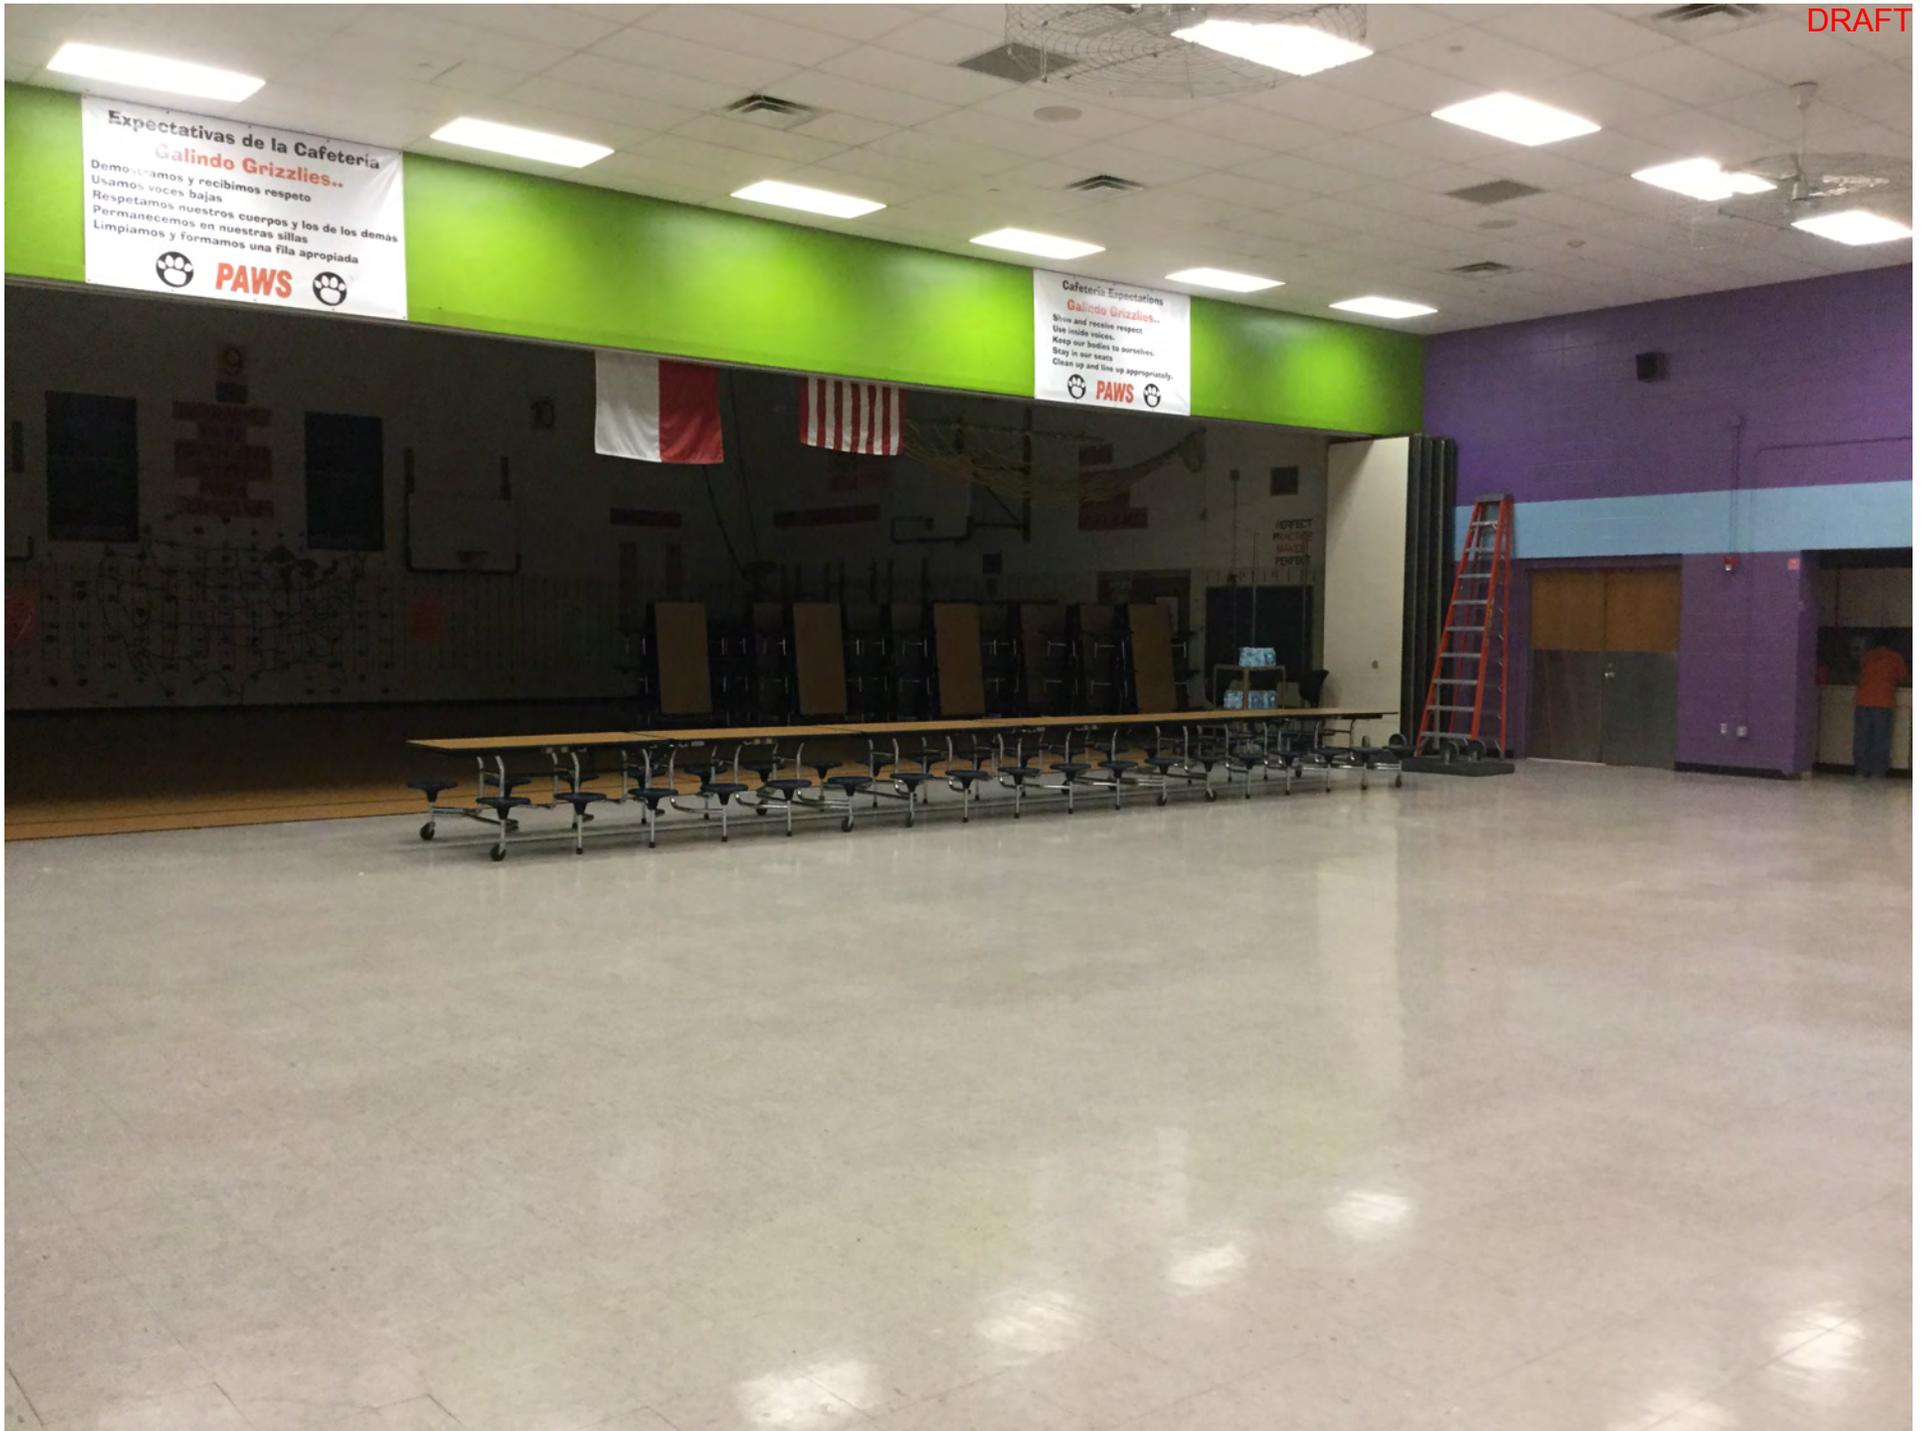
Photo 6.  
3.16 Cafetorium

3.16	Are the student dining facilities appropriately configured?					5		Comments	1.00 <b>5.00</b>
1) Very unsatisfactory - Too small, poor circulation, inflexible seating in poor condition 2) Unsatisfactory - Too small or inadequate circulation, seating in poor condition 3) Average - moderate size, with adequate circulation, seating in okay condition 4) Good - good size, adequate circulation, seating in good condition 5) Very good - good size, adequate circulation, seating in good condition, with more than one option for eating space (ex: connection to outdoor eating space) N/A) Does not apply.								The cafeteria could use more space and natural light.	see photo 6

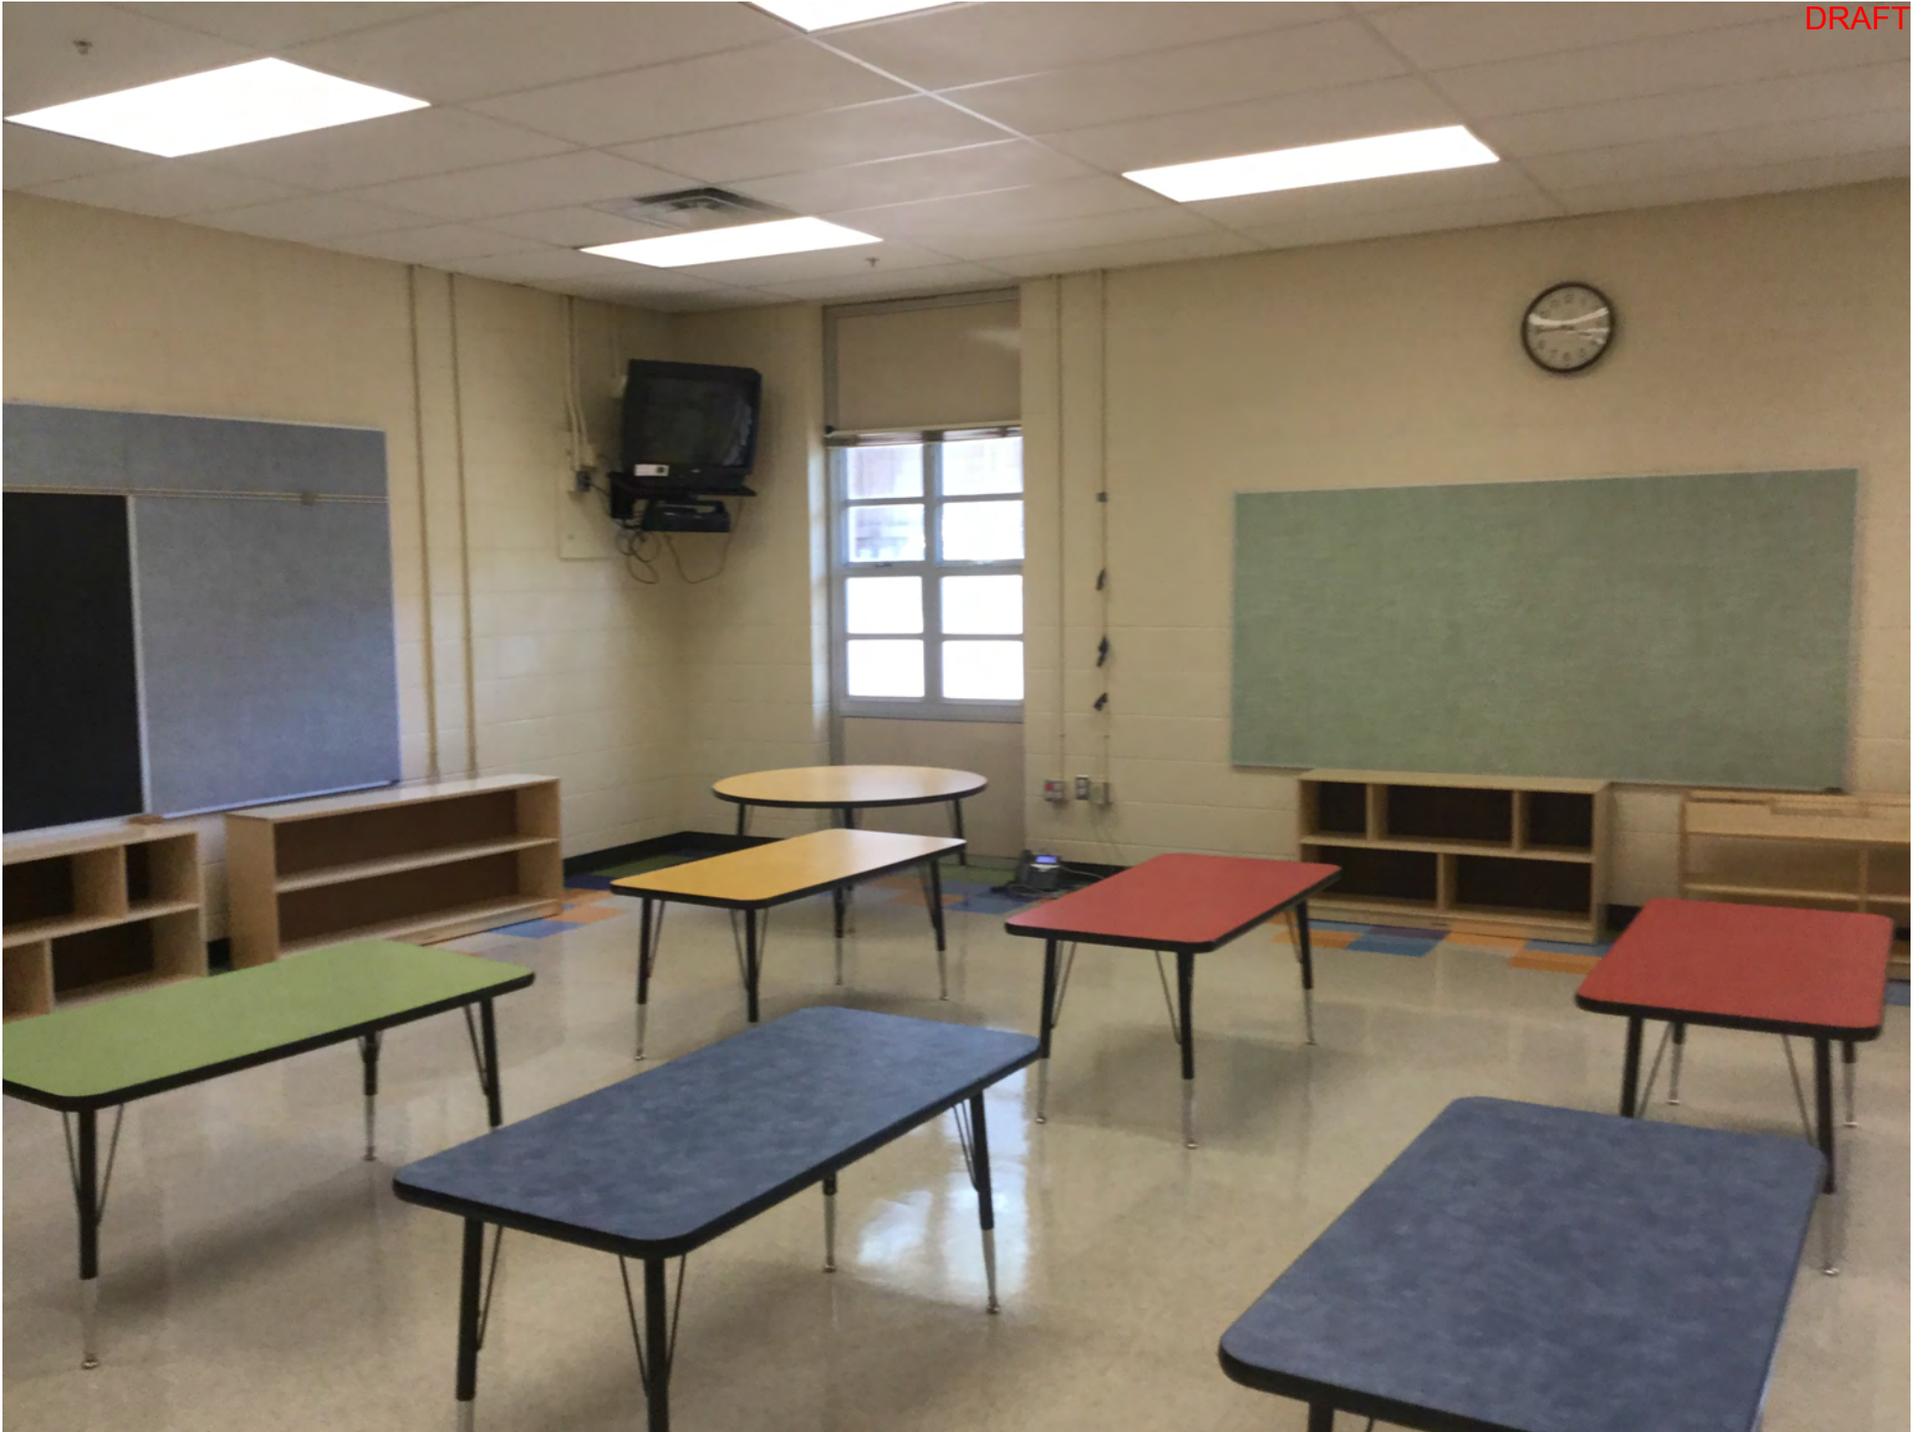
Photo 7.  
4.2 Standard Classroom

4.2	Are general classrooms large enough to support project-based learning and multiple teaching modalities?				4			Comments	1.00	4.00
1) Very unsatisfactory -too small to move, set for lecture only, no connectivity, no flexibility 2) Unsatisfactory - adequate size but set for lecture only, no connectivity, no flexibility 3) Neutral - have flexibility and space for hands on or project based learning 4) Satisfactory - have flexibility and space for hands on or project based learning and connectivity for global learning 5) Very Satisfactory - space for hands on learning, flexibility for different groupings, and connectivity for global classrooms N/A) Does not apply.		see photo 7
