## Educational Suitability Summary Report

Galindo Elementary School

Date: 08/01/2016 (Rev 1 – 12/20/16 – Updated Survey Responses)

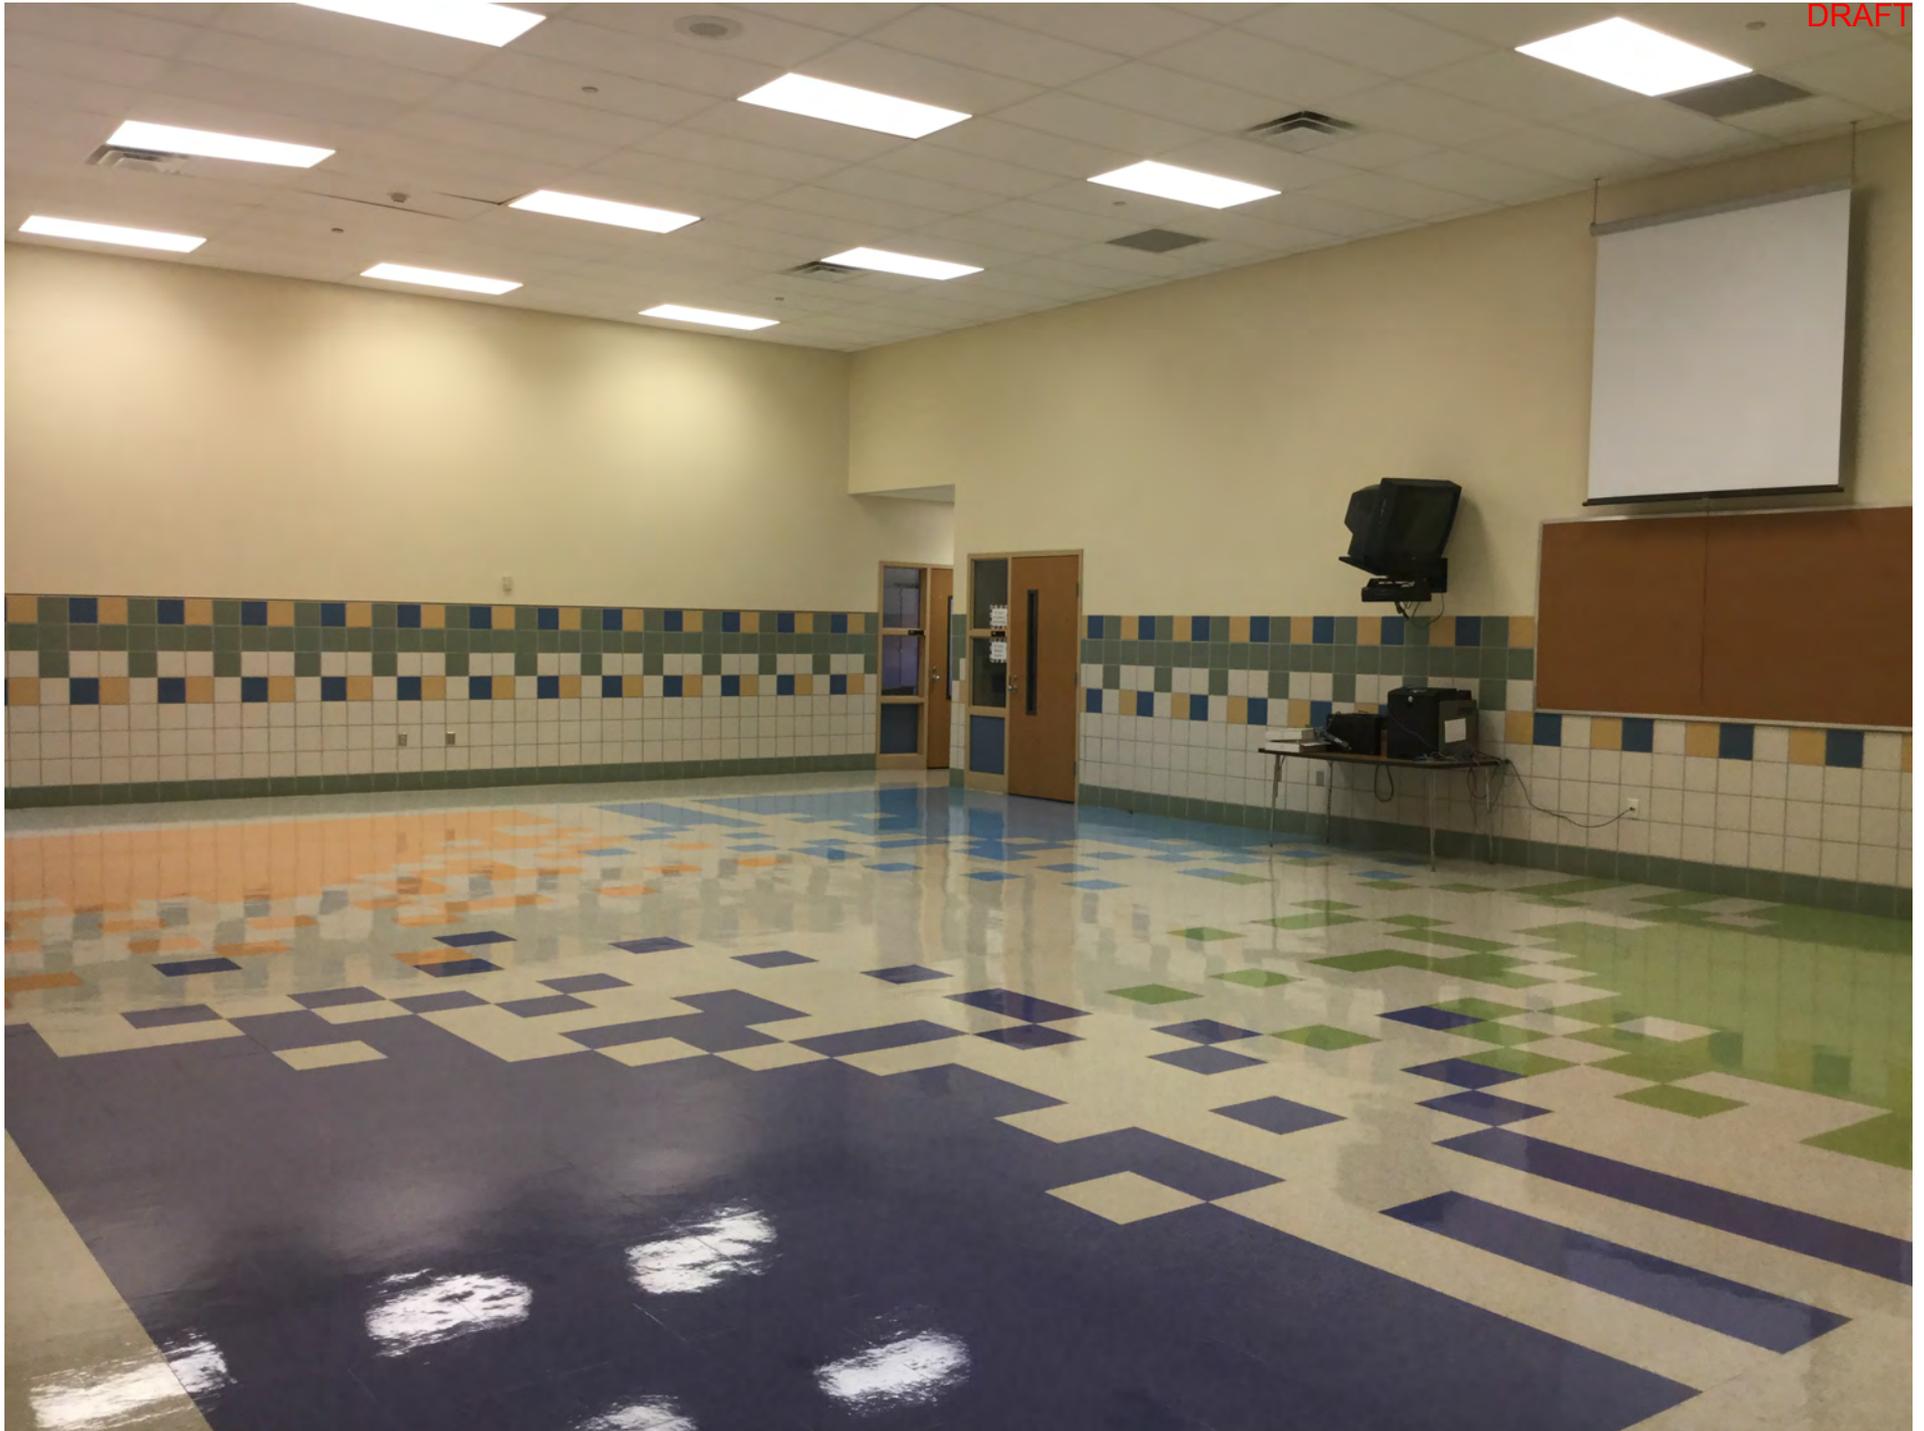
Photo 8.  
4.5 Collaborative Space

1) Very unsatisfactory - no common spaces or meeting rooms or in very poor condition 2) Unsatisfactory - a few common spaces or meeting rooms in unsatisfactory condition 3) Average - a few common spaces and meeting areas needing updates 4) Good - multiple common spaces and meeting rooms in good condition 5) Very good - adequate common spaces and meeting rooms of excellent quality N/A) Does not apply.								There is only one conference room, which is inadequate in size.			<b>see photo 8</b>

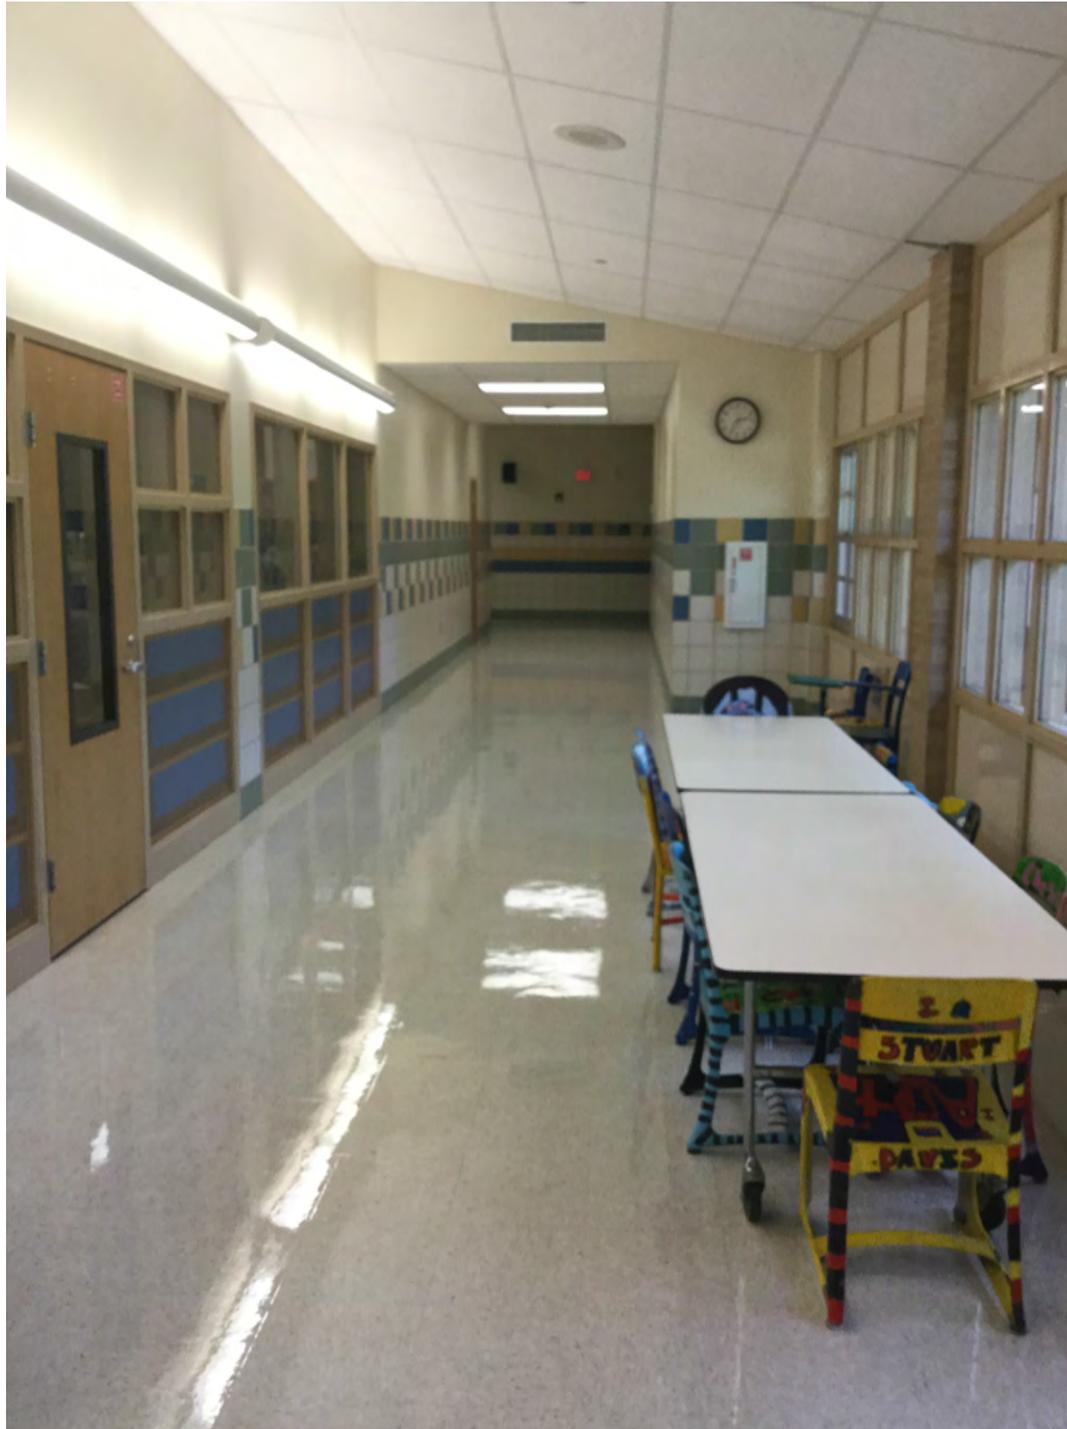
Photo 9.  
4.7 Break-Out Learning Space

4.7	Does the building provide adequate opportunities for students to work independently?				4				Comments	1.00	4.00	
1) Very unsatisfactory - None/poor condition 2) Unsatisfactory - One area far from classrooms in unsatisfactory condition 3) Average - one area for independent work with appropriate furniture needing updates 4) Good - clusters or small rooms adjacent to classrooms with furniture in good condition 5) Very good - multiple clusters or small rooms adjacent to classrooms with appropriate furniture in excellent condition N/A) Does not apply.											<b>see photo 9</b>

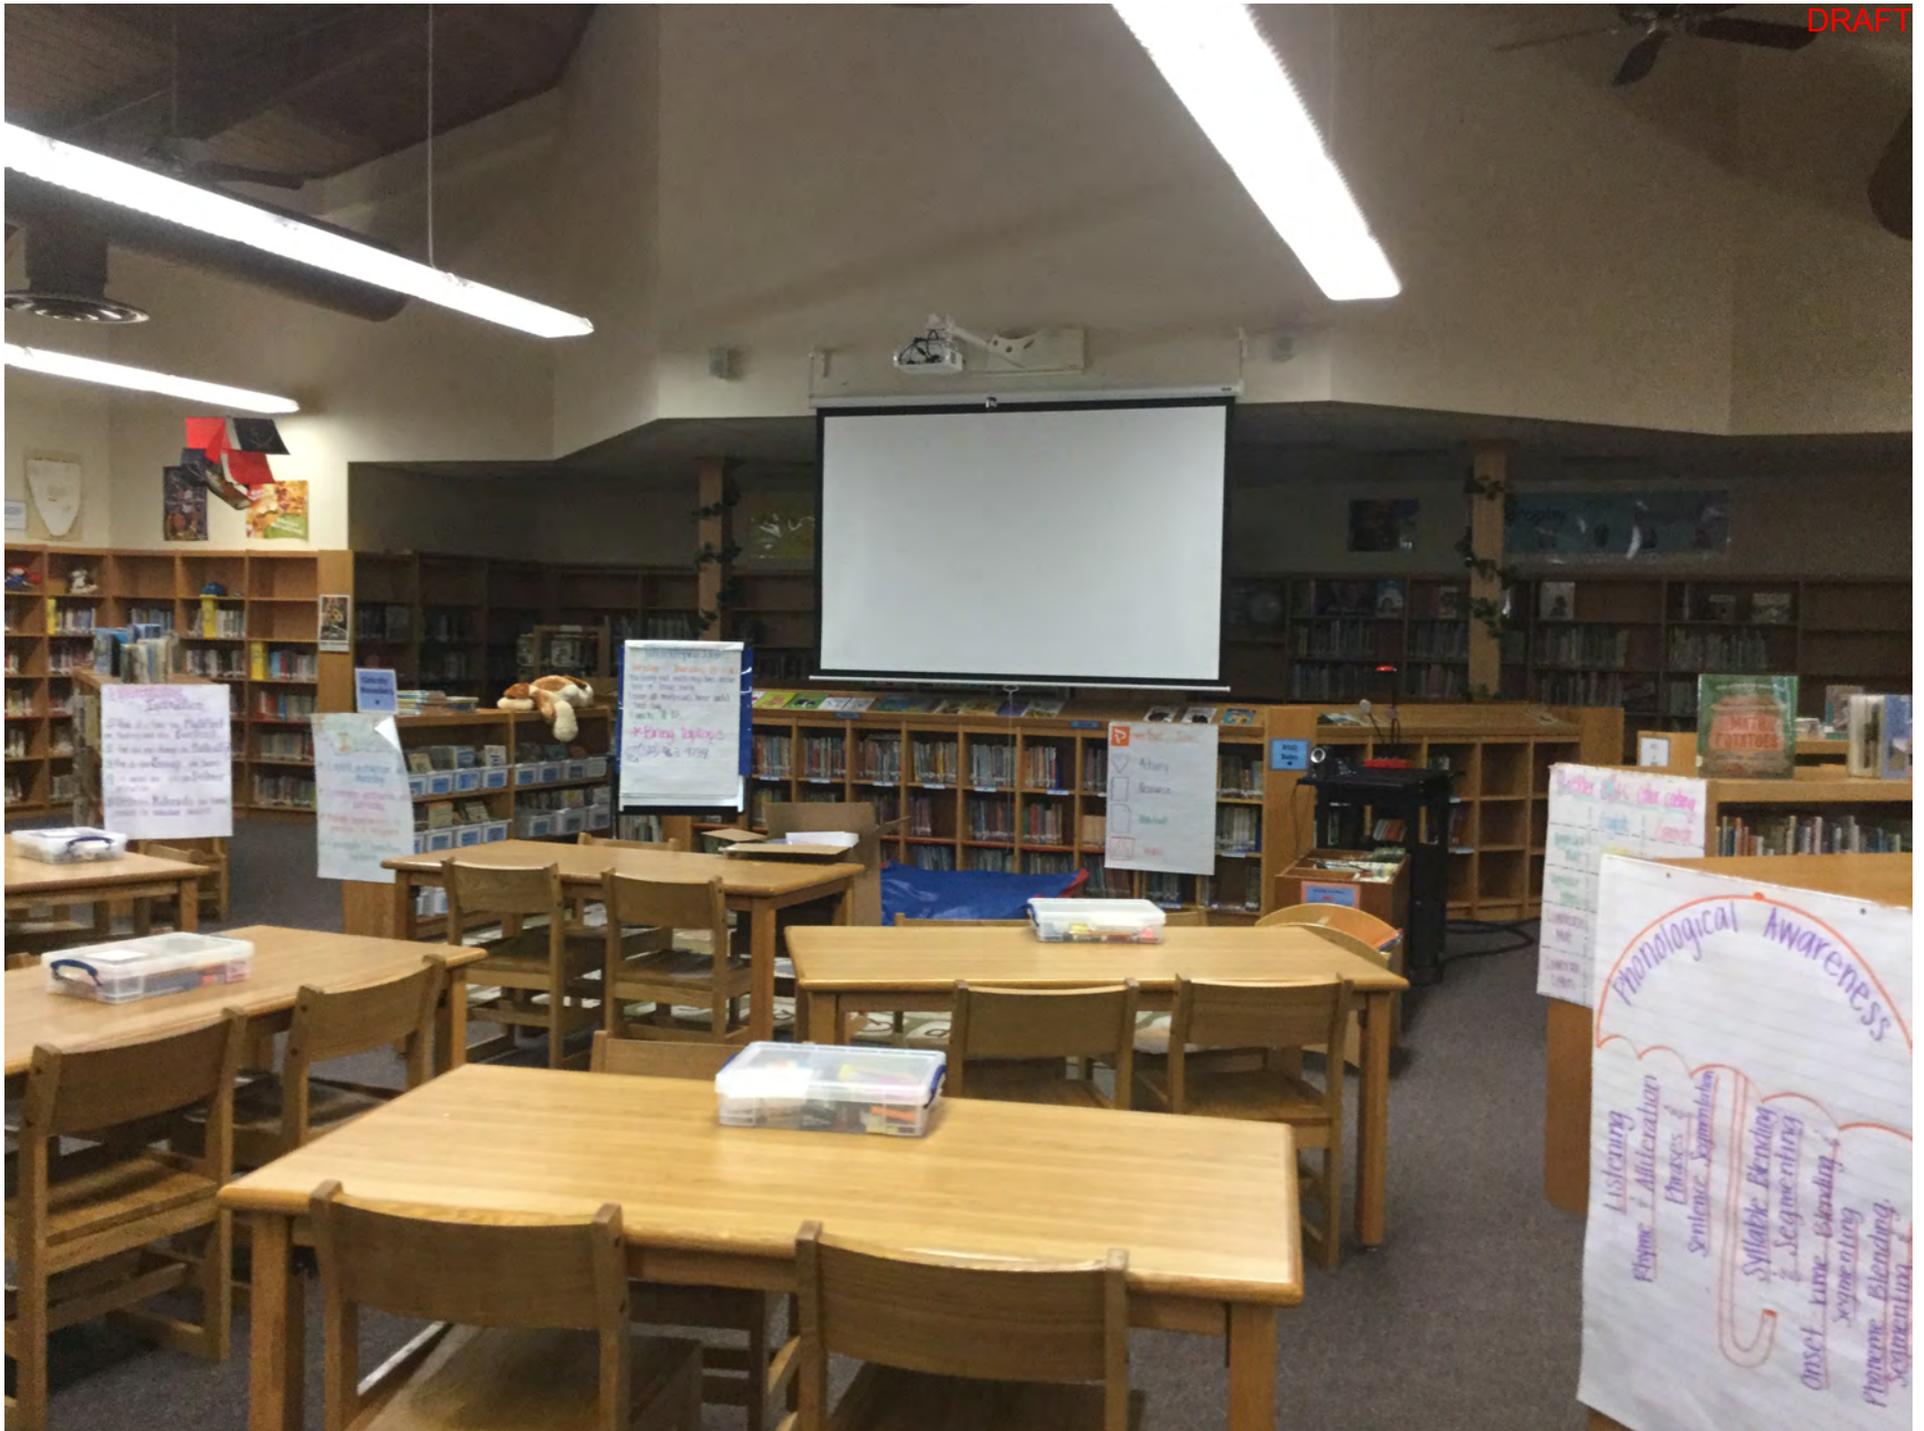
Photo 10.  
5.4 Library

5.4	How well does the Library/Media Center support collaborative work in small groups (4-8 students)?					5		Comments	1.00	5.00
1) Very unsatisfactory 2) Unsatisfactory 3) Average 4) Good 5) Very good N/A) Does not apply.								see photo 10
