## Educational Suitability Summary Report

Govalle Elementary School – BLDG # 116

Date: 05/17/2016 (Rev 1 – 12/20/16 – CAC Comments)

Score 42% Unsatisfactory

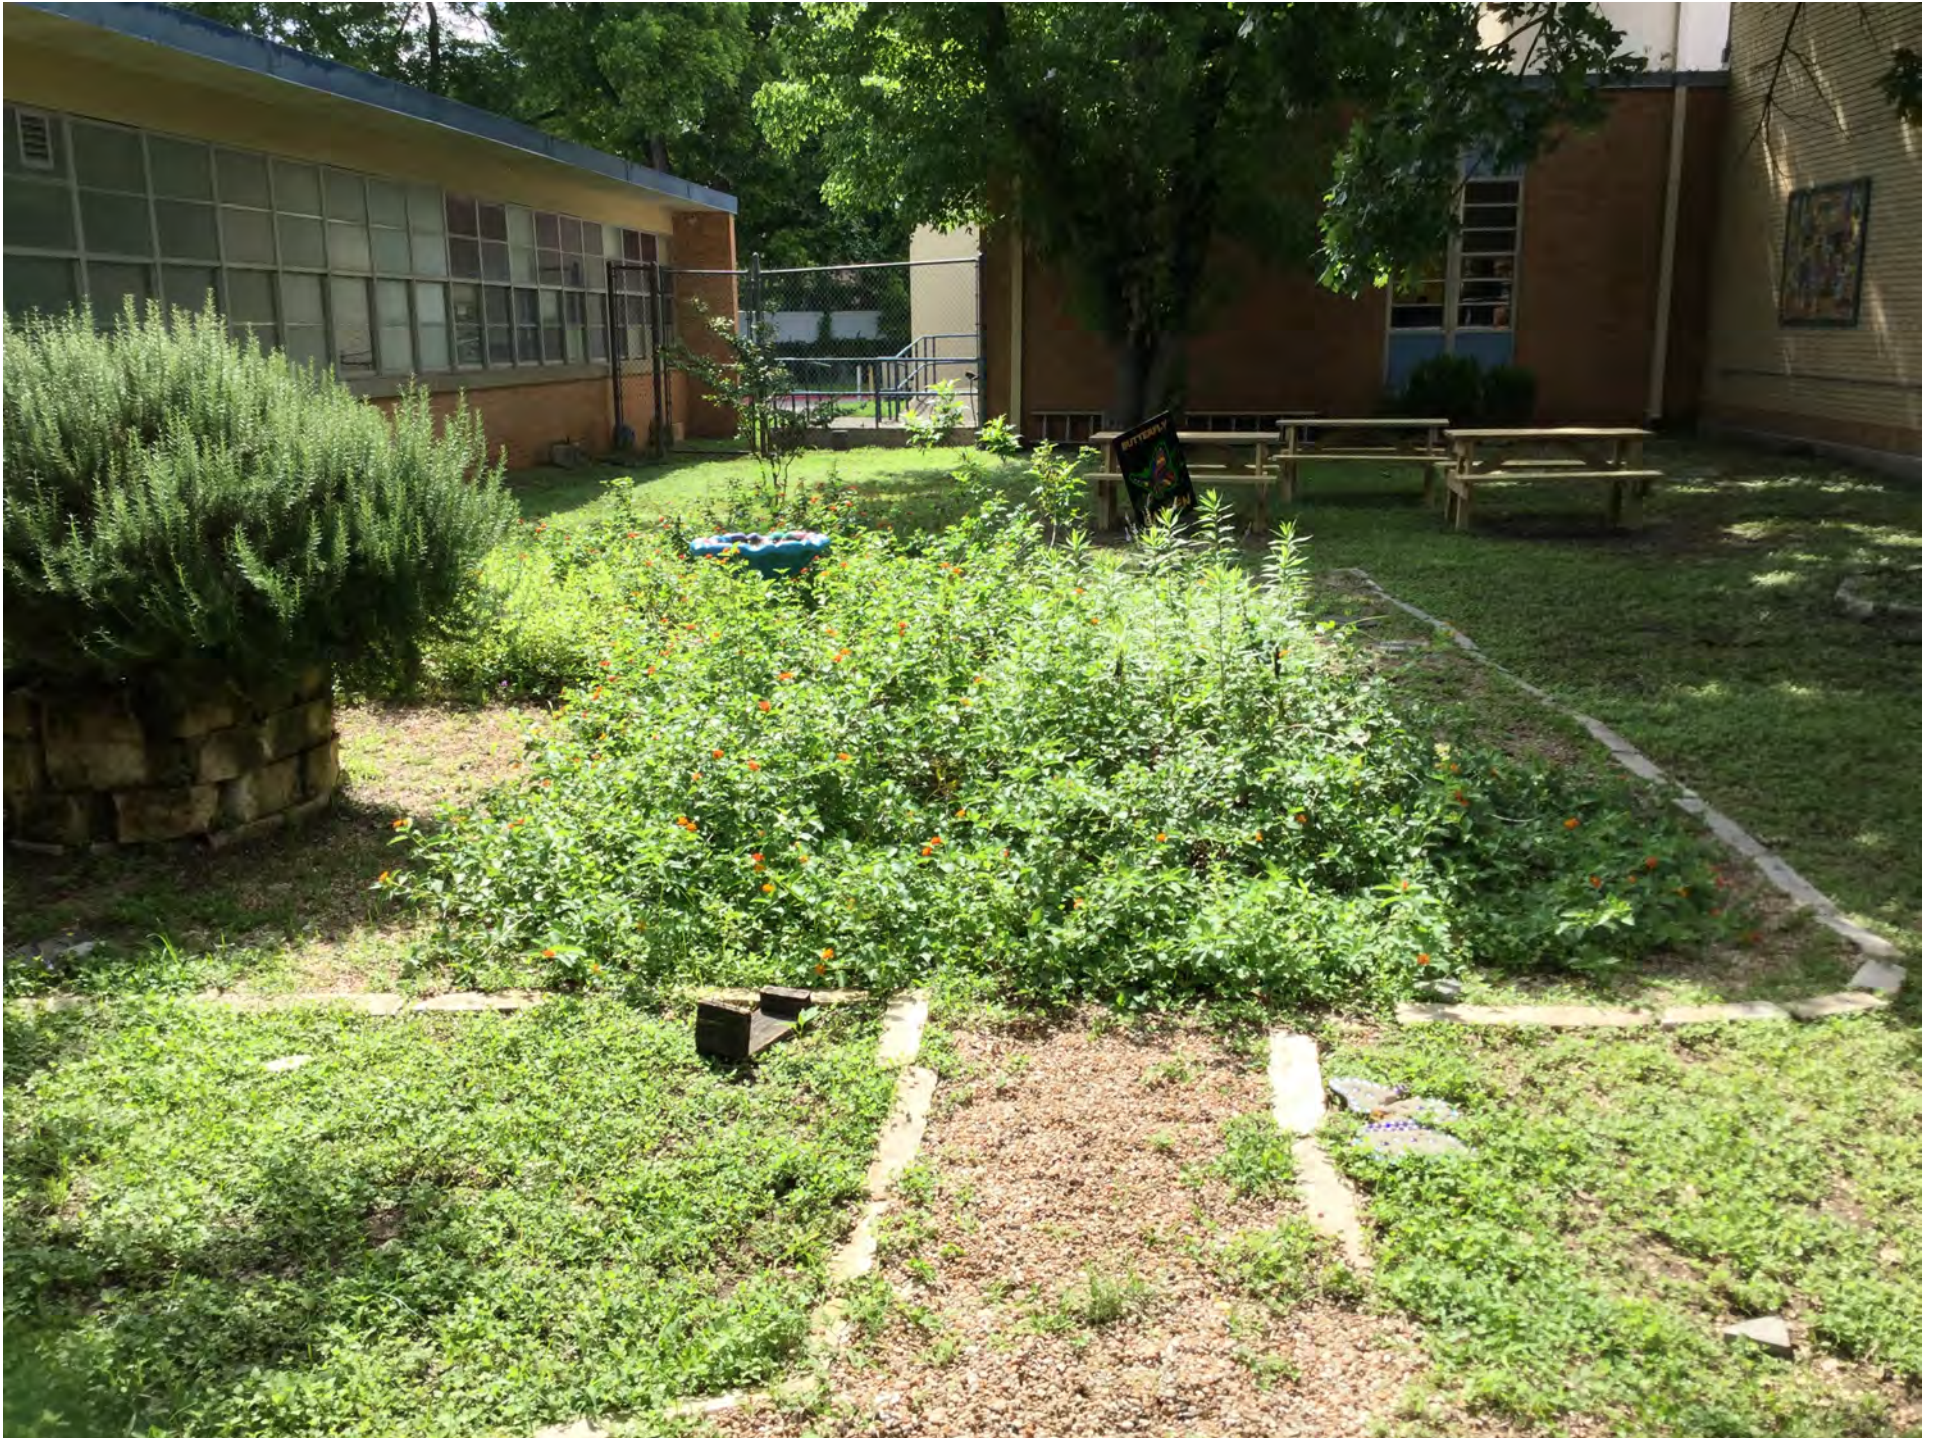
Photo 1. Garden 1

1.2	Are opportunities provided for outdoor learning (outdoor classrooms, gardens, etc.)?		2					Comments	1.00 2.00
	<p>1) Outdoor space exists is not developed</p> <p>2)Outdoor space for learning exists but not connected to classroom learning areas.</p> <p>3. Outdoor learning spaces exist and are accessible but not in good condition.</p> <p>4. Outdoor learning spaces need minor improvements to function well.</p> <p>5. Outdoor learning spaces are in excellent condition.</p> <p>N/A) Does not apply.</p>							There are some outdoor learning spaces including a butterfly courtyard and a large tree surrounded by a wooden deck. The wood deck needs minor repairs. The grounds are so unkept that these are difficult to use for outdoor learning.	
									See photo 1

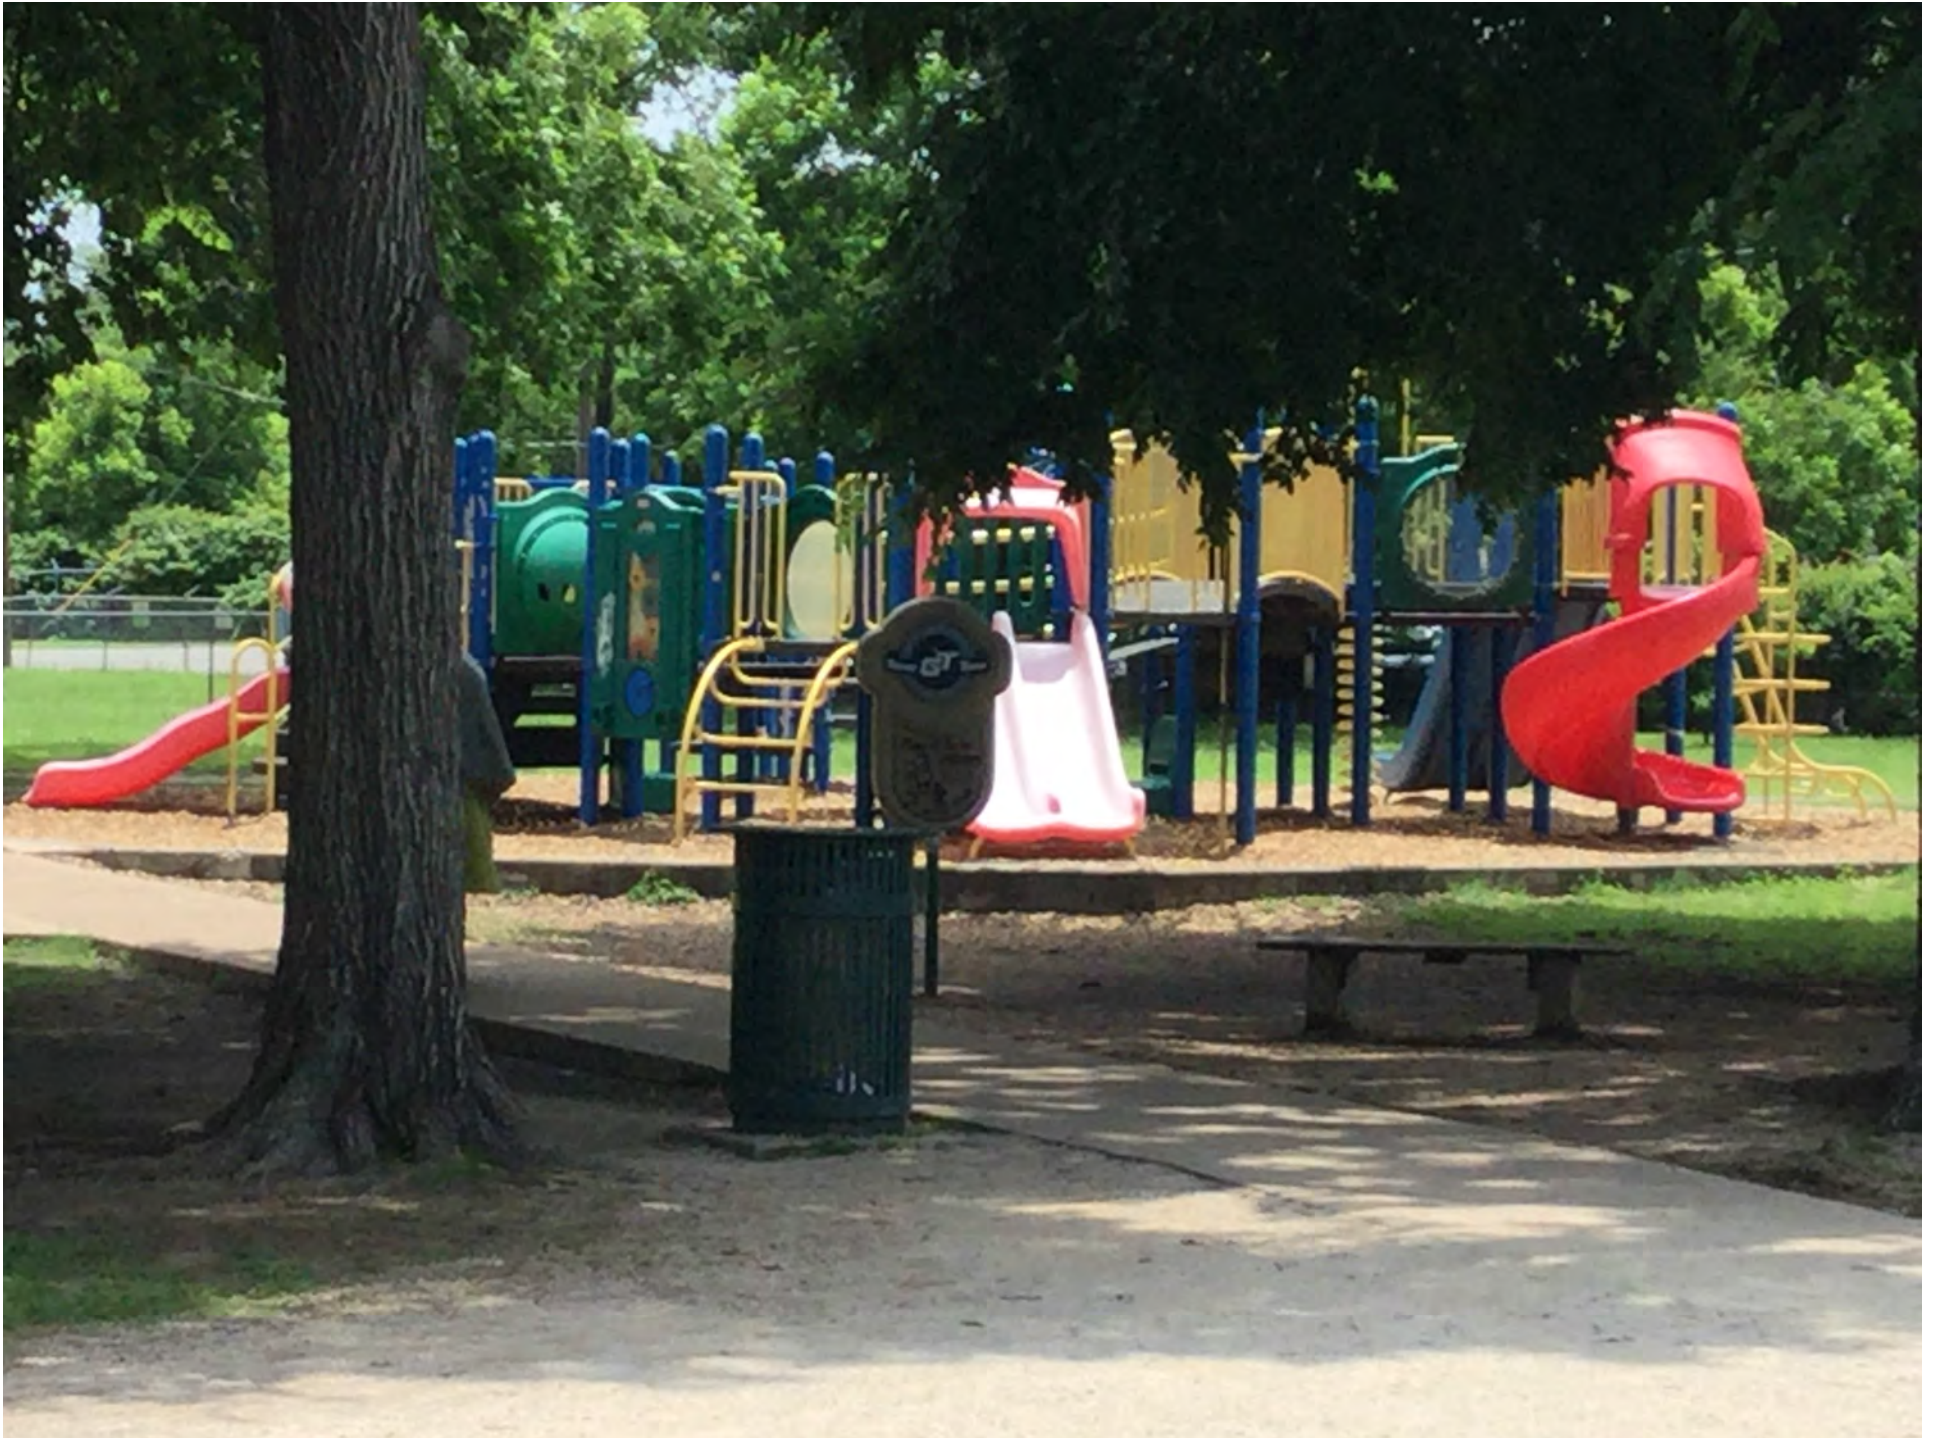
Photo 2. Playground

1.3	Are outdoor play spaces and playfields adequate in size and configuration?				4			Comments	1.00 4.00
	<p>1) Outdoor play space exists, not developed</p> <p>2)Outdoor play space exists but is not connected to gym or other athletic support areas or is too small.</p> <p>3. Outdoor play spaces exist, are connected to other athletic areas, are the right size, but are not in good condition.</p> <p>4. Outdoor play spaces need minor improvements to function well.</p> <p>5. Outdoor play spaces are in excellent condition.</p> <p>N/A) Does not apply.</p>								
									See photo 2

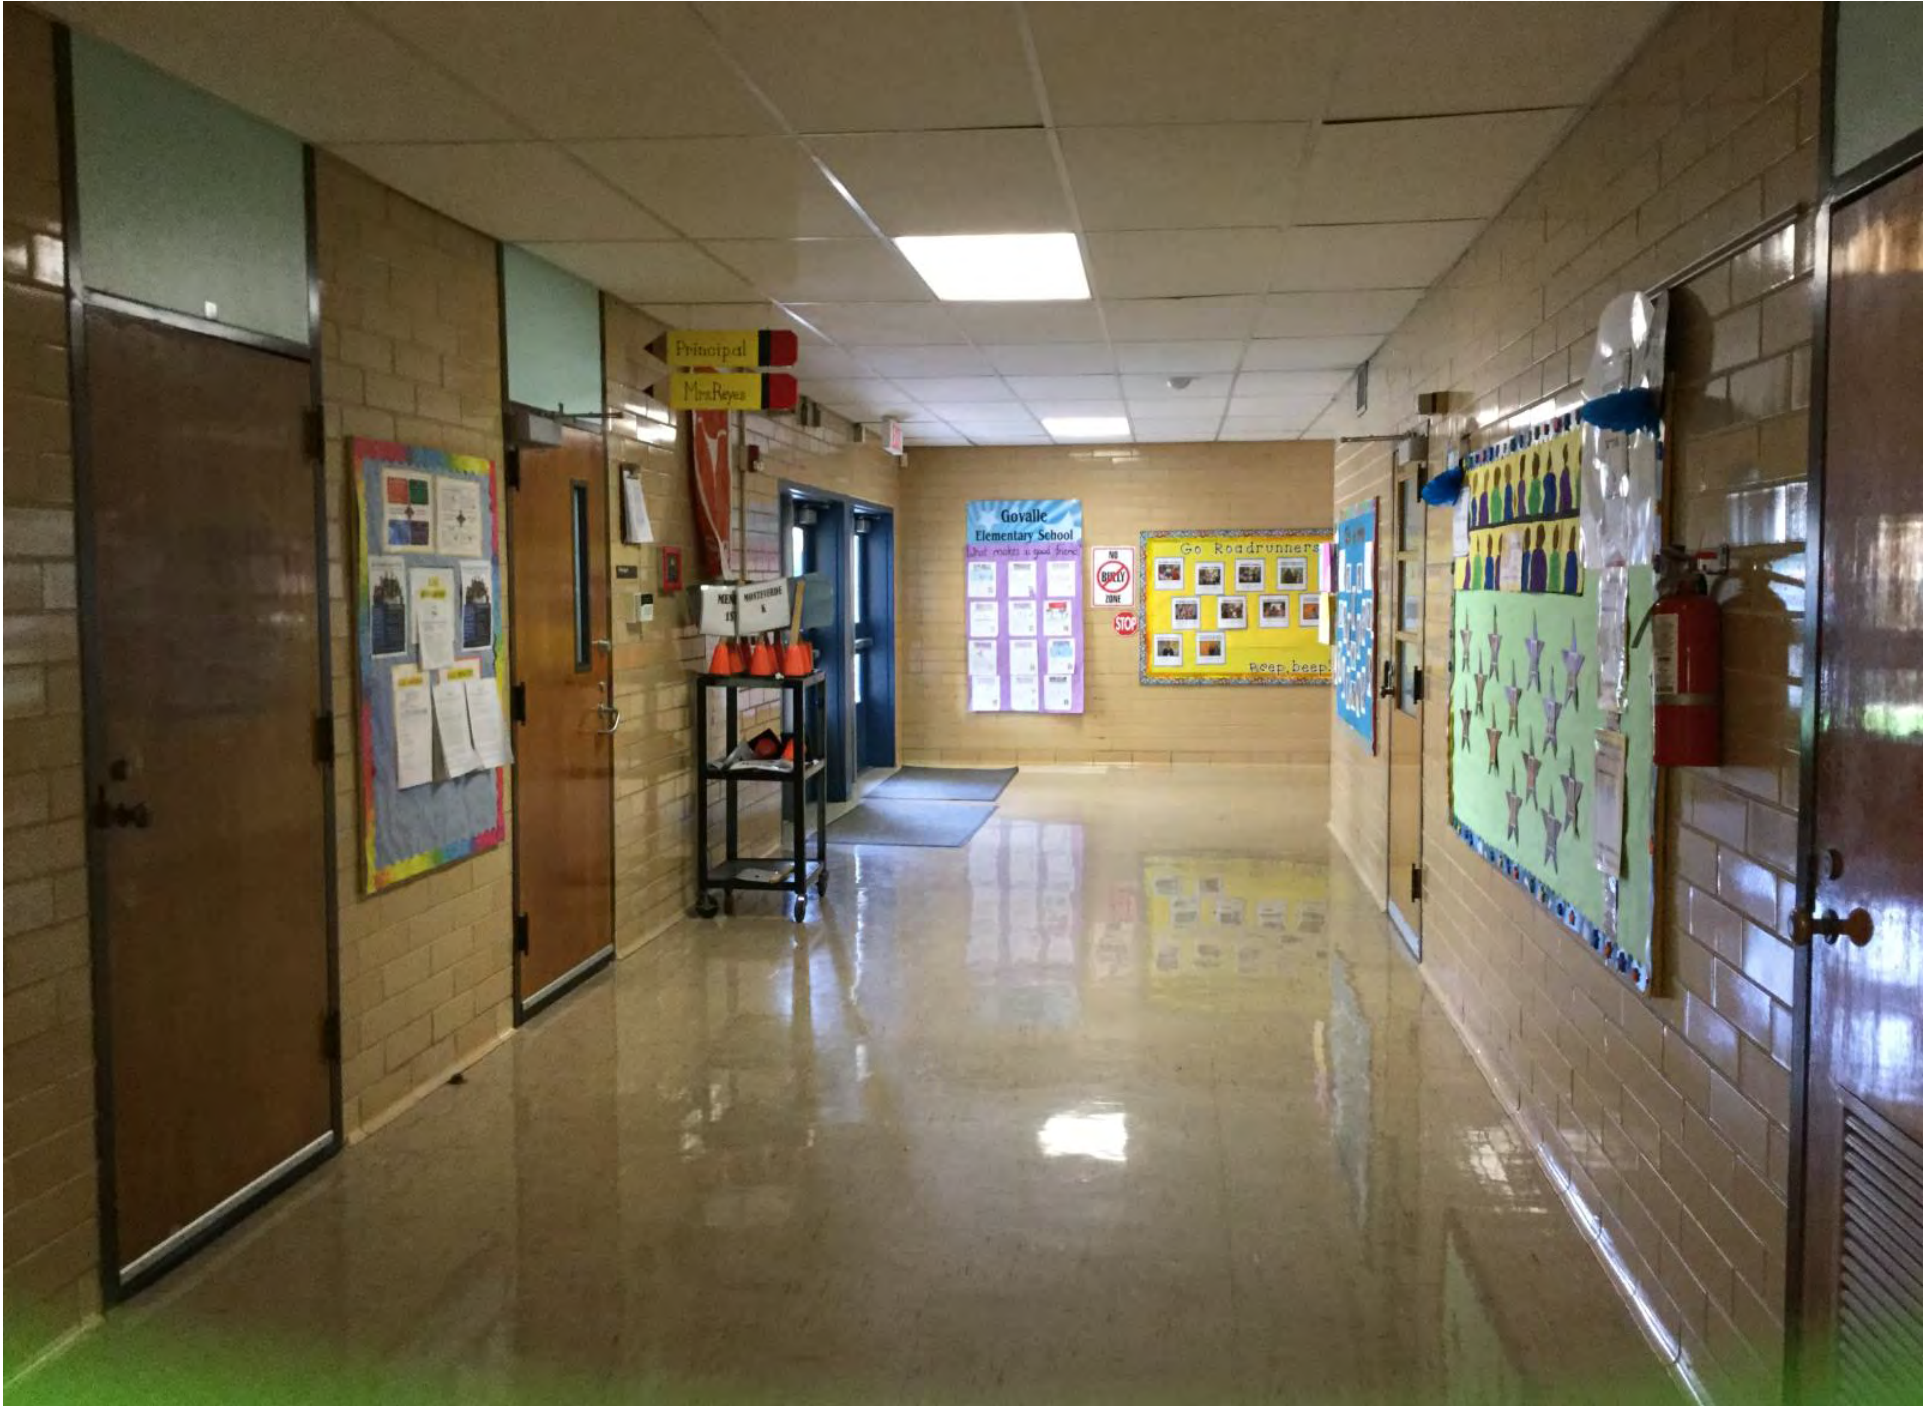
Photo 3. Corridor

1) Primary circulation is 5'-0" to 6'-0" wide. 2) Primary circulation is 6'-0" to 7'-0" wide 3) Primary circulation is 7'-0" to 8'-0" wide 4) Primary circulation is 8'-0"-10'-0" wide 5) Primary circulation is 10'-0"+ wide N/A) Does not apply.							The corridors are 10'-0" wide.	See photo 3

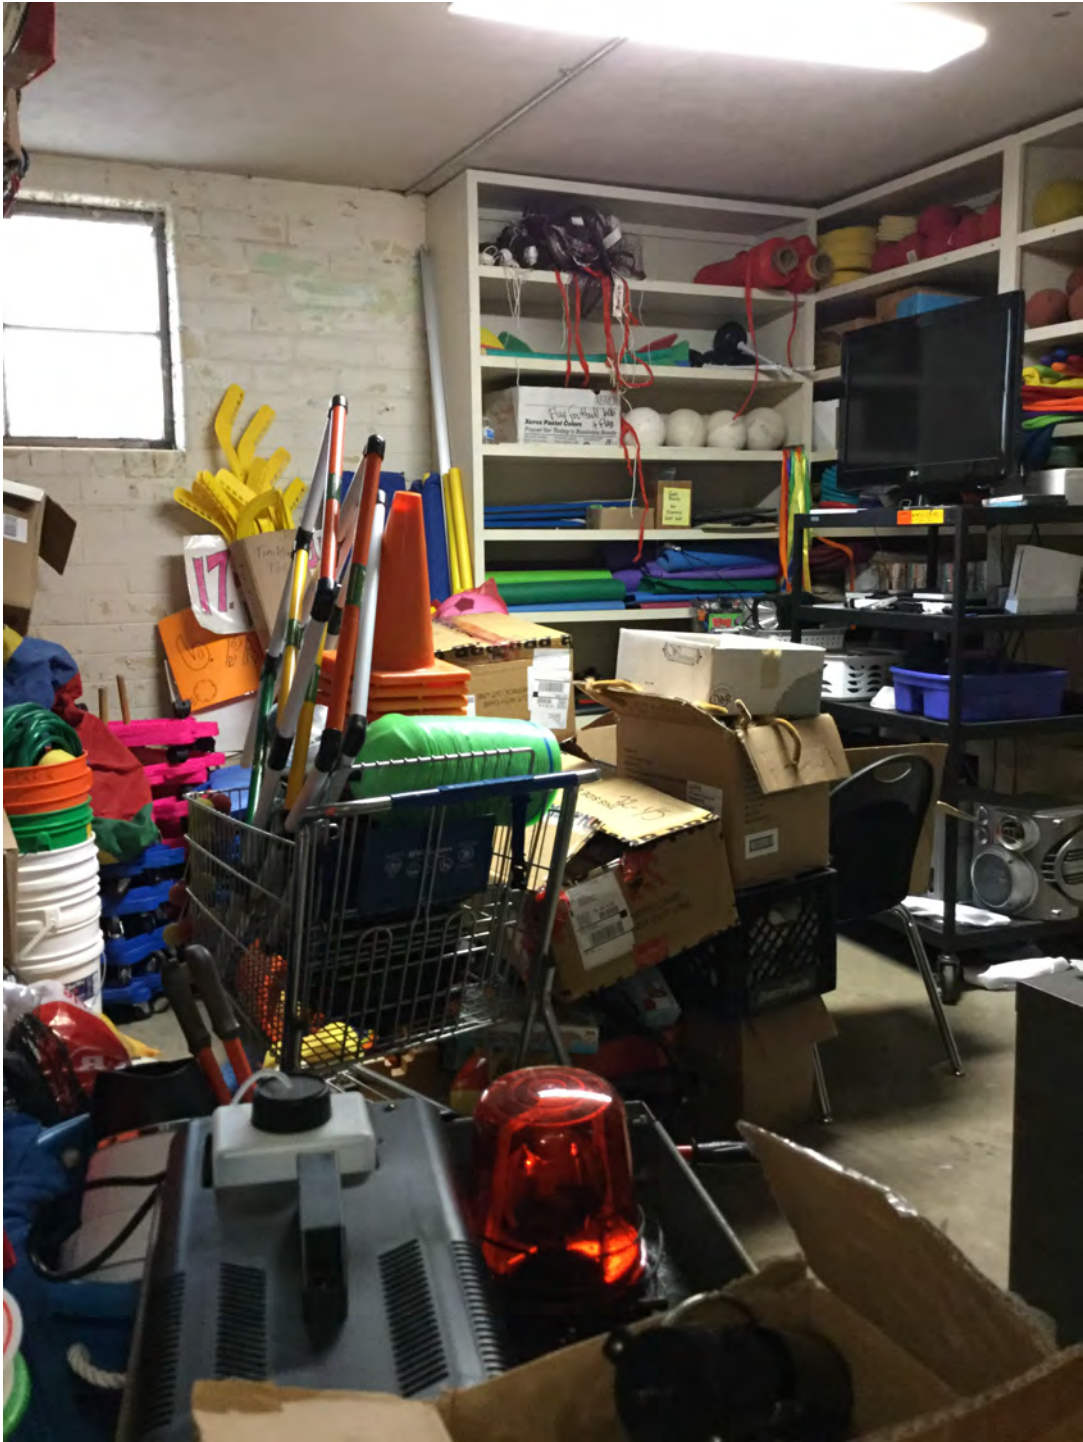
Photo 4. Gym Storage

3.7	Are Physical Education and Athletic <b>support</b> spaces appropriately configured per the ed spec?	1							Comments	1.00	1.00	
1) Very unsatisfactory - Support spaces are disconnected from served spaces, too small, do not meet needs 2) Unsatisfactory - Support spaces are connected, but too small, inadequate for needs 3) Average - Connected, moderate size, but need some renovations or updates to function well 4) Good - Connected, good size/layout, meets needs/functions well 5) Very good - connected, generous size, nice condition, functions appropriately N/A) Does not apply.									Athletic storage is limited.			
									See photo 4

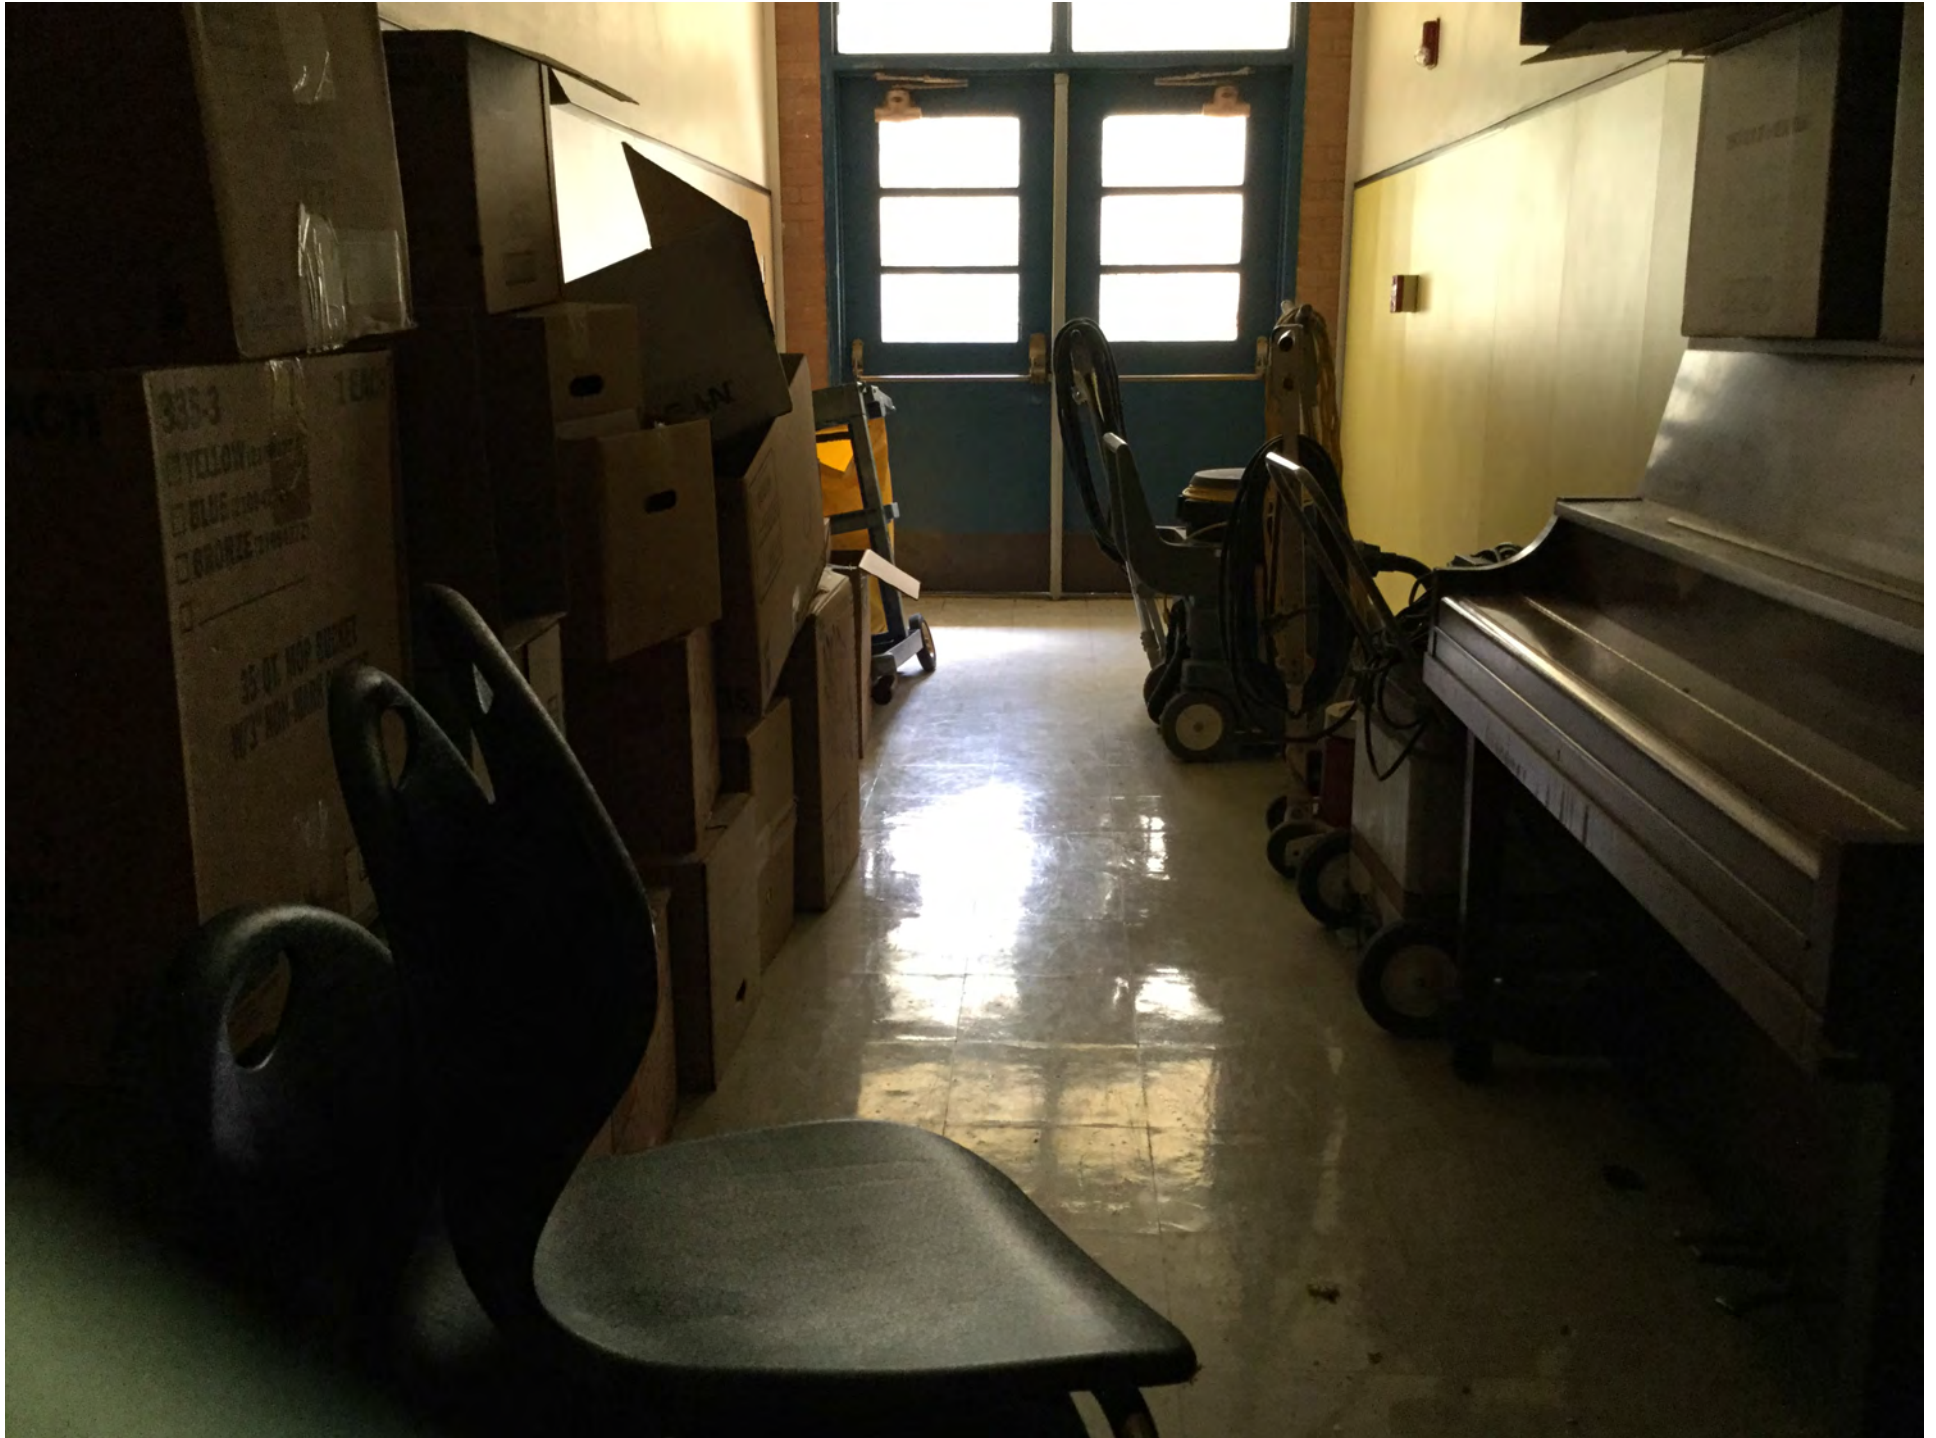
Photo 5. Storage Issues

3.9	Are music, drama, or performance <b>support</b> spaces appropriately configured per the ed spec?		2						Comments	1.00	2.00	
1) Very unsatisfactory - Support spaces are disconnected from served spaces, too small, do not meet needs 2) Unsatisfactory - Support spaces are connected, but too small, inadequate for needs 3) Average - Connected, moderate size, but need some renovations or updates to function well 4) Good - Connected, good size/layout, meets needs/functions well 5) Very good - connected, generous size, nice condition, functions appropriately N/A) Does not apply.									Music and performane storage of material is in the corridor because there is no space.			
									See photo 5

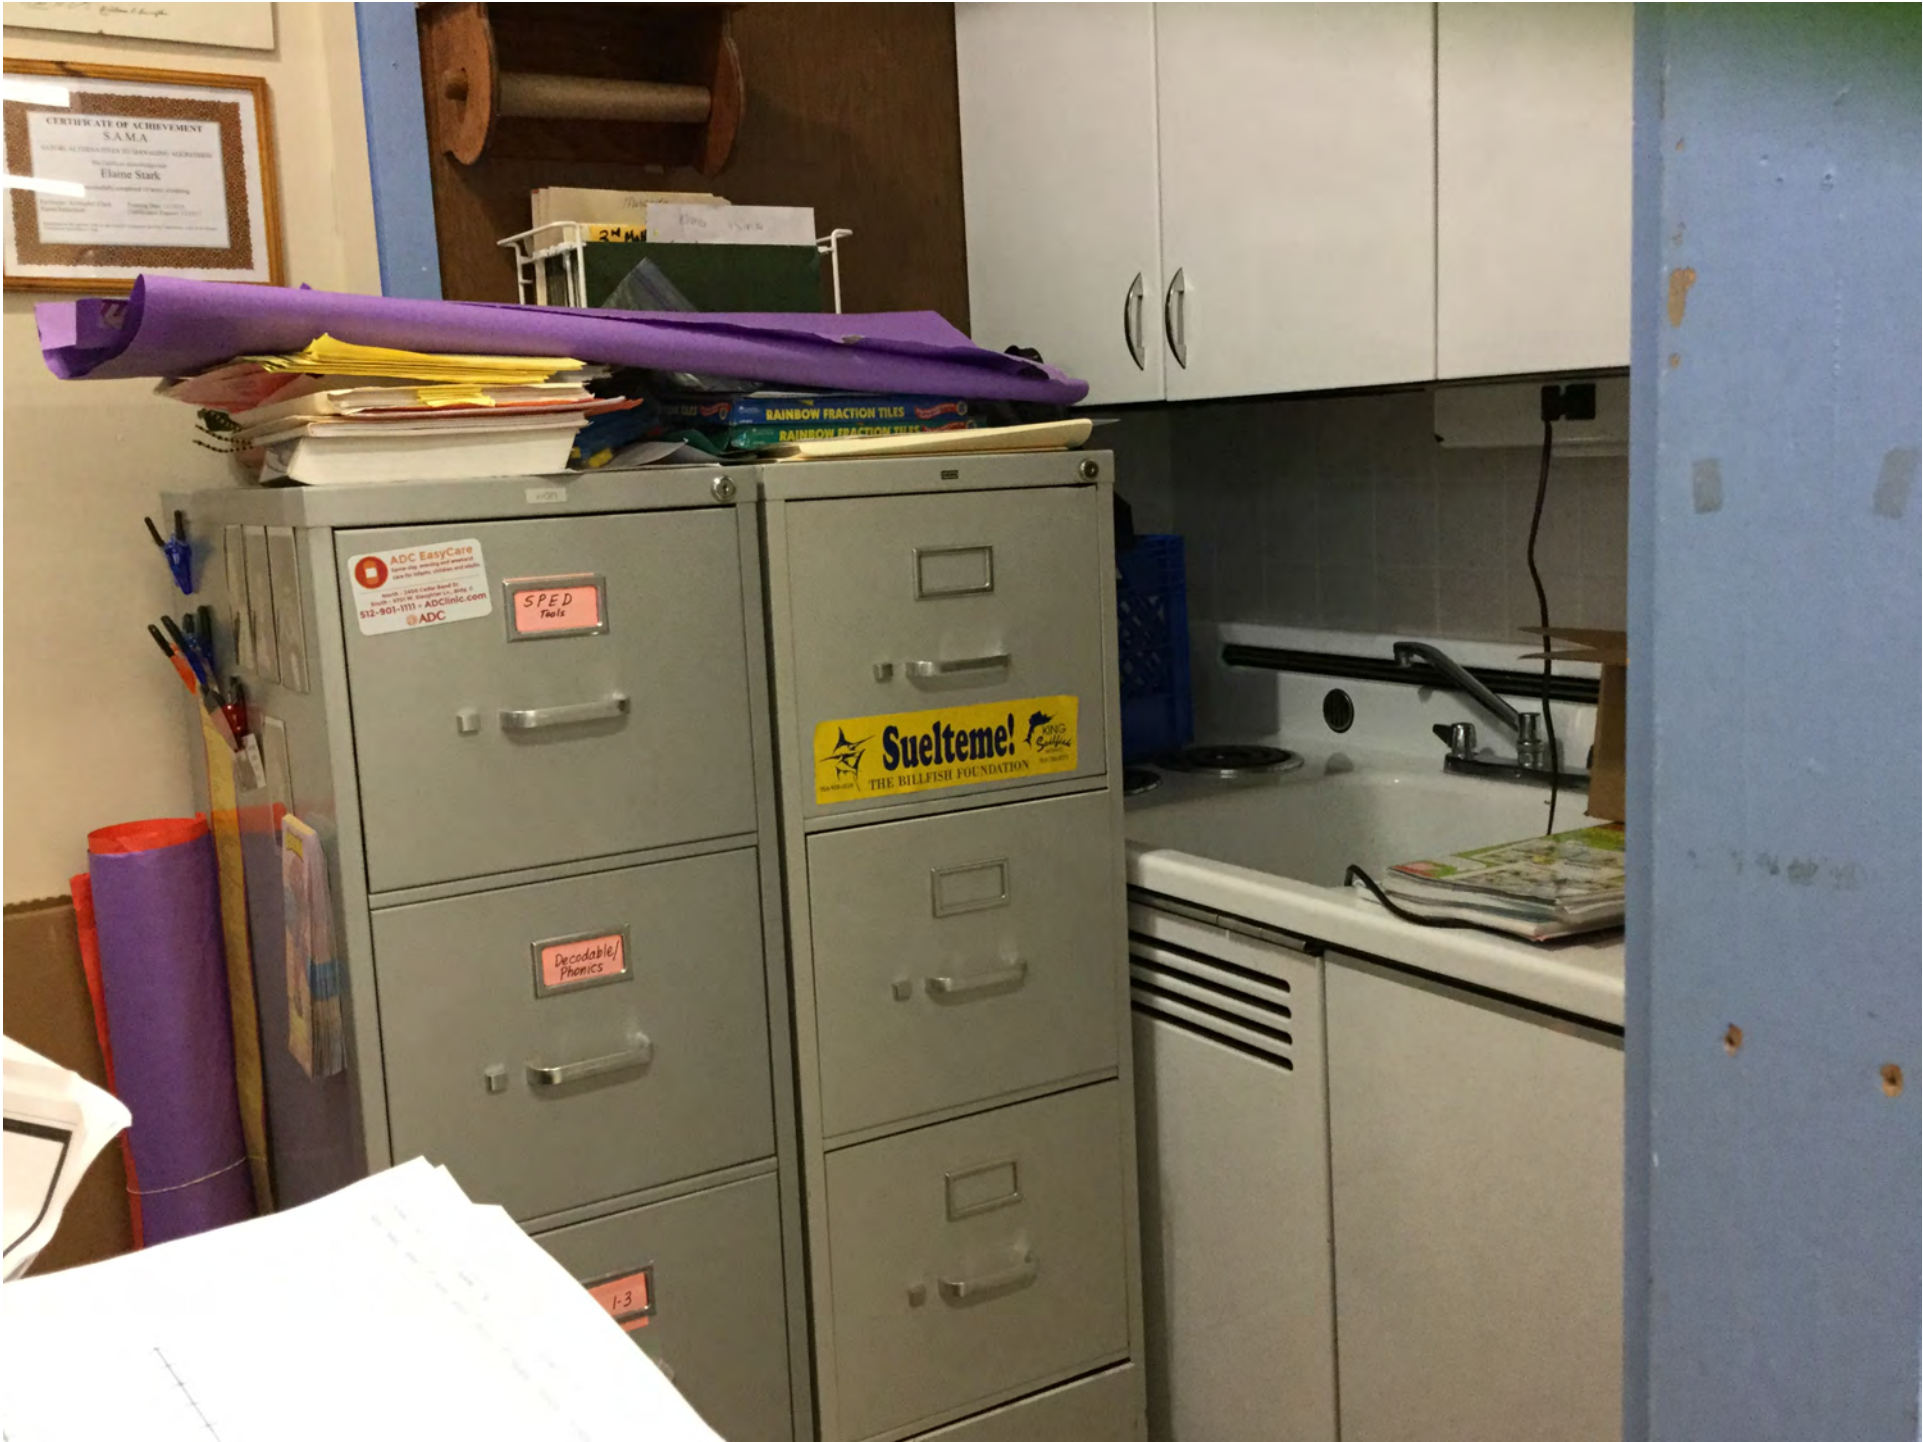
Photo 6. SPED Storage

3.15	Are Special Education <b>support</b> spaces appropriately configured per the ed spec?	1						Comments	1.00 <b>1.00</b>
							1) Very unsatisfactory - Support spaces are disconnected from served spaces, too small, do not meet needs 2) Unsatisfactory - Support spaces are connected, but too small, inadequate for needs 3) Average - Connected, moderate size, but need some renovations or updates to function well 4) Good - Connected, good size/layout, meets needs/functions well 5) Very good - connected, generous size, nice condition, functions appropriately N/A) Does not apply.	There is insufficient storage space for teaching materials so they are all piled up in the kitchen area. This condition is making the kitchen area unusable. <i>SPED Dept Comments: SBS has restrooms in the classroom, not wheelchair accessible. PPCD in portable/not wheelchair accessible.</i>	
							<b>See photo 6</b>

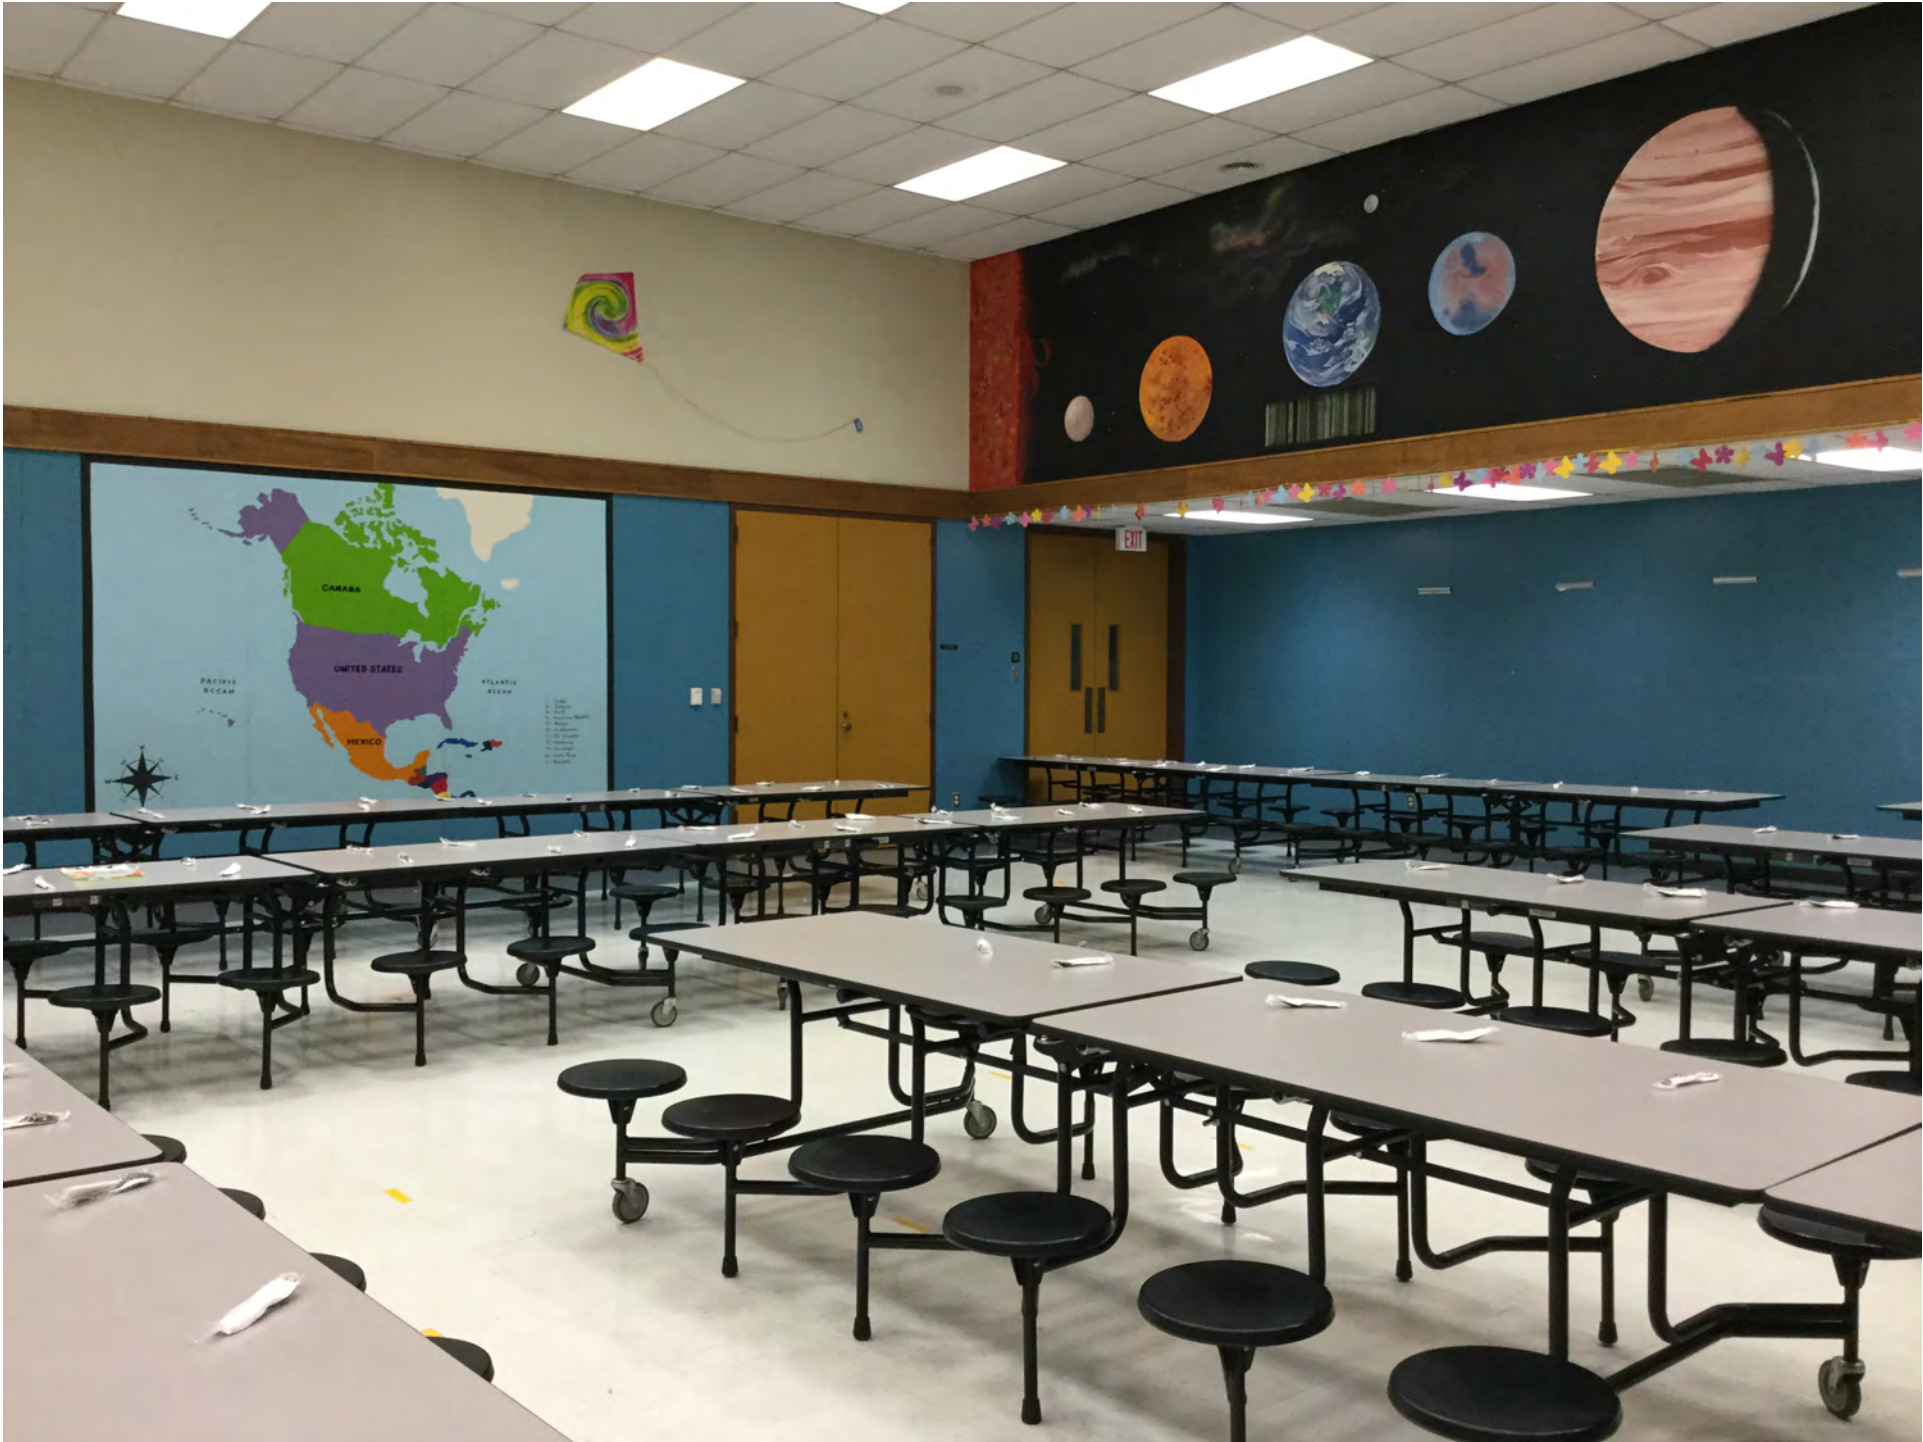
Photo 7. Cafeteria

3.16	Are the student dining facilities appropriately configured?			3				Comments	1.00 <b>3.00</b>
							1) Very unsatisfactory - Too small, poor circulation, inflexible seating in poor condition 2) Unsatisfactory - Too small or inadequate circulation, seating in poor condition 3) Average - moderate size, with adequate circulation, seating in okay condition 4) Good - good size, adequate circulation, seating in good condition 5) Very good - good size, adequate circulation, seating in good condition, with more than one option for eating space (ex: connection to outdoor eating space) N/A) Does not apply.		
							<b>See photo 7</b>

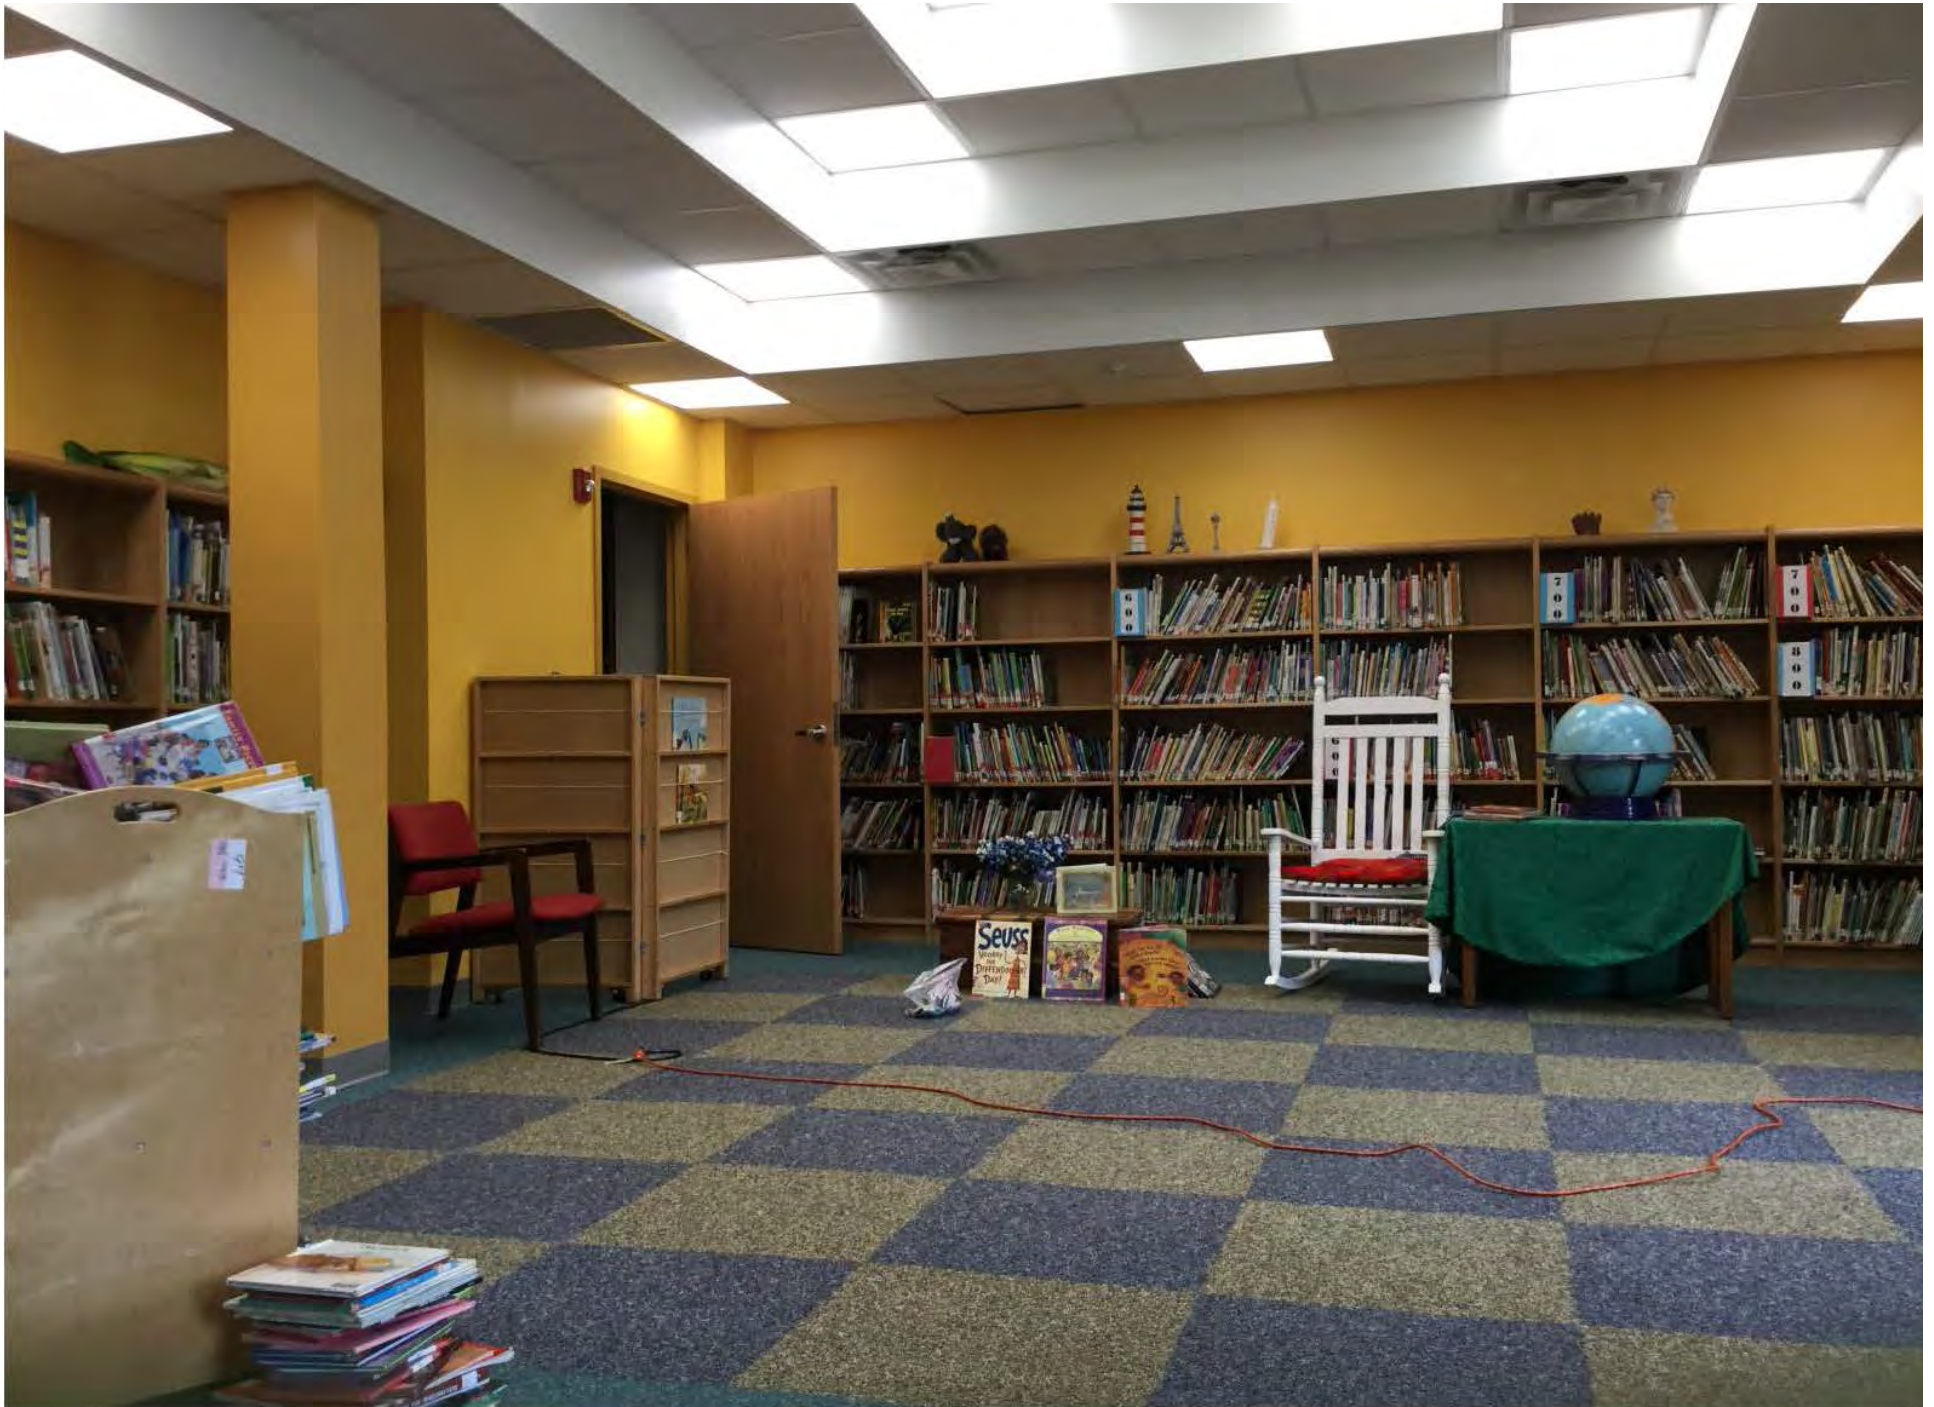
Photo 8. Library

1) Very unsatisfactory 2) Unsatisfactory 3) Average 4) Good 5) Very good N/A) Does not apply.							The library has a good space for larger collaborative groups.		
							See photo 8
