## Educational Suitability Summary Report

Govalle Elementary School – BLDG # 116

Date: 05/17/2016 (Rev 1 – 12/20/16 – CAC Comments)

Score 42% Unsatisfactory

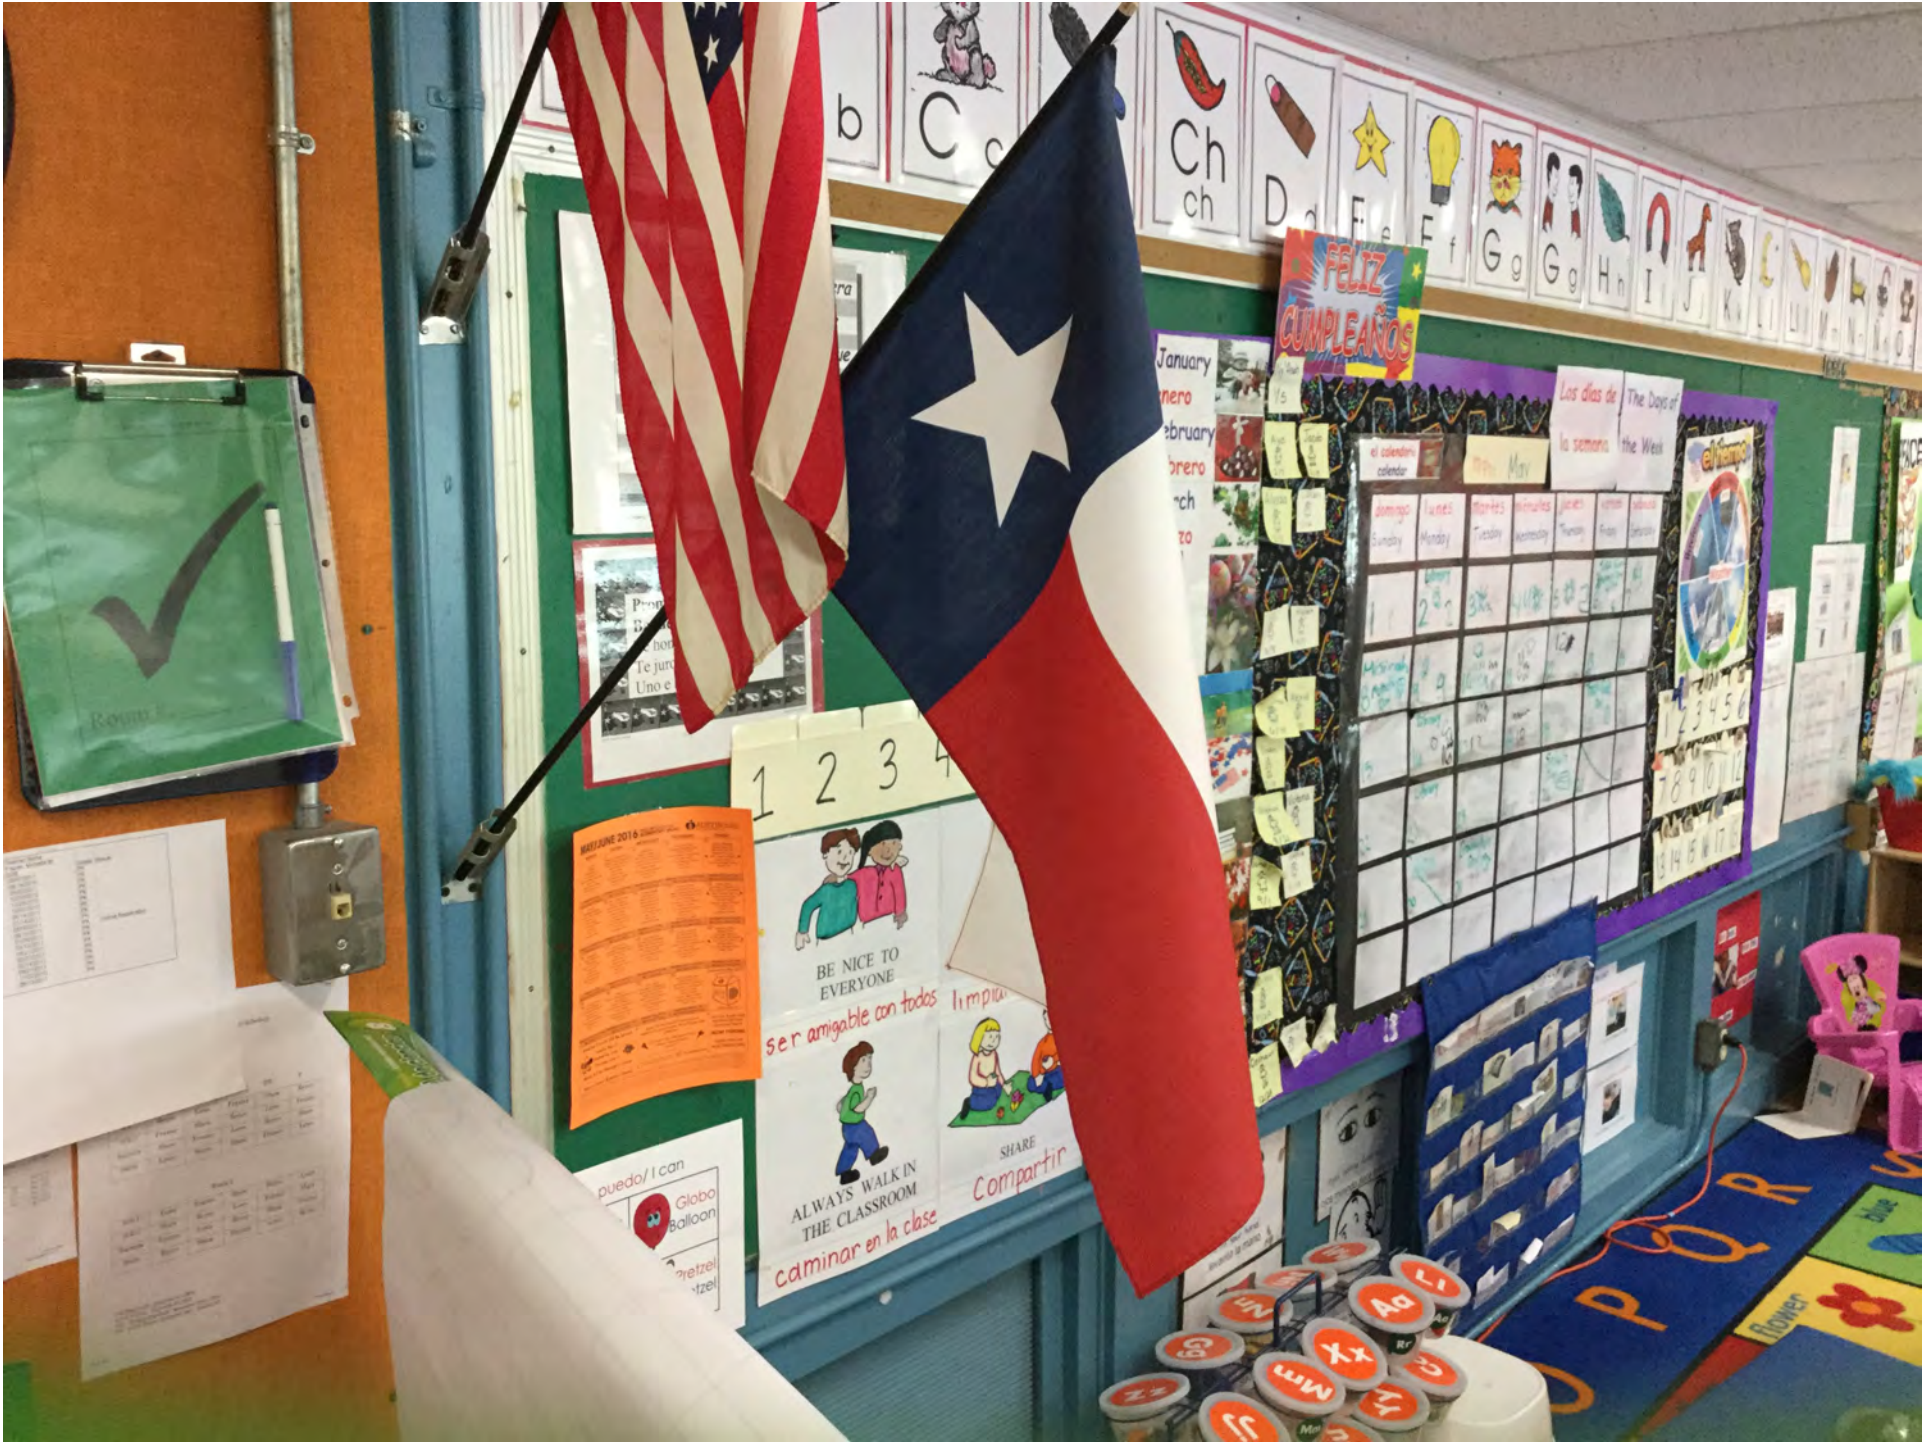
Photo 9. Power Outlets

7.2	Is there an adequate number of power and data outlets in learning spaces?	1						Comments	1.00 1.00
<div>1) Very unsatisfactory - none</div> <div>2) Unsatisfactory - only for teacher</div> <div>3) Average - for teacher and 1-2 students</div> <div>4) Good - 2-3 outlets per wall</div> <div>5) Very good - 3-4 per wall</div> <div>N/A) Does not apply.</div>								Extension cords are being used due to lack of appropriately spaced outlets.	
								See photo 9

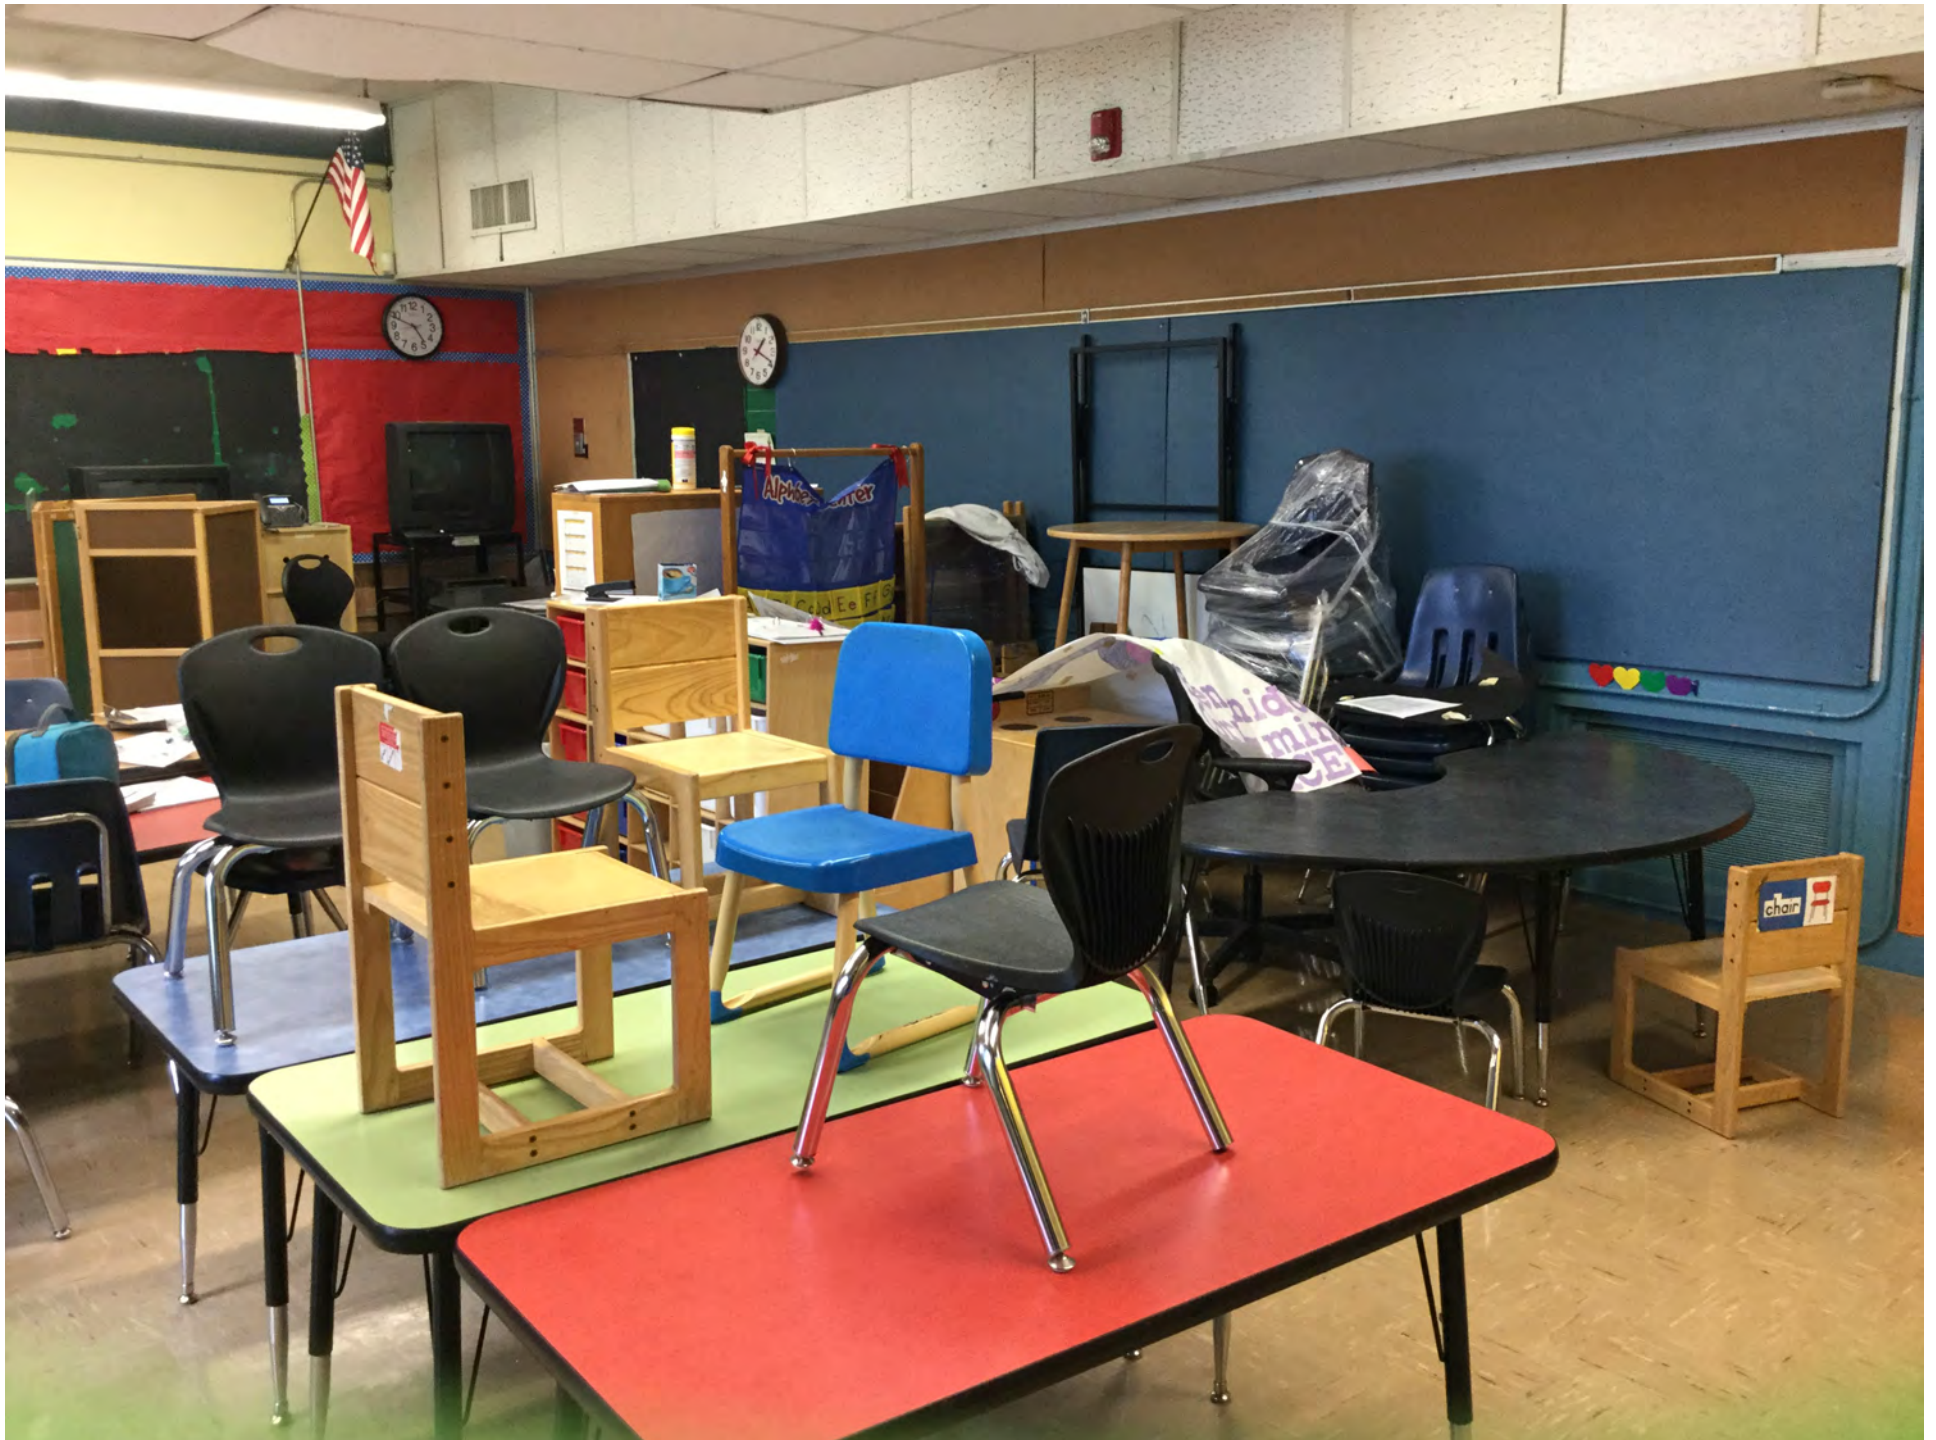
Photo 10. Mentor Space

8 - Storage		1	2	3	4	5	N/A	3.00	
8.1	Is there adequate general storage in the building?	1						Comments	1.00 1.00
1) Very unsatisfactory 2) Unsatisfactory 3) Average 4) Good 5) Very good N/A) Does not apply.								The general storage is limited. The water heater closet is also serving to store excess furniture. One classroom is being used to store furniture and to do tutoring.	
								See photo 10 & 11
