Educational Suitability Summary Report

Graham Elementary School

Date: 07/21/2016

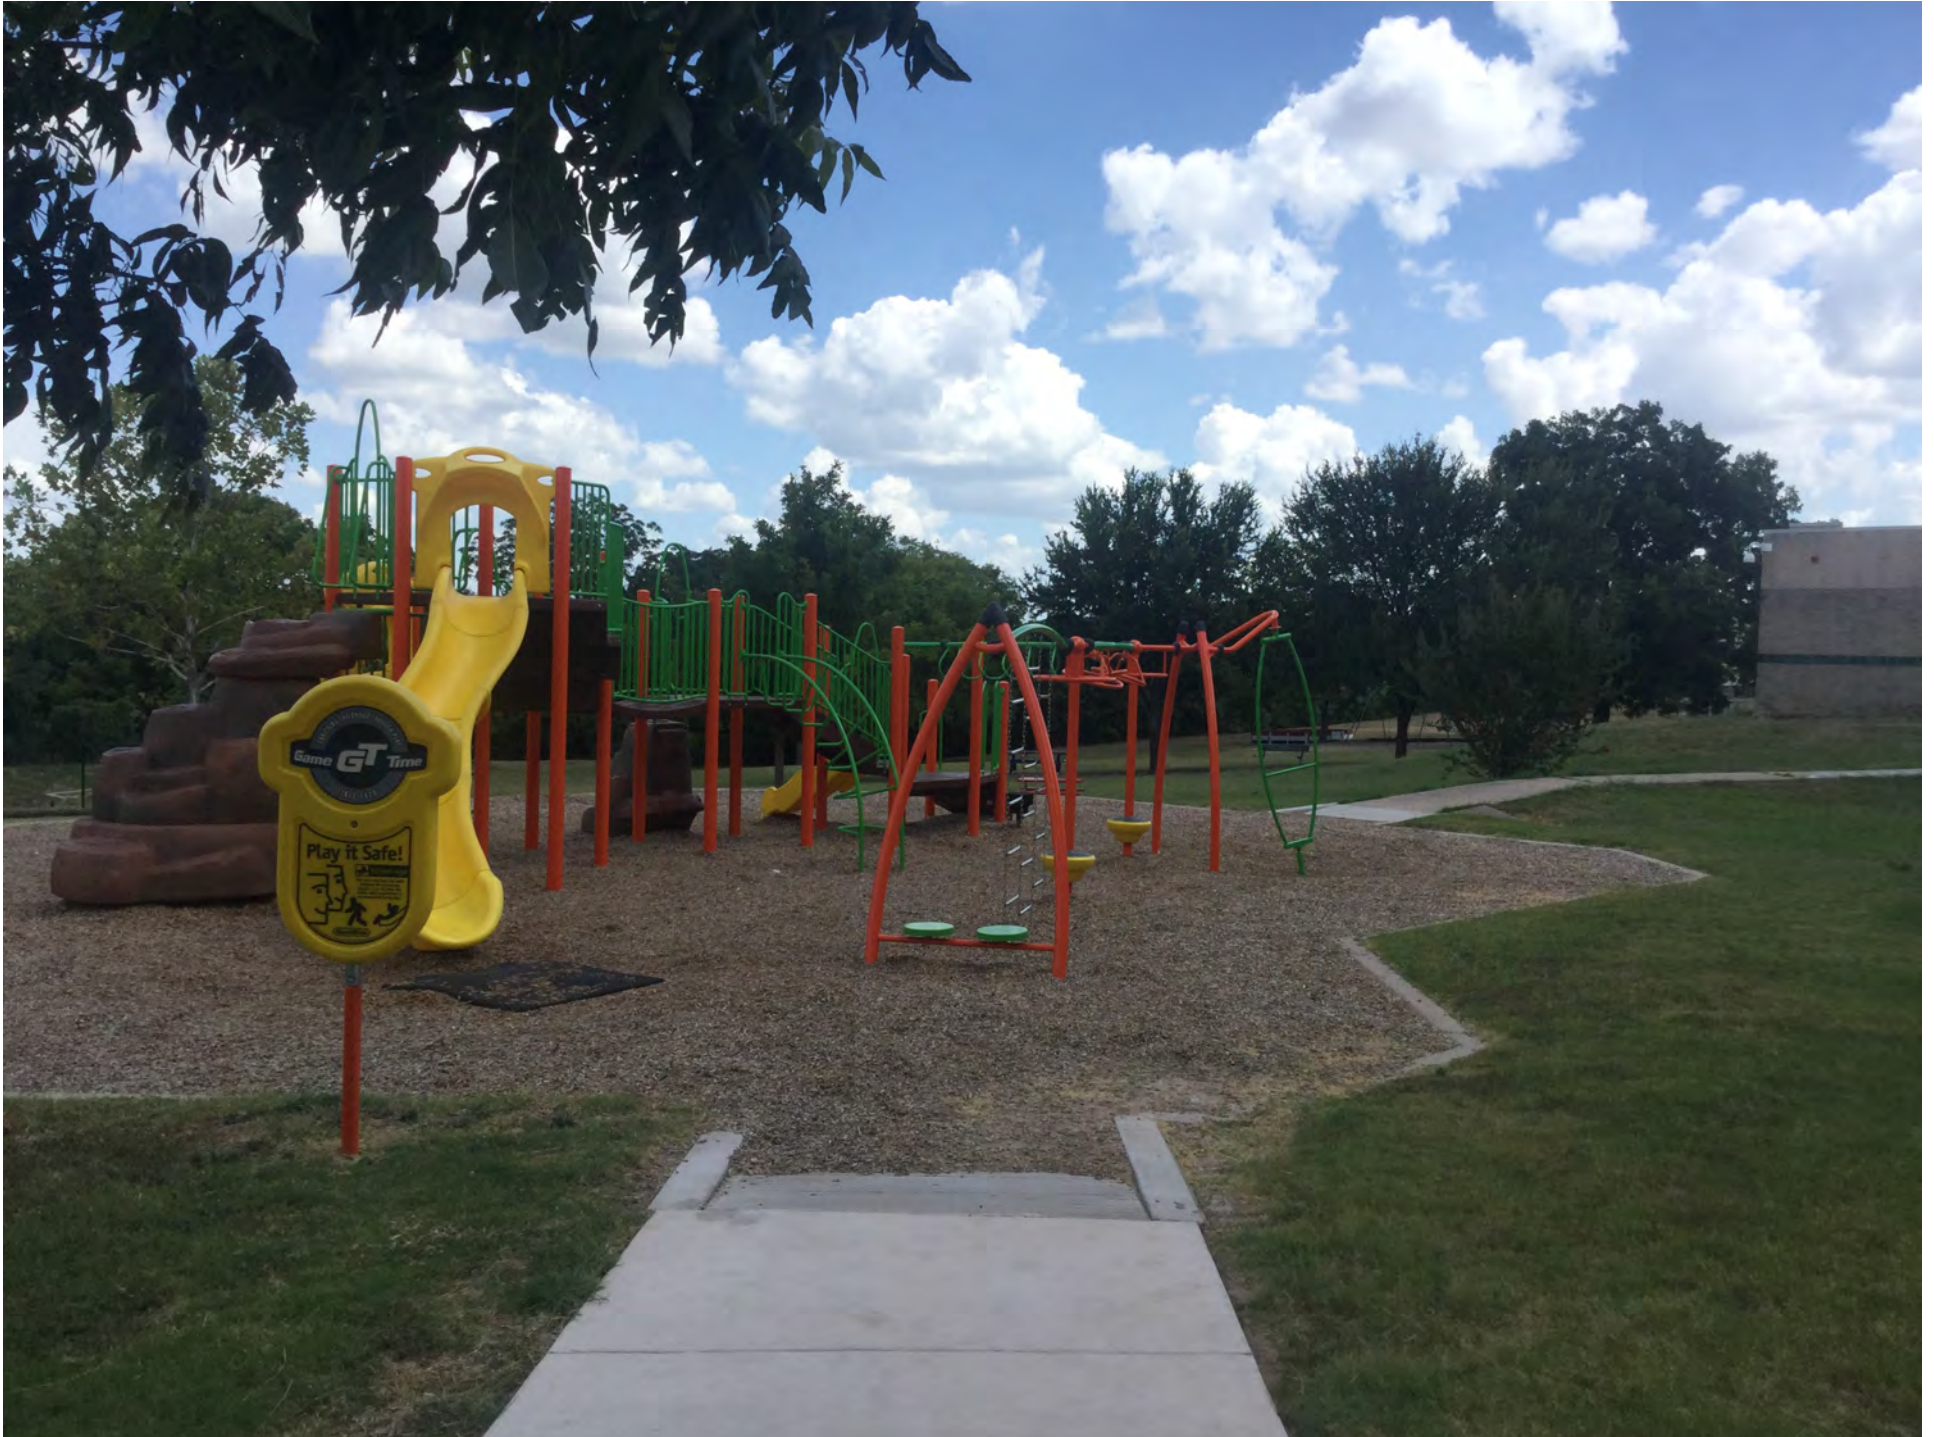
Photo 1.
1.3 Outdoor Playfield

1.3	Are outdoor play spaces and playfields adequate in size and configuration?				4			Comments	1.00 4.00
	1) Outdoor play space exists, not developed 2) Outdoor play space exists but is not connected to gym or other athletic support areas or is too small. 3. Outdoor play spaces exist, are connected to other athletic areas, are the right size, but are not in good condition. 4. Outdoor play spaces need minor improvements to function well. 5. Outdoor play spaces are in excellent condition. N/A) Does not apply.							There is a need for more play space and shade for the large number of students.	
									see photo 1

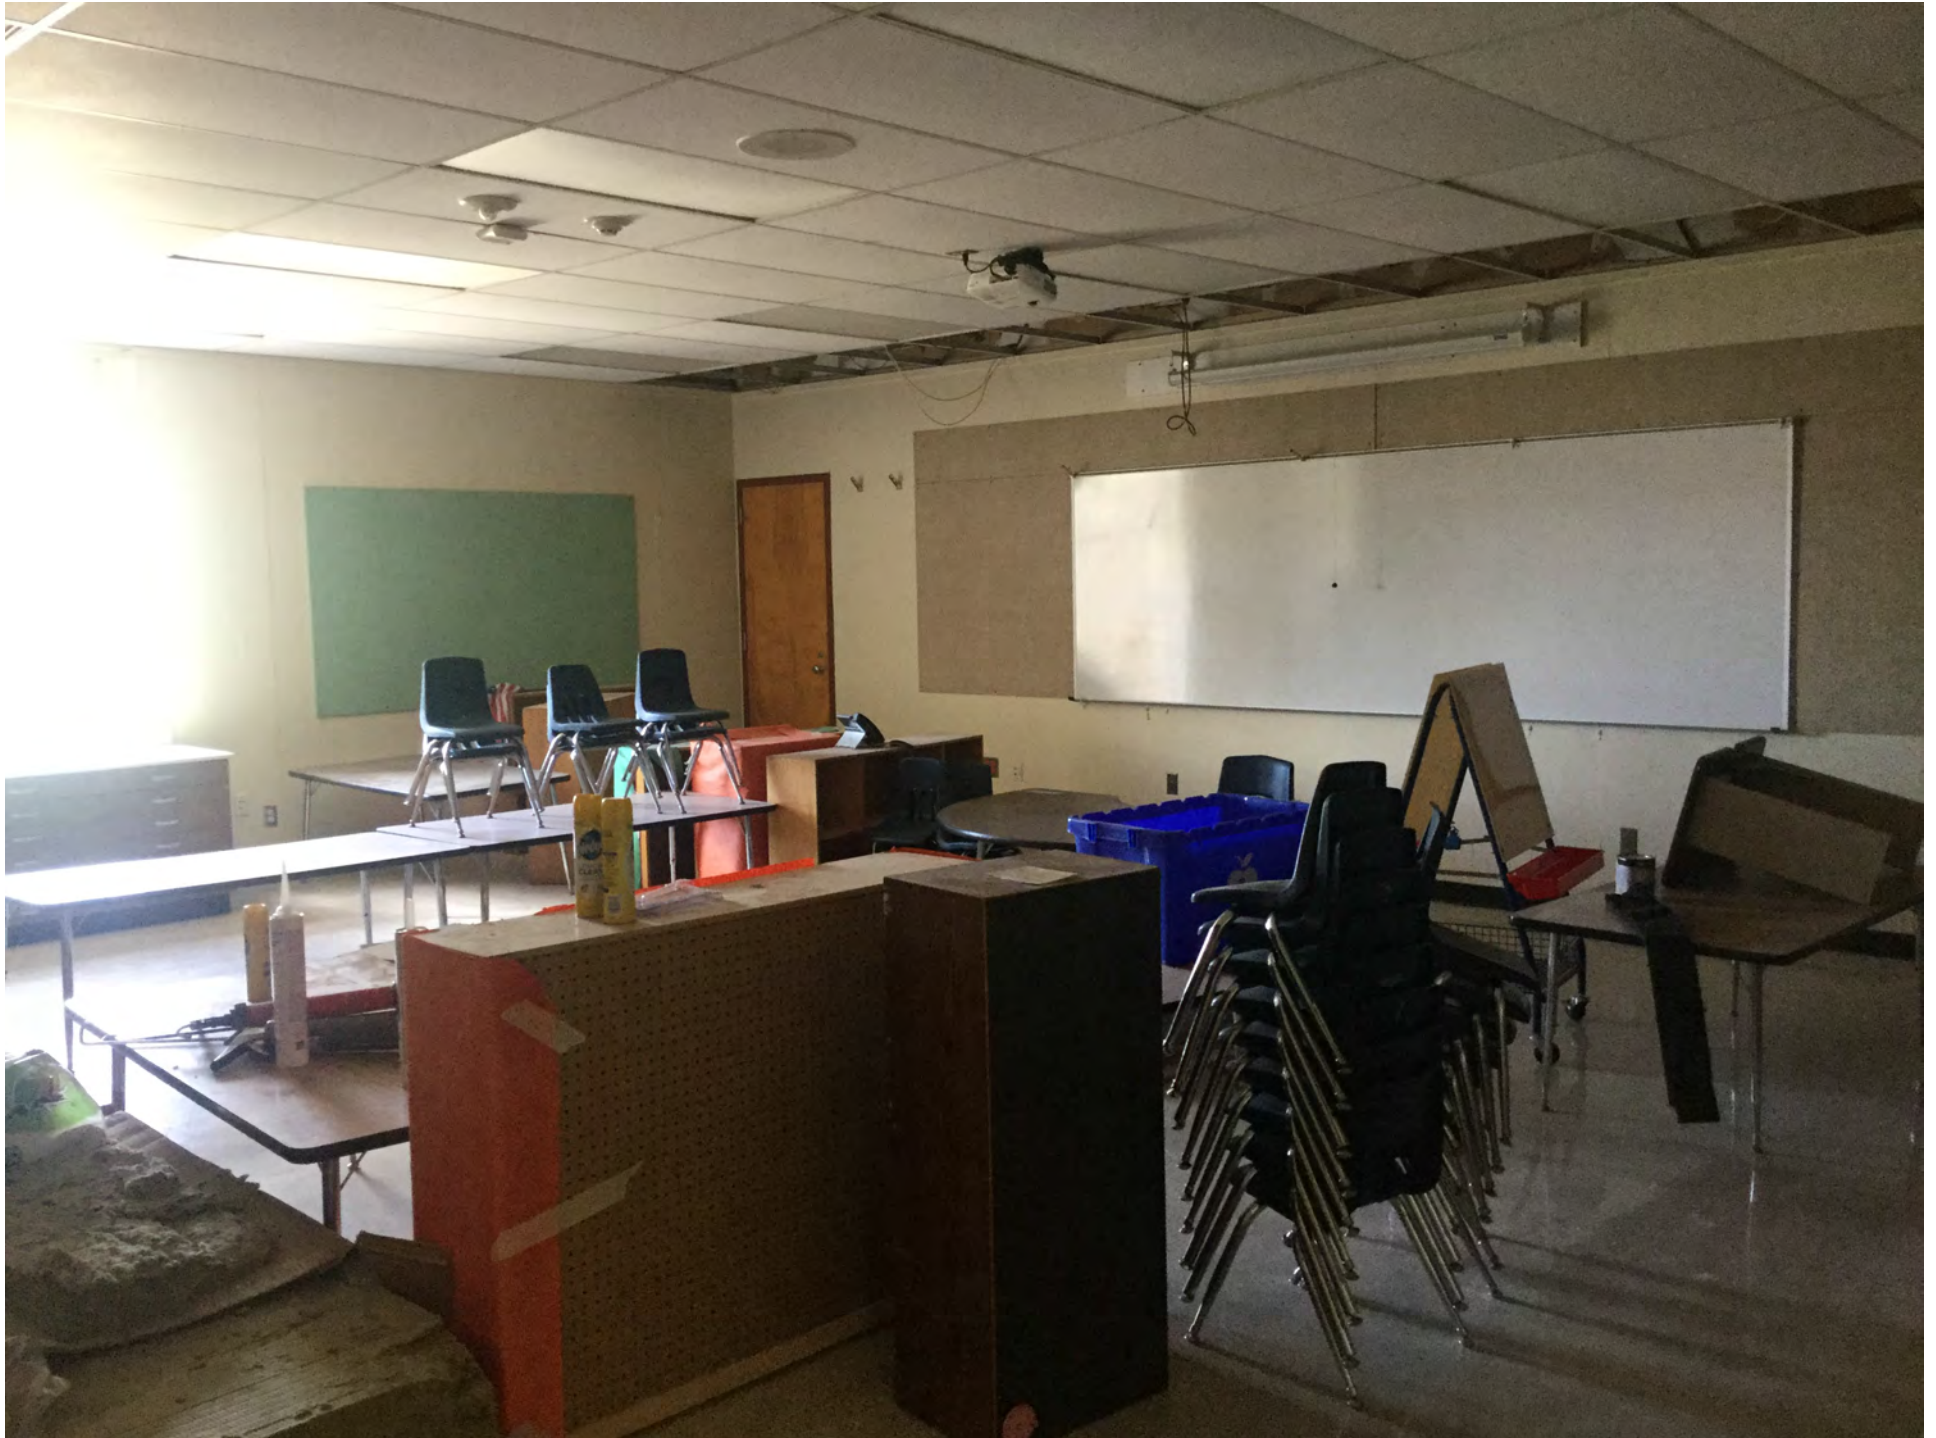
Photo 2.
3.2 Pre-K Space

1) Very unsatisfactory - Too small, awkward layout, does not meet needs 2) Unsatisfactory - Too small, only one area for all teaching methods, limited flexibility 3) Neutral - Moderate size, two areas for different teaching methods, some flexibility, access to student storage/casework 4) Satisfactory - Good size, at least two zones for different teaching methods, flexibility and student storage, not new 5) Very Satisfactory - Good size, two zones for different teaching methods, flexibility and student storage/casework, adequate display area and visual teaching tools N/A) Does not apply.								The classrooms in the main building are outdated.	
									see photo 2

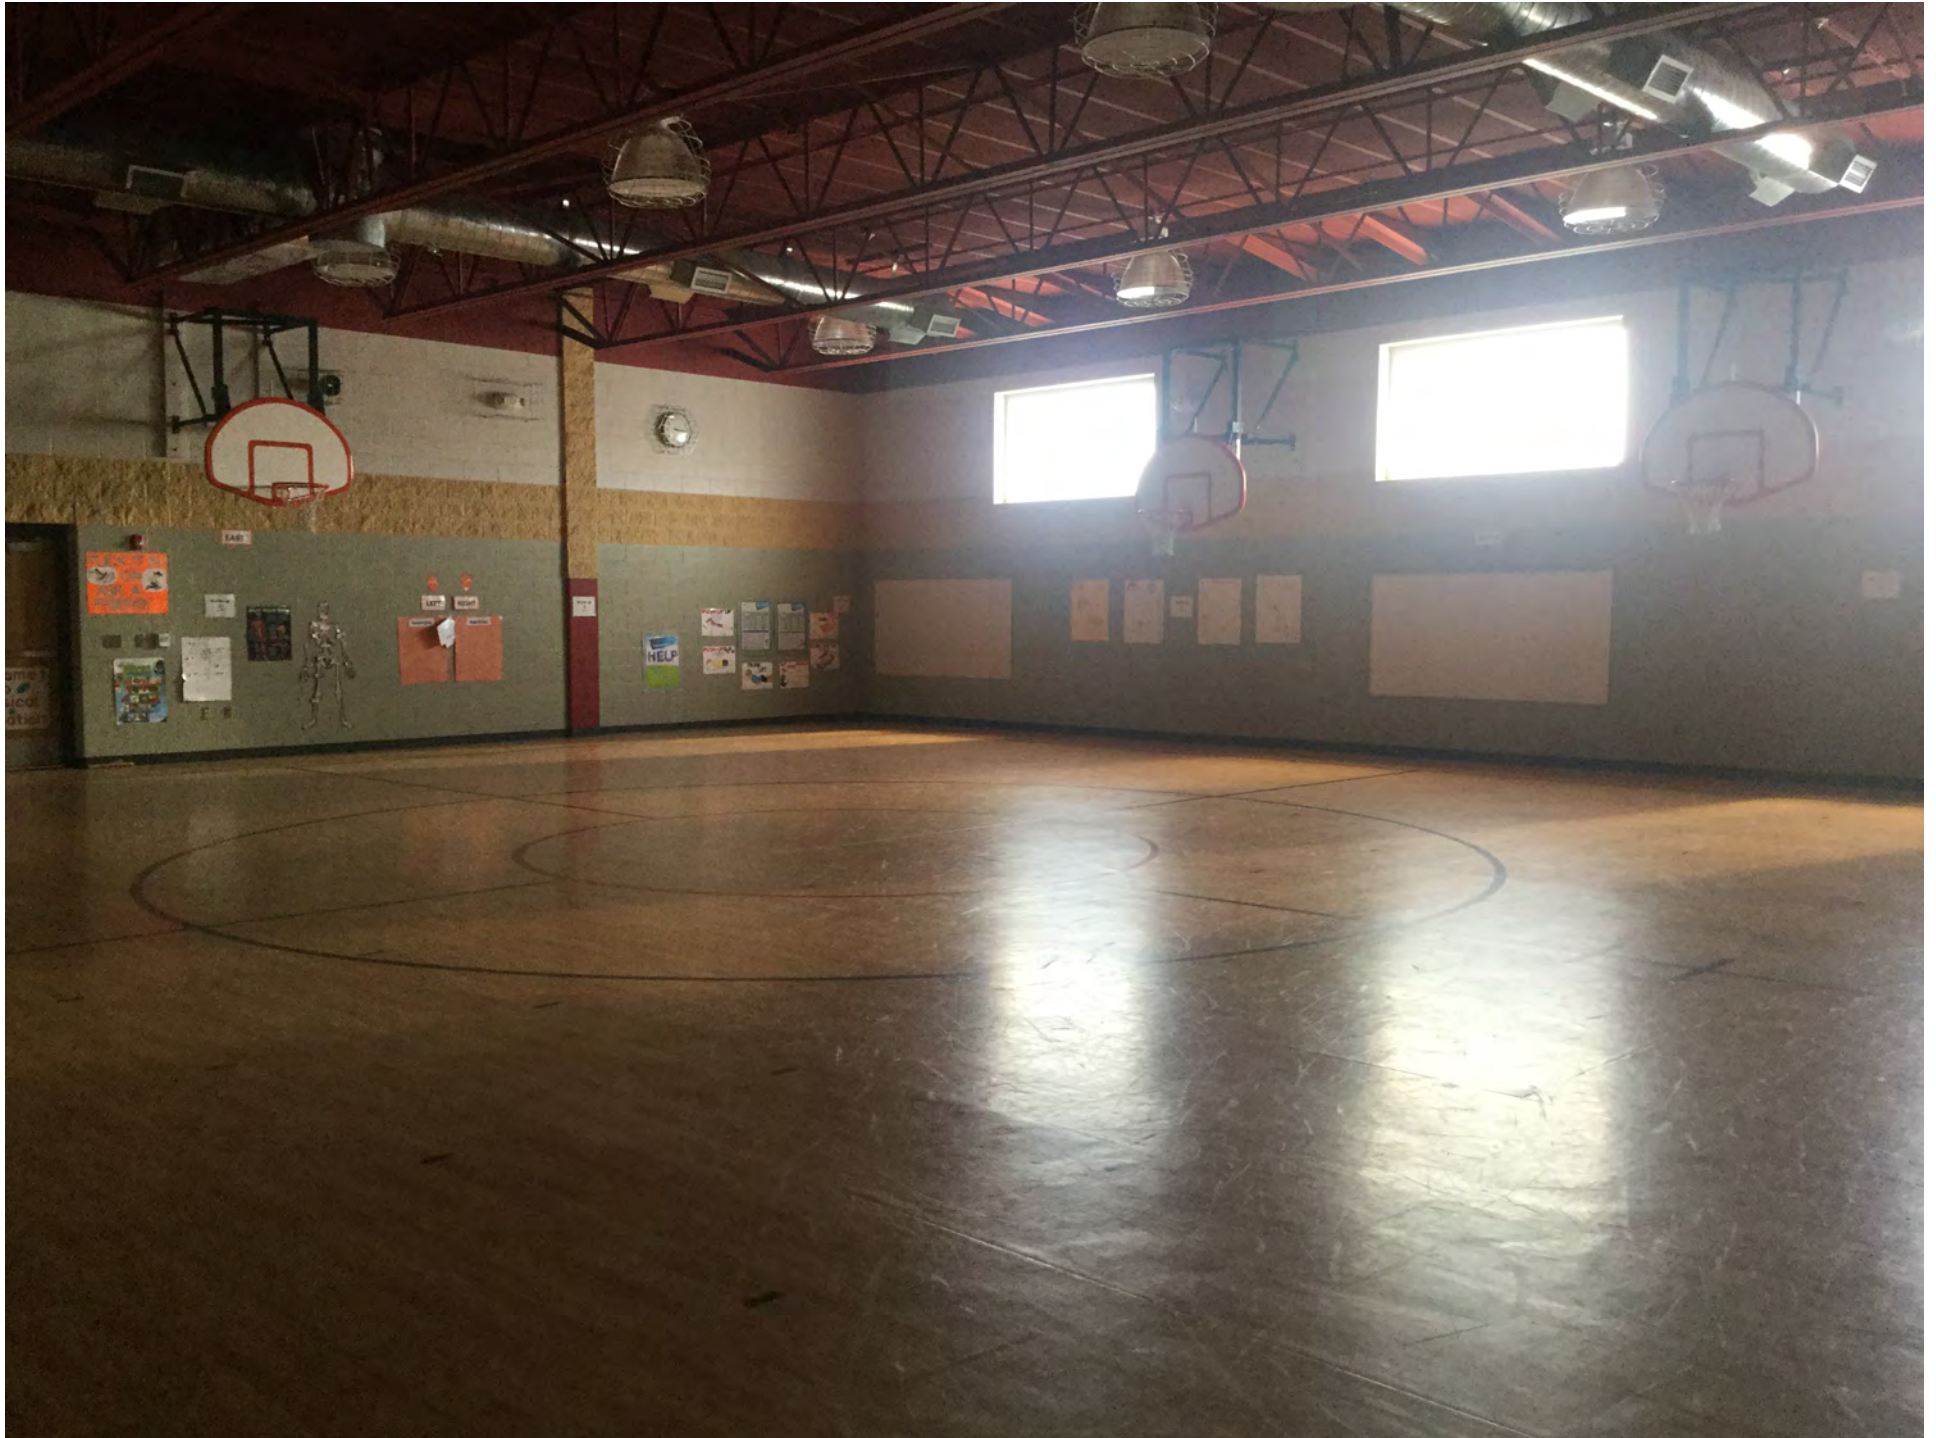
Photo 3.
3.6 Gym

1) Very unsatisfactory 2) Unsatisfactory 3) Average 4) Good 5) Very good N/A) Does not apply.								The gym floor is in poor condition.	see photo 3
3.7	Are Physical Education and Athletic support spaces appropriately configured per the ed spec?		2					Comments	1.002.00

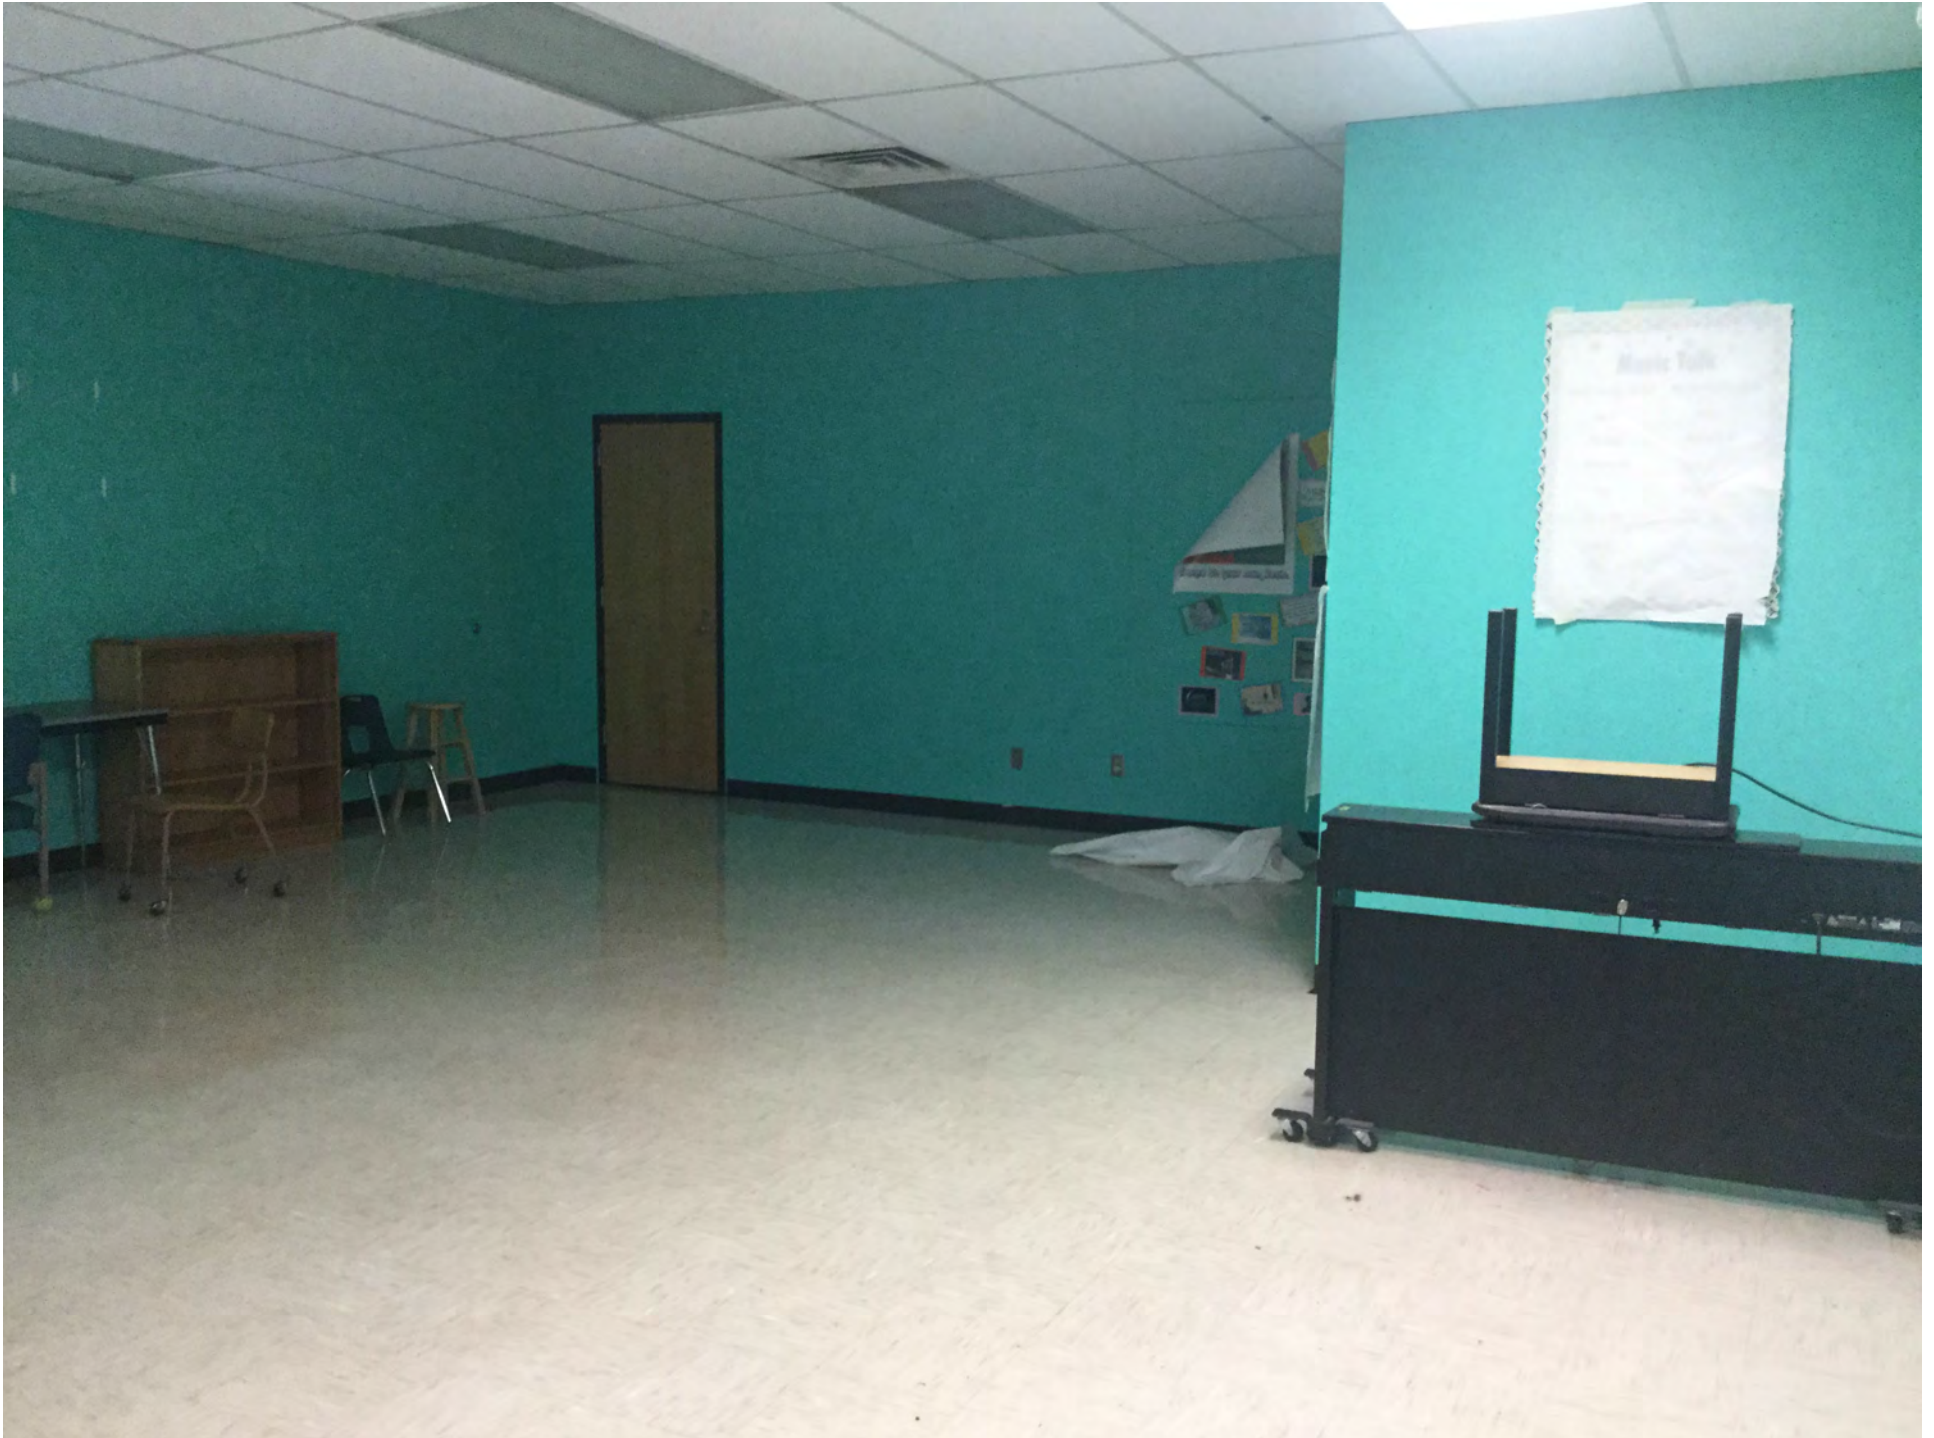
Photo 4.
3.8 Music Room

3.8	Are music, drama, or performance spaces appropriately configured per the ed spec?		2					Comments	1.002.00
1) Very unsatisfactory 2) Unsatisfactory 3) Average 4) Good 5) Very good N/A) Does not apply.								The stage is being used as storage and the music room is slightly undersized per the ed spec.	see photo 4

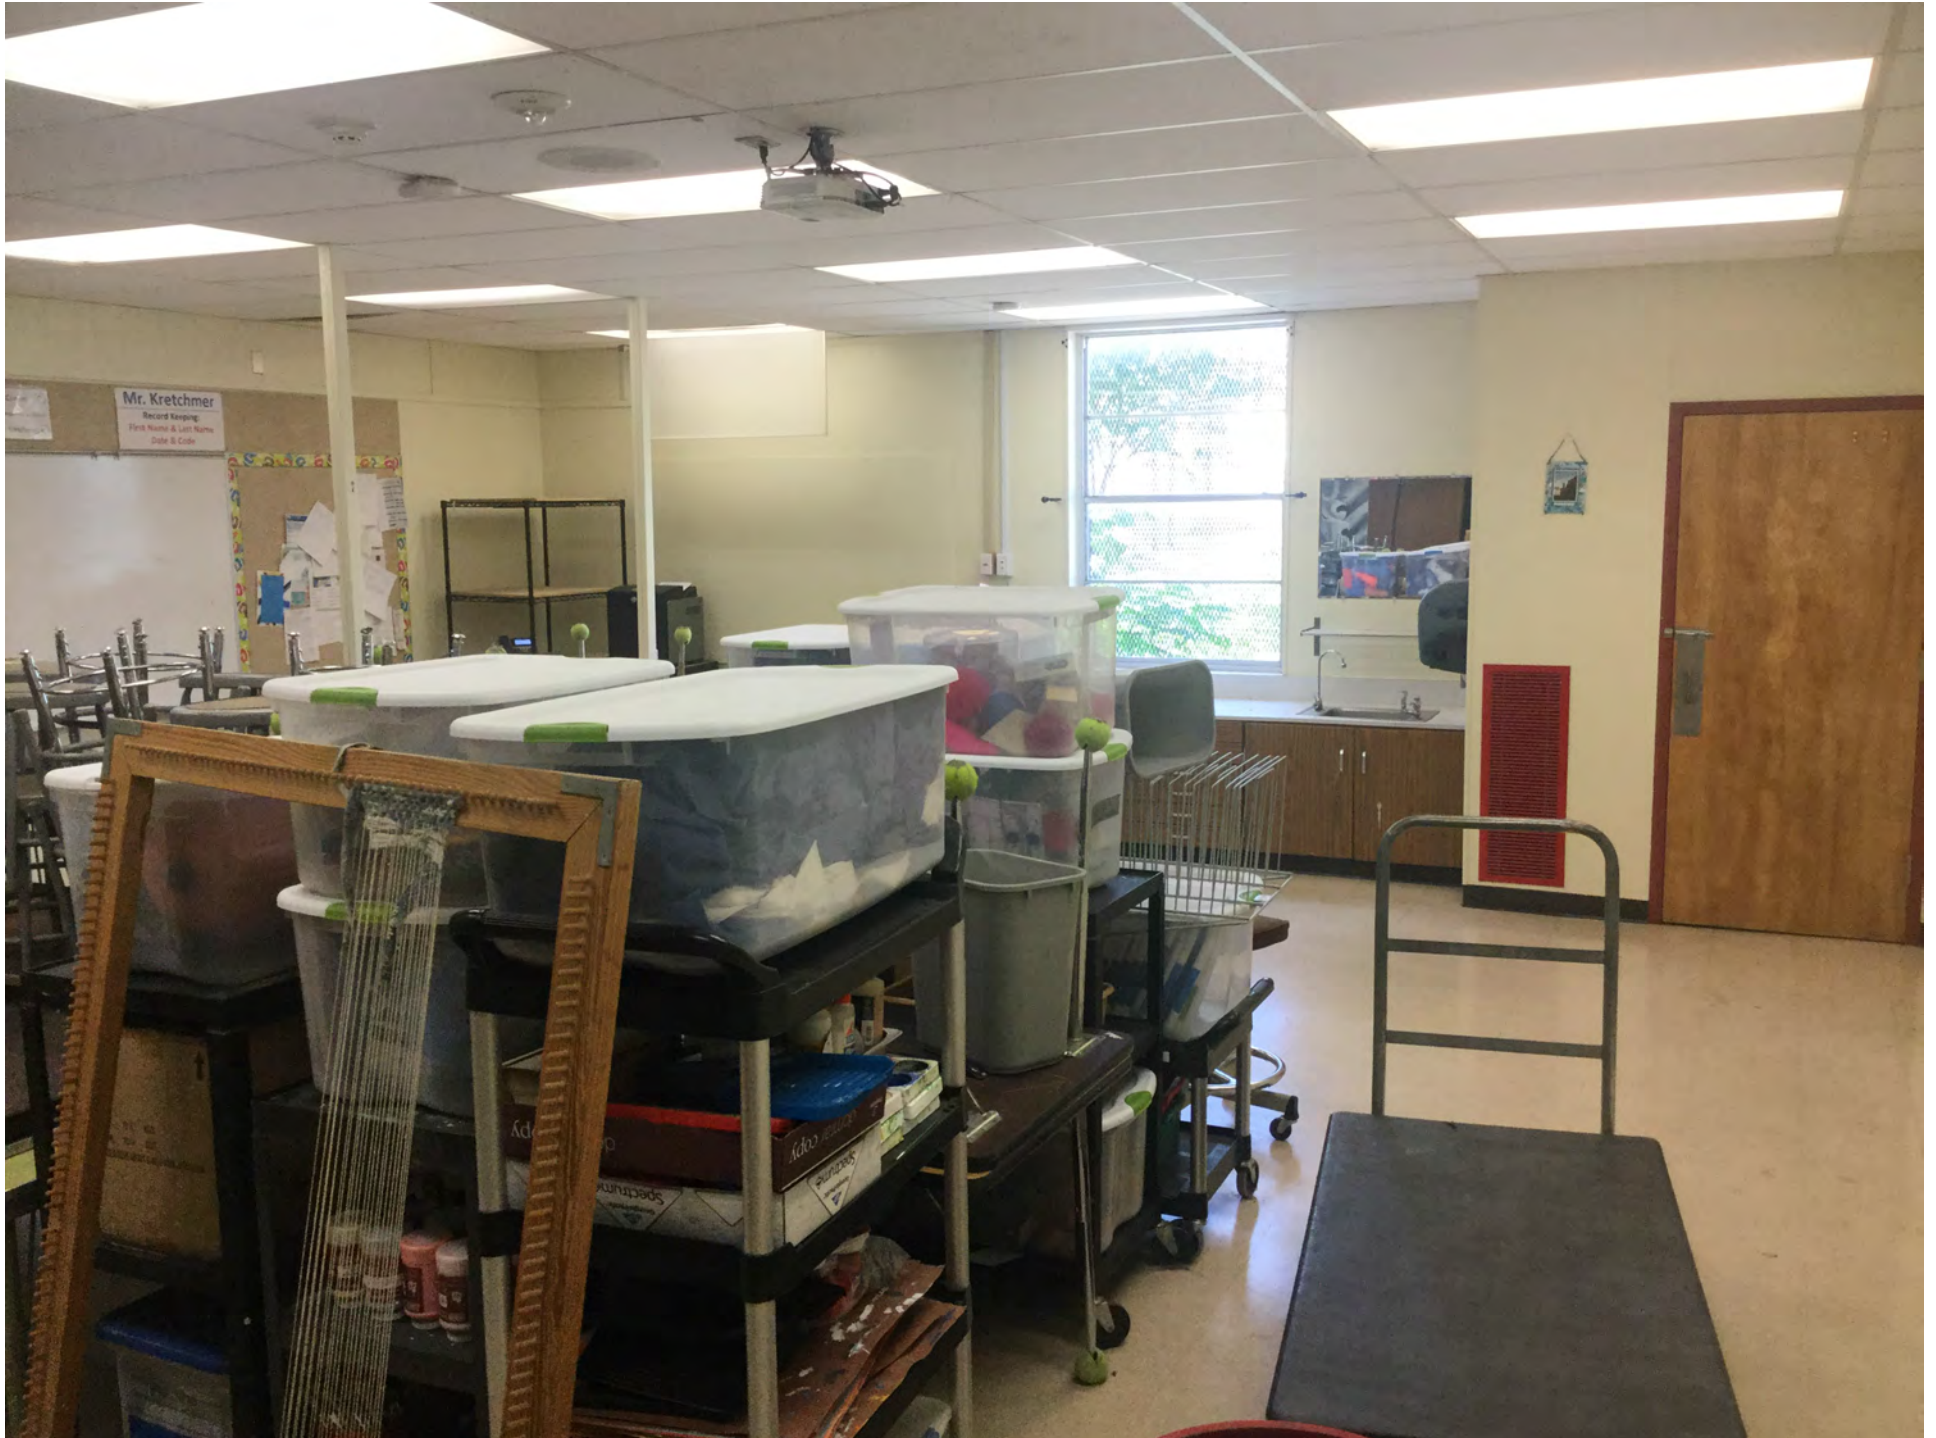
Photo 5.
3.10 Art Room

3 - Academic & Co-Curricular Support - Continued		1	2	3	4	5	N/A		
3.10	Are Visual Arts spaces appropriately configured per the ed spec?			3				Comments	1.00 3.00

1) Very unsatisfactory - Support spaces are disconnected from served spaces, too small, do not meet needs 2) Unsatisfactory - Support spaces are connected, but too small, inadequate for needs 3) Average - Connected, moderate size, but need some renovations or updates to function well 4) Good - Connected, good size/layout, meets needs/functions well 5) Very good - connected, generous size, nice condition, functions appropriately N/A) Does not apply.								There is no kiln in the art room and the storage space is lacking.

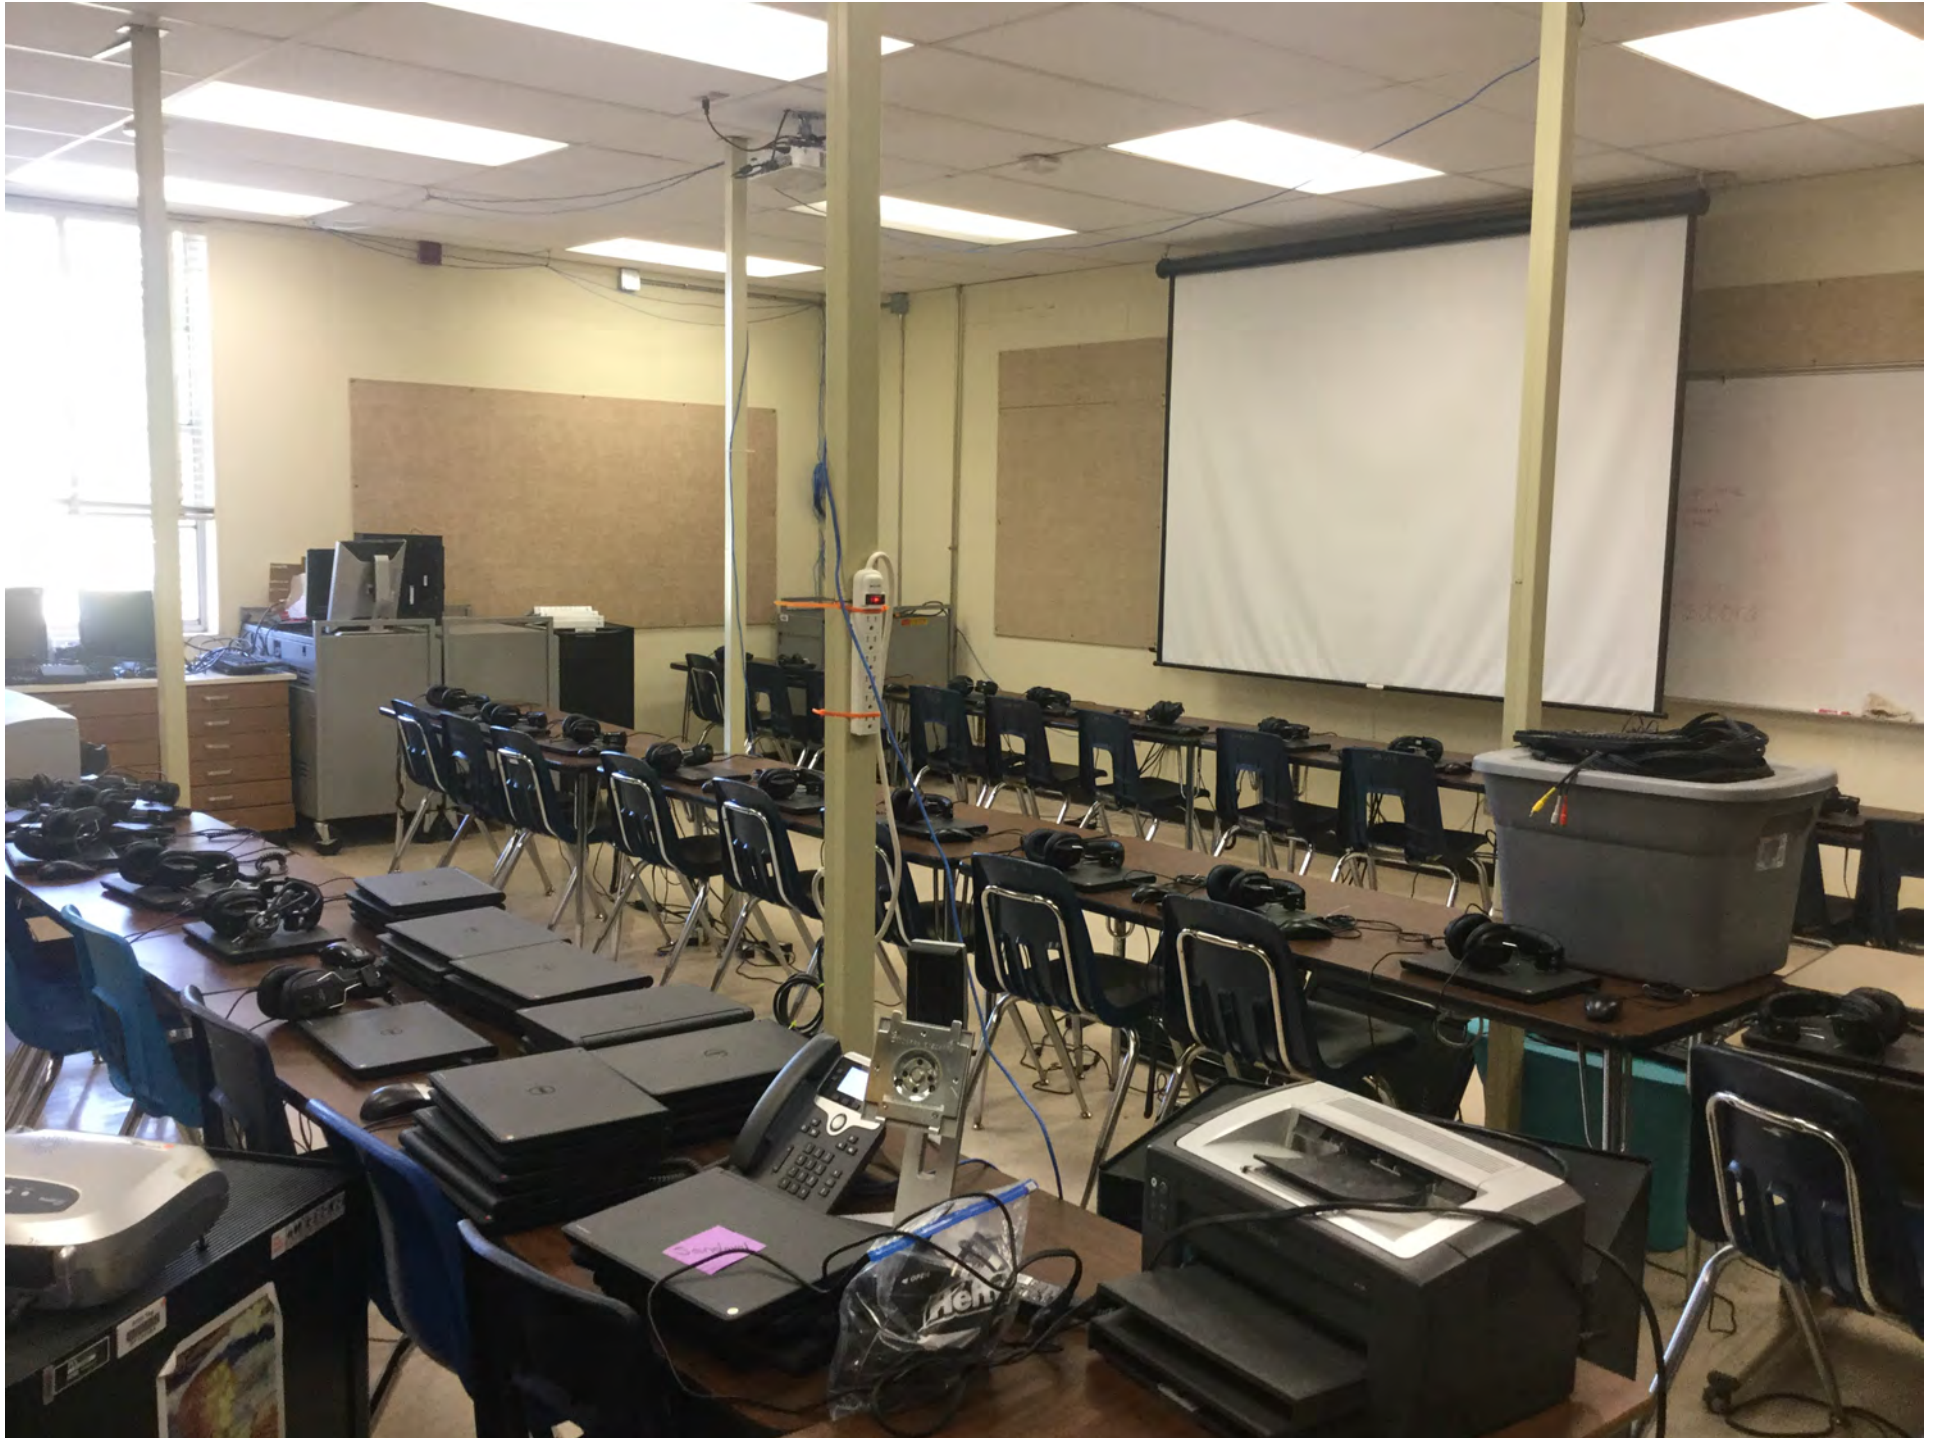
Photo 6.
3.12 Computer Lab

3.12	Are computer lab spaces appropriately configured?				4			Comments	1.00 4.00
1) Very unsatisfactory 2) Unsatisfactory 3) Average 4) Good 5) Very good N/A) Does not apply.								Space is crowded for the size of the campus enrollment.

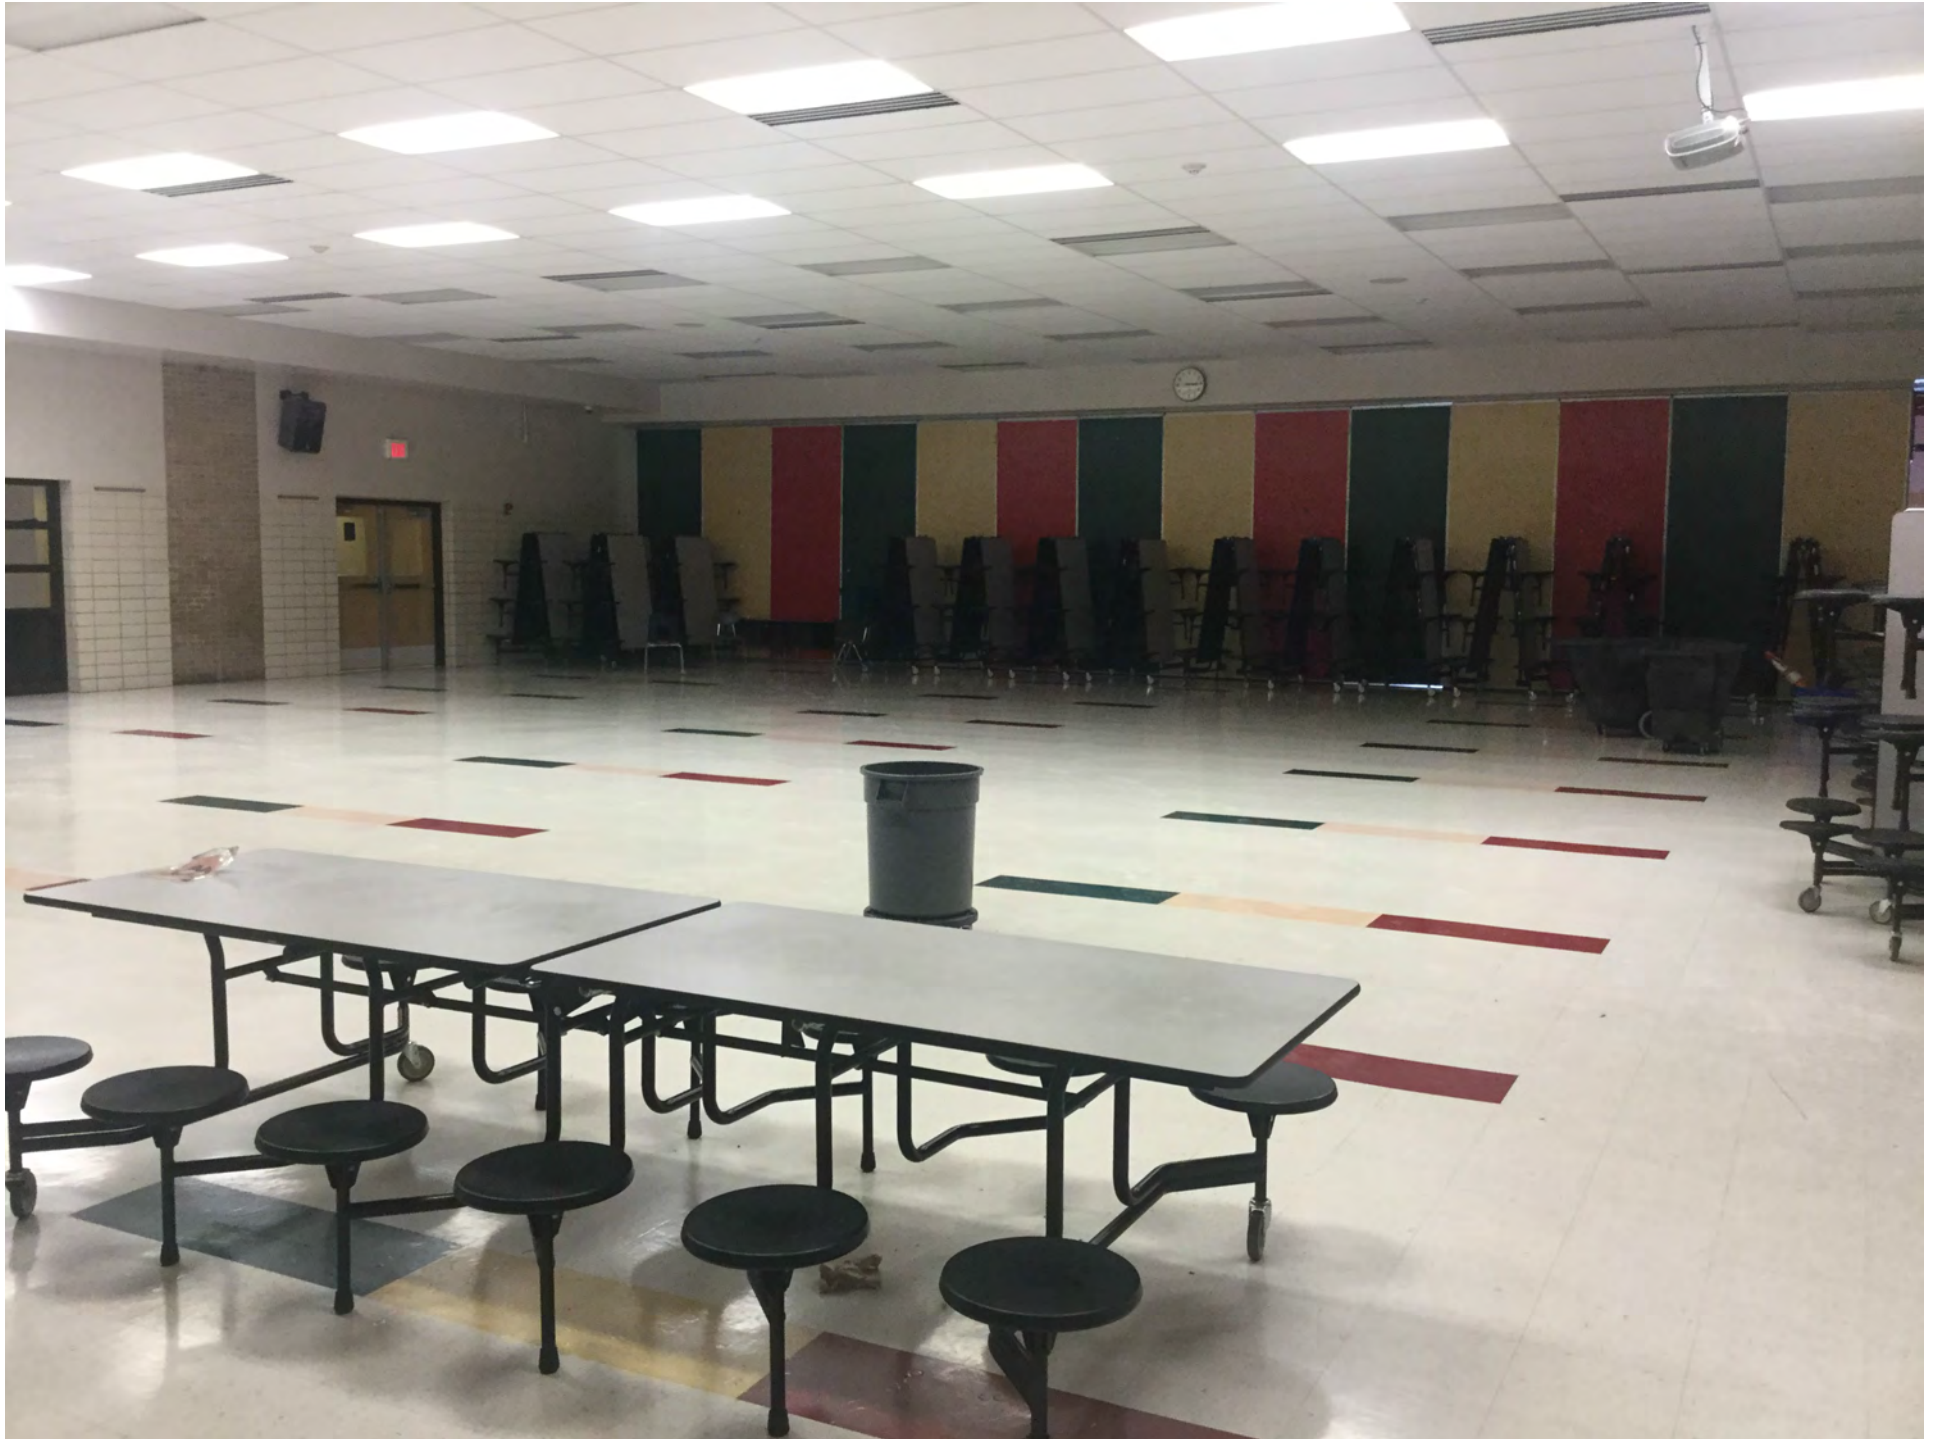
Photo 7.
3.16 Dining Facility

3.16	Are the student dining facilities appropriately configured?				4			Comments	1.00 4.00
							1) Very unsatisfactory - Too small, poor circulation, inflexible seating in poor condition 2) Unsatisfactory - Too small or inadequate circulation, seating in poor condition 3) Average - moderate size, with adequate circulation, seating in okay condition 4) Good - good size, adequate circulation, seating in good condition 5) Very good - good size, adequate circulation, seating in good condition, with more than one option for eating space (ex: connection to outdoor eating space) N/A) Does not apply.		see photo 7
