Educational Suitability Summary Report

Graham Elementary School

Date: 07/21/2016

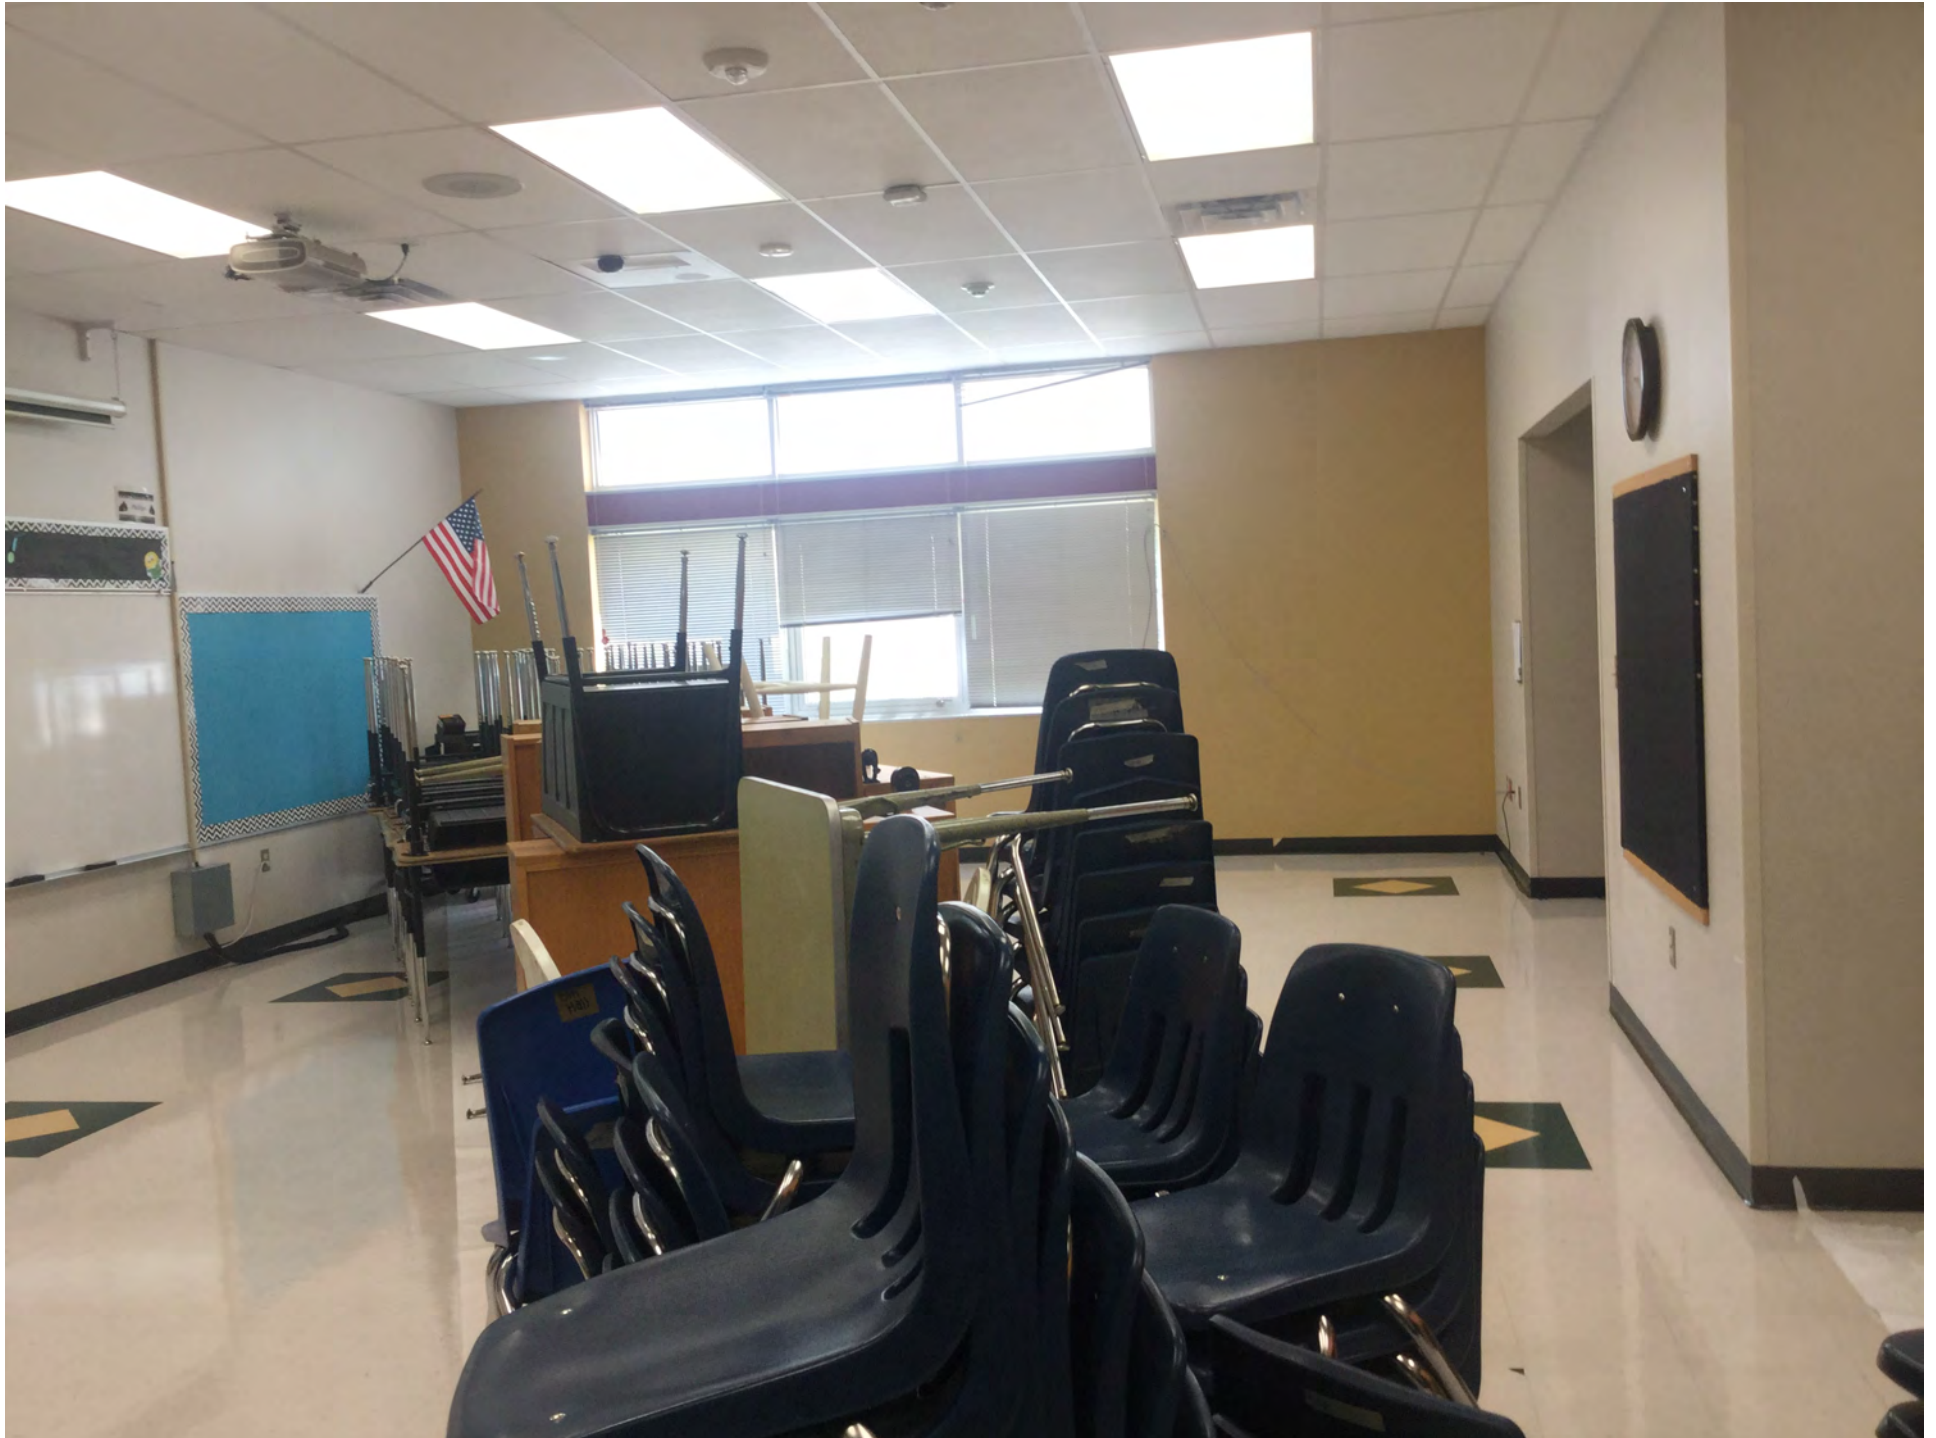
Photo 8.
4.2 Standard Classroom

4.2	Are general classrooms large enough to support project-based learning and multiple teaching modalities?			3				Comments	1.00 3.00
1) Very unsatisfactory -too small to move, set for lecture only, no connectivity, no flexibility 2) Unsatisfactory - adequate size but set for lecture only, no connectivity, no flexibility 3) Neutral - have flexibility and space for hands on or project based learning 4) Satisfactory - have flexibility and space for hands on or project based learning and connectivity for global learning 5) Very Satisfactory - space for hands on learning, flexibility for different groupings, and connectivity for global classrooms N/A) Does not apply.								The main building spaces are inadequate, but the new addition's spaces are in excellent condition and well equipped.	
								see photo 8

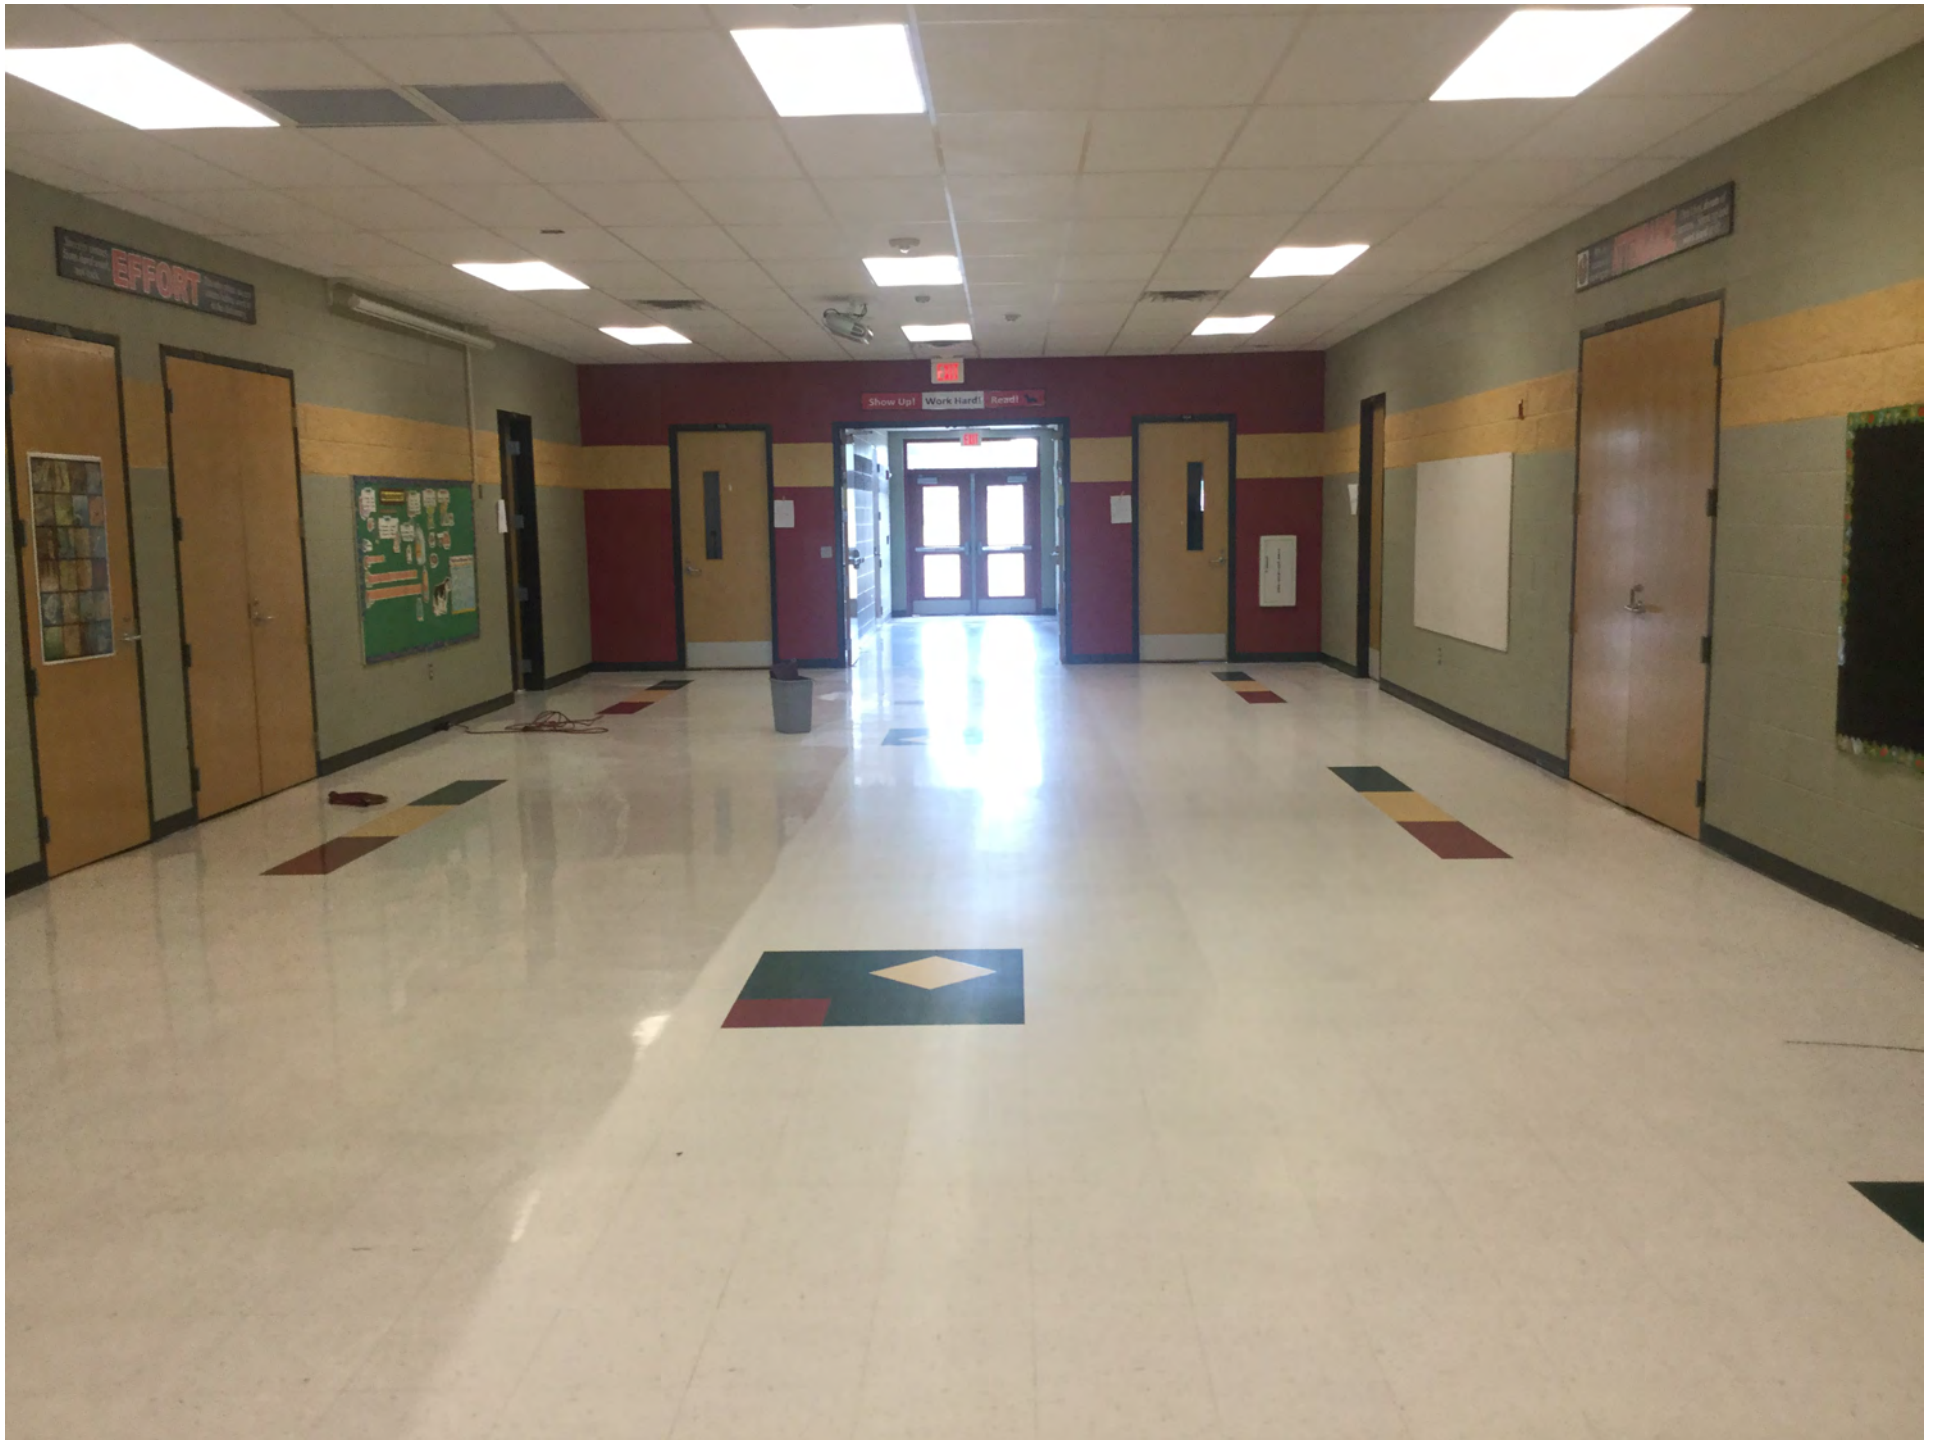
Photo 9.
4.5 Collaborative Space

1) Very unsatisfactory - no common spaces or meeting rooms or in very poor condition 2) Unsatisfactory - a few common spaces or meeting rooms in unsatisfactory condition 3) Average - a few common spaces and meeting areas needing updates 4) Good - multiple common spaces and meeting rooms in good condition 5) Very good - adequate common spaces and meeting rooms of excellent quality N/A) Does not apply.								see photo 9

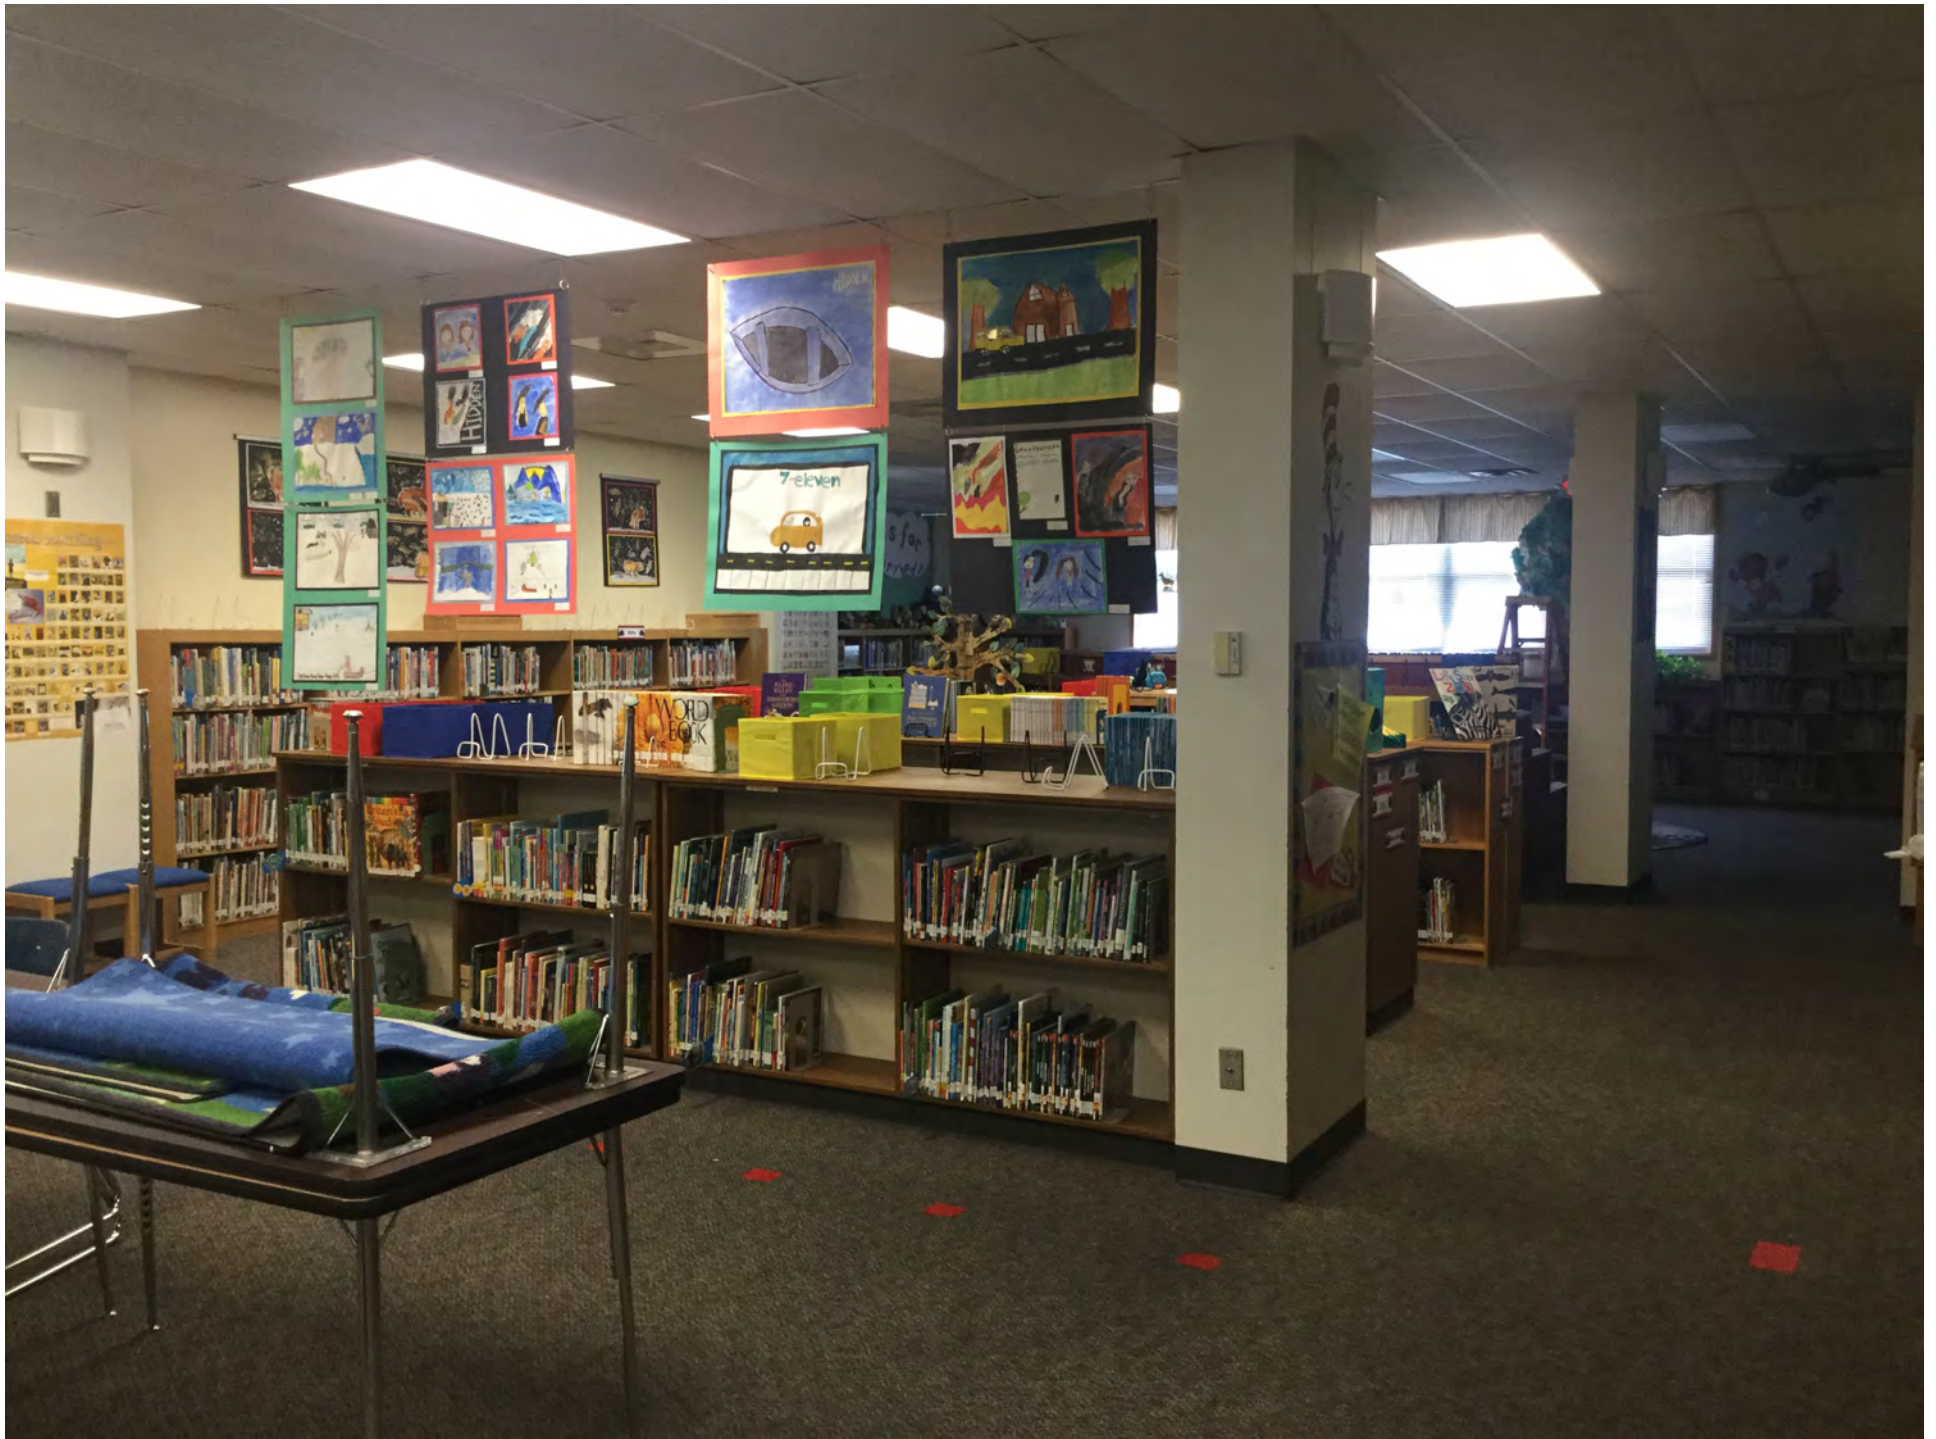
Photo 10.
5.5 Library

1) Very unsatisfactory 2) Unsatisfactory 3) Average 4) Good 5) Very good N/A) Does not apply.							The library is limited in size for large group collaborations.		
							see photo 10
